Facilities Condition Assessment Program

Project Review

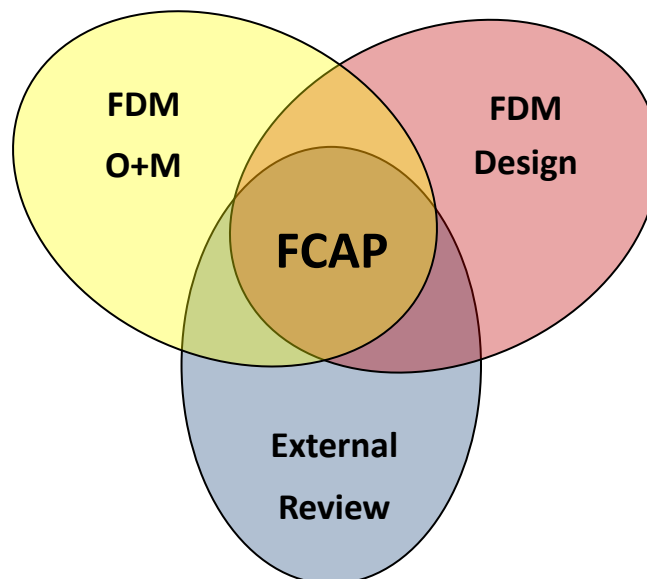
The program is anchored on thorough evaluations at each complex (facility) evaluated and inspected. The information is incorporated into complex specific reports. The individual reports are updated on an annual basis to keep the data accurate.

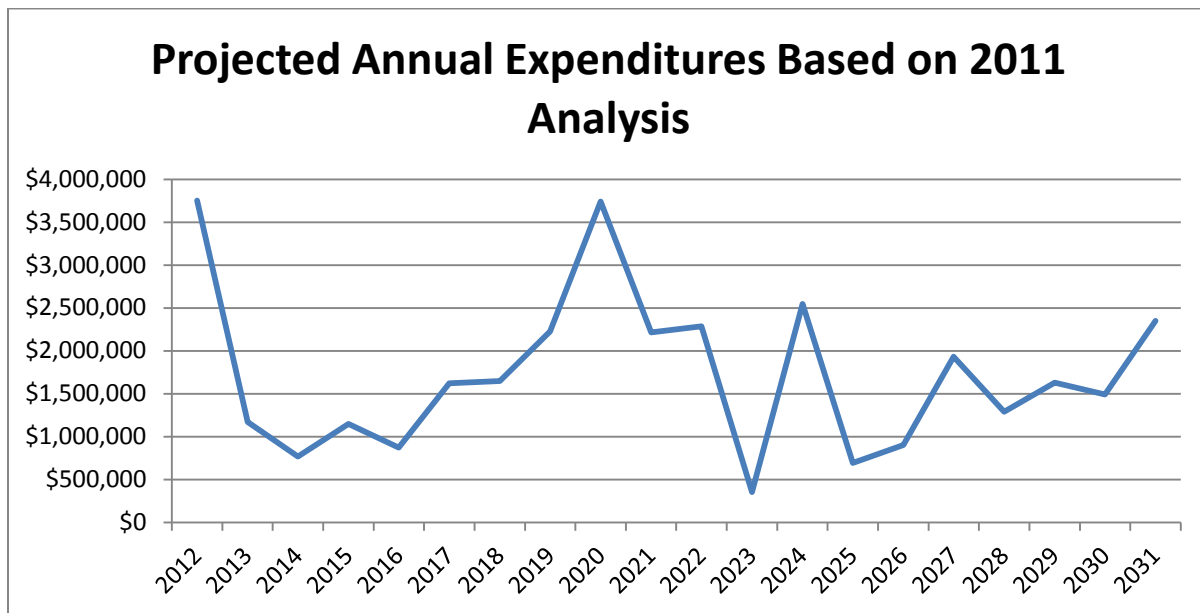
The initial condition assessment of these complexes reveals approximately \$3,750,000 in CRDM and varying annual expenditures thereafter.

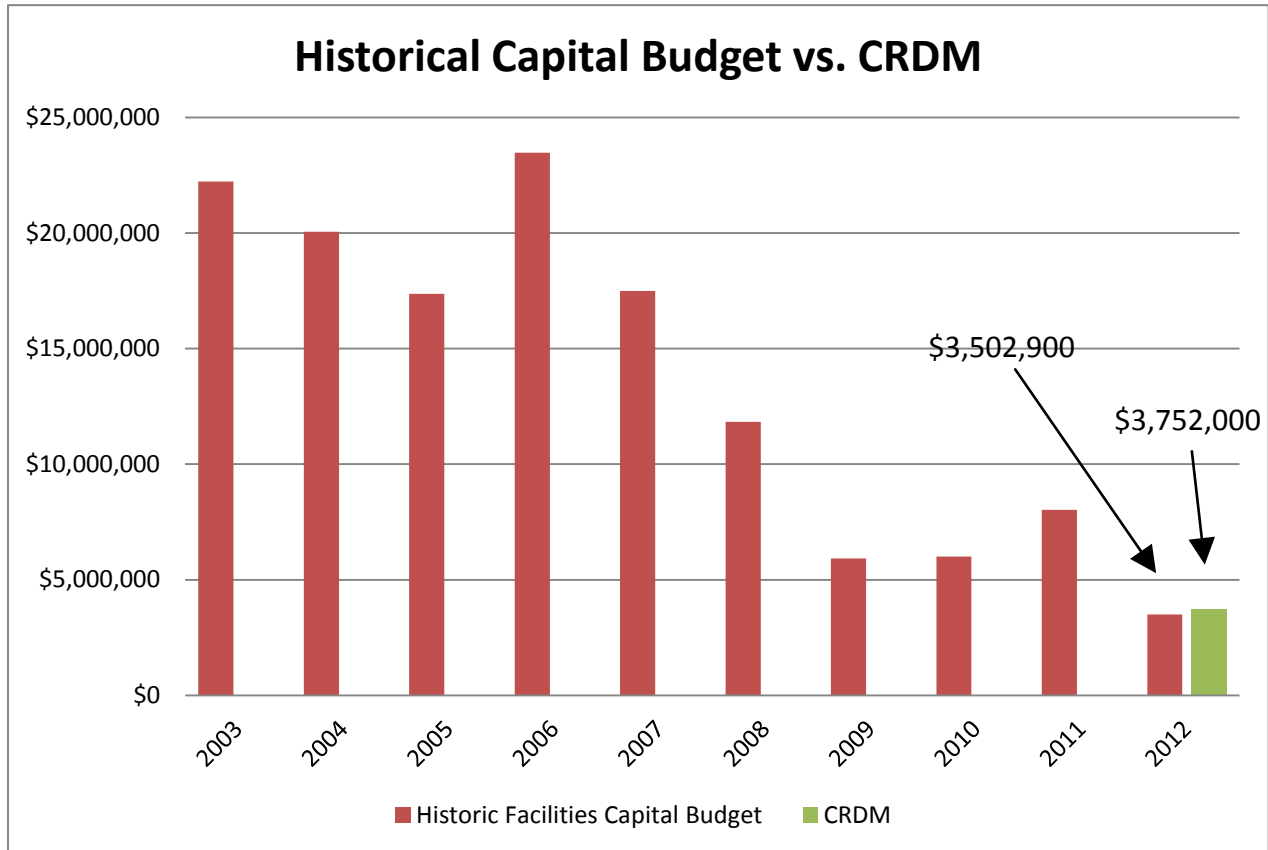
The CRDM is expected to increase once the remaining 91% of facilities are added to the FCAP combined portfolio. A complete portfolio is anticipated in 2013.

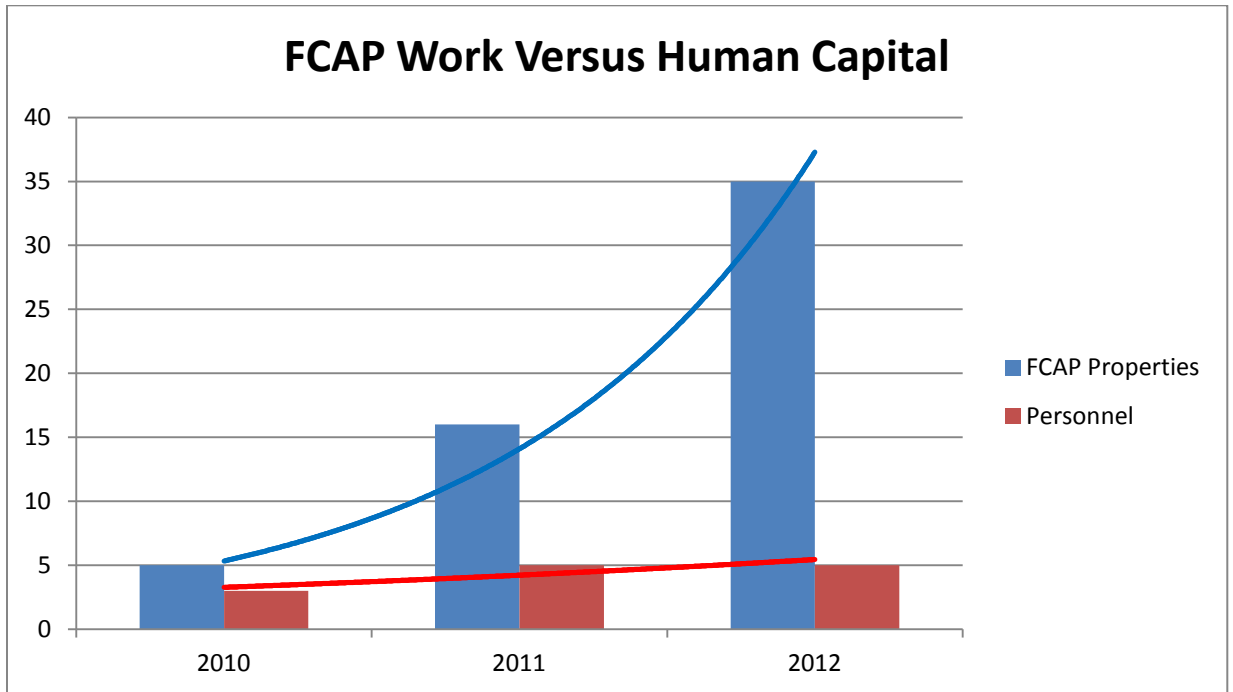
- Does the City of Milwaukee have the staff to sustain excellence? The following graph depicts the FCAP program expansion in one year. 2012 is an estimated amount of FCAP reports based on expected projects.

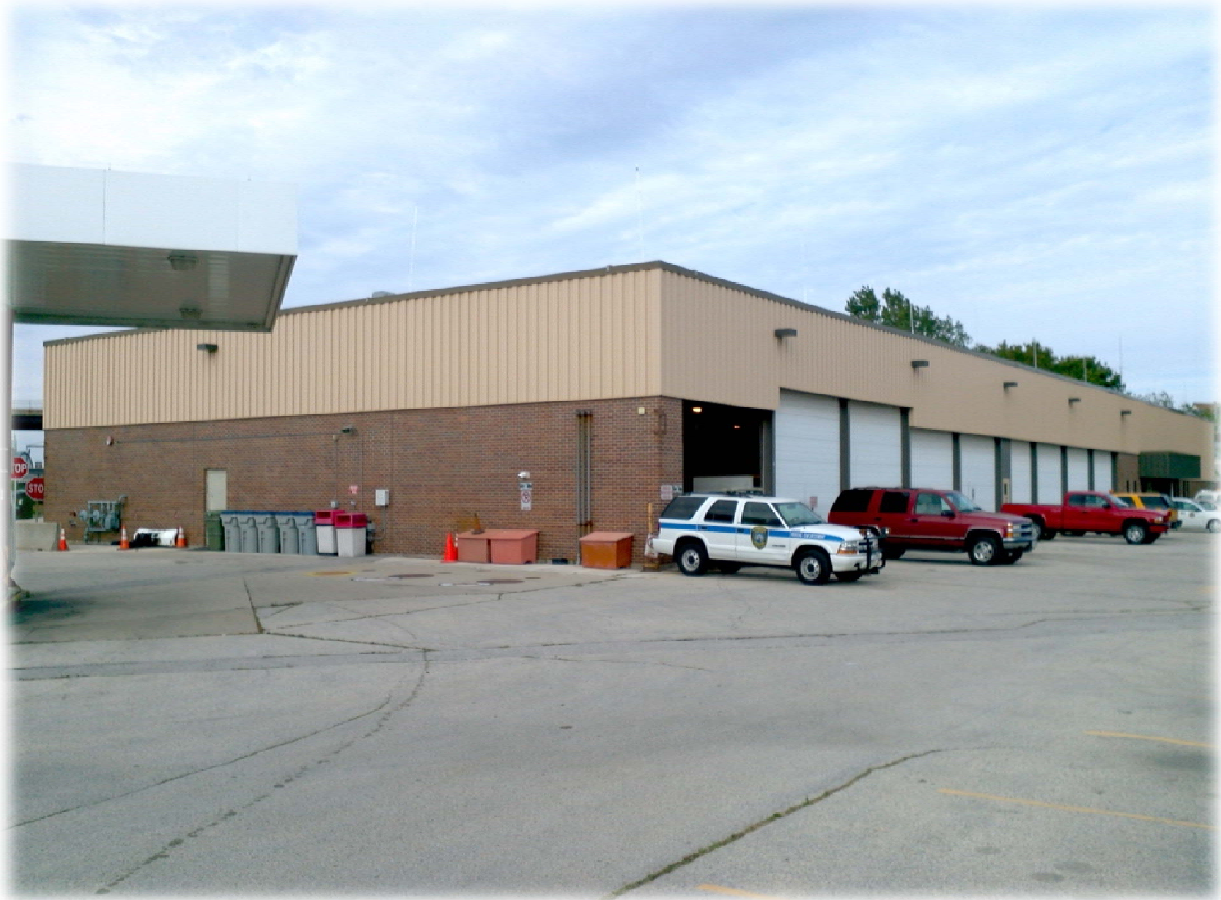
FACILITIES
CONDITION
ASSESSMENT
PROGRAM

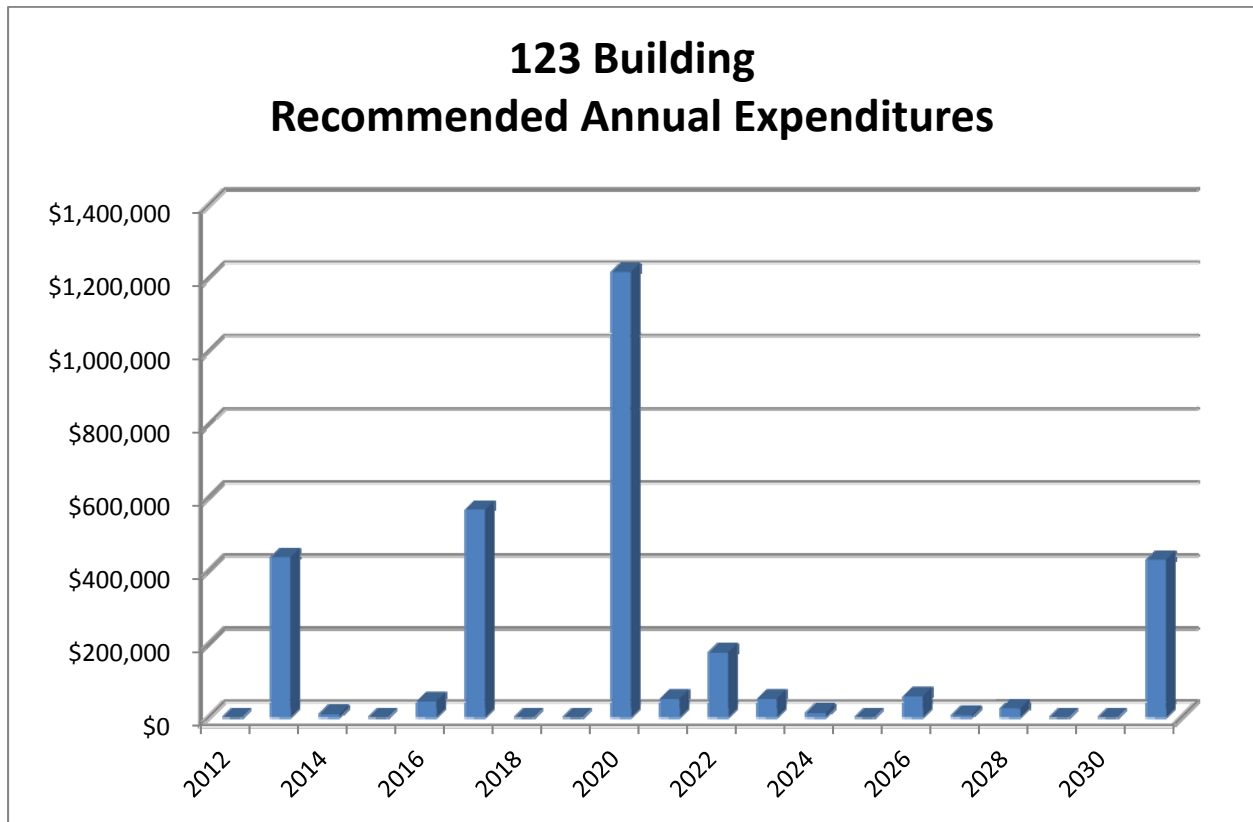
The most significant category of 123 Building expenditures pertains to building envelope repairs as shown below. Building envelope roof repairs is the most significant single component.

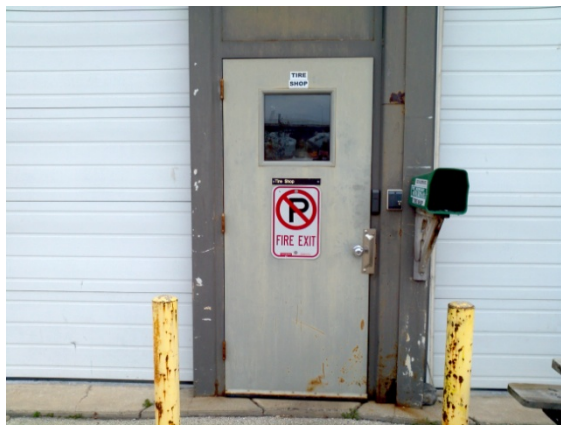
Metal door with rust

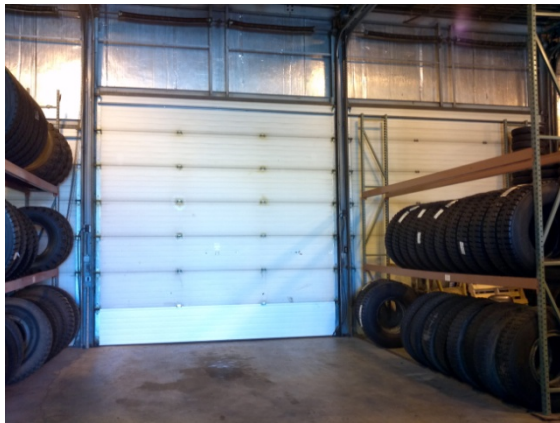
Garage door with replaced lower panel and rusted panel hinges

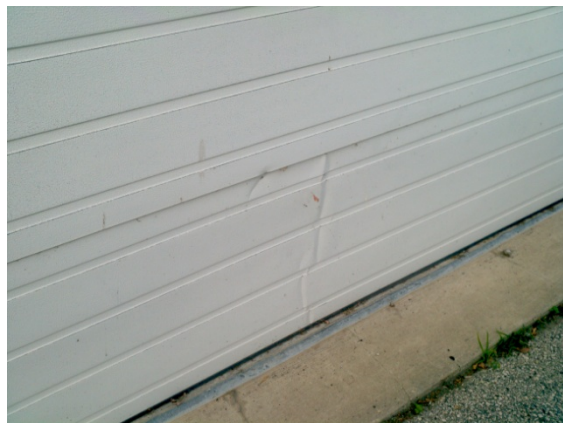
Damaged garage door – fund interim repairs from the operating budget

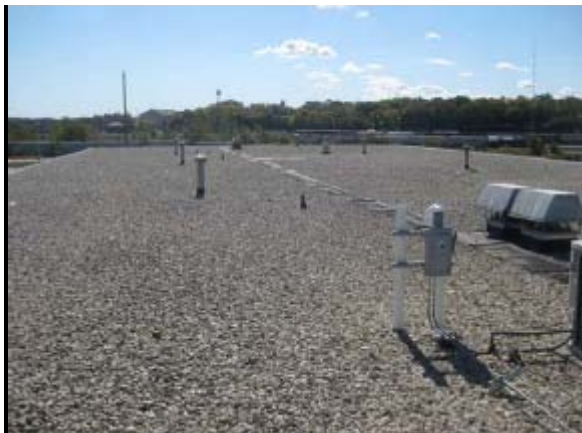
Inventory (SF)		Condition Rating	Age (Years)	RUL (Years)	1st Year of Capital Expenditure
#6 EPDM	2,052	2	20	0	2013

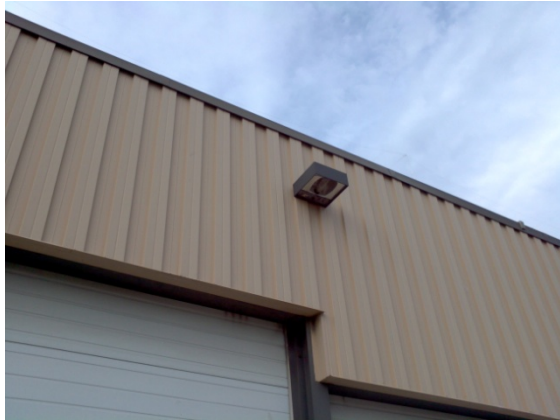
Wall mounted light fixture

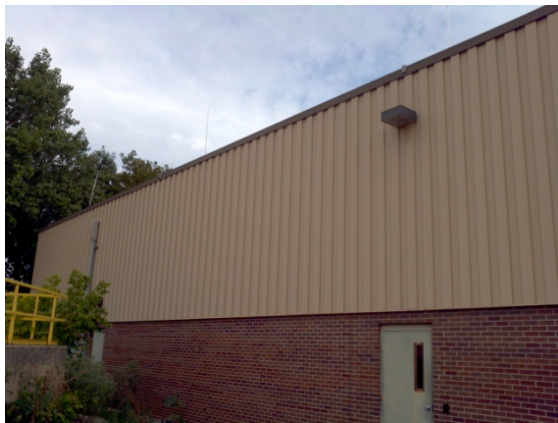
Inventory (SF)		Condition Rating	Age (Years)	RUL (Years)	1st Year of Capital Expenditure
Siding	6,920	6	23	10	2022

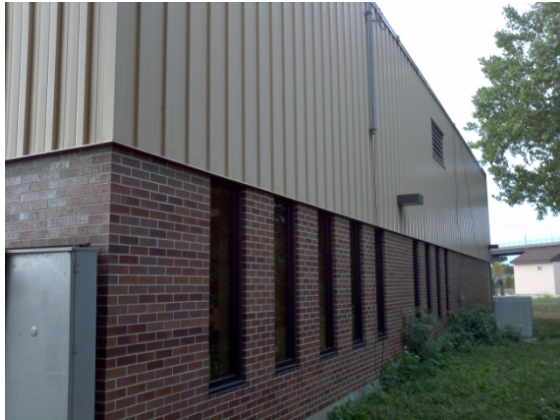
Typical aluminum frame windows at north elevation

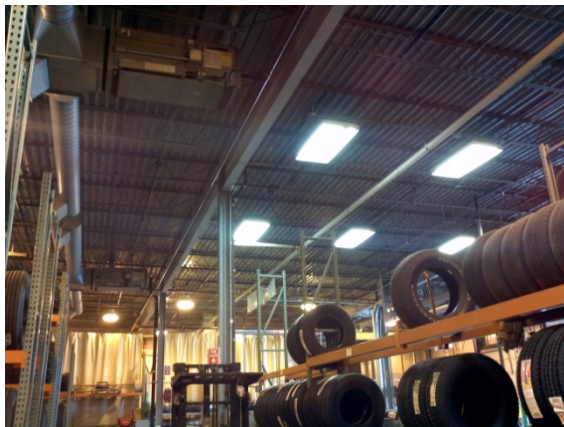
Garage light fixtures

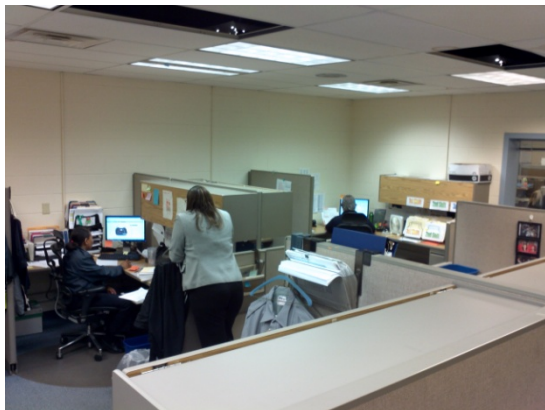
Typical equipment furniture in offices

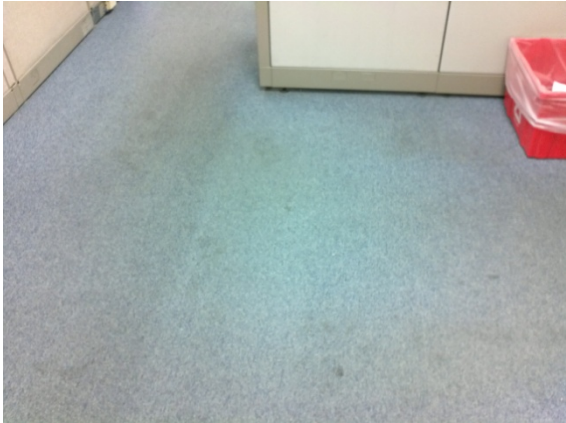
Inventory (EA)		Condition Rating	Age (Years)	RUL (Years)	1st Year of Capital Expenditure
Acoustic Tile Ceiling (SF)	3,242	6	9	8	2020
Painted Walls/Ceiling (SF)	5,084	6	9	8	2020
Carpet (SY)	215	6	9	8	2020
Vinyl Tile (SF)	1,146	6	9	8	2020
Light Fixtures, Fluorescent	77	6	9	8	2020
Drinking Fountain	1	6	9	8	2020

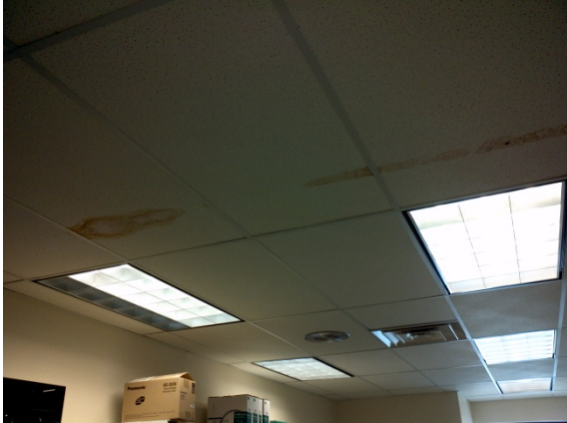
Stained acoustic tile ceiling panels

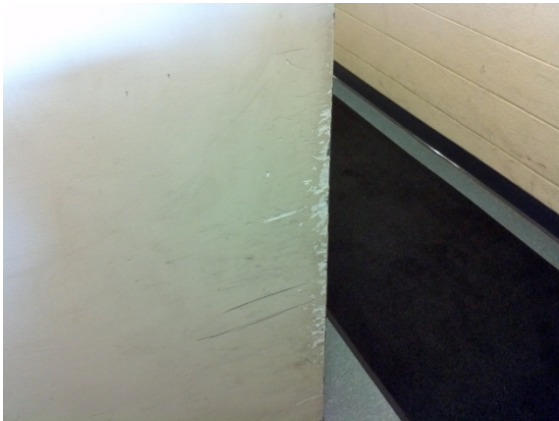
Damaged/begrimed wall finishes

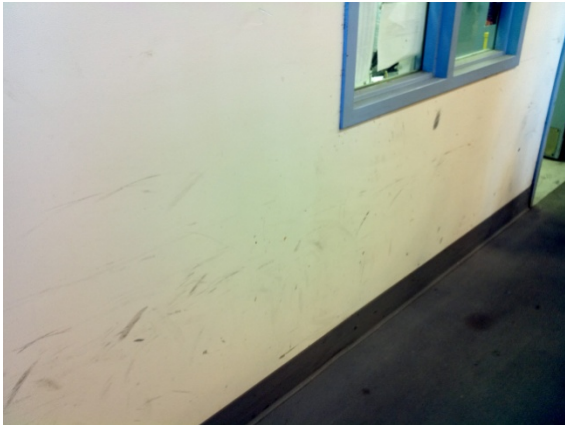
Begrimed wall surface in garage

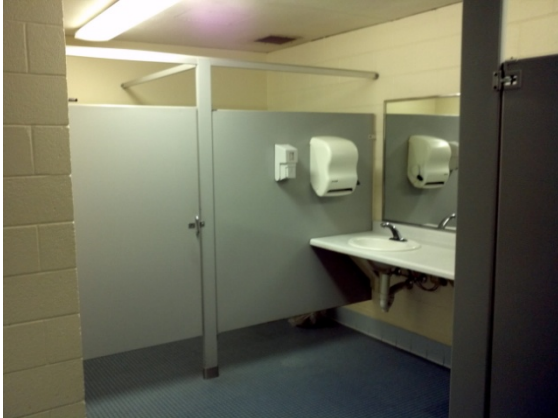
Women's rest room finishes

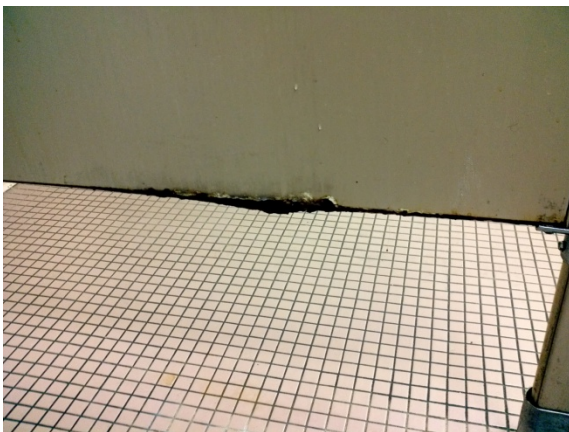
Men's partition w deterioration

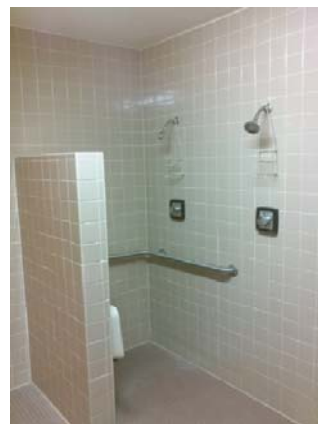
Men's shower finishes

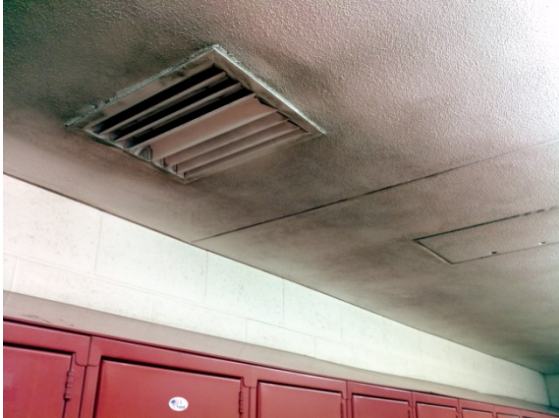
Men's rest room ceiling damage

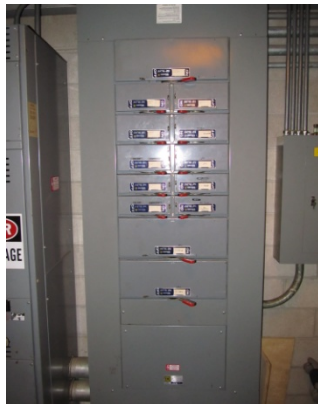
Secondary distribution

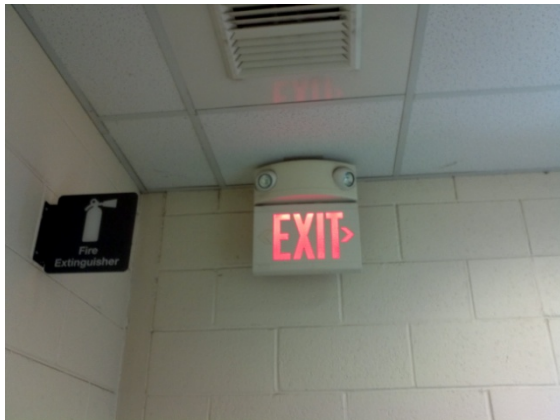
Emergency/Exit light fixture

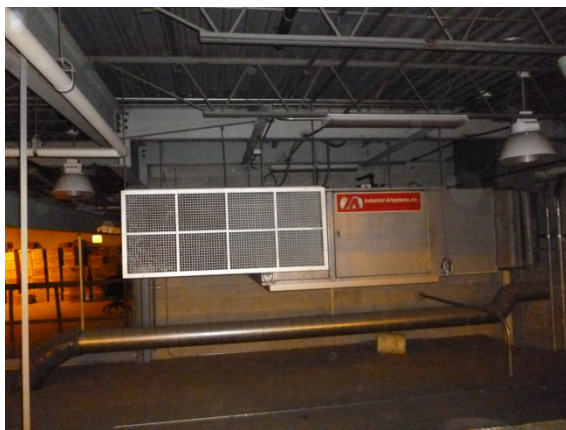
Inventory		Condition Rating	Age (Years)	RUL (Years)	1st Year of Capital Expenditure
MAU #1 - Mezzanine					
CFM	4,000	6	23	8	2020
Furnace (MBH)	500	6	23	8	2020
Motor (HP)	2	6	23	8	2020
MAU #2 – Mech. Room					
CFM	2,000	6	23	8	2020
Furnace (MBH)	250	6	23	8	2020
Motor (HP)	1	6	23	8	2020

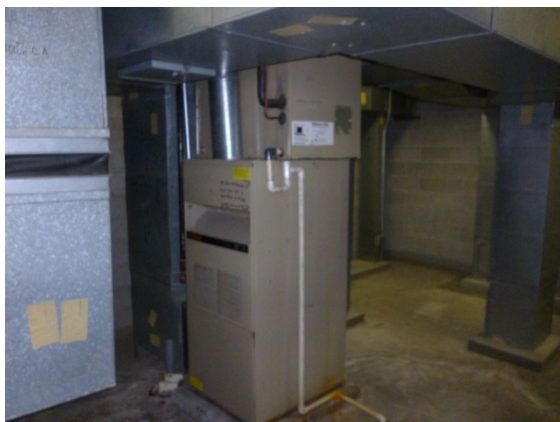
Interior forced air furnace

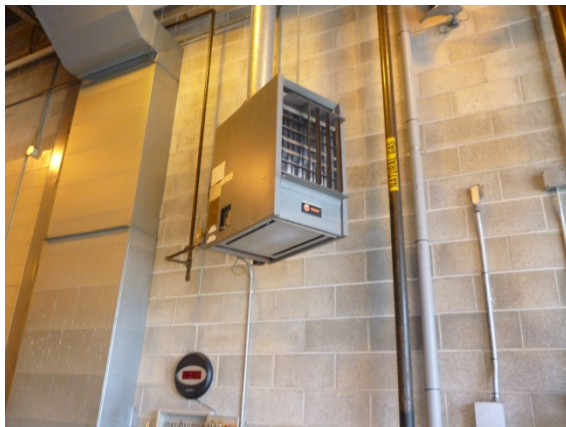
Inventory (EA)		Condition Rating	Age (Years)	RUL (Years)	1st Year of Capital Expenditure
Garage, 140MBH	6	7	24	8	2020
Garage, 100MBH	1	7	24	8	2020
2 nd Floor, Mech. Rm, 60MBH	1	7	24	8	2020
1 st Floor, Hallway, 20MBH	2	7	24	8	2020

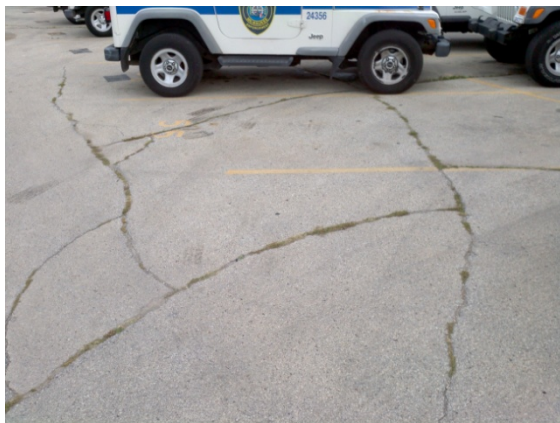
Typical cracked pavement at west lot

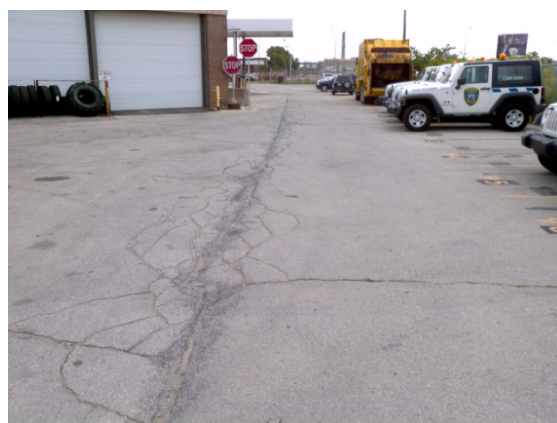
Failed pavement at west lot

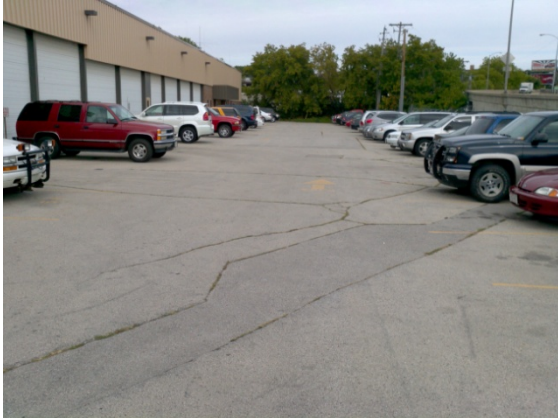
Cracked/Patched pavement at east lot

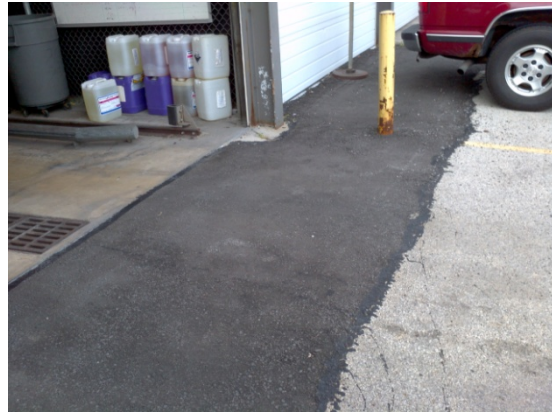
Pavement patch at garage/lot threshold

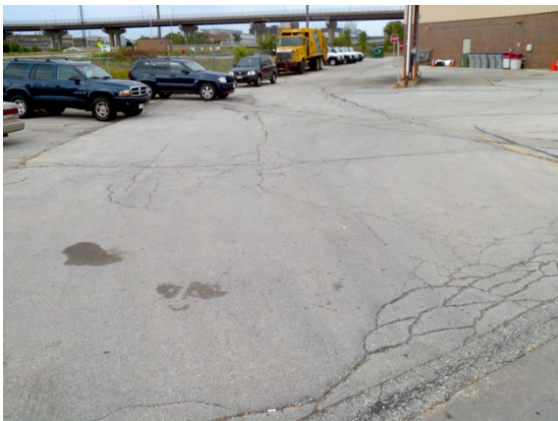
Cracked pavement at entrance

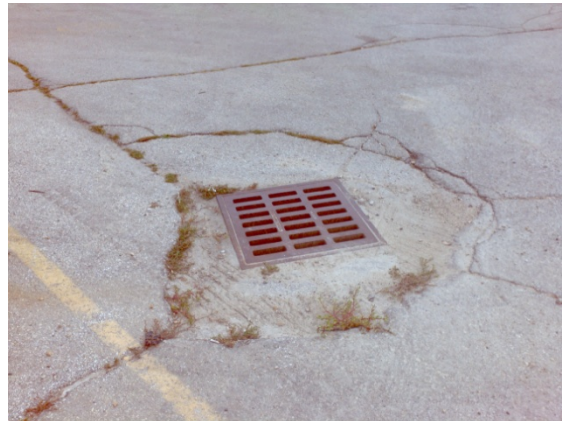
Catch basin with minor settlement

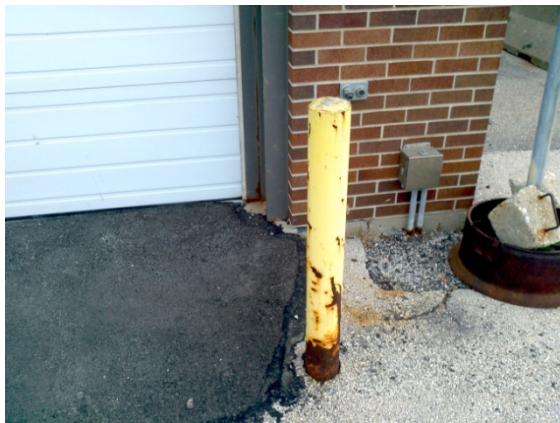
Typical rusted bollard

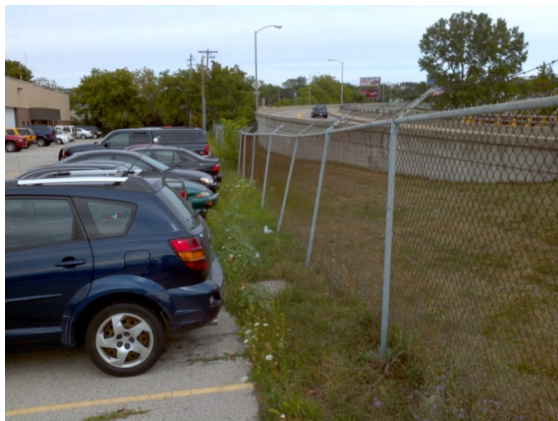
Rusted/Misaligned chain link fence

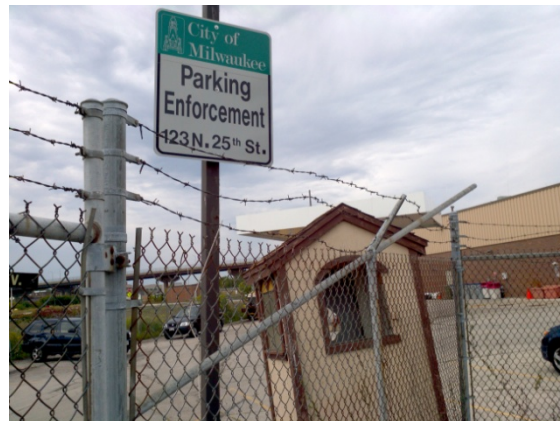
Damaged fence rail and barbed wire

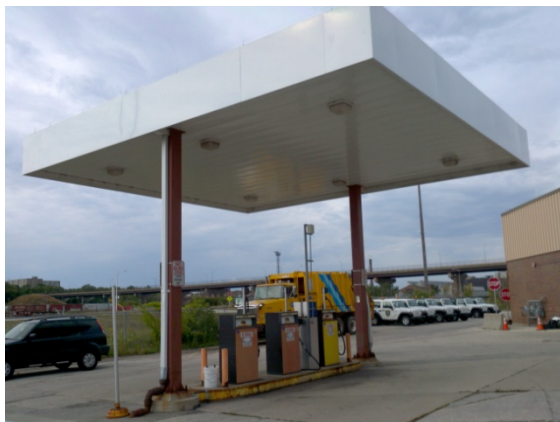
Fuel island and dispensers

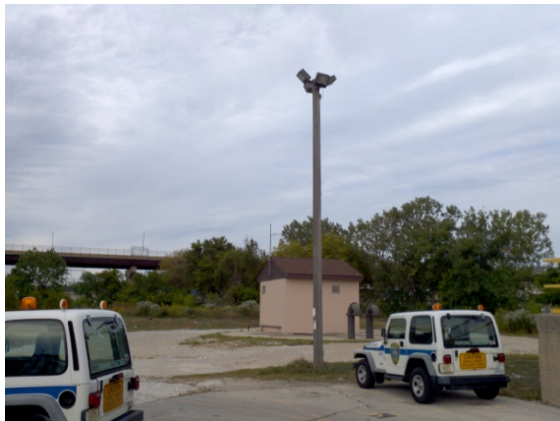
Light pole and fixture at west lot

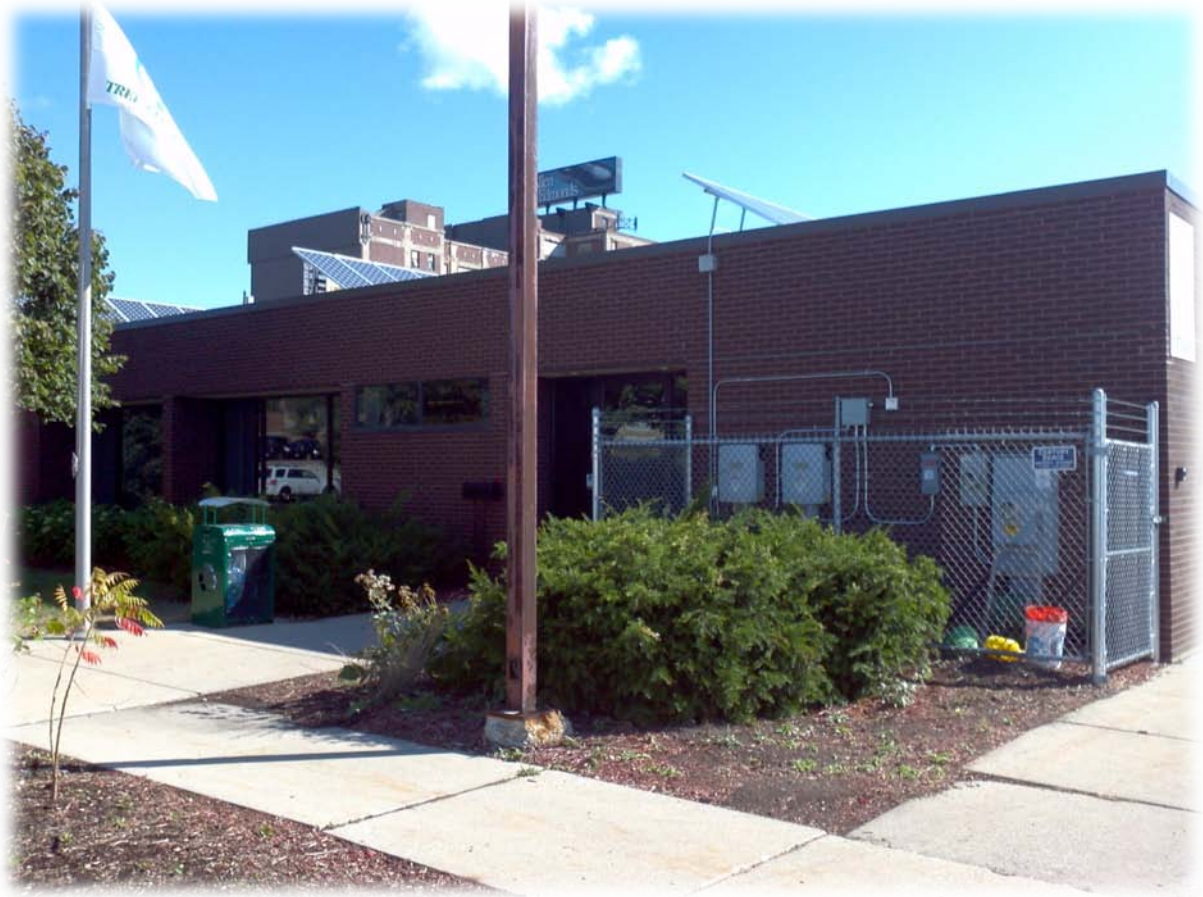
FACILITIES
CONDITION
ASSESSMENT
PROGRAM

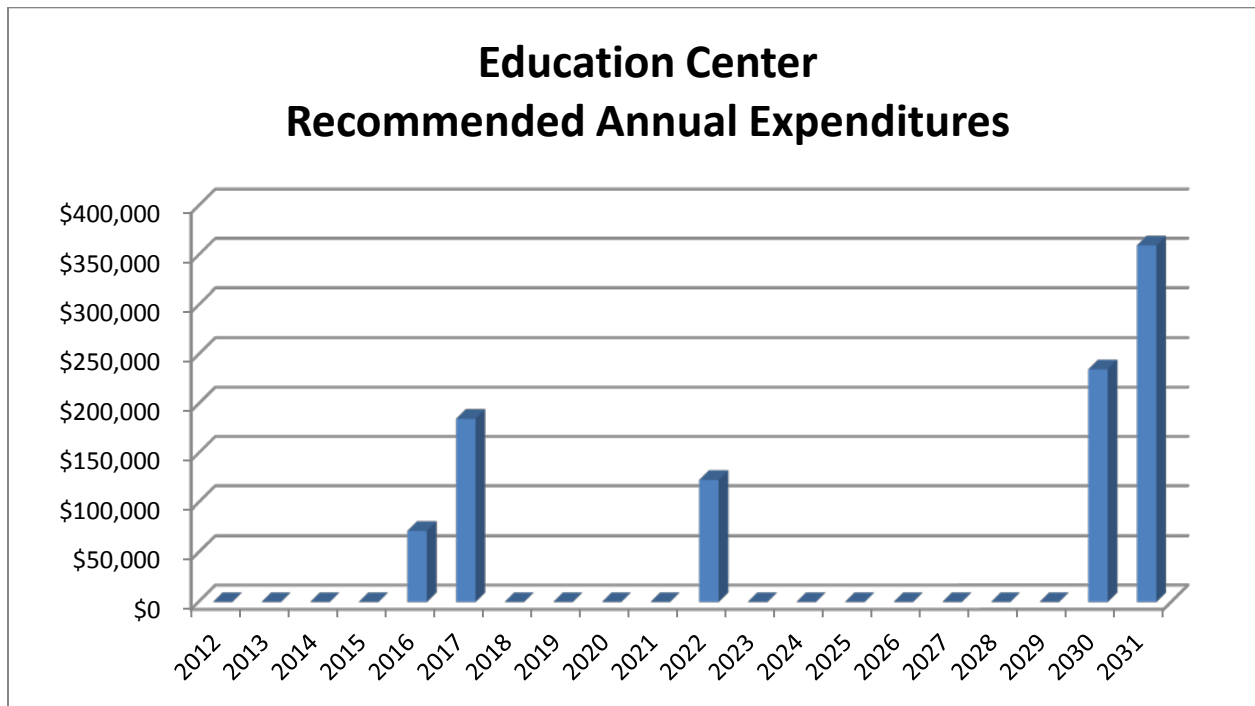
The most significant category of Education Center expenditures pertains to Building Control Components as shown below. The geothermal system is the most significant component.

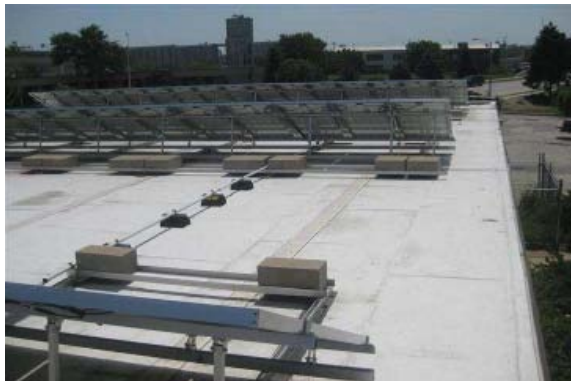
Inventory (SF)		Condition Rating	Age (Years)	RUL (Years)	1st Year of Capital Expenditure
Single Ply Roof	4,012	5	Unknown	4	2016

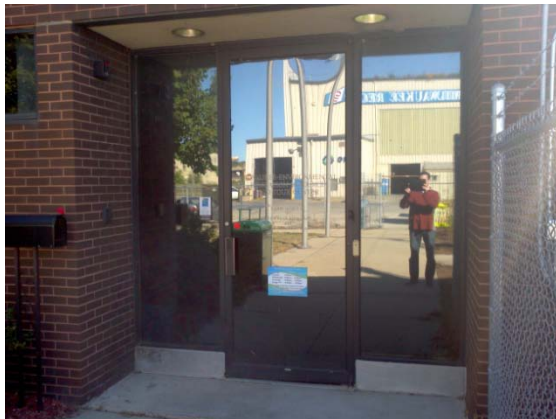
Glass/aluminum framed windows/doors

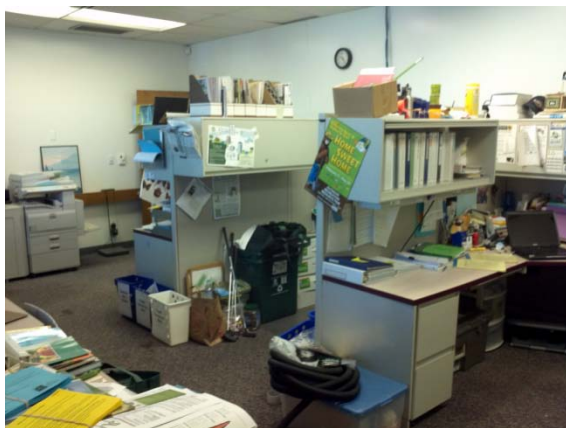
Typical equipment furniture

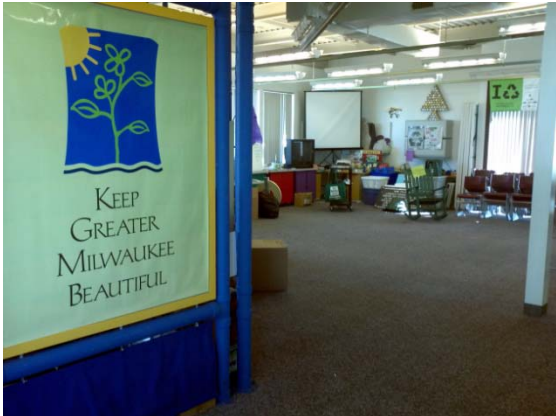
Inventory (EA)		Condition Rating	Age (Years)	RUL (Years)	1st Year of Capital Expenditure
Acoustic Tile Ceiling (SF)	1,450	5	Unknown	6	2017
Painted Walls/Ceiling (SF)	5,450	5	Unknown	6	2017
Carpet (SY)	225	4	Unknown	6	2017
Ceramic Tile (SF)	1,010	5	Unknown	6	2017
Wall Paper (SF)	1,150	5	Unknown	6	2017
Counters (LF)	8	4	Unknown	6	2017
Light Fixtures, Fluorescent	62	7	Unknown	6	2017
Refrigerator	1	4	Unknown	6	2017
Microwave	1	4	Unknown	6	2017
Range	1	3	Unknown	6	2017

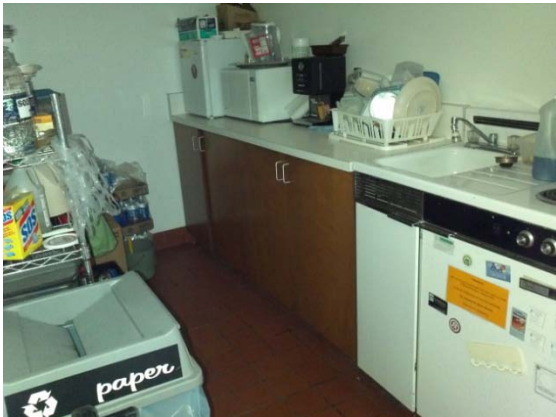
Kitchen equipment and finishes

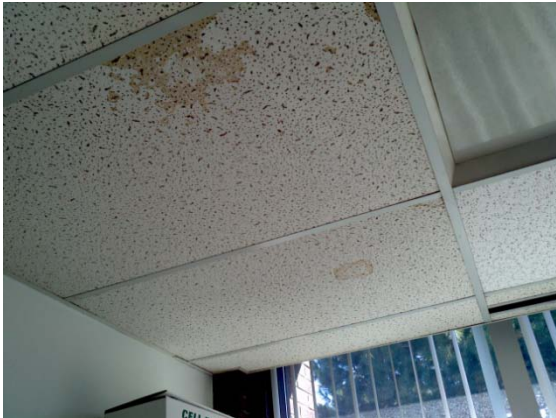
Stained ceiling tile

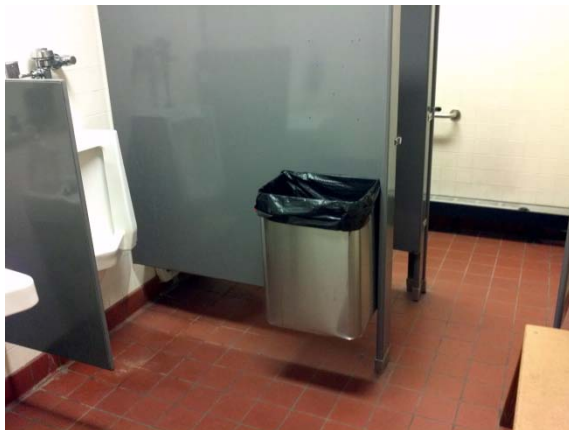
Typical rest room interior finishes

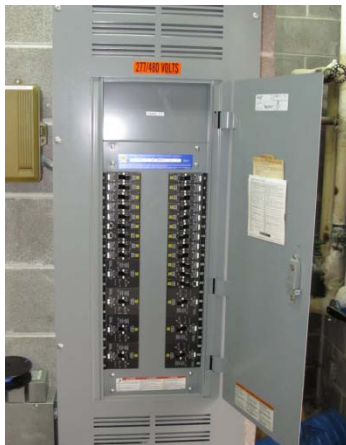
Inventory (LS)		Condition Rating	Age (Years)	RUL (Years)	1st Year of Capital Expenditure
Circuit Branches	1	5	22	6	2017
Secondary Distribution	1	6	22	18	2030

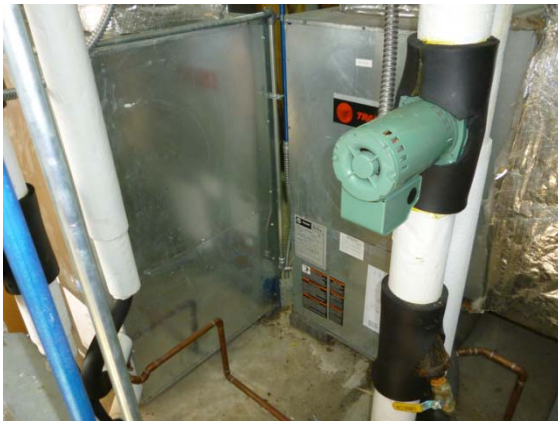
Heat pumps and circulation pump

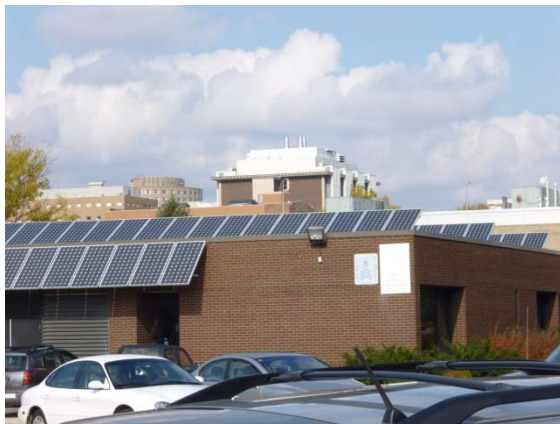
Roof mounted solar panels

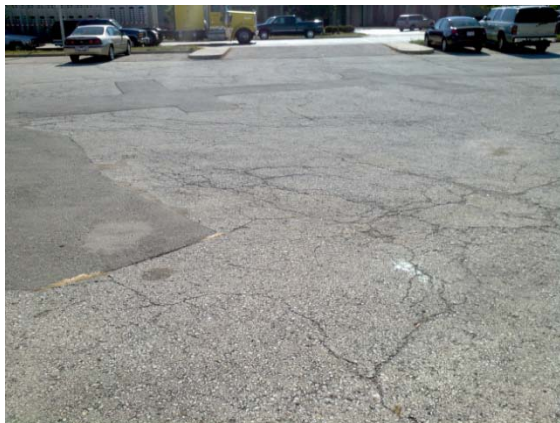
Typical failed pavement

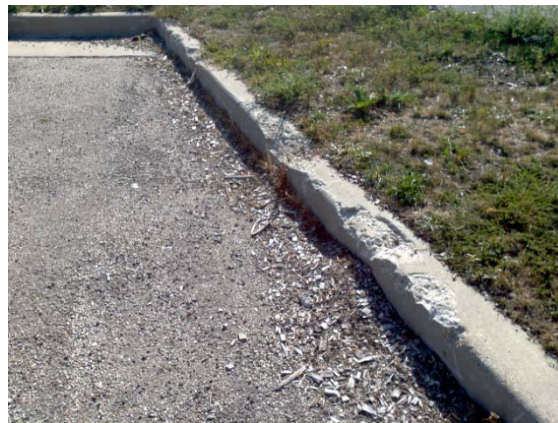
Deteriorated concrete curb

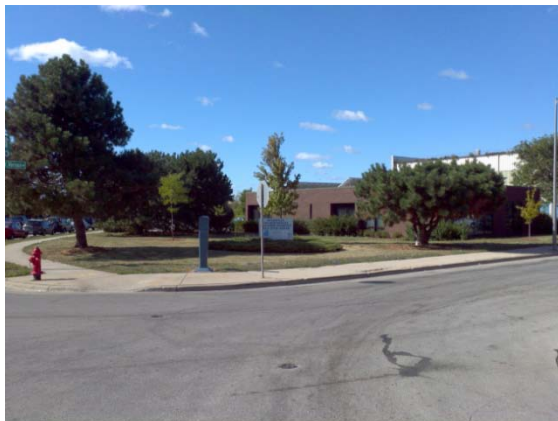
Inventory (EA)		Condition Rating	Age (Years)	RUL (Years)	1st Year of Capital Expenditure
Tree, Conifer	4	5	Unknown	9	2021
Tree, Deciduous	6	5	Unknown	9	2021
Shrub, Deciduous	14	5	Unknown	9	2021
Shrub, Evergreen	16	5	Unknown	9	2021
Grass (SF)	1,650	5	Unknown	9	2021

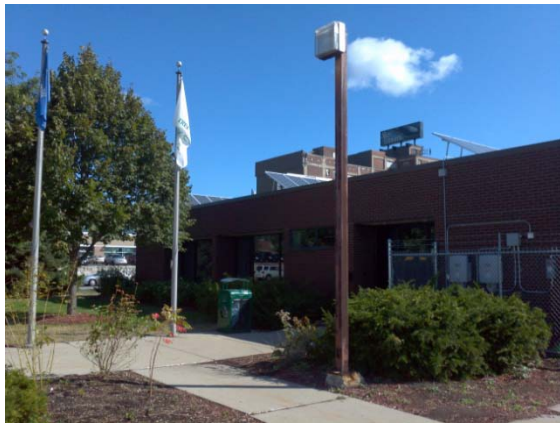
Light pole and flag poles

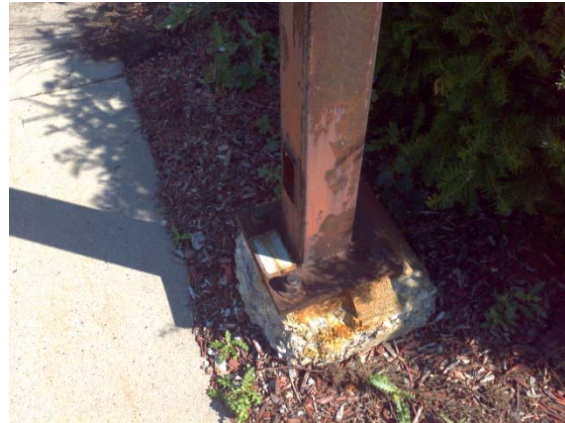
Light pole and base w paint finish deterioration and rust

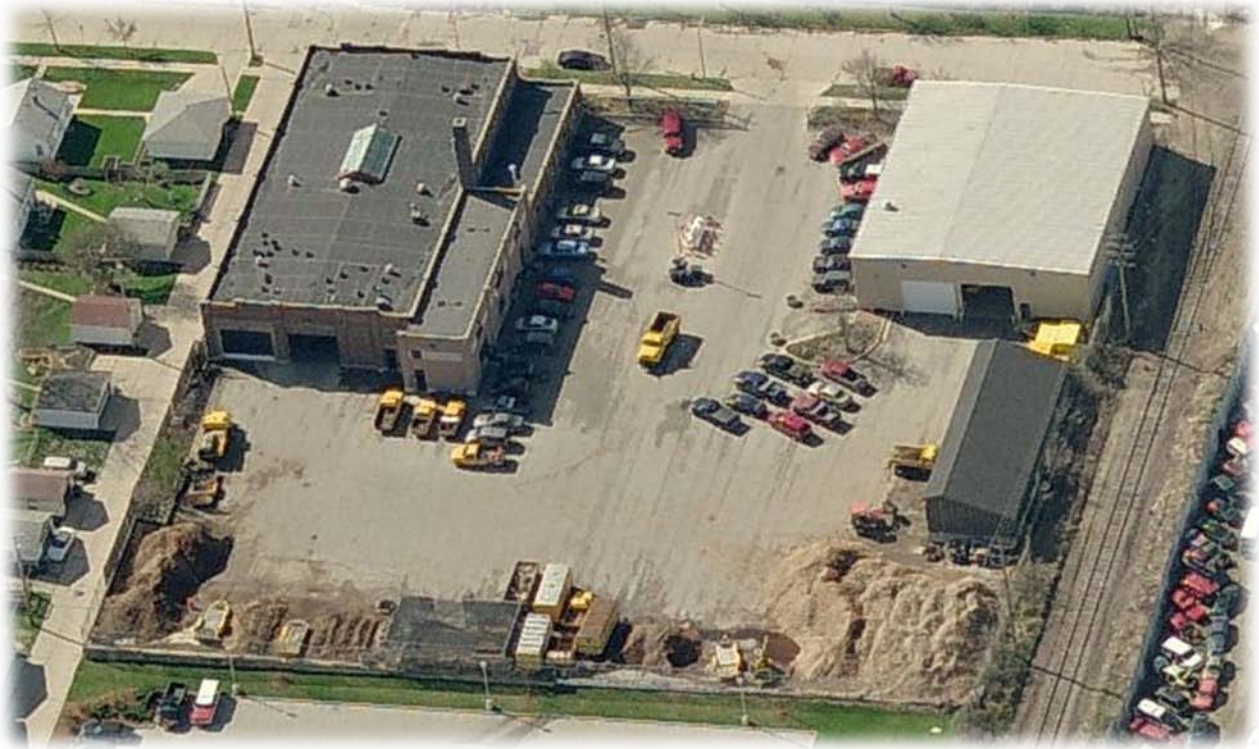
FACILITIES
CONDITION
ASSESSMENT
PROGRAM

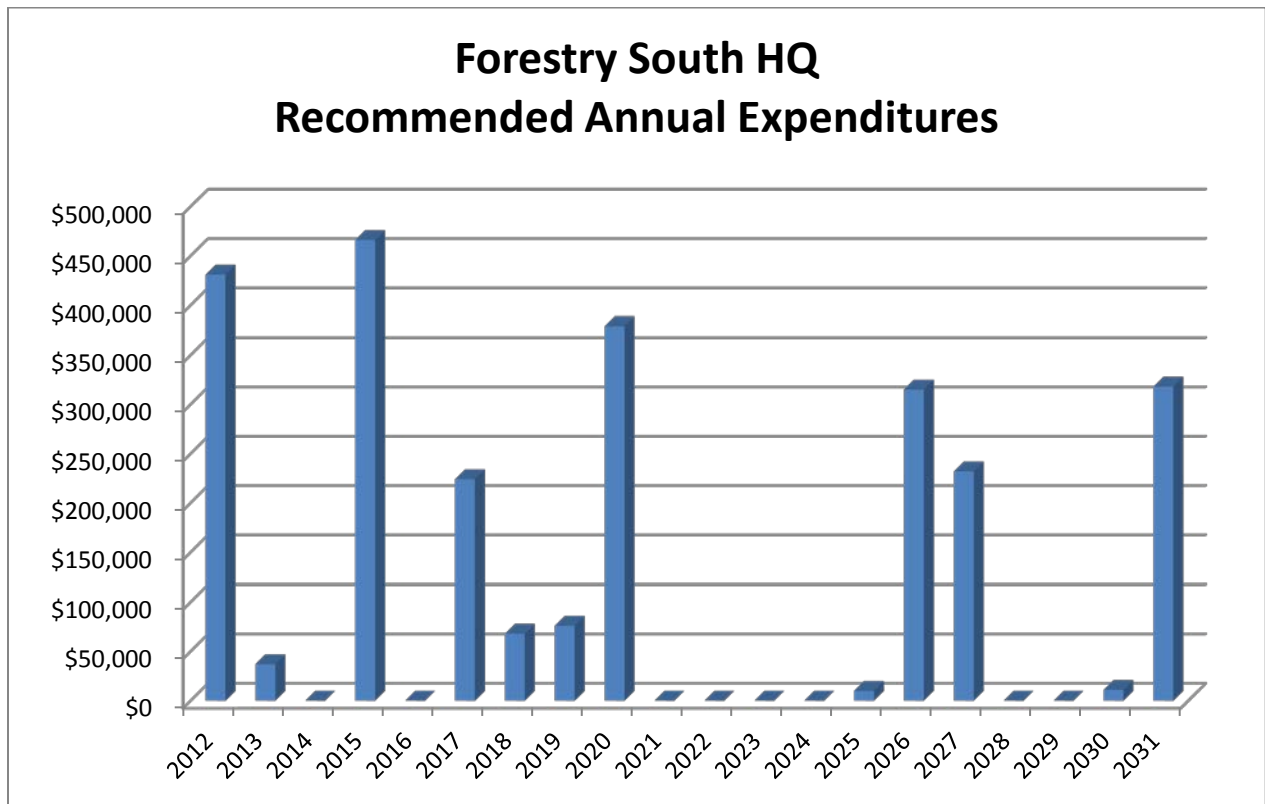
The most significant category of Forestry South HQ expenditures pertains to building envelope repairs as shown below. Building envelope roof repairs is the most significant single component.

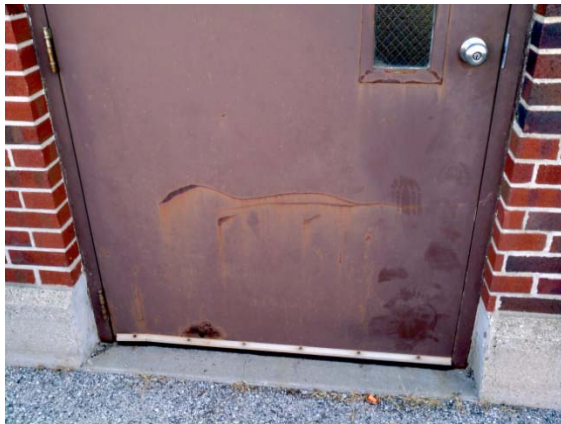
Office Building door with rust

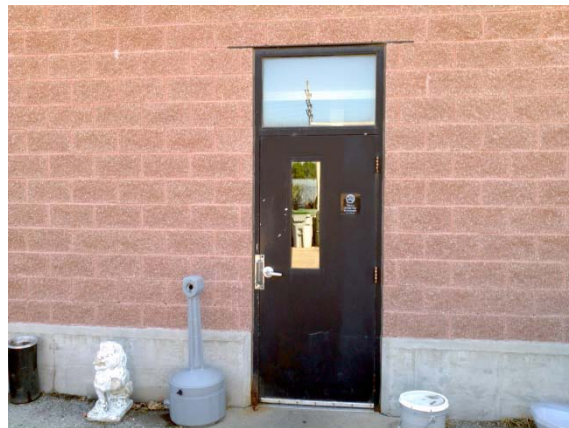
Office Building door with rust

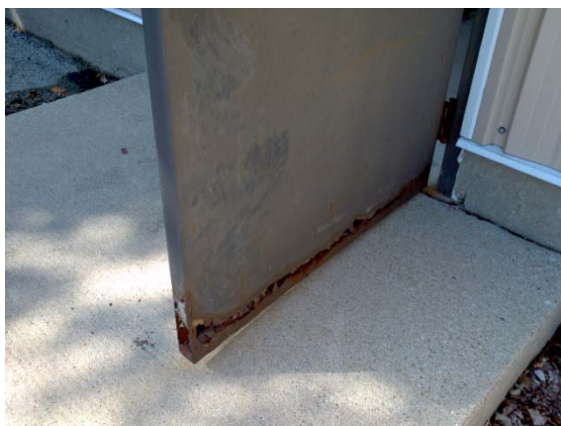
Storage Garage door succumbed to rust

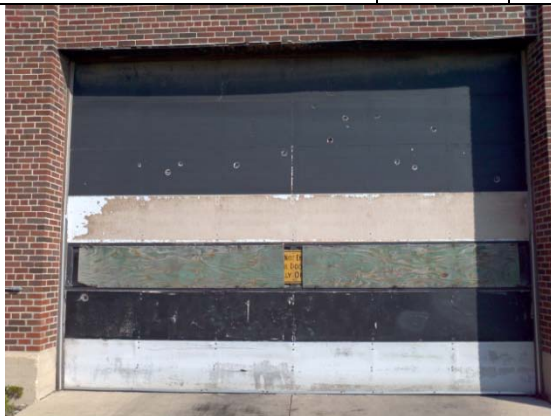
Garage door w repairs at Office Building

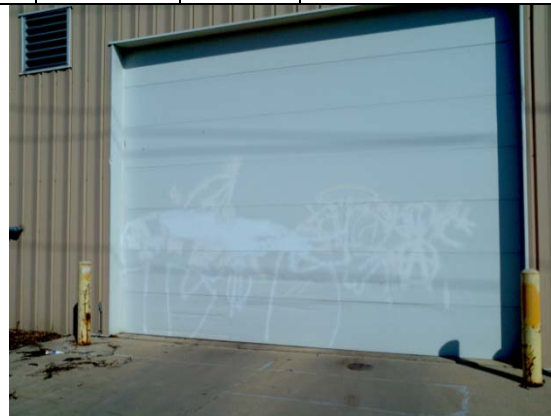
Garage door at Storage Garage

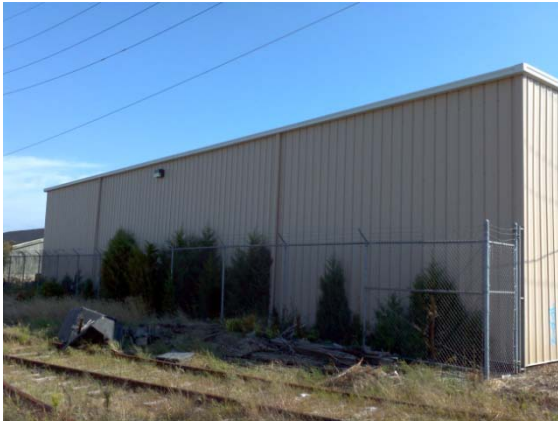
Gutters and downspouts at west elevation

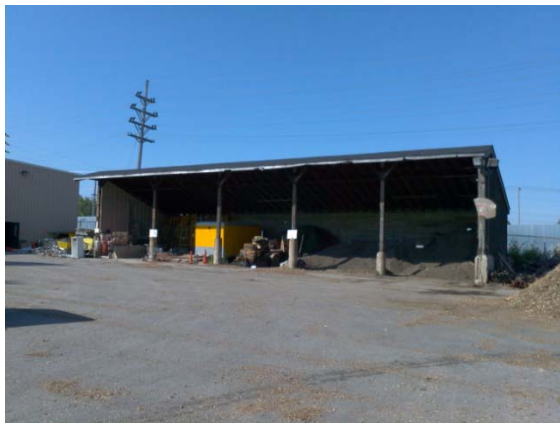
*Projection is based on replacement after soil structure is replaced
