Facilities Condition Assessment Program

Project Review

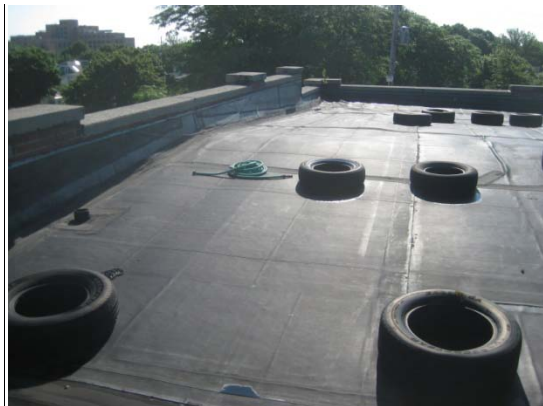
Roof #1 - tires restrain membrane

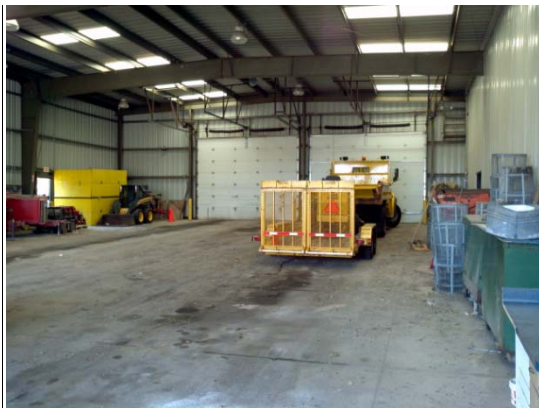
Metal roof w translucent panels

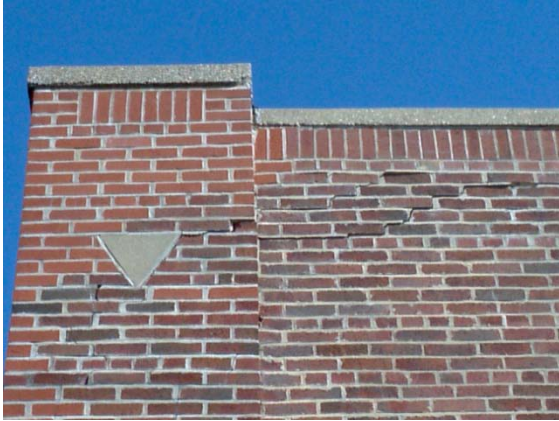
Mortar step crack at south elevation

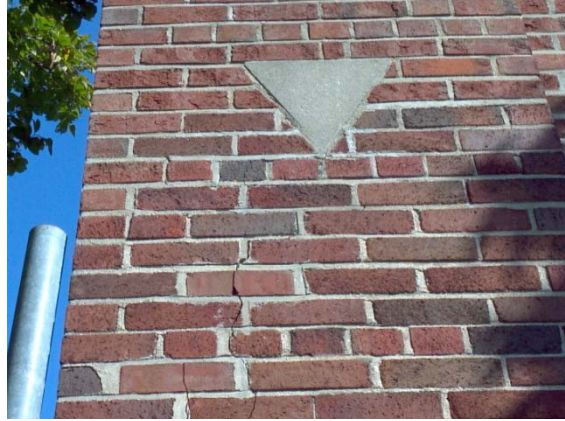
Cracked brick/mortar at south elevation

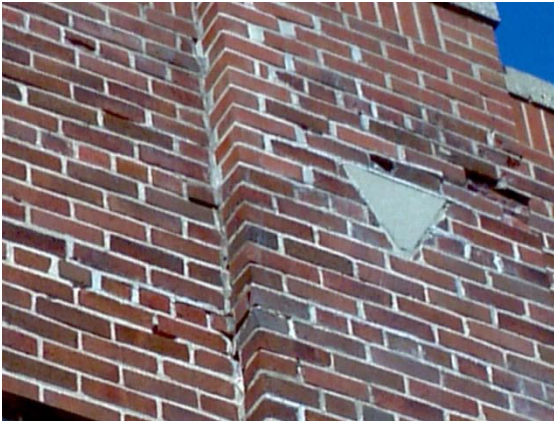
Spalled brick/mortar east elevation

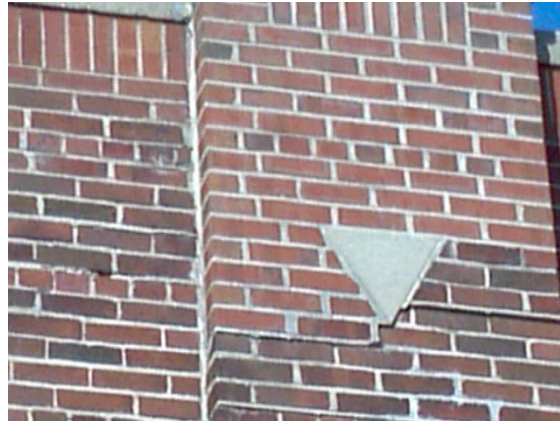
Displaced brick at east elevation

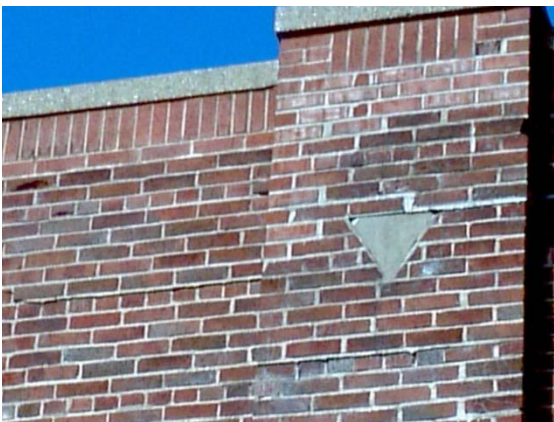
Cracked mortar/spalled brick at east elev.

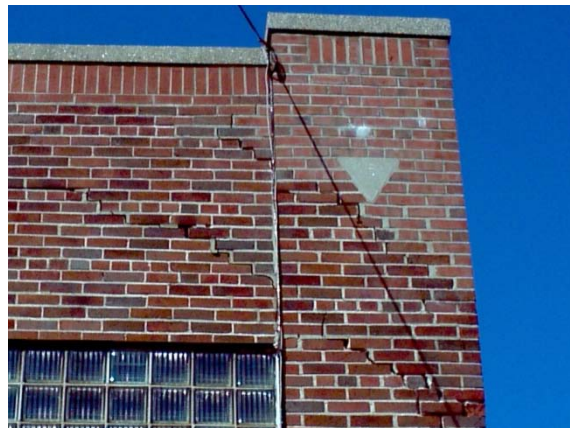
Parallel step cracks east elevation

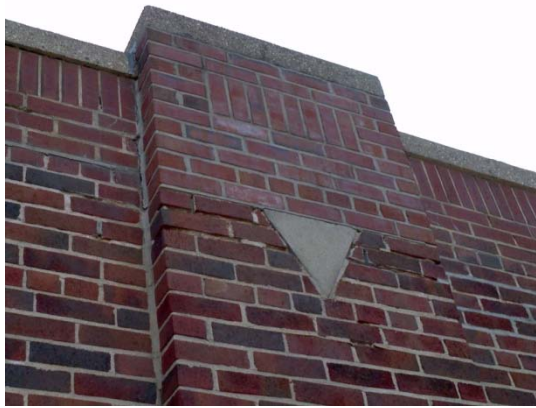
Mortar loss at west elevation

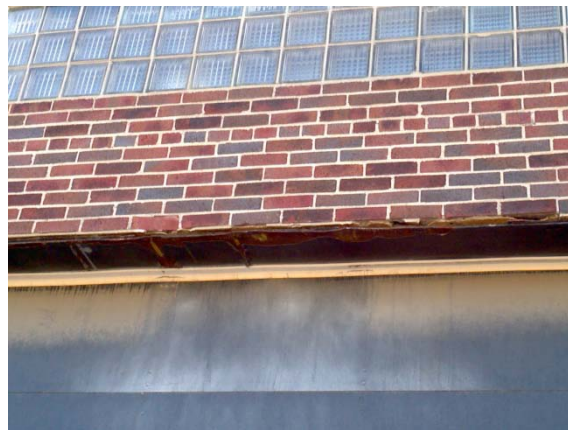
Rusted metal lintel at north elevation

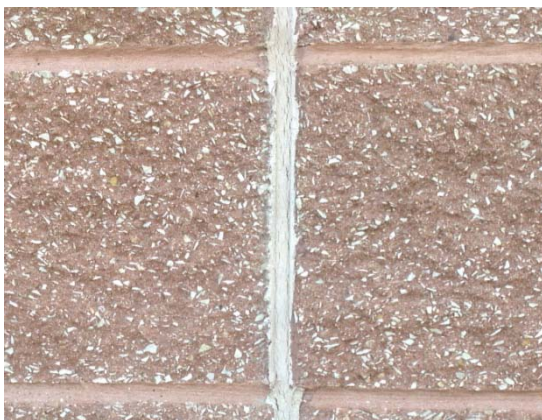
Control joint sealant is cracked/brittle

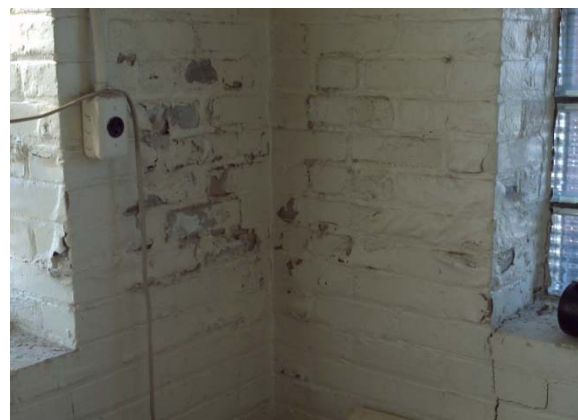
Water infiltration and damaged paint

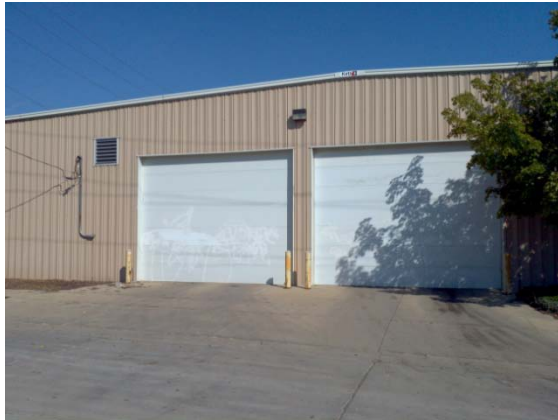
Metal siding at Storage Garage

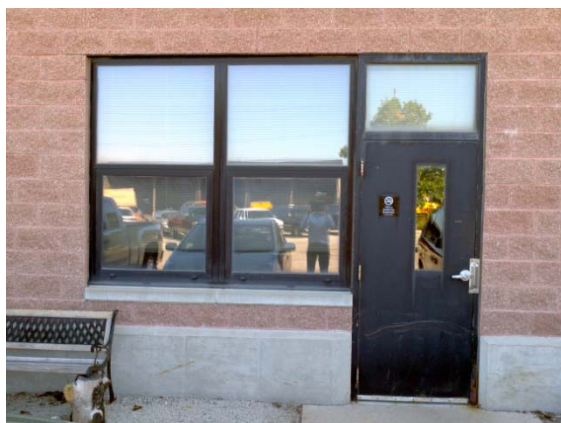
Typical frame window installation

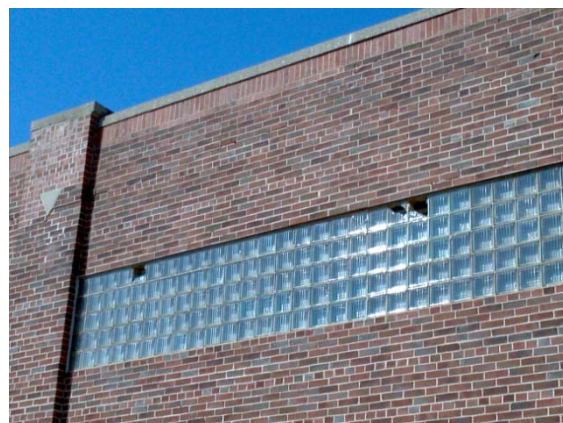
Damaged glass block windows

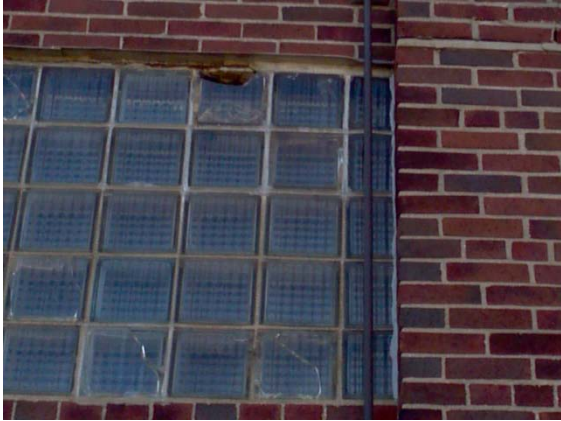
Cracked/damaged glass block

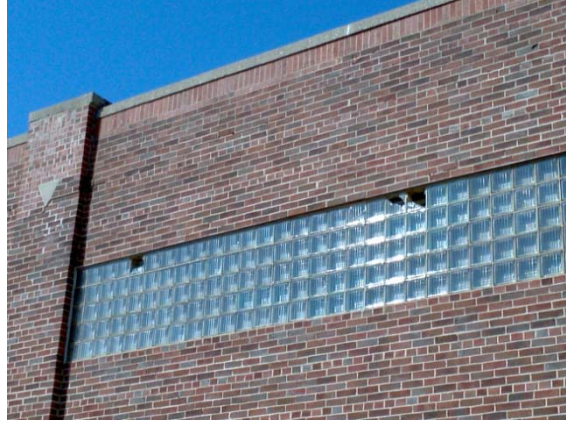
Damaged glass block windows

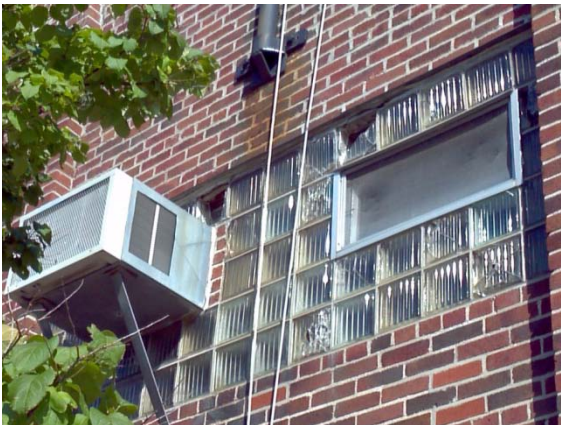
Cracked/damaged glass block

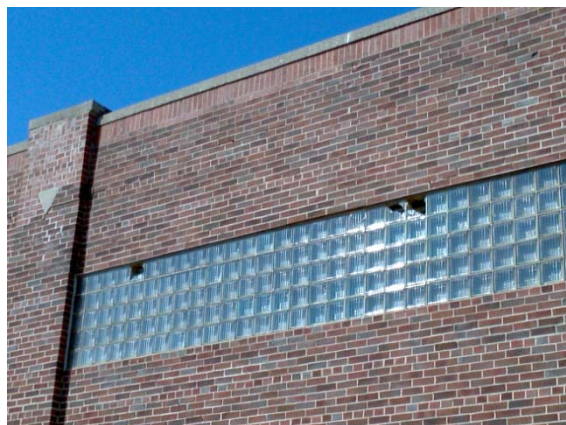
Damaged glass block windows

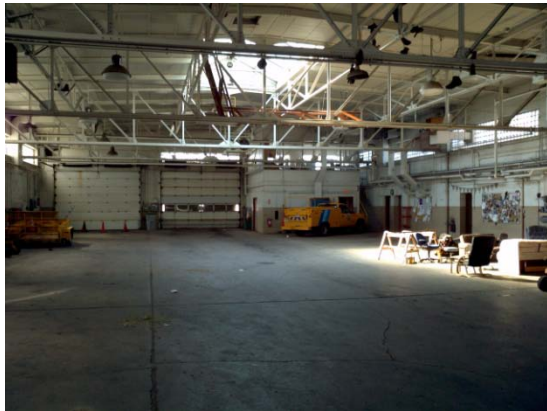
Office Building garage interior

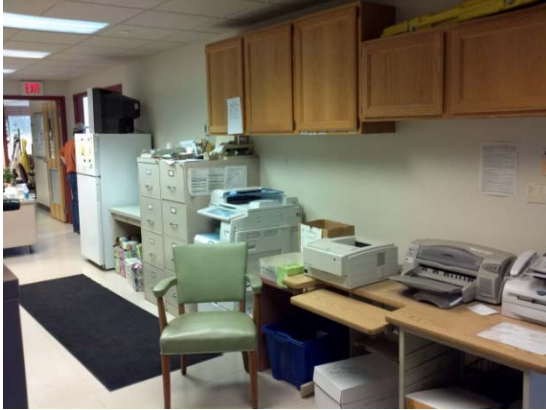
2nd Floor equipment/furniture

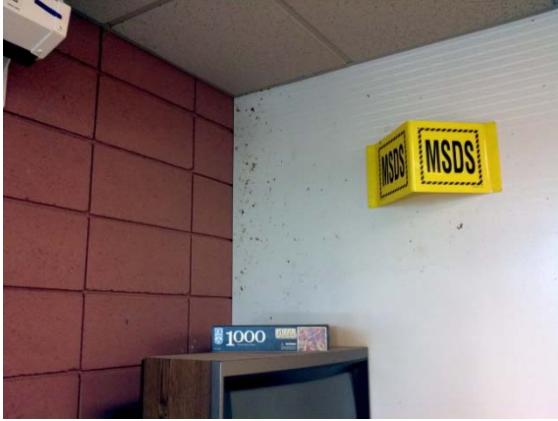
Stained wall in break room

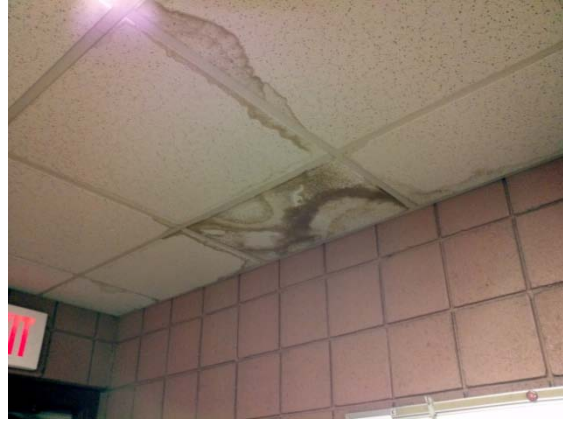
Stained acoustic tile ceiling in break room

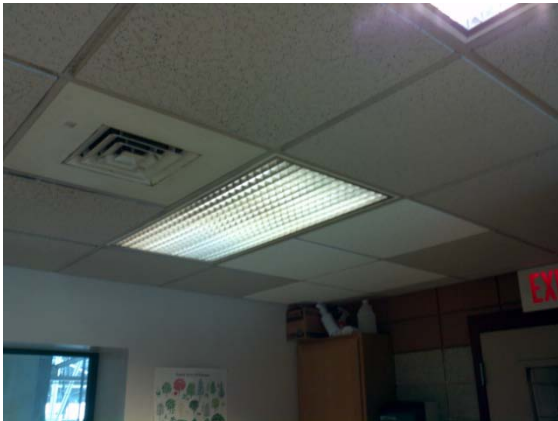
Replaced ceiling tile 2nd Floor offices

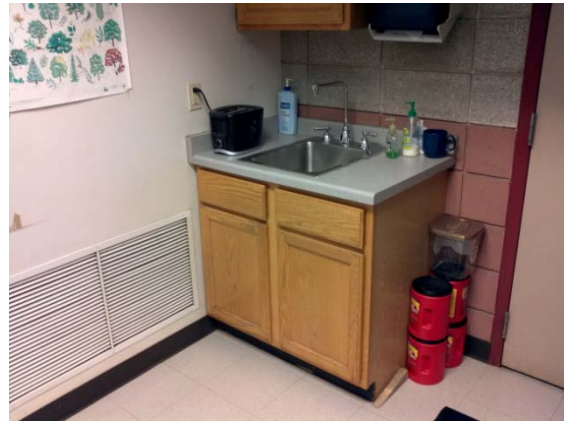
Begrimed wall surface in garage

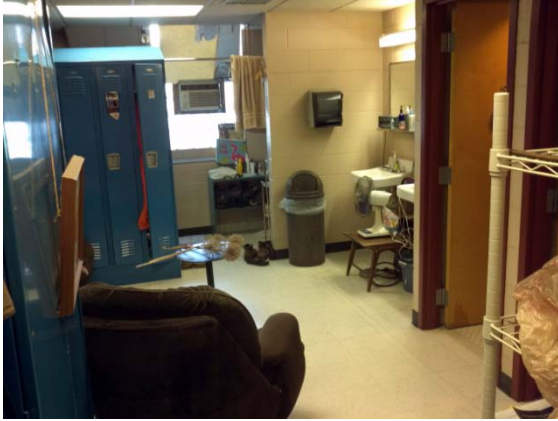
Women's rest room/locker room

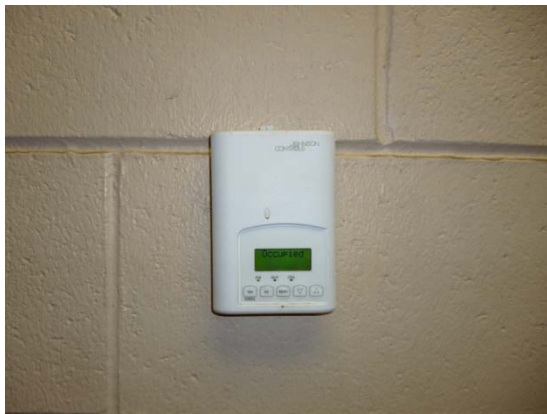
Inventory (EA)		Condition Rating	Age (Years)	RUL (Years)	1st Year of Capital Expenditure
BAS	1	3	Unknown	0	2012

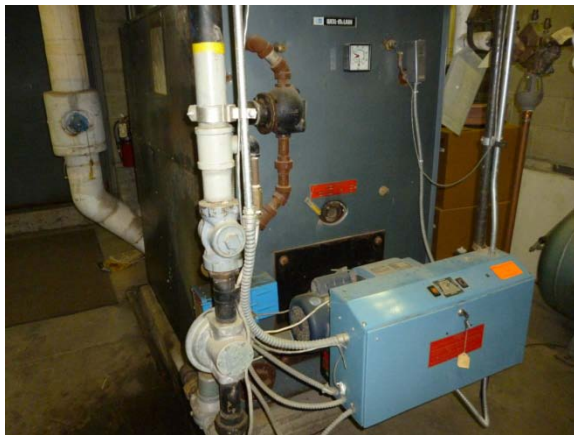
Building heat boiler

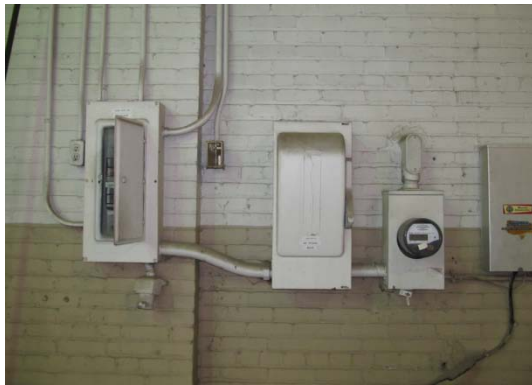
Secondary distribution

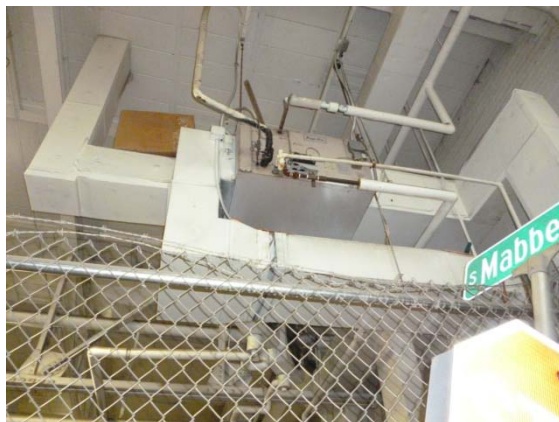
Interior forced air furnace

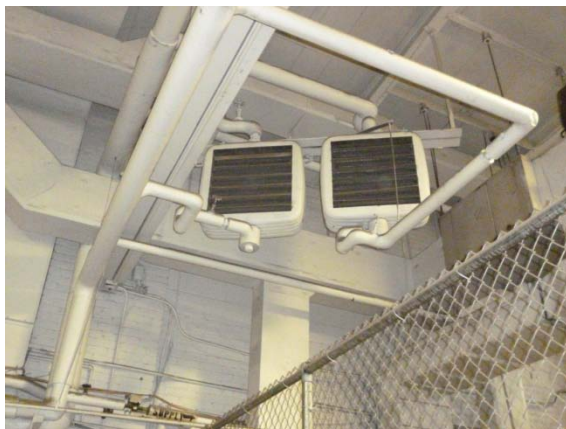
Inventory (EA)		Condition Rating	Age (Years)	RUL (Years)	1st Year of Capital Expenditure
3 MBH	1	6	17	5	2017
5.5 MBH	1	6	28	5	2017
10 MBH	1	6	17	5	2017
75 MBH	1	6	28	5	2017
100 MBH	1	6	28	5	2017
260 MBH	4	6	28	5	2017
364 MBH	1	6	28	5	2017

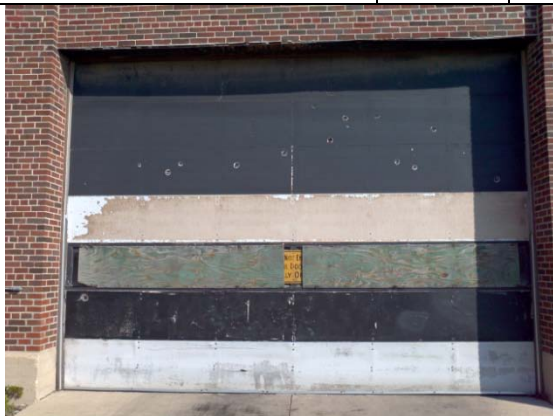
Garage door w repairs at Office Building

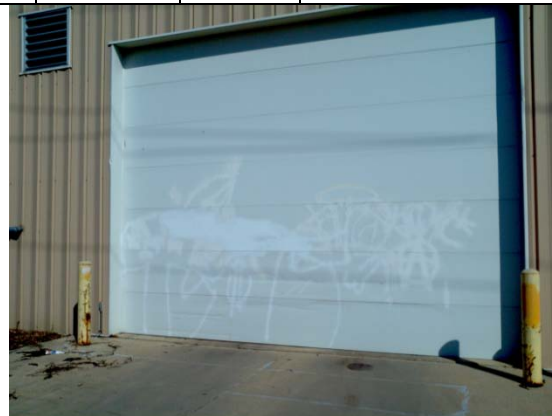
Garage door at Storage Garage

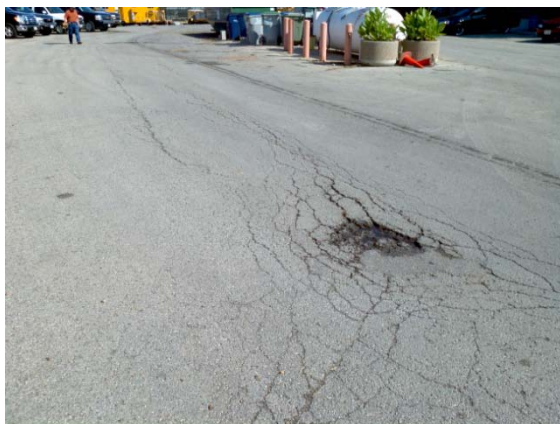
Pothole and failed pavement

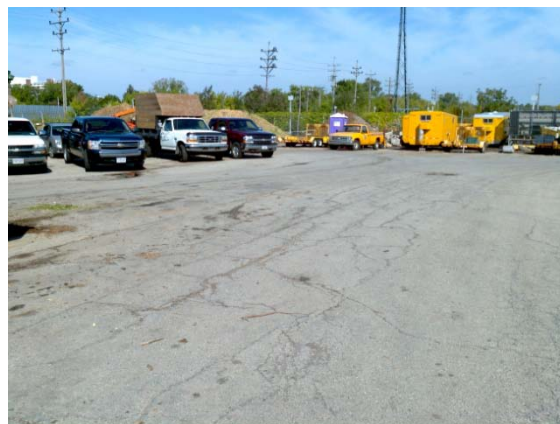
Cracked/failed pavement

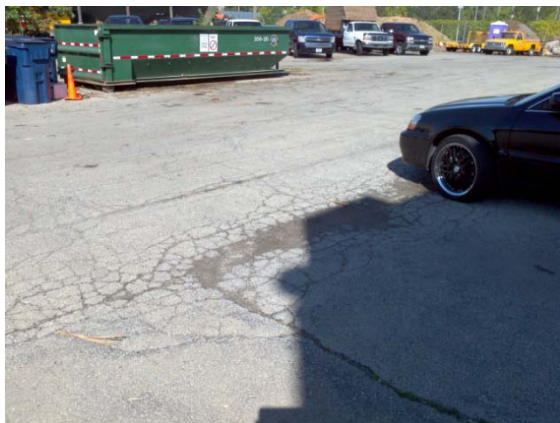
Failed patched/pavement

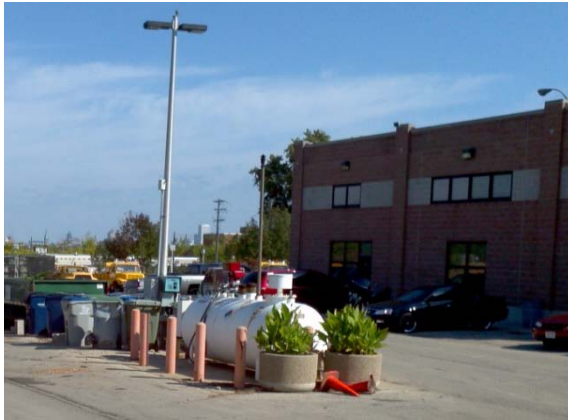
Gasoline fuel station

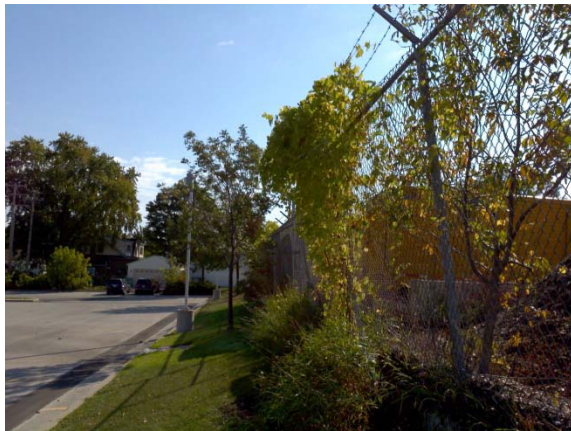
Misaligned fence at north perimeter

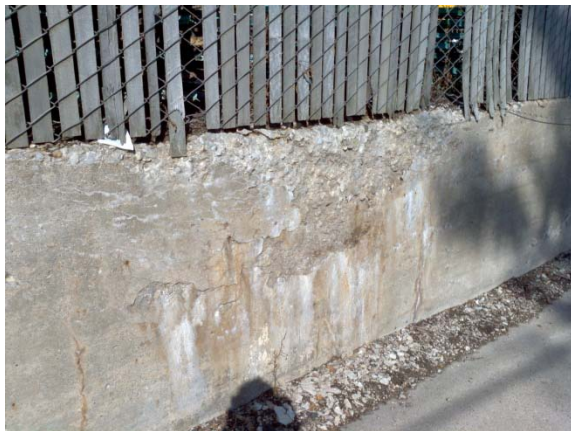
Spalled concrete retaining wall

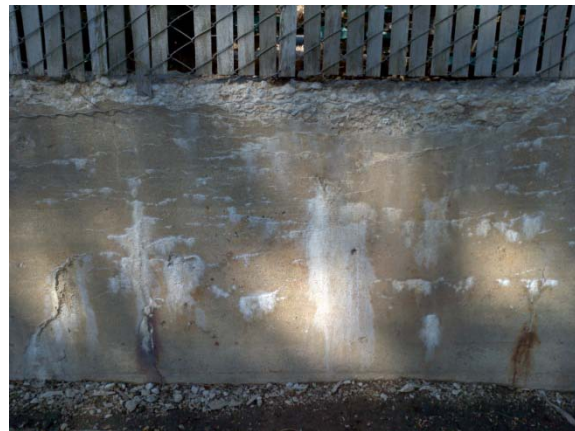
Cracked wall w efflorescence

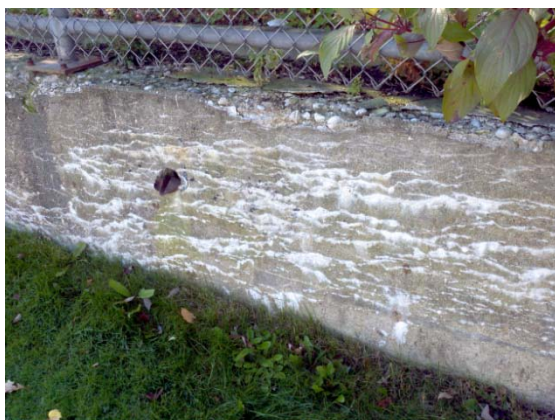
Cracked concrete w efflorescence

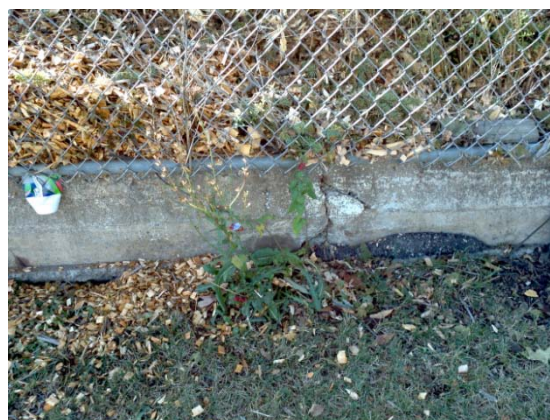
Cracked concrete retaining wall

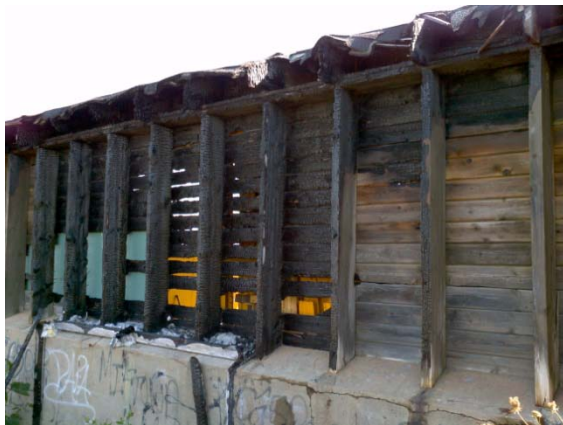
Damaged structural components

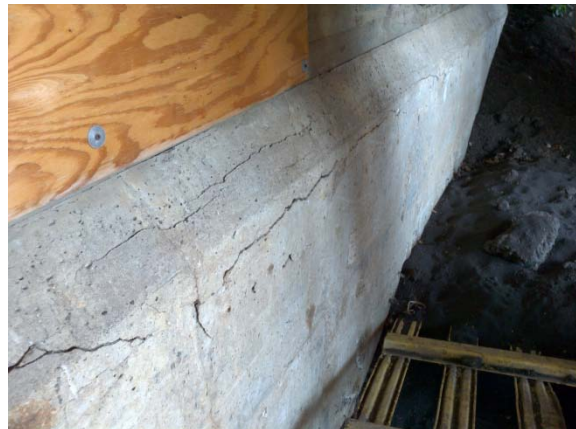
Cracked foundation wall

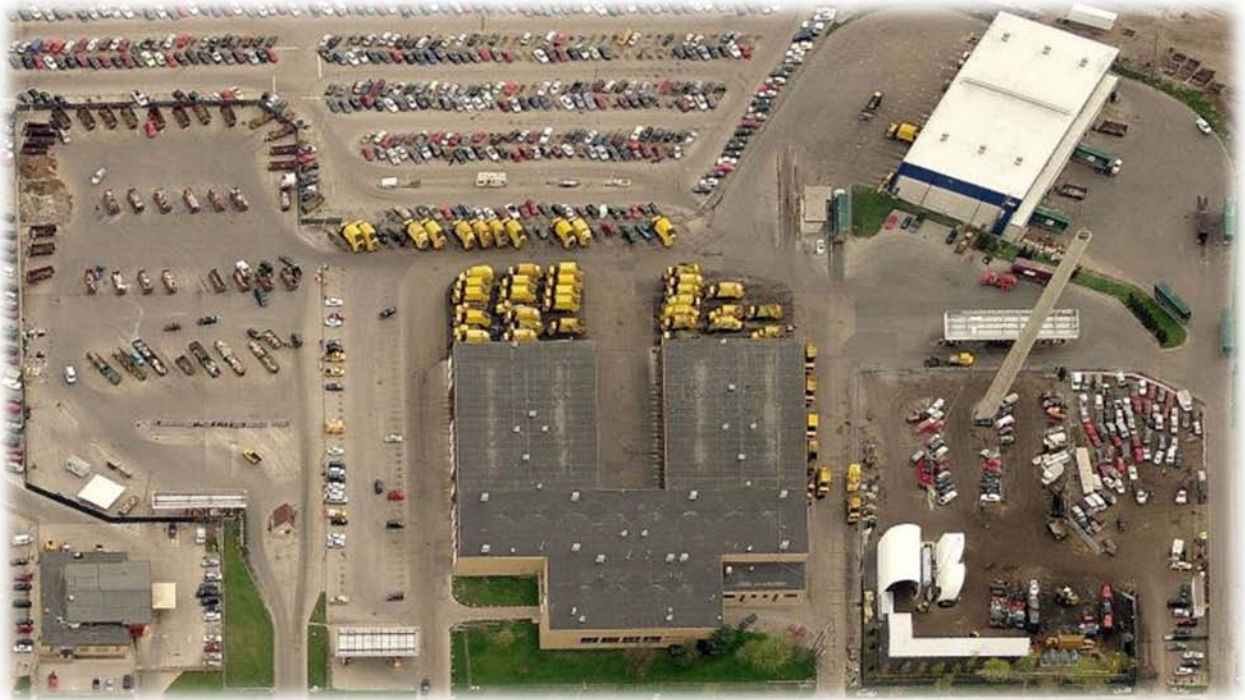
FACILITIES
CONDITION
ASSESSMENT
PROGRAM

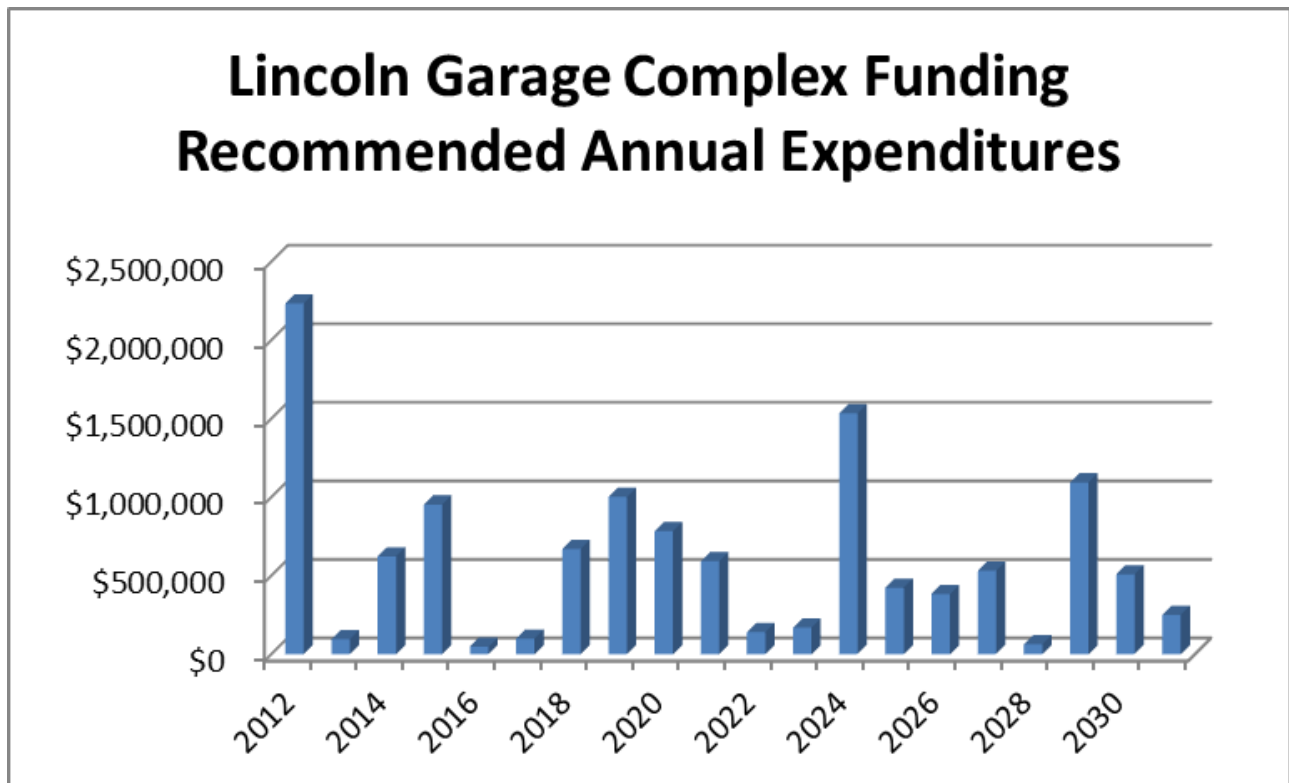
The most significant category of Lincoln Garage Complex expenditures pertains to Site Features as shown below. Pavement partial replacement is the most significant single component.

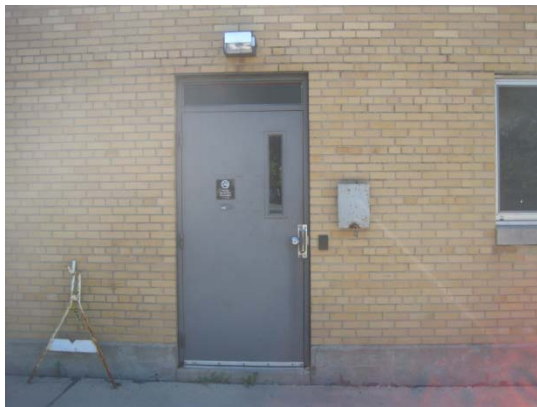
Typical Lincoln Garage door

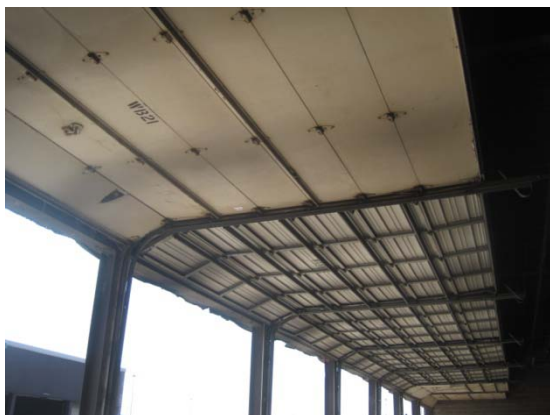
Lincoln Garage, garage doors

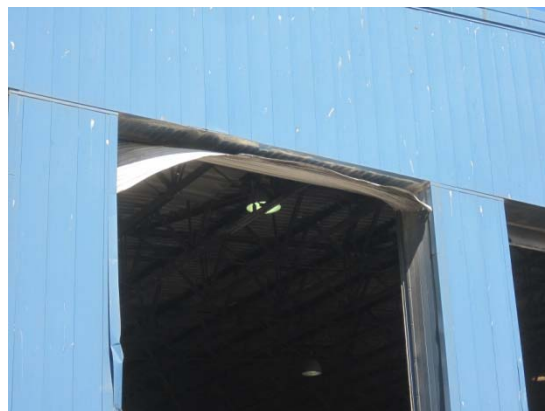
Damaged Transfer Station garage door

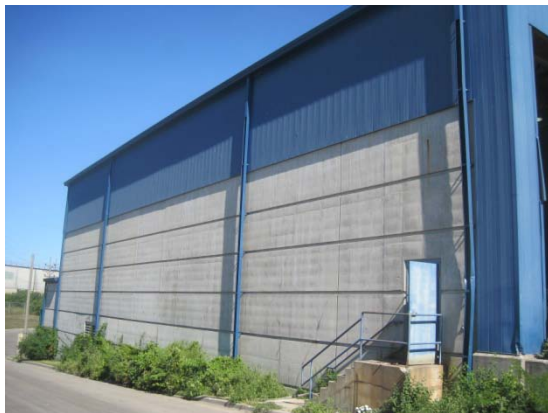
Gutters and downspouts

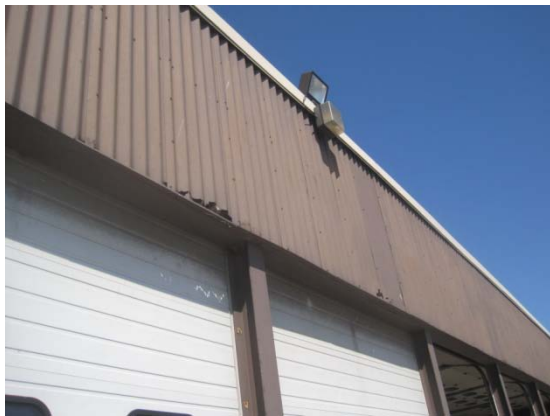
Garage light fixtures

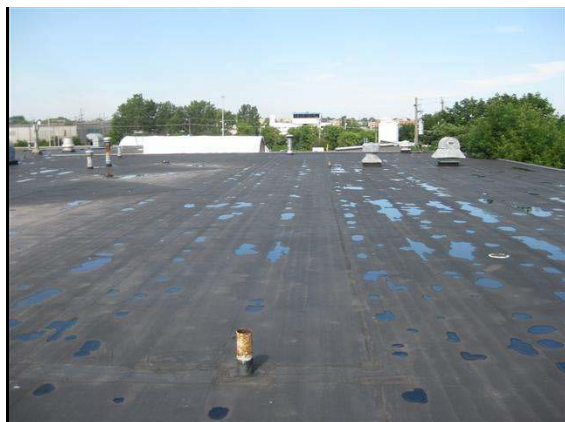
Lincoln Garage roof overview

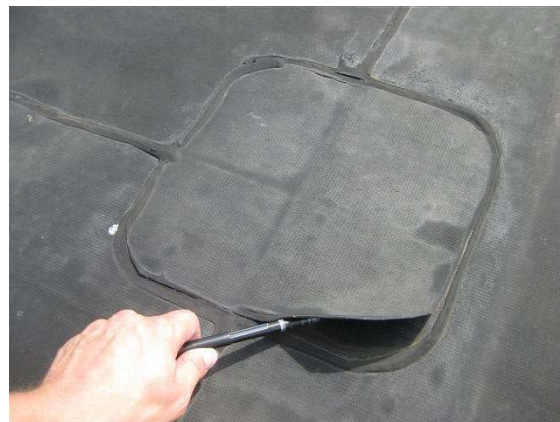
Loose patch at Lincoln Garage roof

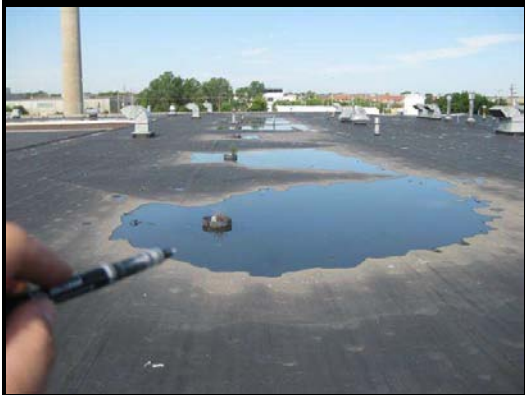
Ponded water at Lincoln Garage

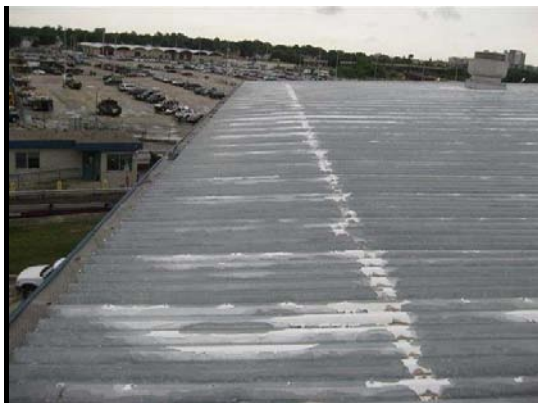
Inventory (SF)		Condition Rating	Age (Years)	RUL (Years)	1st Year of Capital Expenditure
#1 Metal	23,052	4	18	6	2018
#2 Metal	2,332	4	18	6	2018
#3 Metal	24	4	18	6	2018

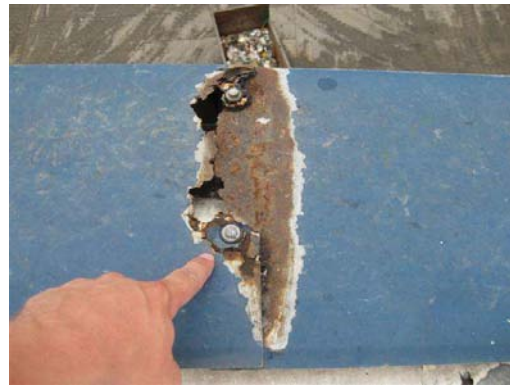
Rusted roof at fasteners every 10 feet

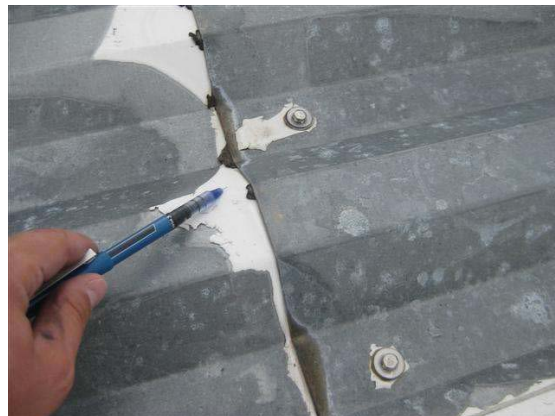
Surface coating missing

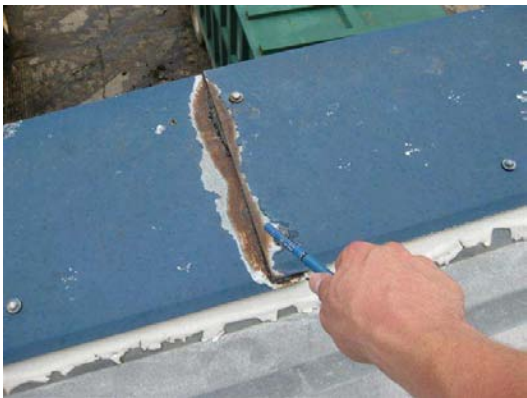
Delaminated surface coating

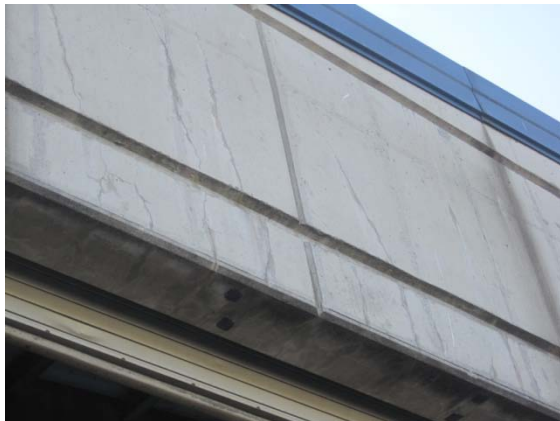
Inventory (SF)		Condition Rating	Age (Years)	RUL (Years)	1st Year of Capital Expenditure
Concrete	9,050	7	Unknown	9	2021

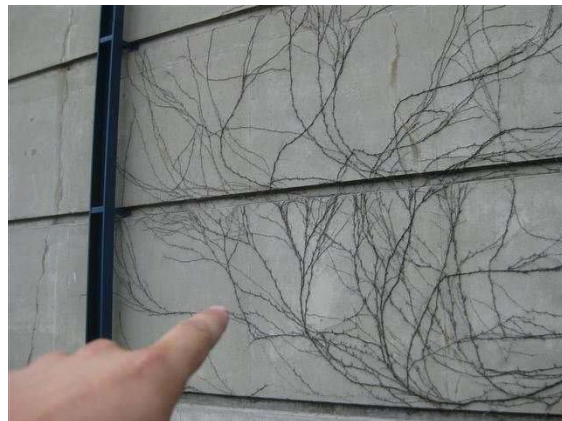
Vines exacerbate deterioration

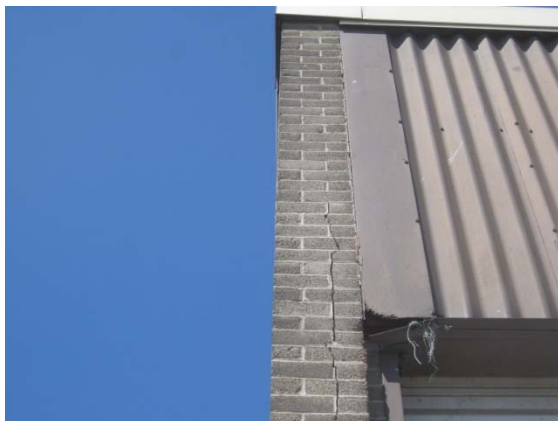
Cracked brick/mortar at Lincoln Garage

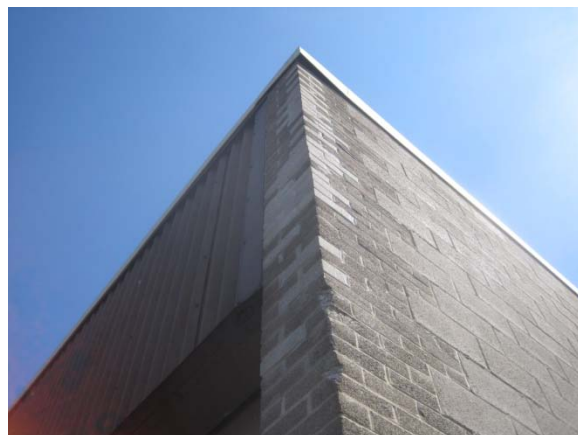
Cracked/replaced brick at Lincoln Garage

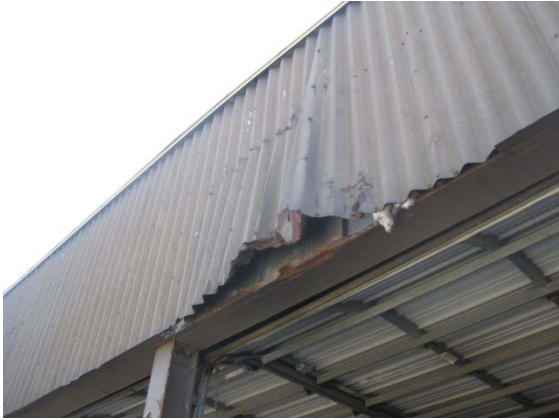
Damaged siding at Lincoln Garage

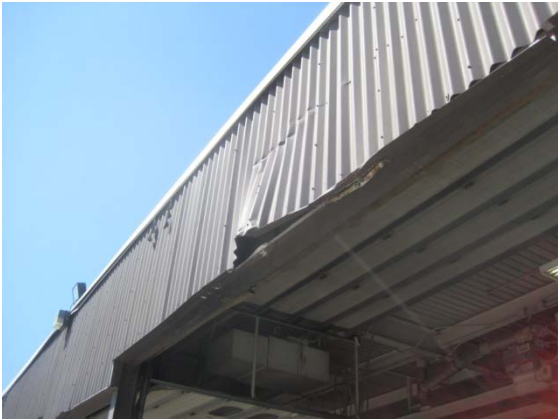
Damaged siding at Lincoln Garage

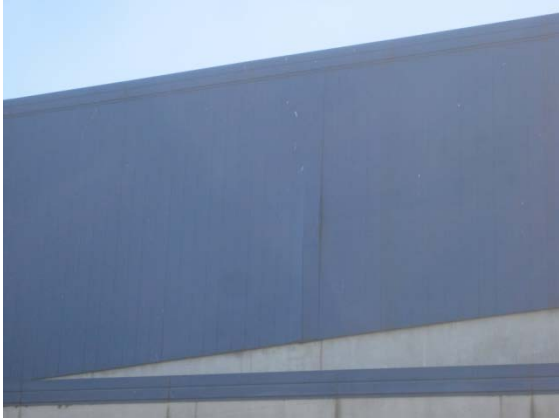
Damaged metal siding

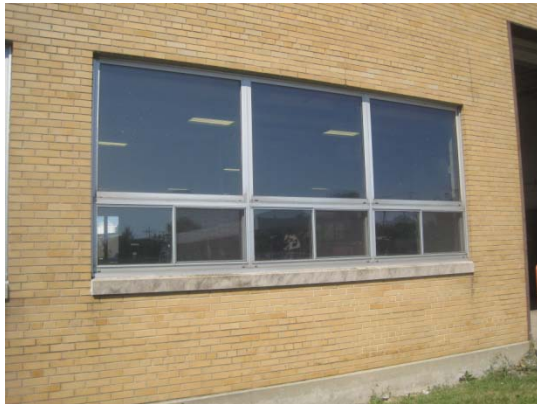
Lincoln Garage windows

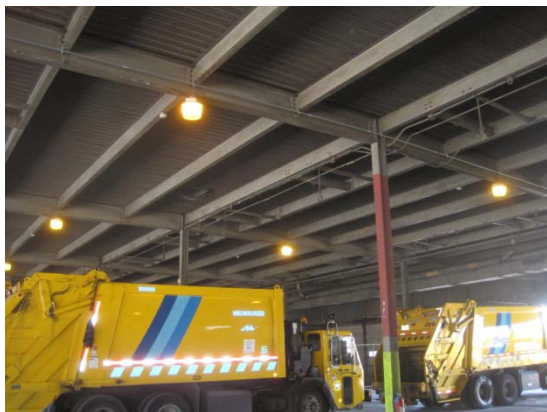
Typical Lincoln Garage light fixture

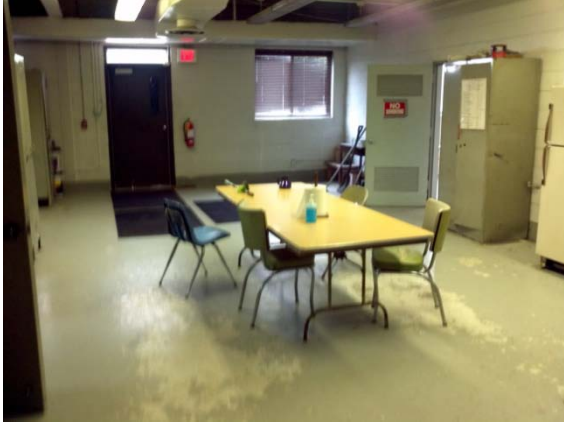
Inventory (EA)		Condition Rating	Age (Years)	RUL (Years)	1st Year of Capital Expenditure
Shelves	70	6	Unknown	13	2025
Chairs	27	5	Unknown	13	2025
Tables	6	5	Unknown	13	2025
Televisions	1	5	Unknown	13	2025
Computers	1	Unknown	Unknown	13	2025
Copiers/Printers	1	Unknown	Unknown	13	2025
Telephones	4	Unknown	Unknown	13	2025
Refrigerator	3	Unknown	Unknown	13	2025
Microwave	3	Unknown	Unknown	13	2025
Vending Machine	2	Unknown	Unknown	13	2025

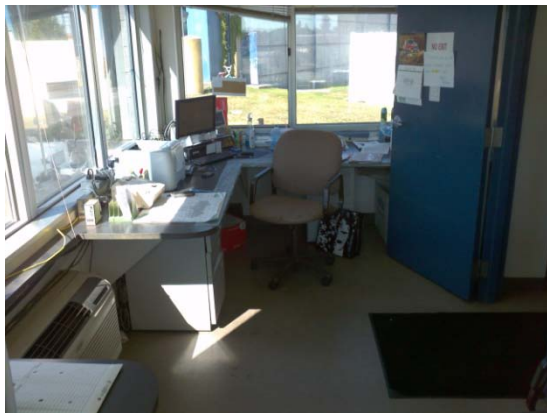
Scale House office finishes

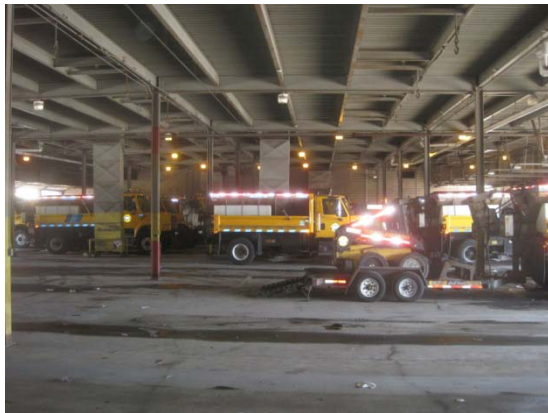
Steel components – Lincoln Garage

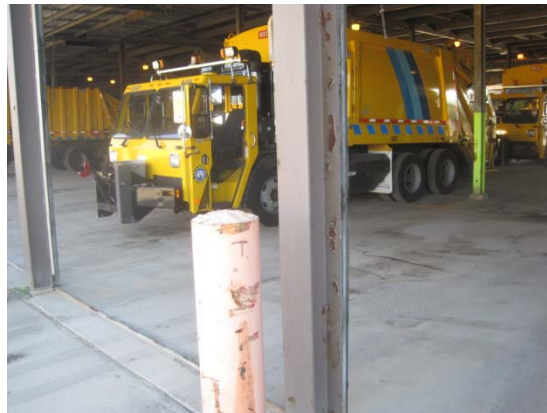
Rusted steel components

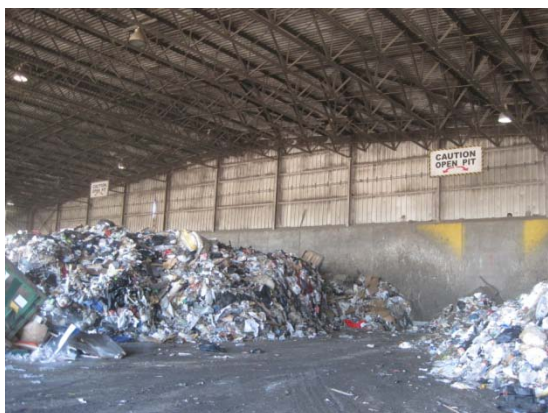
Steel components – Transfer Station

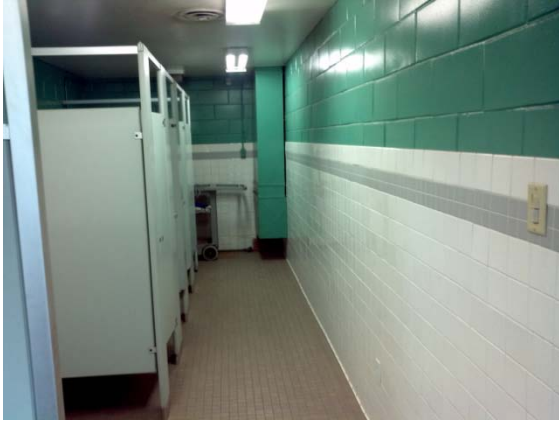
Inventory (EA)		Condition Rating	Age (Years)	RUL (Years)	1st Year of Capital Expenditure
Paint Walls/Ceilings (SF)	1,725	6	Unknown	13	2025
Wall Tile (SF)	1,375	6	Unknown	13	2025
Ceramic Tile Floor (SF)	715	6	Unknown	13	2025
Light Fixtures	16	6	Unknown	13	2025
Toilet	6	6	Unknown	13	2025
Urinal	3	6	Unknown	13	2025
Sink	4	6	Unknown	13	2025
Partition	6	6	Unknown	13	2025
Showers	3	6	Unknown	13	2025
Mirrors	4	6	Unknown	13	2025
Drinking Fountain	1	6	Unknown	13	2025

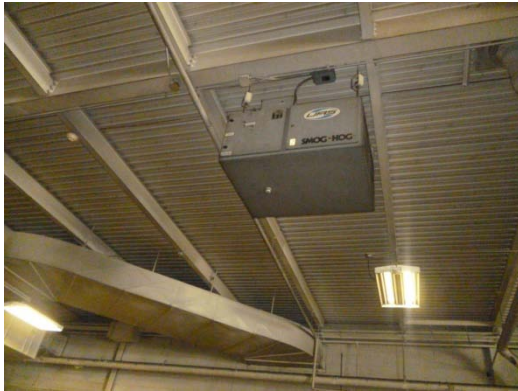
Inventory (EA)		Condition Rating	Age (Years)	RUL (Years)	1st Year of Capital Expenditure
Air Filter Units	21	3	Unknown	0	2012

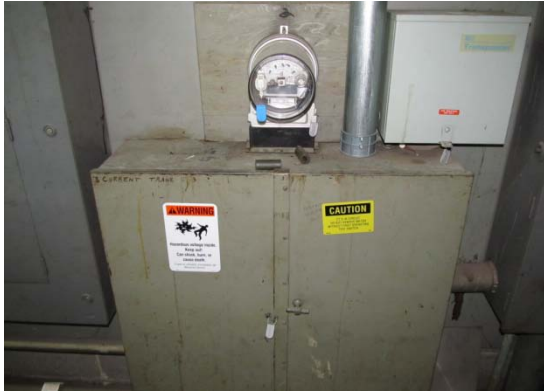
Secondary distribution

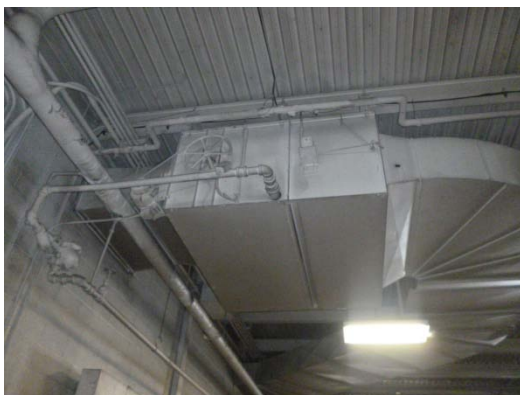
Inventory (EA)	Condition Rating	Age (Years)	RUL (Years)	1st Year of Capital Expenditure	
MUA D9					
Furnace (MBH)	400	2	43	0	2012
MUA D7					
Furnace (MBH)	450	2	43	0	2012
MUA N3, N4, D8					
Furnace (MBH)	500	2	43	0	2012
MUA D1, D2, D10					
Furnace (MBH)	600	2	43	0	2012

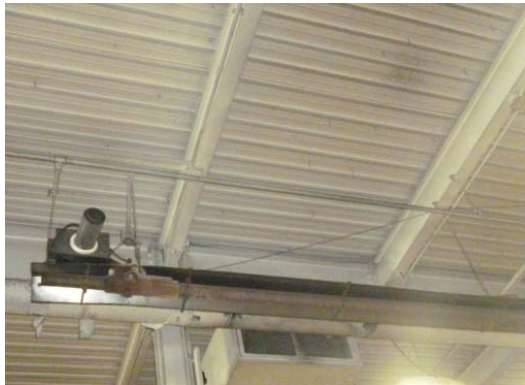
Inventory (EA)		Condition Rating	Age (Years)	RUL (Years)	1st Year of Capital Expenditure
Tube Heater	11	5	25	0	2012
Pump	1	5	25	0	2012

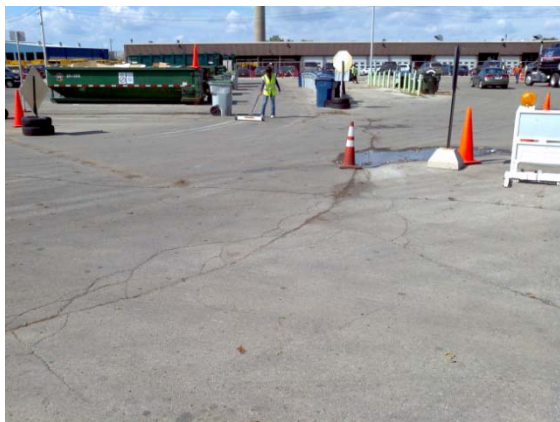
Asphalt pavement at Self Help

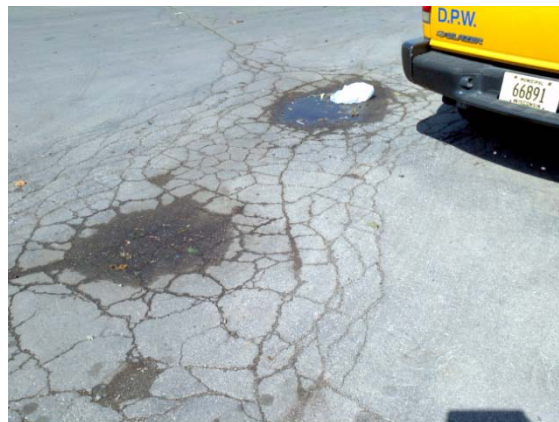
Failed pavement at Self Help

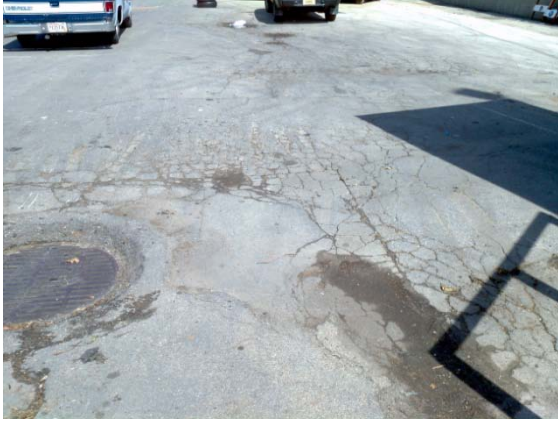
Self Help failed pavement

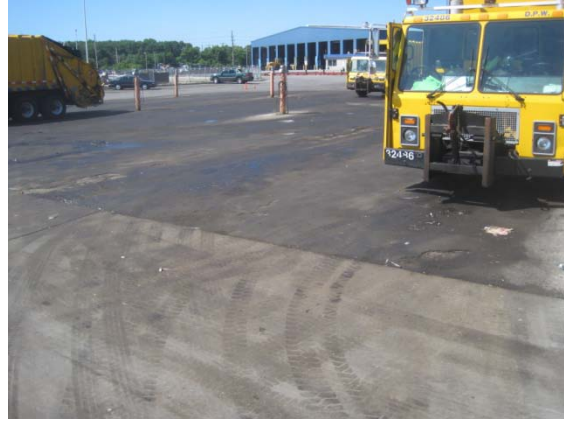
Lincoln Garage asphalt pavement

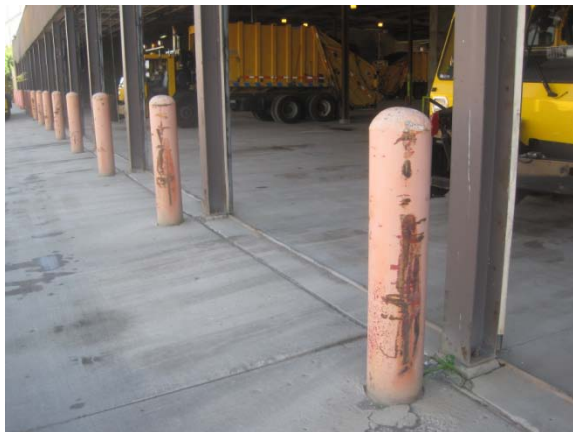
Bollards w surface rust at Lincoln Garage

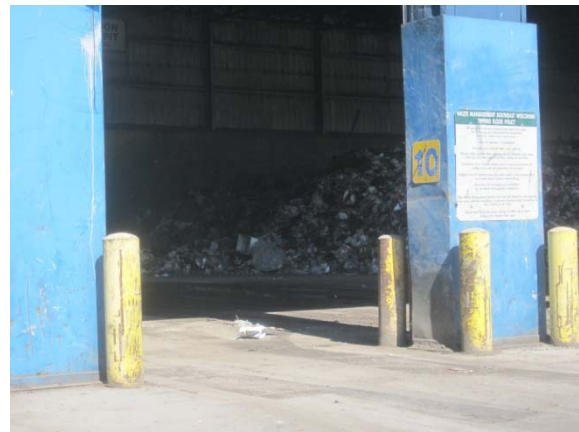
Bollards w surface rust at Transfer Station

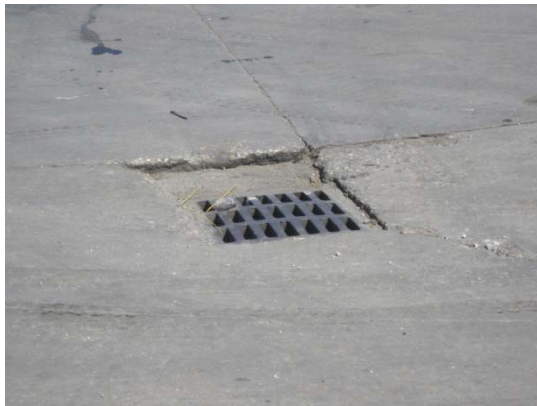
Settled catch basin near Transfer Station

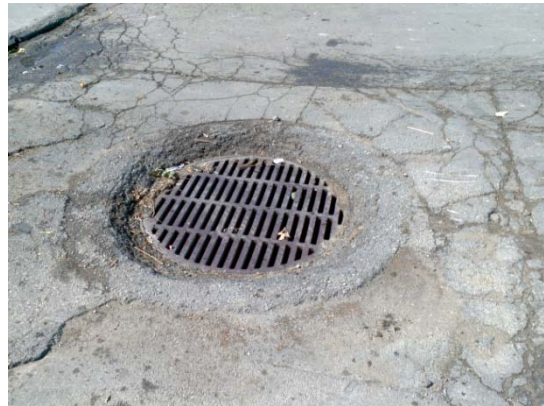
Cracked concrete at entrance drive

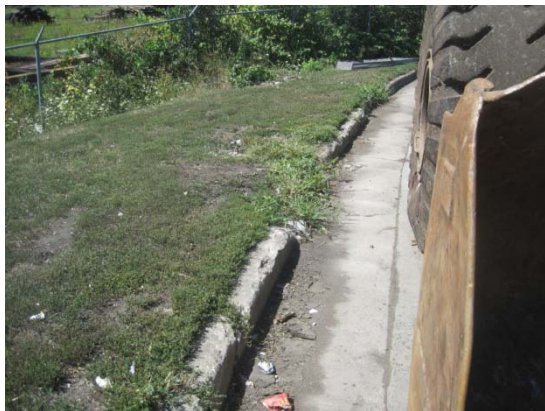
Deteriorated curb near Transfer Station

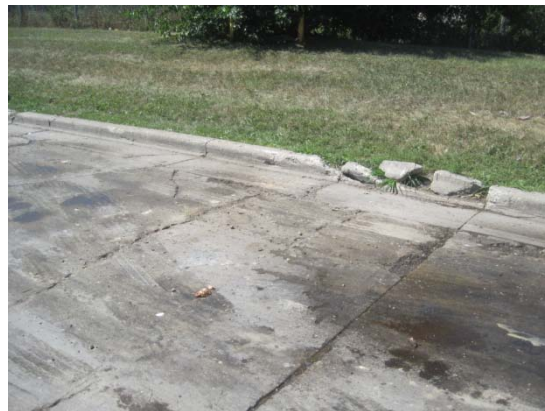
Deteriorated curb near Transfer Station

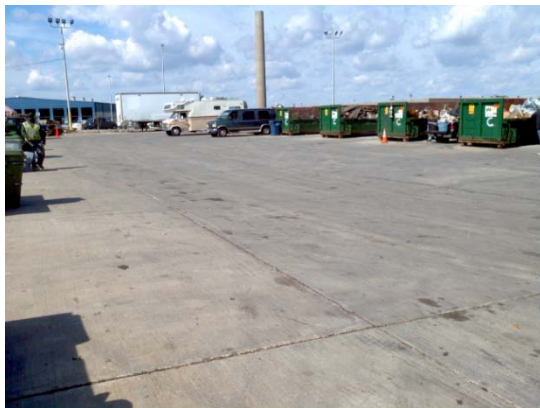
Inventory (SF)		Condition Rating	Age (Years)	RUL (Years)	1st Year of Capital Expenditure
Concrete Pavement	385,000	Varies	Varies	2	2014
