Facilities Condition Assessment Program

Project Review

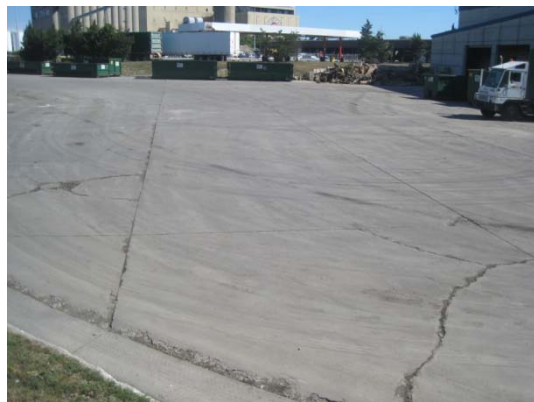
Cracked concrete at Transfer Station

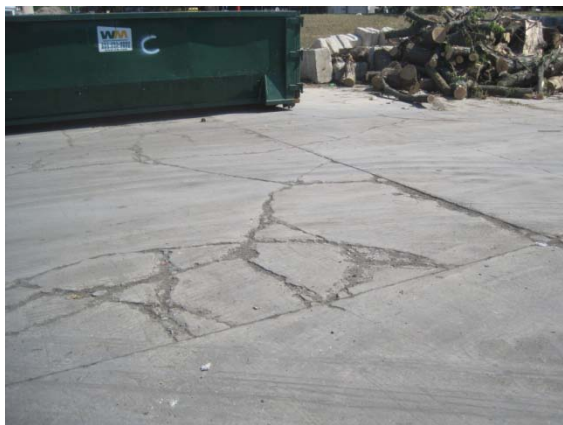
Cracked concrete at Transfer Station

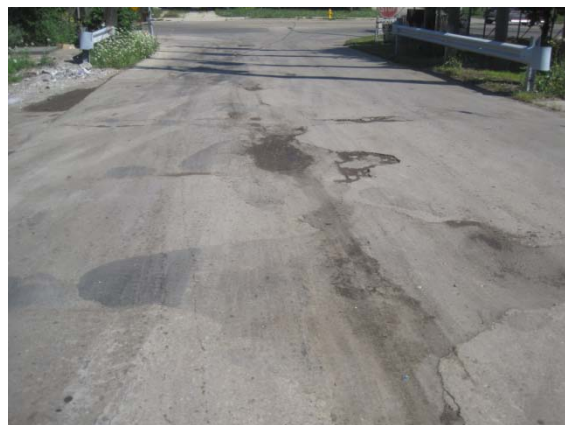
Cracked concrete at Lincoln Garage

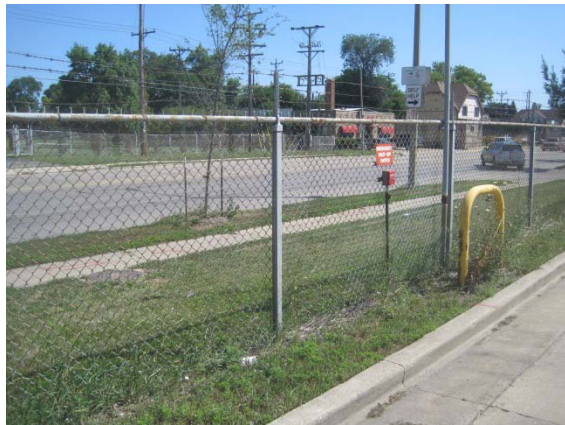
Inventory (EA)		Condition Rating	Age (Years)	RUL (Years)	1st Year of Capital Expenditure
Chain Link Fence (LF)	680	7	Unknown	12	2024
Gates	3	7	Unknown	12	2024
Gate Operator	3	Unknown	Unknown	12	2024

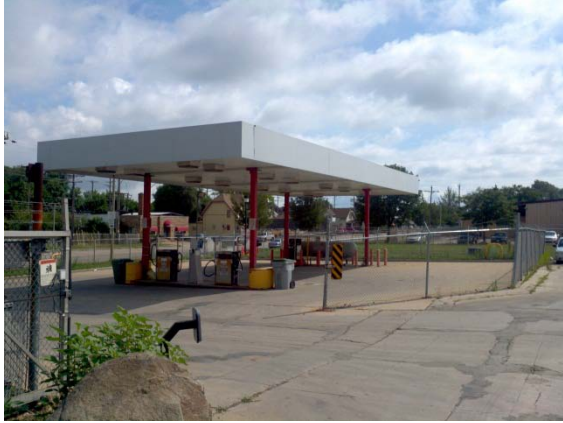
Northeast fuel island

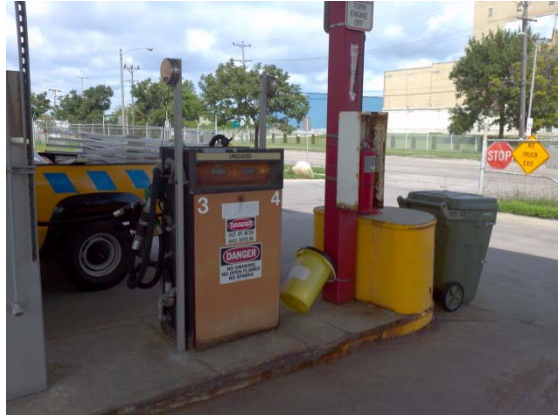
Rusted curb and dispenser

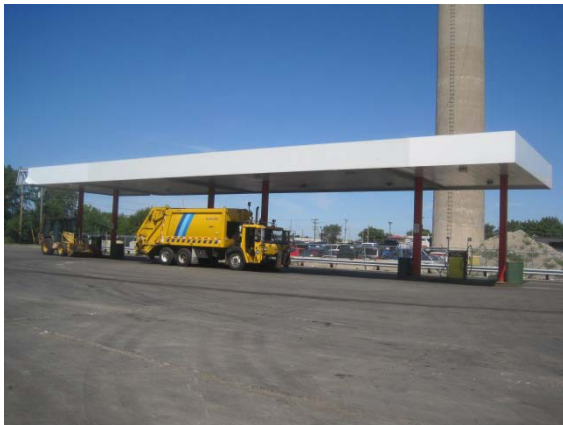
Southwest fuel island

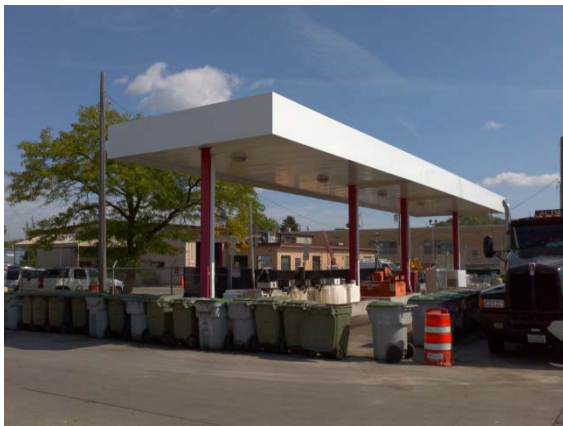
Self Help fuel island

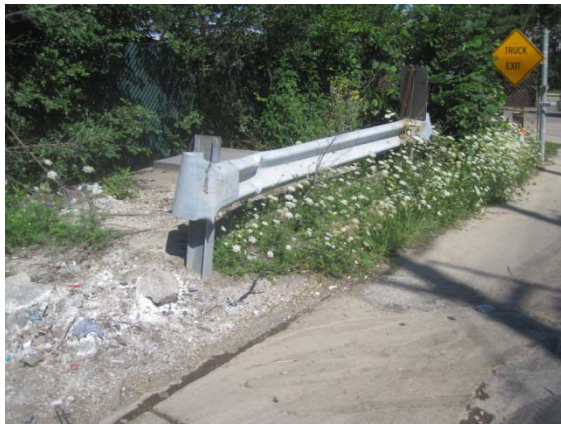
Inventory (EA)		Condition Rating	Age (Years)	RUL (Years)	1st Year of Capital Expenditure
Guard Rail (LF)	460	6	Unknown	12	2024

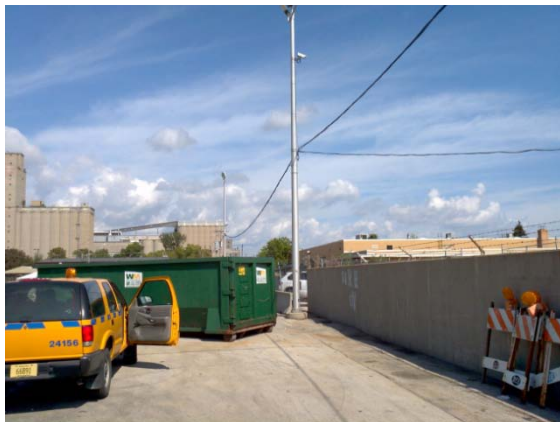
Light pole and fixture

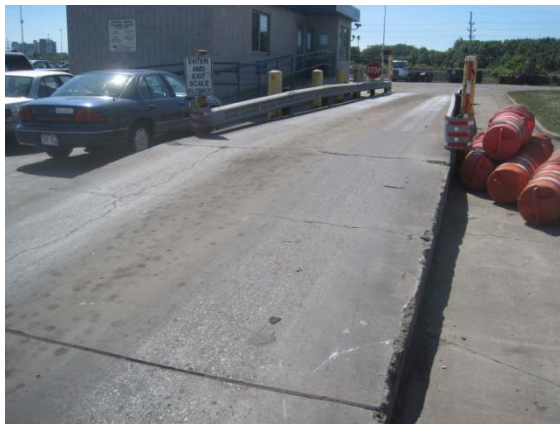
Inventory (EA)		Condition Rating	Age (Years)	RUL (Years)	1st Year of Capital Expenditure
Scales	2	6	Unknown	8	2020

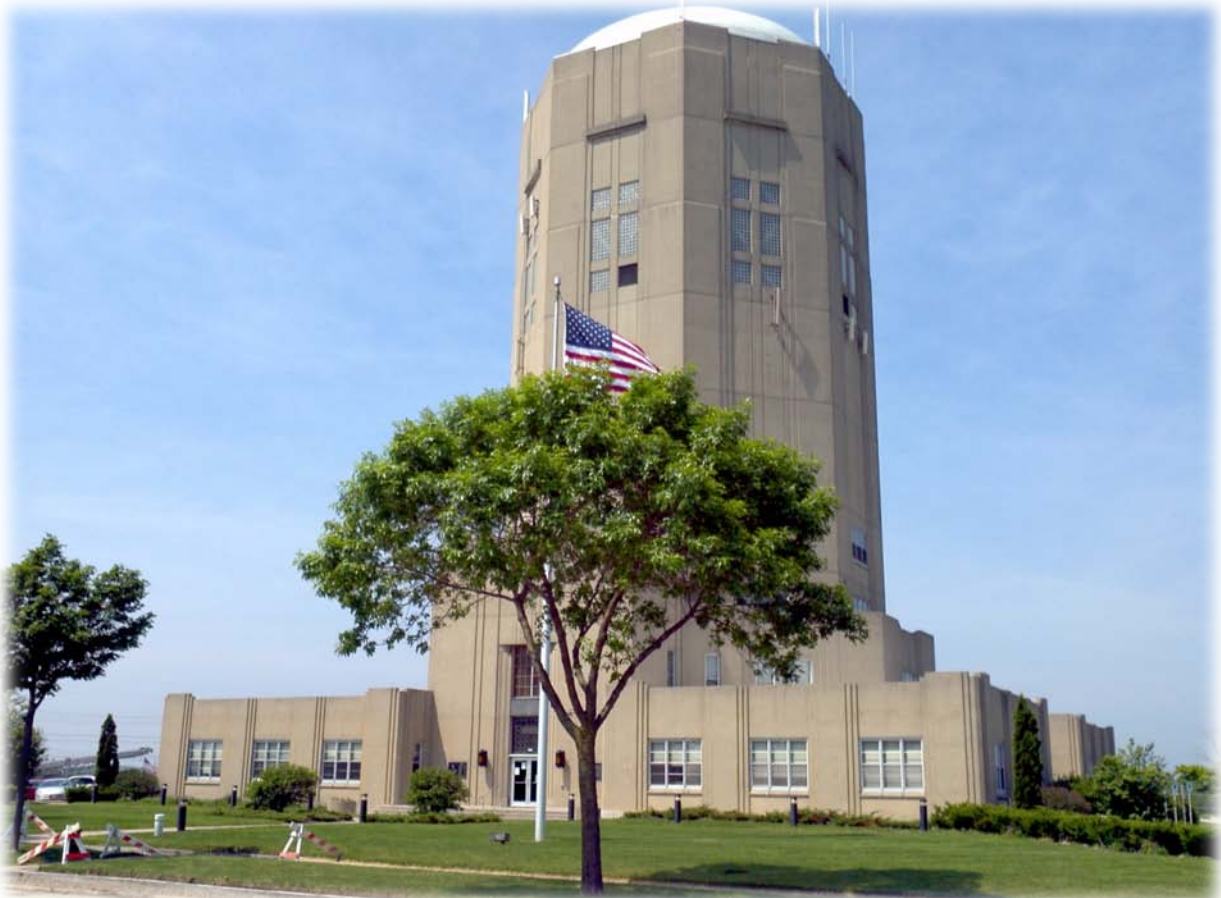
FACILITIES
CONDITION
ASSESSMENT
PROGRAM

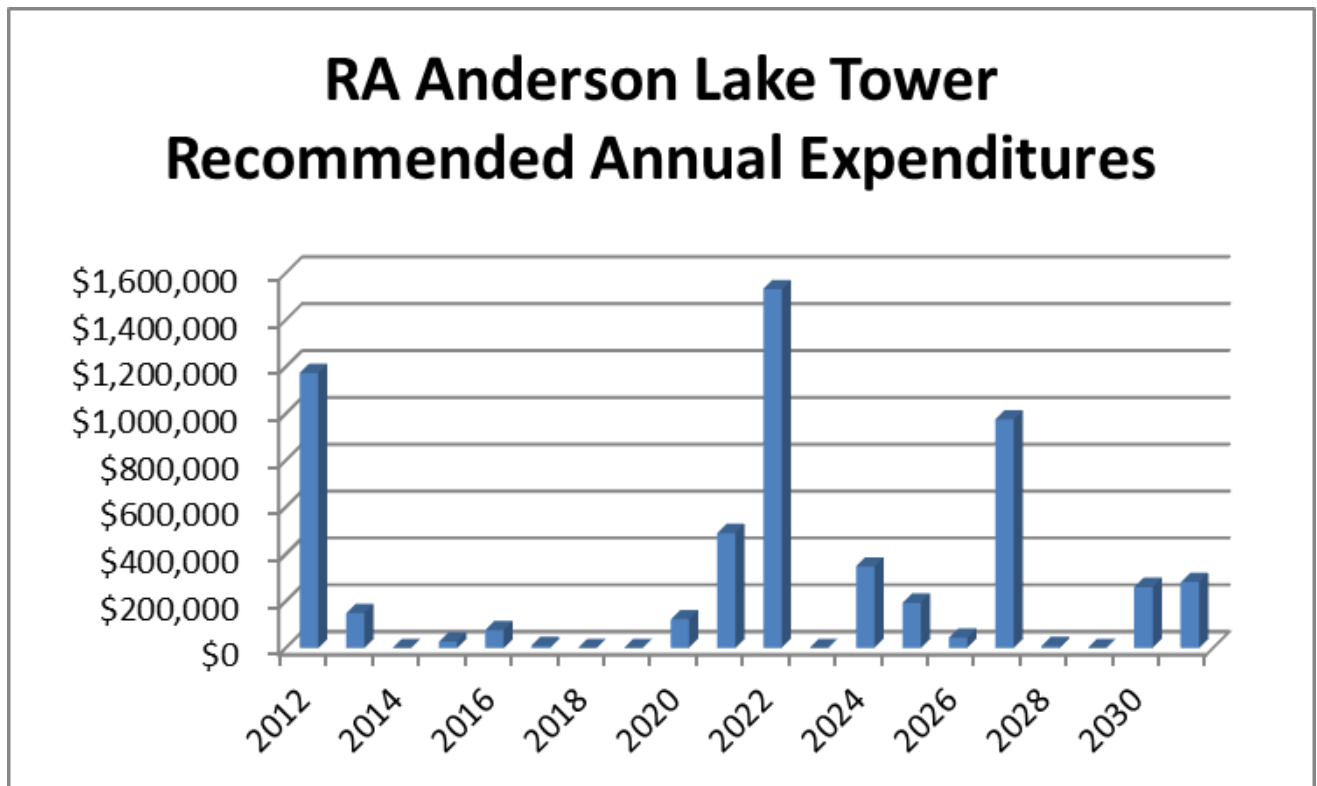
The most significant category of RA Anderson expenditures pertains to building envelope repairs as shown below. Building envelope façade repairs is the most significant components.

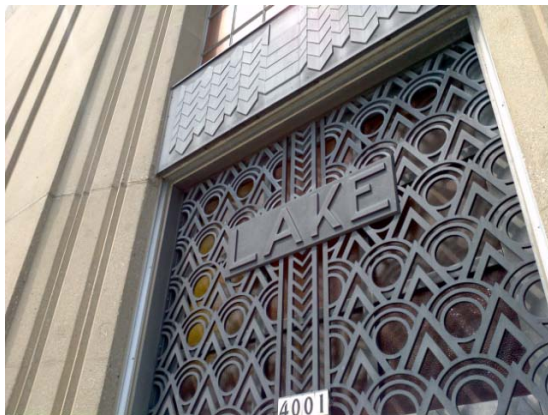
Metal architectural detail

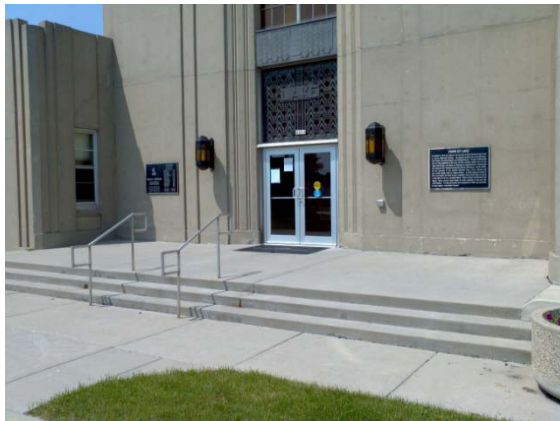
Front entrance doors

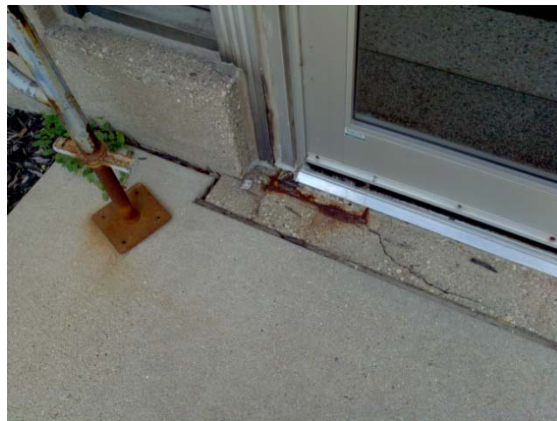
Cracked threshold at door

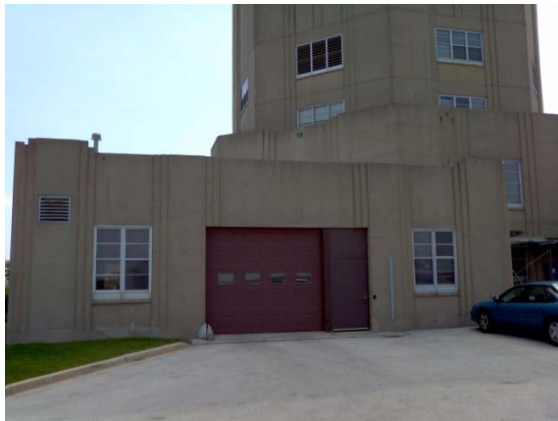
Inventory (EA)		Condition Rating	Age (Years)	RUL (Years)	1st Year of Capital Expenditure
Garage Door	1	5	Unknown	5	2017

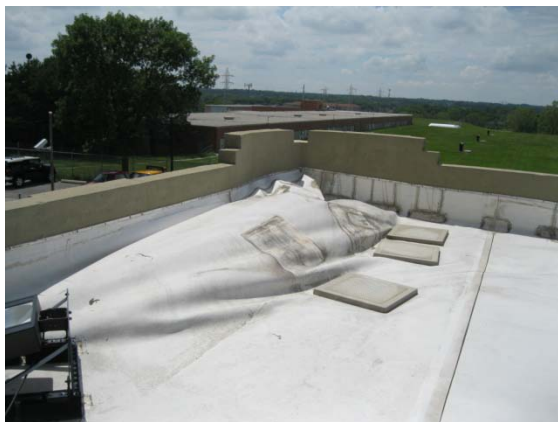
Roof 5 EPDM membrane detached

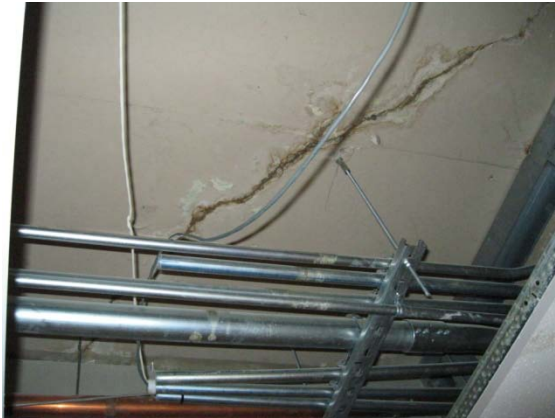
Roof deck underside is cracked and leaks

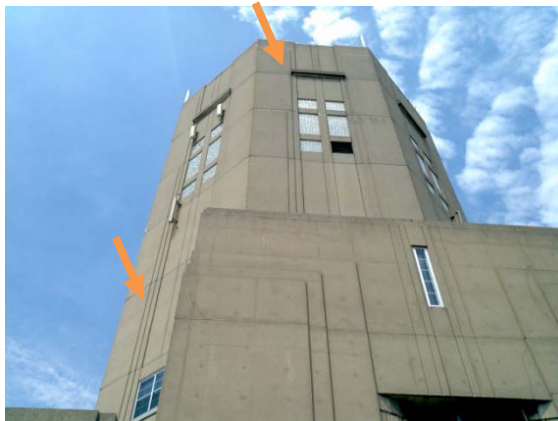
Inventory (LF)		Condition Rating	Age (Years)	RUL (Years)	1st Year of Capital Expenditure
Caulk	5,200	7	0	15	2027

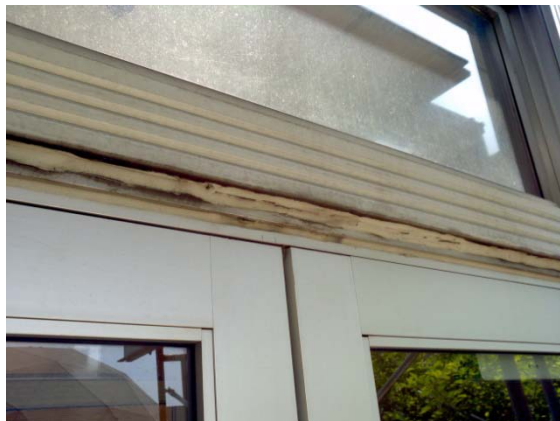
Caulk at doors replaced in 2011

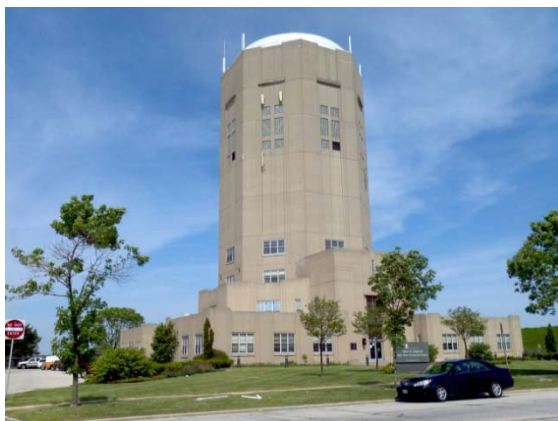
Inventory (Ls)		Condition Rating	Age (Years)	RUL (Years)	1st Year of Capital Expenditure
Critical Façade Examination	34,500	6	72	5	2016
2012Repairs (LS)	1	3	N/A	0	2012
Remaining Repairs	1	3	N/A	0	2012
Subsequent	1	N/A	N/A	15	2027

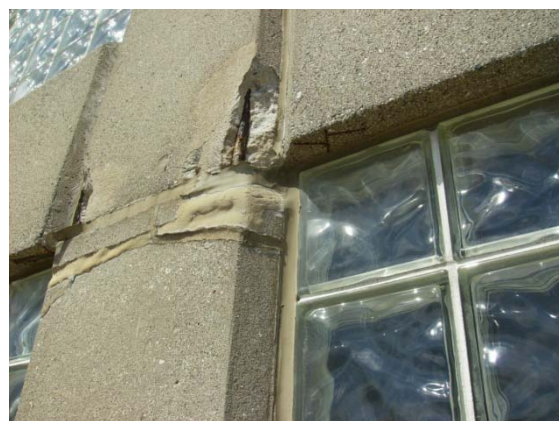
Spalled concrete facade

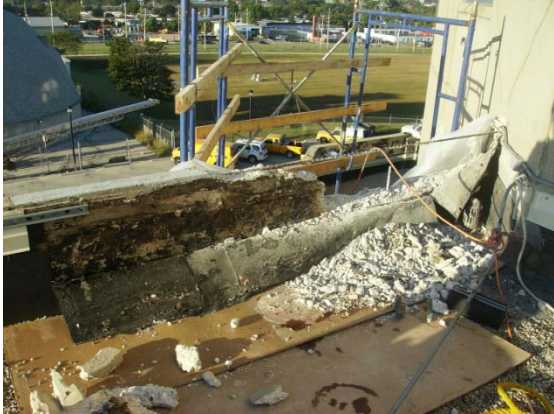
3rd floor parapet wall rebuild

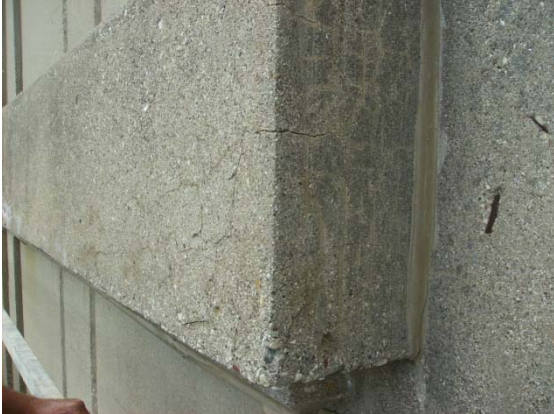
Cracked concrete eyebrow

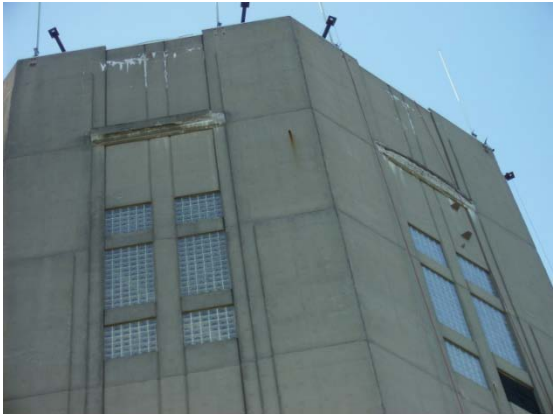
Concrete eyebrow restoration

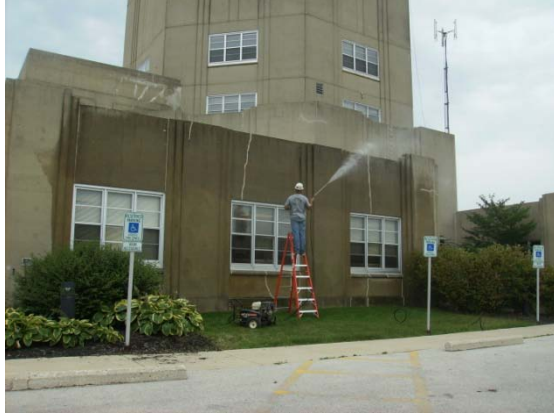
Concrete sealer application

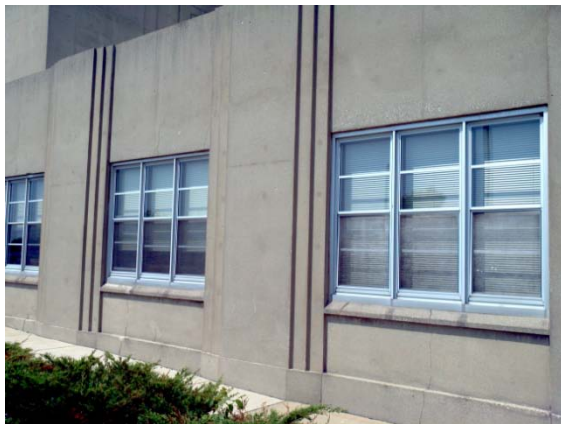
Typical aluminum frame windows

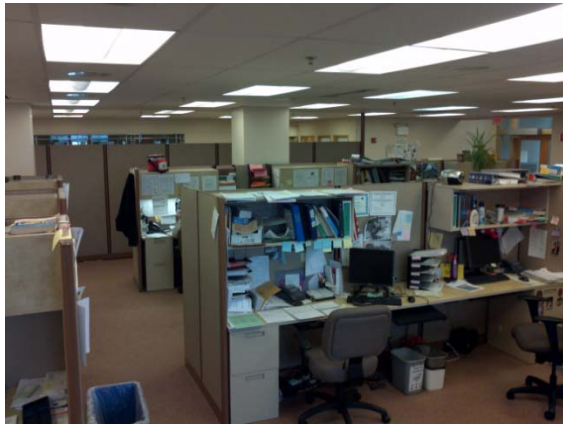
Typical equipment furniture

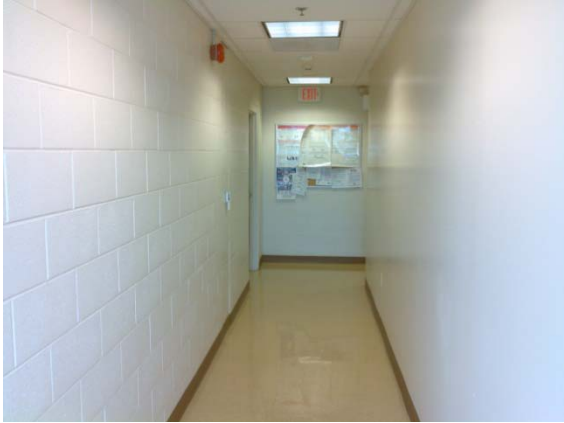
First floor hallway finishes

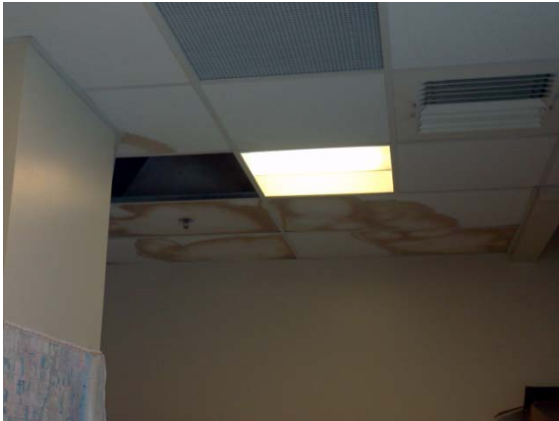
Stained ATC 2nd floor southeast office

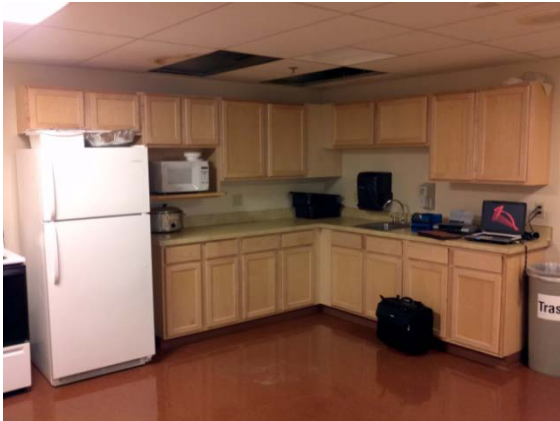
Third floor kitchen, note damaged ATC

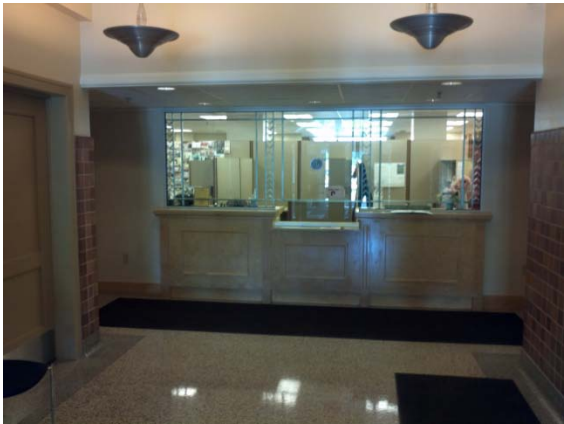
Lobby light fixtures, tile, floor long lived

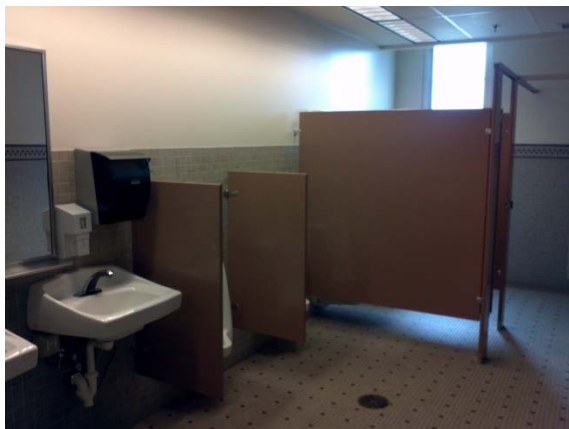
Typical rest room interior finishes

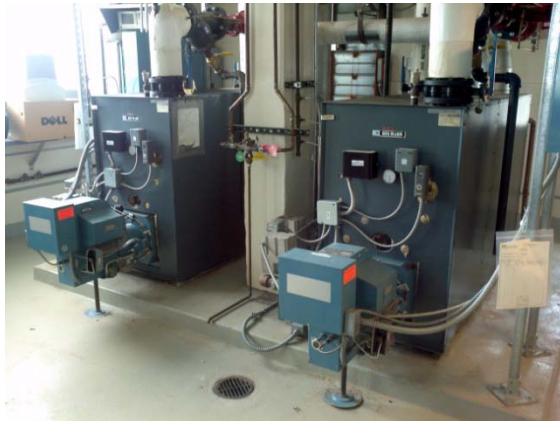
Building heat boilers

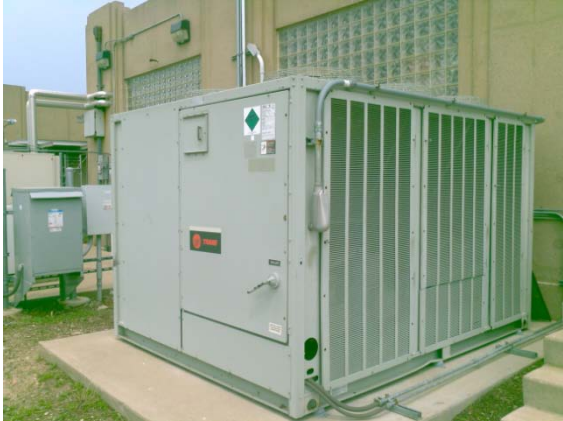
Inventory (EA)		Condition Rating	Age (Years)	RUL (Years)	1st Year of Capital Expenditure
Chiller (50 Tons)	1	7	10	13	2025

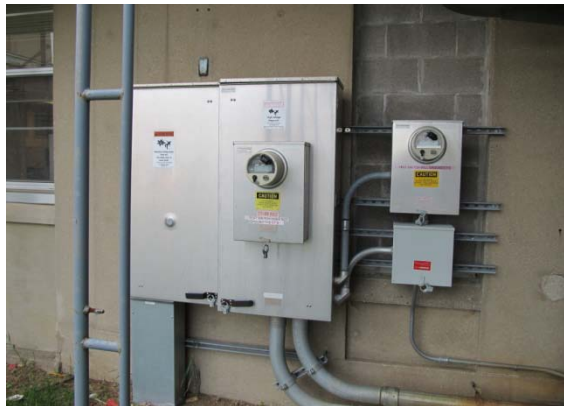
Secondary distribution

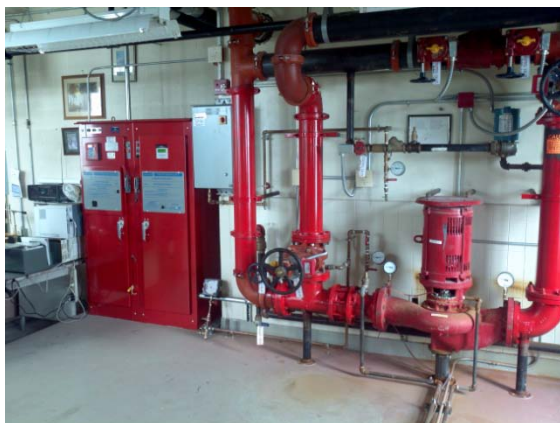
Fire control equipment and pump

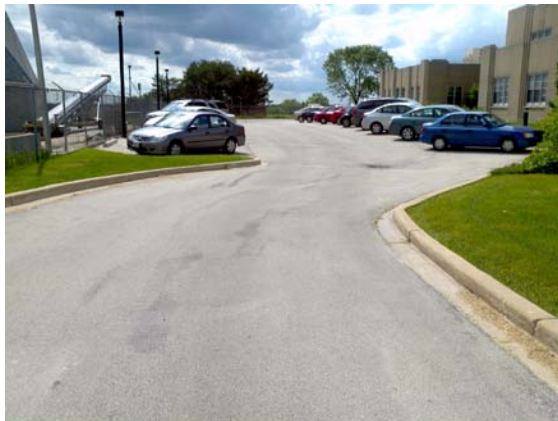
Inventory		Condition Rating	Age (Years)	RUL (Years)	1st Year of Capital Expenditure
Asphalt Pavement (SY)	3,900	5	11	12	2024
Catch Basins (EA)	4	6	11	12	2024
Concrete Curbs (LF)	405	6	11	12	2024
Concrete Car Stops (EA)	61	6	11	12	2024

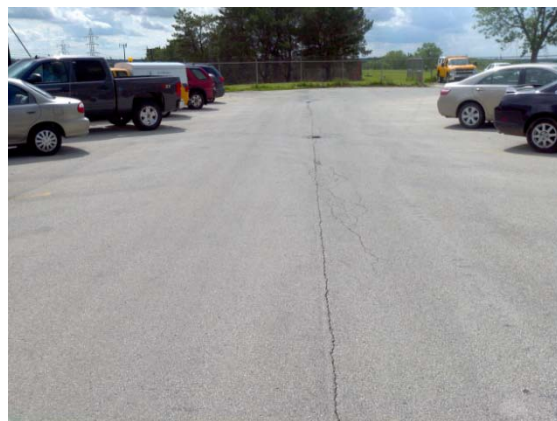
Transverse crack at centerline drainage

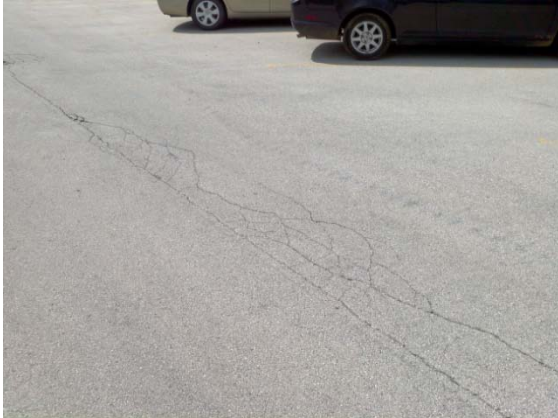
Alligator cracking/failed pavement

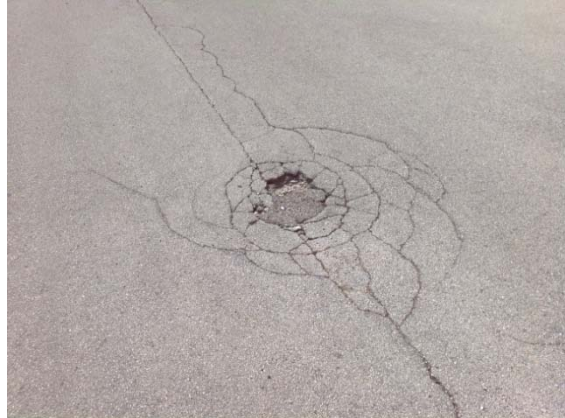
Failed pavement/pot hole

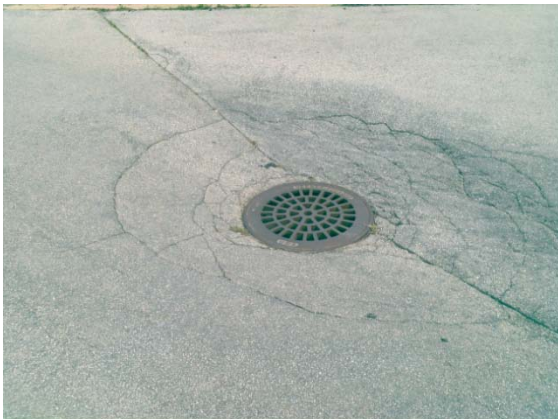
Failed pavement and settled catch basin

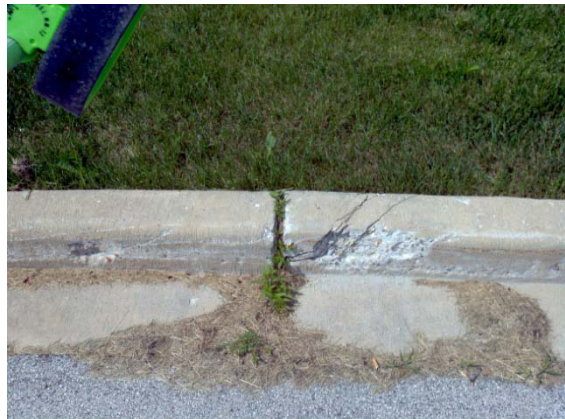
Damaged concrete curb

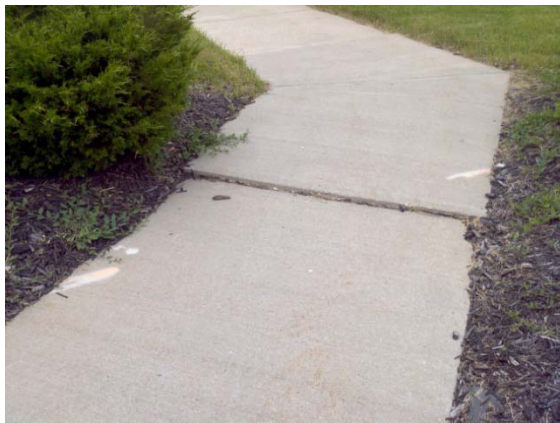
Concrete trip hazard – grind and level

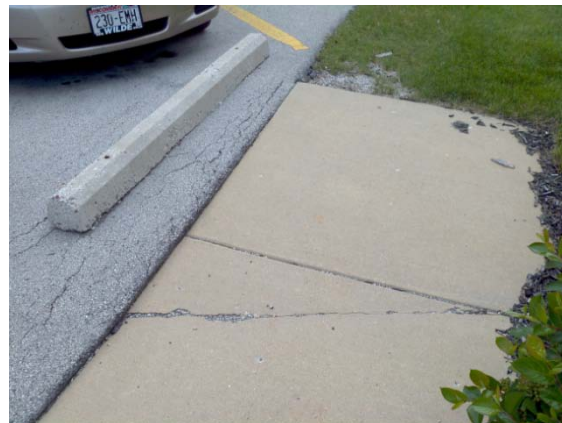
Cracked concrete sidewalk w settlement

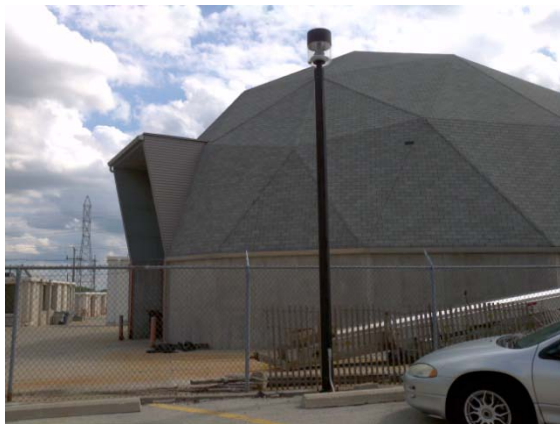
Typical light pole and fixture

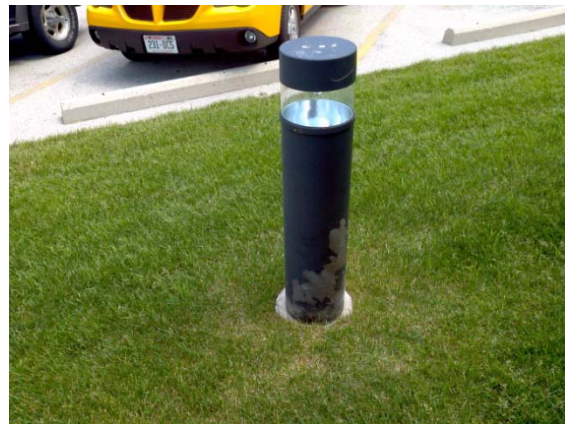
Bollard light w factory finish deterioration

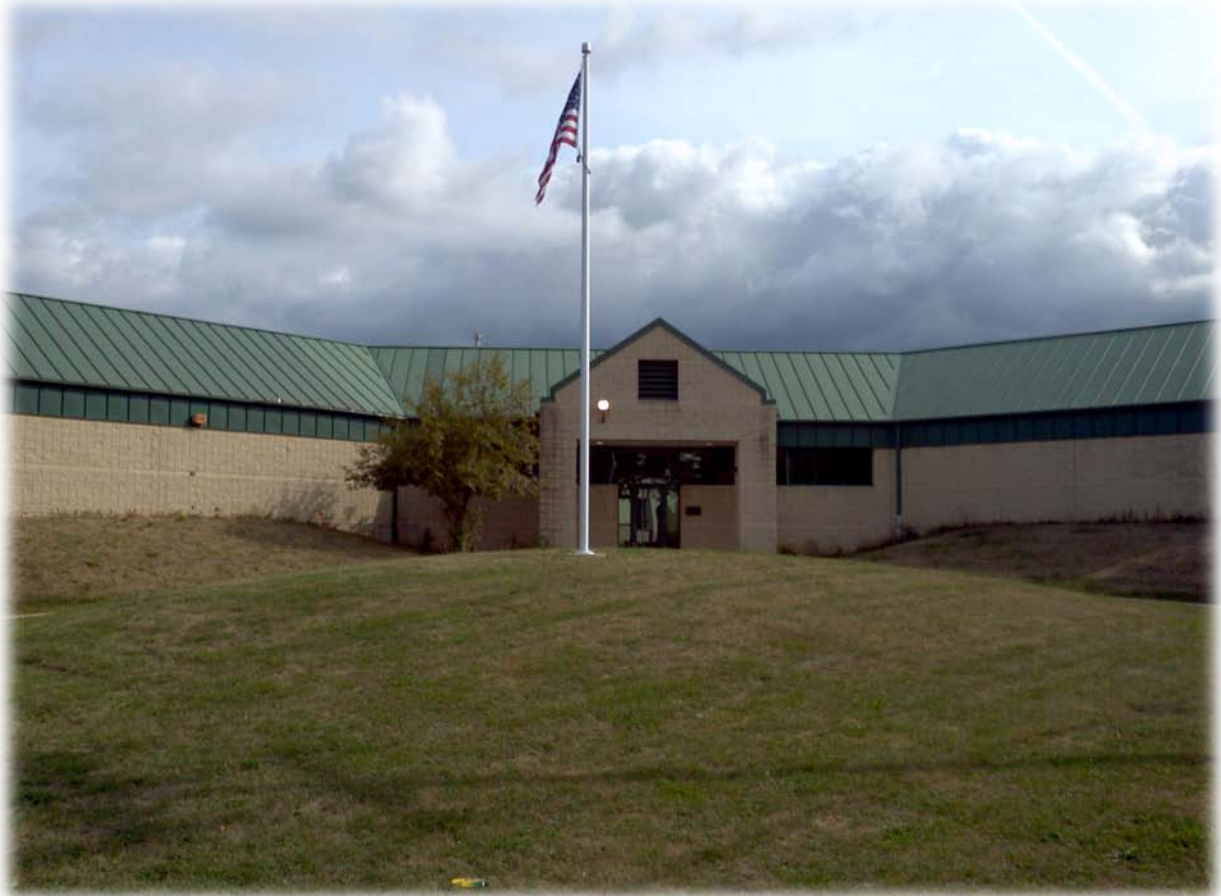
FACILITIES
CONDITION
ASSESSMENT
PROGRAM

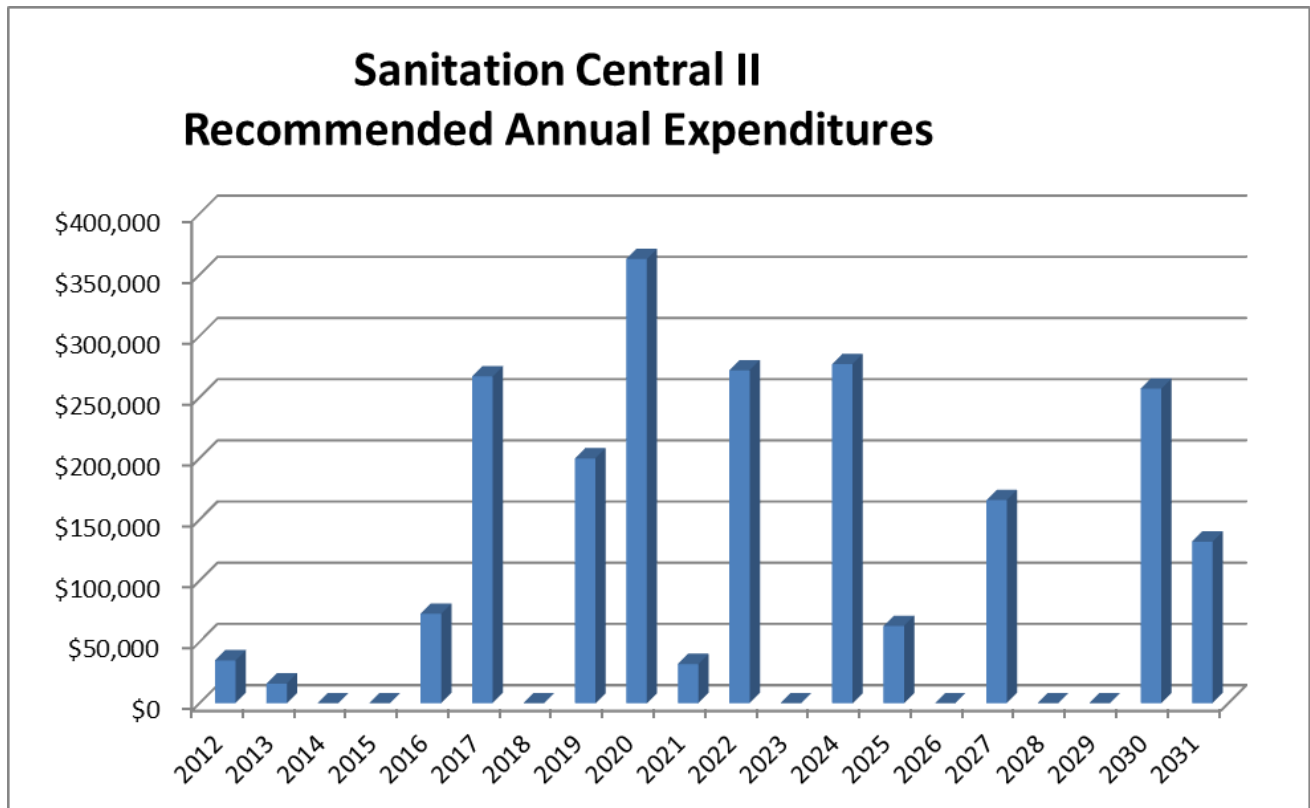
The most significant category of expenditures pertains to the office building as shown below.

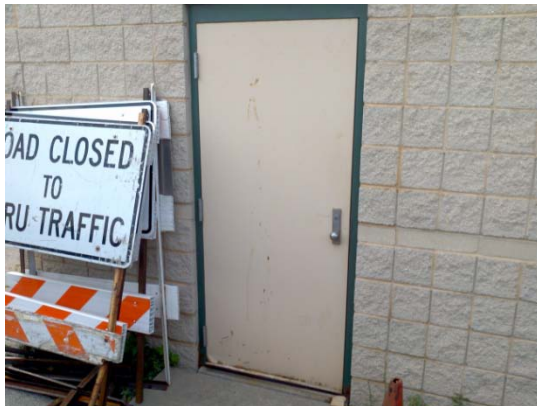
Metal door with rust

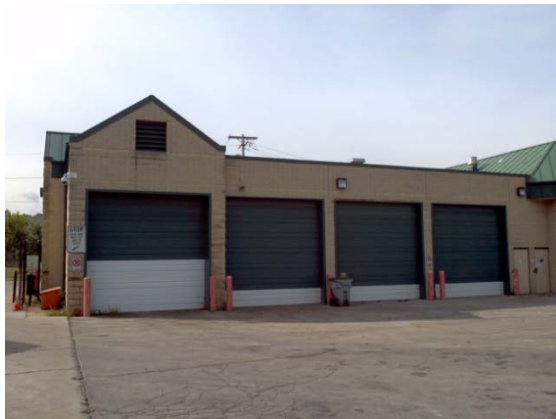
Office building garage doors

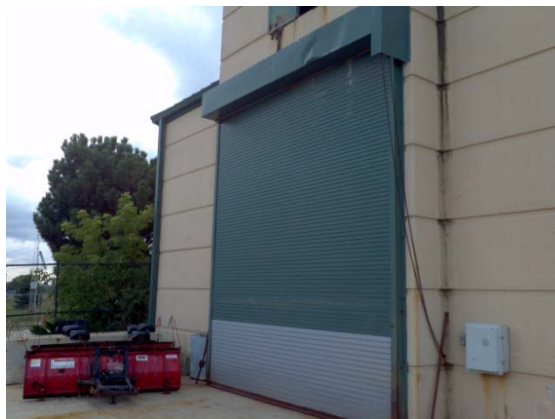
Salt dome garage door – note rust/damage

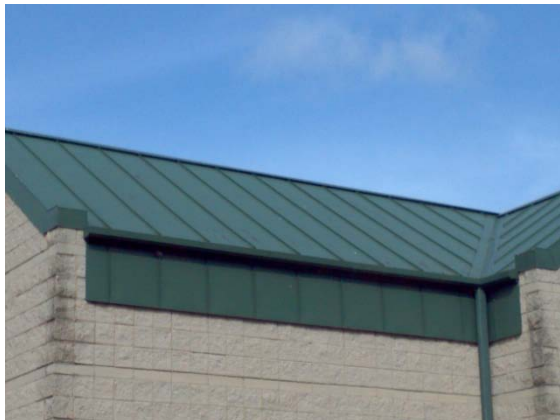
Gutters and downspout

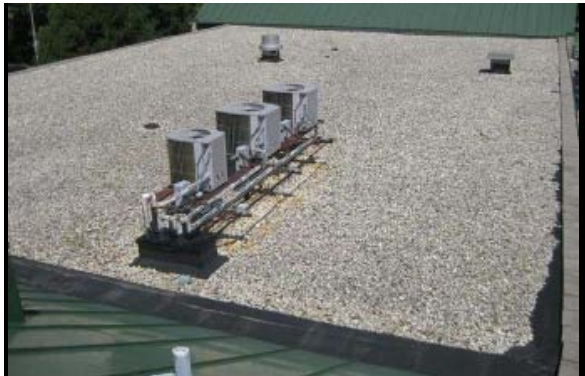
Inventory (SF)		Condition Rating	Age (Years)	RUL (Years)	1st Year of Capital Expenditure
#1 Office	4,612	5	Unknown	7	2019
#3 Office	2,210	5	Unknown	7	2019
#4 Salt Dome	110	5	Unknown	7	2019

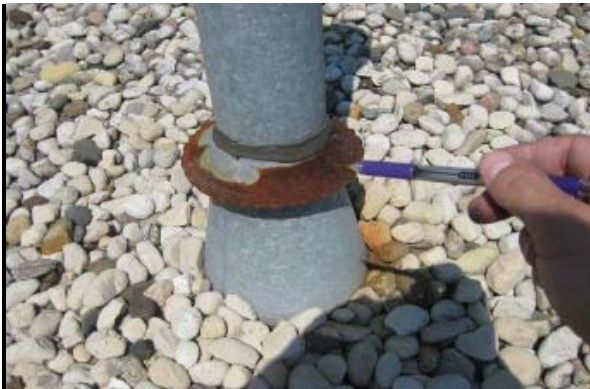
Rusted bonnet at vent

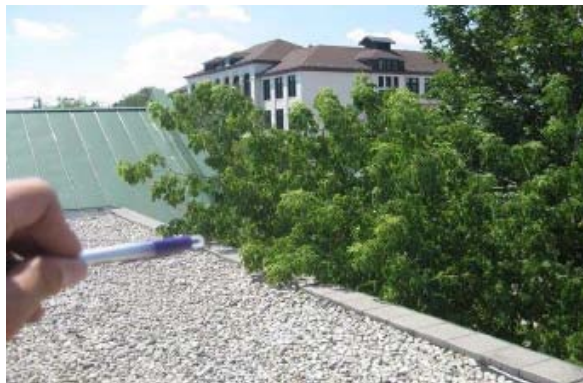
Overgrown tree deposits debris atop roof

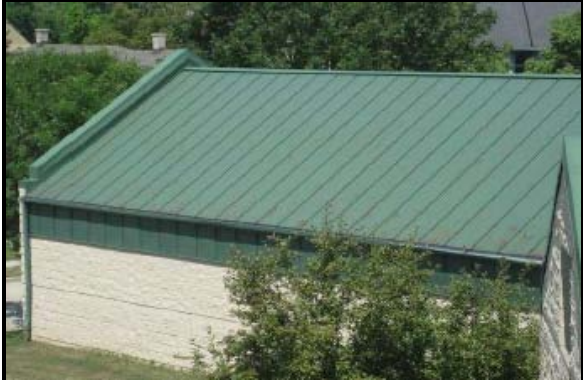
Tented edge flashings

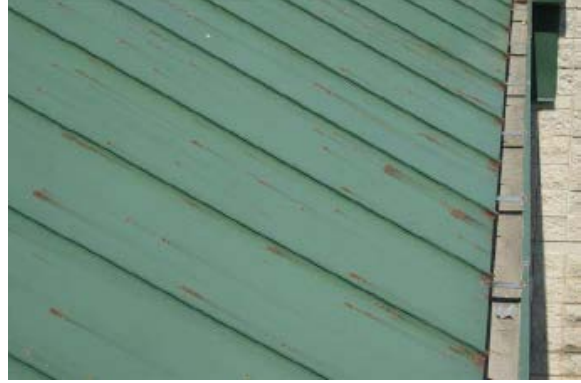
Rusted roof – typical condition

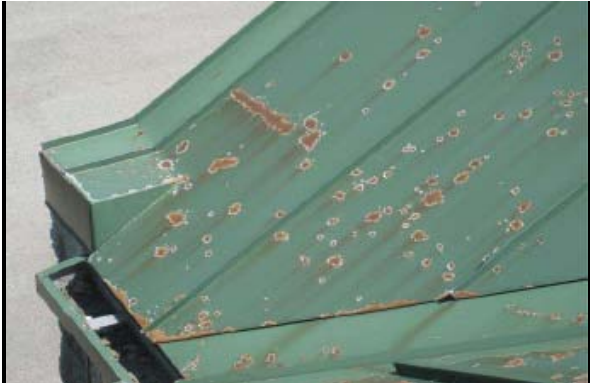
Rusted roof – typical condition

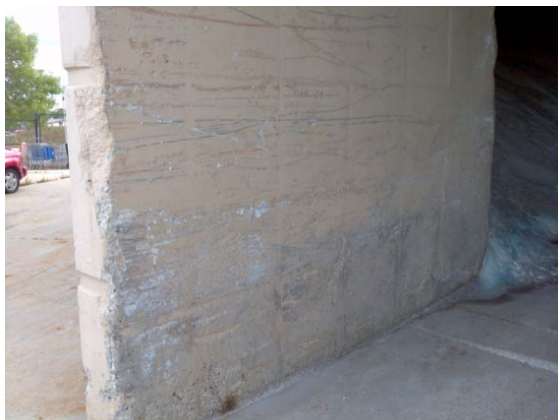
Inventory (SF)		Condition Rating	Age (Years)	RUL (Years)	1st Year of Capital Expenditure
Masonry	11,150	6	Unknown	7	2019
Concrete	9,350	5	Unknown	7	2019
Caulk (LF)	1,370	6	Unknown	7	2019

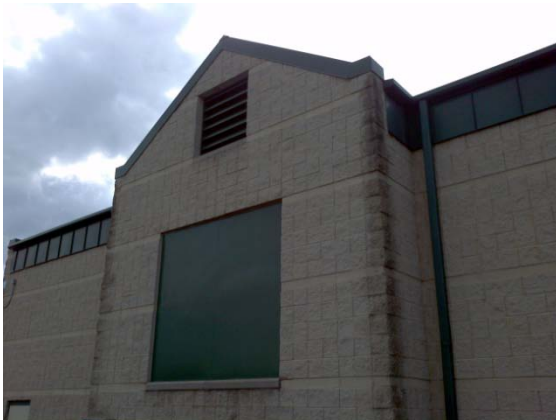
Panel siding and fascia

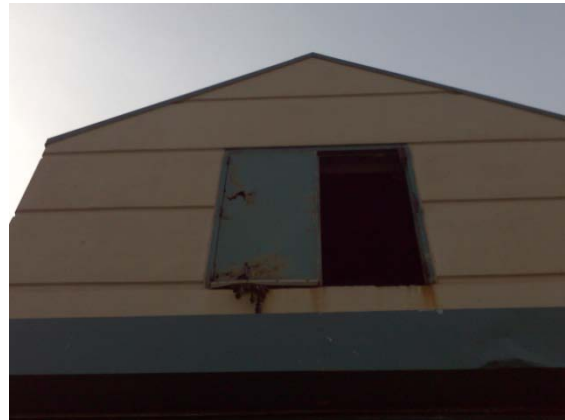
Rusted access door at salt dome

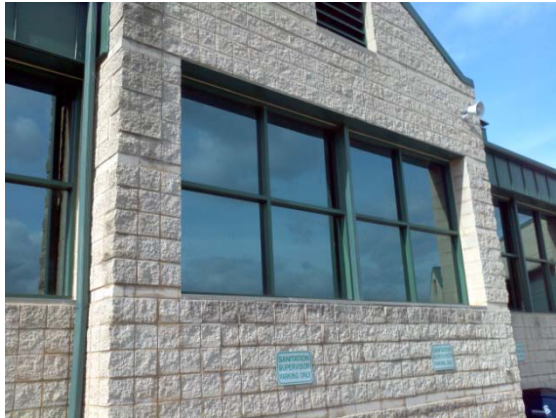
Typical aluminum frame windows

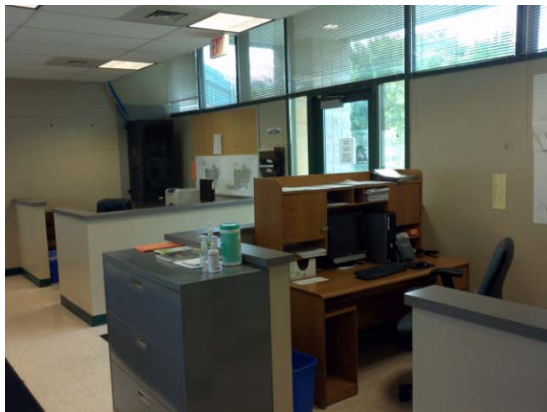
Inventory (EA)		Condition Rating	Age (Years)	RUL (Years)	1st Year of Capital Expenditure
Chairs	80	7	9	8	2020
Desks	20	7	9	8	2020
Tables	8	7	9	8	2020
Televisions	4	6	9	8	2020
Printers/Copiers	3	N/A	Unknown	8	2020
Computers	10	N/A	Unknown	Varies	2020
Telephones	13	N/A	Unknown	10	2020

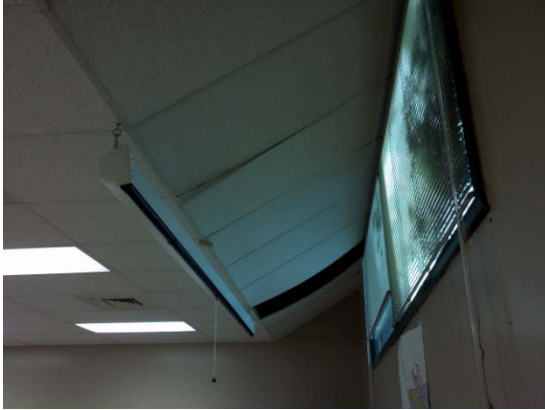
Acoustic ceiling tile missing

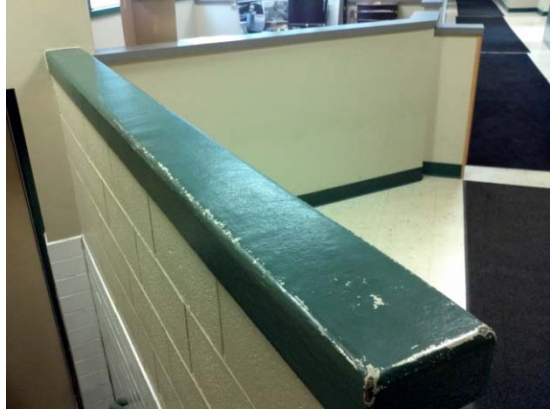
Worn paint at wall ledge

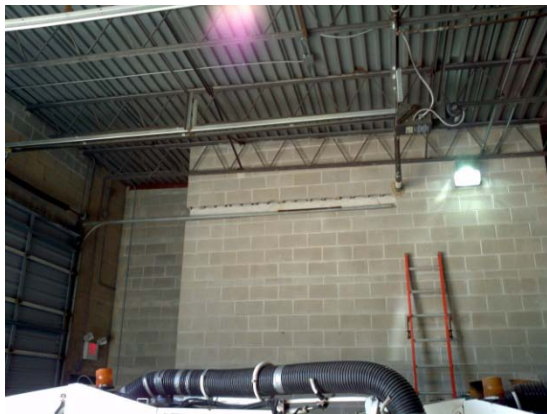
Garage light fixtures

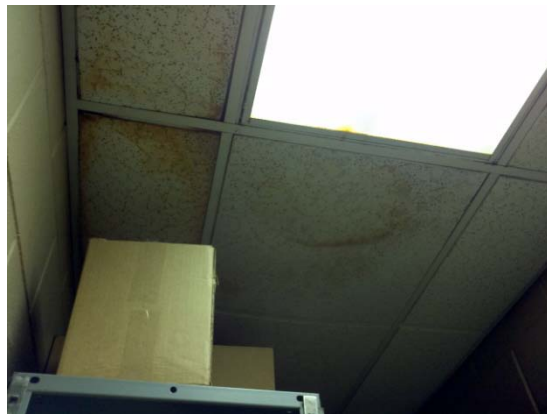
Storage room light fixture – replace damaged tile from O + M funds

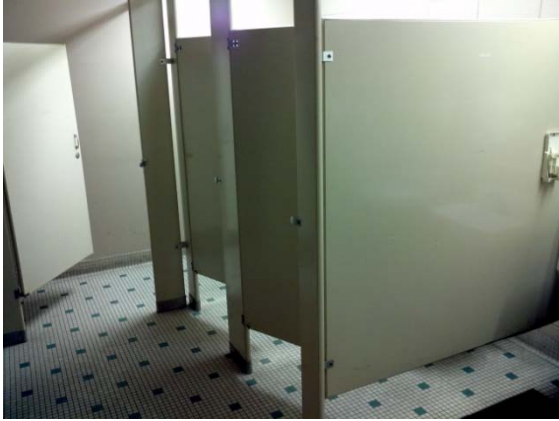
Inventory (EA)		Condition Rating	Age (Years)	RUL (Years)	1st Year of Capital Expenditure
Paint Walls/Ceilings (SF)	1,115	6	22	8	2020
Acoustic Tile Ceiling (SF)	344	6	22	8	2020
Ceramic Tile Floor (SF)	344	6	22	8	2020
Light Fixtures, Strip	4	6	22	8	2020
Light Fixtures, Recessed	5	6	22	8	2020
Toilet	5	6	22	8	2020
Urinal	1	6	22	8	2020
Sink	3	6	22	8	2020
Partition	4	6	22	8	2020
Showers	2	6	22	8	2020
Mirrors	2	6	22	8	2020

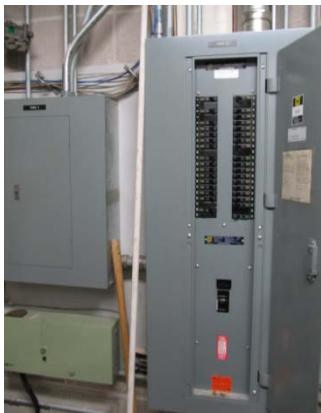
Secondary distribution

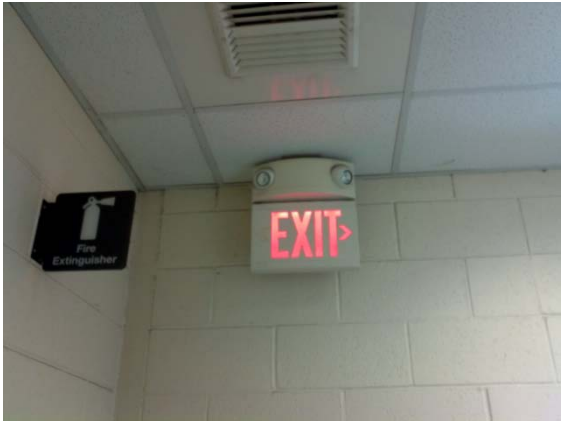
Emergency/Exit light fixture

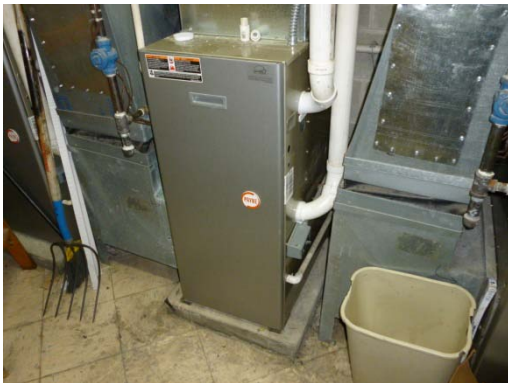
Interior forced air furnace

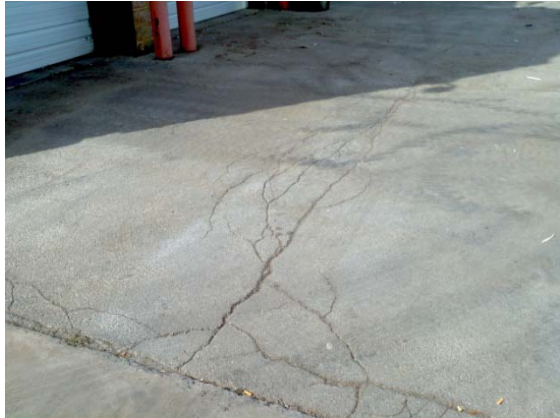
Cracked/failed pavement

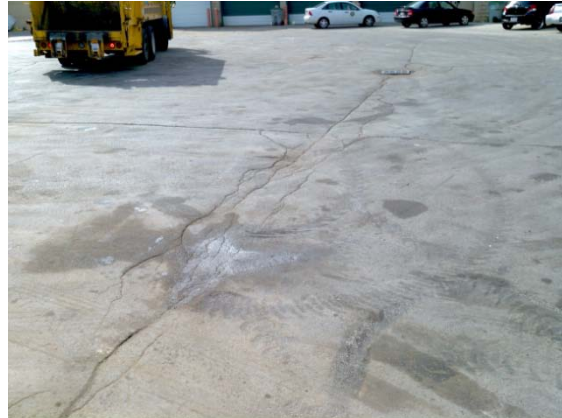
Cracked/failed pavement

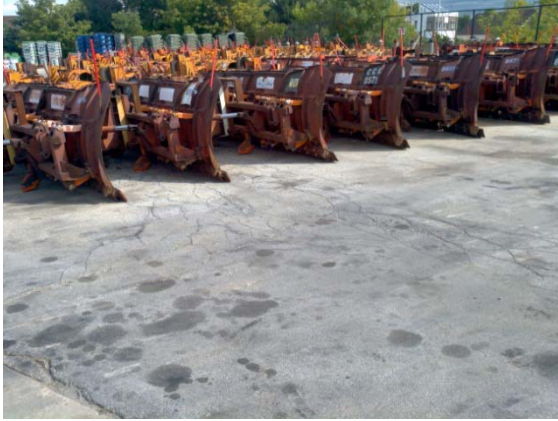
Cracked/failed pavement

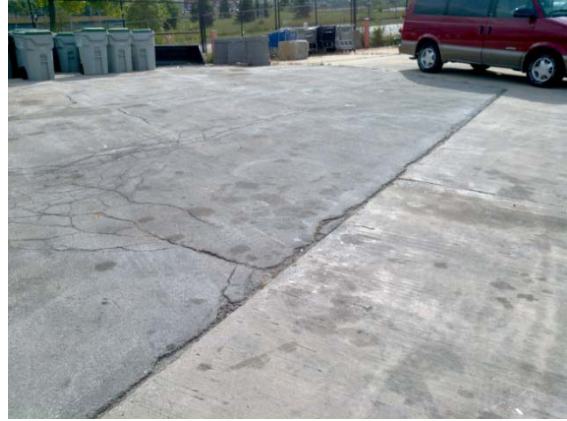
Pavement/concrete threshold

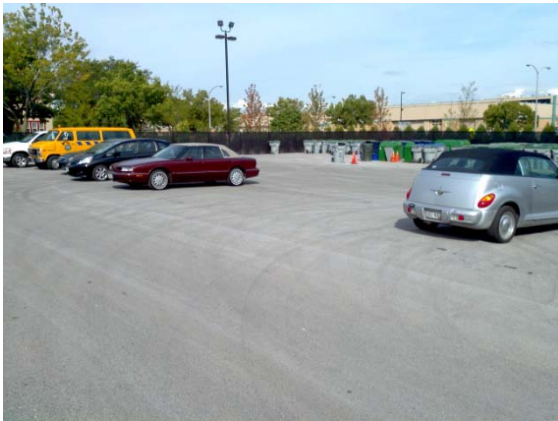
Northwest pavement – relatively good condition

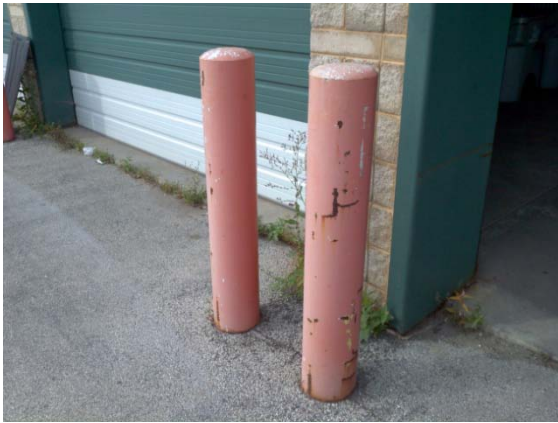
Bollard with surface rust

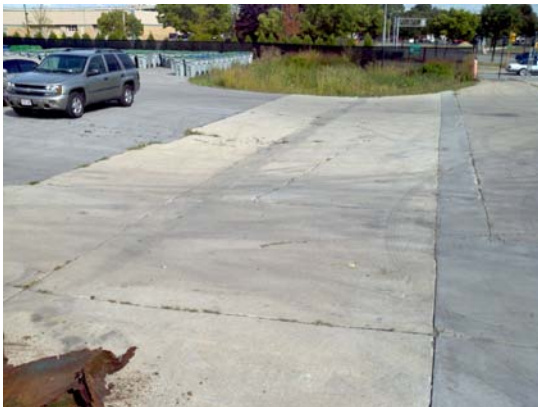
Cracked driveway near rain garden
