Facilities Condition Assessment Program

Project Review

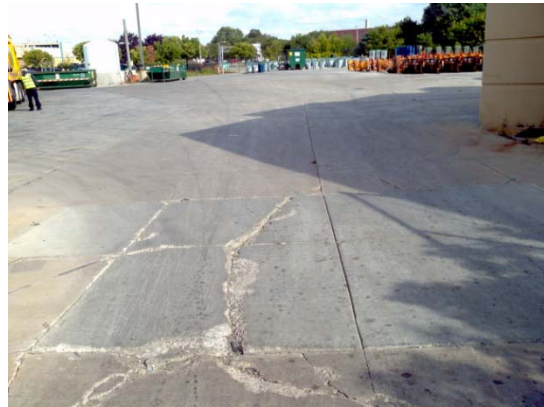
Cracked concrete at entrance drive

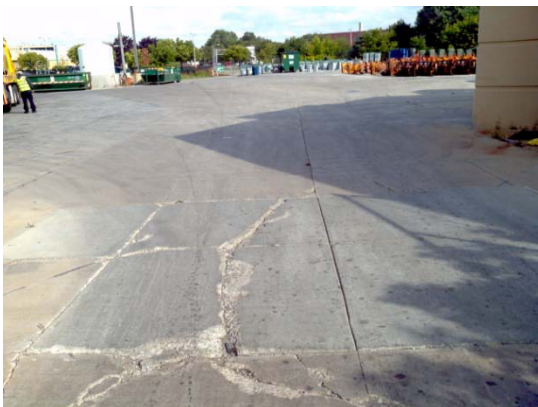
Cracked driveway near salt dome

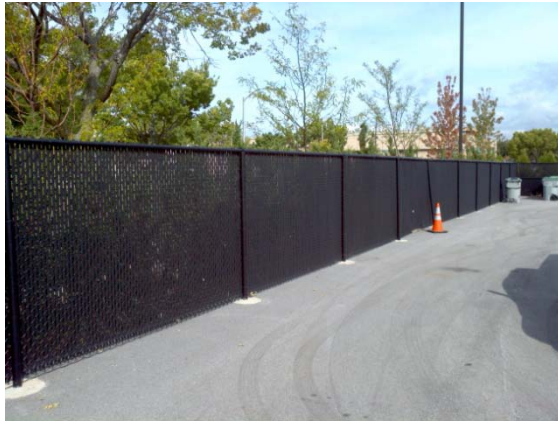
Rusted/Misaligned chain link fence

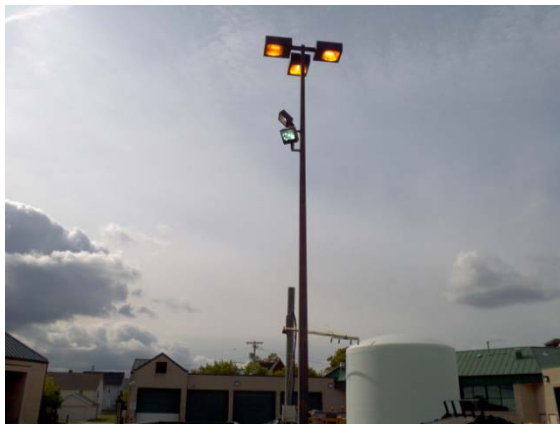
Light pole and fixture

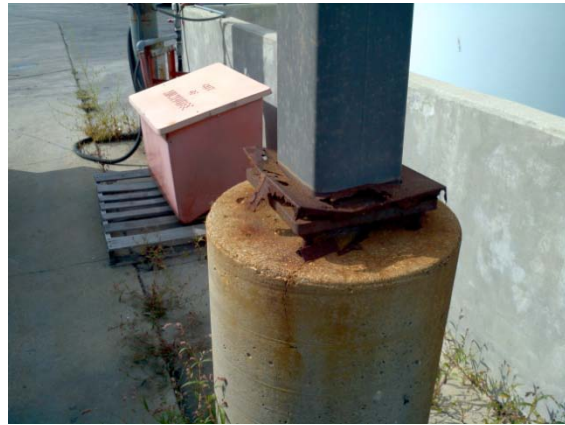
Light pole and fixture w rusted base

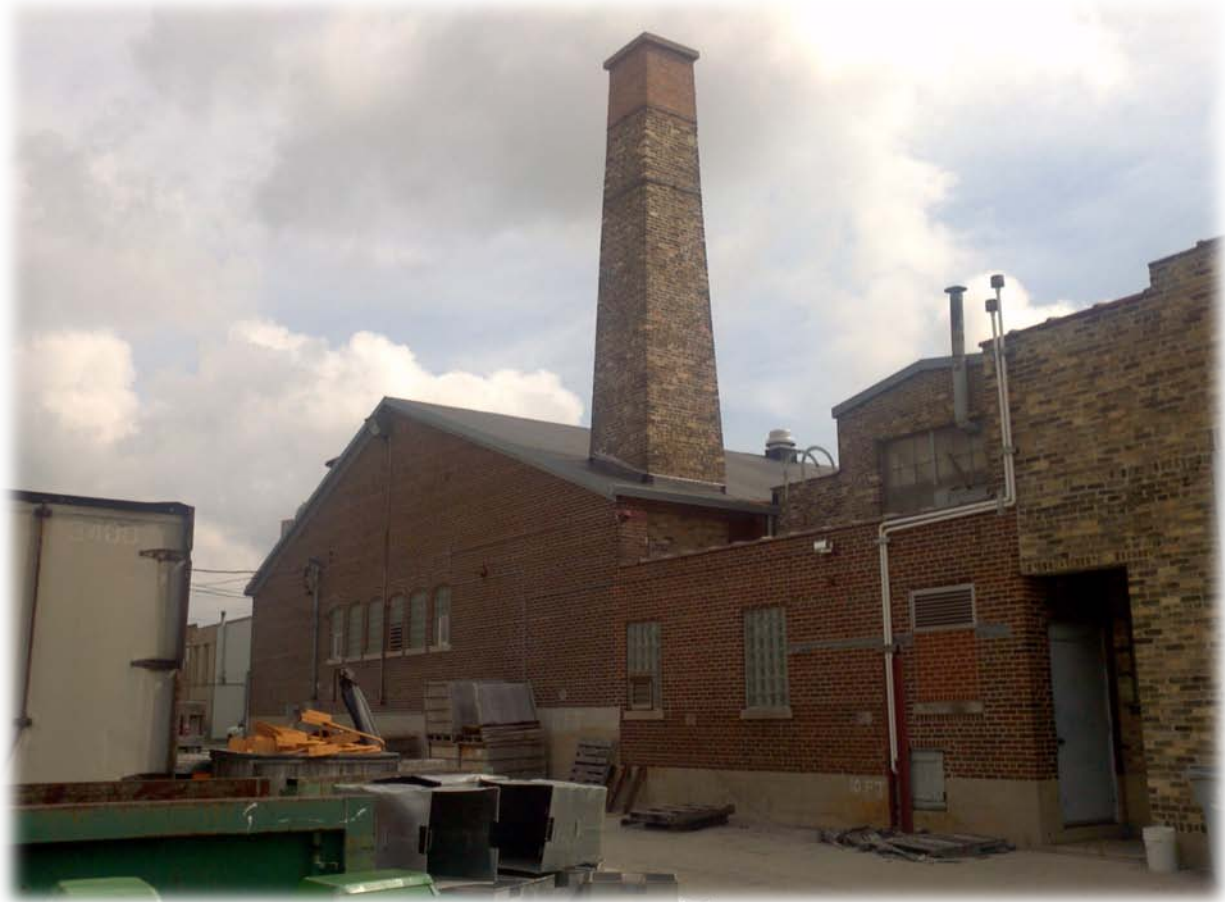
FACILITIES
CONDITION
ASSESSMENT
PROGRAM

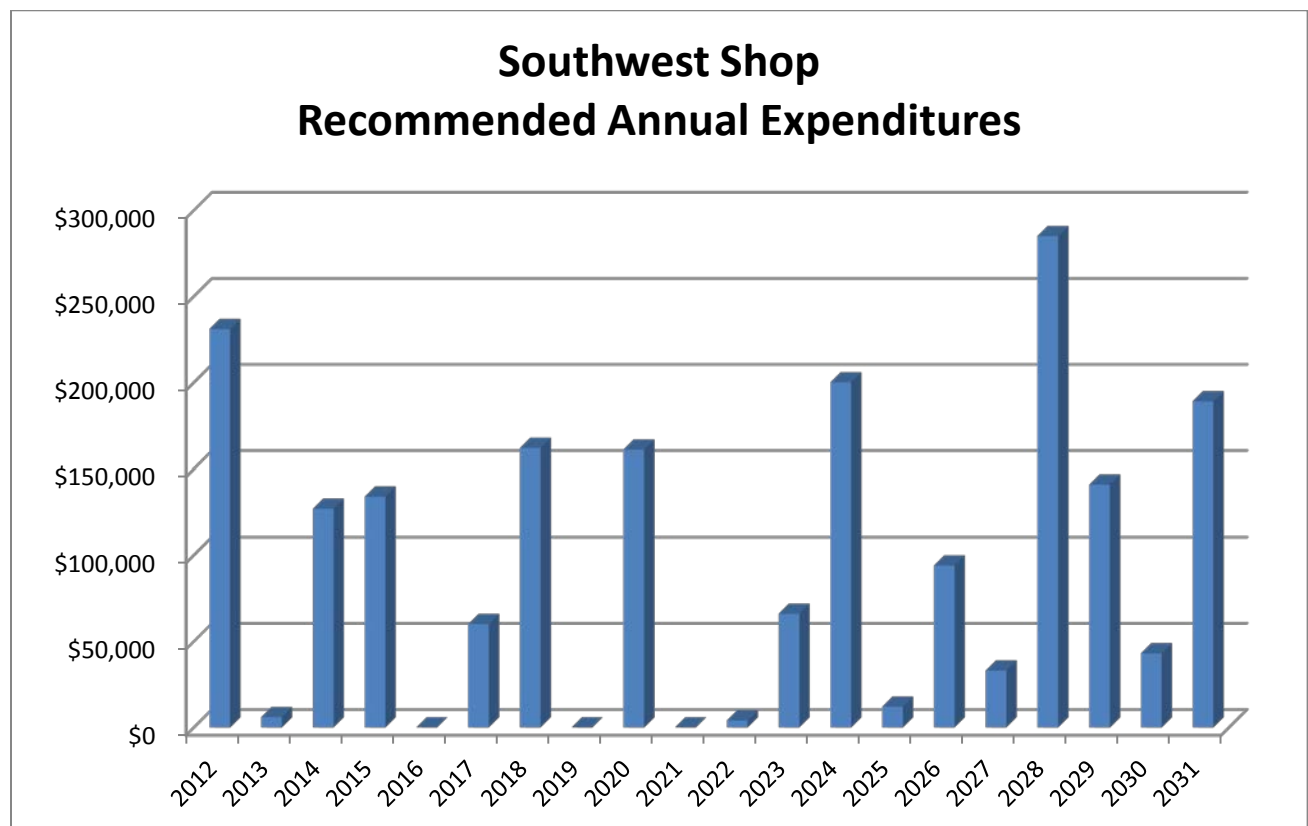
The most significant category of Southwest Shop expenditures pertains to building envelope repairs as shown below. Building envelope Roof repairs is the most significant single component.

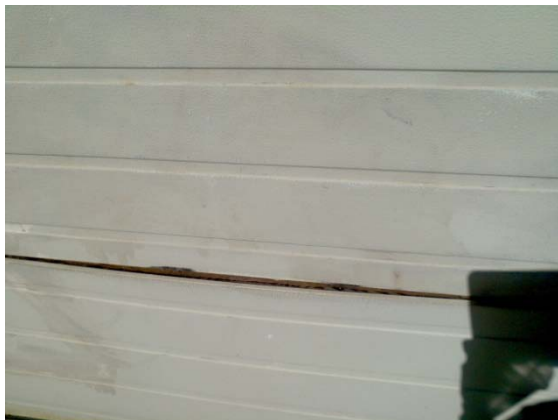
Damaged garage door panel

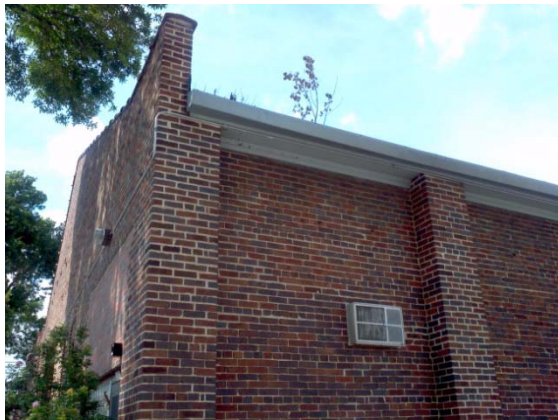
Inventory (LF)		Condition Rating	Age (Years)	RUL (Years)	1st Year of Capital Expenditure
Gutters	130	5	Unknown	2	2014
Downspouts	40	5	Unknown	2	2014

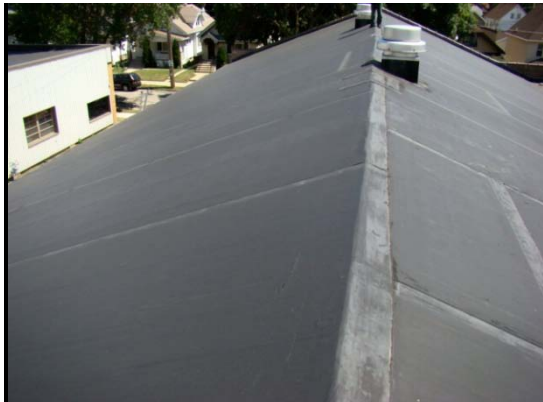
Inventory (SF)		Condition Rating	Age (Years)	RUL (Years)	1st Year of Capital Expenditure
#1	8,179	4	Unknown	2	2014
#2	11,318	3	Unknown	0	2012
#3	1,407	4	Unknown	2	2014
#4	292	4	Unknown	2	2014

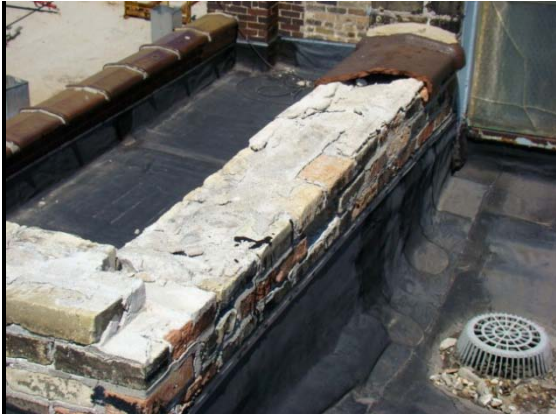
Floating insulation underneath membrane

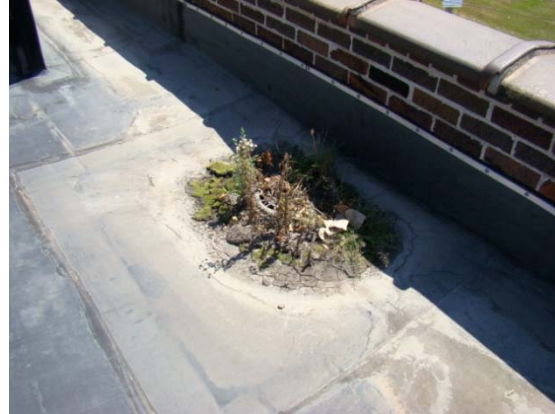
Plant growth at drain

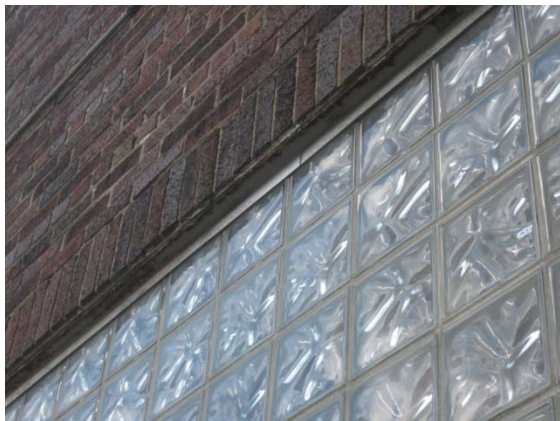
Typical rusted lintel

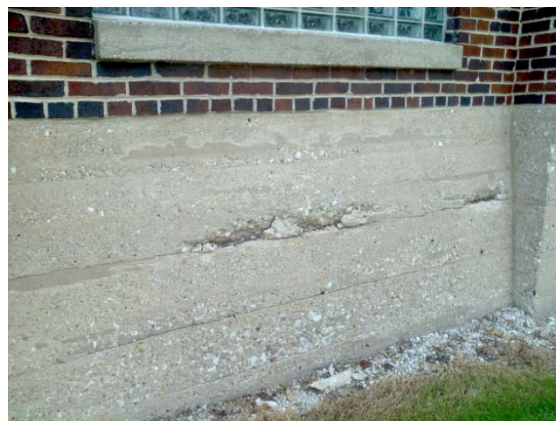
Cracked/deteriorated concrete

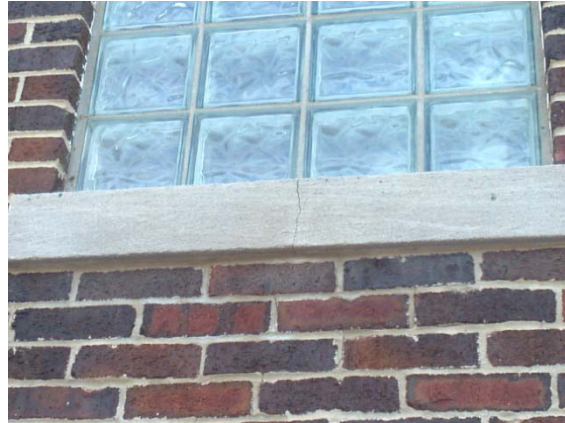
Cracked concrete sill

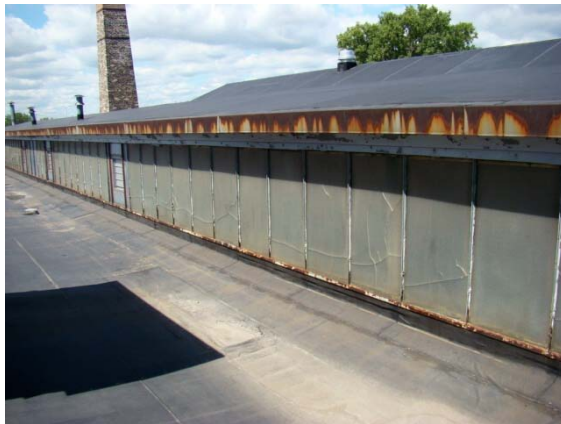
Cracked clerestory windows

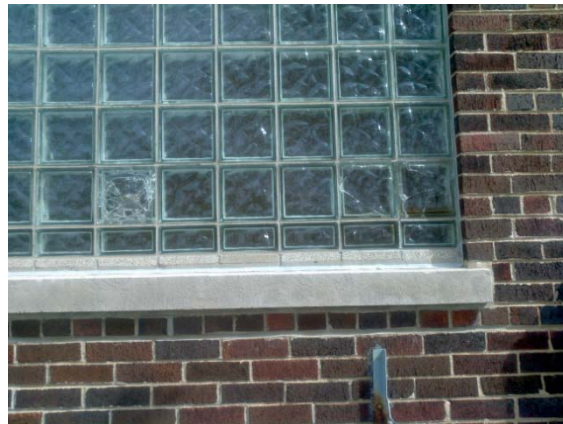
Cracked glass block windows

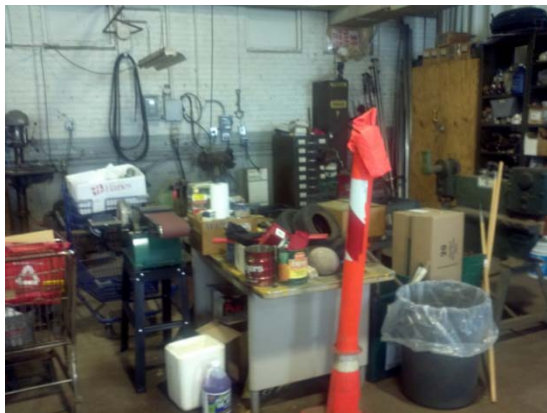
Inventory (EA)		Condition Rating	Age (Years)	RUL (Years)	1st Year of Capital Expenditure
Chairs	17	6	Unknown	8	2020
Desks	9	6	Unknown	8	2020
Printers/Copiers	2	N/A	Unknown	8	2020
Computers	2	N/A	Unknown	8	2020
Telephones	2	N/A	Unknown	8	2020
Refrigerator	1	N/A	Unknown	8	2020
Microwave	2	N/A	Unknown	8	2020
Lockers	2	N/A	Unknown	8	2020

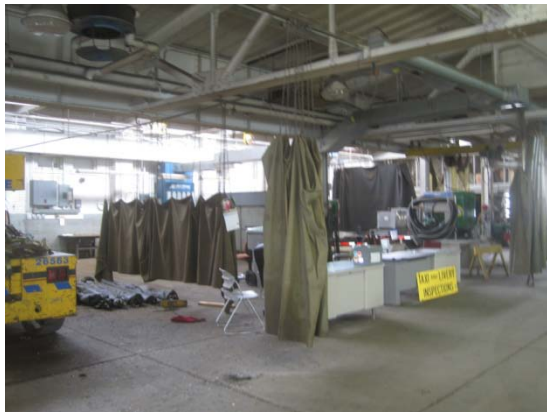
Interior w painted ceiling

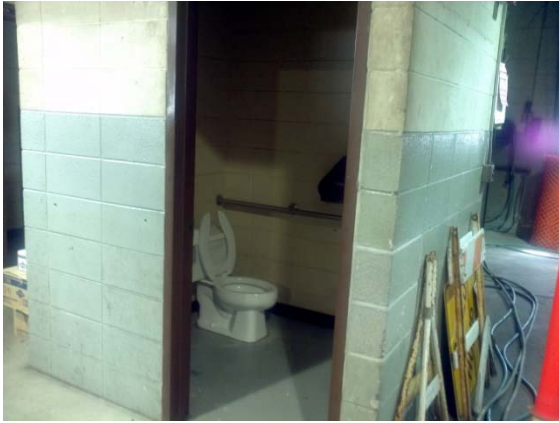
Inventory (EA)		Condition Rating	Age (Years)	RUL (Years)	1st Year of Capital Expenditure
Paint Walls/Ceilings (SF)	1,115	6	22	8	2020
Acoustic Tile Ceiling (SF)	344	6	22	8	2020
Ceramic Tile Floor (SF)	344	6	22	8	2020
Light Fixtures, Strip	4	6	22	8	2020
Light Fixtures, Recessed	5	6	22	8	2020
Toilet	5	6	22	8	2020
Urinal	1	6	22	8	2020
Sink	3	6	22	8	2020
Partition	4	6	22	8	2020
Showers	2	6	22	8	2020
Mirrors	2	6	22	8	2020

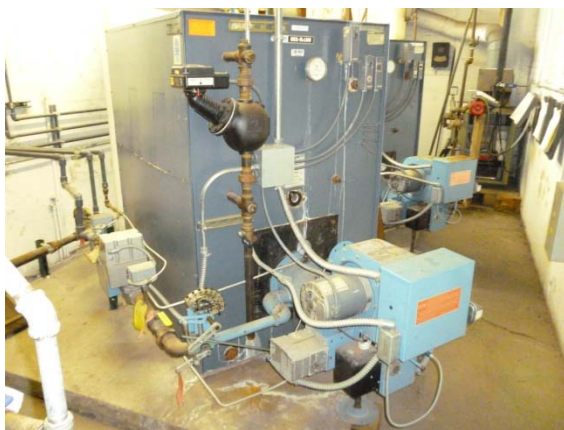
Building heat boilers

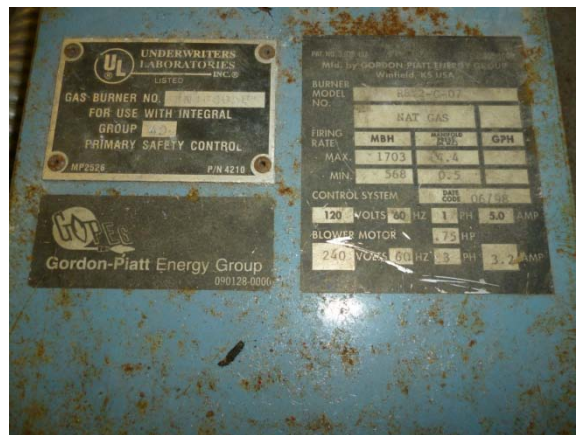
Boiler casing w onset of rust

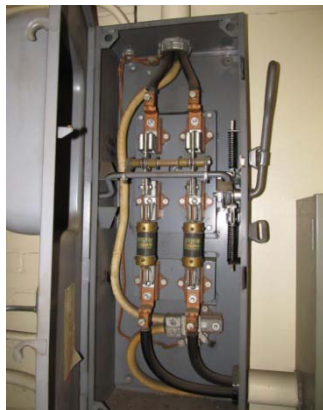
Secondary distribution

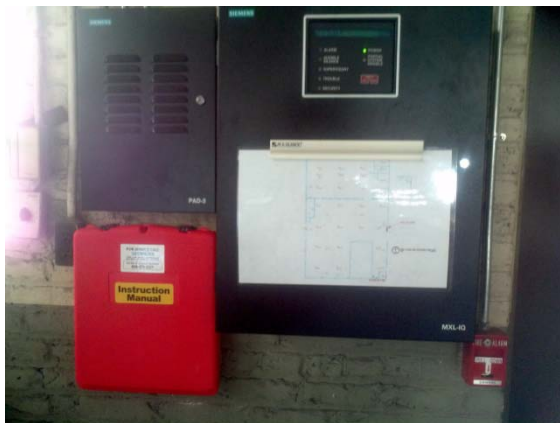
Inventory (EA)		Condition Rating	Age (Years)	RUL (Years)	1st Year of Capital Expenditure
Smoke/Heat Detectors	21	7	7	18	2030
Exit Lights	5	7	7	18	2030
Annunciators	11	7	7	18	2030
Pull Boxes	3	7	7	18	2030
Control Panel	1	7	7	18	2030

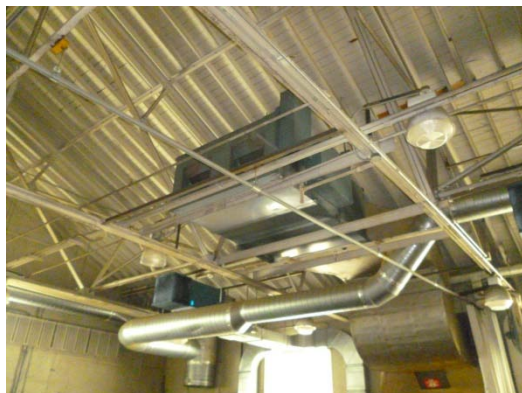
Inventory (EA)		Condition Rating	Age (Years)	RUL (Years)	1st Year of Capital Expenditure
MUA #1 and MUA #2					
Furnace (MBH)	432	5	32	3	2015
Motor Size (HP)	2	5	32	3	2015
MUA #3					
Furnace (MBH)	337	5	32	3	2015
Motor Size (HP)	2	5	32	3	2015
MUA #4					
Furnace (MBH)	1,123	5	32	3	2015
Motor Size (HP)	5	5	32	3	2015

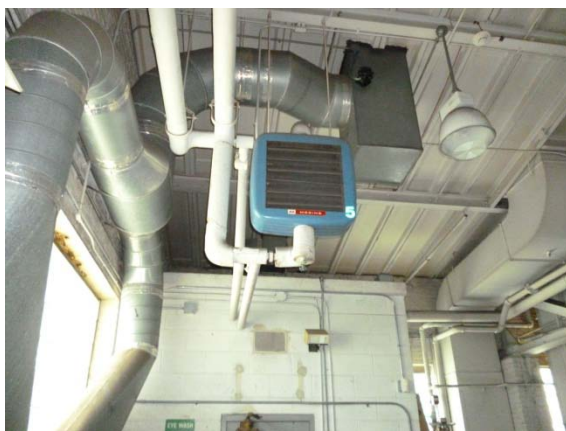
Inventory (EA)		Condition Rating	Age (Years)	RUL (Years)	1st Year of Capital Expenditure
90 MBH	3	6	32	11	2023
139 MBH	1	6	32	11	2023
140 MBH	2	6	32	11	2023
184 MBH	1	6	32	11	2023
198 MBH	3	6	32	11	2023
209 MBH	1	6	32	11	2023
210 MBH	2	6	32	11	2023

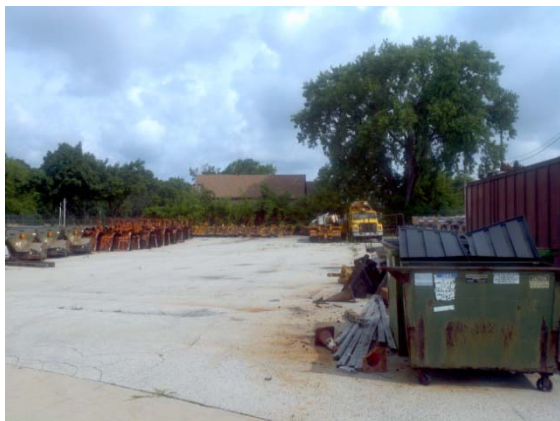
Typical asphalt pavement

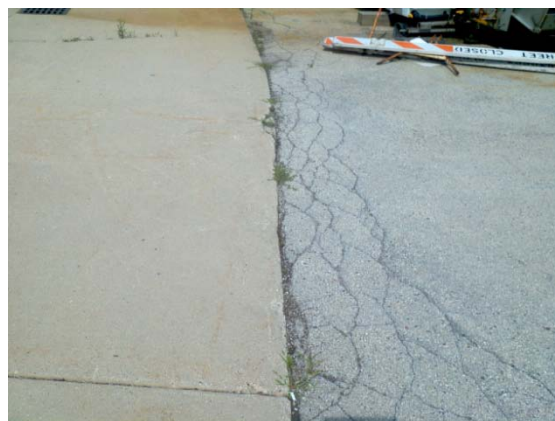
Cracked/failed pavement

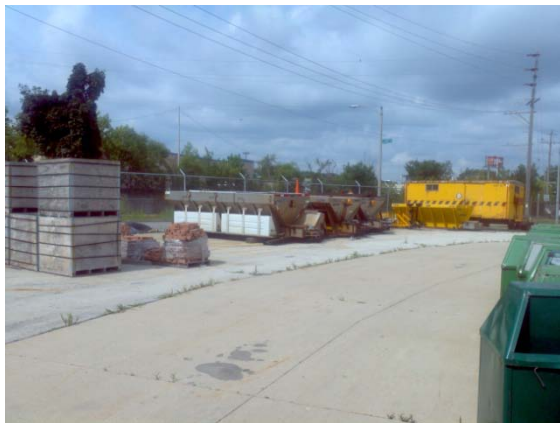
Inventory (SF)		Condition Rating	Age (Years)	RUL (Years)	1st Year of Capital Expenditure
Concrete Driveway	3,300	7	Unknown	19	2031

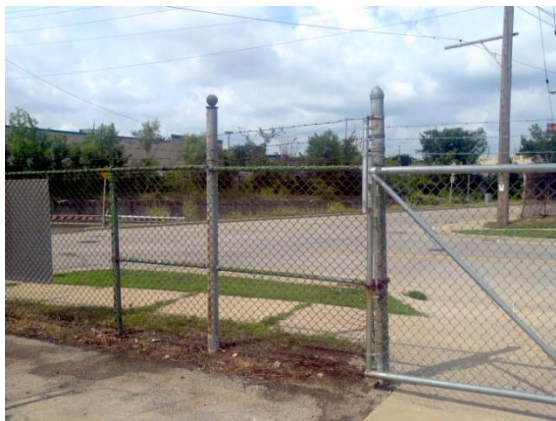
Rusted/damaged fence at adjacent lot

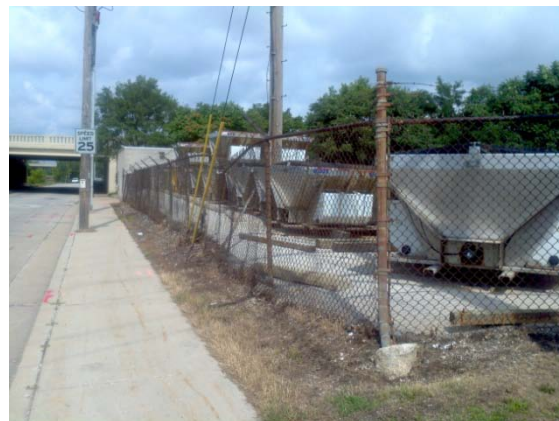
Damaged fence at remote lot

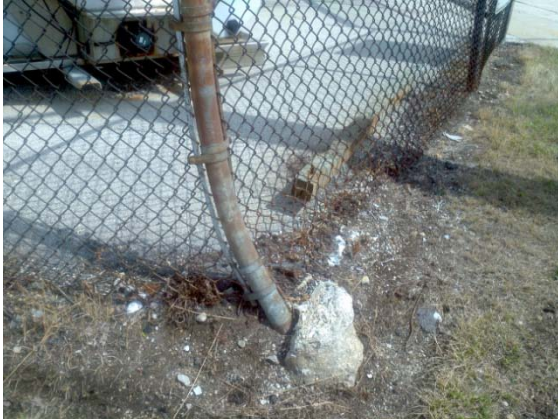
Damaged fence post at remote lot

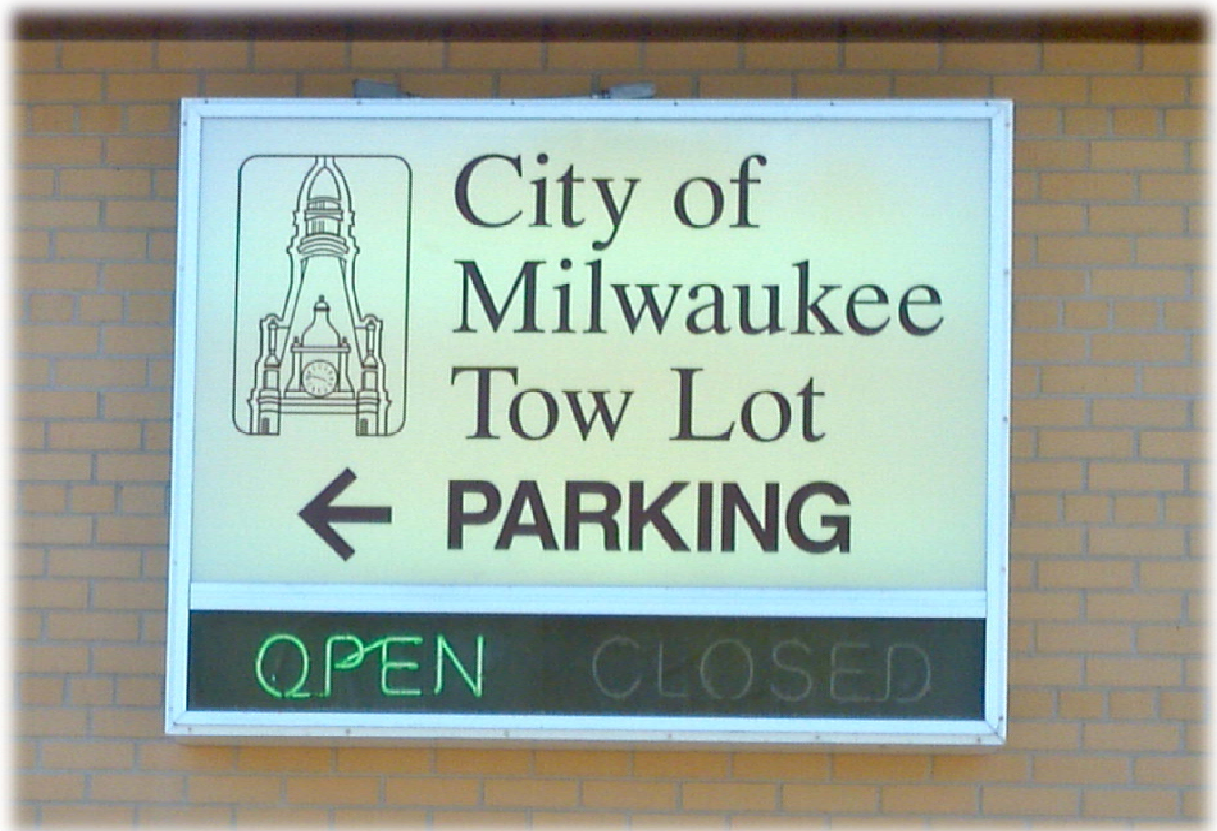
FACILITIES
CONDITION
ASSESSMENT
PROGRAM

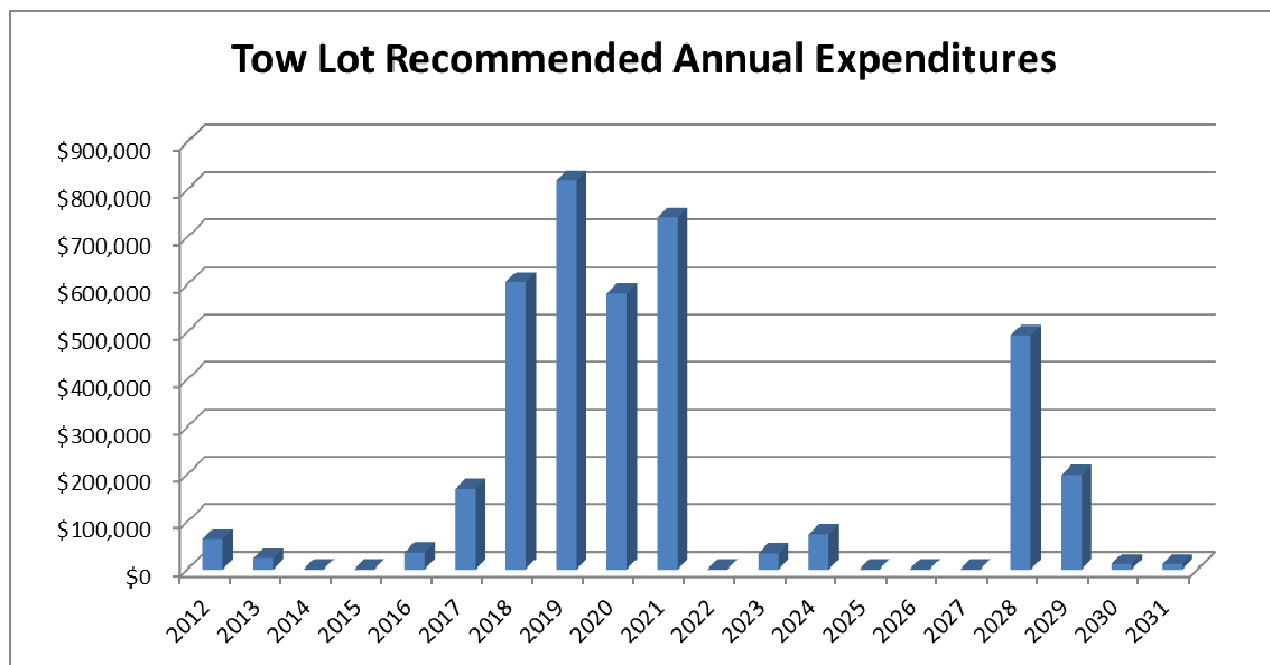
The most significant category of expenditures pertains to site features as shown below. Pavement is the most significant single component.

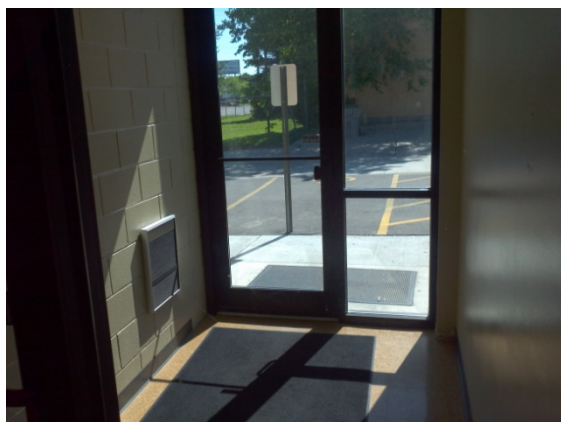
Inventory (EA)		Condition Rating	Age (Years)	RUL (Years)	1st Year of Capital Expenditure
Metal	3	6	19	15	2031
Glass	1	9	19	2	2031

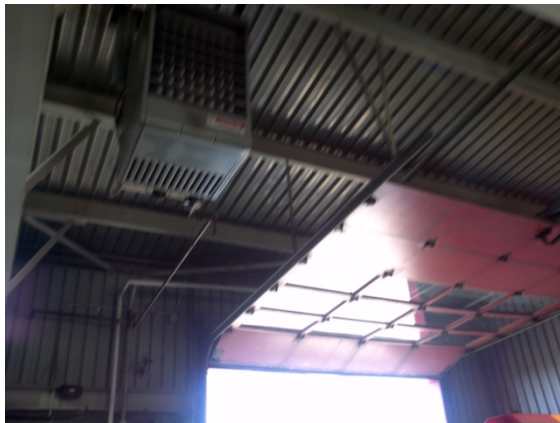
Inventory (EA)		Condition Rating	Age (Years)	RUL (Years)	1st Year of Capital Expenditure
12' x 12'	2	5	Unknown	7	2019

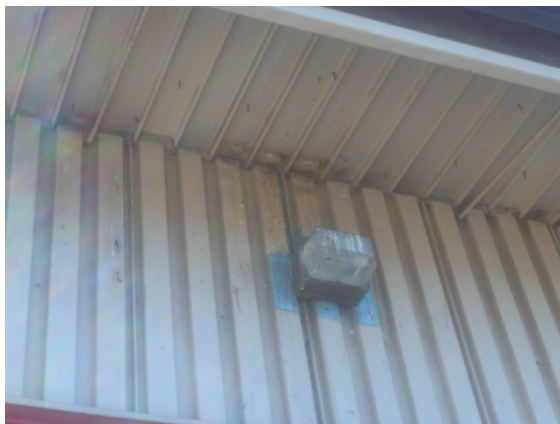
Wall mounted light fixture

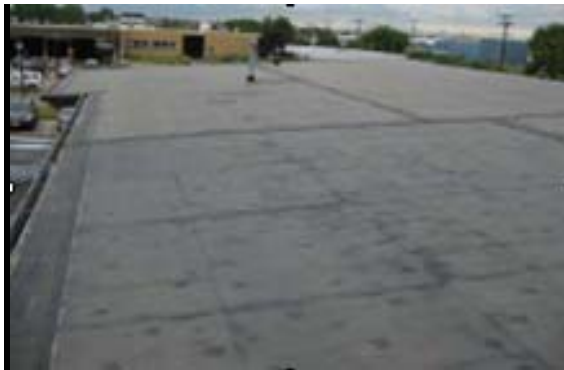
Inventory (SF)		Condition Rating	Age (Years)	RUL (Years)	1st Year of Capital Expenditure
#1, EPDM	5,297	5	Unknown	7	2019
#2, EPDM	4,750	5	Unknown	7	2019

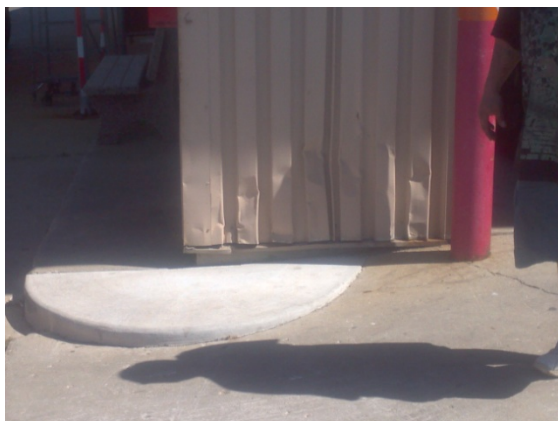
Damaged metal siding

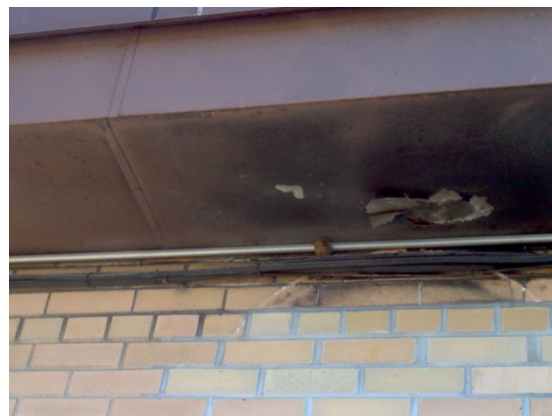
Damaged fascia at rear elevation

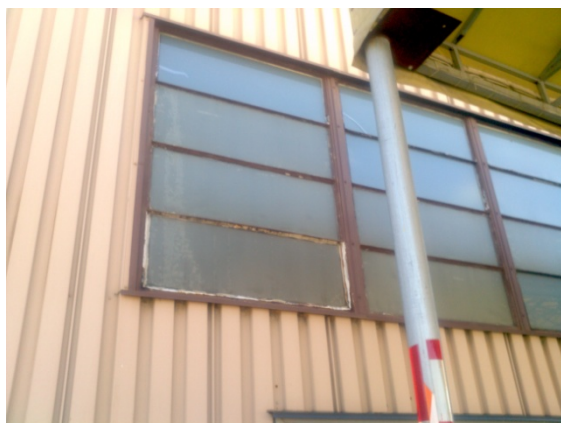
Inventory (SF)		Condition Rating	Age (Years)	RUL (Years)	1st Year of Capital Expenditure
Glass Block	750	7	Unknown	N/A	N/A
Mirrored	100	7	Unknown	N/A	N/A
Single Pane	450	4	Unknown	7	2019

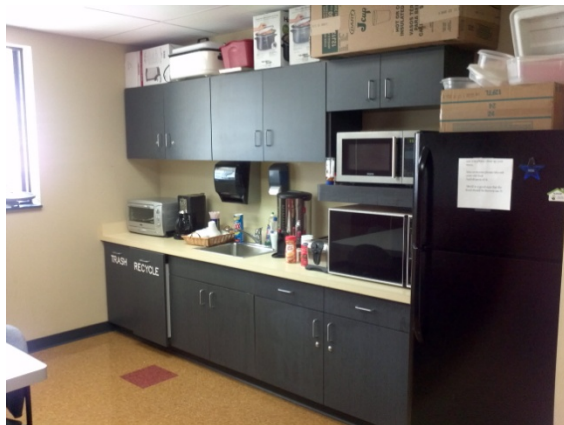
Inventory (SF)		Condition Rating	Age (Years)	RUL (Years)	1st Year of Capital Expenditure
Vinyl Tile	250	8	1	16	2028
Paint Finishes	250	8	1	16	2028
Ceiling Tile	250	8	1	16	2028
Counters (LF)	10	8	1	16	2028
Cabinets (LF)	10	8	1	16	2028
Microwave	2	7	1	16	2028
Refrigerator	1	7	1	16	2028
Range	1	7	1	16	2028

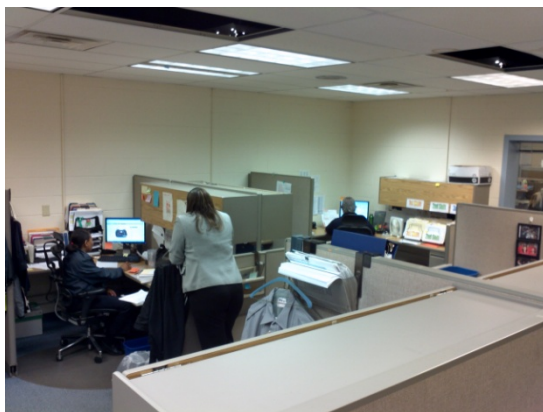
Typical equipment furniture in offices

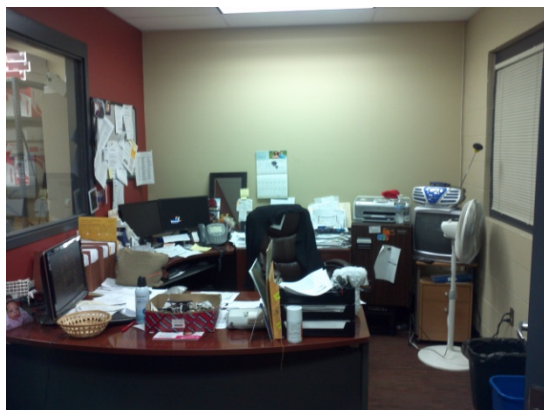
Typical equipment furniture in offices

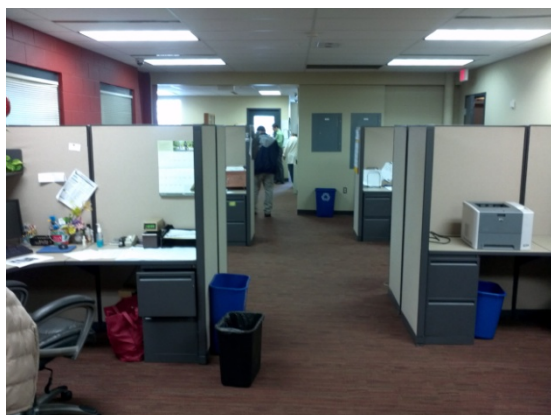
Typical office interior finishes including carpet, paint, and ceiling tile

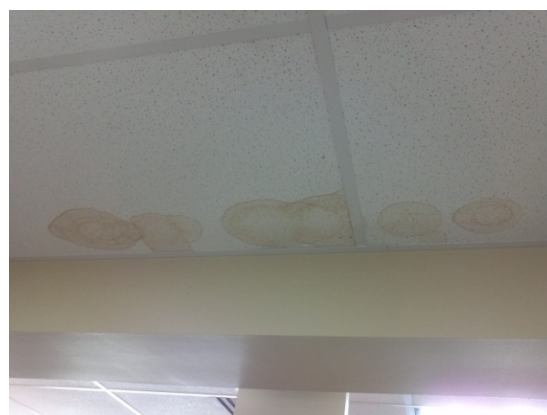
Water stained acoustic tile ceiling

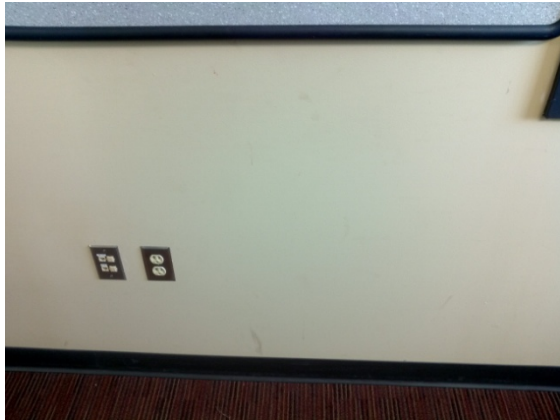
Begrimed wall surface

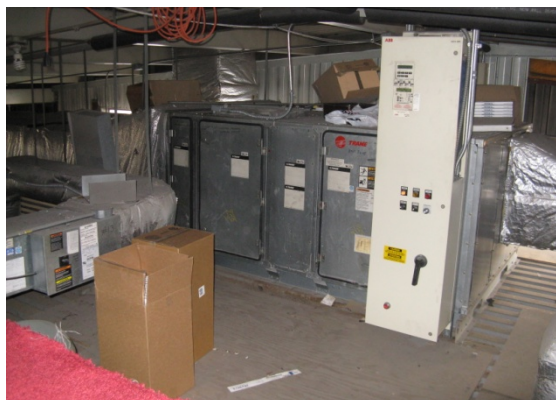
Air handling unit and variable frequency drive at the garage loft

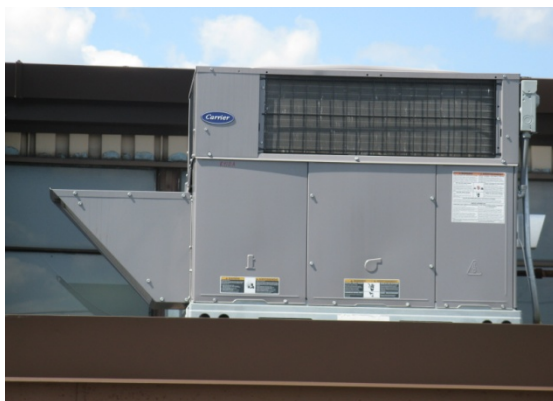
Air handling unit at south offices

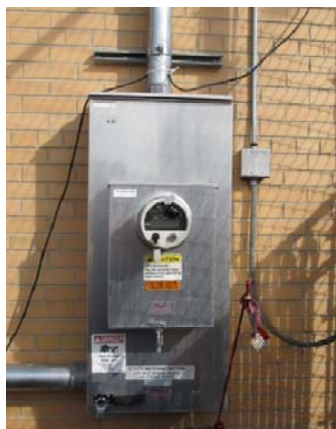
Secondary distribution

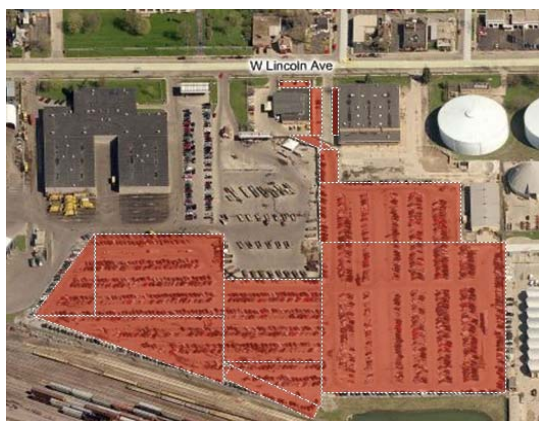
Typical cracked pavement at west lot

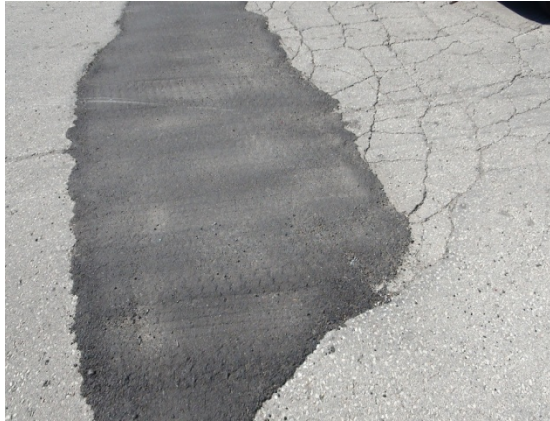
Prior patch w/ adjacent failed pavement

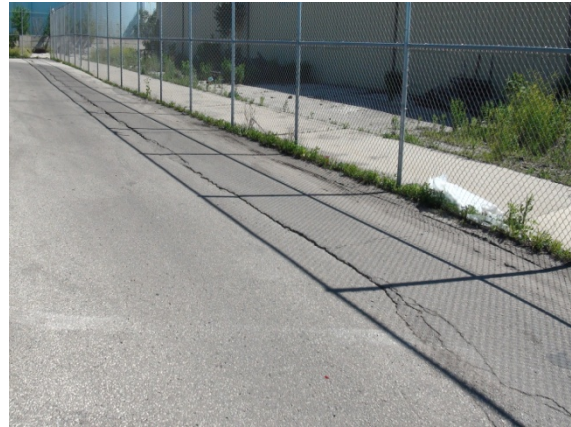
Transverse crack at eastern edge of Tow Lot

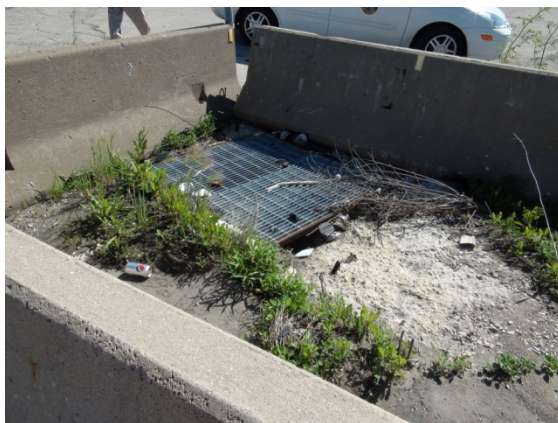
Settled storm water inlet and failed pavement

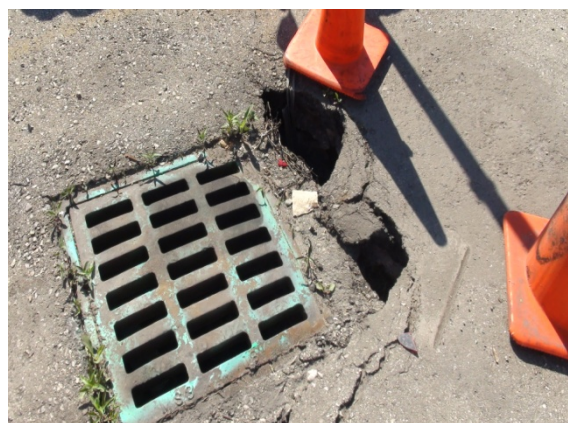
Settled asphalt pavement adjacent to catch basin

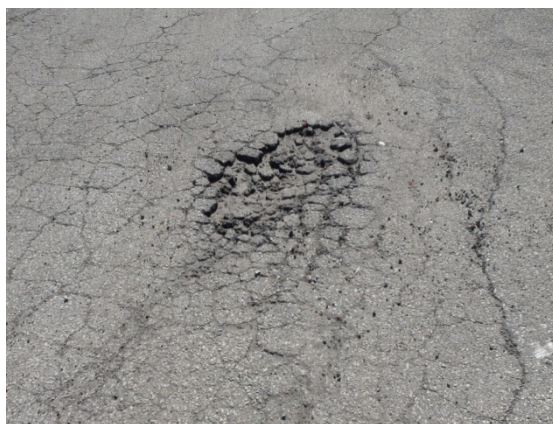
Settled storm water inlet and failed pavement

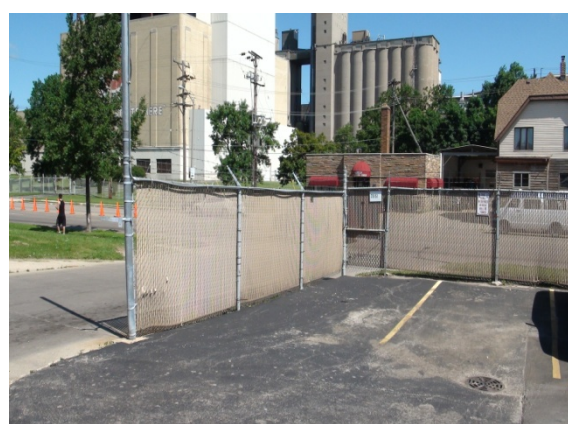
Settled asphalt pavement adjacent to catch basin

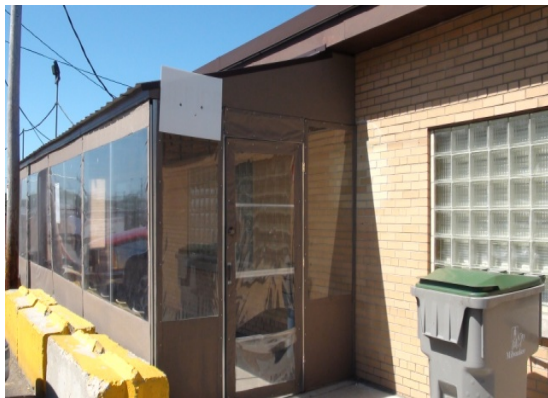
Inventory (SF)		Condition Rating	Age (Years)	RUL (Years)	1st Year of Capital Expenditure
Pedestrian Canopy	340	7	Unknown	12	2024

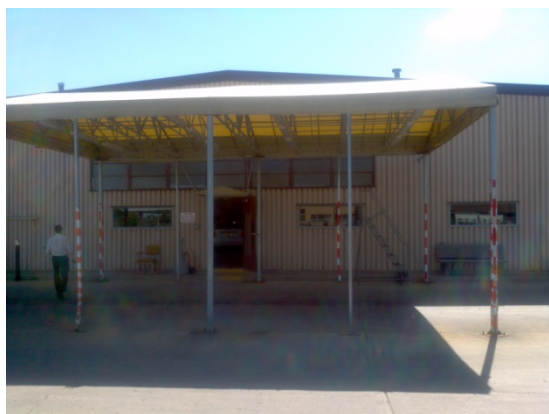
Inventory (EA)		Condition Rating	Age (Years)	RUL (Years)	1st Year of Capital Expenditure
Carport	600	5	Unknown	7	2019

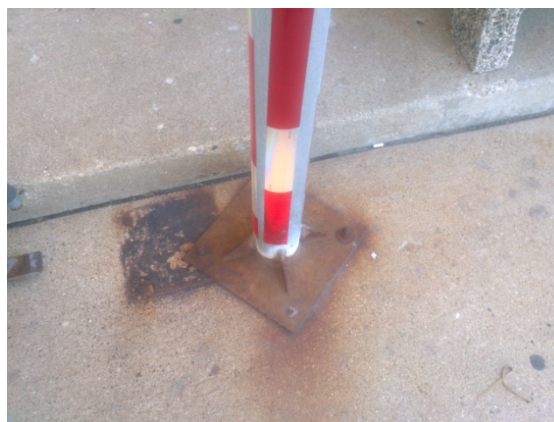
Rusted base plate with missing fasteners

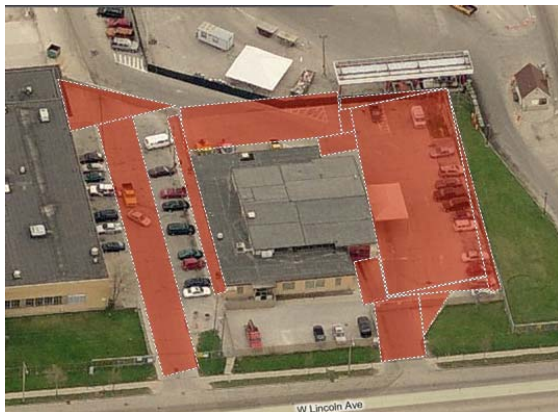
Inventory (EA)		Condition Rating	Age (Years)	RUL (Years)	1st Year of Capital Expenditure
Concrete	29,200	5	Unknown	7	2019

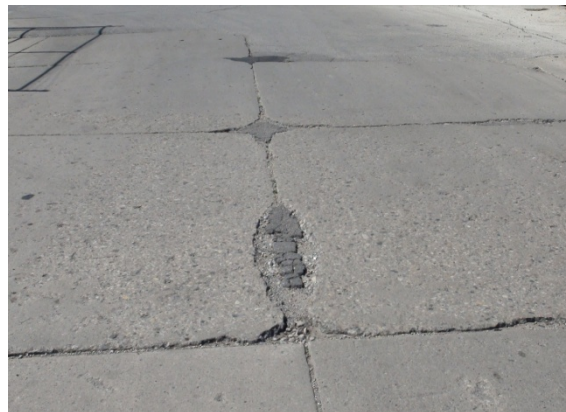
Damaged concrete with asphalt patches

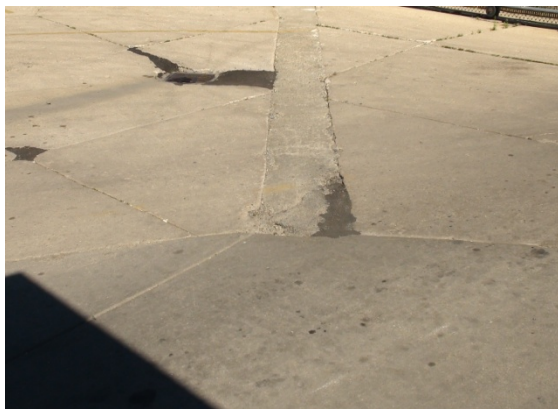
Damaged concrete with asphalt patches

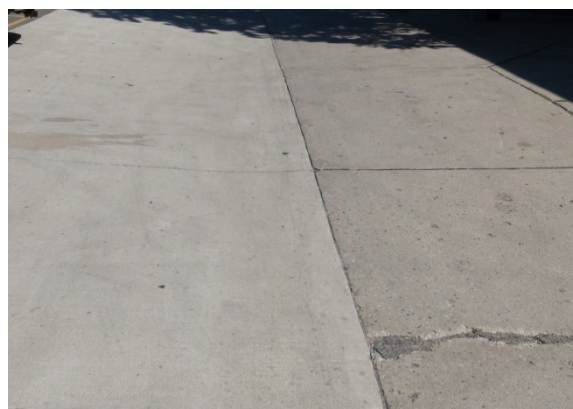
Partial concrete replacement

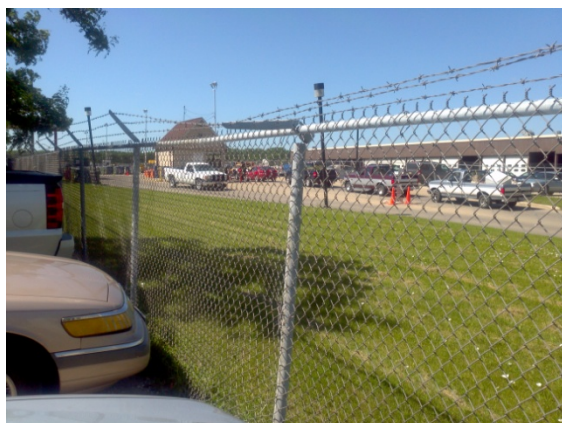
Inventory (EA)		Condition Rating	Age (Years)	RUL (Years)	1st Year of Capital Expenditure
Chain Link Fence (LF)	4,950	6	Unknown	6-9	2018
Gates	5	6	Unknown	6-9	2018
Gate Operator	5	6	Unknown	6-9	2018
