Certificate of Appropriateness

1801 N. PROSPECT Charles Allis House an individually designated historic site

PTS ID 109045 COA Roof and Gables

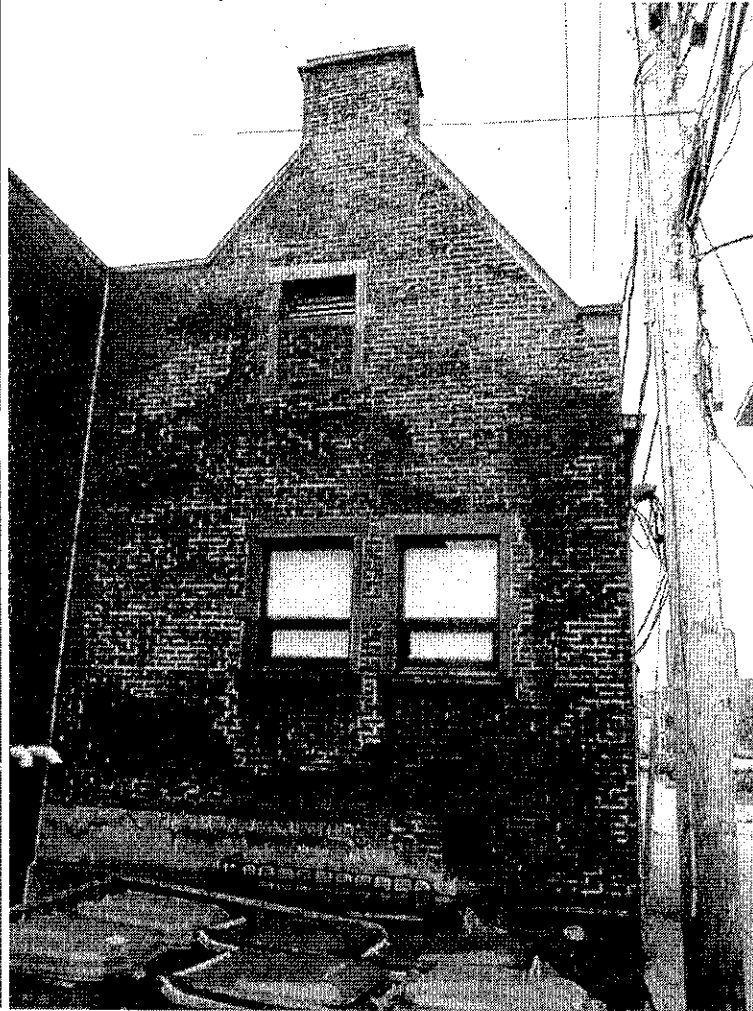
North Elevation – Garage, Charles Allis House

Repointing has been carried out in the past without regard to appropriate mortar composition and color as evidenced here.

At the north elevation of the garage, the upper portion of the gable, the gable parapet wall and the chimney will be taken down to sound masonry and reconstructed using salvaged face brick and new back up brick

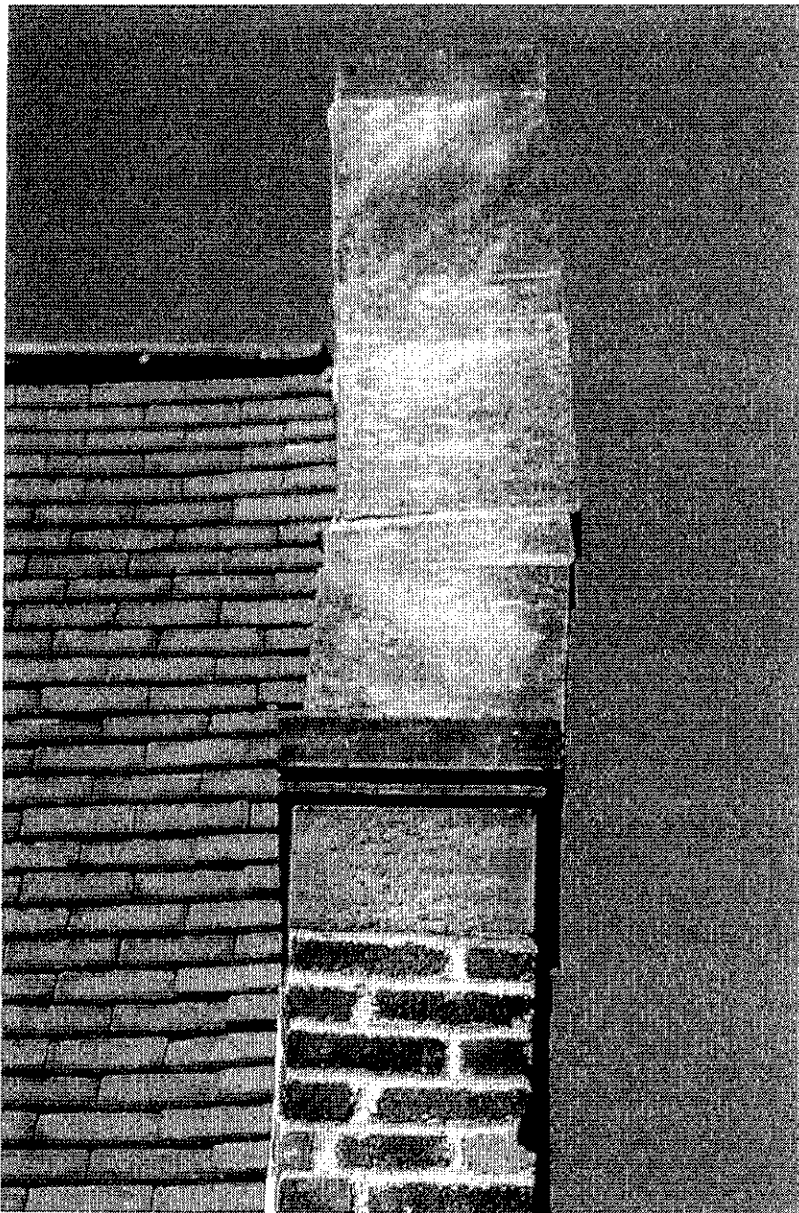
Leaning parapet and displaced gable coping – NE corner – Charles Allis House. Condition is typical to all of the gables, but to varying degrees.

Various gables at the house will be taken down to solid masonry and reconstructed using salvage face brick and new back up brick. Stone copings will be reset and remaining portion of gables will be repointed

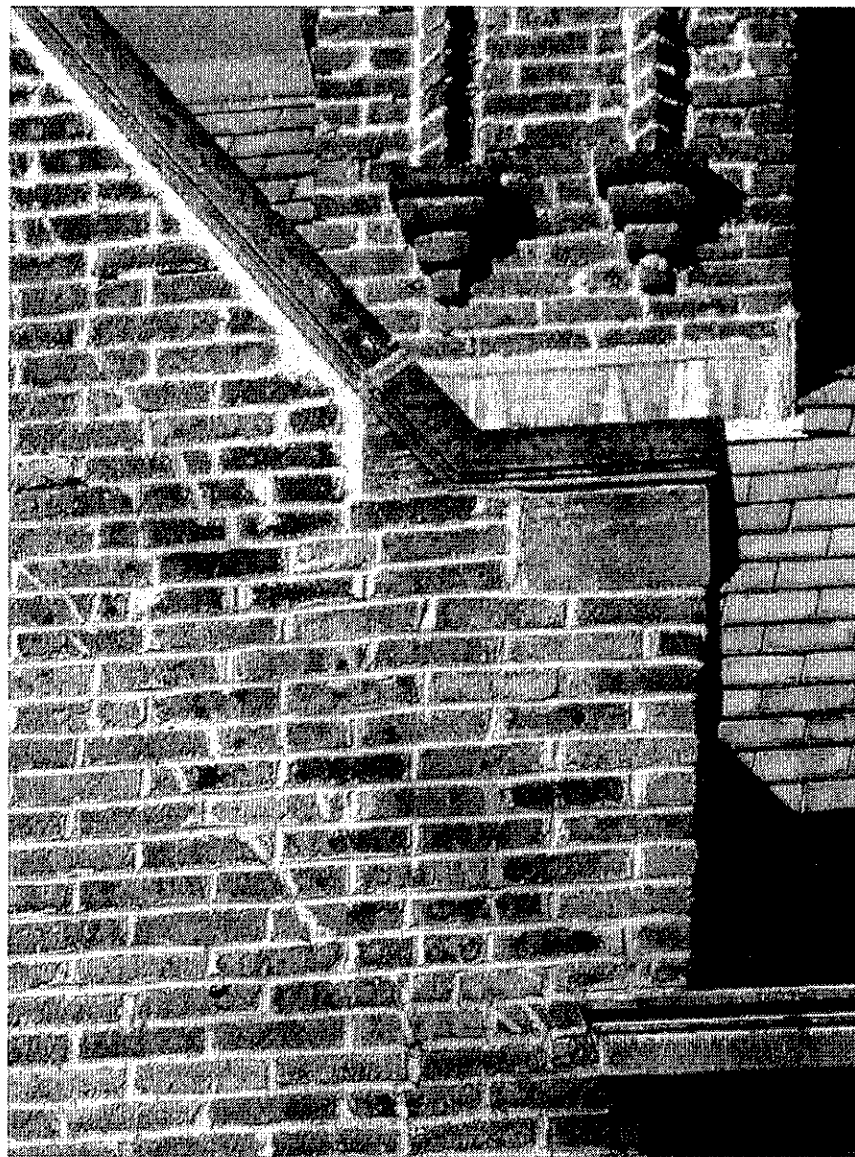
Cracked gable parapet walls – East Elevation, Charles Allis House. Condition is typical of all gables but to varying degrees. Note repaired cracks have re-cracked. Note condition of chimney in background.

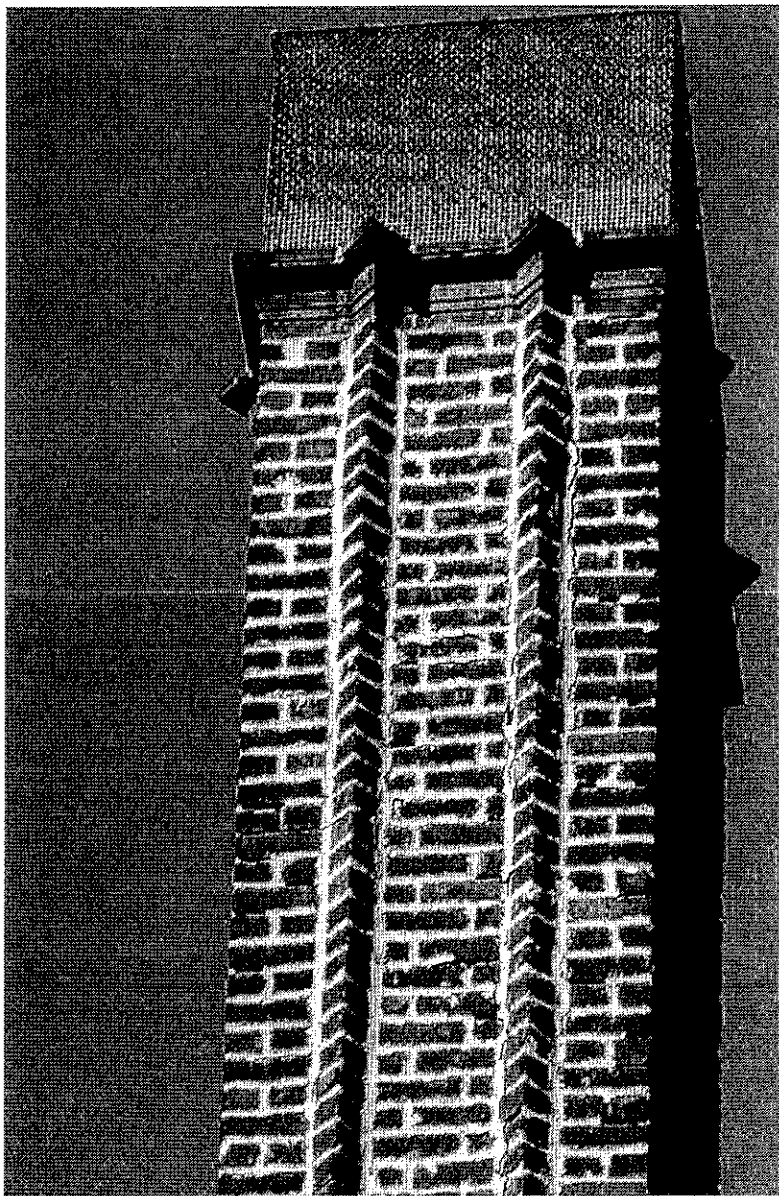
Typical Chimney Condition – East Chimney, East Elevation – Charles Allis House. Excessive spalling of hard grey pointing mortar and join cracking with brick displacement of stacked rotated brick accents.

Portions of chimneys extending above the roof will be repointed and repaired. Lead coated copper covers will replace metal cages at the flues and vented caps will be placed over unused flues.

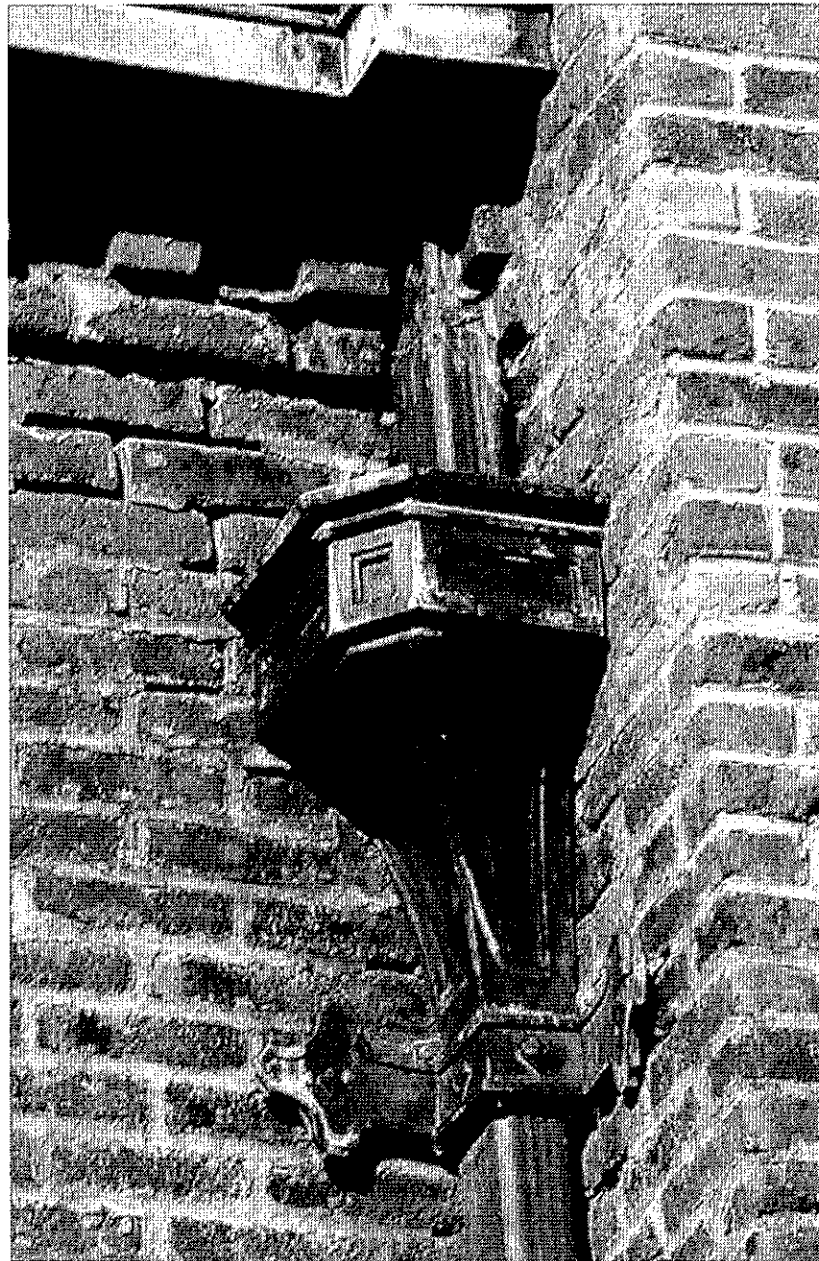
Mortar Deterioration at Downspouts, South Elevation – Charles Allis House. Typical at all downspouts.

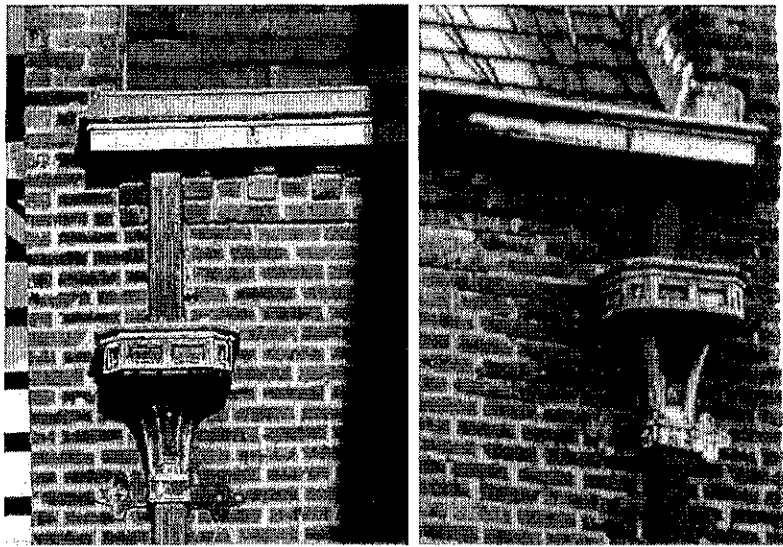
Existing Gutters – SE & NW Corners of Charles Allis House. It is proposed to raise the outer lip of the remaining unrepaired gutters to reduce the occurrence of rain runoff overflows which are contributing to the deterioration of the masonry immediately below and further downstream of the gutters. The previous gutter work was accomplished in the 1990s as part of the previous restoration work.

Gutters at the west and north elevations were previously raised at the outboard gutter lip to keep water from cascading over the top of the gutters. This will also be done to the gutters on the other elevations as well as the gutters on the west elevation of the garage.

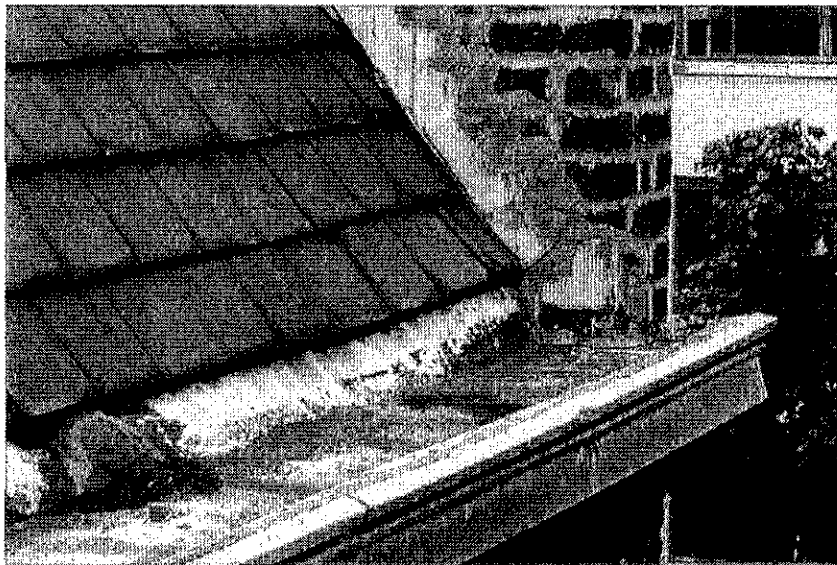
1.5" Deep Gutter at Termination - East Elevation, Charles Allis House

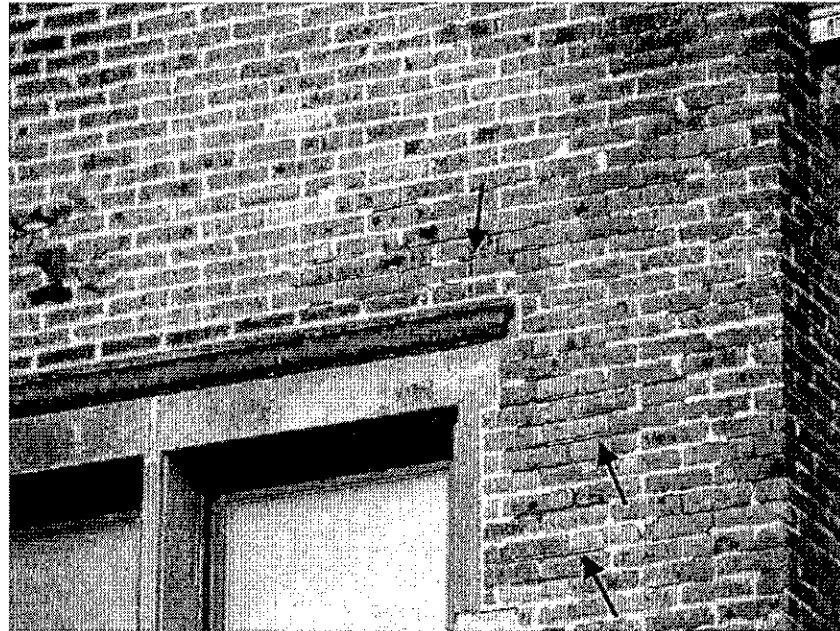
SE Corner – Charles Allis House. Wind blown runoff has repeatedly deteriorated the masonry in this area. Note the overcut bricks from a previous repointing project.

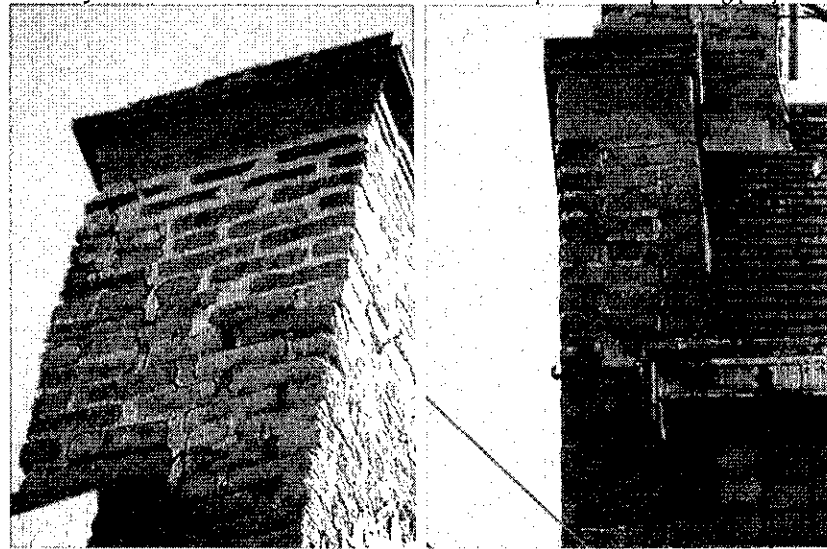
Garage North Gable & Chimney Deterioration – Charles Allis House. The leaning of the gable and chimney, along with the cracks, brick displacement required reconstruction of these elements.

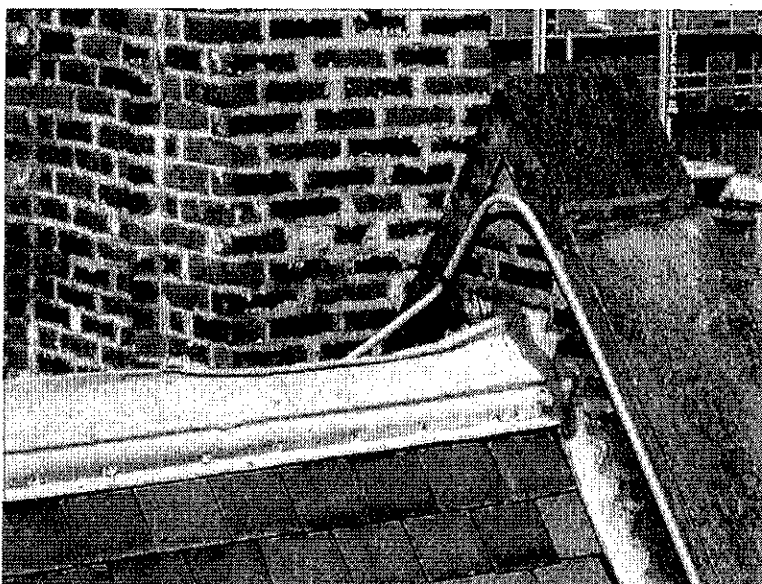
Crushed & Loose Ridge Cap - NW corner of Charles Allis House. Note excessive use of sealant on flashing, brick, and coping.

Copper ridge caps and valley flashings to be replaced or resecured

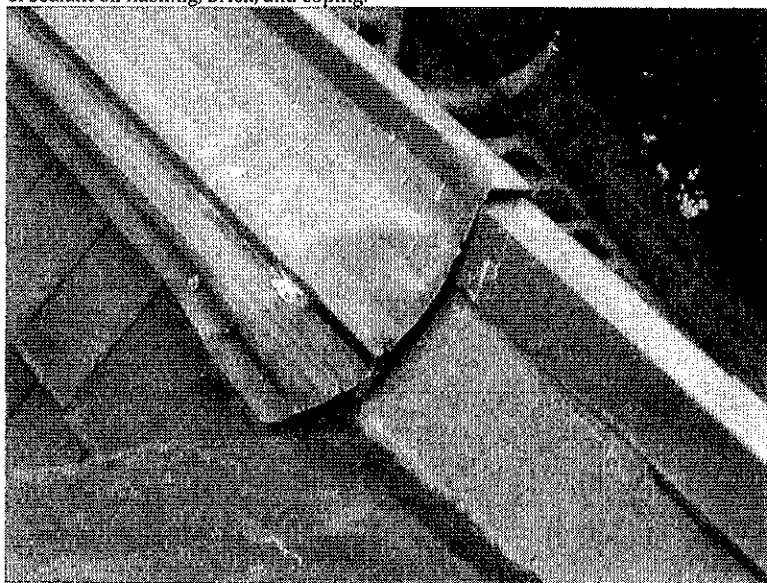
Loose Ridge Cap - NE Corner of Charles Allis House. A previous replacement, this cap was subsequently peeled open by wind or roof tile repair.
