# Facilities Condition Assessment Program

## Port of Milwaukee Analysis Update

August 2012

## BRADFORD AND COIL BUILDINGS

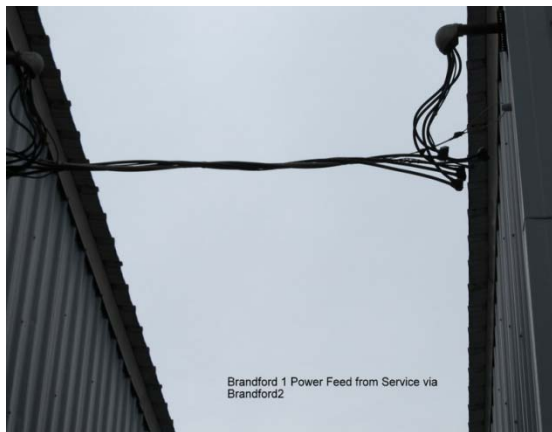
Bradford 2 electrical components include service conduit from Bradford 1 and a 200 amp service panel. These components are at an age of 18 years and are reported in good condition. Port of Milwaukee should anticipate replacement of these components by 2032

Bradford 2 service from Bradford 1

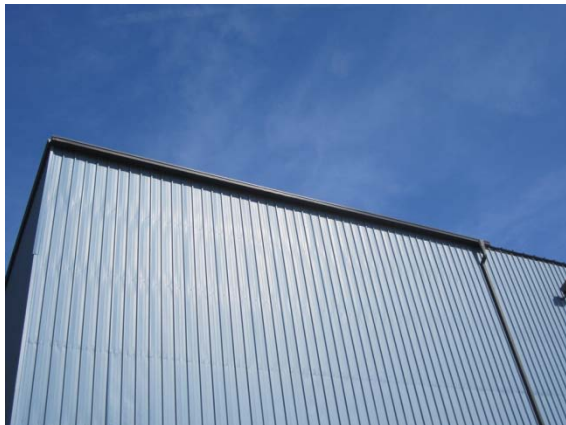
The Coil Warehouse includes 300 linear feet of gutters and 300 linear feet of downspouts. The useful life of gutters and downspouts is 35 years. Replacement of gutters and downspouts should be conducted with the metal roof replacement by 2029.

Gutters and downspout

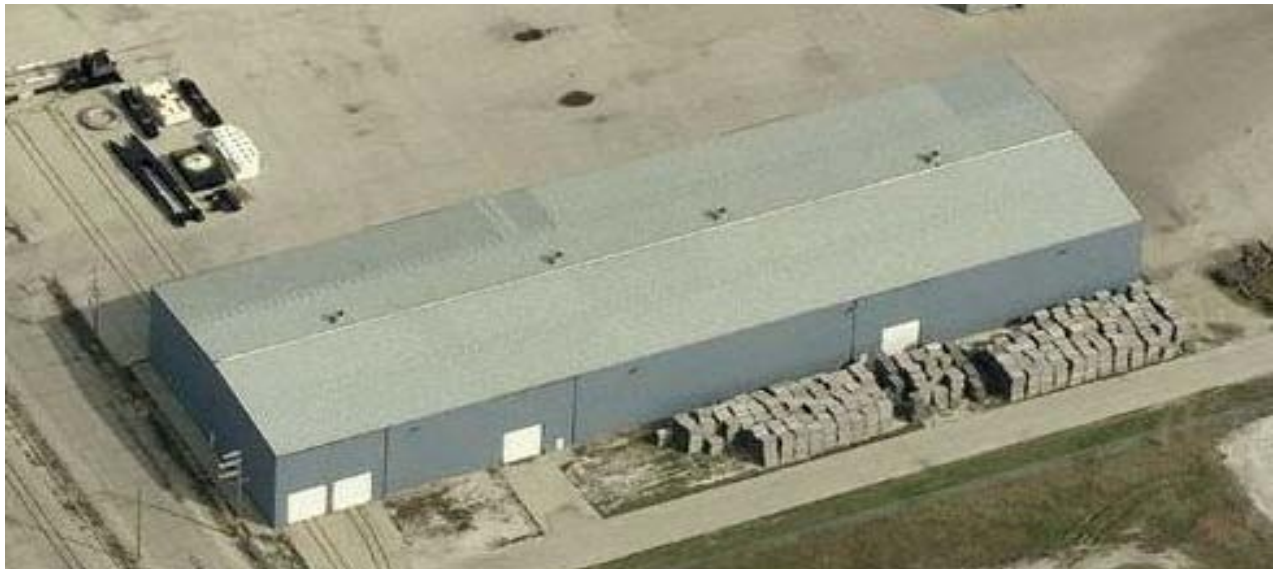
The Coil Warehouse includes a 500 square metal roof. The roofs are inspected and maintained by a third party. Currently there is no inspection report available. The useful life of metal roofs is up to 35 years. Its replacement is anticipated by 2029.

Roof overview

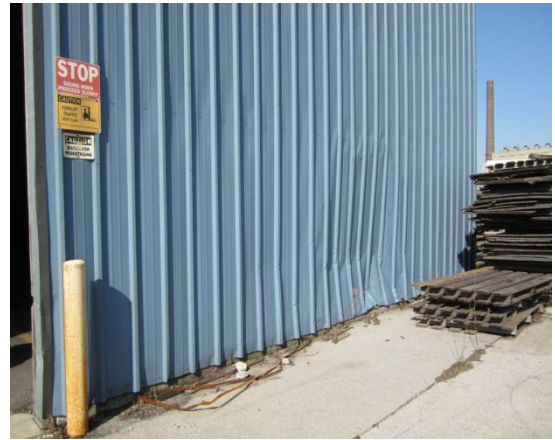
Damaged siding at the east elevation

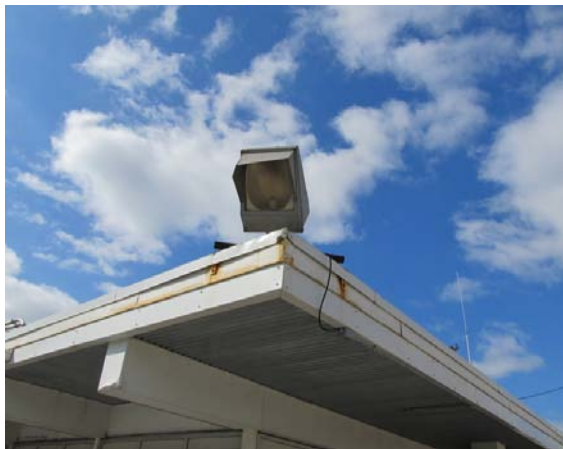
IMC Salt Office Building contains six 400Watt metal halide fixtures and one light pole and fixture. Upgrade to LED Beta Lighting is recommended. The useful life of light fixtures is up to 35 years. Port of Milwaukee should anticipate their replacement by 20XX. Interim partial replacements and repairs are funded by O + M.

Outdoor lighting

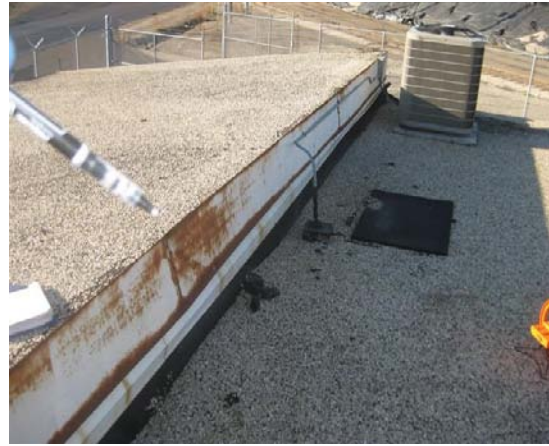
Roof-2 edge metals rusting

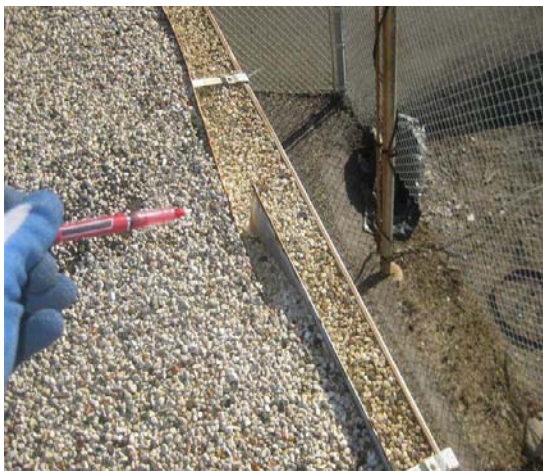
Roof-2 gutter is clogged full with gravel

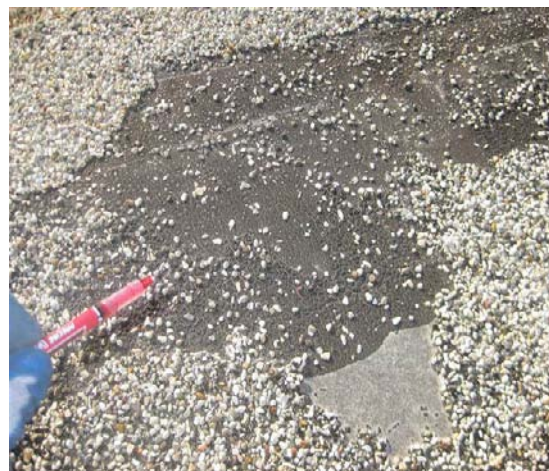
Roof-2 tar dry and cracking

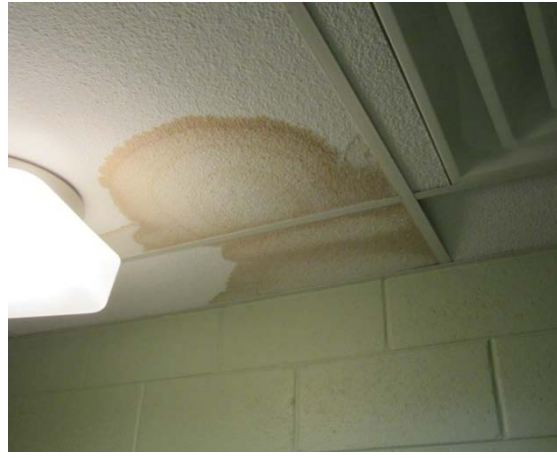
The inspection revealed that the interior spaces were in good overall condition. Several acoustic ceiling tiles had water damage. The Port of Milwaukee defers interior costs to lessees. However, in the event IMC Salt office is vacant and tenant improvements are required, budgetary estimates for improvements are included for renovations.

Water damaged ceiling tile

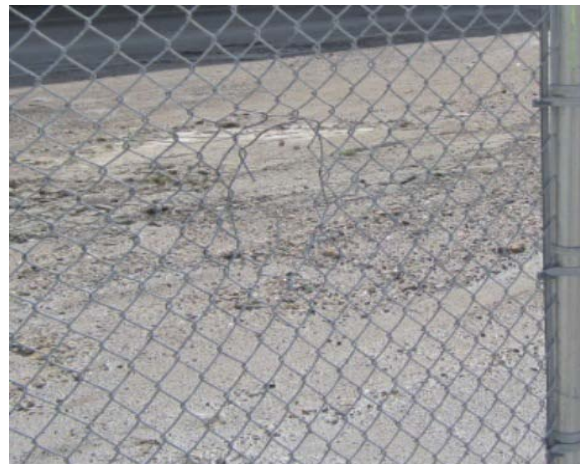
Damaged chain link section

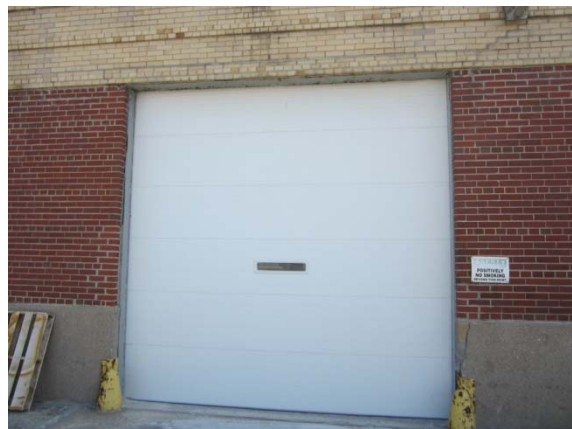
West elevation garage door recently replaced

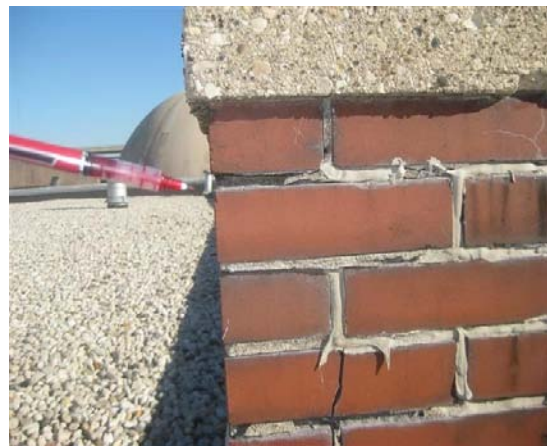
Roof-1 parapet deterioration

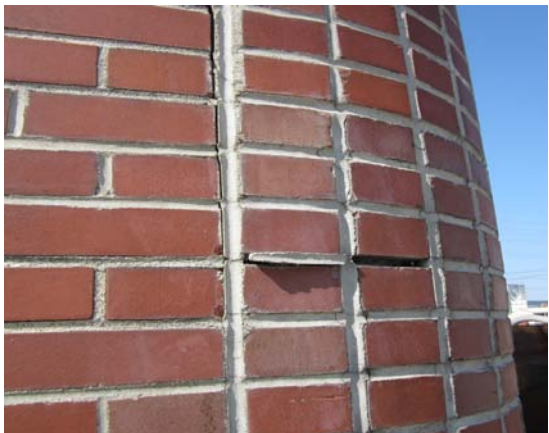
Mortar/brick separation at NE corner

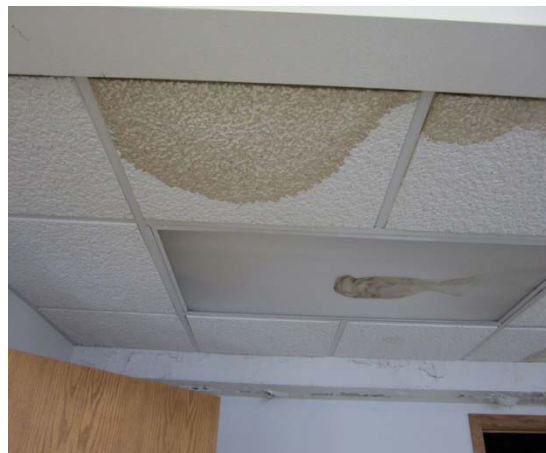
Ceiling tiles with water damage

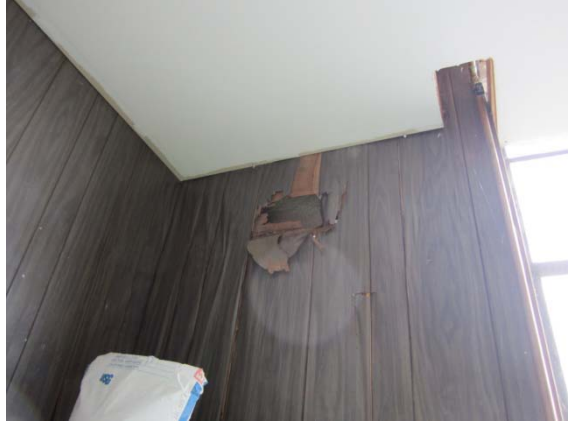
Damaged wall finish

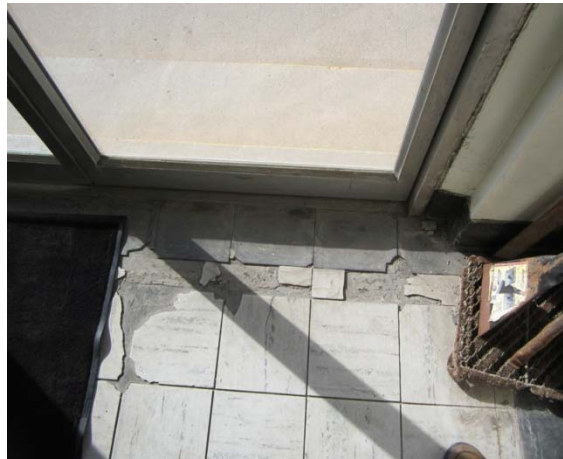
Damaged floor tiles

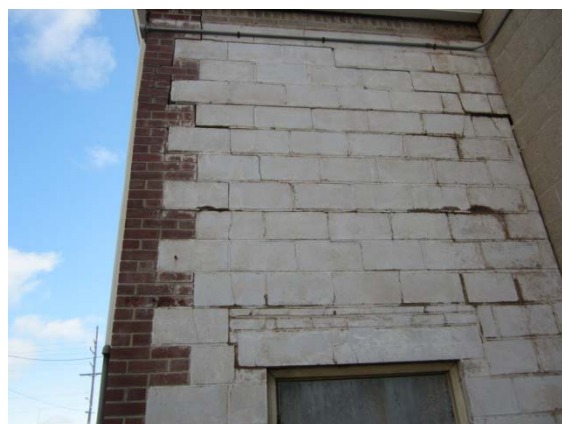
CMU and brick step cracking

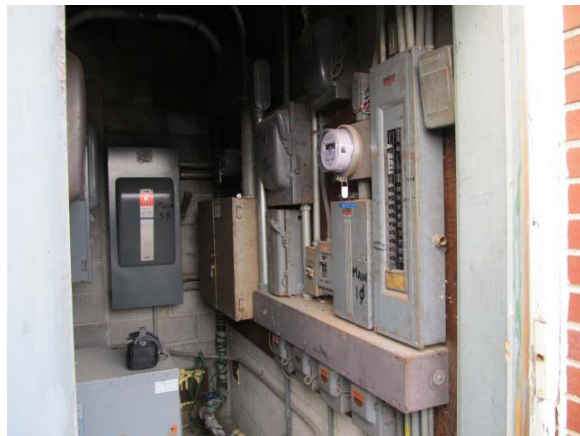
Outdated electrical equipment and NEC non-compliant

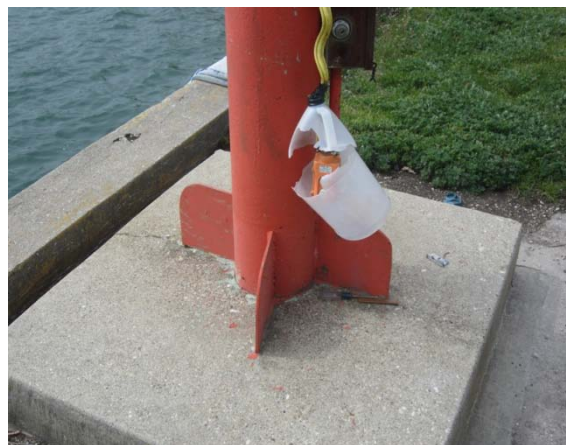
Cracked foundation

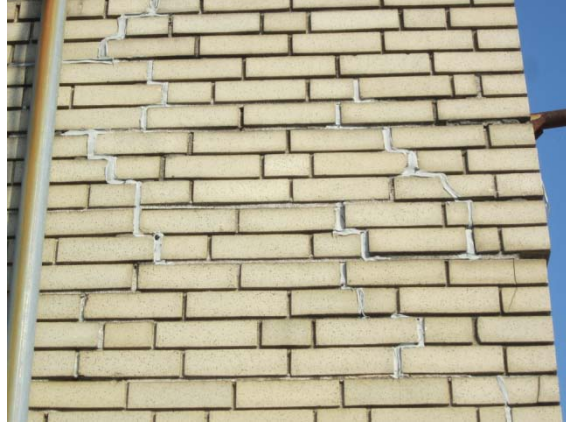
Sealant (not mortar) repair at masonry

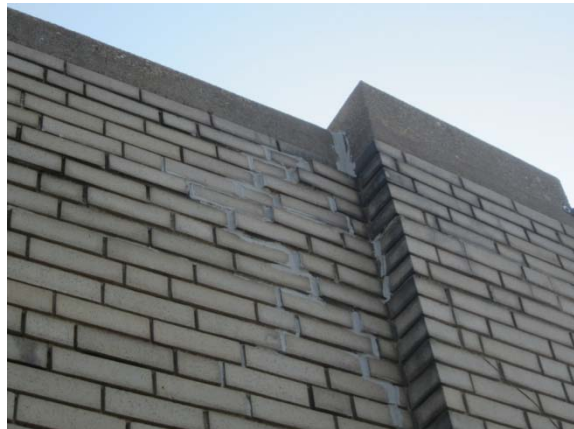
Sealant (not mortar) repair
