# Facilities Condition Assessment Program

## Port of Milwaukee Analysis Update

August 2012

## BRADFORD AND COIL BUILDINGS

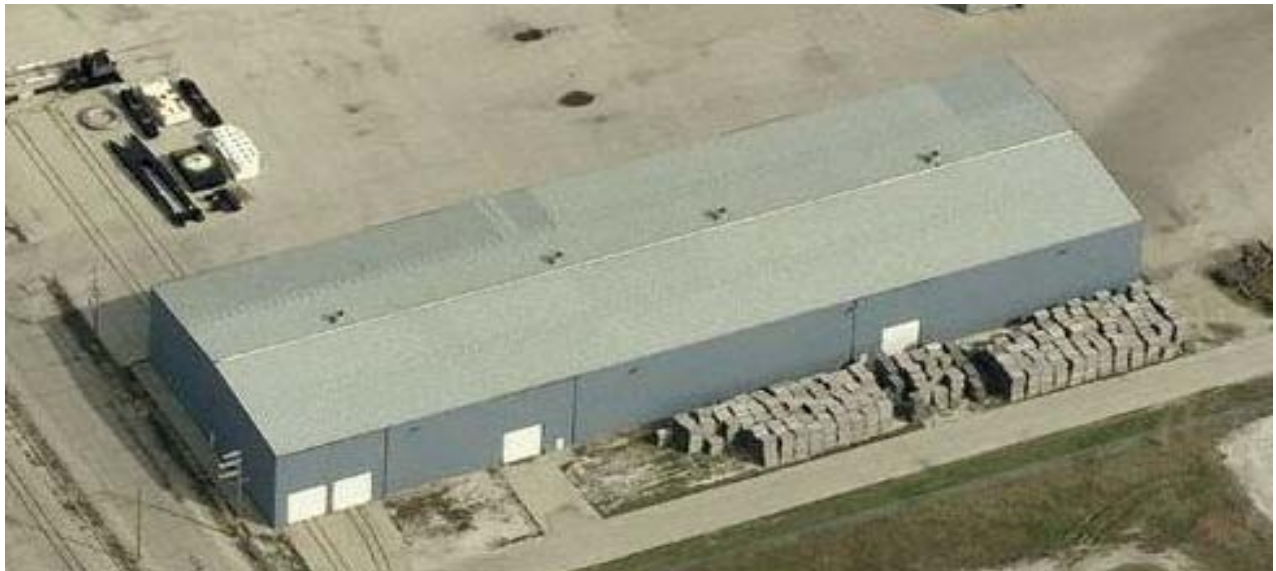
The Coil Warehouse includes a 500 square metal roof. The roofs are inspected and maintained by a third party. Currently there is no inspection report available. The useful life of metal roofs is up to 35 years. Its replacement is anticipated by 2029.

Roof overview

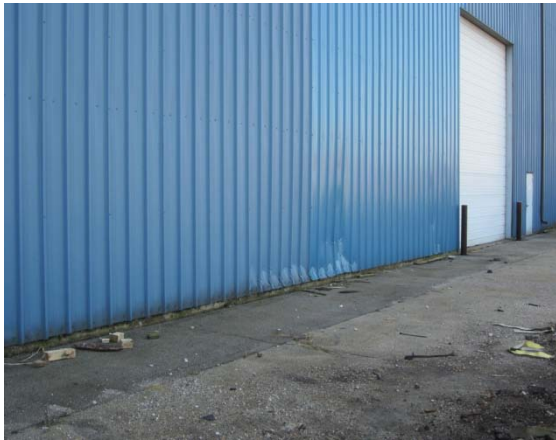
The Coil Warehouse contains 50,592 square feet of corrugated siding. The siding is at an age of 14 years. The inspection revealed isolated occurrences of damaged/bent siding mostly concentrated around the ground level and from the inside of the warehouse. The damage is consistent with the age and use of the facility. The useful life of exterior siding is up to 35 years. Port of Milwaukee should anticipate its replacement by 2032.

Damaged siding at north elevation

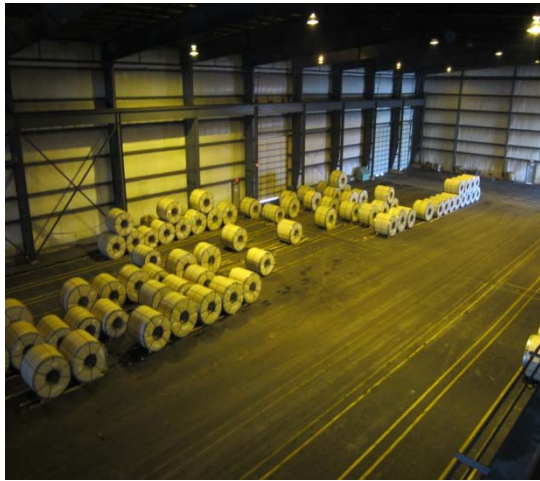
Interior photograph – not light fixtures

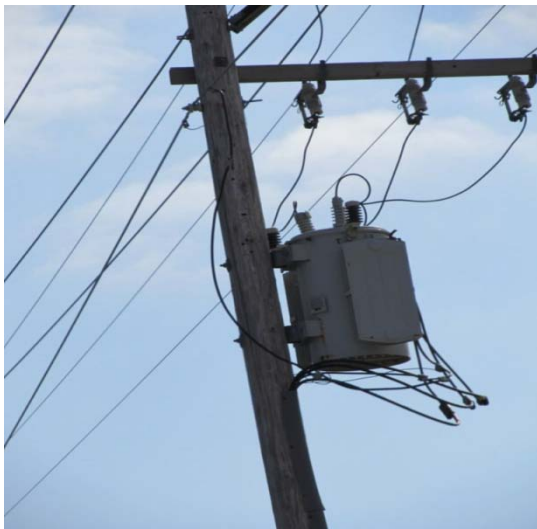
The Coil Warehouse electrical main feeder transformer is at an unknown age and in good condition. Port of Milwaukee should anticipate replacement of the transformer by 2031.

Main feeder transformer

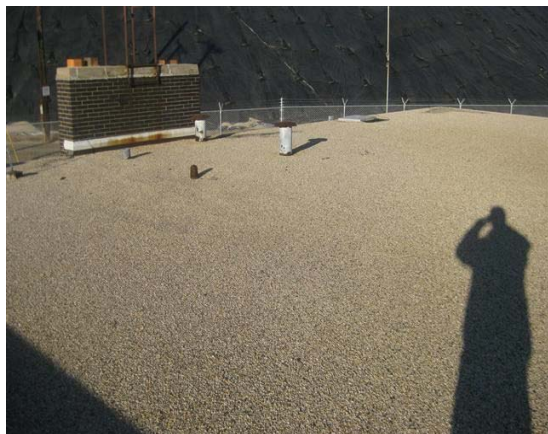
Roof-1 elevation view

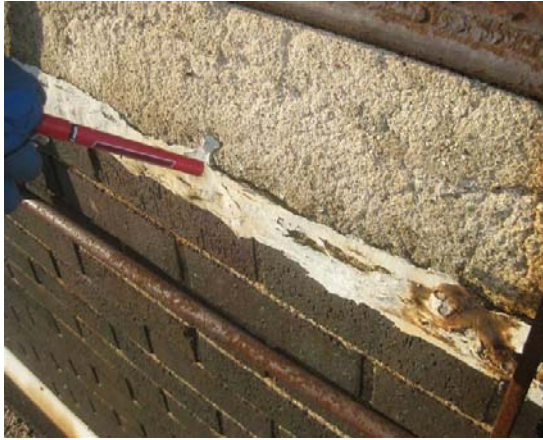
Roof-1 pan mastic is cracking

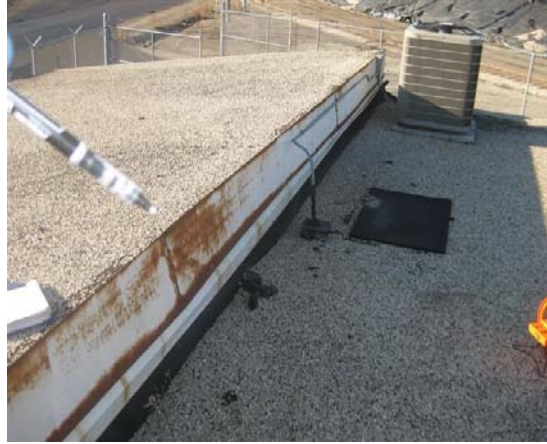
Roof-2 edge metals rusting

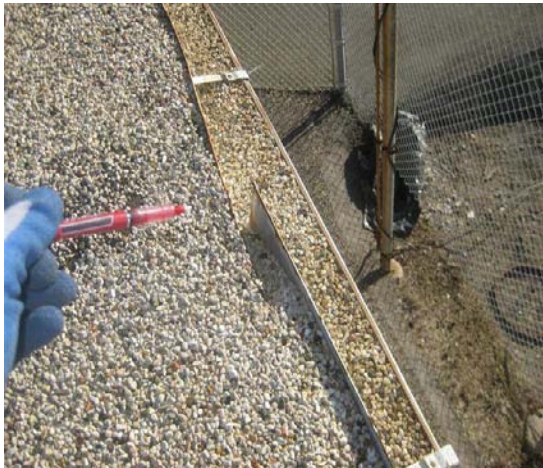
Roof-2 gutter is clogged full with gravel

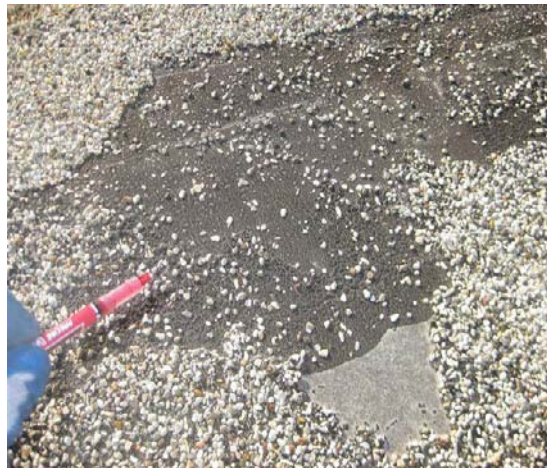
Roof-2 tar dry and cracking

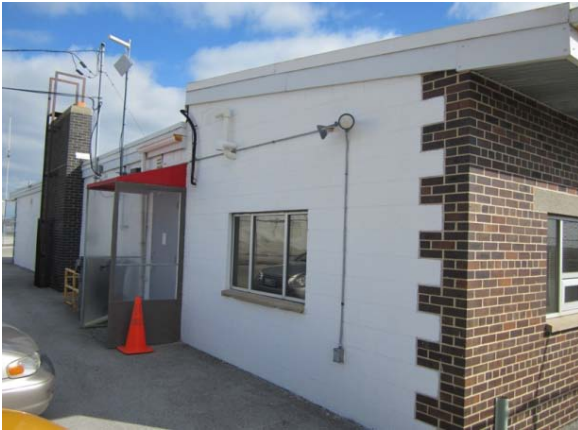
CMU and brick west elevation

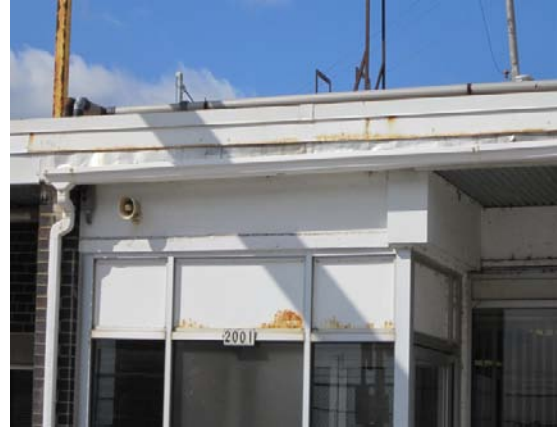
Rusting panels and facade

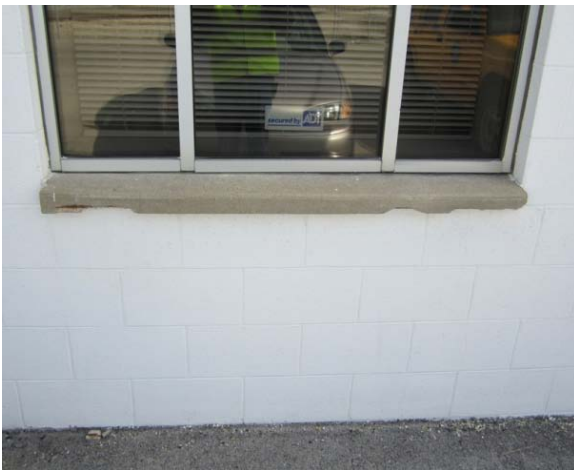
Damaged concrete sill

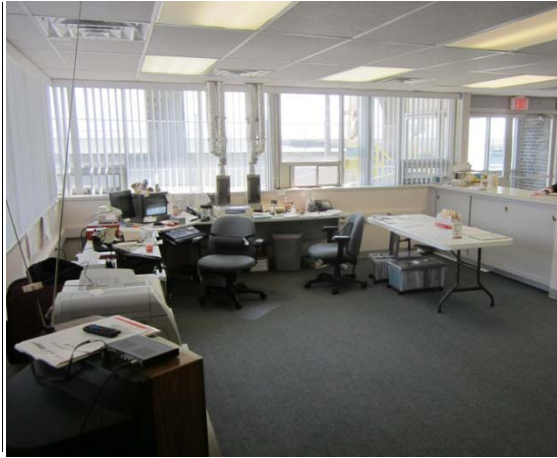
Typical office finishes

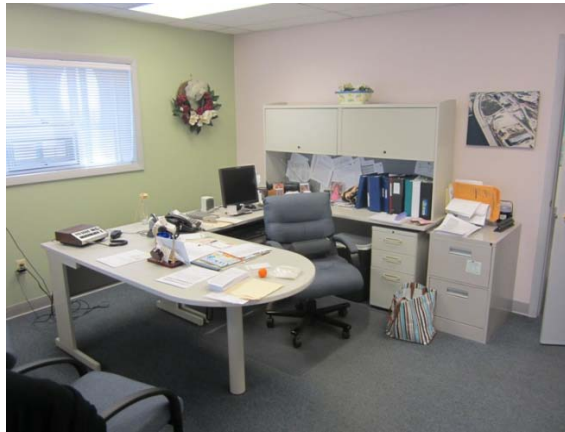
Office finishes

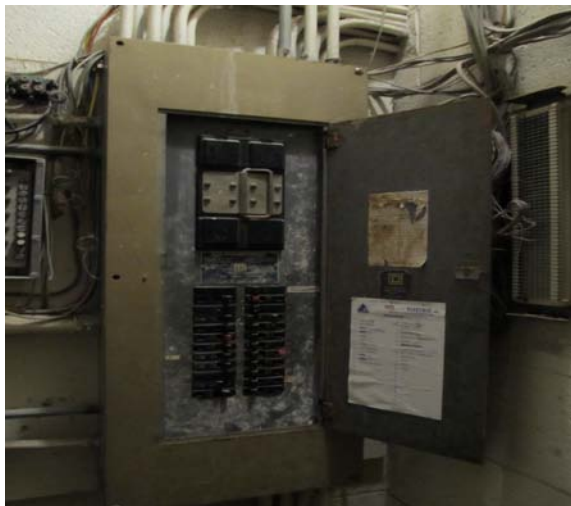
Service panel

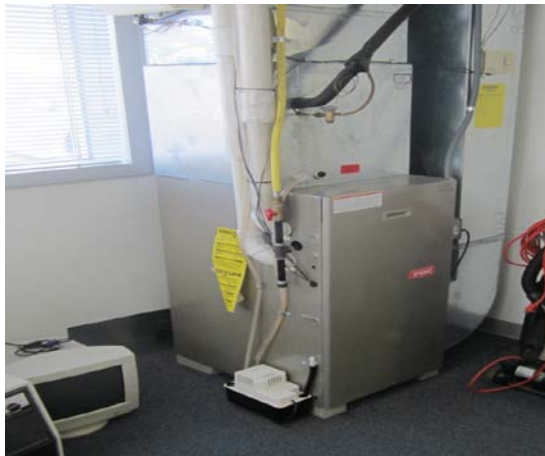
Furnace heating unit

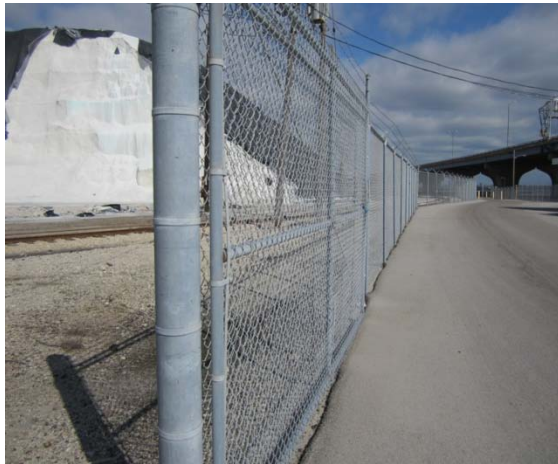
Fence and gate

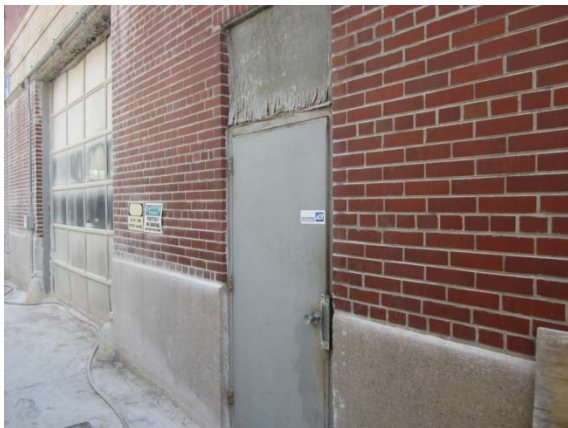
Onset of rust at west door

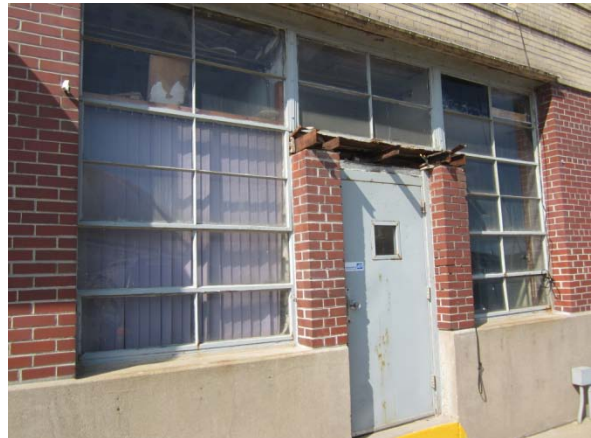
Onset of rust at east door

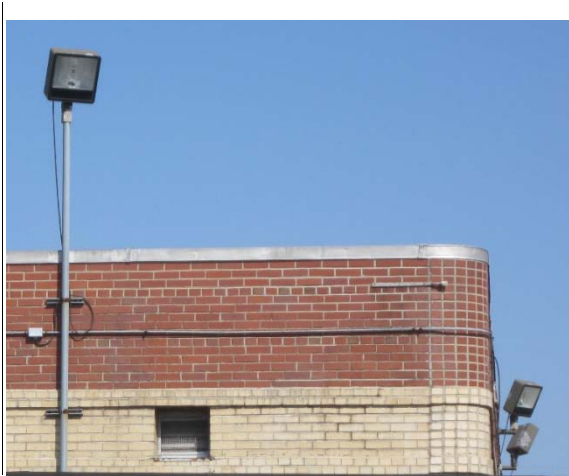
Outdoor lighting

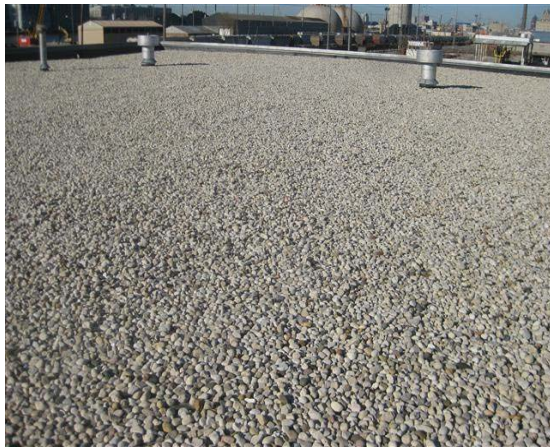
Roof-1 elevation view

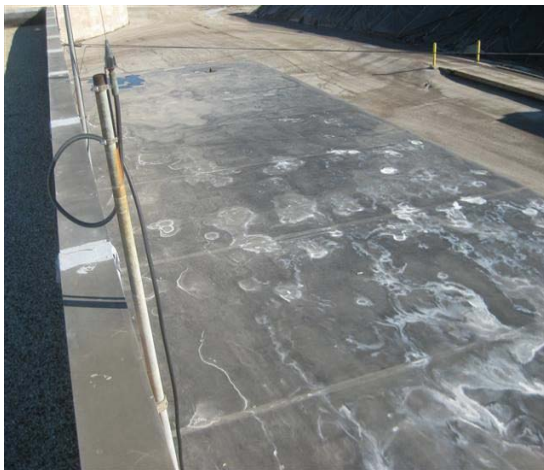
Roof-3 elevation view

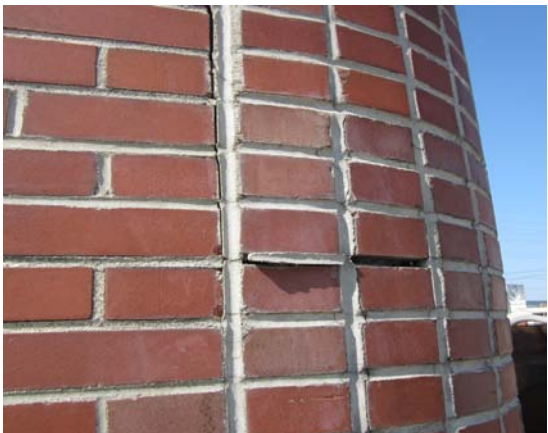
Mortar/brick separation at NE corner

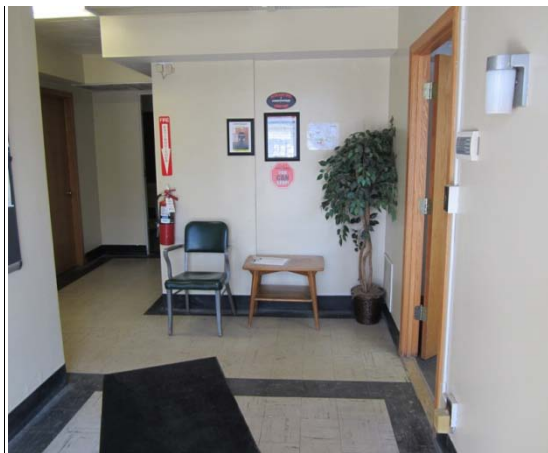
Entrance

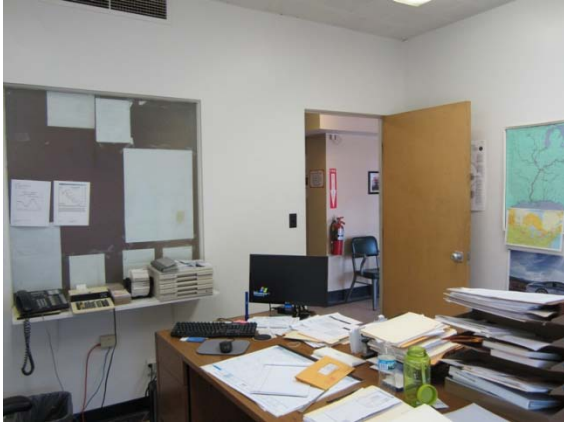
Typical office view

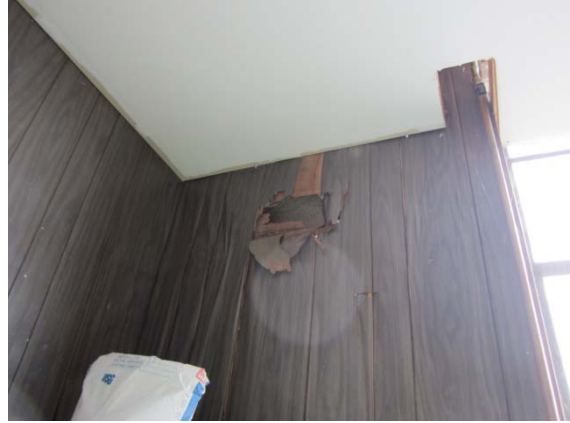
Damaged wall finish

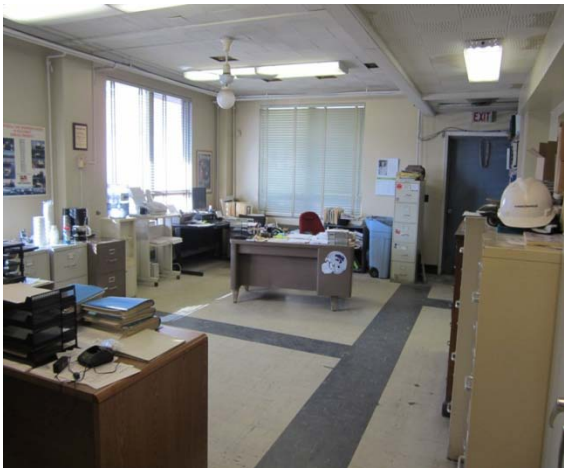
Finished office space

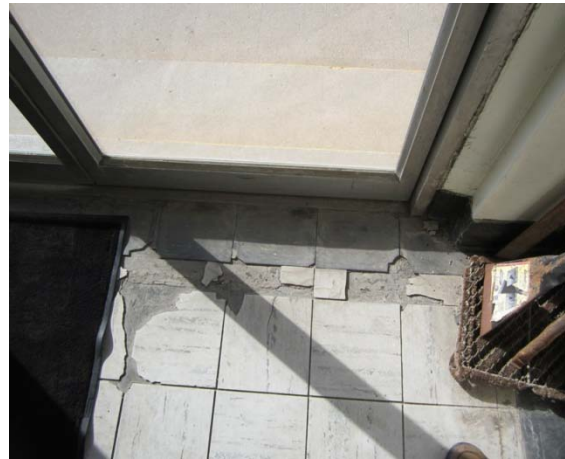
Damaged floor tiles

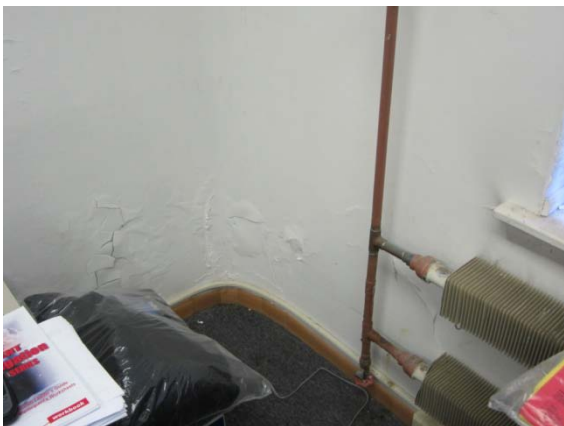
Damaged wall finish

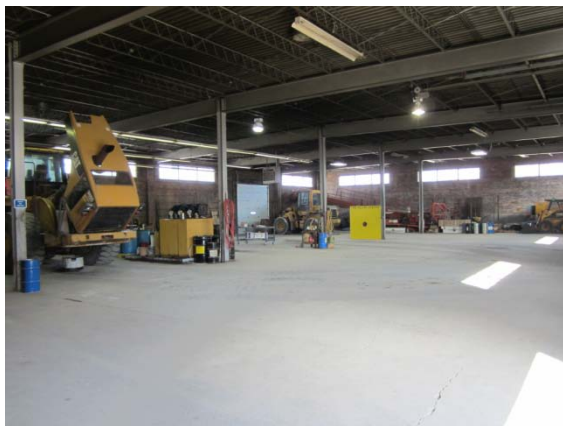
Light fixtures

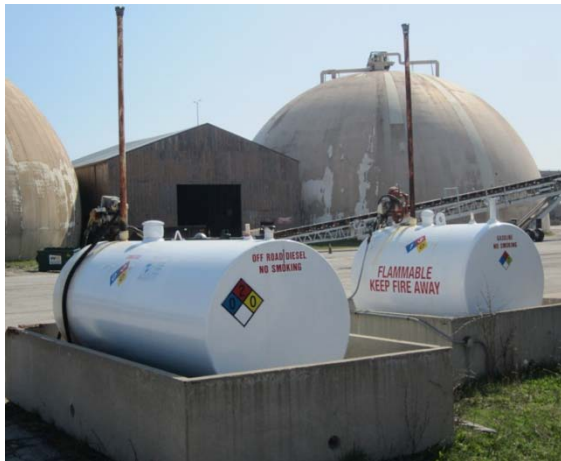
Fuel tanks and dispenser system

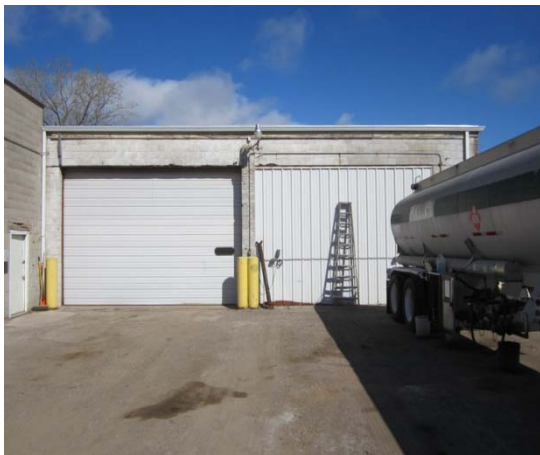
South elevation overhead garage door

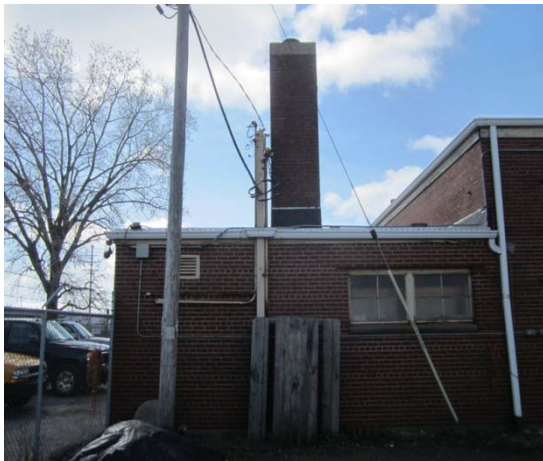
Gutters at north elevation

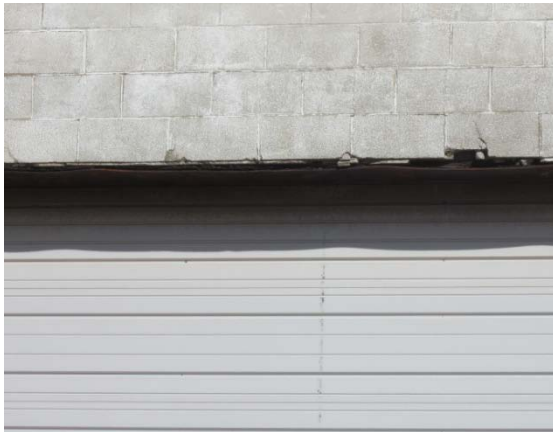
Deflected/damaged lintel and CMU

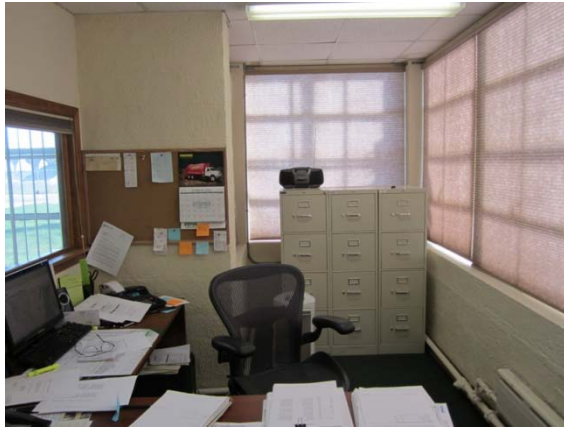
Typical office view

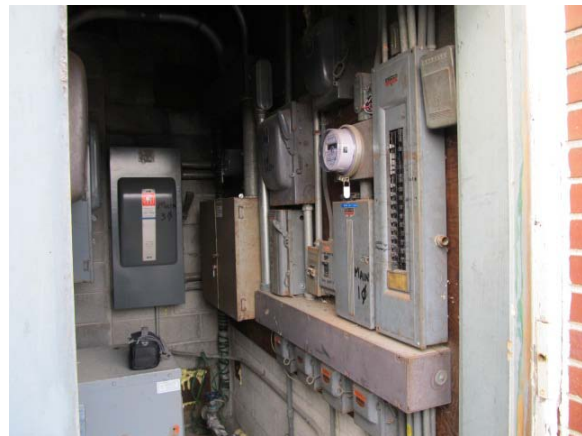
Outdated electrical equipment and NEC non-compliant

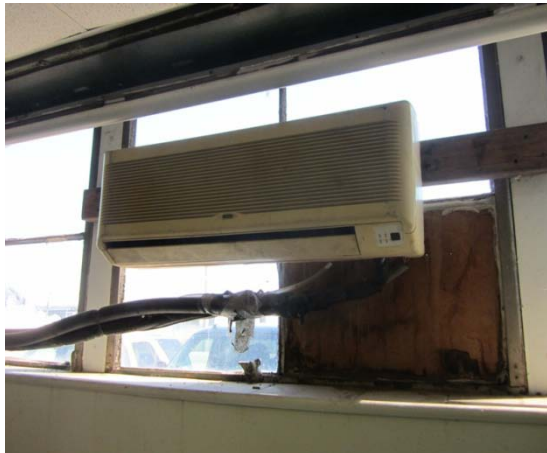
Air Conditioner unit

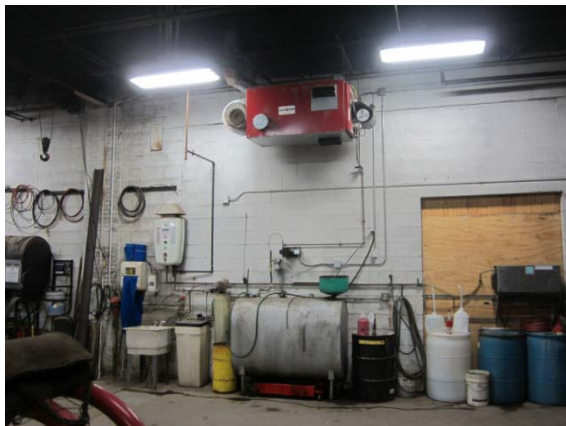
Light fixtures at lessee garage

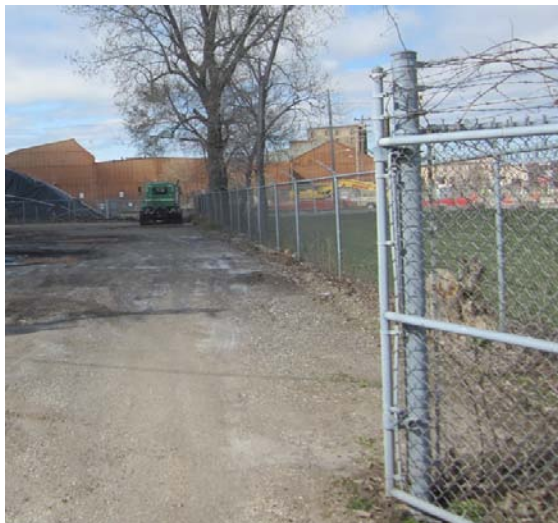
Fence at north perimeter

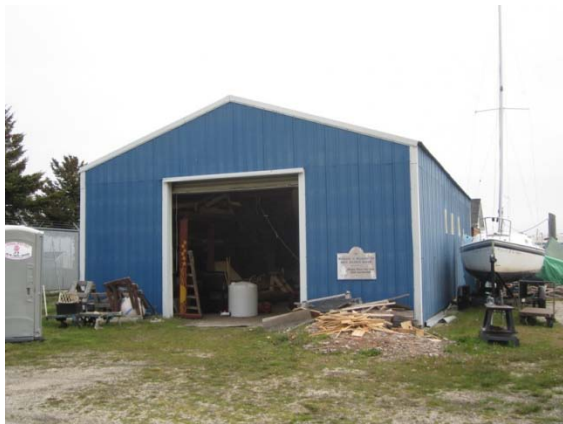
Overhead door

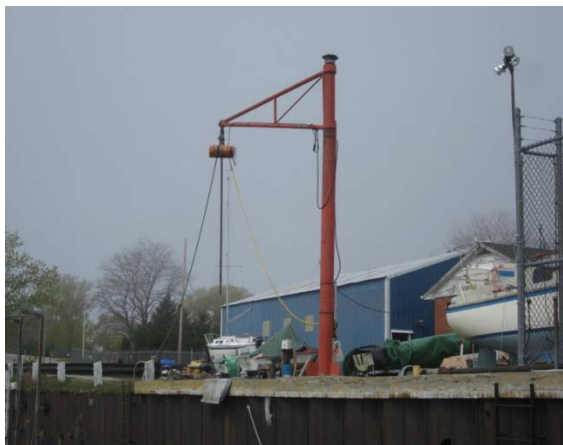
Boat Crane east elevation

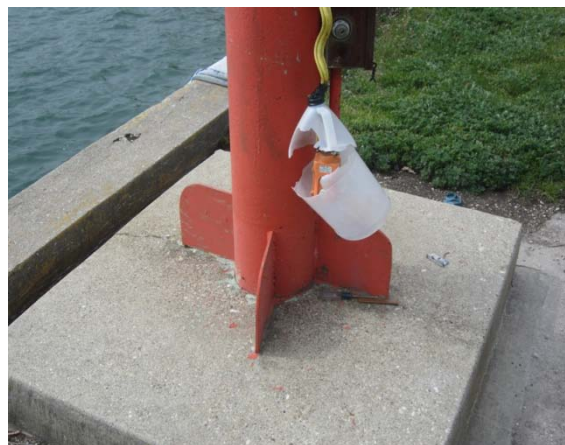
Cracked foundation

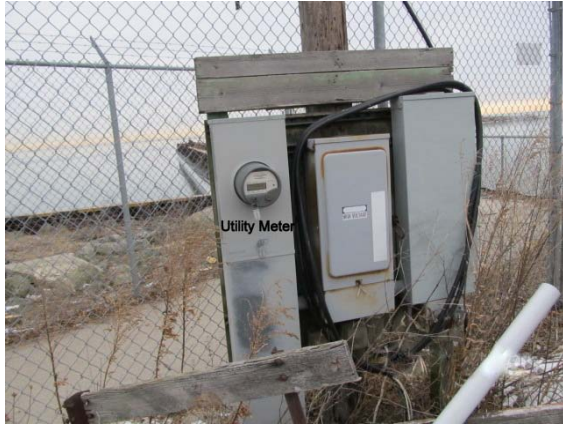
Secondary distribution and utility meter

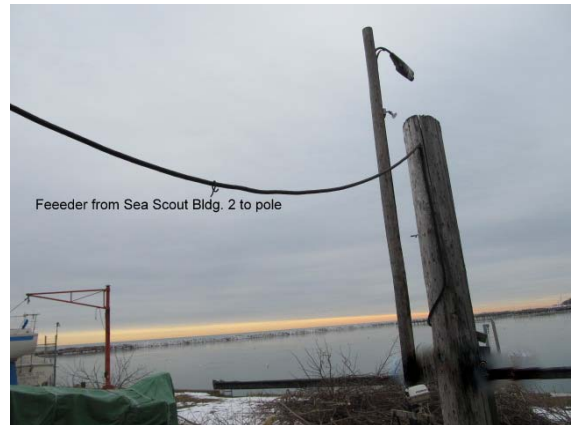
Feeder line

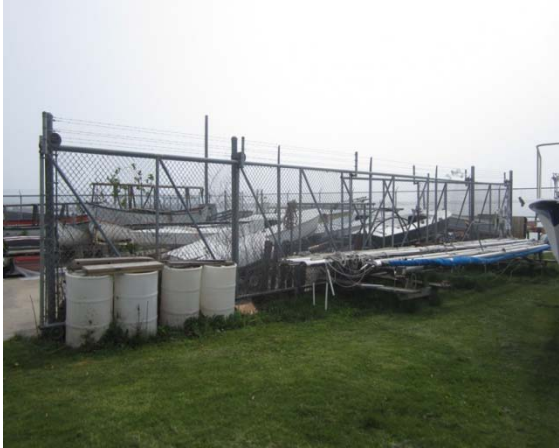
East elevation chain link sliding gate

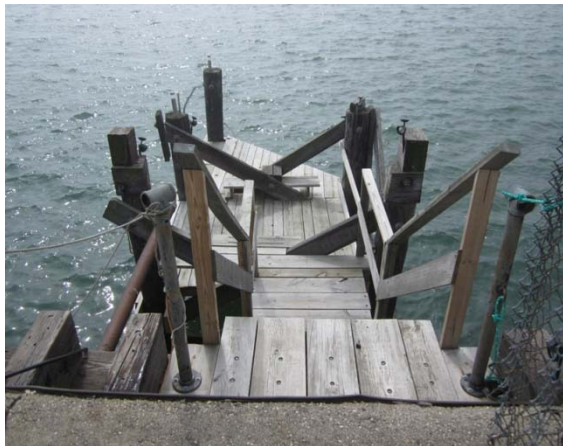
Wooden Pier east elevation

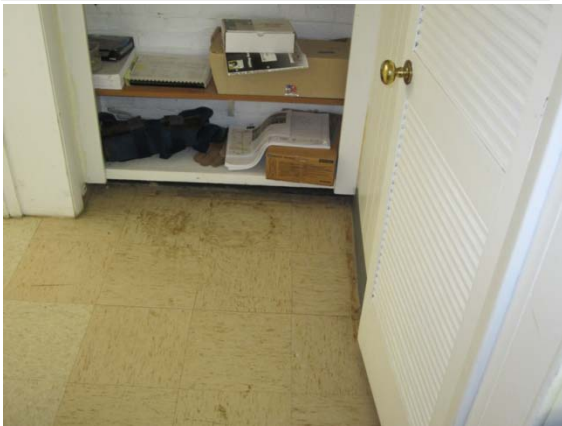
Vinyl floor tile

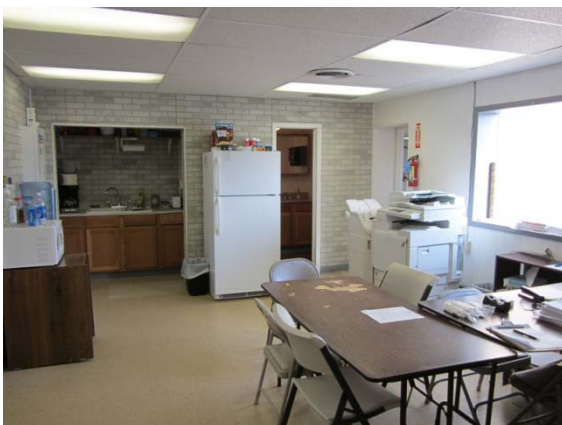
Kitchen and lunch room
