# Milwaukee Water Works

## Infrastructure Condition Assessment for Capital Improvements Committee

July 2011

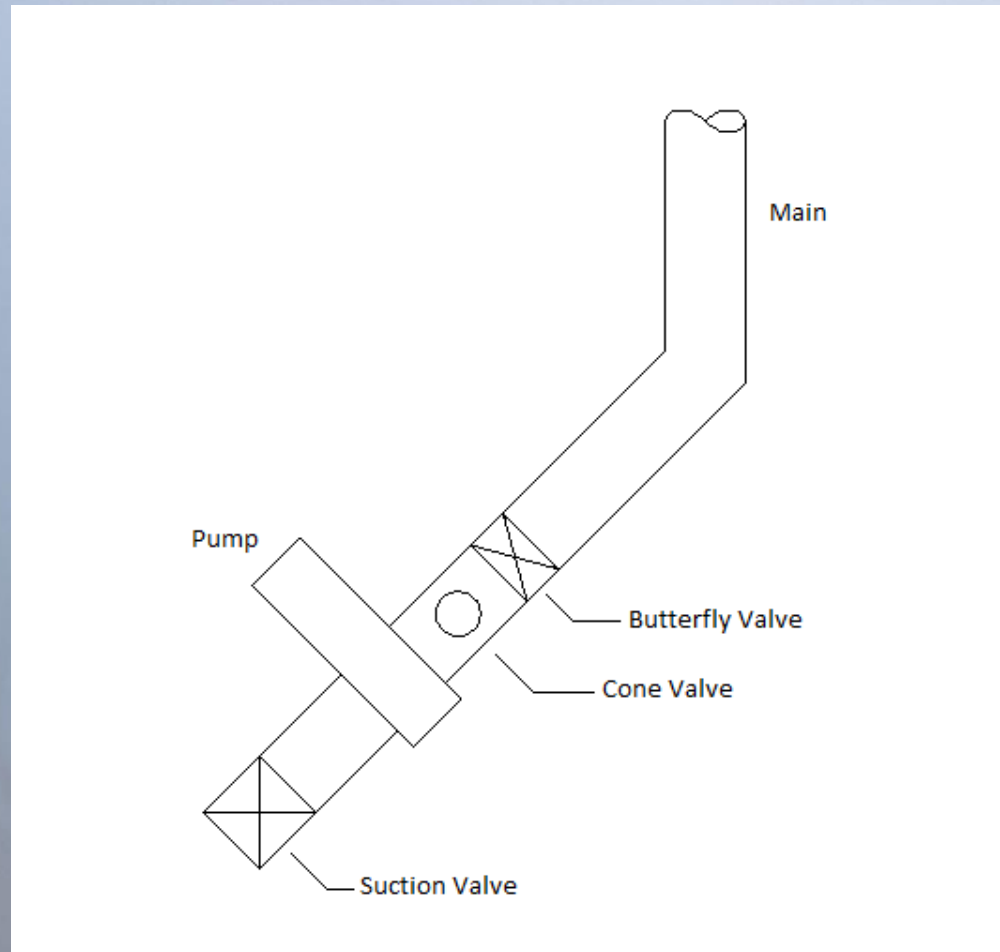
# Riverside Pumping Station

Tunnel from Linnwood	Unknown
Structure	3
Electrical	4
Pump Number 1A	1
Pump Number 1B	3
Pump Number 2	3
Pump Number 3A	3
Pump Number 3B	3
Pump Number 4	5
Pump Number 5	3
Pump Number 6A	5
Pump Number 6B	5
Pipes and Valves	2
<b>Average</b>	<b>3.3</b>
