RES-RPR-18-00441 ORD-18-05322

Certificate of Appropriateness

Property Description of work 4378 N. 25TH ST. Garden Homes Historic District

PTS ID 114550 COA: rebuild porch railings

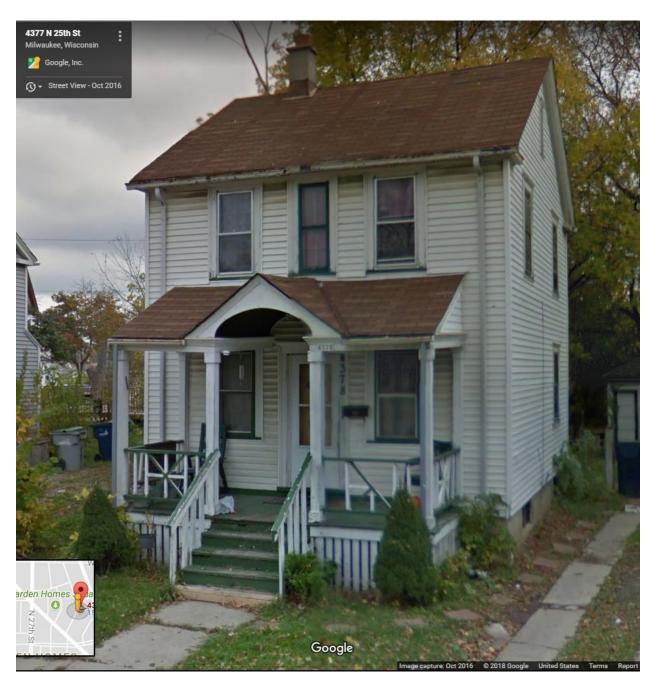
Current conditions at property

Description of workRebuild/repair porch railings to original design as shown in attached 1988 photo. Design and existing height of 33.25" is acceptable as a registered historic building and this has a permit as a repair. If required to extend height to 36", the design as shown consists of simple mitering and is flexible enough to be extended to that height or the rail may be raised higher from deck surface to achieve 36".

Replace stair railings per attached design at 33" or 36" at the discretion of the building inspector.

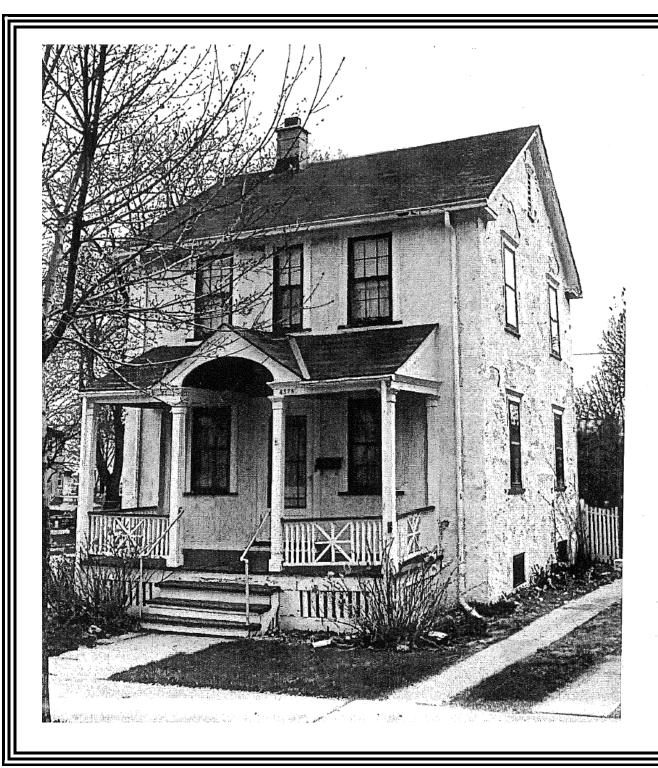
Original porch design as existing in 1988. Rebuild as shown with 2x2 square balusters, spaced 1.5" apart. Starburst design at center of each panel is required

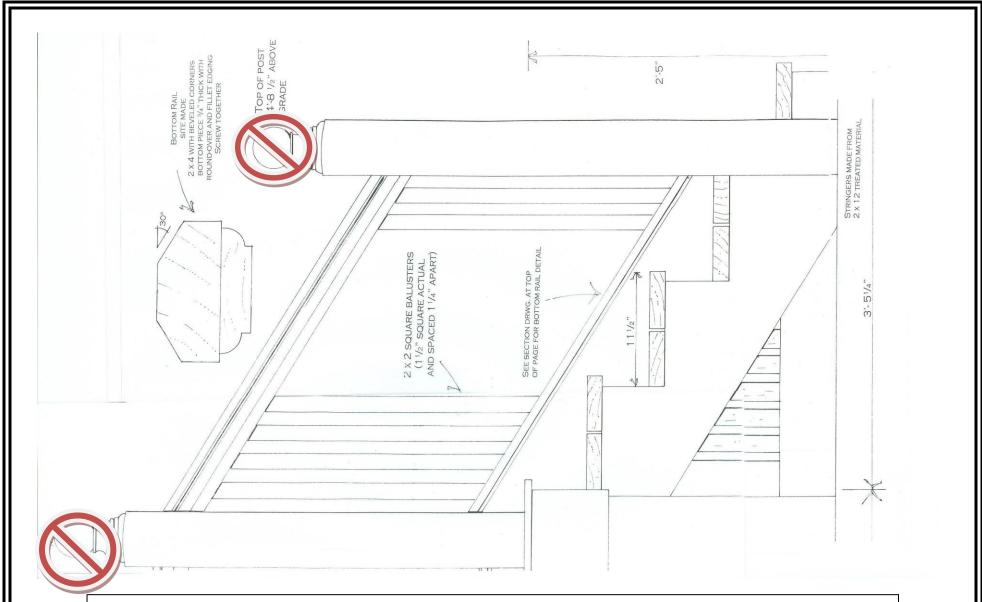
Example design for stair railing. A graspable handrail is required, but the balusters and bottom rail may e skipped on stair railing. Attach to existing column at top. Do not use ball newel cap. Newels shall be square. Use newel cap design on next page

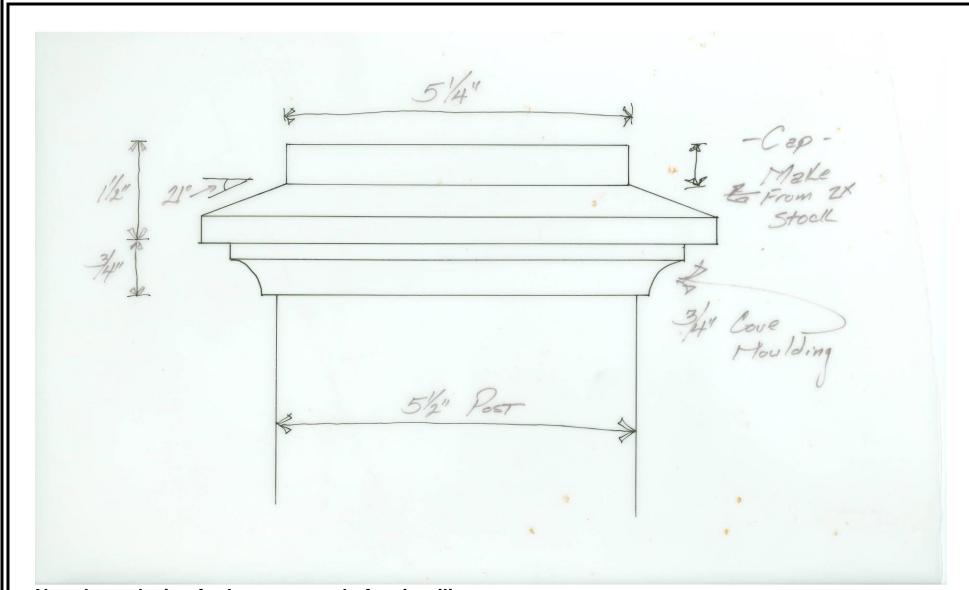
Newel cap design for bottom newel of stair railing.

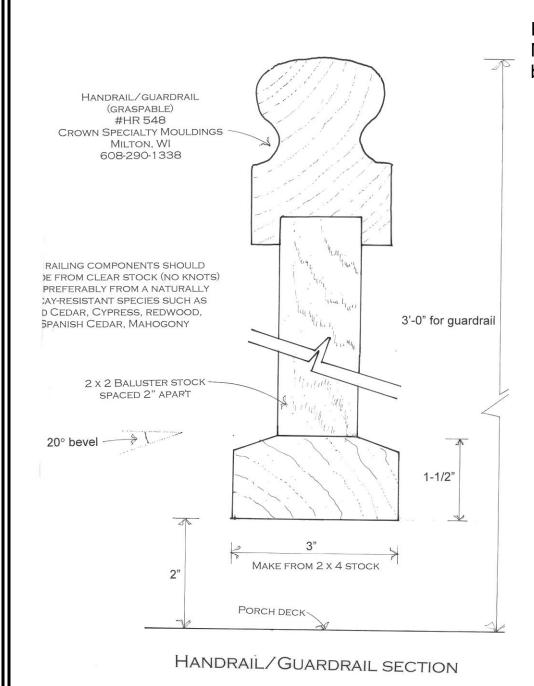
Recommended handrail design for stair railing. May use this design for porch railing. Beveled bottom rail is required if bottom rail is replaced.

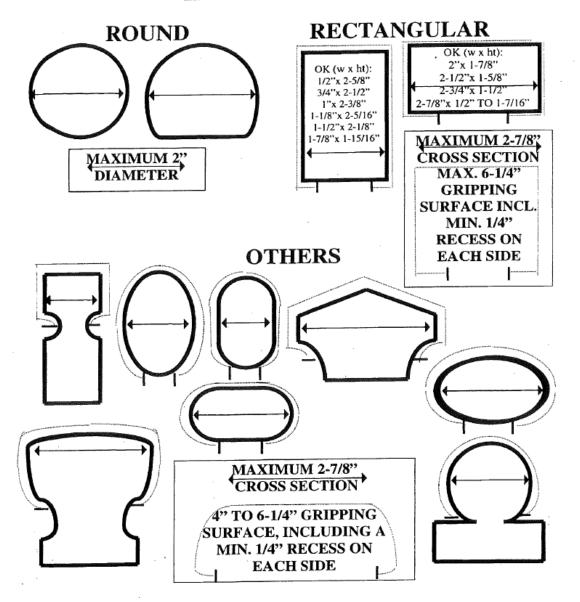
Alternate stair hand rail options. Do not use for porch top railing. Rectangular designs are strongly disouraged.
