## WISCONSIN LAKEFRONT PROPERTY MANAGEMENT LLC

Claim: Water Main Break Property Damage  
Property: Manorview Apartments  
Address: 8509 W Oklahoma Ave., Milwaukee, WI 53227  
Owner: Manorview Apartment Homes LLC  
Managing Member: Eileen Robarge  
Owner Contact Info: (858)761-2980, [erobarge@windwardcovelc.com](mailto:erobarge@windwardcovelc.com)  
Property Manager: Allen Boelk  
Property Manager Contact Info: (414)322-6677 [allenb@windwardcovelc.com](mailto:allenb@windwardcovelc.com)  
Administator Contact: Ann Henry 866-542-5851 [annh@windwardcovelc.com](mailto:annh@windwardcovelc.com)  
Business Registered Mailing Address: 4712 Whispering Oak Court, Apt. 16, Sheboygan, WI 53083  
Date of Event: January 24<sup>th</sup> 2025, Time: Noticed at 6:30 am

GZA GeoEnvironmental, Inc. (GZA) is pleased to submit this Memorandum ("Memo") to Wisconsin Lakefront Property Management LLC ("Client") for the above-referenced project located at 8509 West Oklahoma Avenue in Milwaukee, Wisconsin ("Site"). A Site Location Plan is provided as **Figure 1**. This Memo provides a summary of findings and recommendations from GZA's Site visit and fieldwork performed on April 30, 2025, and subsequent labo

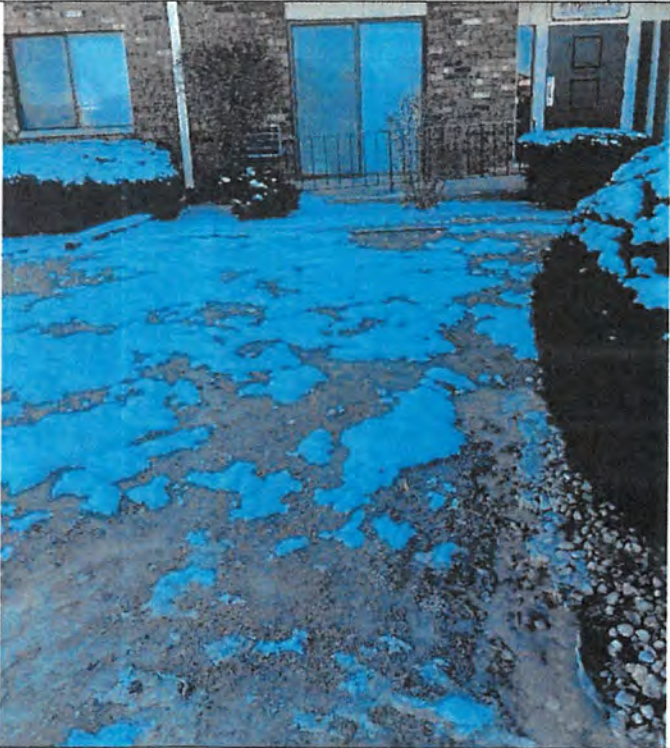
| <b>Photo No.</b><br>23 | <b>Date:</b><br>1/24/25 | | |

| <b>Description:</b><br>Client-provided photograph at the time of the water main break.<br>Condition of property. | | | |

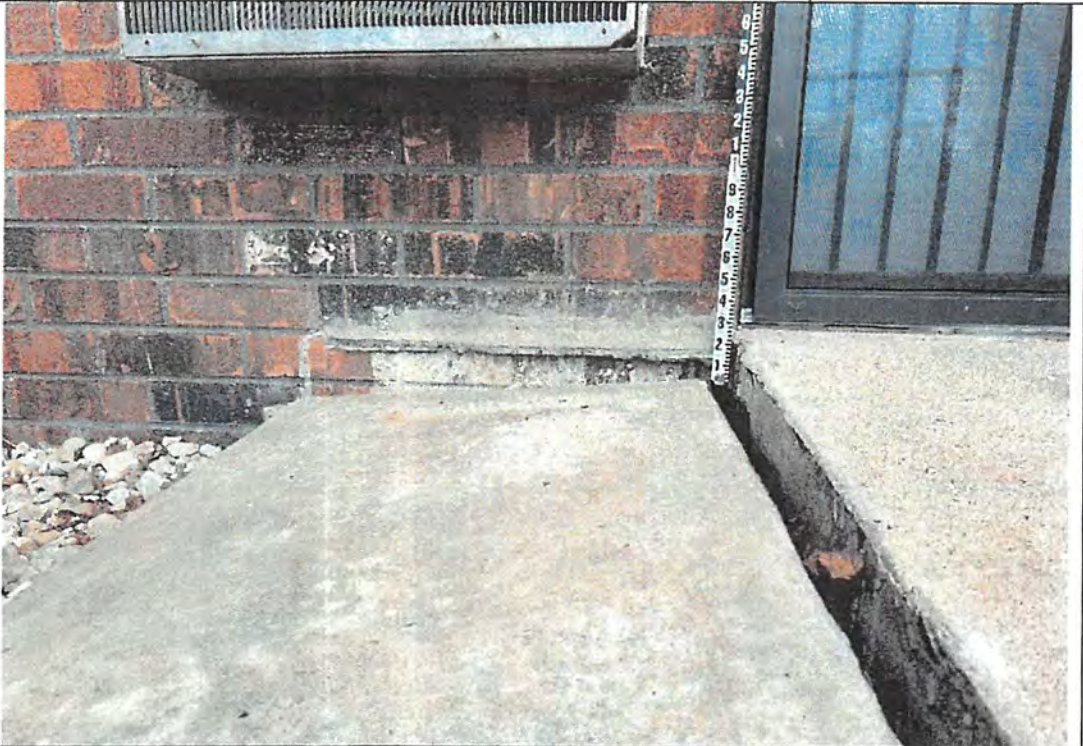
| <b>Photo No.</b><br>13 | <b>Date:</b><br>4/30/25 | | |

| <b>Description:</b><br>Separation of patio from structure on north side of building. | | | |

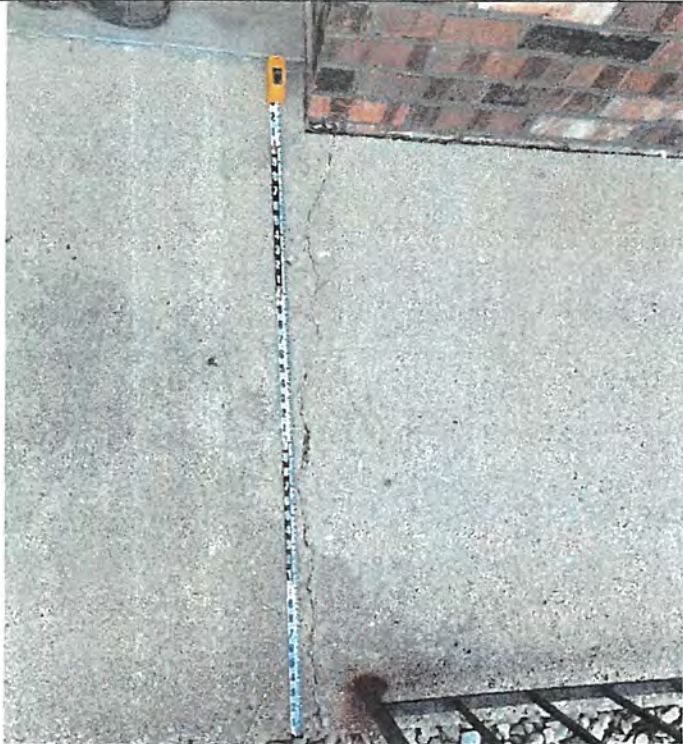
| <b>Photo No.</b><br>15 | <b>Date:</b><br>4/30/25 | | |

| <b>Description:</b><br>Separation and cracking of patio from structure on north side of building. | | | |
