## WISCONSIN LAKEFRONT PROPERTY MANAGEMENT LLC

Claim: Water Main Break Property Damage  
Property: Manorview Apartments  
Address: 8509 W Oklahoma Ave., Milwaukee, WI 53227  
Owner: Manorview Apartment Homes LLC  
Managing Member: Eileen Robarge  
Owner Contact Info: (858)761-2980, [erobarge@windwardcovelc.com](mailto:erobarge@windwardcovelc.com)  
Property Manager: Allen Boelk  
Property Manager Contact Info: (414)322-6677 [allenb@windwardcovelc.com](mailto:allenb@windwardcovelc.com)  
Administator Contact: Ann Henry 866-542-5851 [annh@windwardcovelc.com](mailto:annh@windwardcovelc.com)  
Business Registered Mailing Address: 4712 Whispering Oak Court, Apt. 16, Sheboygan, WI 53083  
Date of Event: January 24<sup>th</sup> 2025, Time: Noticed at 6:30 am

GZA GeoEnvironmental, Inc. (GZA) is pleased to submit this Memorandum ("Memo") to Wisconsin Lakefront Property Management LLC ("Client") for the above-referenced project located at 8509 West Oklahoma Avenue in Milwaukee, Wisconsin ("Site"). A Site Location Plan is provided as **Figure 1**. This Memo provides a summary of findings and recommendations from GZA's Site visit and fieldwork performed on April 30, 2025, and subsequent labo

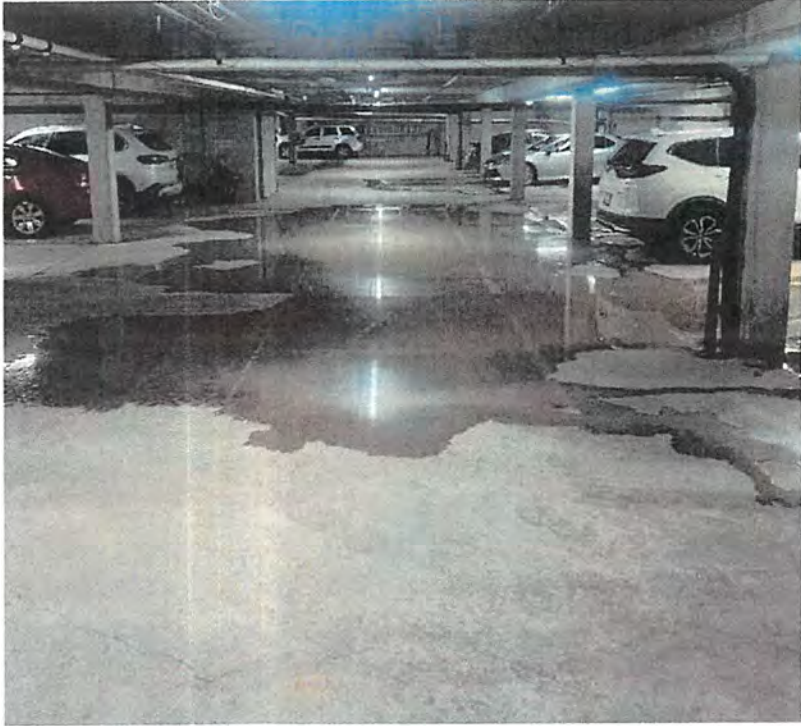
| <b>Photo No.</b><br>1 | <b>Date:</b><br>1/24/25 | | |

| <b>Description:</b><br>Client-provided photograph at the time of the water main break.<br>Condition of basement/parking structure. | | | |

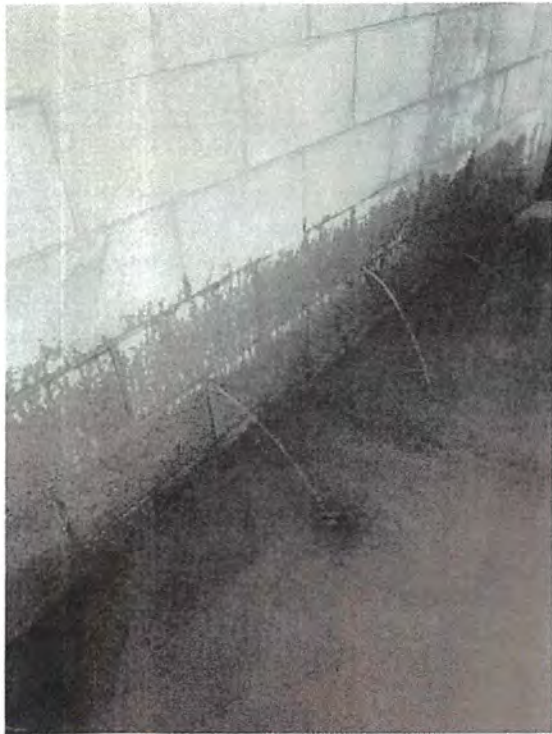
| <b>Photo No.</b><br>3 | <b>Date:</b><br>1/24/25 | | |

| <b>Description:</b><br>Client-provided photograph at the time of the water main break. Condition of basement/parking structure. | | | |

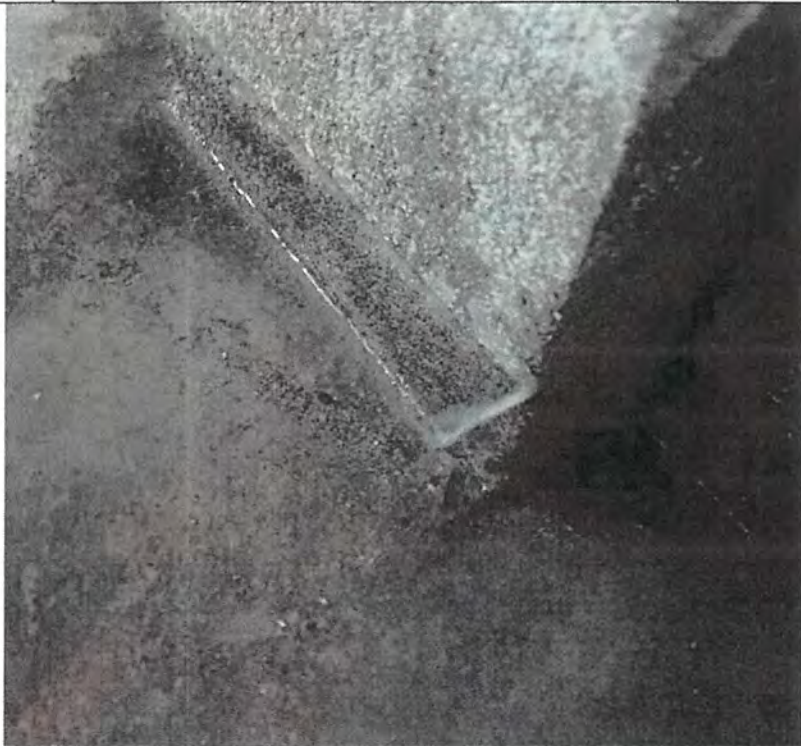
| <b>Photo No.</b><br>7 | <b>Date:</b><br>1/24/25 | | | |

| <b>Description:</b><br>Client-provided photograph at the time of the water main break. Condition of basement/parking structure. | | | | |

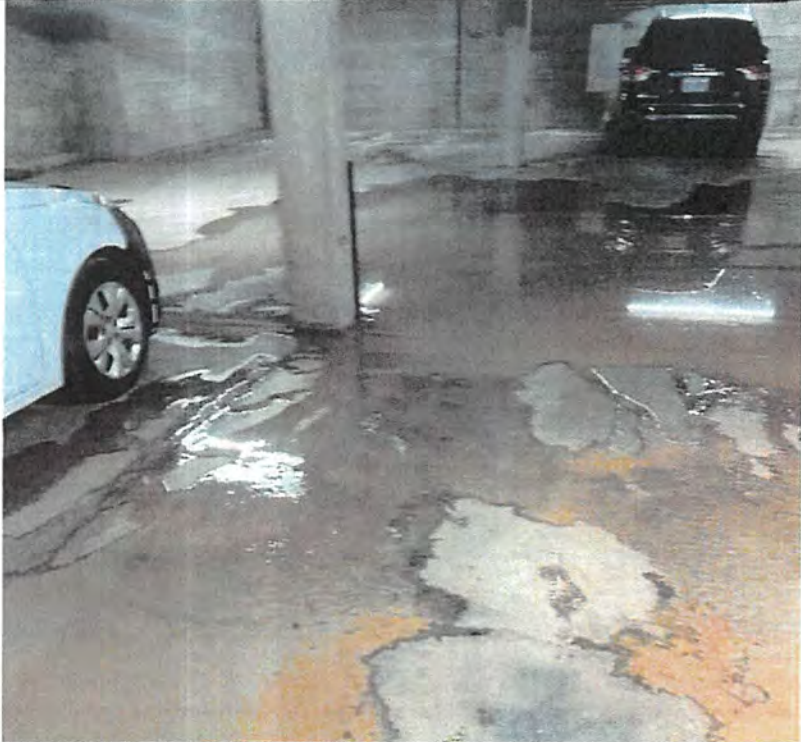
| <b>Photo No.</b><br>9 | <b>Date:</b><br>1/24/25 | | | |

| <b>Description:</b><br>Client-provided photograph at the time of the water main break.<br>Condition of basement/parking structure. | | | | |

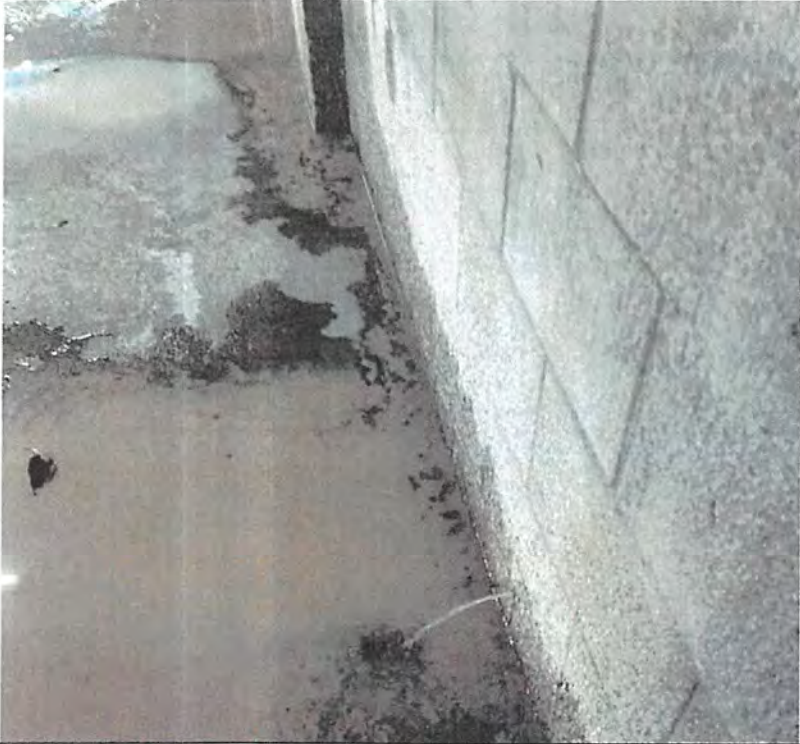
| <b>Photo No.</b><br>11 | <b>Date:</b><br>1/24/25 | | |

| <b>Description:</b><br>Client-provided photograph at the time of the water main break.<br>Condition of basement/parking structure. | | | |

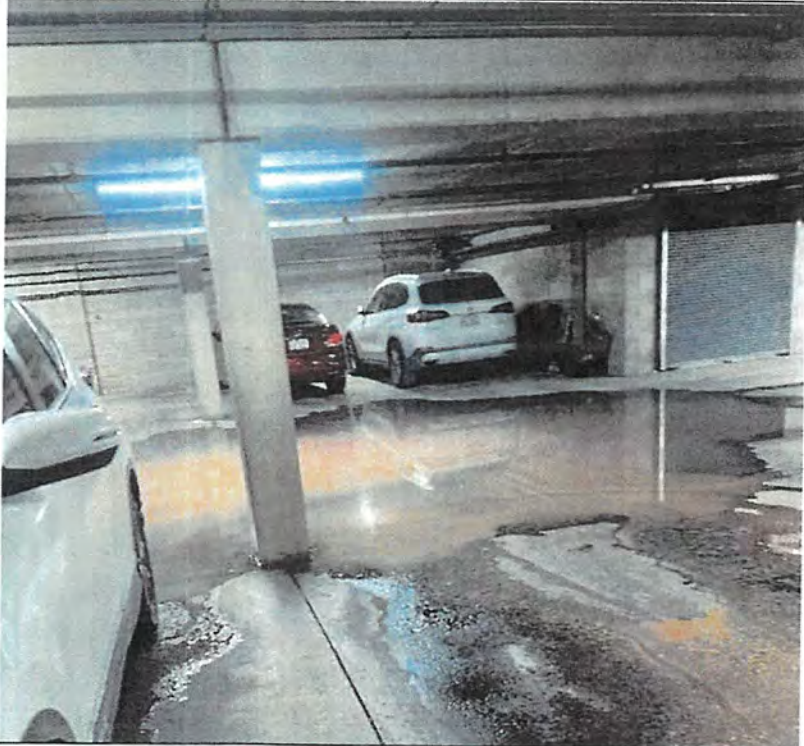
| <b>Photo No.</b><br>13 | <b>Date:</b><br>1/24/25 | | |

| <b>Description:</b><br>Client-provided photograph at the time of the water main break. Condition of basement/parking structure. | | | |

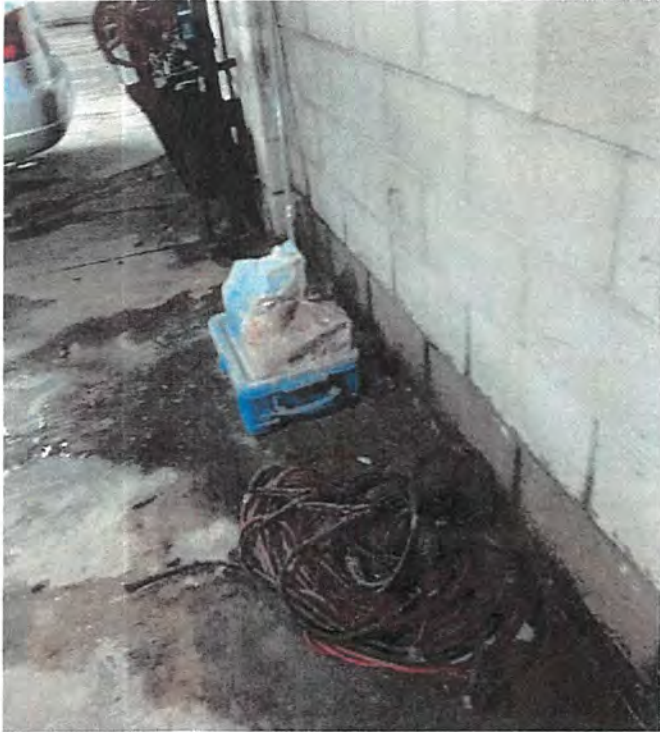
| <b>Photo No.</b><br>15 | <b>Date:</b><br>1/24/25 | | |

| <b>Description:</b><br>Client-provided photograph at the time of the water main break.<br>Condition of basement/parking structure. | | | |

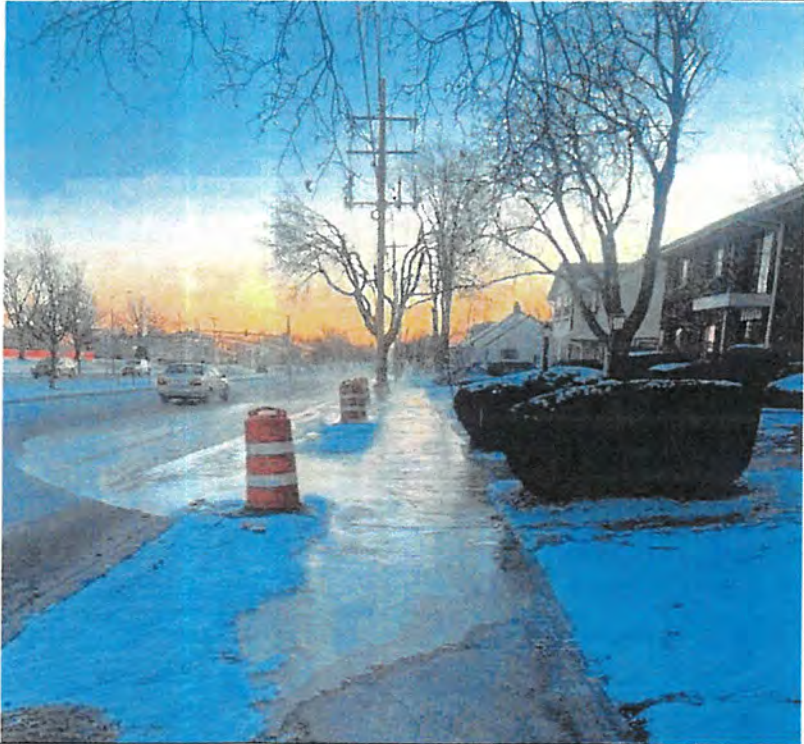
| <b>Photo No.</b><br>17 | <b>Date:</b><br>1/24/25 | | |

| <b>Description:</b><br>Client-provided photograph at the time of the water main break.<br>Condition of property. | | | |

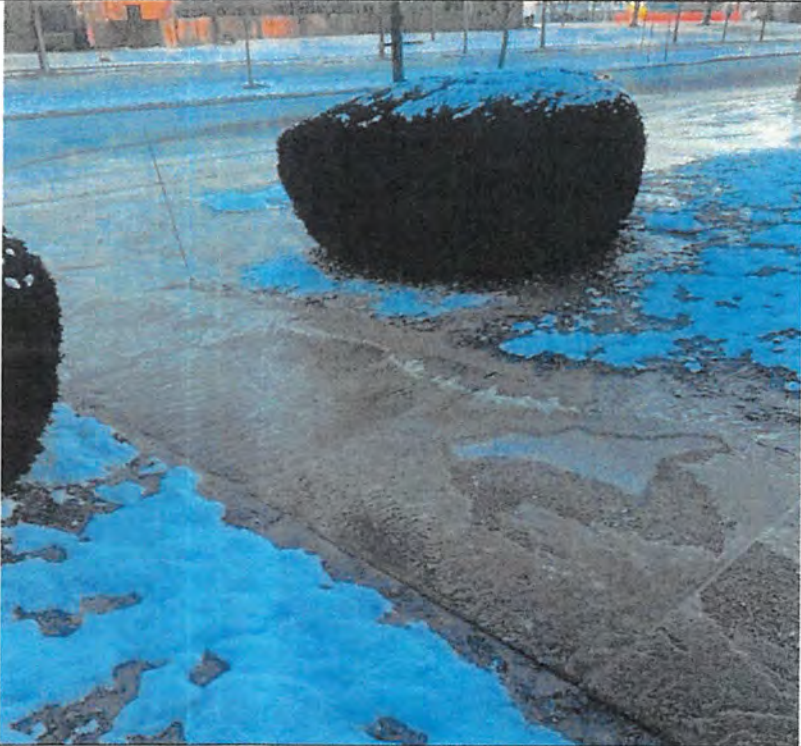
| <b>Photo No.</b><br>19 | <b>Date:</b><br>1/24/25 | | | |

| <b>Description:</b><br>Client-provided photograph at the time of the water main break.<br>Condition of property. | | | | |

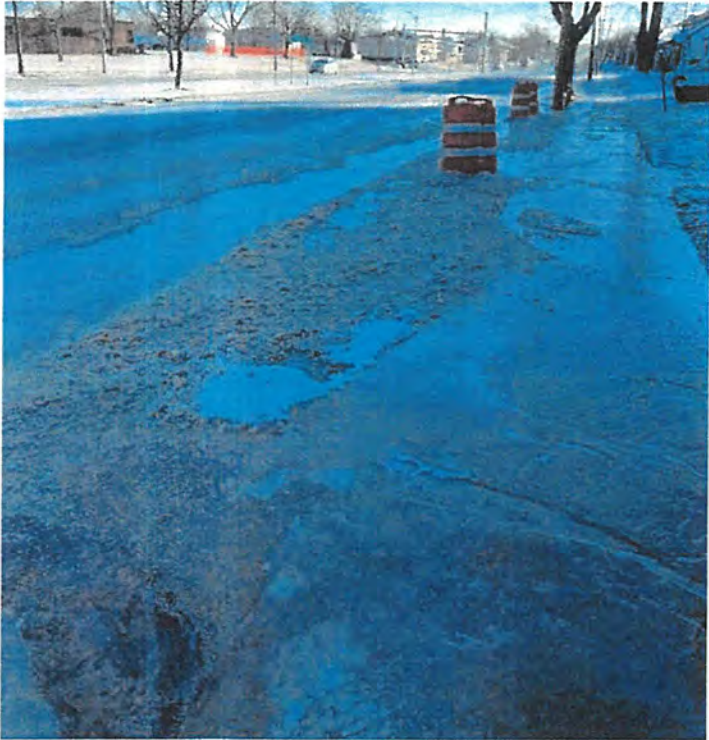
| <b>Photo No.</b><br>21 | <b>Date:</b><br>1/24/25 | | |

| <b>Description:</b><br>Client-provided photograph at the time of the water main break.<br>Condition of property. | | | |

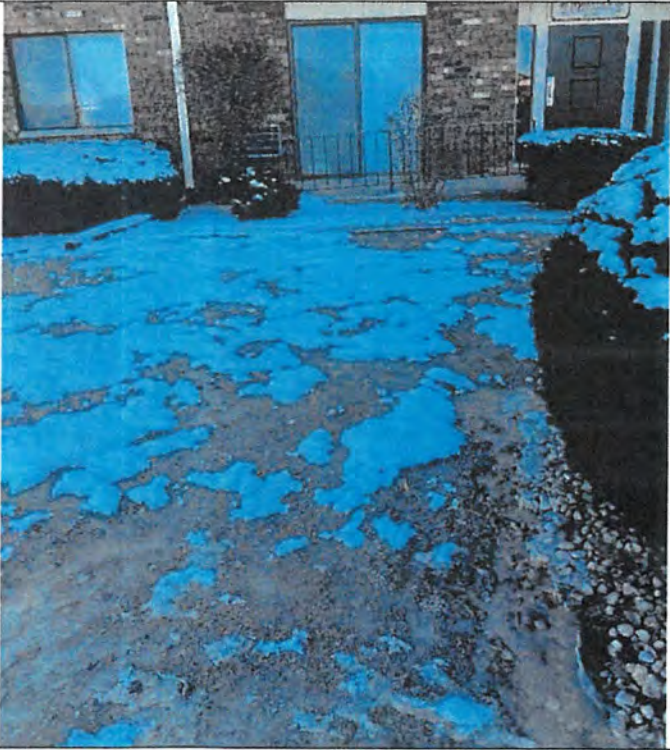
| <b>Photo No.</b><br>23 | <b>Date:</b><br>1/24/25 | | |

| <b>Description:</b><br>Client-provided photograph at the time of the water main break.<br>Condition of property. | | | |

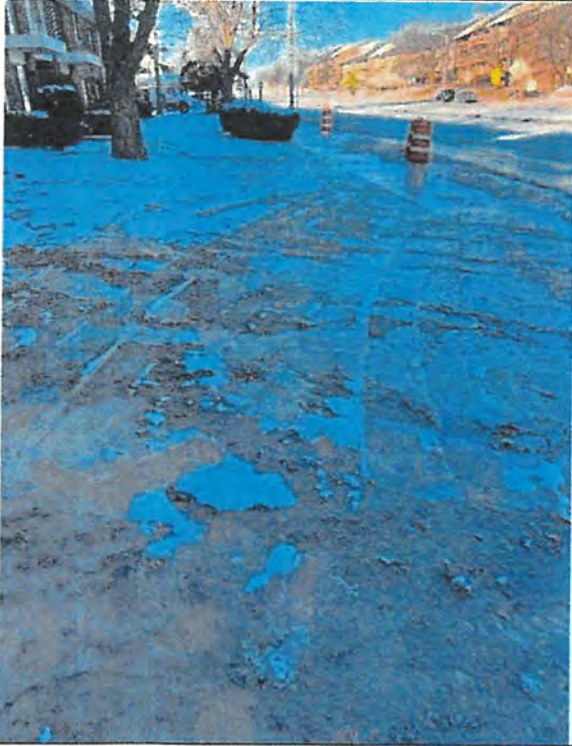
| <b>Photo No.</b><br>25 | <b>Date:</b><br>1/24/25 | | |

| <b>Description:</b><br>Client-provided photograph at the time of the water main break.<br>Condition of property. | | | |

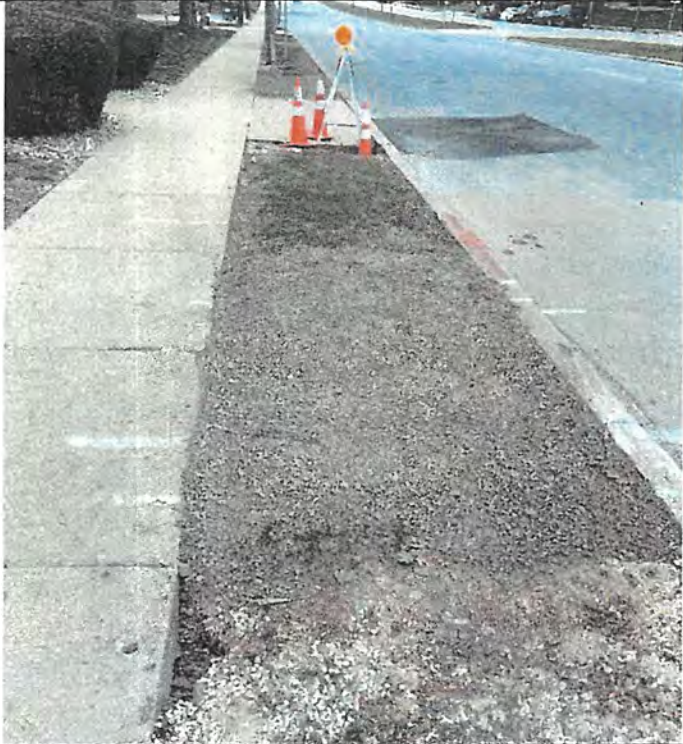
| <b>Photo No.</b><br>11 | <b>Date:</b><br>4/30/25 | | |

| <b>Description:</b><br>Area of water main repair on Oklahoma Avenue. | | | |
