Department Copy

Dear Jim,

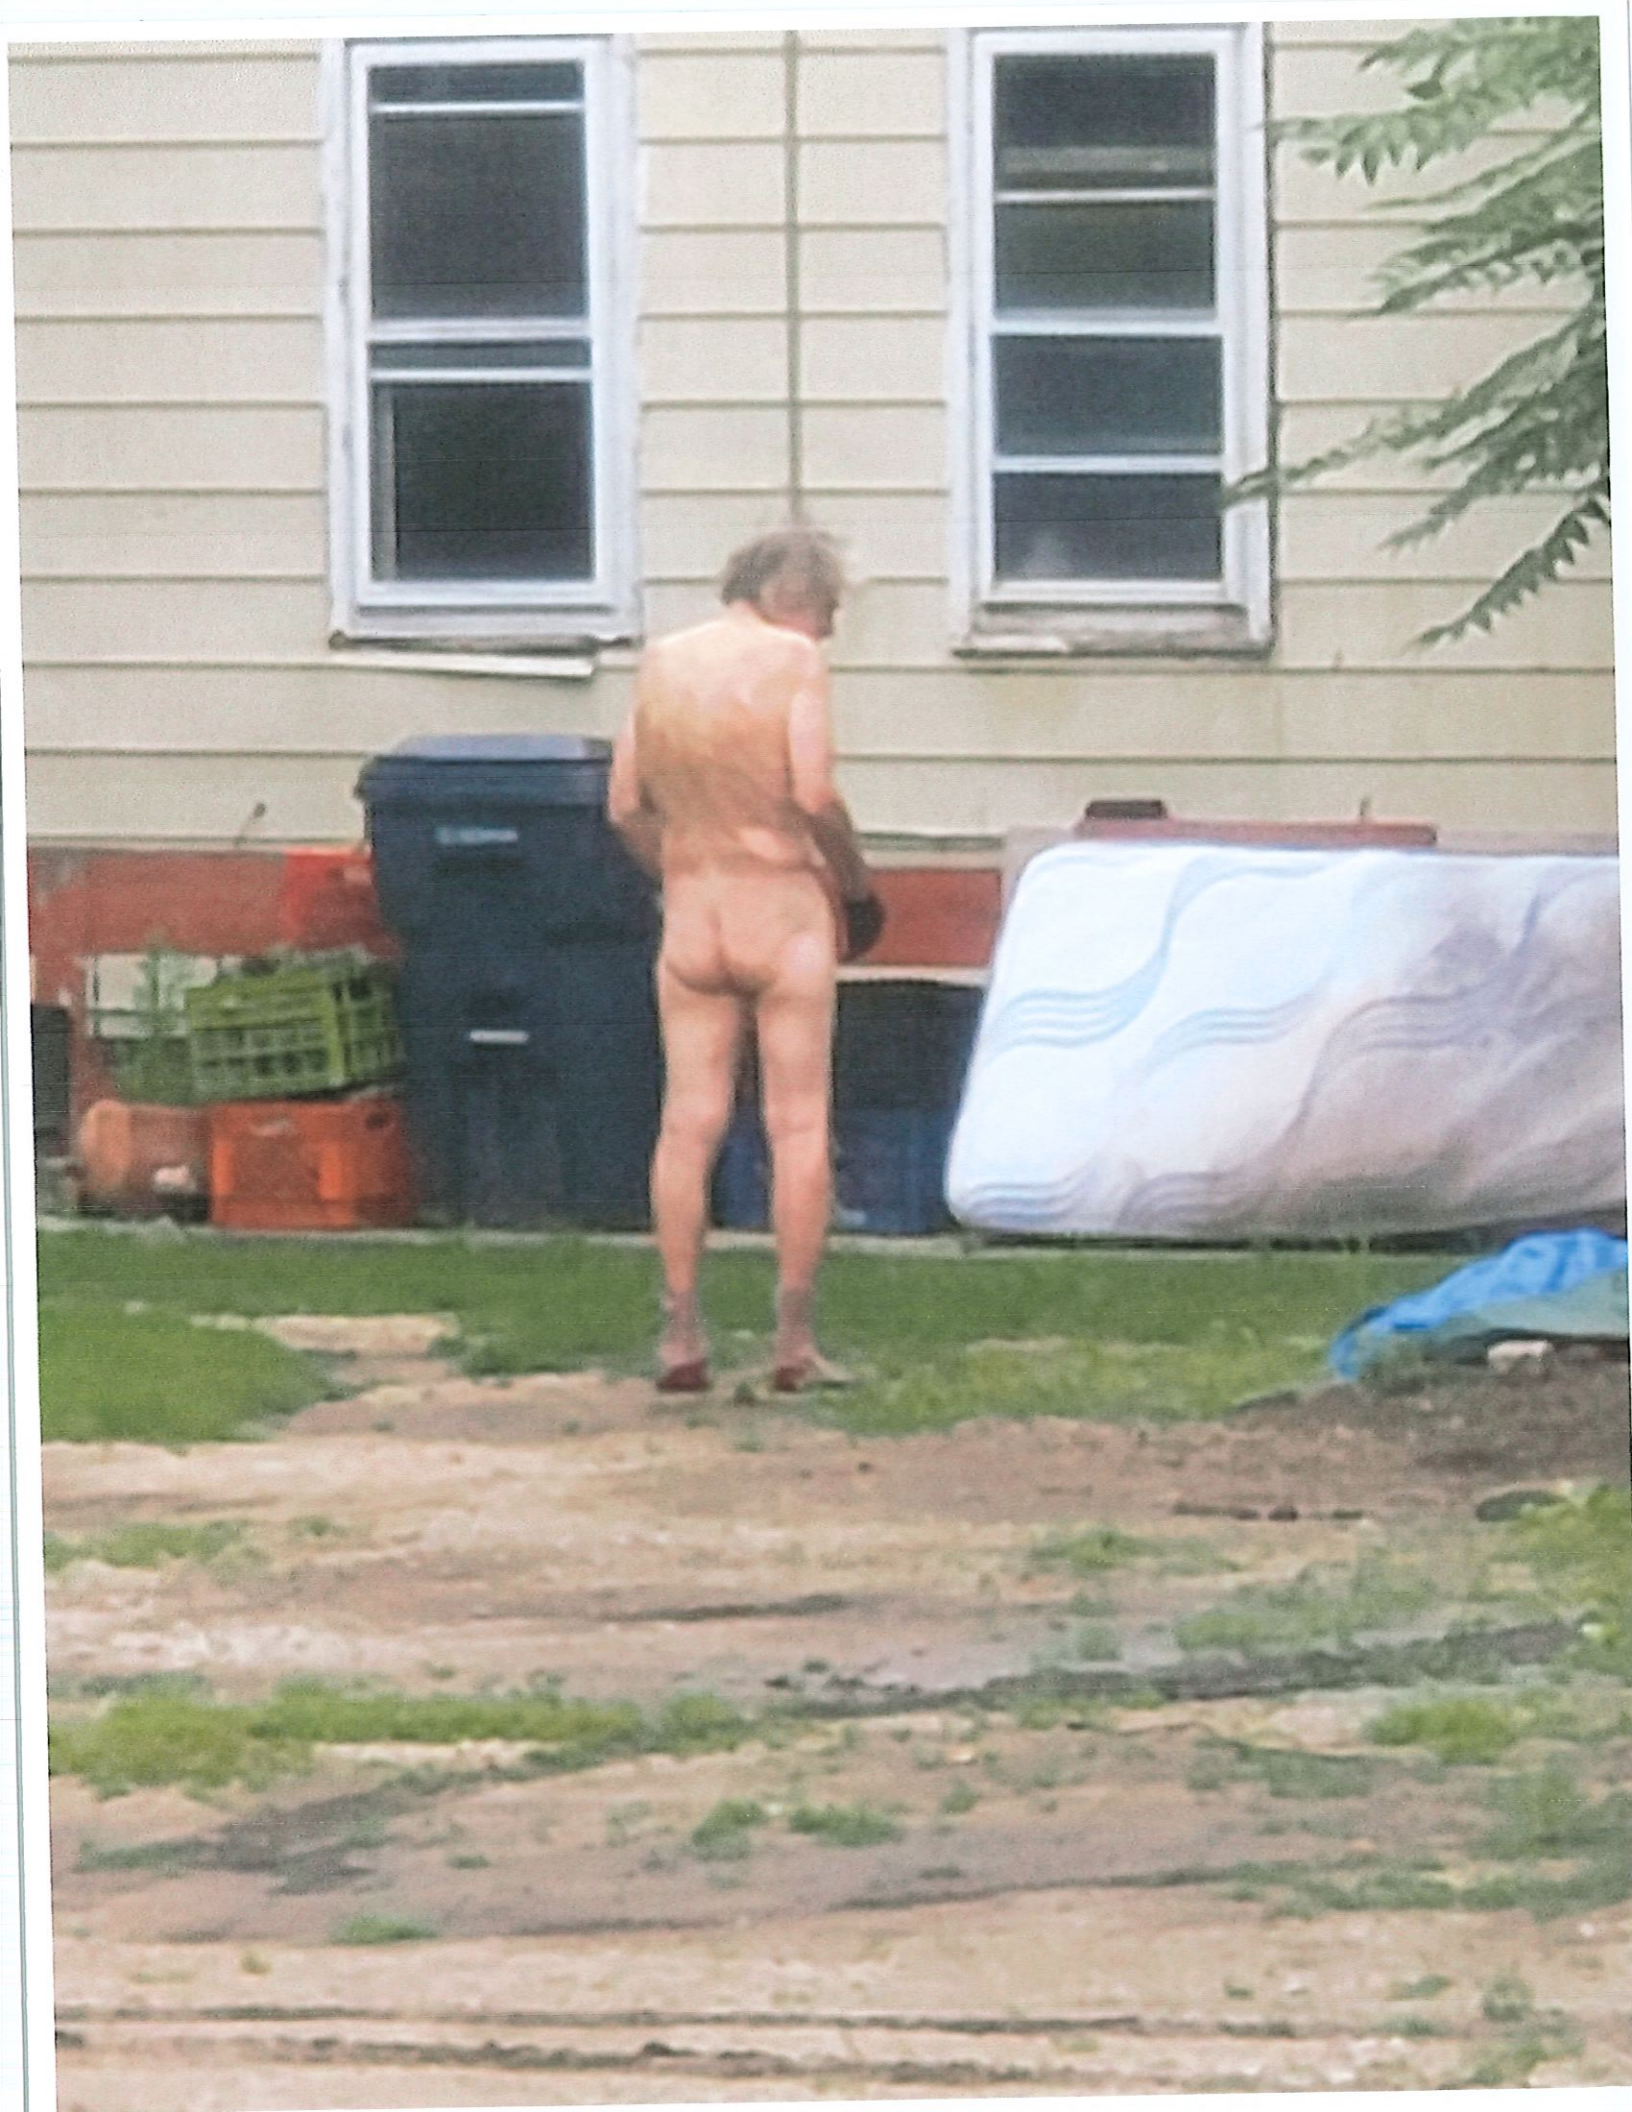
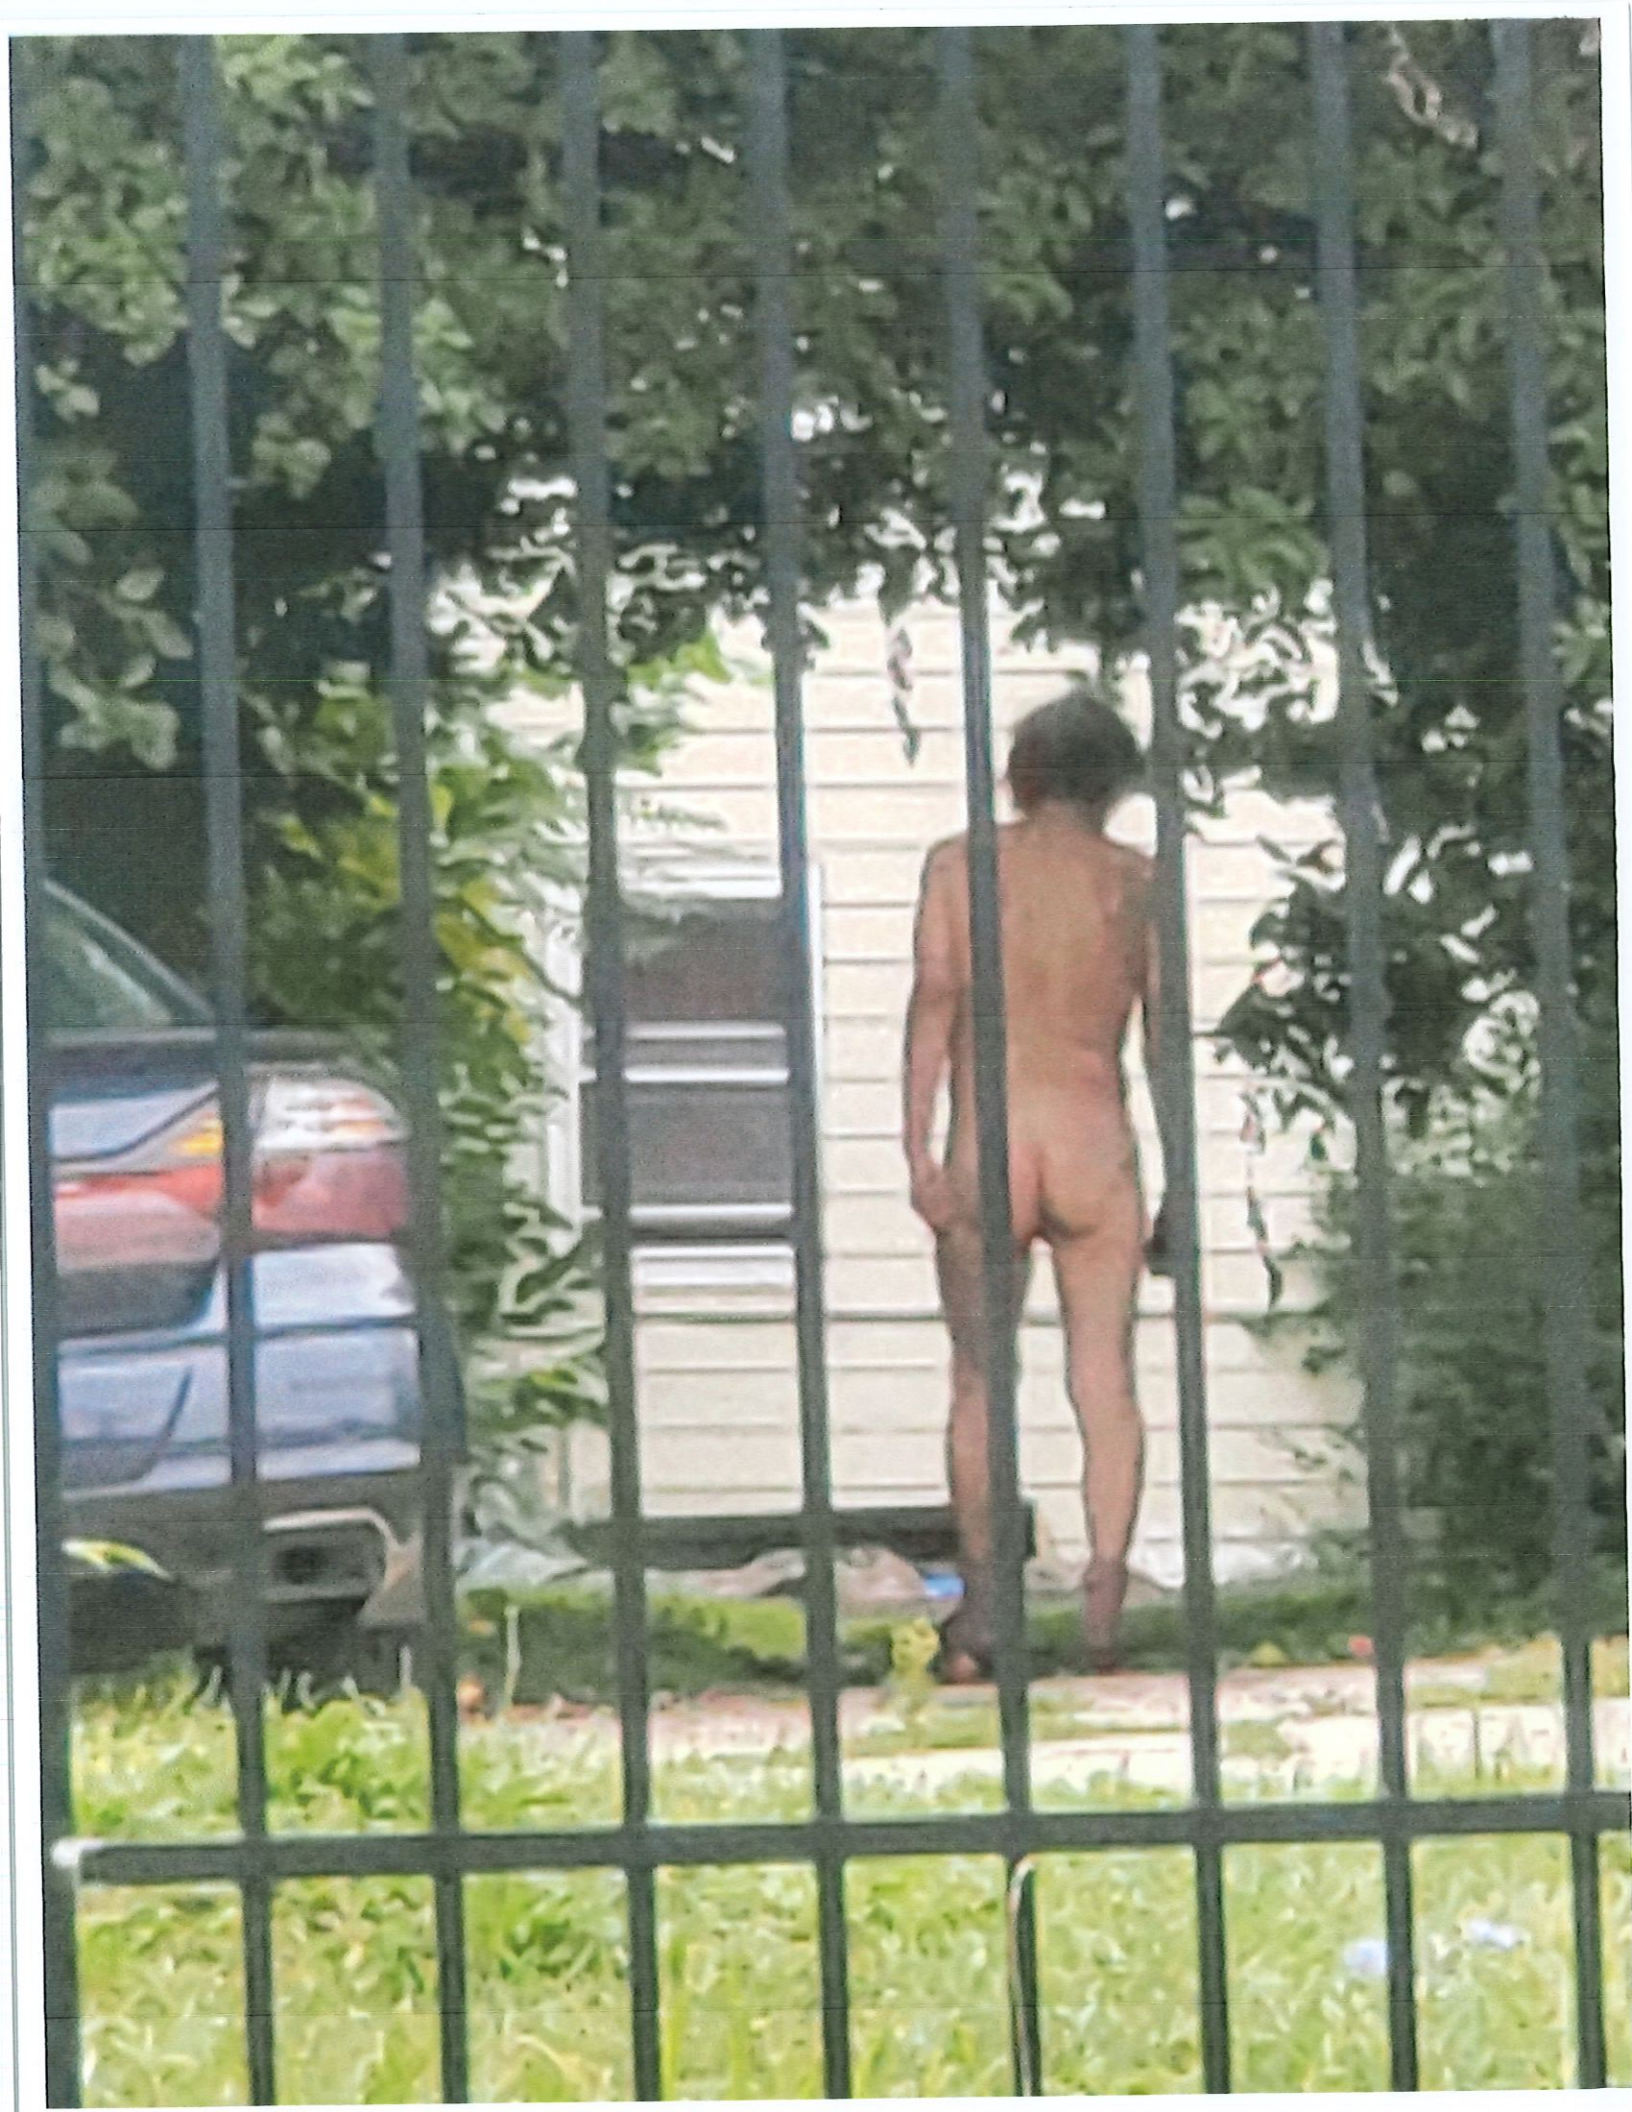
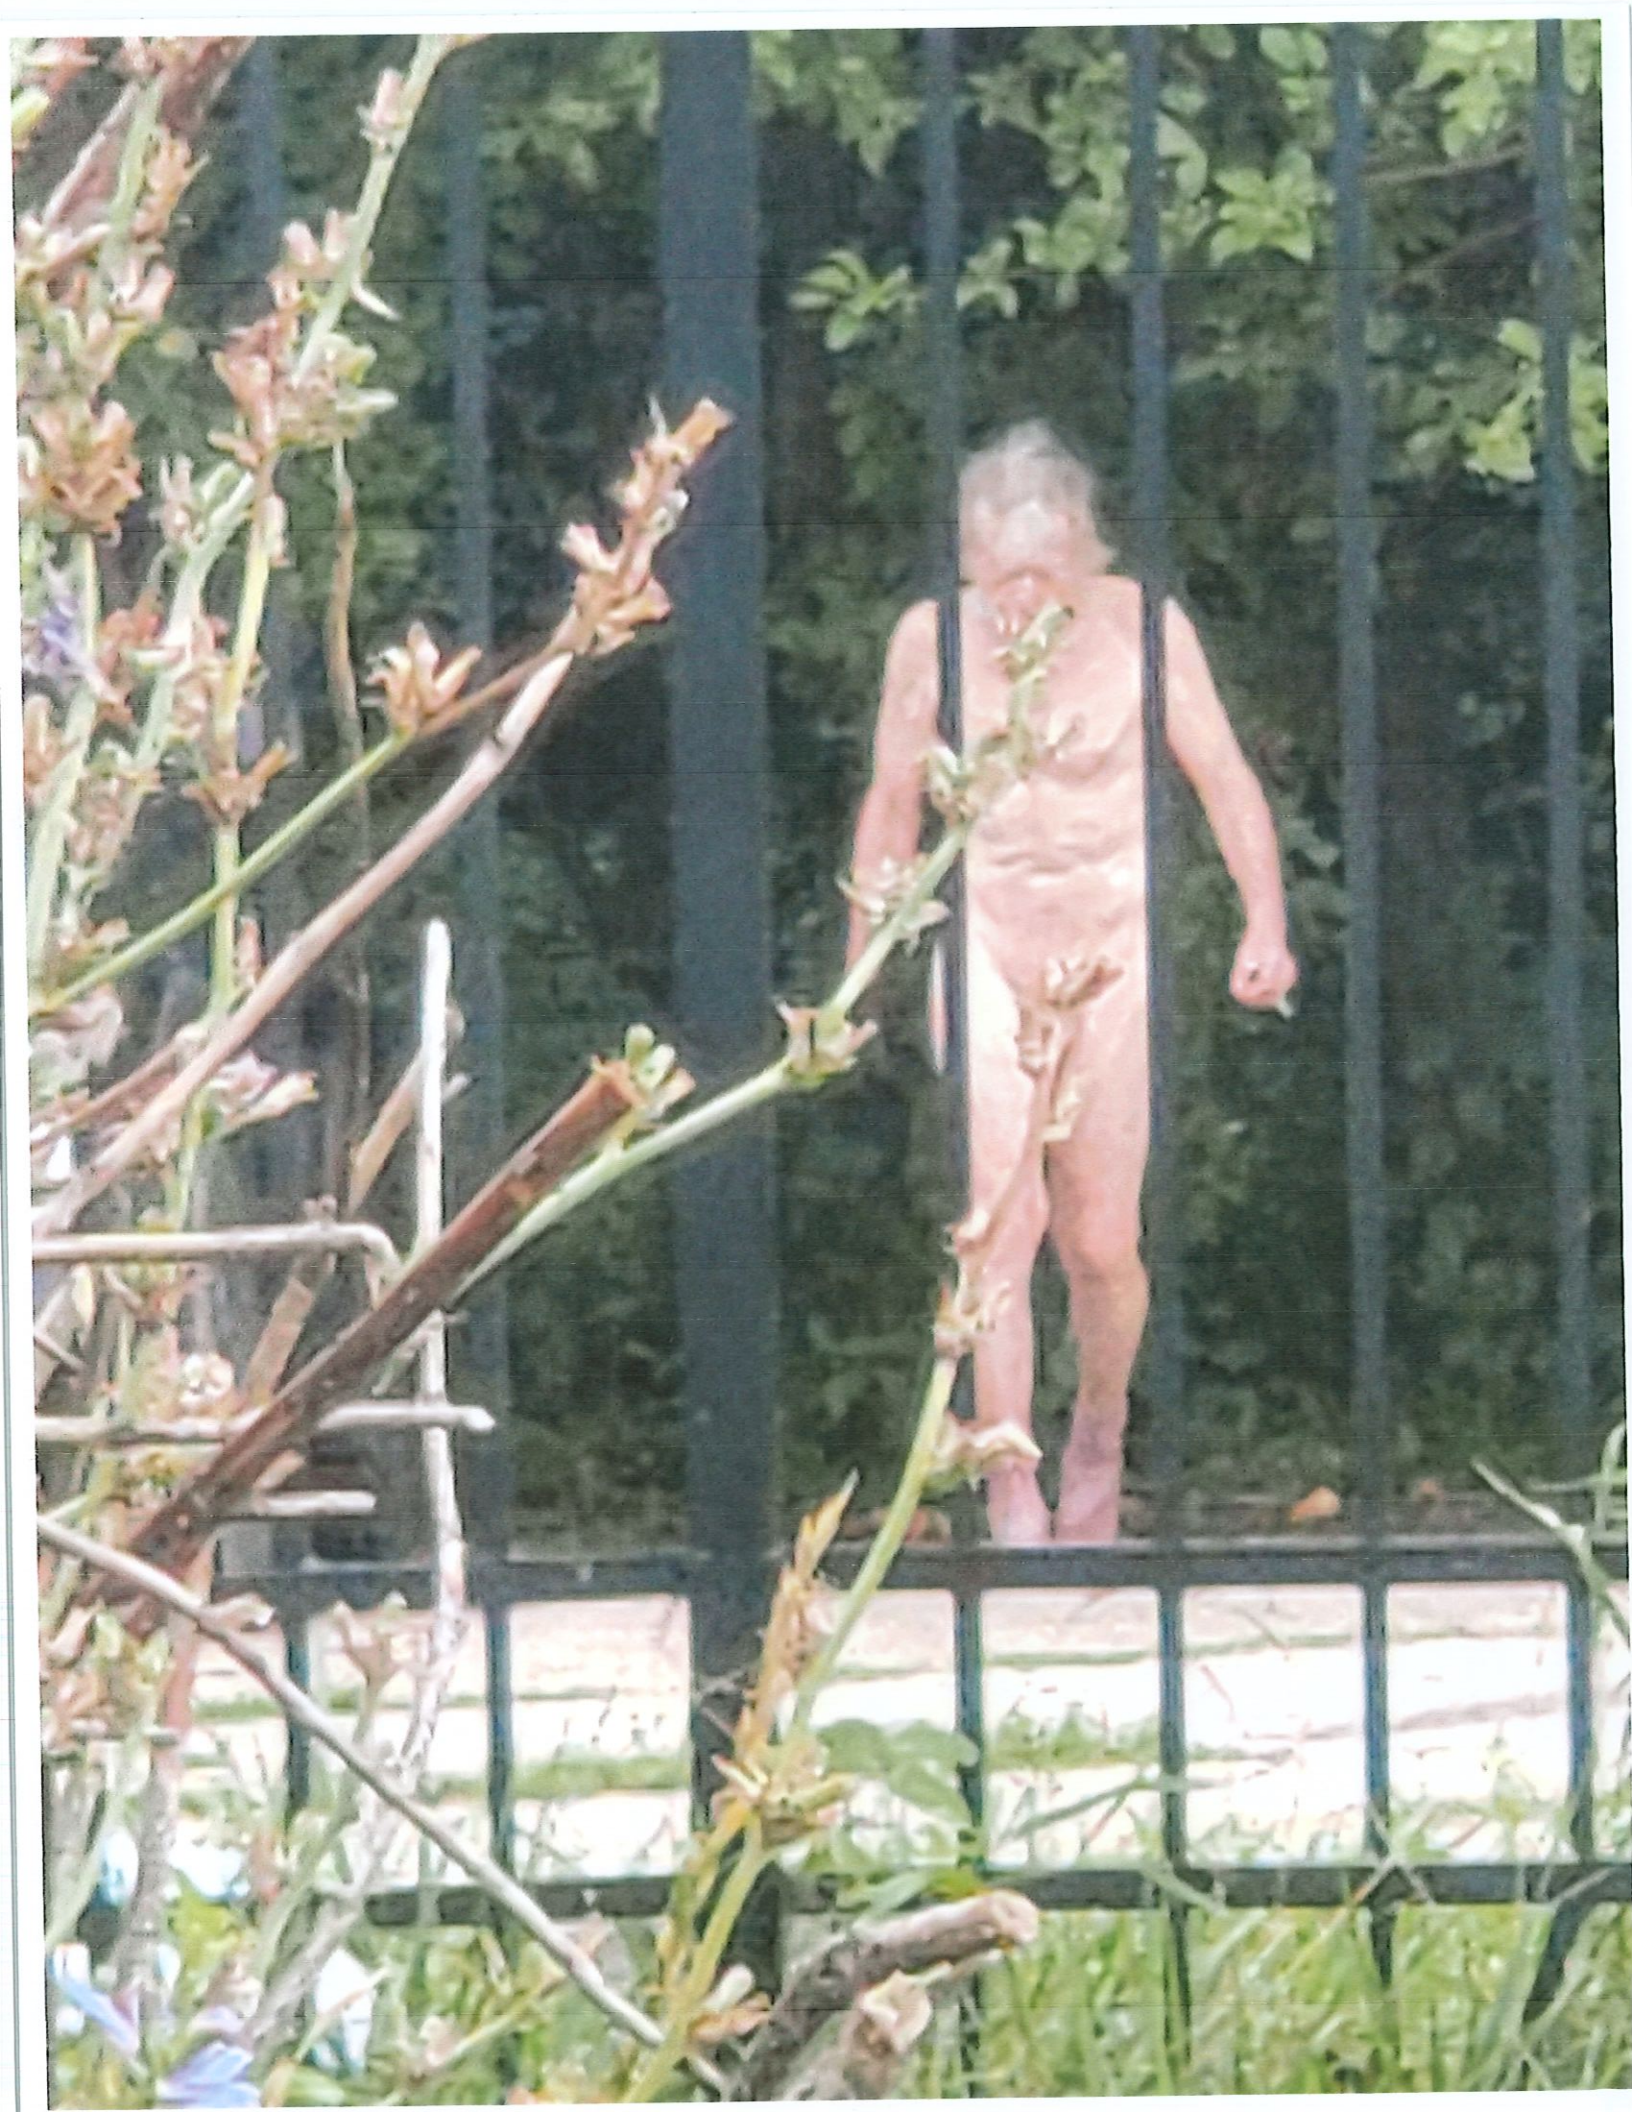
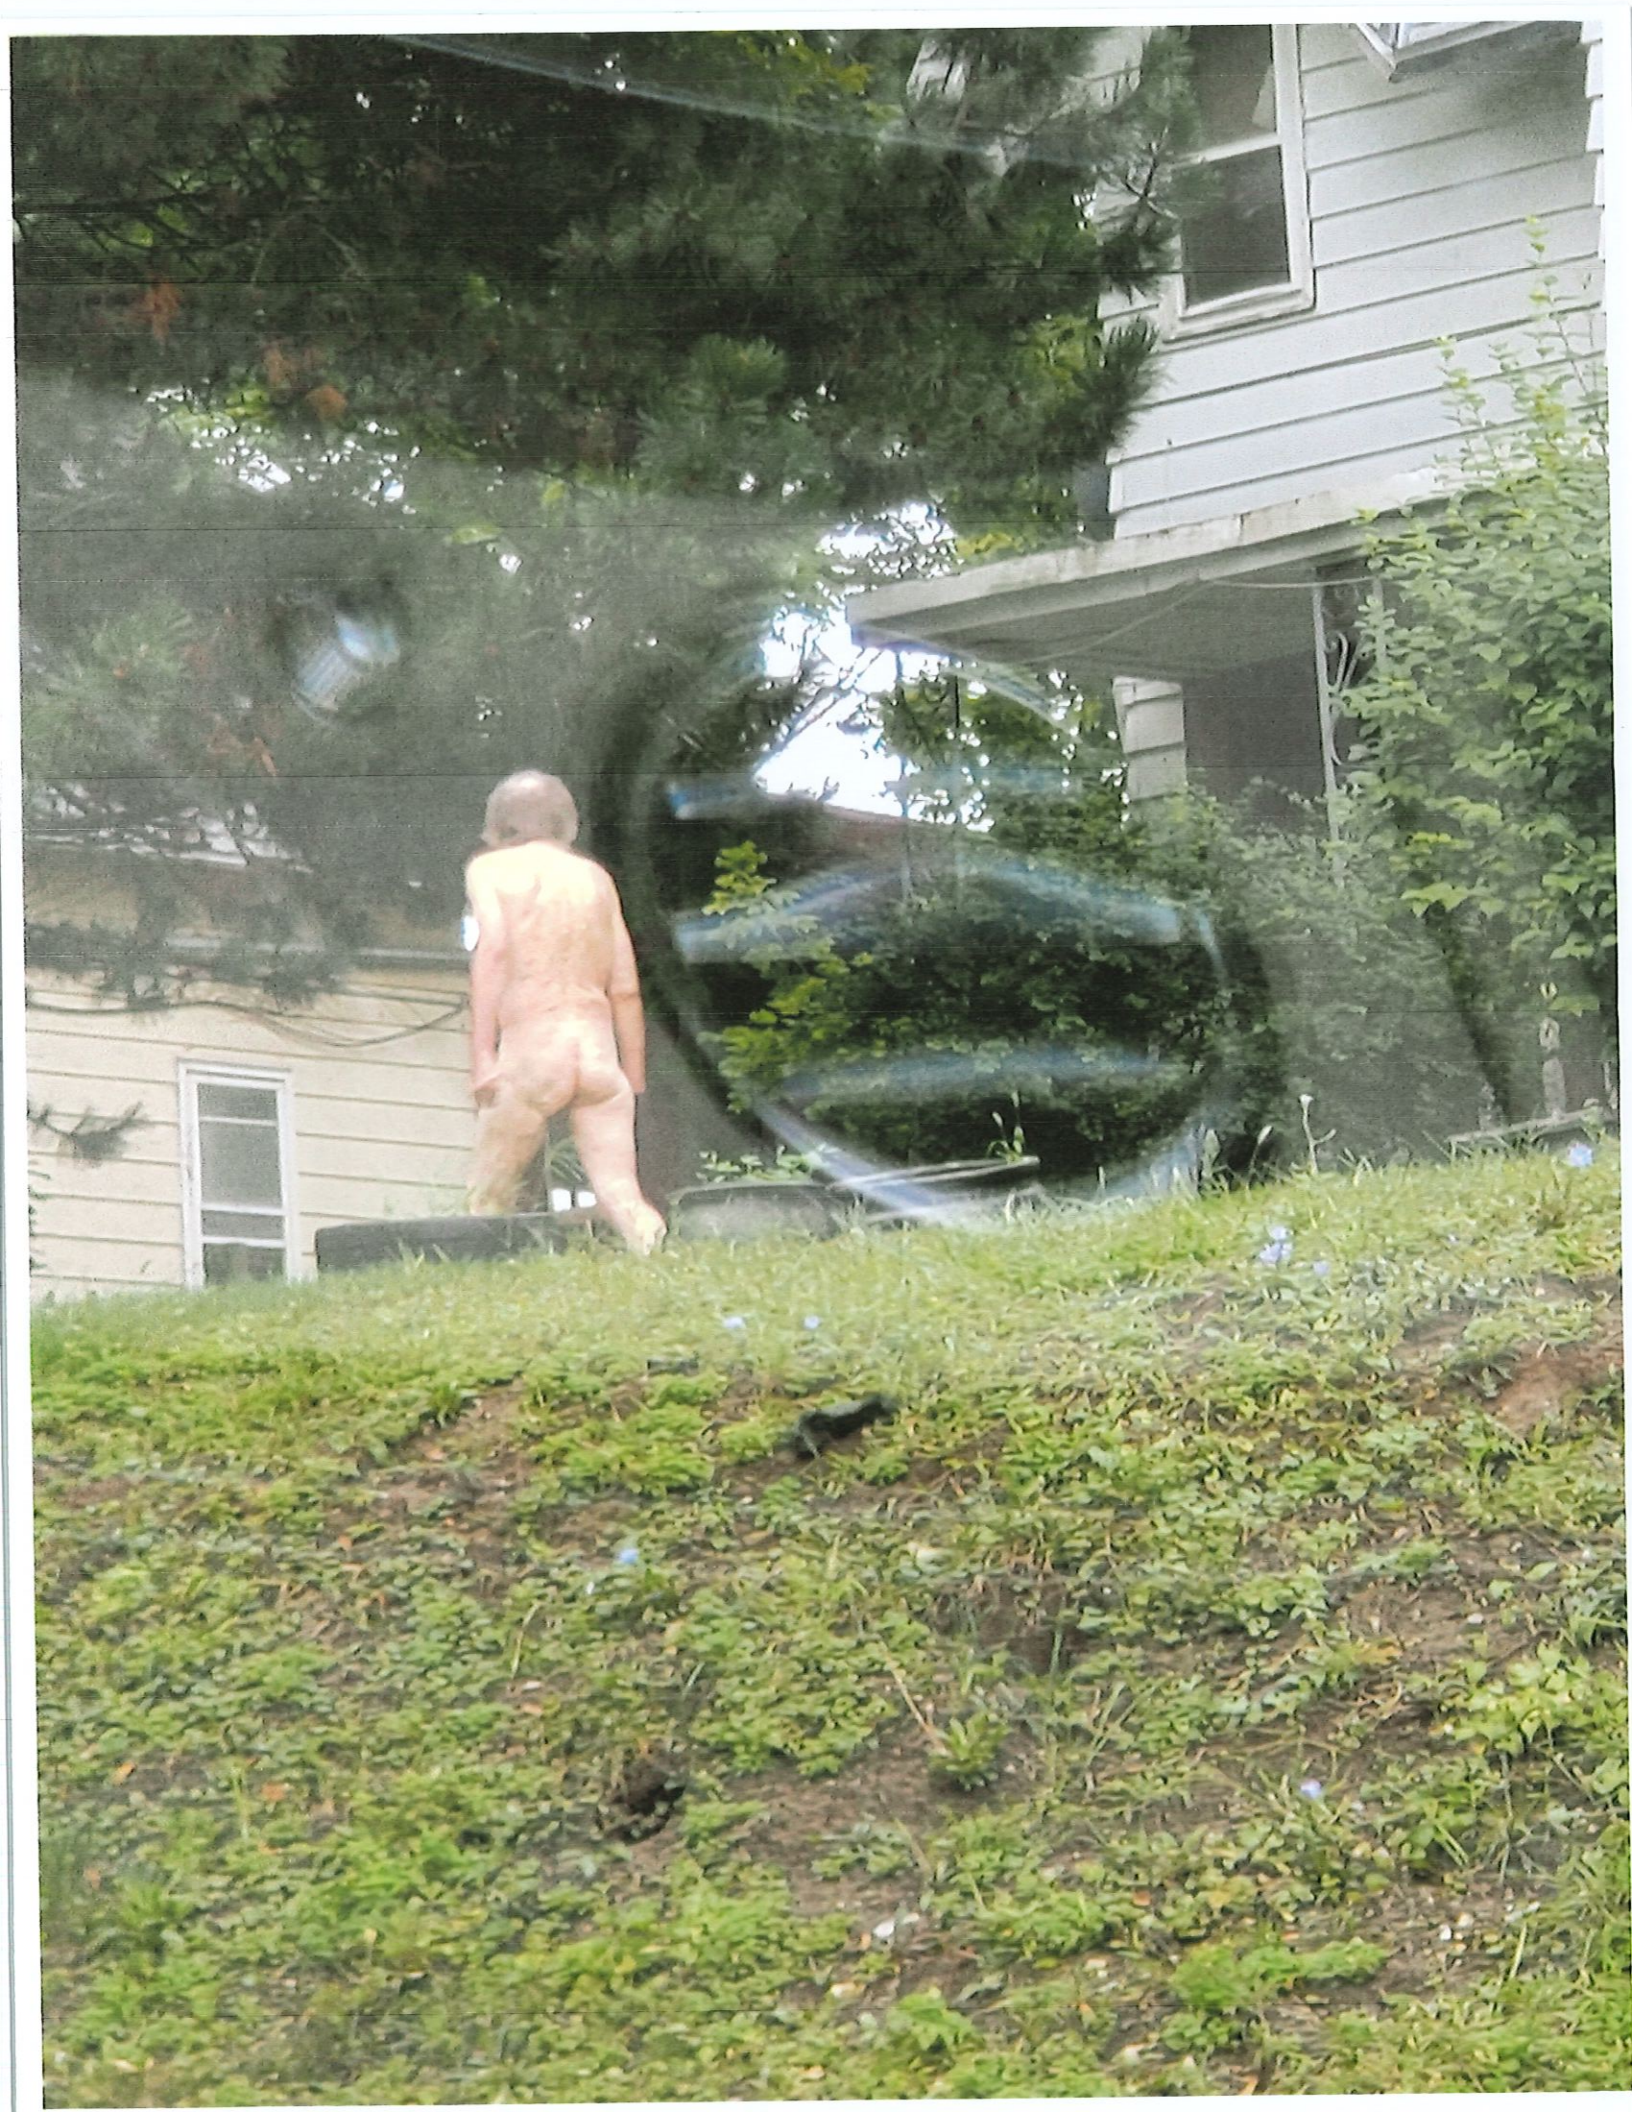
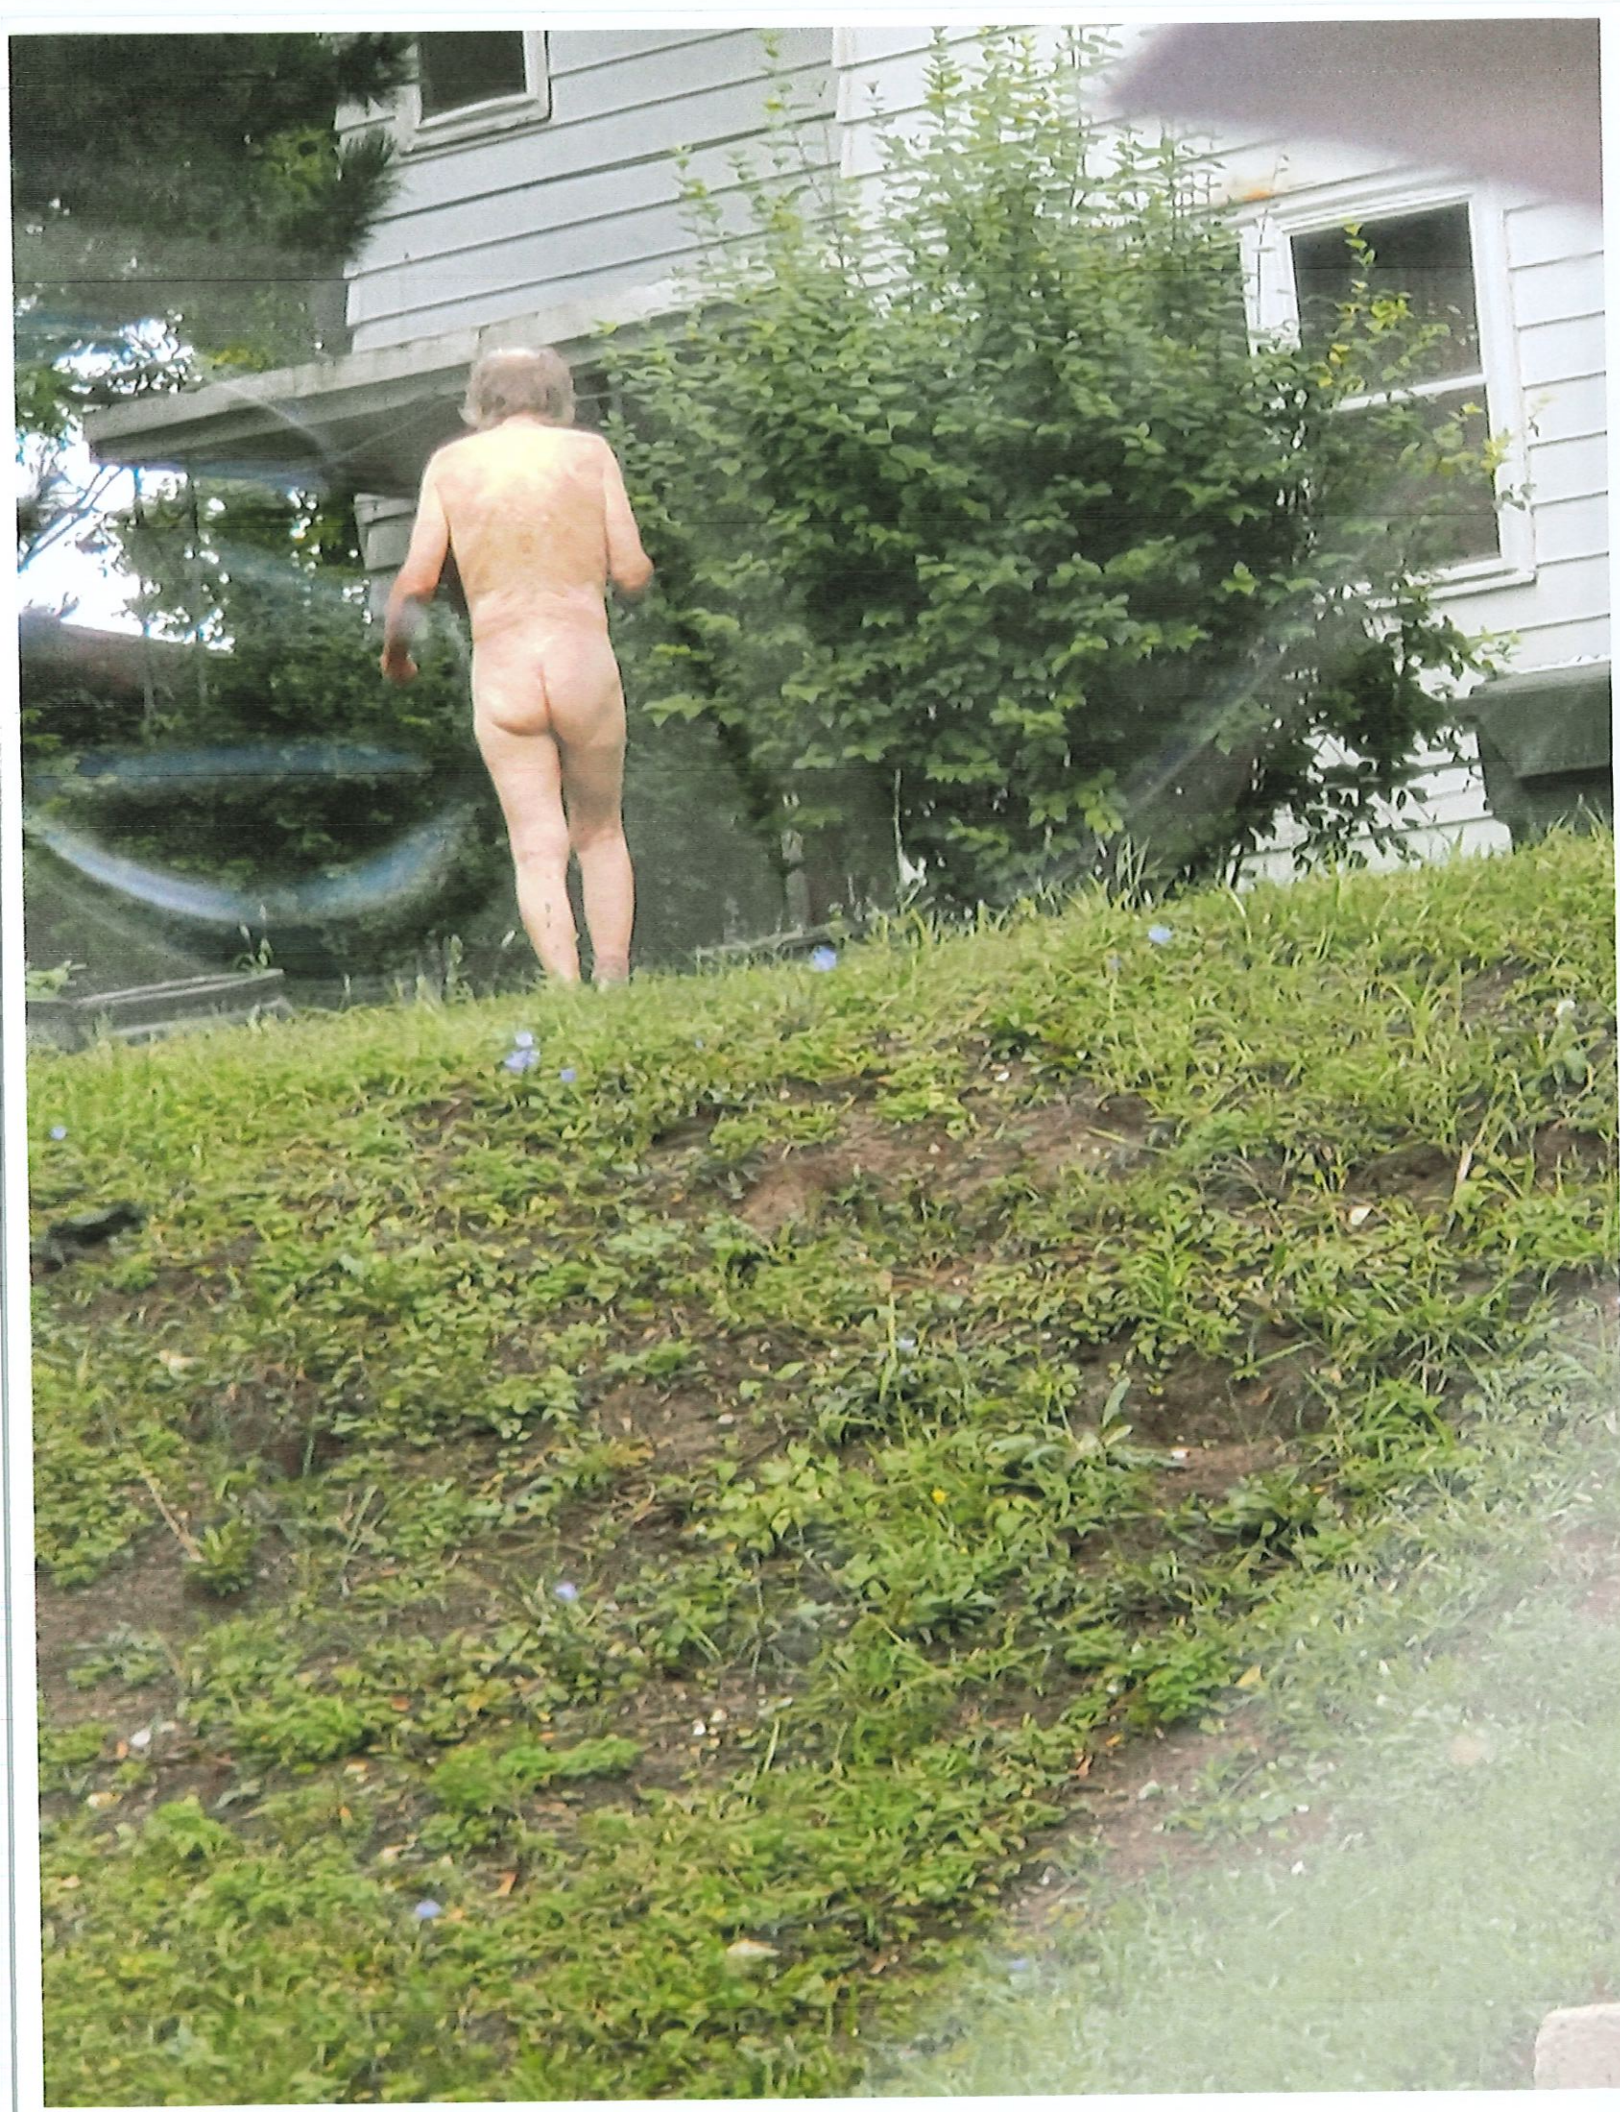
ProBuColls “Clark Rooming Houses”

Outside Entrance conditions of buildings

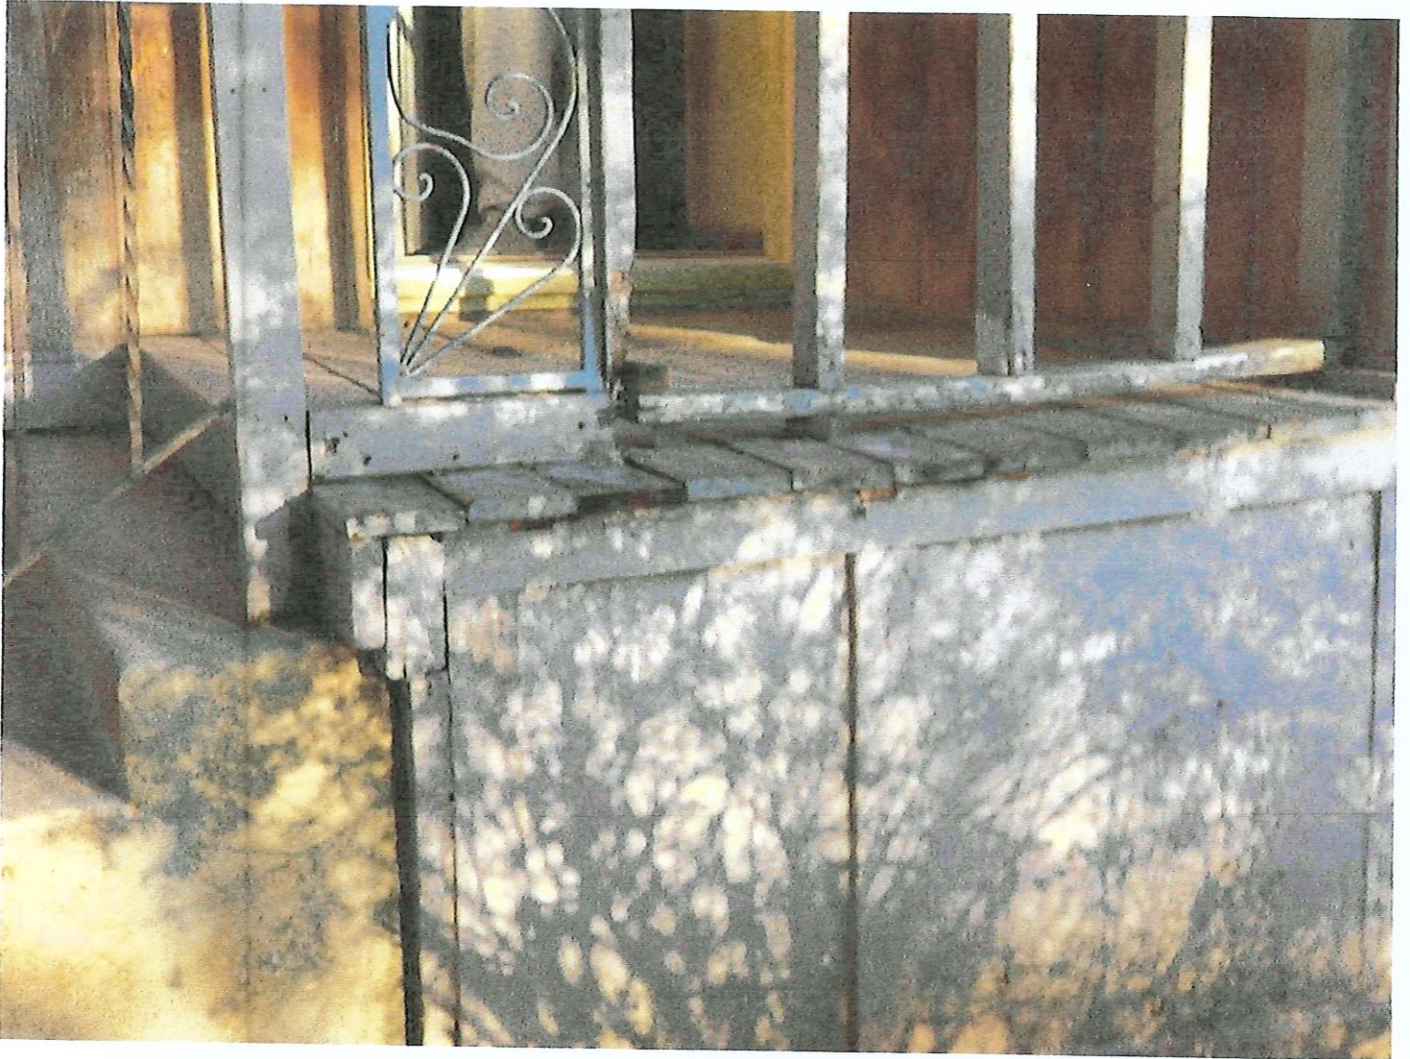
[Sent from Yahoo Mail on Android](#)

939 North 24th Street & 933 North 24th Street

Conditions behind 939 and 933 North 24th Street, Town & Country Building Inspect Report
