PORT OF MILWAUKEE

Dockwall Condition Report

Capital Improvements Committee

January 20, 2016

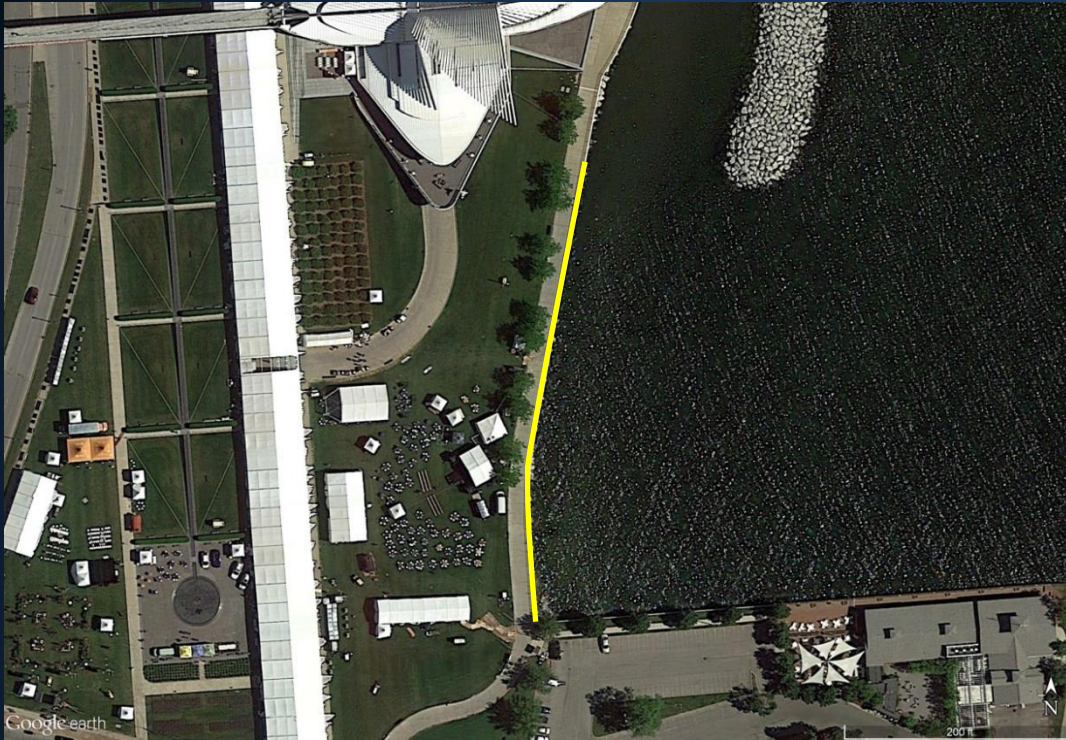
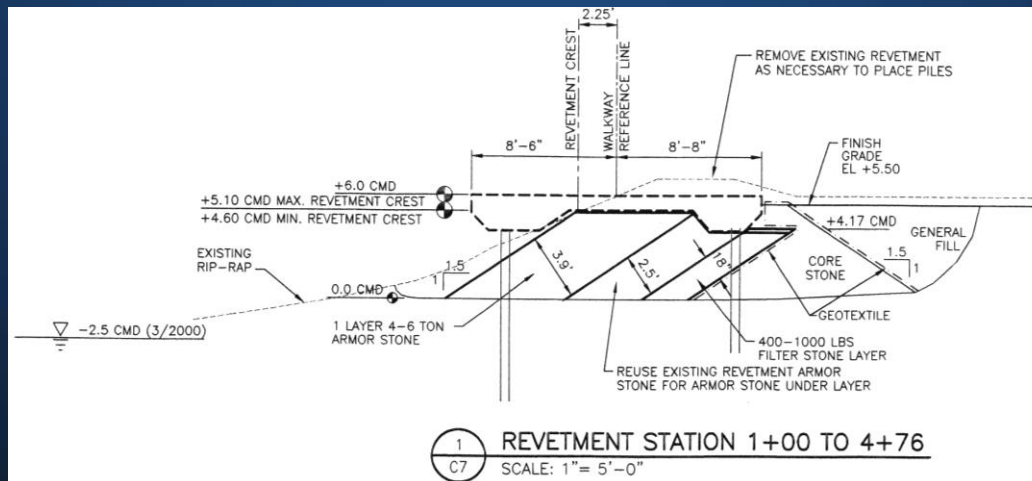
2. Walkway at Art Museum

Condition: Good

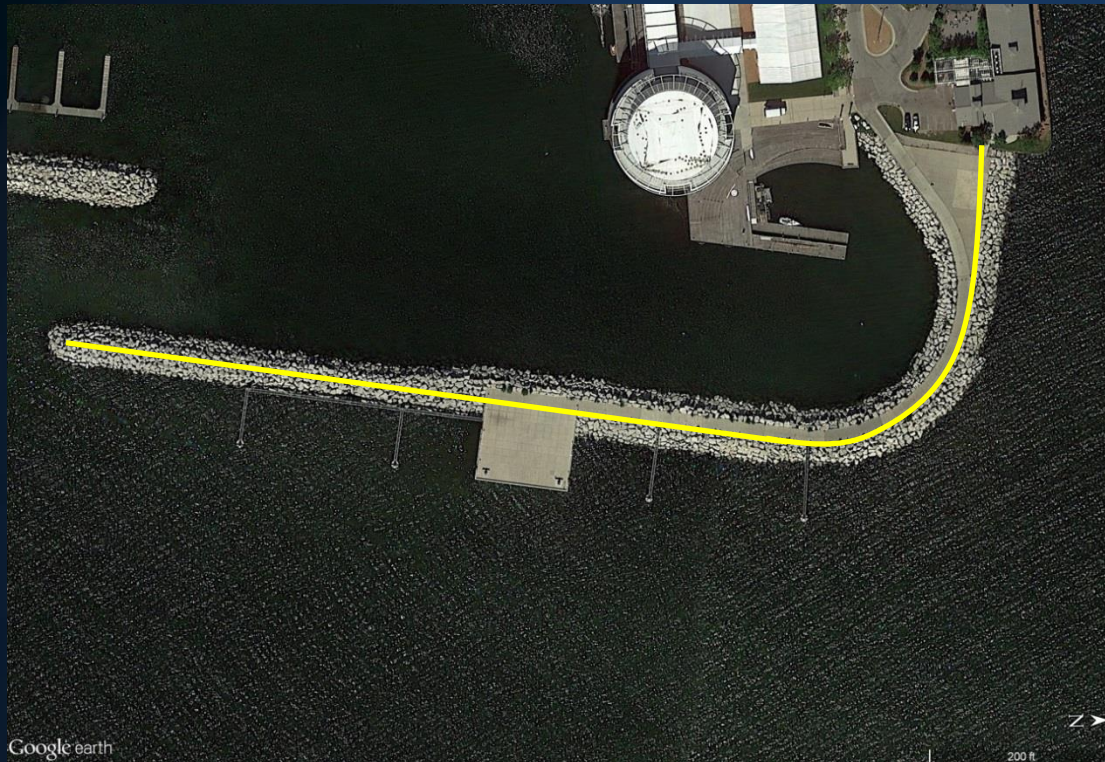
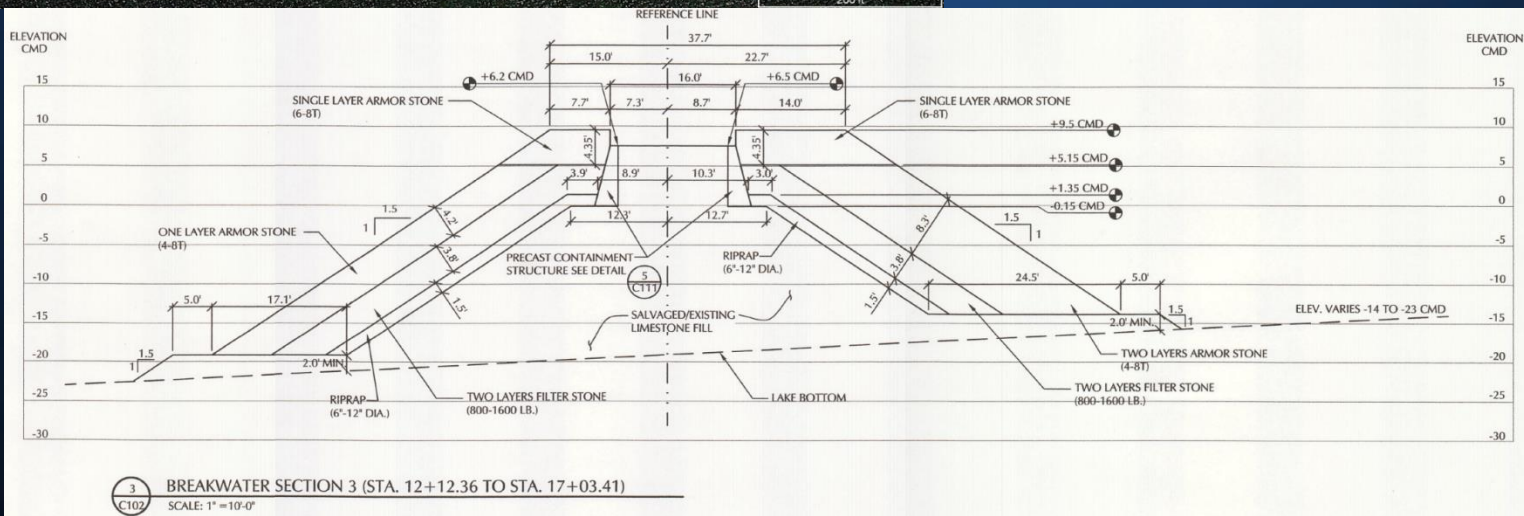
4. Municipal Pier Breakwater

Condition: Good

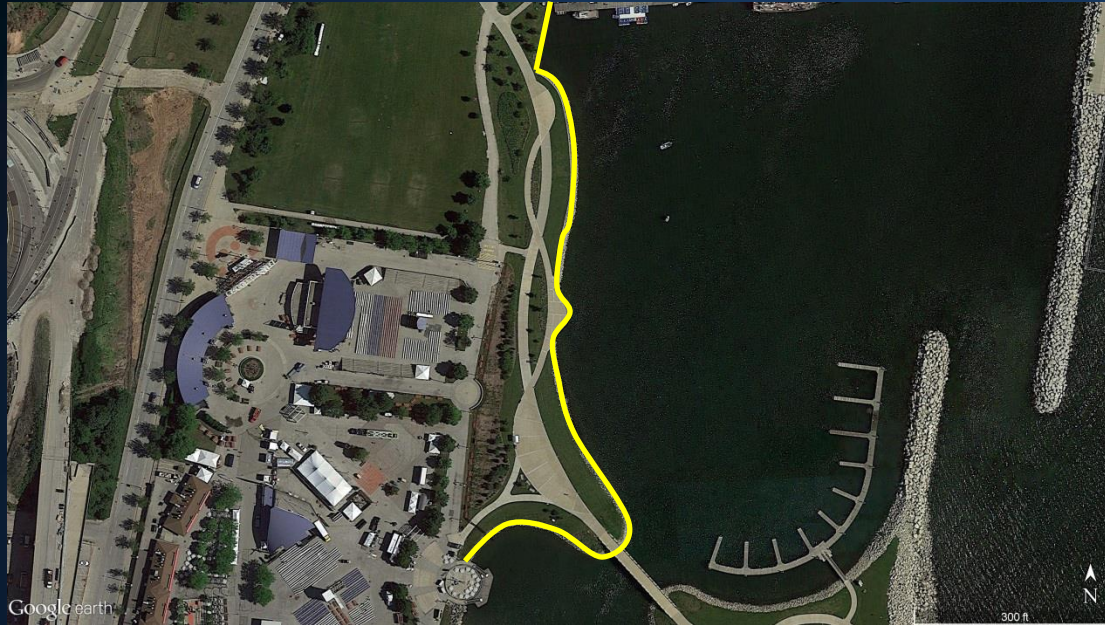
5. Urban Park South Fill Area

Condition: Good

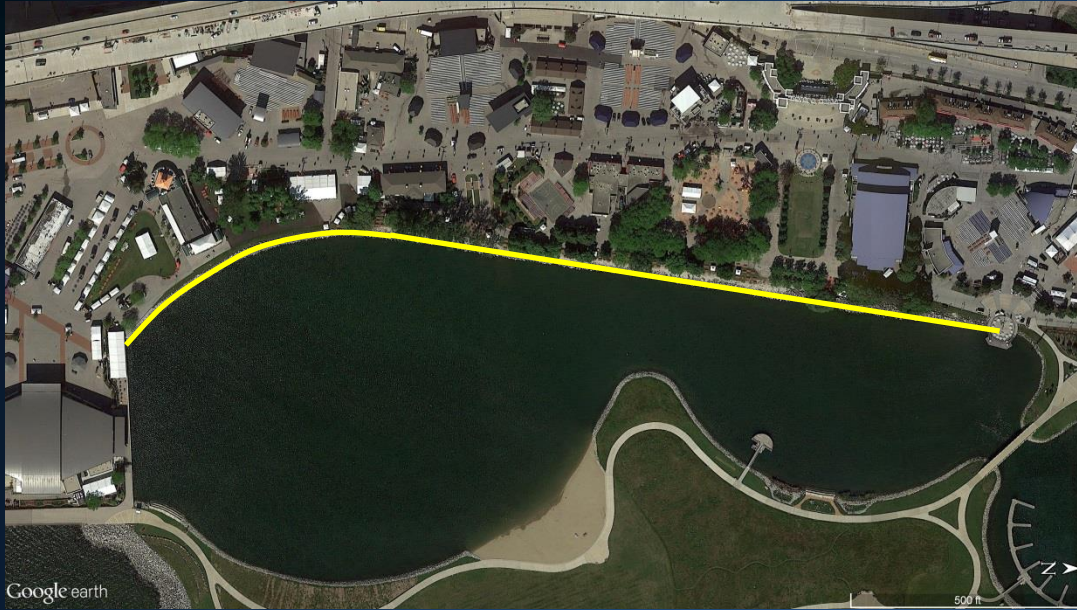
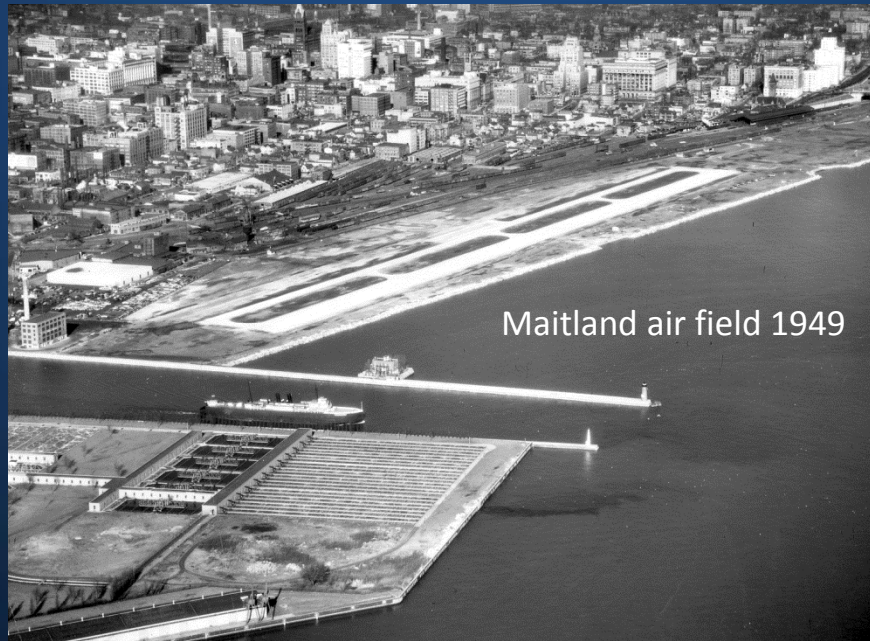
6. Rubble Mound along Summerfest

Condition: Fair

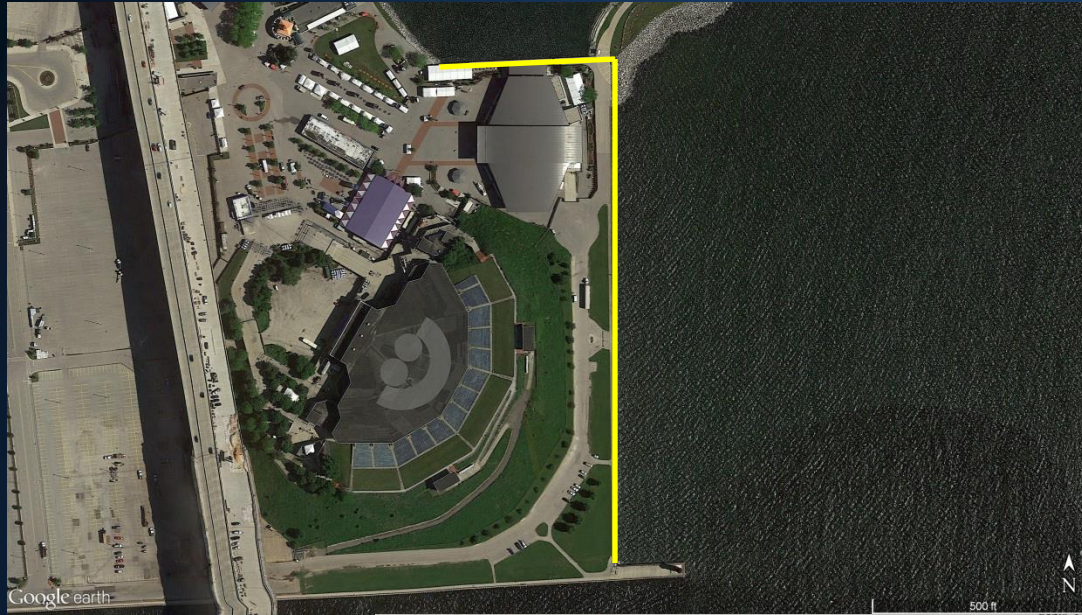
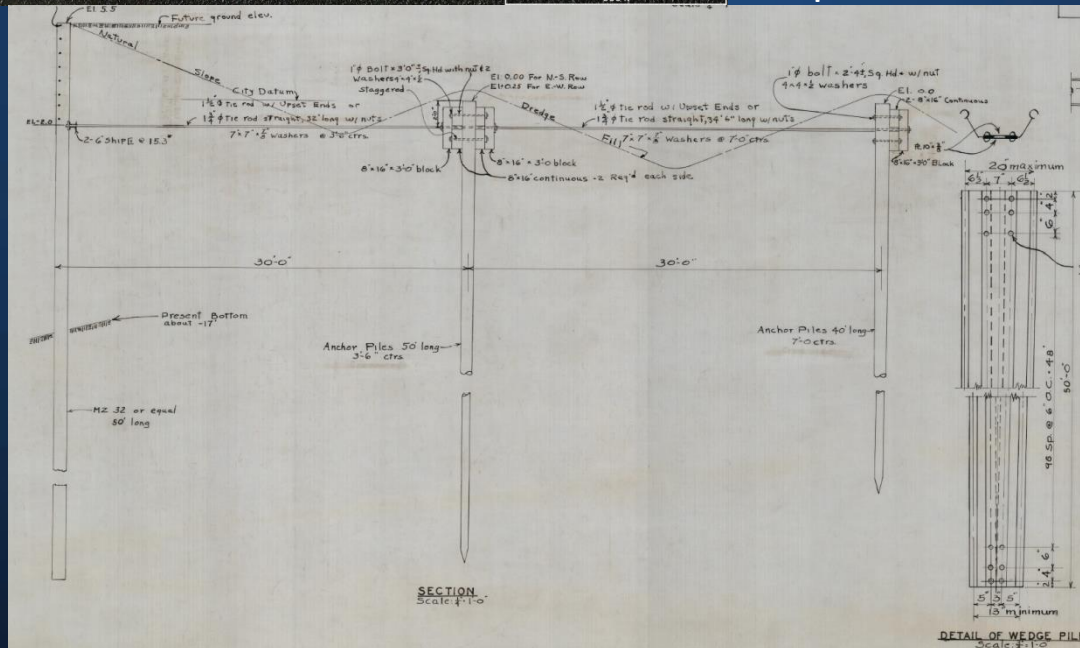
7. 20 Acre Fill Site (Marcus Amphitheater)

Condition: Fair

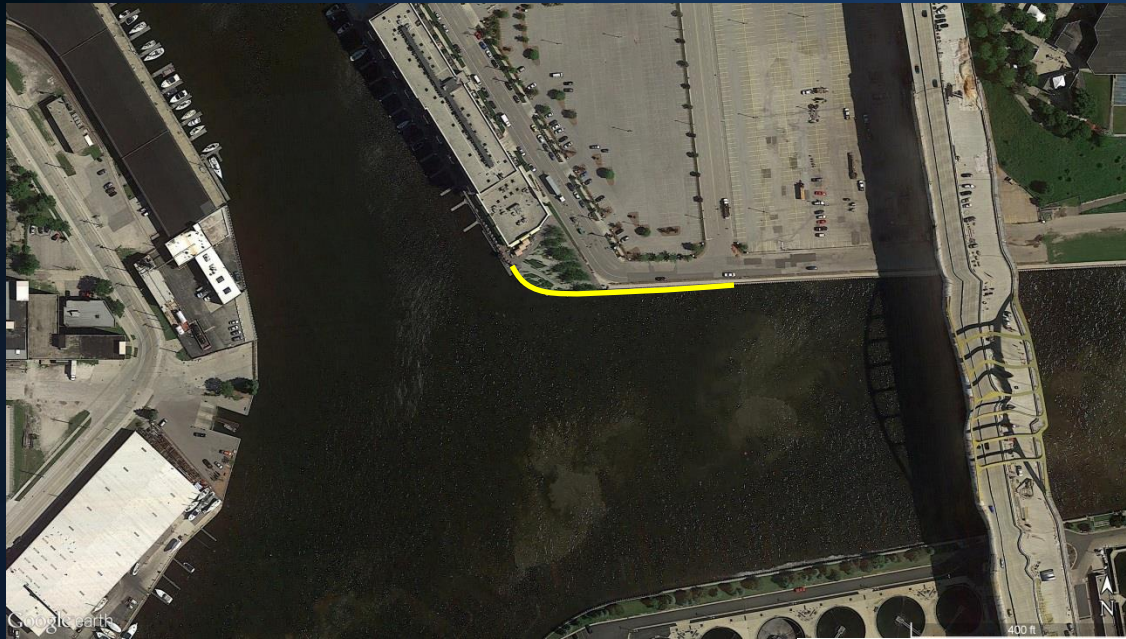
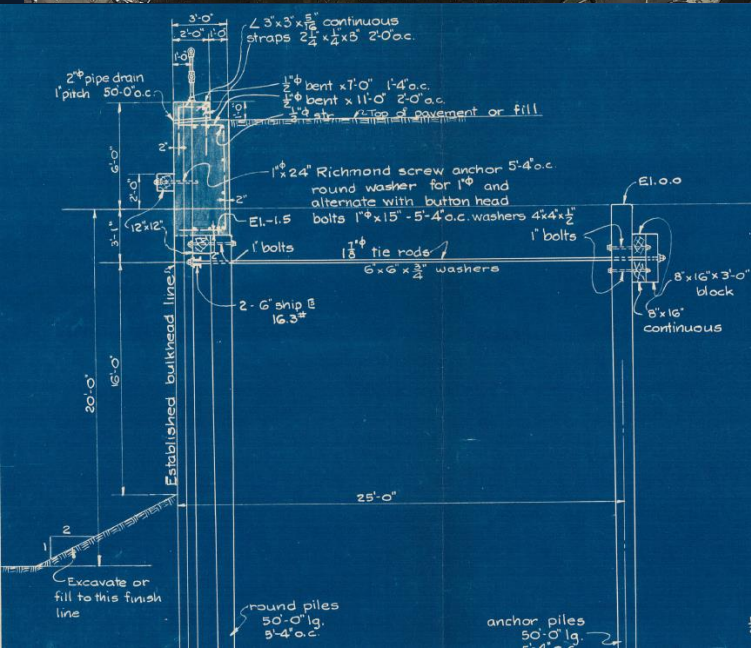
8. East Erie Street Dock

Condition: Poor

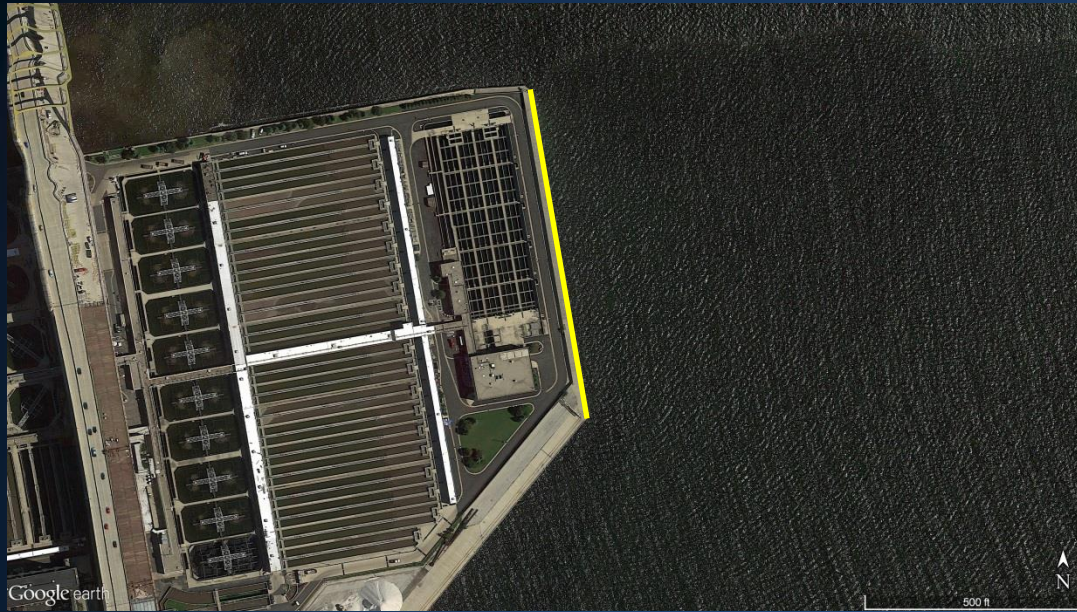
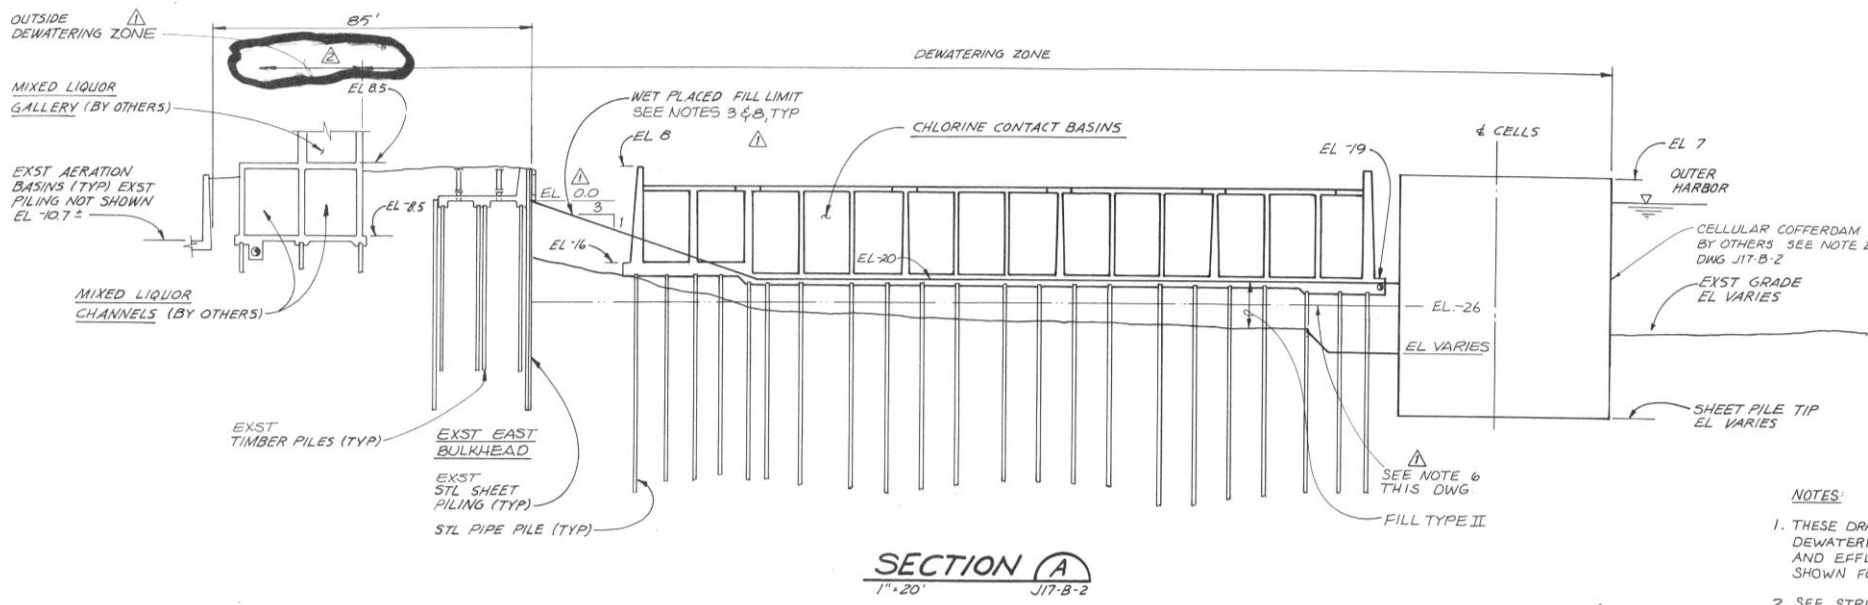
9. Dock East of MMSD Plant

Condition: Good

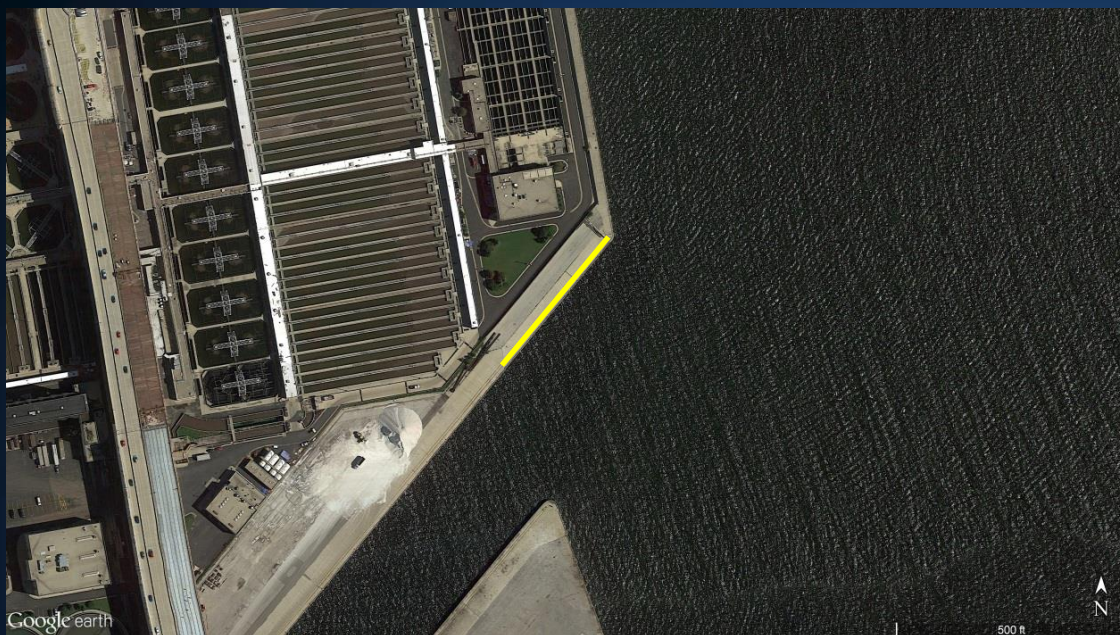
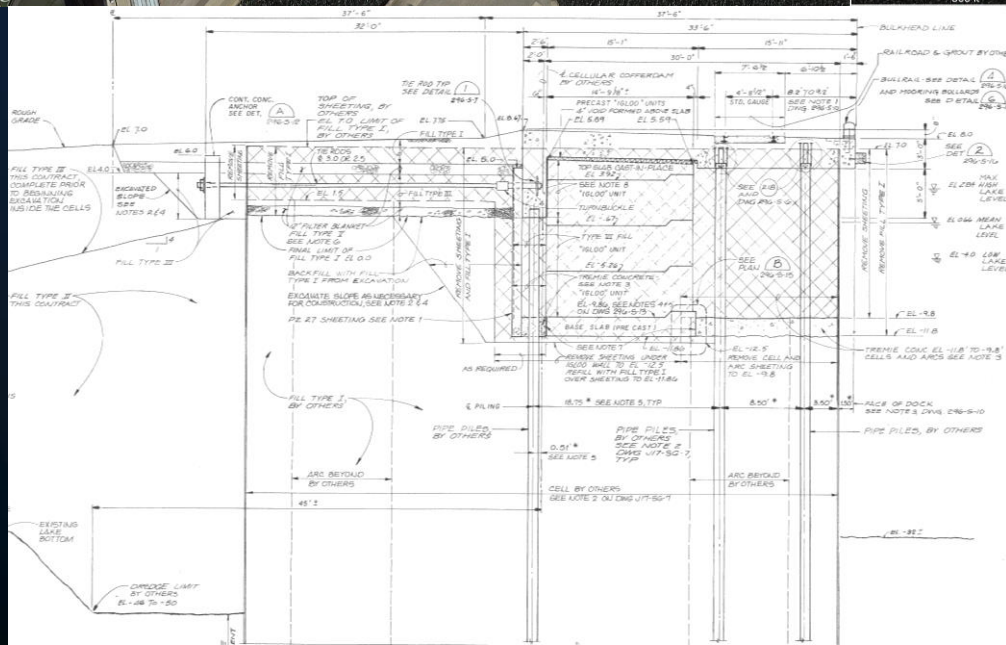
10. Dock South East of MMSD Plant

Condition: Good

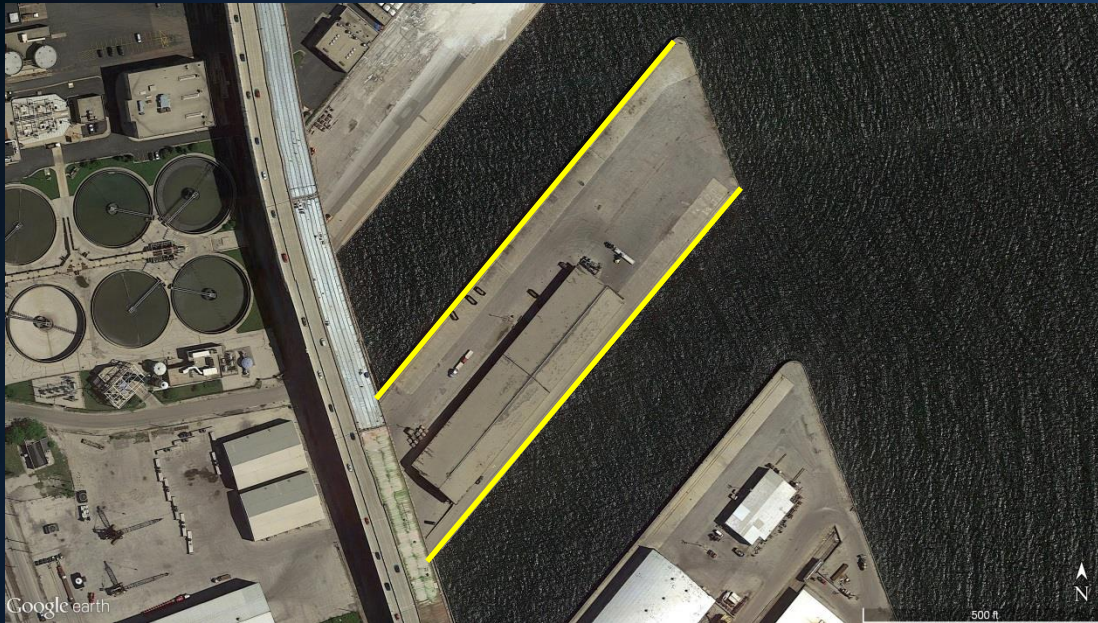
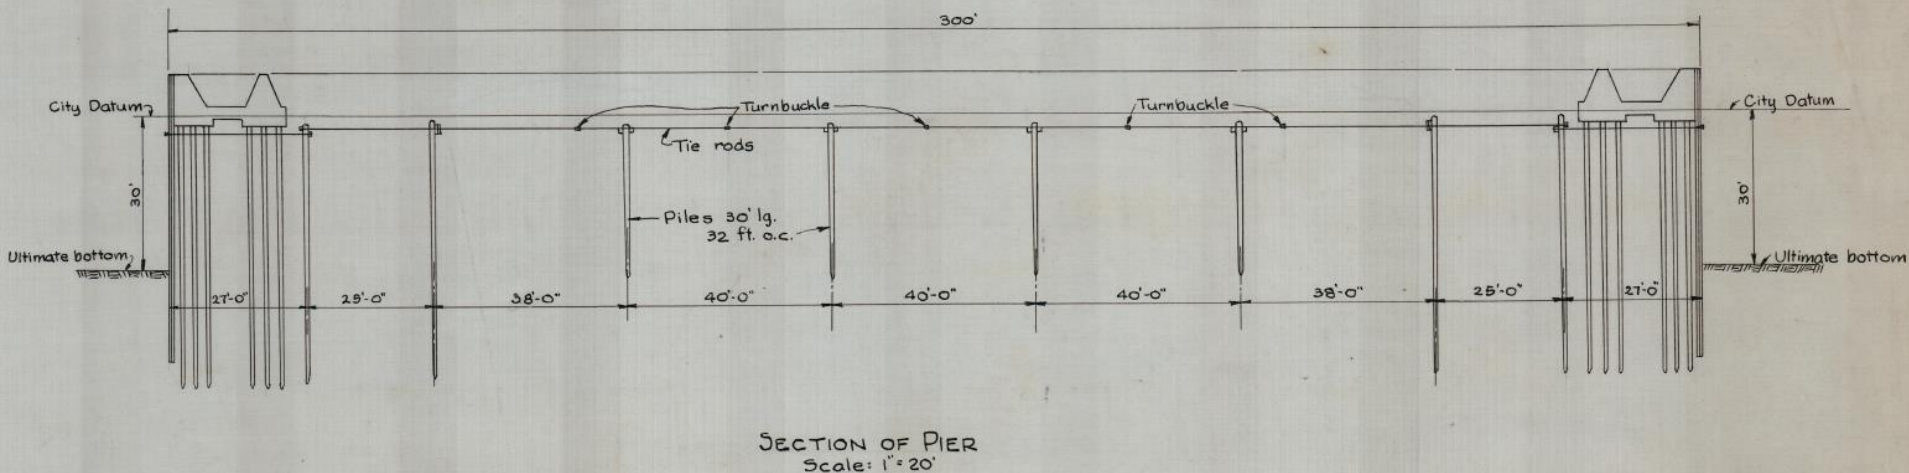
13. Type "B" Dock

Condition: Poor

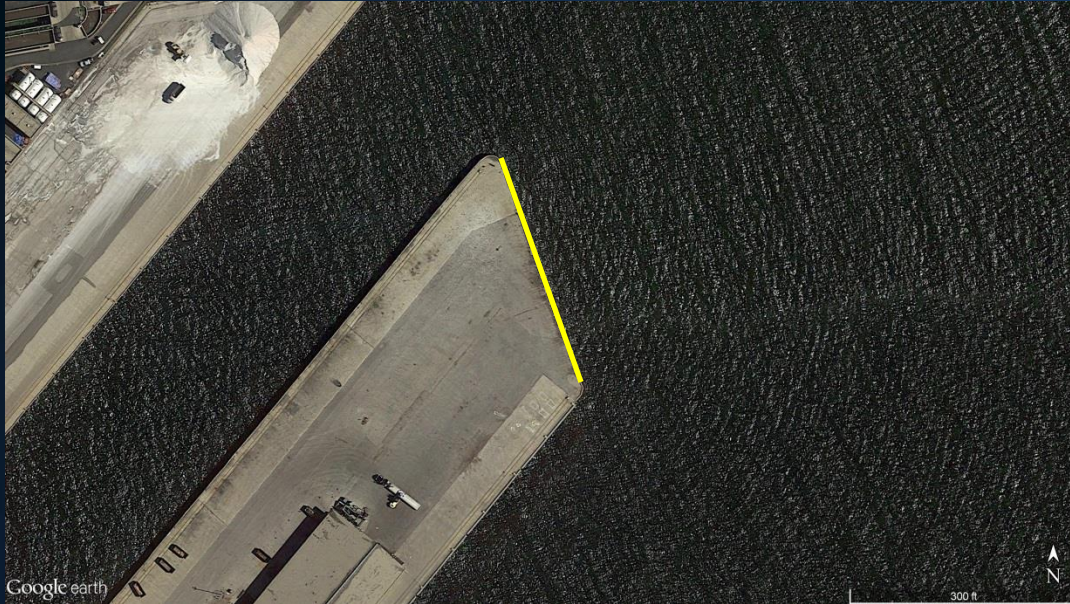
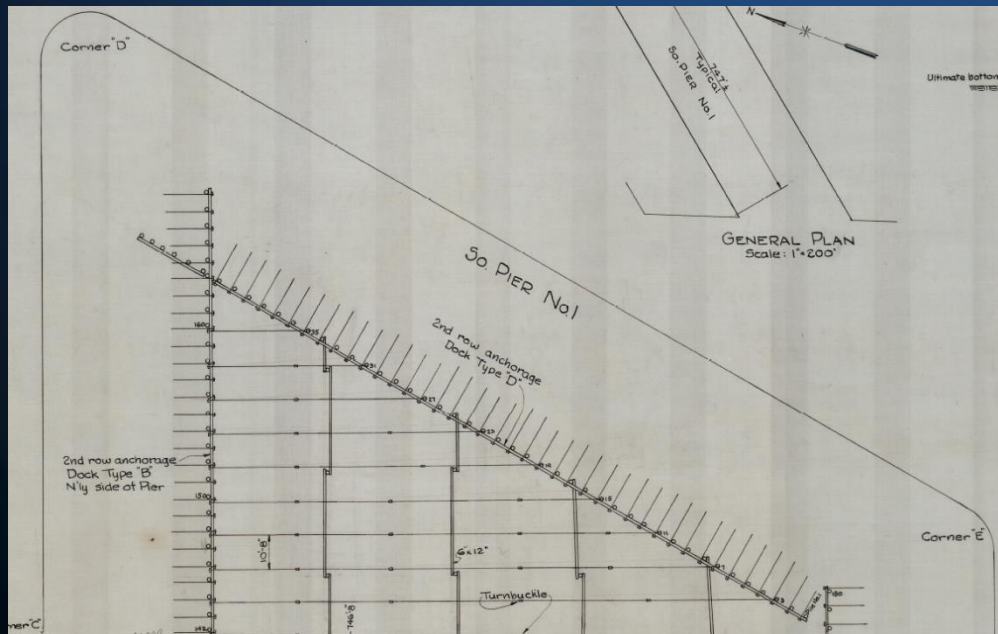
14. Type "D" Dock

Condition: Poor

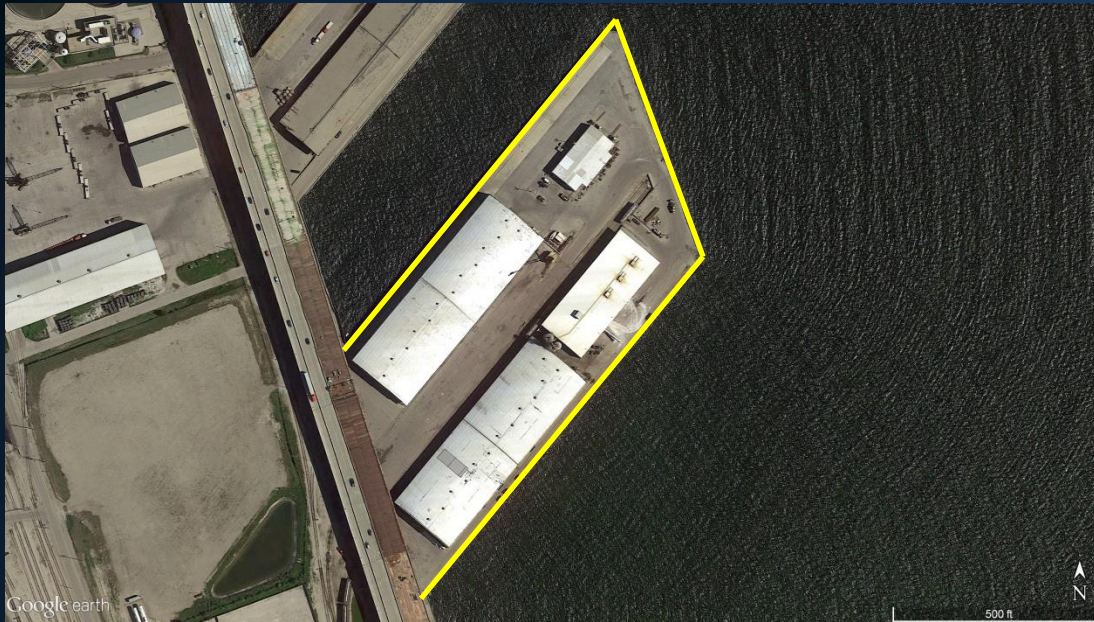
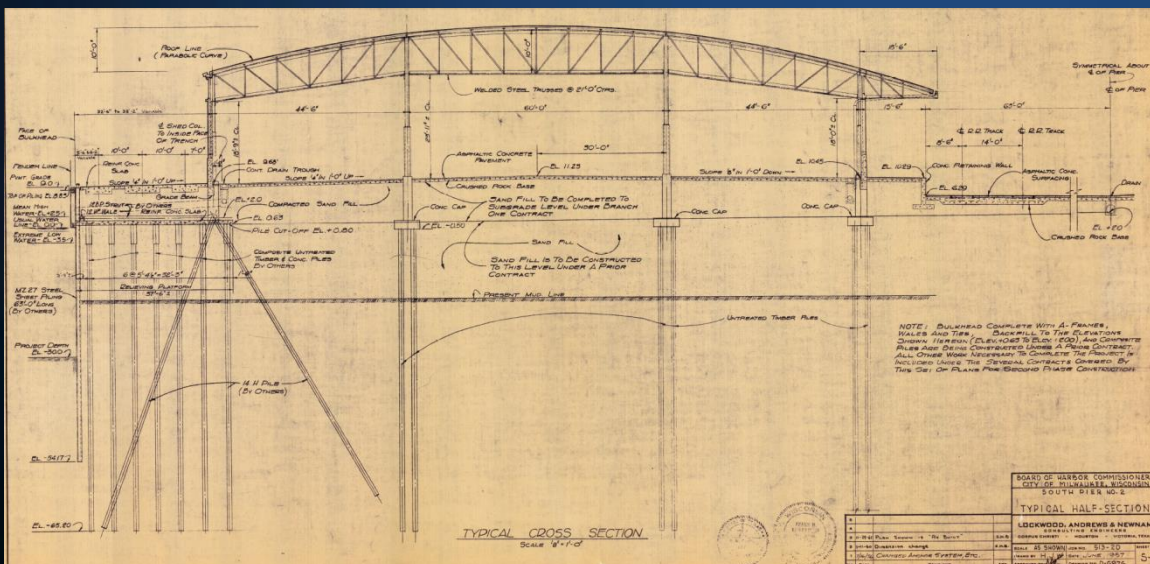
15. South Pier No. 2

Condition: Poor

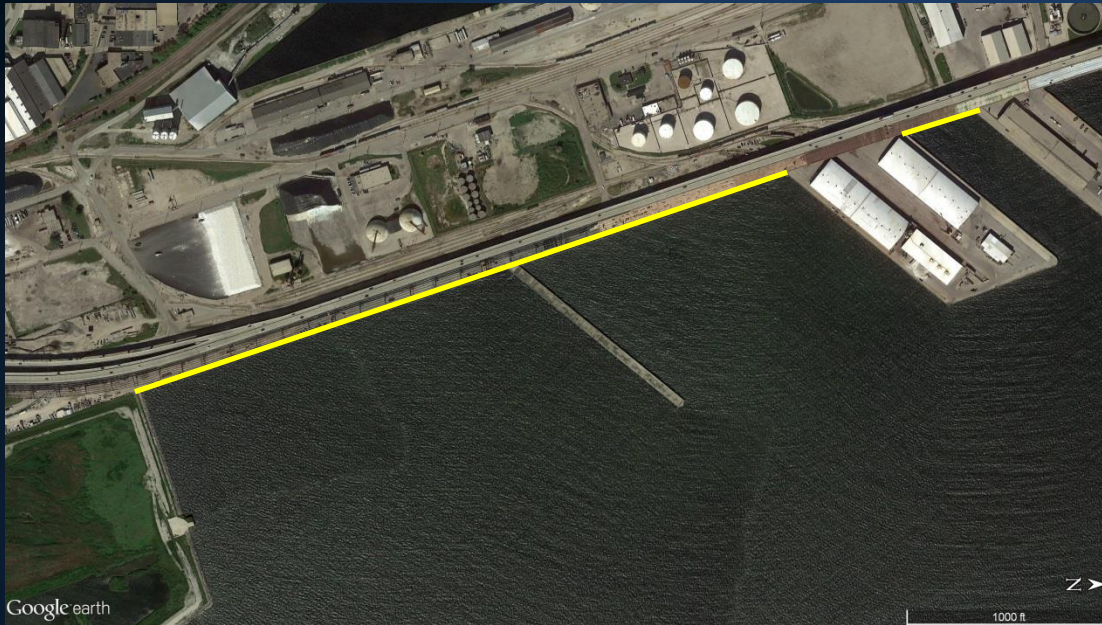
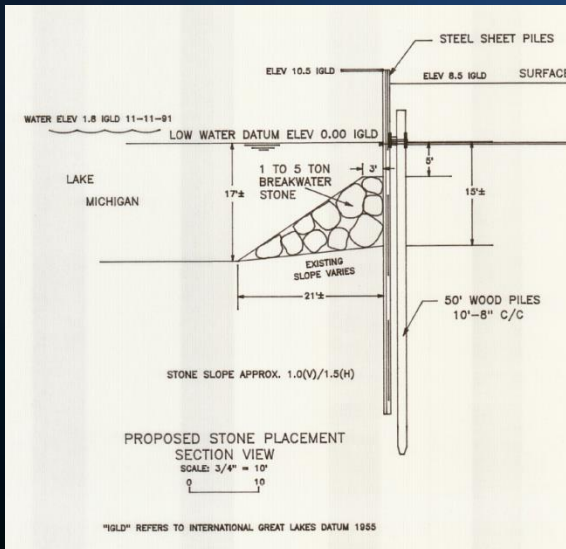
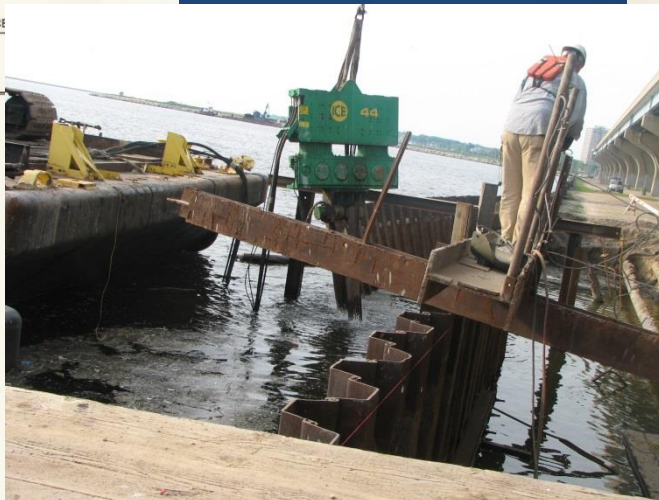
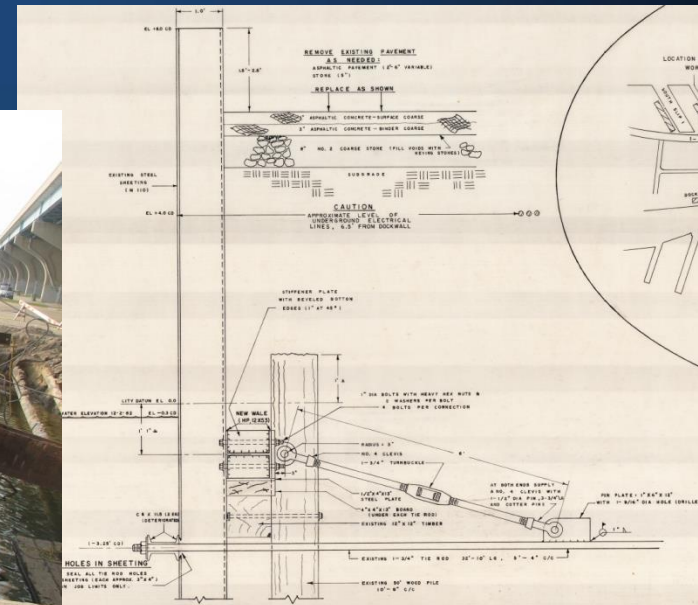
16. Type "E" Dock

Condition: Poor

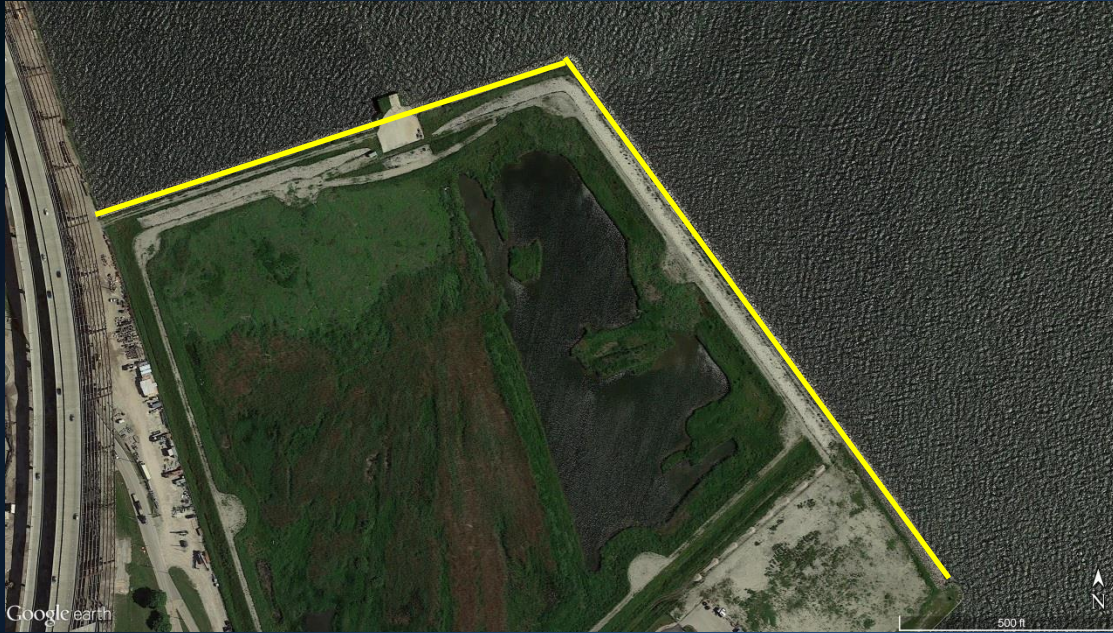
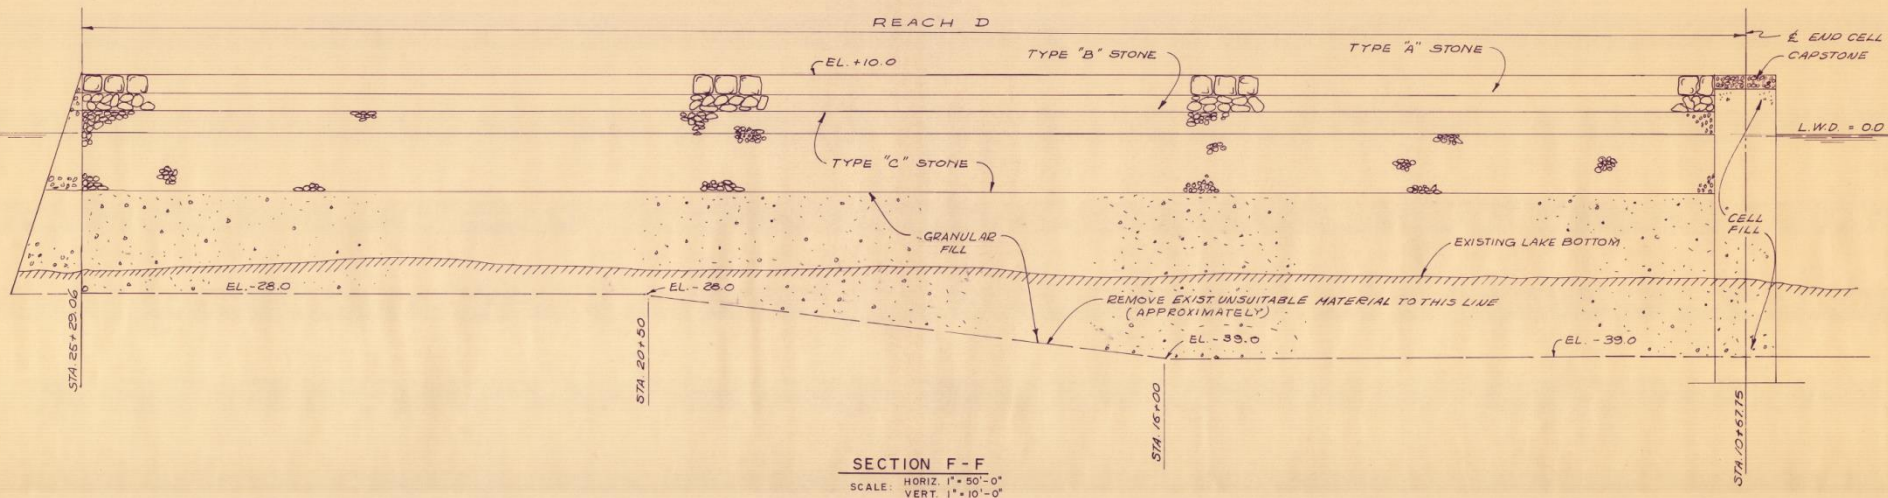
17. Confined Disposal Facility North & East Sides

Condition: Fair

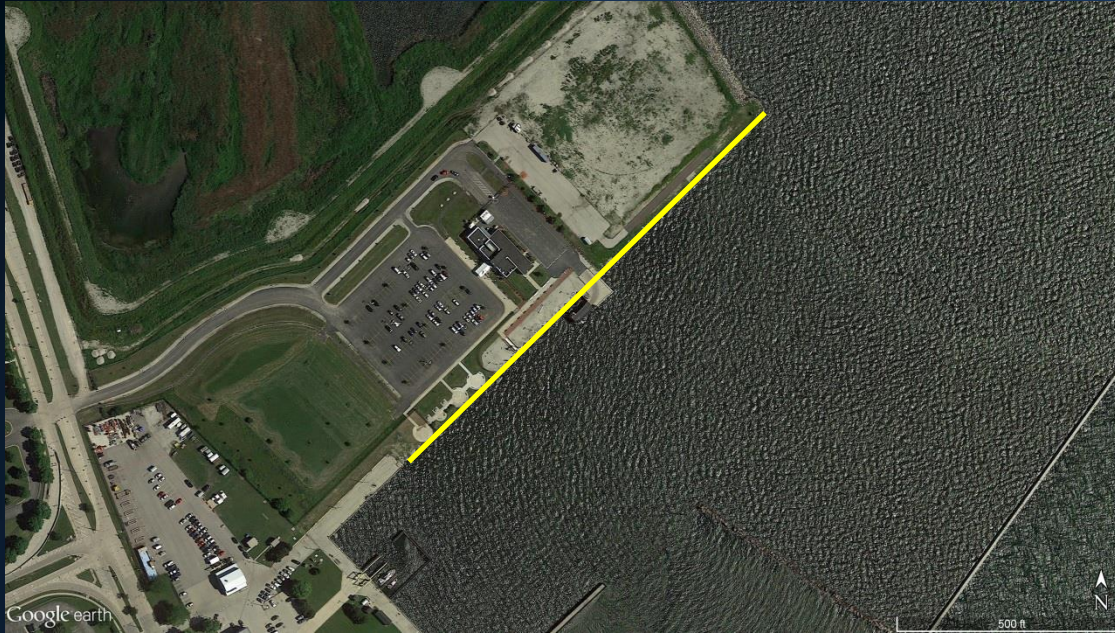
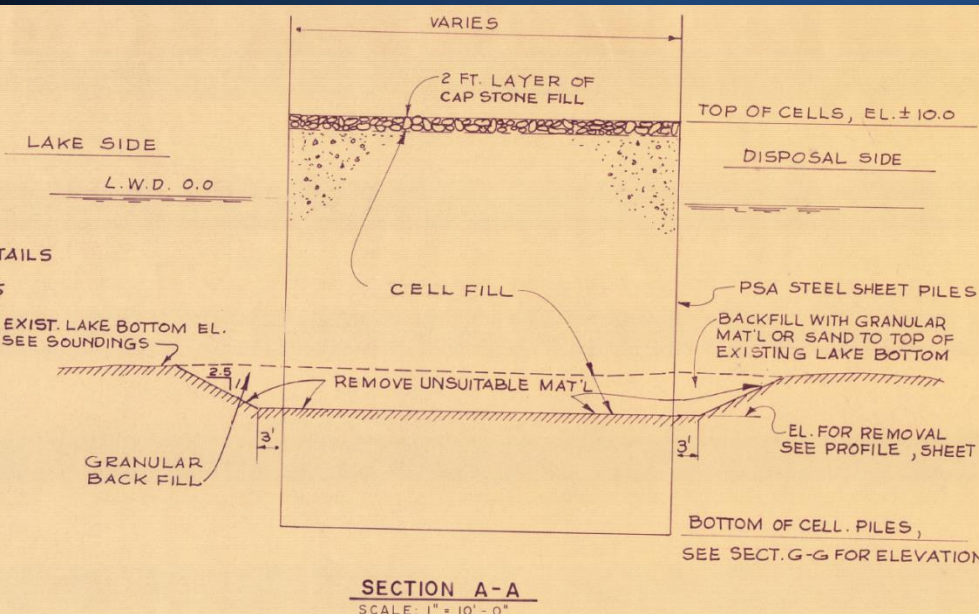
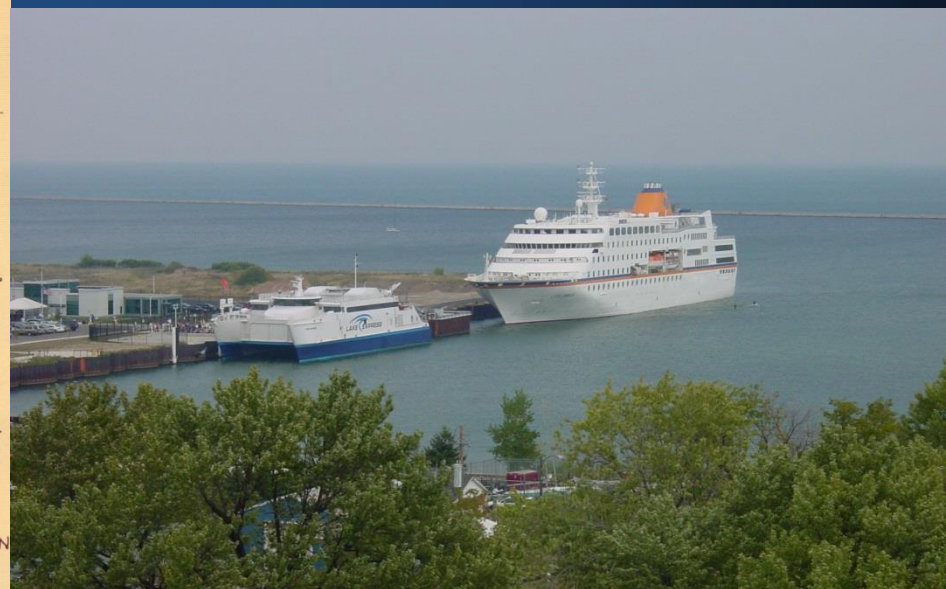
18. Confined Disposal Facility South Side

Condition: Fair

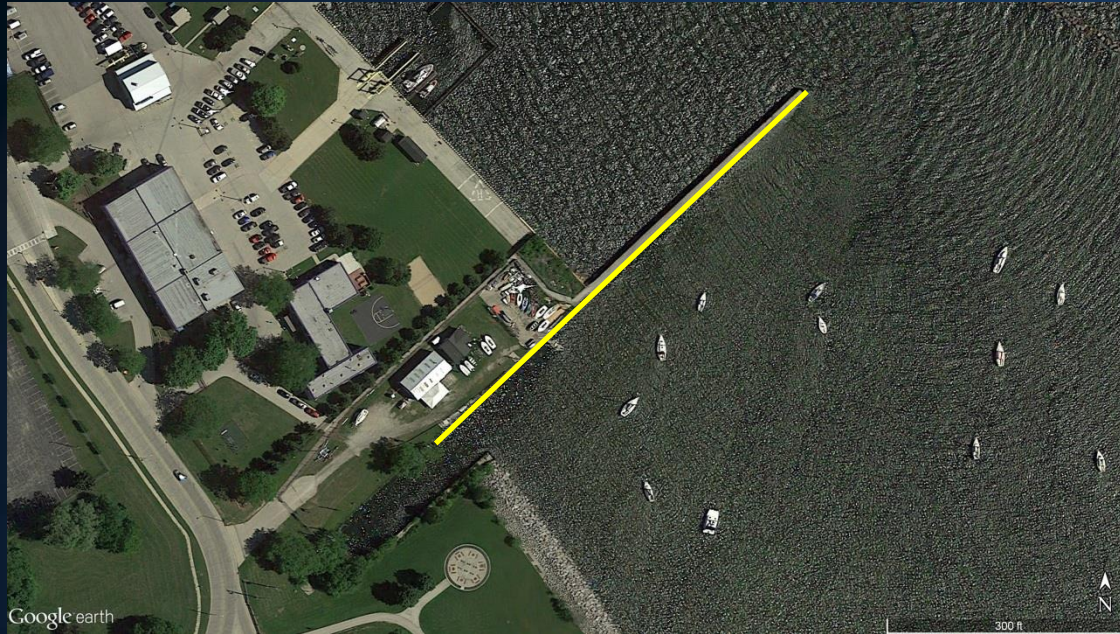
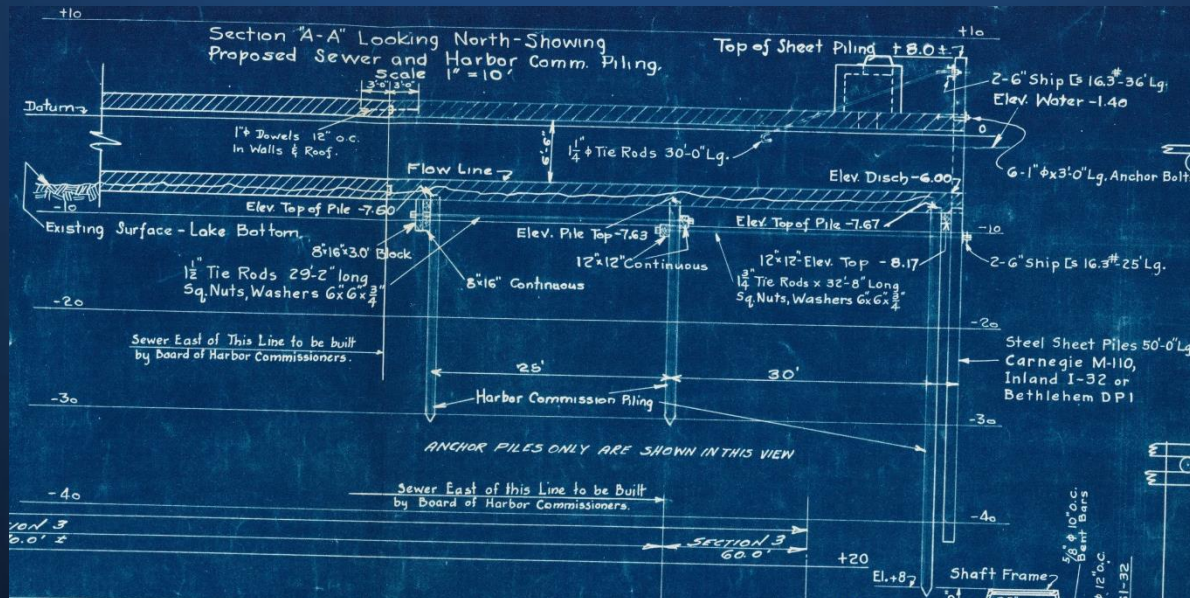
19. Russell Avenue Intake Sheeting

Condition: Poor
