PORT OF MILWAUKEE

Dockwall Condition Report

Capital Improvements Committee

January 20, 2016

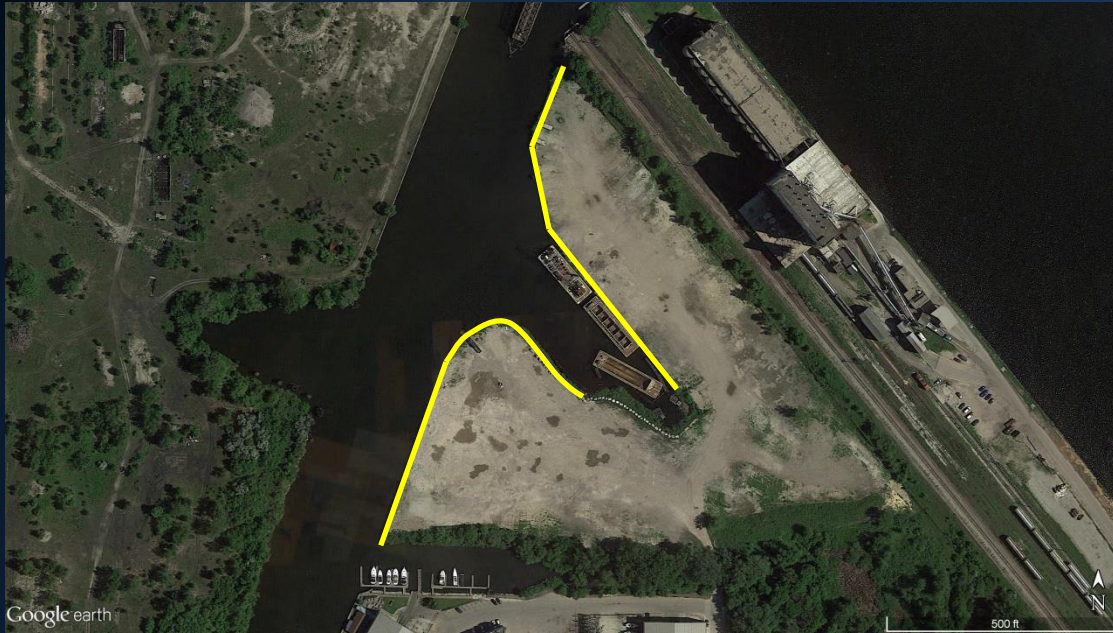
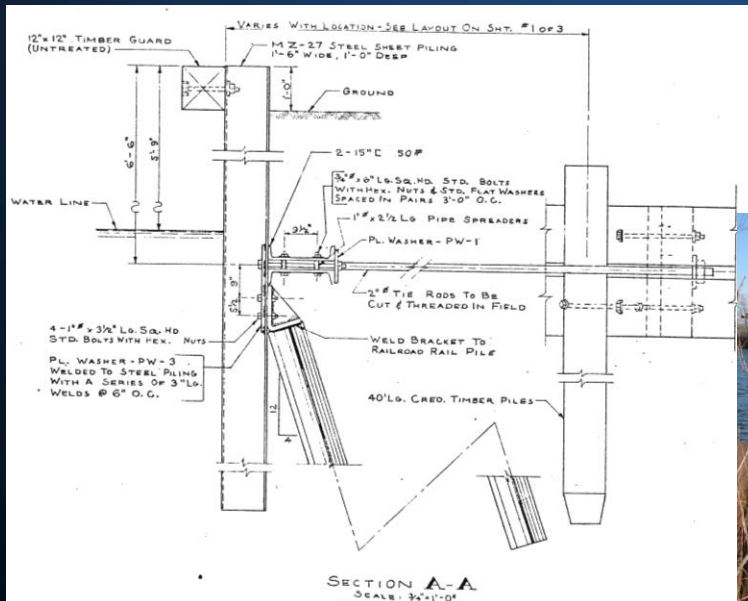
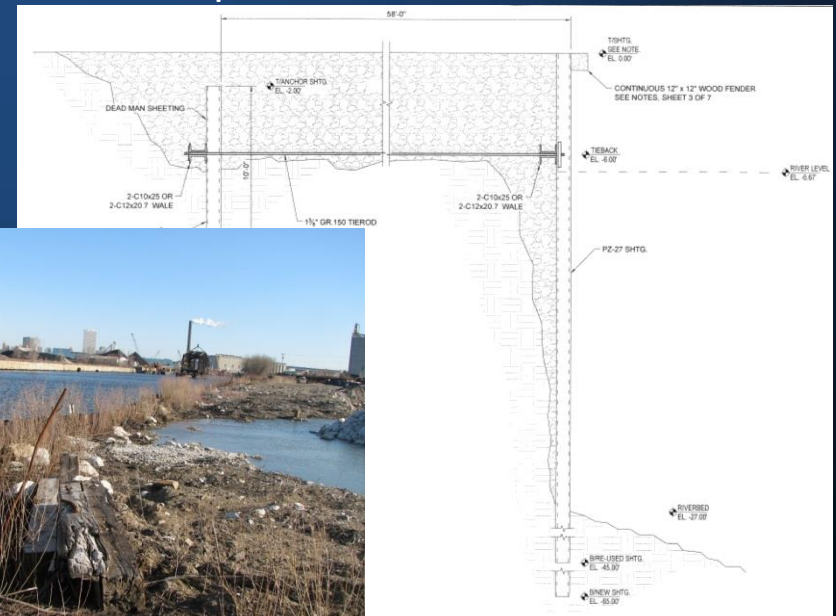
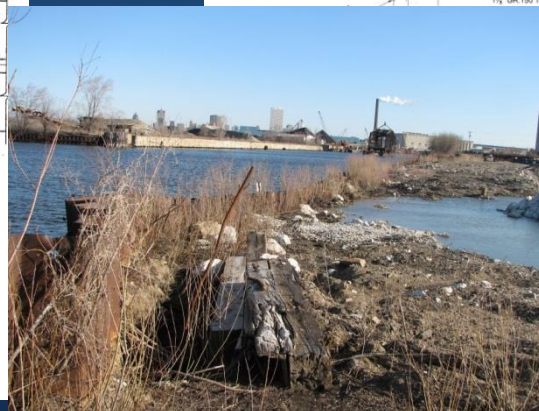
20. Grand Trunk Dock

Condition: Fair

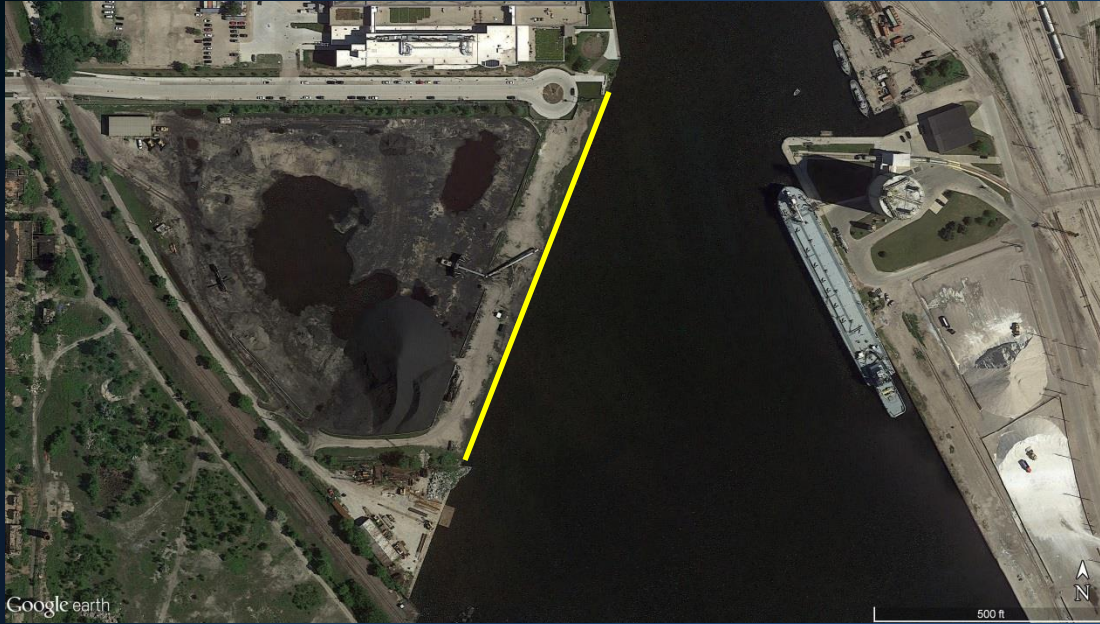
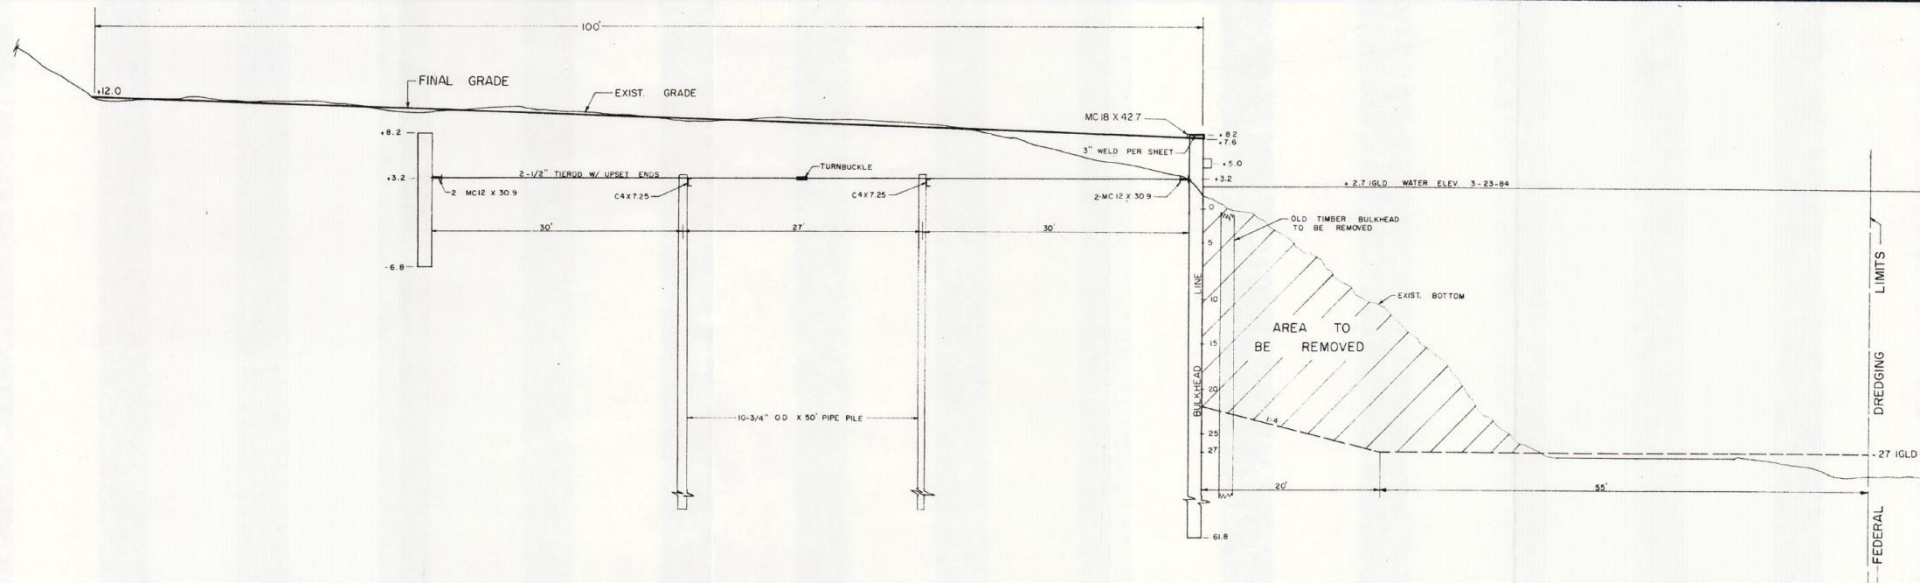
21. Greenfield Avenue Dock

Condition: Fair

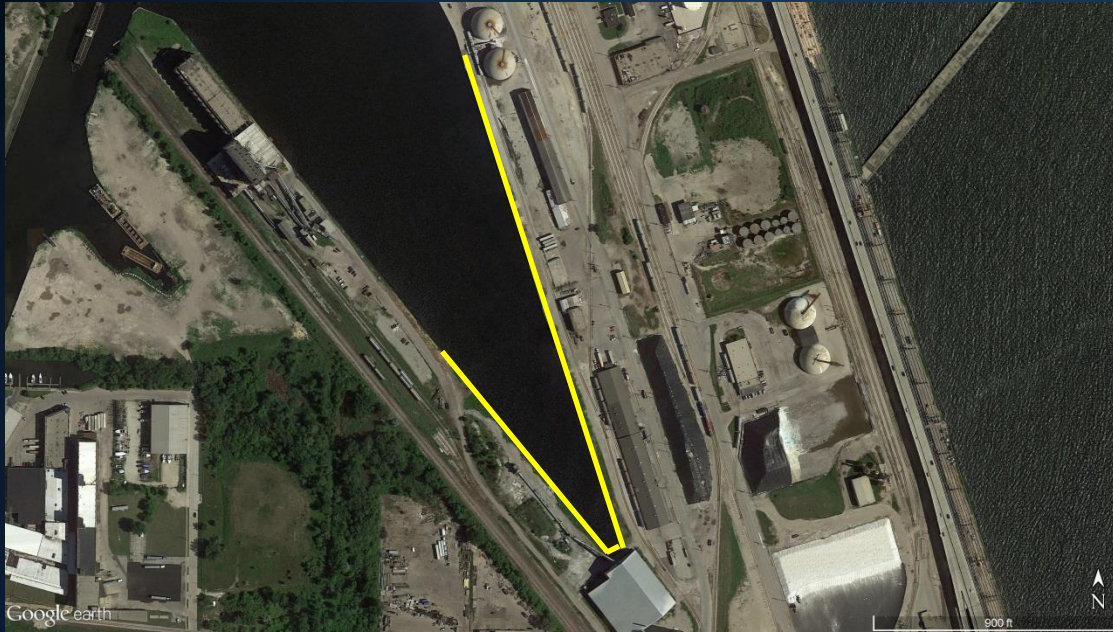
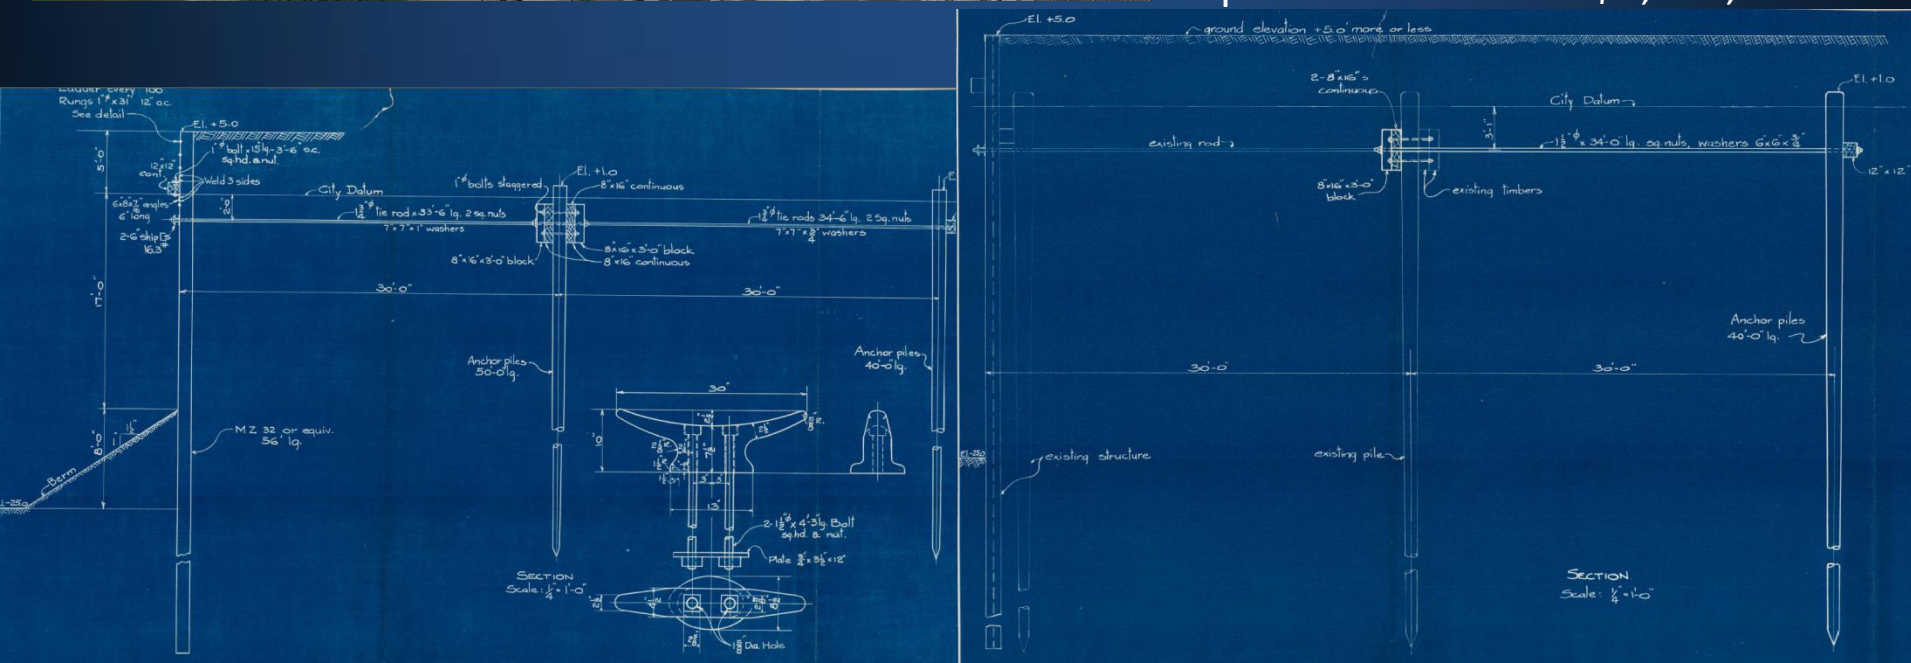
22. Municipal Mooring Basin Dock

Condition: Poor

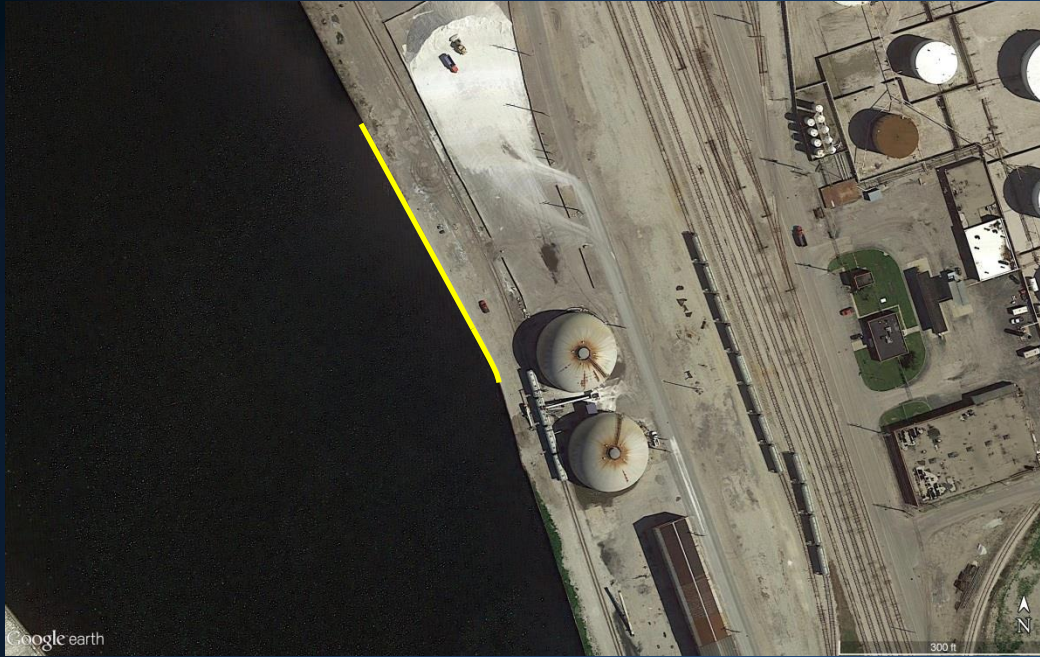
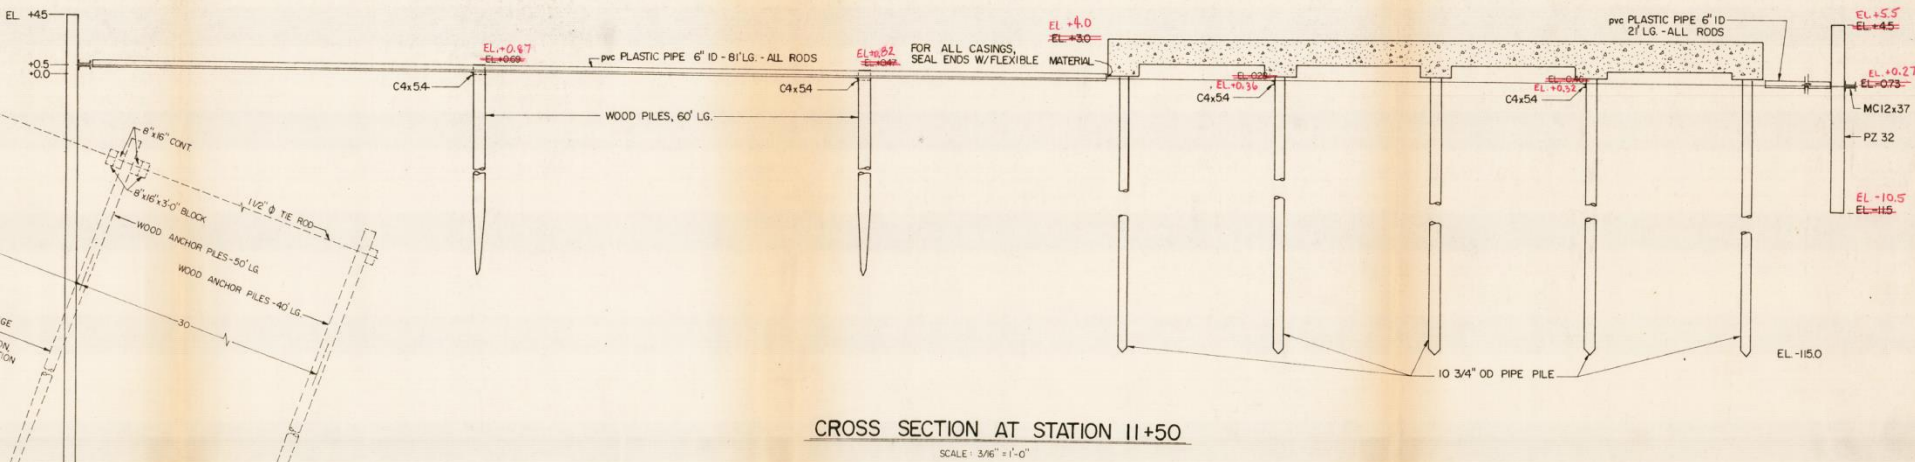
23. City Bulk Cargo Dock Reinforced

Condition: Poor

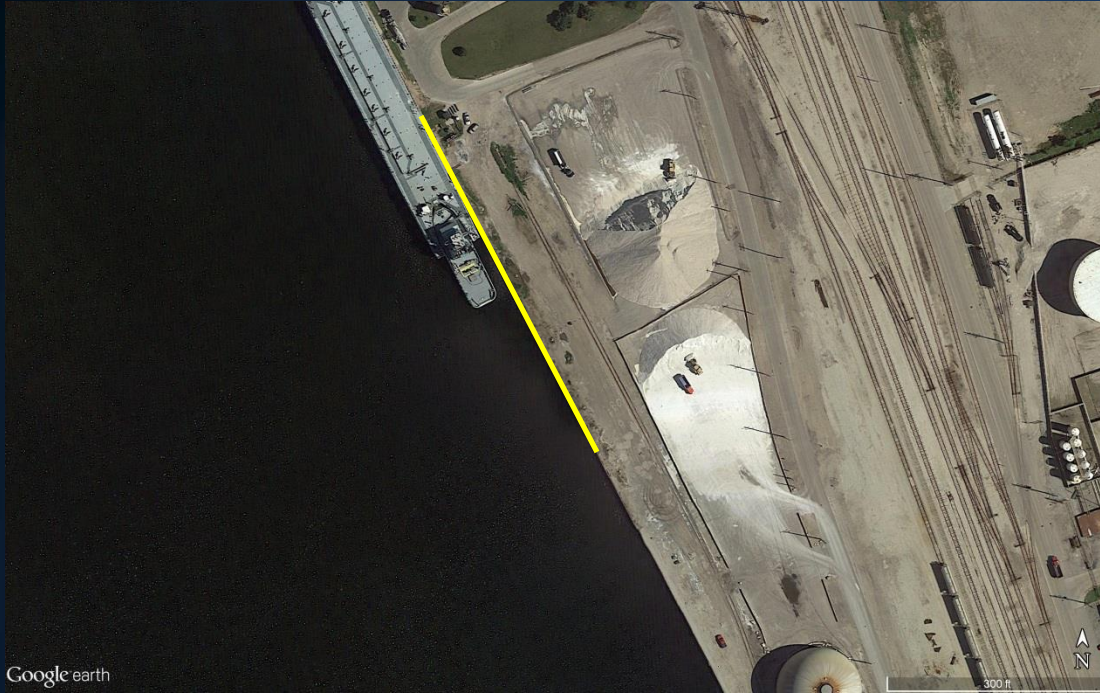
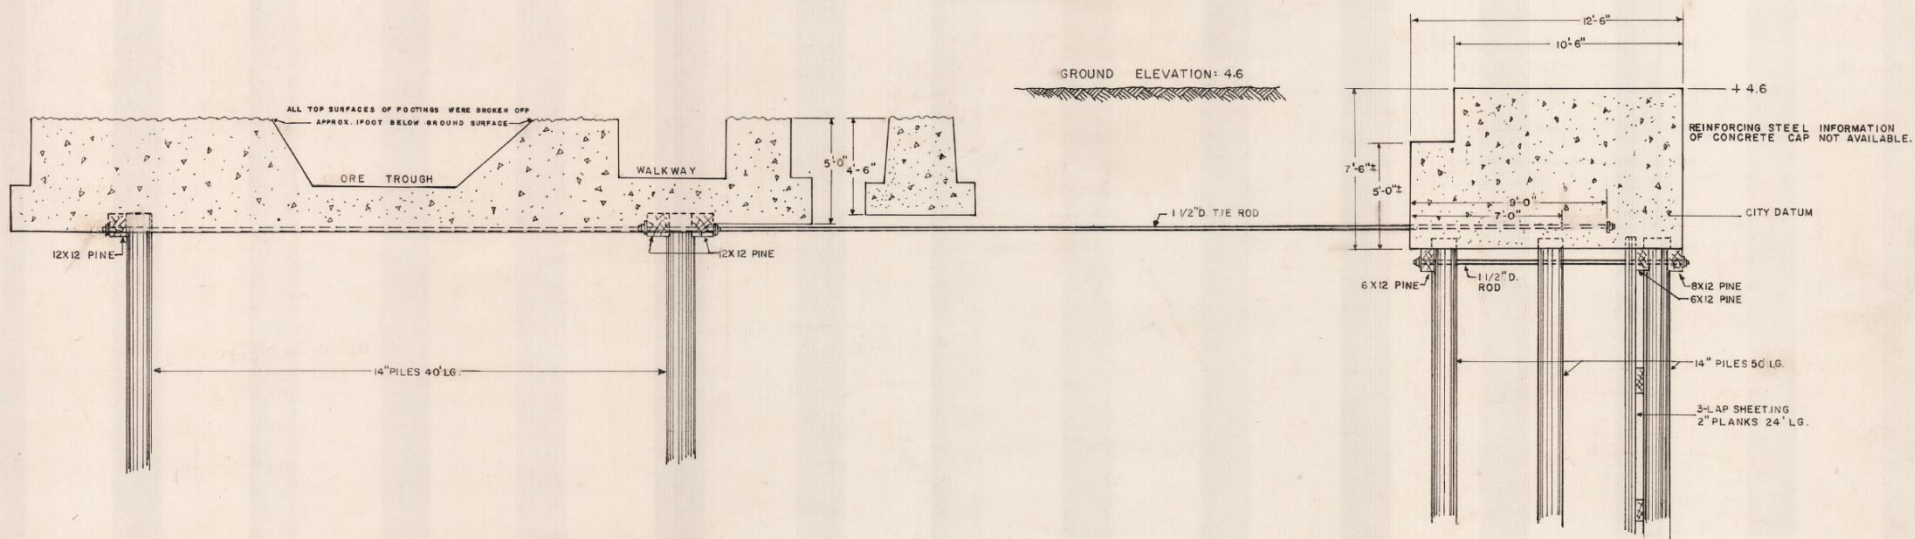
24. City Bulk Cargo Dock

Condition: Poor

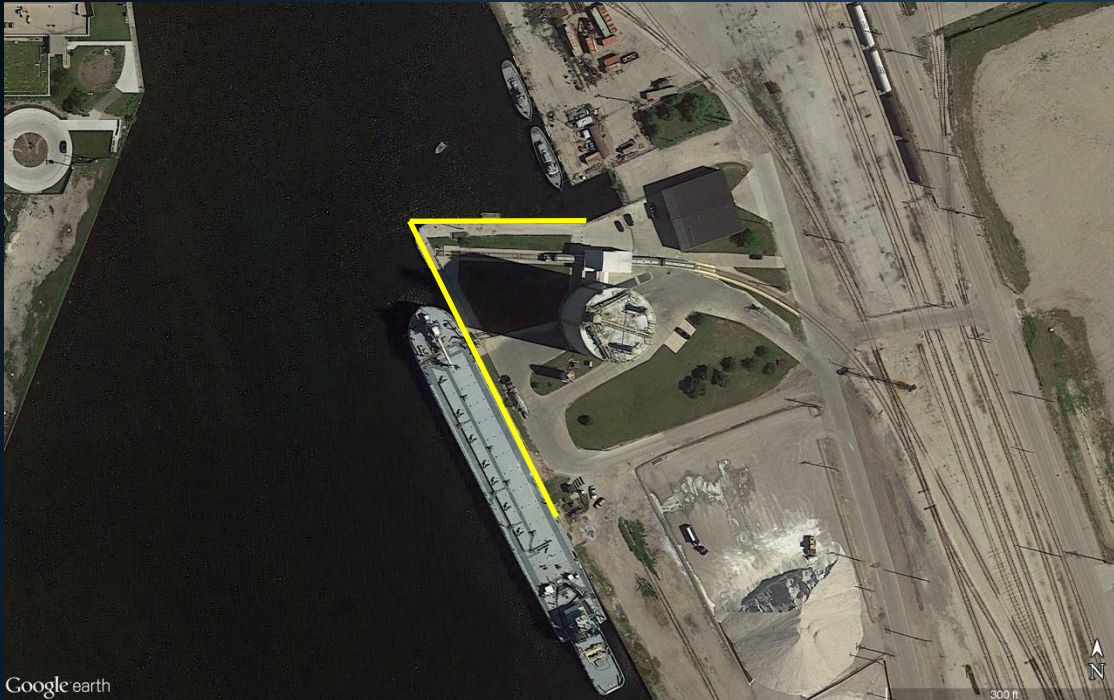
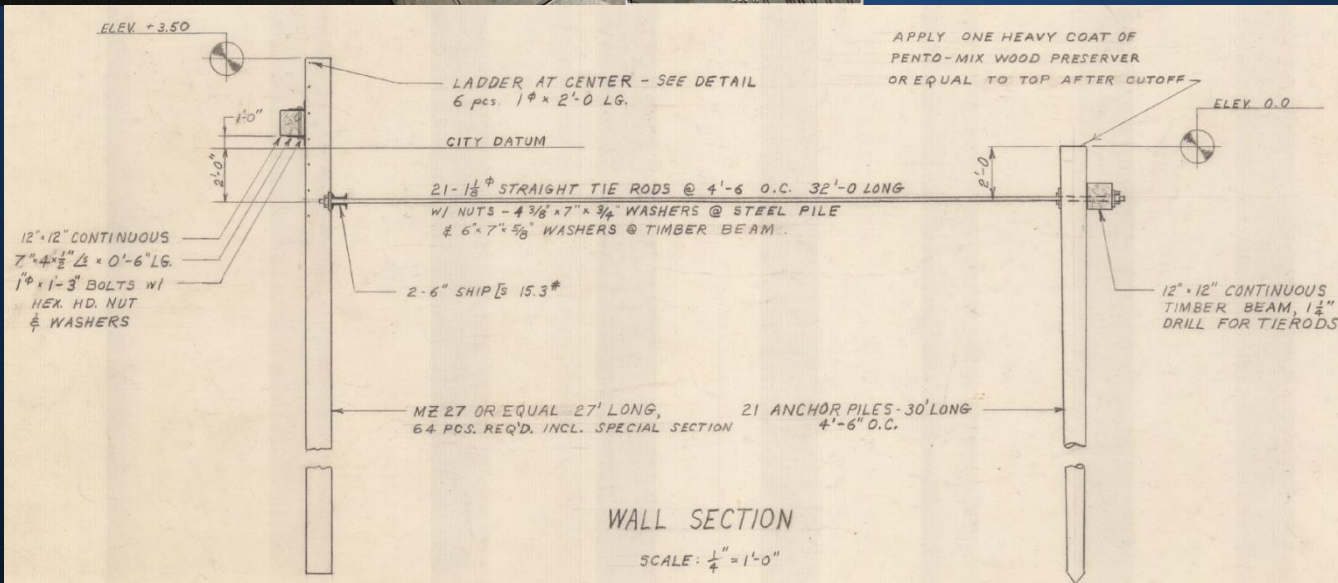
25. LaFarge North Dock

Condition: Fair

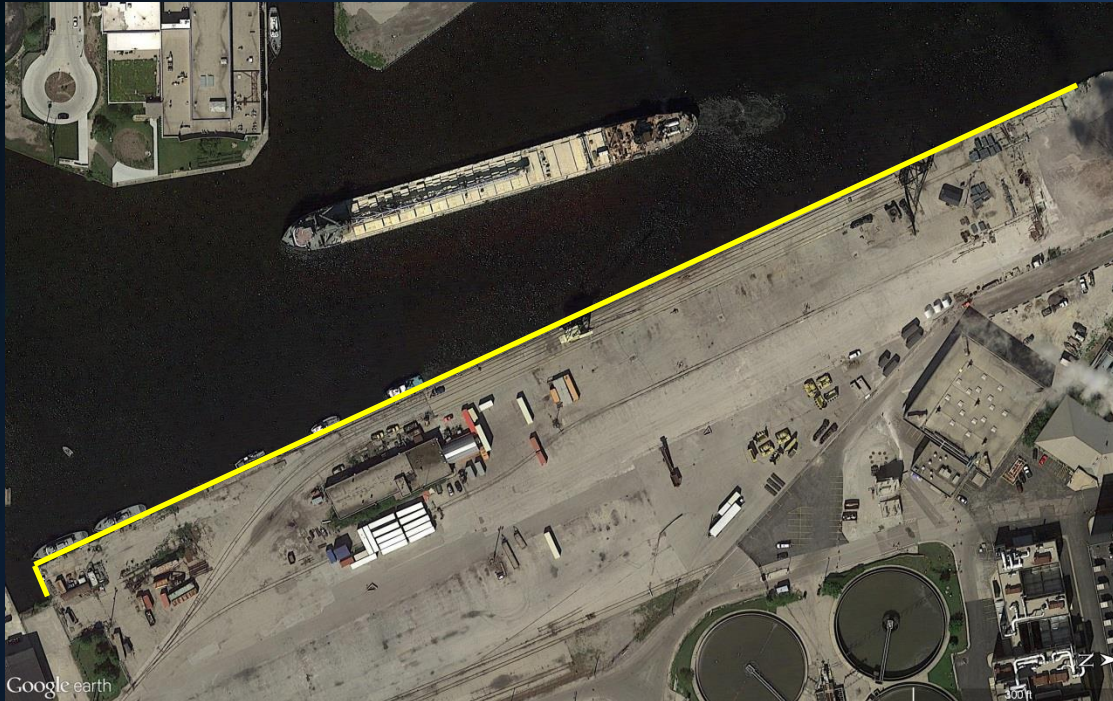
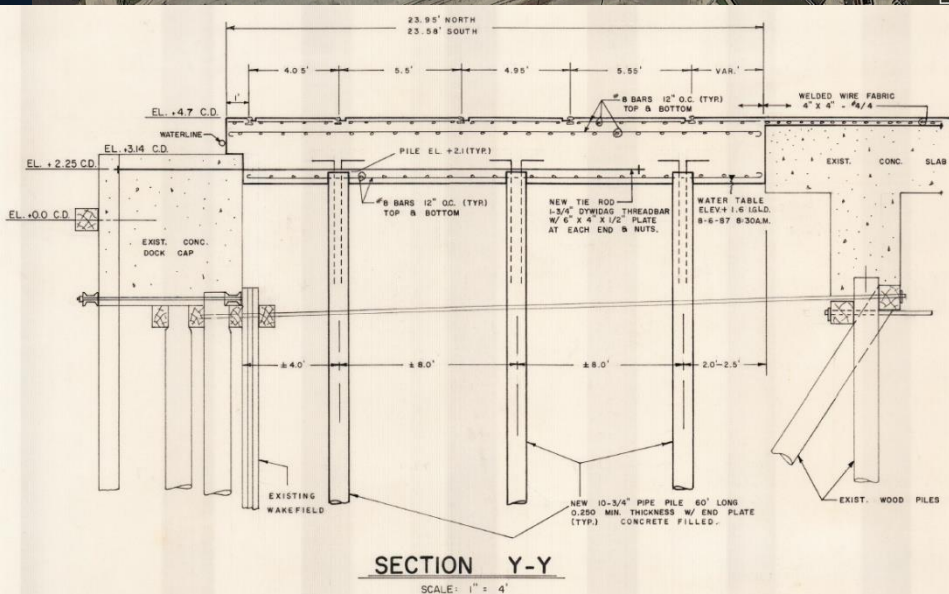
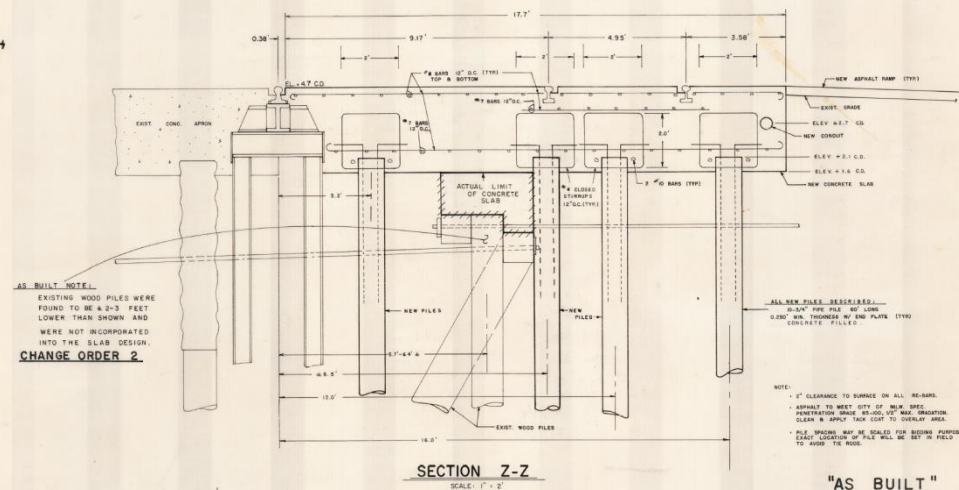
26. City Heavy Lift Dock

Condition: Poor

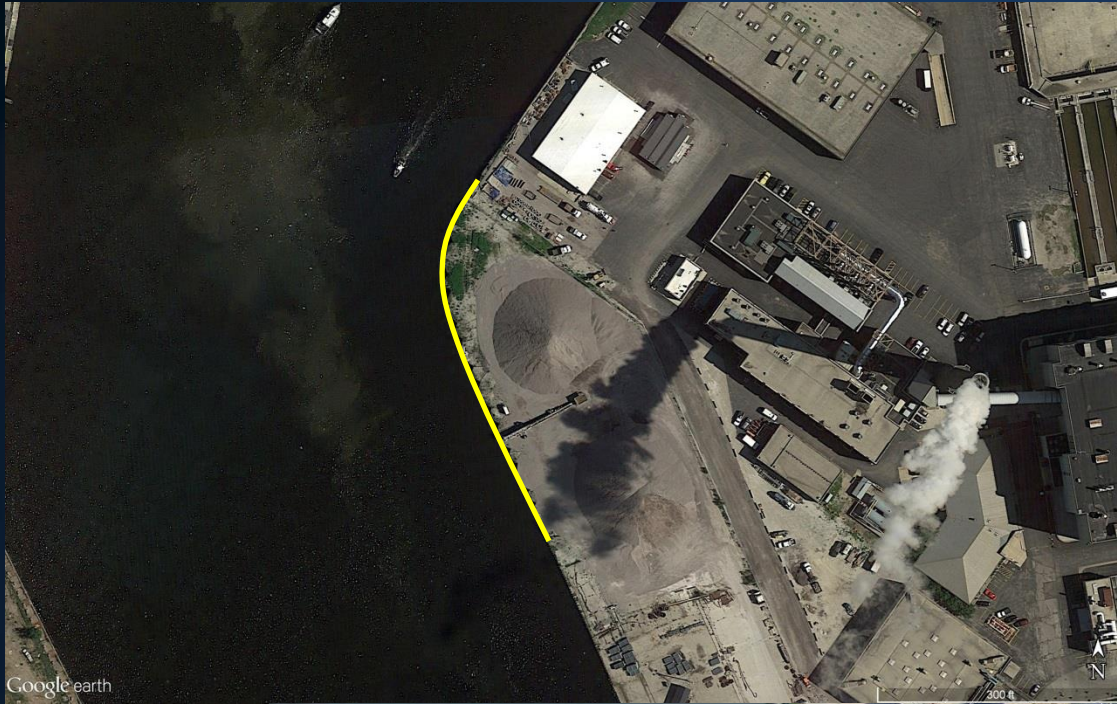
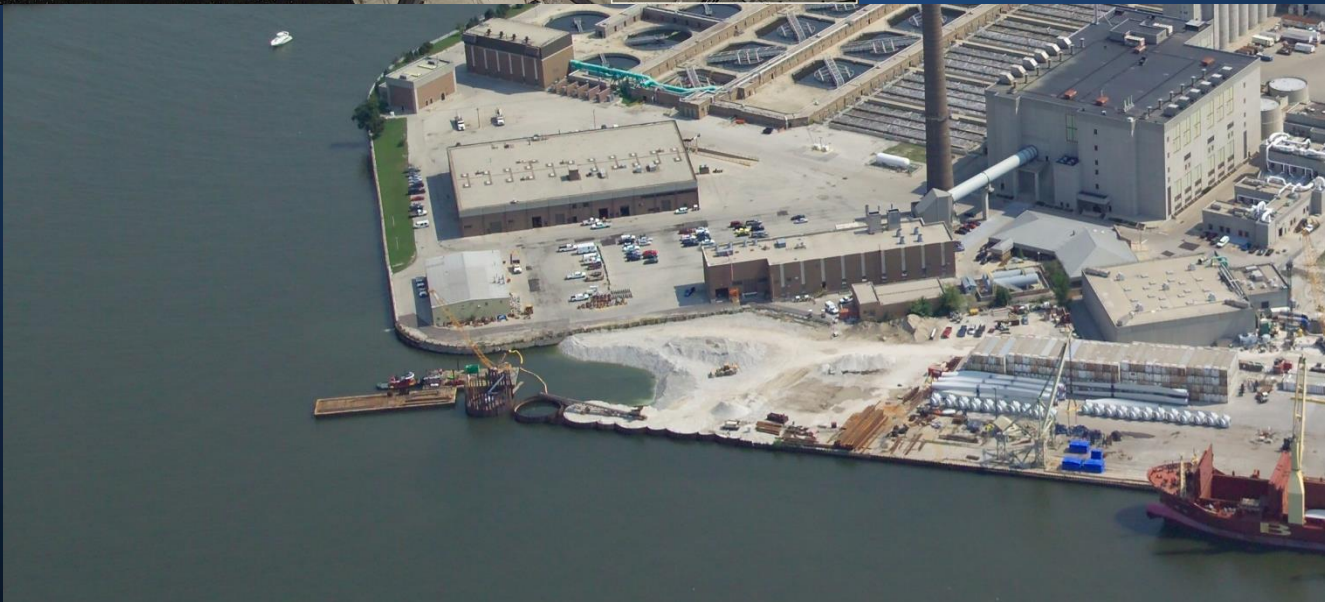
27. Former Carferry Slip

Condition: Good
