# Window Condition Survey

McKinley School Renovation

2001 W. Vliet St.  
Milwaukee WI, 53205

## **McKinley School Restoration Window Condition Survey**

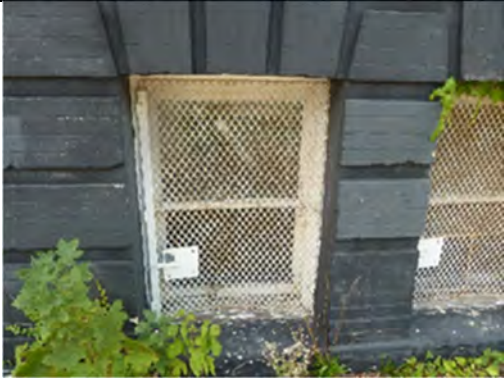
<p>W108-01: Interior view of lower sash      W108-02: Exterior view</p> <p><b>Condition Comments</b></p> <ul style="list-style-type: none"> <li>- Obscured glazing intact at both sashes.</li> <li>- No ropes or sash balance springs visible. Sash was originally pinned in place.</li> <li>- Paint is crazed (multiple layers of paint / lead paint).</li> <li>- Exterior sill is rotted due to exposure and being adjacent to grade and little paint coverage. 1/2" blade penetration.</li> <li>- Bottom rail of lower sash split out at exterior side on face.</li> <li>- Security screen mountings are mortised into the brickmold.</li> <li>- Glazing caulk is tested as having ACM.</li> </ul>

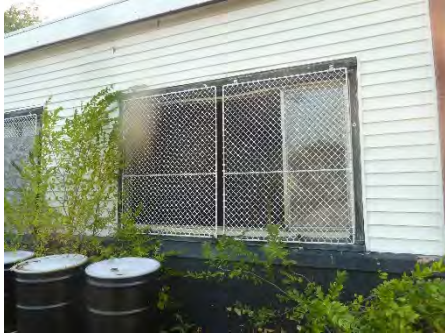
W123-04: Exterior view

- Smoke / fire damage.
- Missing fixed center and right slider sashes.
- Broken glazing in remaining slider unit
- Vinyl seals and track deformed.
- Non-original window in this portion of building.

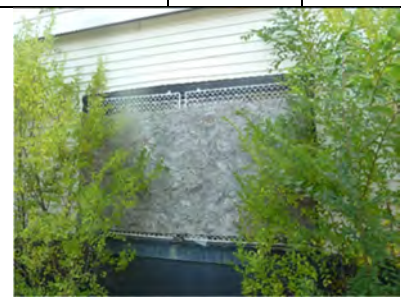
<p>W121-03: Exterior view</p> </div> </div> <p><b>Condition Comments</b></p> <ul style="list-style-type: none"> <li>- Smoke / fire damage.</li> <li>- Broken glazing in slider sash.</li> <li>- Vinyl seals and track deformed.</li> <li>- Non-original window in this portion of building.</li> <li>- Slider sashes don't move.</li> <li>- Sashes are water damage and warped.</li> </ul>

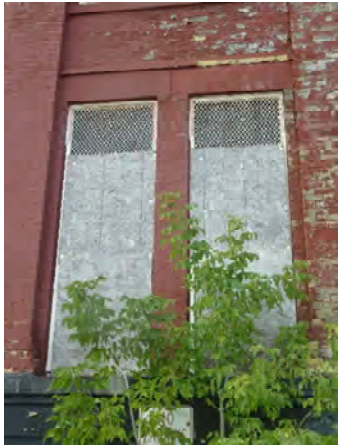
<p>N235-04: Exterior view on left</p>

<p>N235-01: Interior view of lower sash      N235-02: Interior view of upper sash      N235-03: Bottom of sash is split out</p> <p><b>Condition Comments</b></p> <ul style="list-style-type: none"> <li>- Missing upper fixed transom sash - replaced with Transite (ACM) panel.</li> <li>- Broken glazing in both sashes.</li> <li>- Original hardware damaged / missing.</li> <li>- Casings and trims dive behind continuous wood sill. Sill needs to be removed to pull the weight boxes/jambs.</li> <li>- Paint is crazed (multiple layers of paint / lead paint).</li> <li>- Exterior sill is decayed.</li> <li>- Security screen mountings are mortised into the brickmold.</li> <li>- Upper sash painted in place.</li> <li>- Glazing caulk is tested as having ACM.</li> <li>- Accessing window weight box will require removing the galvanized metal jamb guides - access port is blocked.</li> <li>- Lower rail of bottom sash is split out at weather strip groove.</li> </ul>

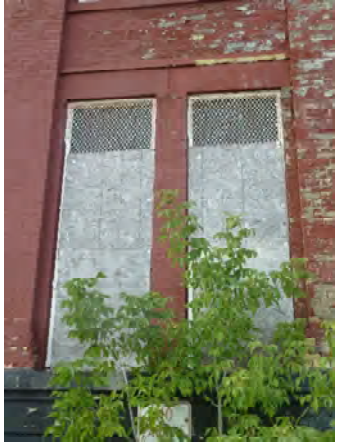
<p>N236-04: Exterior view on right</p>

<p>N236-01: Interior view of lower sash      N236-02: Interior view of upper sash      N236-03: Severely rotted sill and jamb</p> <p><b>Condition Comments</b></p> <ul style="list-style-type: none"> <li>- Missing upper fixed transom sash - replaced with Transite (ACM) panel.</li> <li>- Broken glazing in both sashes.</li> <li>- Original hardware damaged / missing.</li> <li>- Casings and trims dive behind continuous wood sill. Sill needs to be removed to pull the weight boxes/jambs.</li> <li>- Paint is crazed (multiple layers of paint / lead paint).</li> <li>- Exterior sill is severely rotted. Blade penetration of 3".</li> <li>- Security screen mountings are mortised into the brickmold.</li> <li>- Upper sash painted in place.</li> <li>- Glazing caulk is tested as having ACM.</li> <li>- Accessing window weight box will require removing the galvanized metal jamb guides - access port is blocked.</li> <li>- Bottom sash not square / racked.</li> </ul>

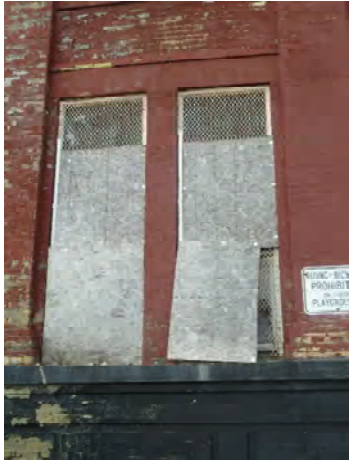
<p>N237-04: Exterior view on left</p>

<p>N237-01: Interior view of lower sash      N237-02: Interior view of upper sash      N237-03: Galv. jamb guide blocking weight box access</p> <p><b>Condition Comments</b></p> <ul style="list-style-type: none"> <li>- Missing upper fixed transom sash - replaced with Transite (ACM) panel.</li> <li>- Broken glazing in both sashes.</li> <li>- Original hardware damaged / missing.</li> <li>- Casings and trims dive behind continuous wood sill. Sill needs to be removed to pull the weight boxes/jambs.</li> <li>- Paint is crazed (multiple layers of paint / lead paint).</li> <li>- Exterior sill is decayed.</li> <li>- Security screen mountings are mortised into the brickmold.</li> <li>- Upper sash painted in place.</li> <li>- Glazing caulk is tested as having ACM.</li> <li>- Accessing window weight box will require removing the galvanized metal jamb guides - access port is blocked.</li> <li>- Lower sash corners are open.</li> </ul>

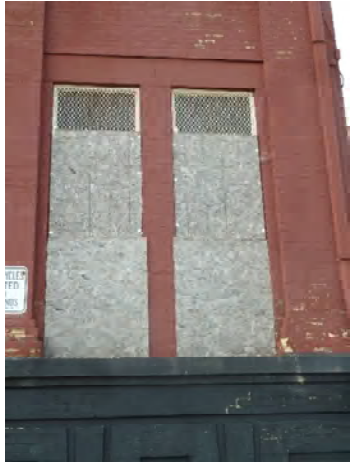
<p>N239-04: Exterior view on left</p>

<p>N239-01: Interior view of lower sash</p> <p>N239-02: Interior view of upper sash</p> <p>N239-03: Galv. jamb guide blocking weight box access</p>		<p><b>Condition Comments</b></p> <ul style="list-style-type: none"> <li>- Missing upper fixed transom sash - replaced with Transite (ACM) panel.</li> <li>- Broken glazing in both sashes.</li> <li>- Original hardware damaged / missing.</li> <li>- Casings and trims dive behind continuous wood sill. Sill needs to be removed to pull the weight boxes/jambs.</li> <li>- Paint is crazed (multiple layers of paint / lead paint).</li> <li>- Exterior sill is decayed.</li> <li>- Security screen mountings are mortised into the brickmold.</li> <li>- Upper sash painted in place.</li> <li>- Glazing caulk is tested as having ACM.</li> <li>- Accessing window weight box will require removing the galvanized metal jamb guides - access port is blocked.</li> </ul>

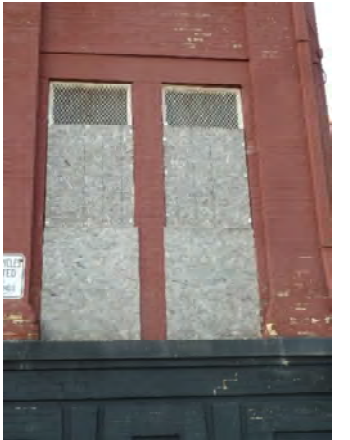
<p>N240-04: Exterior view on right</p>

<p>N240-01: Interior view of lower sash</p> <p>N240-02: Interior view of upper sash</p> <p>N240-03: Severely rotted sill and jamb</p>		<p><b>Condition Comments</b></p> <ul style="list-style-type: none"> <li>- Missing upper fixed transom sash - replaced with Transite (ACM) panel.</li> <li>- Broken glazing in both sashes.</li> <li>- Original hardware damaged / missing.</li> <li>- Casings and trims dive behind continuous wood sill. Sill needs to be removed to pull the weight boxes/jambs.</li> <li>- Paint is crazed (multiple layers of paint / lead paint).</li> <li>- Exterior sill is severely rotted. Blade penetration of 3".</li> <li>- Security screen mountings are mortised into the brickmold.</li> <li>- Upper sash painted in place.</li> <li>- Glazing caulk is tested as having ACM.</li> <li>- Accessing window weight box will require removing the galvanized metal jamb guides - access port is blocked.</li> </ul>

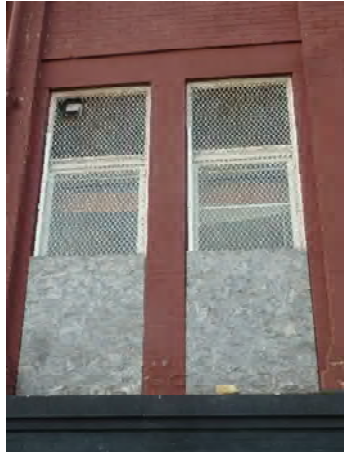
<p>N233-04: Exterior view on left</p>

<p>N233-01: Interior view of lower sash      N233-02: Interior view of upper sash      N233-03: View of fixed transom panel</p> <p><b>Condition Comments</b></p> <ul style="list-style-type: none"> <li>- Missing upper fixed transom sash - replaced with Transite (ACM) panel. Vent through existing transom panel.</li> <li>- Glazing in both sashes intact.</li> <li>- Original hardware damaged / missing.</li> <li>- Casings and trims dive behind continuous wood sill. Sill needs to be removed to pull the weight boxes/jamb.</li> <li>- Paint is crazed (multiple layers of paint / lead paint).</li> <li>- Exterior sill is decayed.</li> <li>- Security screen mountings are mortised into the brickmold.</li> <li>- Upper sash painted in place.</li> <li>- Glazing caulk is tested as having ACM.</li> <li>- Accessing window weight box will require removing the galvanized metal jamb guides - access port is blocked.</li> </ul>

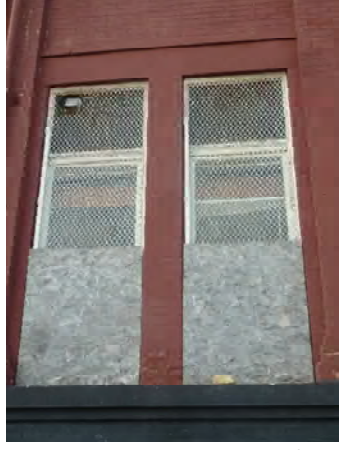
<p>N234-04: Exterior view on right</p>

<p>N234-01: Interior view of lower sash      N234-02: Interior view of upper sash      N234-03: Fixed transom above ceiling</p> <p><b>Condition Comments</b></p> <ul style="list-style-type: none"> <li>- Missing upper fixed transom sash - replaced with Transite (ACM) panel.</li> <li>- Glazing in both sashes intact.</li> <li>- Original hardware damaged / missing.</li> <li>- Casings and trims dive behind continuous wood sill. Sill needs to be removed to pull the weight boxes/jamb.</li> <li>- Paint is crazed (multiple layers of paint / lead paint).</li> <li>- Exterior sill is decayed.</li> <li>- Security screen mountings are mortised into the brickmold.</li> <li>- Upper sash painted in place.</li> <li>- Glazing caulk is tested as having ACM.</li> <li>- Accessing window weight box will require removing the galvanized metal jamb guides - access port is blocked.</li> <li>- Lower sash will not open.</li> </ul>

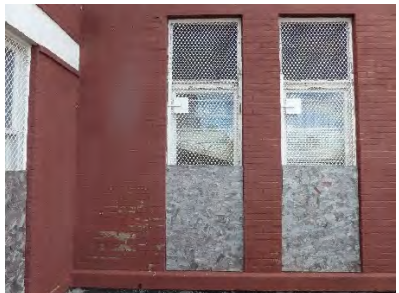
N242-04: Exterior view on right

- Missing upper fixed transom sash - replaced with Transite (ACM) panel.
- Broken glazing in lower sash.
- Original hardware damaged / missing.
- Casings and trims dive behind continuous wood sill. Sill needs to be removed to pull the weight boxes/jamb.
- Paint is crazed (multiple layers of paint / lead paint).
- Exterior sill is severely rotted. Blade penetration of 1".
- Security screen mountings are mortised into the brickmold.
- Upper sash painted in place.
- Glazing caulk is tested as having ACM.
- Accessing window weight box will require removing the galvanized metal jamb guides - access port is blocked.
- Water damage at fixed transom head.

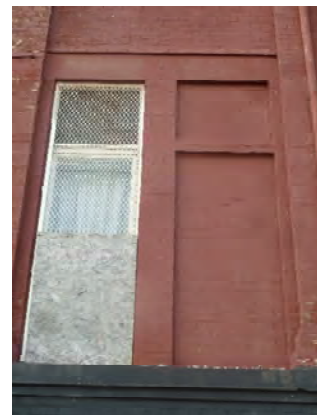
N231-04: Exterior view on left

- Missing upper fixed transom sash - replaced with Transite (ACM) panel.
- Broken glazing in lower sash.
- Original hardware damaged / missing.
- Casings and trims dive behind continuous wood sill. Sill needs to be removed to pull the weight boxes/jambs.
- Paint is crazed (multiple layers of paint / lead paint).
- Exterior sill is decayed.
- Security screen mountings are mortised into the brickmold.
- Upper sash painted in place. Lower sash is screwed to upper sash.
- Glazing caulk is tested as having ACM.
- Accessing window weight box will require removing the galvanized metal jamb guides - access port is blocked.
- Water damage at fixed transom head.
- Bottom rail of lower sash is decayed - 1/4" blade penetration.
- Exterior stops are decayed / damaged.

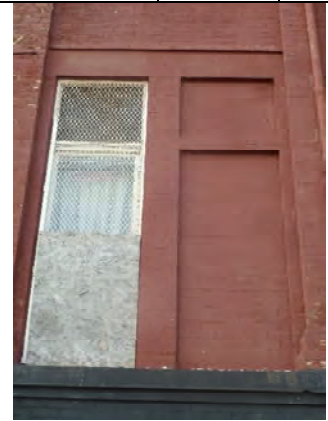
N232-04: Exterior view on right

- No window at this location. Opening is bricked in.

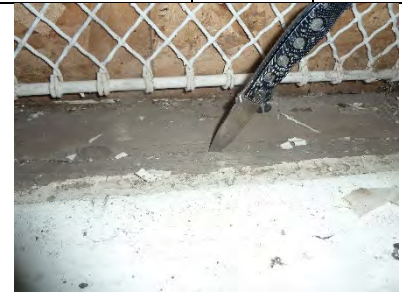
W203-03: Exterior jamb condition

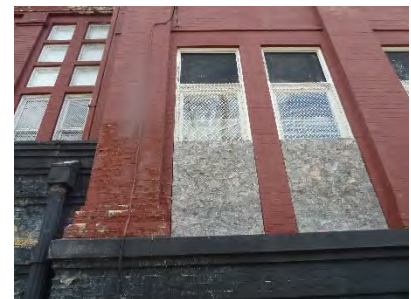
W203-04: Exterior view on left

- Missing upper fixed transom sash - replaced with Transite (ACM) panel.
- Glass intact at both sashes.
- Original hardware damaged / missing.
- Casings and trims dive behind continuous wood sill. Sill needs to be removed to pull the weight boxes/jamb.
- Paint is crazed (multiple layers of paint / lead paint).
- Exterior sill is rotted / checked. Blade penetration of 3/8".
- Security screen mountings are mortised into the brickmold.
- Upper sash painted in place.
- Glazing caulk is tested as having ACM.
- Accessing window weight box will require removing the galvanized metal jamb guides - access port is blocked.
- Jamb rot at bottom right.

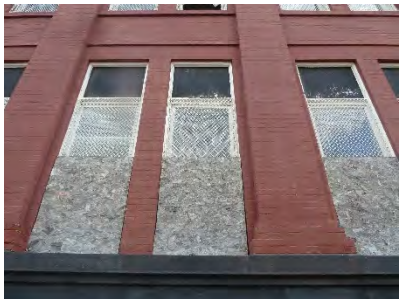
W212-04: Exterior view at center

- Missing upper fixed transom sash - replaced with Transite (ACM) panel.
- Glazing intact at both sashes.
- Original hardware damaged.
- Casings and trims dive behind continuous wood sill. Sill needs to be removed to pull the weight boxes/jamb.
- Paint is crazed (multiple layers of paint / lead paint).
- Exterior sill is decayed.
- Security screen mountings are mortised into the brickmold.
- Upper sash painted in place.
- Glazing caulk is tested as having ACM.
- Accessing window weight box will require removing the galvanized metal jamb guides - access port is blocked.
- Window rope broken.
- Lower sash is stuck in place.

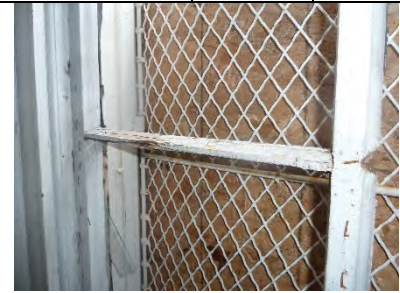
N217-03: Broken muntin bar

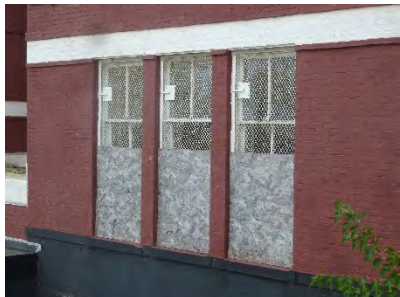
N218-04: Exterior view at center

- Glazing broken / missing at both sashes.
- Lower sash bottom rail broken out.
- Lower sash missing muntin bars.
- Lower sash is not original and is a replacement. Ogee is dissimilar and muntins are thicker than originals at typical window.
- Upper sash not original and is a replacement. Ogee is dissimilar and muntins are thicker than originals at typical window.
- Paint is crazed (multiple layers of paint / lead paint).
- Exterior sill is decayed.
- Security screen mountings are mortised into the brickmold.
- Upper sash painted in place.
- Glazing caulk is tested as having ACM.
- Accessing window weight box will require removing the galvanized metal jamb guides - access port is blocked.

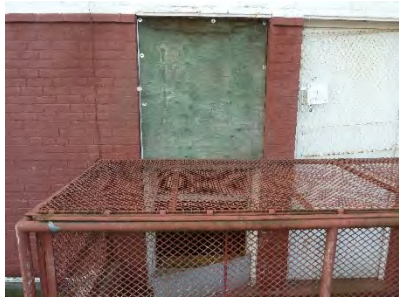
N211-04: Exterior view at center

N211-01: Interior view of lower sash	N211-02: Interior view of upper sash	
		N211-03: Decayed wood at sill		
<b>Condition Comments</b>				
<ul style="list-style-type: none"> <li>- Glazing broken / missing at lower sash.</li> <li>- Muntins missing at lower sash.</li> <li>- Lower sash racked.</li> <li>- Paint is crazed (multiple layers of paint / lead paint).</li> <li>- Exterior sill is decayed – 3/8" blade penetration.</li> <li>- Interior sill is decayed / water damaged.</li> <li>- Security screen mountings are mortised into the brickmold.</li> <li>- Upper sash painted in place.</li> <li>- Glazing caulk is tested as having ACM.</li> <li>- Accessing window weight box will require removing the galvanized metal jamb guides - access port is blocked.</li> <li>- Window stuck in open position.</li> </ul>

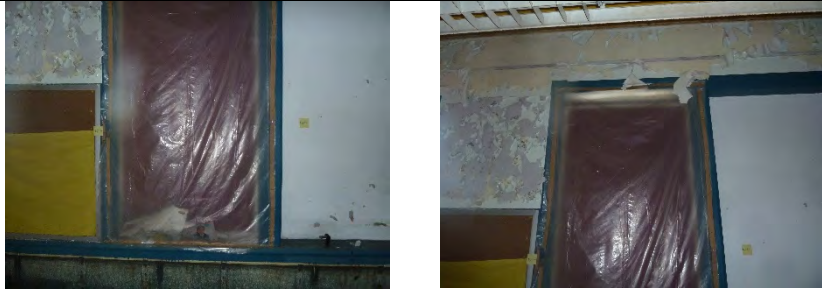
<p>N202-01: Interior view of lower sash      N202-02: Interior view of upper sash</p> <p><b>Condition Comments</b></p> <ul style="list-style-type: none"> <li>- Glazing broken / missing at lower both sashes.</li> <li>- Muntins missing at lower sash.</li> <li>- Lower sash racked.</li> <li>- Paint is crazed (multiple layers of paint / lead paint).</li> <li>- Exterior sill is decayed.</li> <li>- Security screen mountings are mortised into the brickmold.</li> <li>- Upper sash painted in place.</li> <li>- Glazing caulk is tested as having ACM.</li> <li>- Accessing window weight box will require removing the galvanized metal jamb guides - access port is blocked.</li> <li>- Window covered at the interior with stapled plastic.</li> </ul>

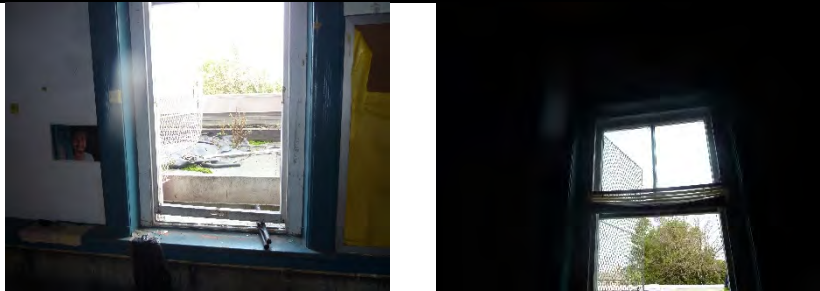
<p>N203-01: Interior view of lower sash      N203-02: Interior view of upper sash</p> <p><b>Condition Comments</b></p> <ul style="list-style-type: none"> <li>- Glazing broken / missing at both sashes.</li> <li>- Muntins missing at lower sash.</li> <li>- Lower sash racked.</li> <li>- Paint is crazed (multiple layers of paint / lead paint).</li> <li>- Exterior sill is decayed.</li> <li>- Security screen mountings are mortised into the brickmold.</li> <li>- Upper sash painted in place.</li> <li>- Glazing caulk is tested as having ACM.</li> <li>- Accessing window weight box will require removing the galvanized metal jamb guides - access port is blocked.</li> <li>- Window is covered at interior w/ plastic.</li> </ul>

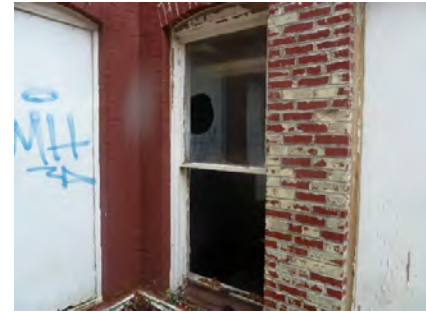
LC205-04: Exterior view

- Broken / missing glazing in both sashes.
- Original hardware damaged / missing.
- Casings and trims dive behind continuous wood sill. Sill needs to be removed to pull the weight boxes/jamb.
- Paint is crazed (multiple layers of paint / lead paint).
- Exterior sill is severely decayed and covered with metal flashing.
- Upper sash painted in place.
- Glazing caulk is tested as having ACM.
- Accessing window weight box will require removing the galvanized metal jamb guides - access port is blocked.
- Lower rail of bottom sash is badly decayed at exterior face - covered with metal flashing.

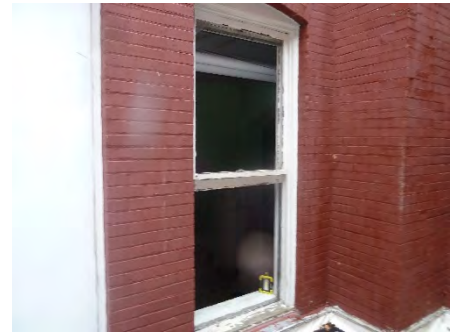
LC209-04: Exterior view

- Broken / missing glazing in both sashes.
- Casings and trims dive behind continuous wood sill. Sill needs to be removed to pull the weight boxes/jamb.
- Paint is crazed (multiple layers of paint / lead paint).
- Exterior wood sill is severely decayed - 1/2" blade penetration. Stone sill covered in metal flashing.
- Lower sash bottom rail decayed at exterior bottom rail edge and lower left corner is open.
- Upper sash painted in place.
- Glazing caulk is tested as having ACM.
- Accessing window weight box will require removing the galvanized metal jamb guides - access port is blocked.

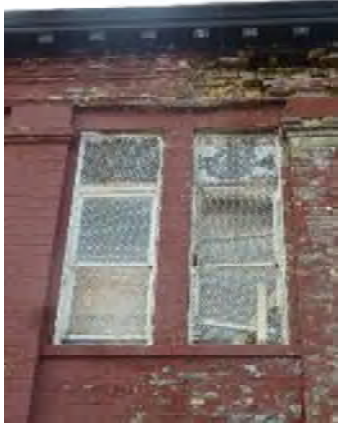
<p>N343-04: Exterior view on left</p>

<p>N343-01: Interior view of lower sash      N343-02: Interior view of upper sash      N343-03: Top of sash is deteriorating</p> <p><b>Condition Comments</b></p> <ul style="list-style-type: none"> <li>- Missing upper fixed transom sash - replaced with Transite (ACM) panel.</li> <li>- Original hardware damaged / missing.</li> <li>- Casings and trims dive behind continuous wood sill. Sill needs to be removed to pull the weight boxes/jambs.</li> <li>- Paint is crazed (multiple layers of paint / lead paint).</li> <li>- Upper sash painted in place.</li> <li>- Glazing caulk is tested as having ACM.</li> <li>- Accessing window weight box will require removing the galvanized metal jamb guides - access port is blocked.</li> <li>- Water damage at transom head.</li> <li>- Lintel condition shared with N344 and is suspect.</li> </ul>

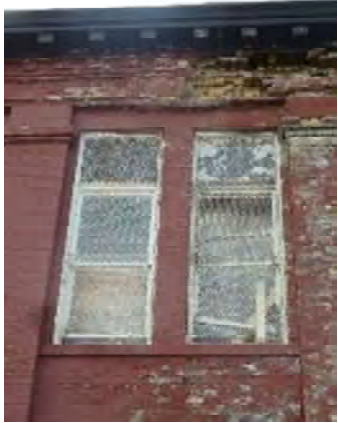
<p>N344-04: Exterior view on right</p>

<p>N344-01: Interior view of window      N344-02: Wall next to window showing water damage      N344-03: Severely rotted header</p> <p><b>Condition Comments</b></p> <ul style="list-style-type: none"> <li>- Missing upper fixed transom sash - replaced with Transite (ACM) panel.</li> <li>- Original hardware damaged / missing.</li> <li>- Casings and trims dive behind continuous wood sill. Sill needs to be removed to pull the weight boxes/jambs.</li> <li>- Paint is crazed (multiple layers of paint / lead paint).</li> <li>- Upper sash painted in place.</li> <li>- Glazing caulk is tested as having ACM.</li> <li>- Accessing window weight box will require removing the galvanized metal jamb guides - access port is blocked.</li> <li>- Severe water damage at transom head jamb.</li> <li>- Bottom rail for upper sash broken.</li> <li>- Lintel condition in question.</li> <li>- Severe water damage to adjacent wall.</li> </ul>

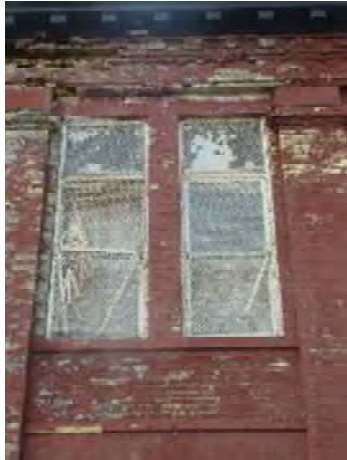
<p>N345-04: Exterior view on left</p>

<p>N345-01: Interior view of lower sash      N345-02: Interior view of upper sash      N345-03: Severely rotted header</p> <p><b>Condition Comments</b></p> <ul style="list-style-type: none"> <li>- Missing upper fixed transom sash - replaced with Transite (ACM) panel.</li> <li>- Original hardware damaged / missing.</li> <li>- Casings and trims dive behind continuous wood sill. Sill needs to be removed to pull the weight boxes/jambs.</li> <li>- Paint is crazed (multiple layers of paint / lead paint).</li> <li>- Upper sash painted in place.</li> <li>- Glazing caulk is tested as having ACM.</li> <li>- Accessing window weight box will require removing the galvanized metal jamb guides - access port is blocked.</li> <li>- Severe water damage at transom head jamb.</li> <li>- Bottom rail for upper sash broken.</li> <li>- Lintel condition in question.</li> <li>- Severe water damage to adjacent wall.</li> </ul>

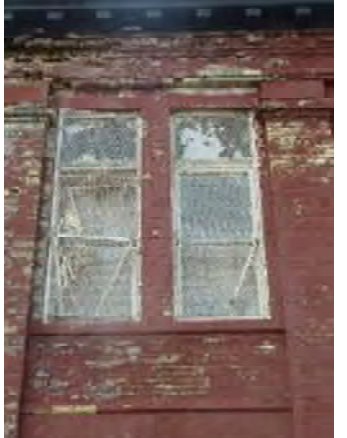
<p>N346-04: Exterior view on right</p>

<p>N346-01: Interior view of lower sash      N346-02: Interior view of transom      N346-03: Missing rail of upper sash</p> <p><b>Condition Comments</b></p> <ul style="list-style-type: none"> <li>- Missing upper fixed transom sash - replaced with Transite (ACM) panel.</li> <li>- Original hardware damaged / missing.</li> <li>- Casings and trims dive behind continuous wood sill. Sill needs to be removed to pull the weight boxes/jambs.</li> <li>- Paint is crazed (multiple layers of paint / lead paint).</li> <li>- Upper sash painted in place.</li> <li>- Glazing caulk is tested as having ACM.</li> <li>- Accessing window weight box will require removing the galvanized metal jamb guides - access port is blocked.</li> <li>- Severe water damage at transom head jamb.</li> <li>- Bottom rail for upper sash missing.</li> </ul>

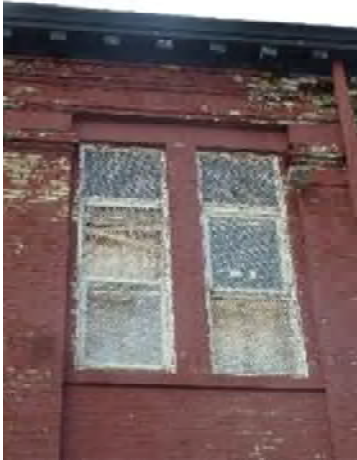
<p>N347-04: Exterior view on left</p>

<p>N347-01: Interior view of lower sash      N347-02: Interior view of upper sash &amp; transom      N347-03: Blown corner of upper sash</p> <p><b>Condition Comments</b></p> <ul style="list-style-type: none"> <li>- Missing upper fixed transom sash - replaced with Transite (ACM) panel.</li> <li>- Broken glazing in both sashes.</li> <li>- Original hardware damaged / missing.</li> <li>- Casings and trims dive behind continuous wood sill. Sill needs to be removed to pull the weight boxes/jambs.</li> <li>- Paint is crazed (multiple layers of paint / lead paint).</li> <li>- Exterior sill is severely rotted.</li> <li>- Security screen mountings are mortised into the brickmold.</li> <li>- Upper sash painted in place.</li> <li>- Glazing caulk is tested as having ACM.</li> <li>- Accessing window weight box will require removing the galvanized metal jamb guides - access port is blocked.</li> <li>- Lower left exterior stop channel split in jamb.</li> <li>- Upper sash rail corners blown.</li> <li>- No visible water damage to transom head.</li> </ul>

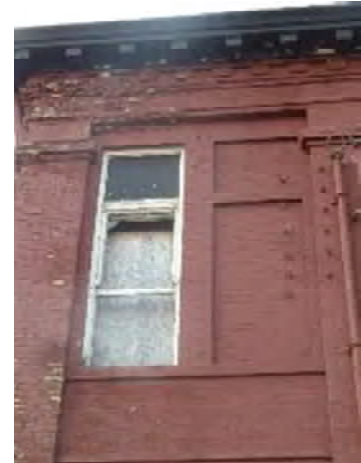
N340-01: Exterior view on right

- Window opening bricked-in at exterior. Wall is plastered over at interior.

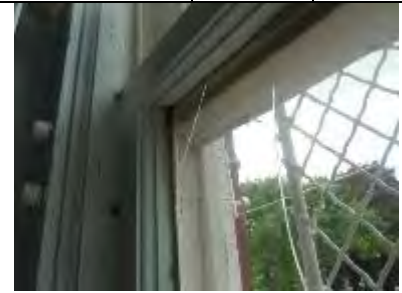
W310-03: Blown corner of upper sash

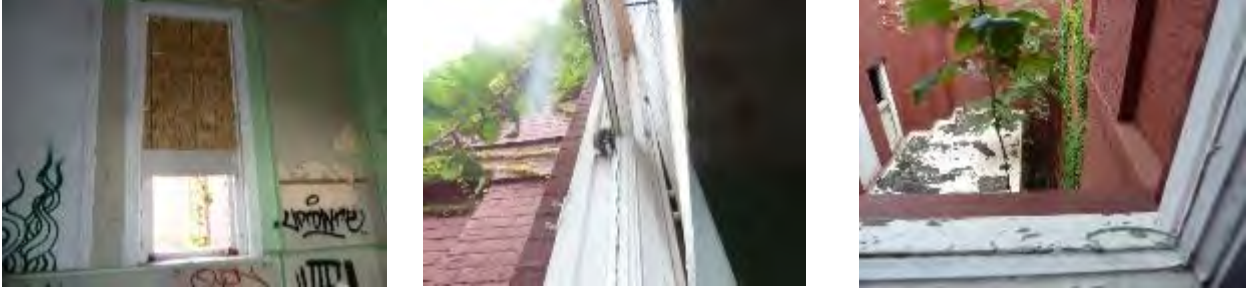
<p>LC310-01: Interior view      LC310-02: Missing upper sash rail      LC310-03: Exterior sill condition</p> <p><b>Condition Comments</b></p> <ul style="list-style-type: none"> <li>- Broken / missing glazing at lower sash.</li> <li>- Casings and trims dive behind continuous wood sill. Sill needs to be removed to pull the weight boxes/jamb.</li> <li>- Paint is crazed (multiple layers of paint / lead paint).</li> <li>- Upper sash meeting rail missing.</li> <li>- Missing hardware.</li> <li>- Glazing caulk is tested as having ACM.</li> <li>- Accessing window weight box will require removing the galvanized metal jamb guides - access port is blocked.</li> </ul>

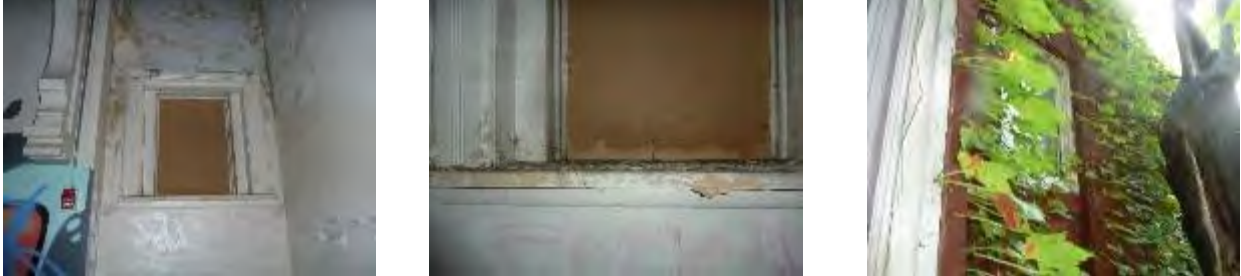
<p>LC317-01: Interior view      LC317-02: Interior sill condition      LC317-02: Exterior view showing half bricked-in</p> <p><b>Condition Comments</b></p> <ul style="list-style-type: none"> <li>- Fixed single sash.</li> <li>- Water damage of surrounding wall</li> <li>- Exterior wood sill is decayed.</li> <li>- Bottom of window bricked-in.</li> <li>- Window painted in place.</li> <li>- Glazing caulk is tested as having ACM.</li> <li>- Accessing window weight box will require removing the galvanized metal jamb guides - access port is blocked.</li> </ul>				
Room	Window	Window Configuration Type	Replace	Repair
Light Court B	LC318	Bricked-in window opening.		
Light Court B	LC319	Bricked-in window opening.		
Light Court B	LC320	Bricked-in window opening.

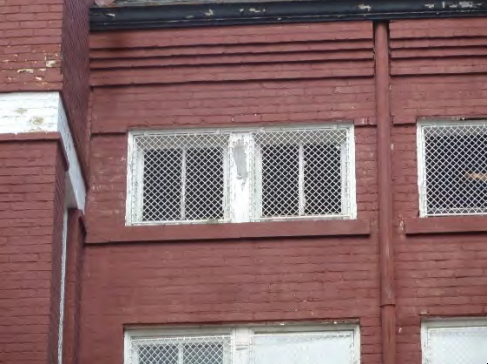
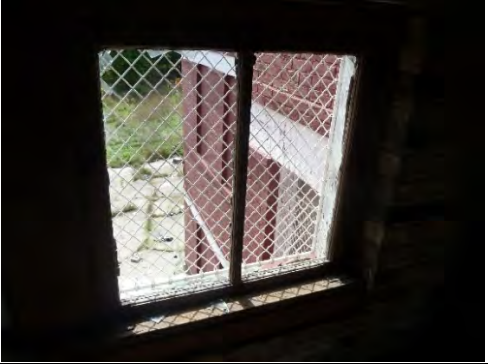
S407A/S407B-01: Exterior view from left		S407A-02: Interior view		
<p><b>Condition Comments</b></p> <p><b>S407A</b></p> <ul style="list-style-type: none"> <li>- Severely decayed sill.</li> <li>- Sash joints loose.</li> <li>- Glazing is broken</li> </ul> <p><b>S407B</b></p> <ul style="list-style-type: none"> <li>- Severely decayed sill.</li> <li>- Hopper hardware still functional</li> <li>- Sash is not original – has been replaced.</li> </ul>

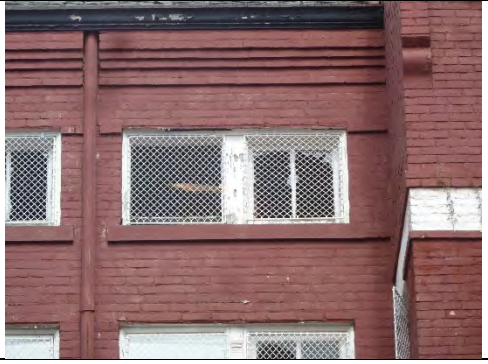
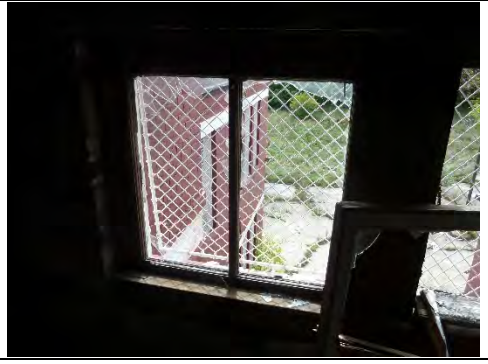
S408A/S408B-01: Exterior view from right		S408A-02: Interior view from right		
<p><b>Condition Comments</b></p> <p><b>S408A</b></p> <ul style="list-style-type: none"> <li>- Severely decayed sill.</li> <li>- Bottom sash rail is loose.</li> <li>- Glazing is broken</li> </ul> <p><b>S408B</b></p> <ul style="list-style-type: none"> <li>- Severely decayed sill.</li> <li>- Sash is completely broken.</li> </ul>
