PROPOSAL AND SCOPE OF WORK

819 North Cass, Milwaukee, Wi

Rustic Restoration Inc.

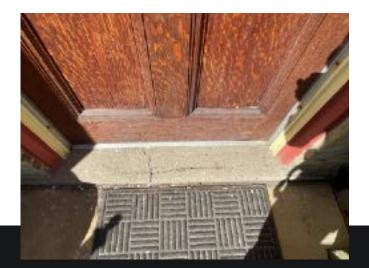
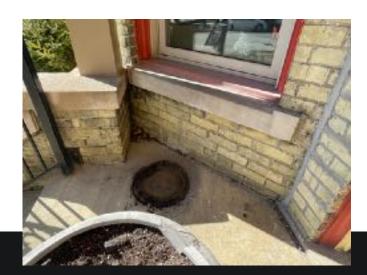
The front of the building facing East is in overall good condonation. The largest issue is the check walls along the stairs are falling apart and need to be rebuilt. We also find some of the joints within the face brick have deteriorated. Overall, 10% of the elevation would require spot pointing.

- 1. Take down coping stones on cheek walls and remove brick
- a. Clean off mortar to reuse stone and brick
- 2. Address any foundation issues.
 - a. Review and repair foundation as needed.
 - b. Repairs to be charged as change order
- 3. Rebuild Cheek Walls
 - a. New mortar
 - b. Sealant at coping joints
- 4. Install sealant at vertical joints at water table stone.
- 5. Spot point 10% of mortar joints
- 6. Repair cracks in entry stone
- 7. Staging and site protection

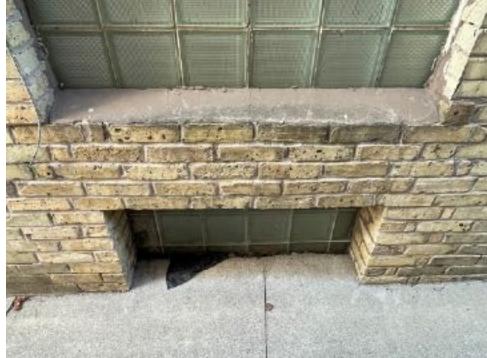
The north elevation appears to have the most amount of repairs needed. We find open joints in the masonry. Deteriorated masonry and joints around openings that were added at one point. Missing lintels above windows. An arch that needs rebuilding. Open joints in the water table stone. Open vent holes and growing vines on the masonry brick. We recommend addressing all these issues at once.

- 1. Install scaffolding/staging
- 2. Spot point 10% of masonry joints
- Remove the growing vines on the elevation
- Open brick headers above windows and install lintels
 - a. Install galvanized lintels
 - b. Rebuild original brick and joints
- 5. Open brick arch and rebuild plum and level
- 6. Install sealant joint at new/old brick expansion joint.
- 7. Install sealant around glaze block windows
- 8. Install a sill stone at the lower glaze block window
- 9. Install sealant at water table vertical joints
- 10. Recommending installing covers over vent openings in masonry

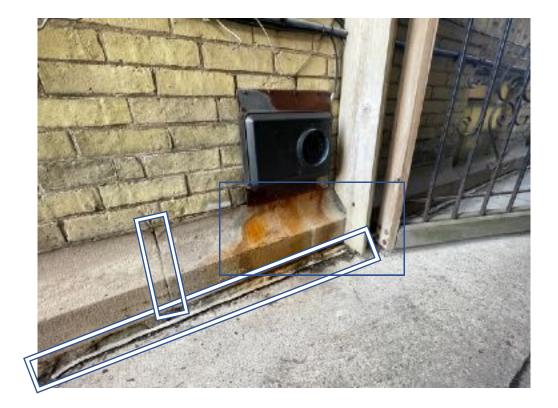
South Elevation looks to be original and unaltered. Typical joint deterioration around down spouts and natural weathering. We find another jacked arch that will need rebuilding. As well as sealant will need to be installed at vertical water table joints.

- 1. Staging
- Remove and rebuild arch above 2nd floor window
 a. Clean and salvage brick for reuse
- Spot point 10% of elevation

Main focus at stone under water table and by downspout
- 4. Install sealant at all vertical water table joints
- 5. Remove rust spots from metal vent

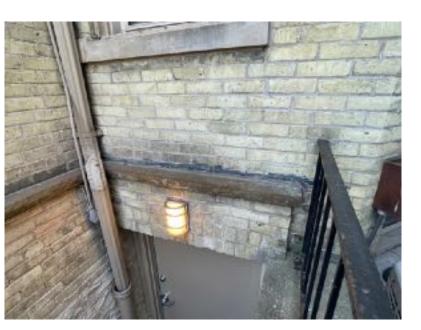
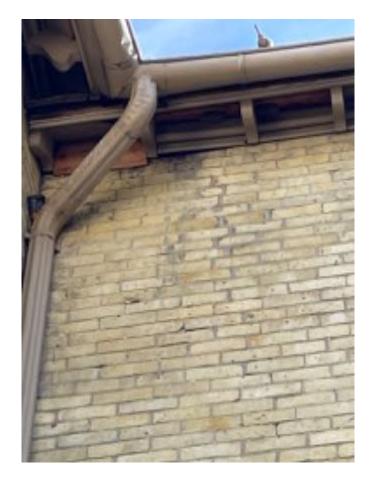
West Elevation looks to be original and unaltered. Typical joint deterioration around down spouts and natural weathering. We find another jacked arch that will need rebuilding. As well as sealant will need to be installed at vertical water table joints.

- 1. Staging
- 2. Repair step crack and arch
- 3. Install sealant at window sill
- 4. Remove parging at stone
- 5. Grind and repoint 100% of stone foundation
- 6. Spot point 10% of elevation
- 7. Remove roof membrane from brick
- 8. Address issue at downspout and under roofing soffit
