CERTIFICATE OF APPROPRIATENESS APPLICATION FORM

MRS. WILLIS DANFORD HOUSE
819 N. CASS STREET

Certificate of Appropriateness Application

21 August 2023

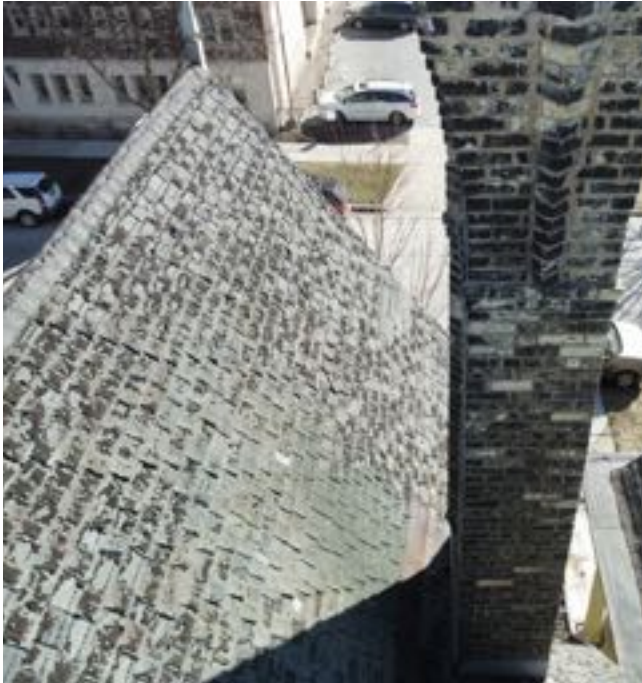
IMAGE 1: South roof slope, east end existing conditions.

The existing asphalt roofing is in a severe state of deterioration. The sand surface is worn away on most shingles. Many of the three-tab shingles are torn, loose, or missing. The southwest quadrant has one layer of asphalt roofing. The southeast quadrant has three layers of asphalt roofing. The north-roof half has a layer of wood shingles covered by three layers of asphalt roofing. Wood tongue and groove sheathing was inspected from the attic and found to be in good condition; no sheathing replacement is anticipated.

- Tear off all roofing layers down to the sheathing. Remove all flashing, gutters, and downspouts.
- Repair sheathing in kind as necessary.
- Install 6' of ice and water shield membrane at the sloped-eave edges.

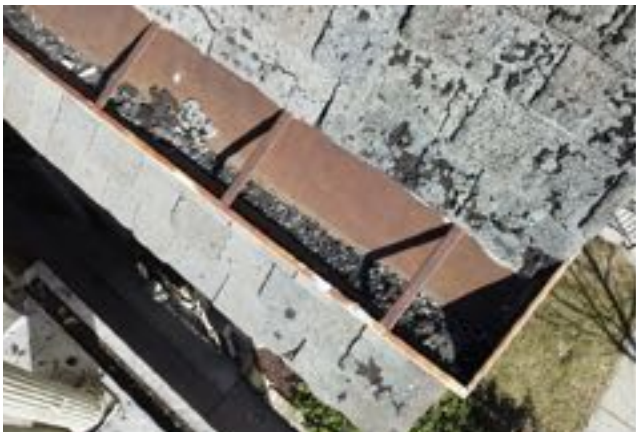
IMAGE 2: South roof slope, east edge eave and surface-mounted gutter corrosion.

Drainage consists of a combination of eave-mounted steel gutters and surface mounted Yankee gutters. Downspouts are steel and connected to the north and south storm drains. The steel is severely corroded and several bird nests are located within the gutters, indicative of non-functioning drainage. Consequently, leaks are present each time it rains resulting in plaster wall and ceiling damage. Foundation moisture-meter readings range from 8% to 40% WME (wood moisture equivalent) due to the aforementioned drainage deficiencies.

- Remove existing gutters and downspouts.
- Replace rotted fascia members as necessary in kind.
- Install new seamless 6" K-style pre-finished aluminum gutters where existing were removed, color B12/TB Terra Bronze
- Attach gutter with new aluminum fascia brackets and screws (not nails) every 18"-24".
- Install new 4" x 3" downspouts and coordinating downspout elbows, color B12/TB Terra Bronze.
- Down spouts to out let at grade via downspout extensions set a minimum of 6' away from the foundation in the east and west yard directions.

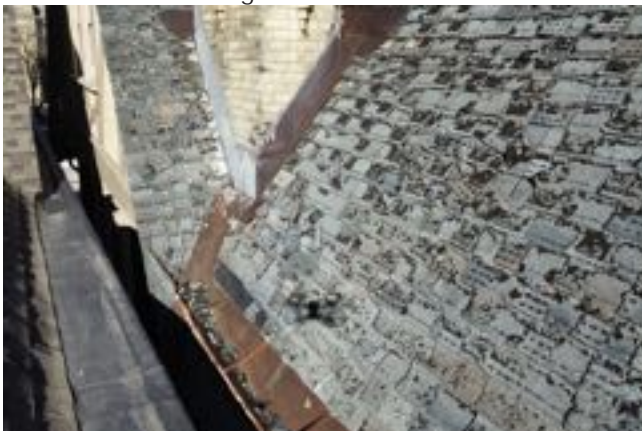
IMAGE 3: South roof slope, east edge eave, chimney flashing, and surface-mounted gutter corrosion.

- Install new lumber framing and sheathing as needed to the northwest chimney to fabricate a new chimney saddle; install new 26-gauge pre-finished steel over the newly fabricated lumber saddle (aka water-diverter) adjacent to the rear chimney flashing.

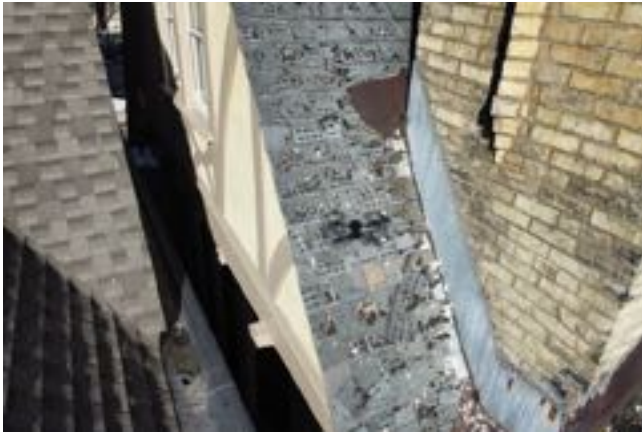
IMAGE 4: South eave at chimney.

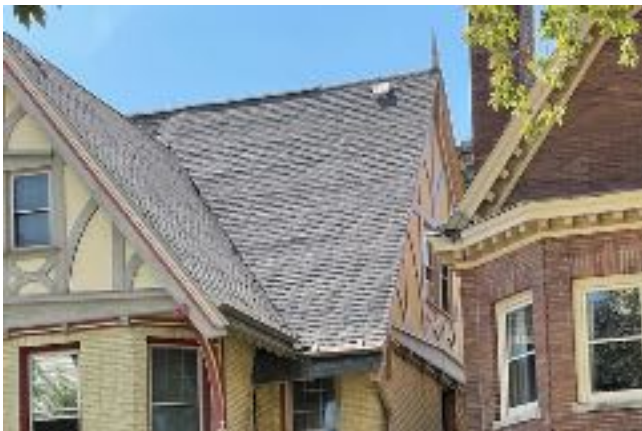
IMAGE 5: North and east roof slopes at the north roof half.

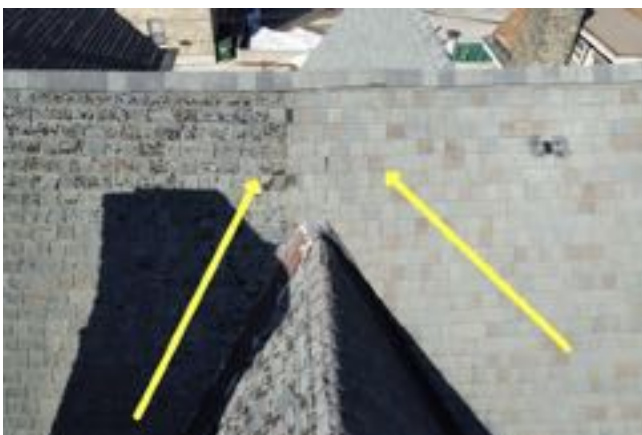
IMAGE 6: East main roof slope where differing roof layers are clearly evident.

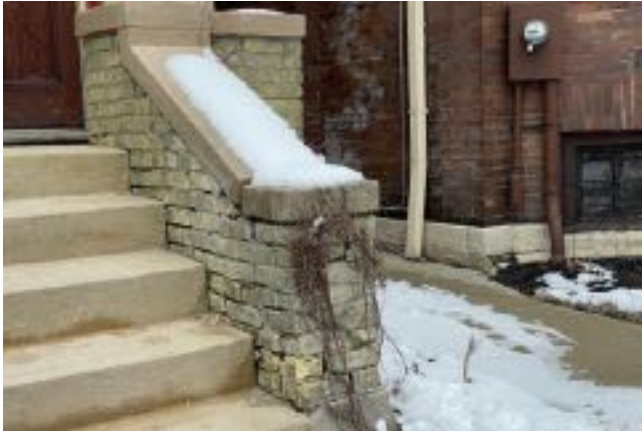
IMAGE 7: Stair check wall masonry deterioration.

Item 2: The front entry stair cheek walls are composed of bell-curve honed Indiana limestone base units (atop a rubble-coursed limestone foundation), Milwaukee cream pressed brick topped, and honed Indiana honed Indiana limestone coping. Use of deicing salts and incompatible mortar has resulted in fully decomposed mortar and thus loose brick and stone units. The adjacent porch railing wall has what appears to be an imbedded segment of a wrought-iron railing remnant, north elevation. The original porch encompasses what is now the interior vestibule/foyer. The north elevation once had an elegant wrought iron railing spanning the porch. Based upon existing conditions, a part of this railing length was imbedded in the masonry rather than removing it, resulting in masonry conditions that will continue deteriorate until this 6" remnant is removed.

- Repoint deteriorated mortar joints as necessary using lime-patty mortar above the water table line.
- Repoint deteriorated joints below the water table line as needed utilizing NHL 3.5 mortar.
- Remove cracked/deteriorated mortar using the center-cut approach; do not over cut the brick.
- Finish new mortar to match historic raked profile.
- Do not artificially color mortar; use mortar with a sand

- mix that is similar in color or matches the original mortar
- Rebuild areas of severe cracking/dislodged brick by resetting the existing wherever possible. Replace with matching brick units only as necessary.

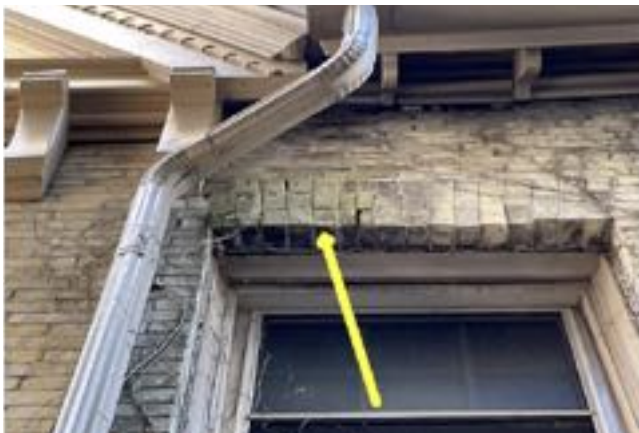
IMAGE 8: North elevation third-floor window head is near collapse.

No steel lintel is present at original window heads. Wood-head blocks are located on the interior; however, there is nothing supporting the exterior wythe soldier course elliptical. Step cracks and bulging are located atop each window rough opening. At the north elevation third-floor stair window and west elevation second-floor bedroom window brick units are loose and have slipped. Bulging is significant. (Both areas have been exposed to prolonged moisture.) Brick will be reset in the areas with the project mortar. Steel lintels will be installed at all flat-head arches with cotton rope weeps. Work efforts will begin with the most dire conditions until all window units are repaired.-

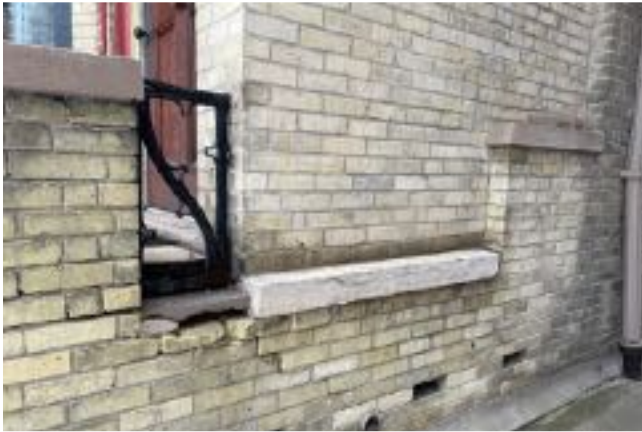
IMAGE 9: Main entry porch remnant with wrought iron on the north elevation.

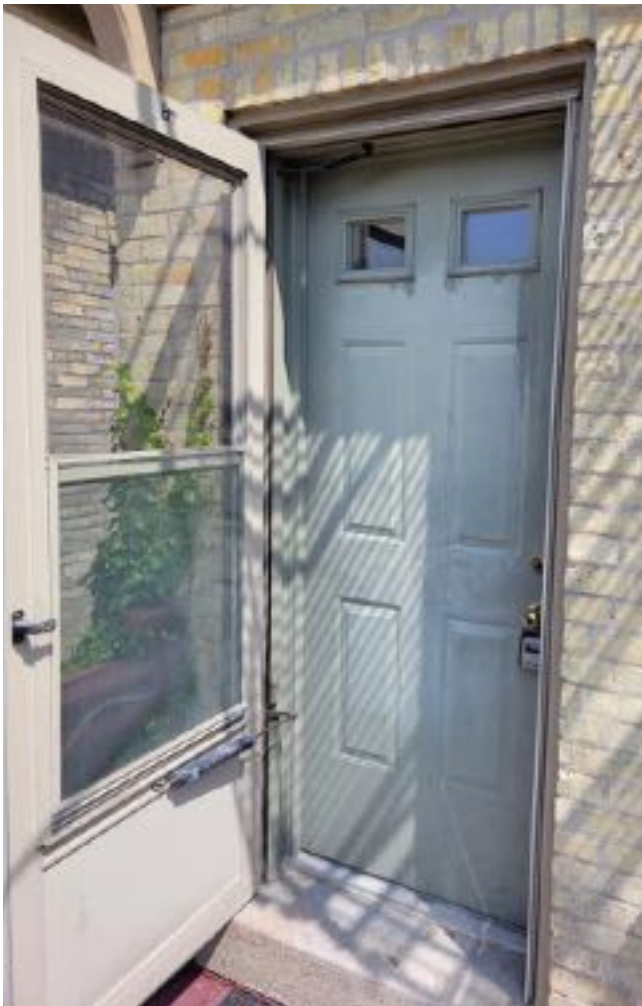
IMAGE 10: Current second floor west (rear) door.

The existing second-floor entry door consists of a modern era steel six-panel leaf unit. The top two panels in this configuration are small rectangular lights. The doors style does not fit the building and the door is damaged from wear and lack of maintenance. The existing door leaf is 34" x 80". A jamb extension was utilized to reduce the opening size. An aluminum storm door with screen was installed years after the main door (undated).

- Replace the main door leaf with a 36" x 80" Simpson Door Company, 7118 Thermal Sash, Wood: Fir, clear upper light, three lower recessed panels. Finish: Painted.
- Note: If a storm door is permitted, the wood species and finish will be change to reflect a varnish to match the historic main east entry door.
- Replace the existing storm door with a powdered-coated aluminum Larson Premier Classic Elegance EasyVent® with Retractable Screen Away®, 2/3 glass doors with retractable Screen Away® design converts the storm door to a screen door with an unobstructed view
