## Certificate of Appropriateness

**1003 N. 33RD ST. Concordia Historic District**

PTS ID 89229 COA, total exterior restoration

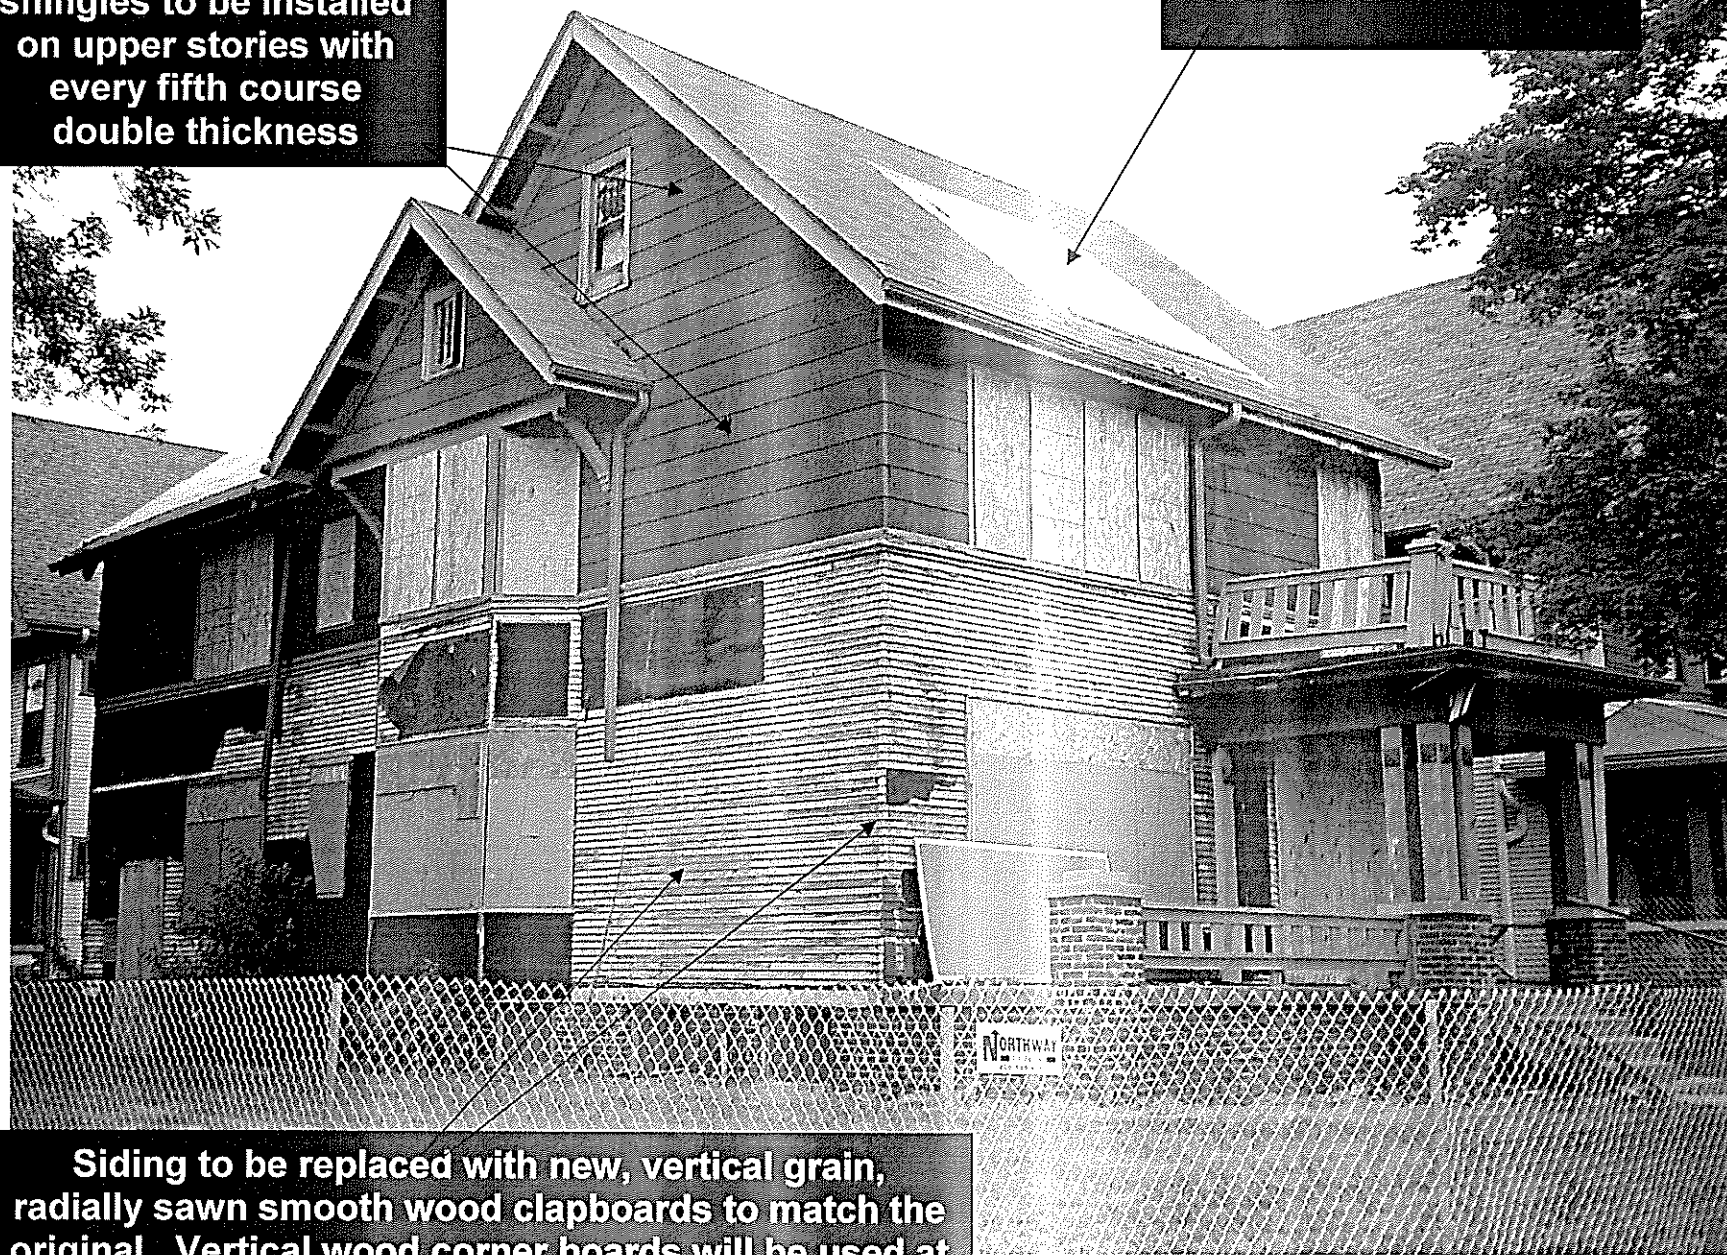
**Vertical grain wood shingles to be installed on upper stories with every fifth course double thickness**

**Dormer removed due to fire. Will not be rebuilt.**

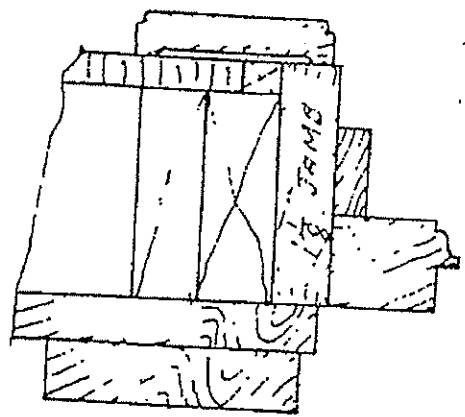
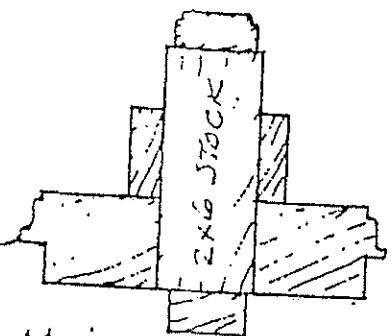
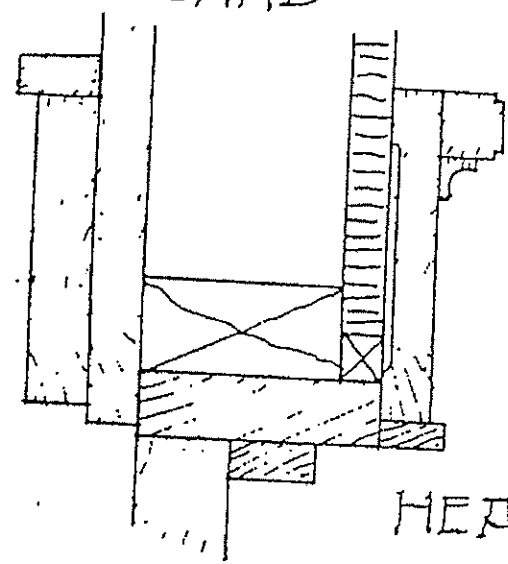
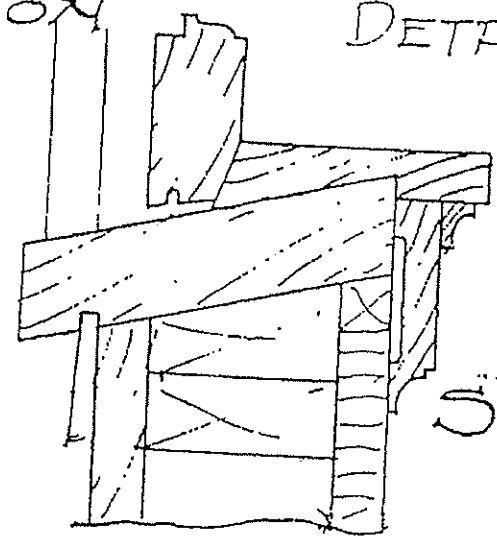
TYPICAL  
CASEMENT WINDOW  
DETAILS (3" SCALE)

Architect's original details for sash must be followed exactly. These are for the casement windows and are specifically related to windows on the north elevation

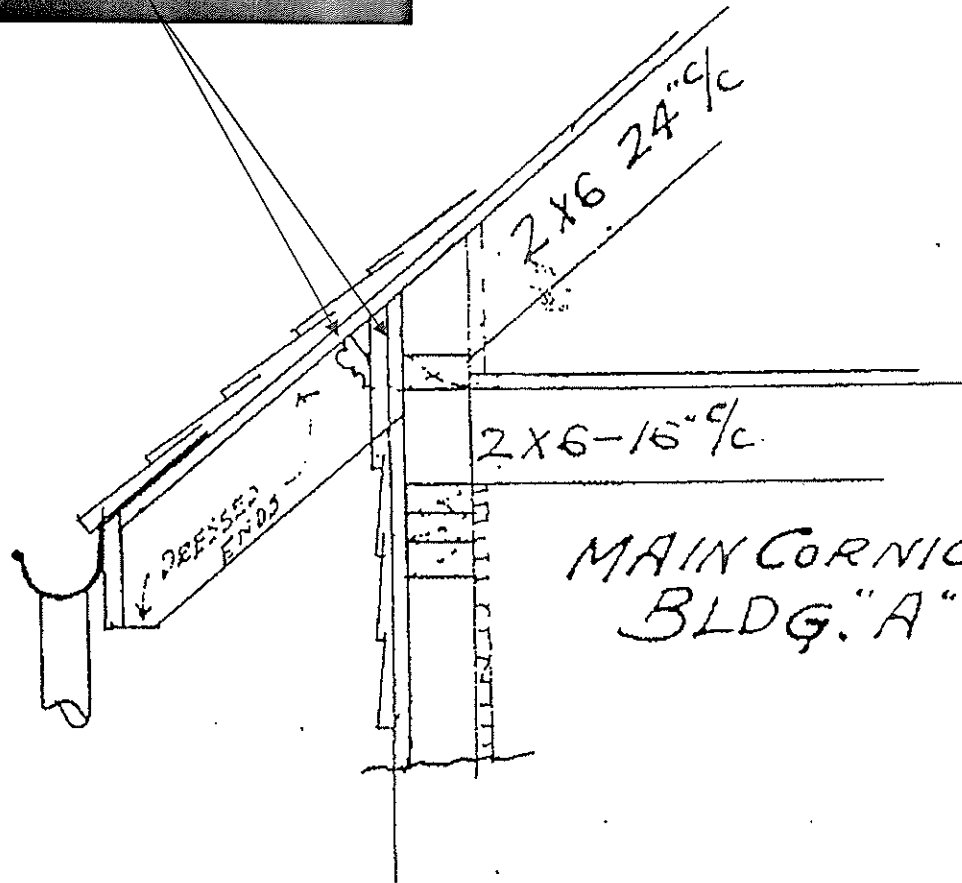
MAIN CORNICE DETAIL  
BLDG. "A" (BLDG. "B" SIMILAR.)

Typical wall section. Note that the flat frieze board at the top of the wall must be installed and that there is crown molding between each rafter tail.

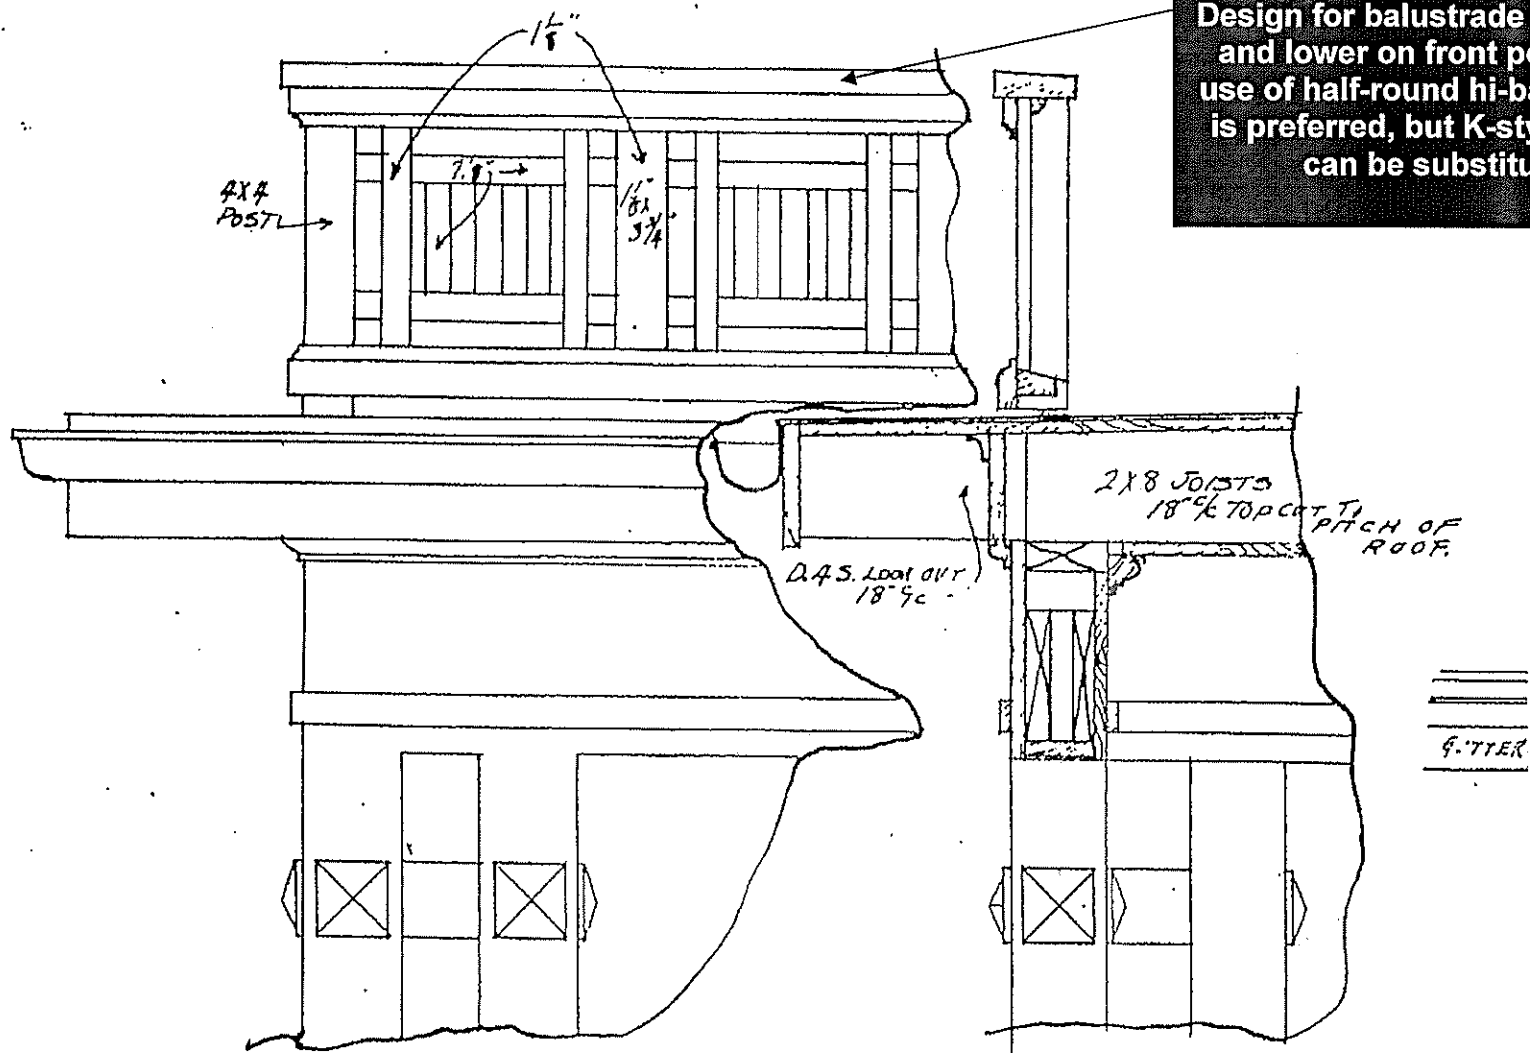
PORCH CORNICE FOR BLDG. "A"

Design for balustrade both upper and lower on front porch. The use of half-round hi-back gutters is preferred, but K-style gutters can be substituted.

Front porch will be repaired/; rebuilt to original specifications and design

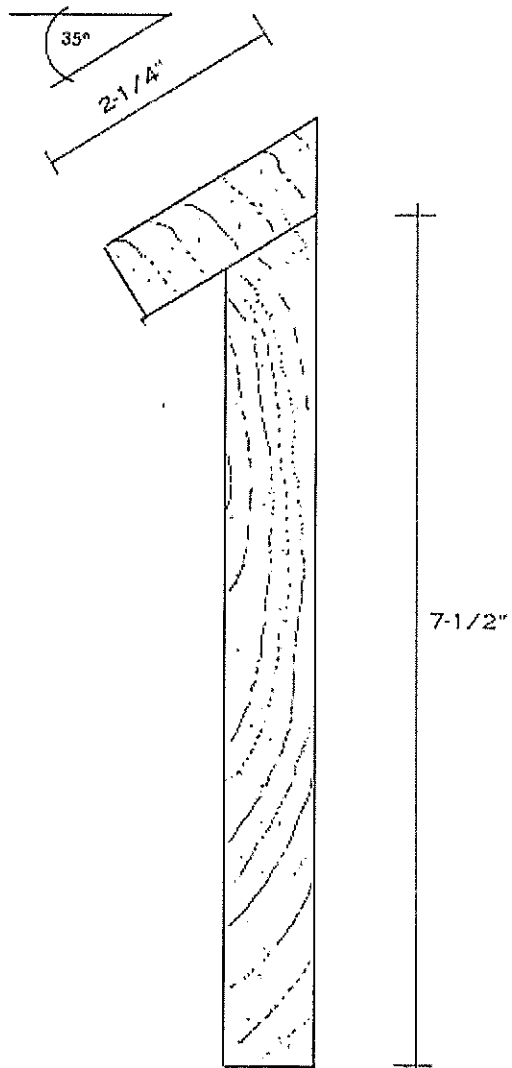
WATER TABLE

**Section of water table that will be installed at the top of the raised foundation around the entire perimeter of the house.**

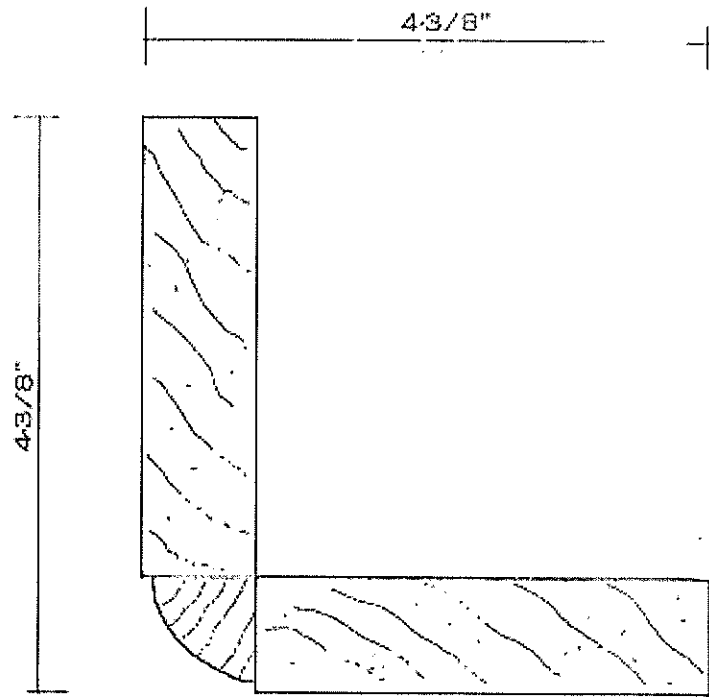
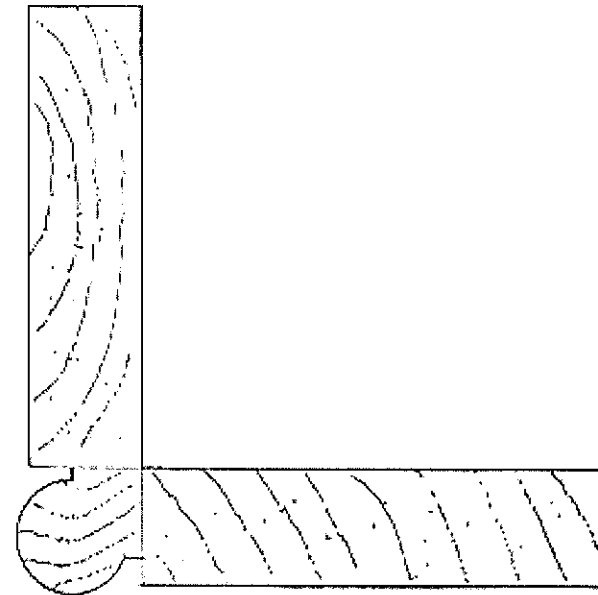
### CORNER BOARDS

Corner board details for first story only. Either design is permissible, but option B is regarded as the easiest to install using stock corner bead.
