Facilities Condition Assessment Program

1000 N. Water Parking Garage

May 2011

Facilities Condition Assessment Program—1000 N. Water

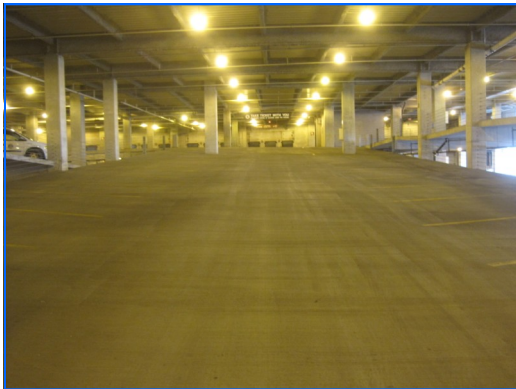
The elevated structural slab exhibits very few areas of deterioration in the form of cracks.

Elevated concrete floor slab at 8th level

The useful life of sealer application is up to three years. Parking should apply the sealer every six years beginning in 2011. In conjunction with sealer applications, parking should budget for partial replacements of elevated concrete floor slab.

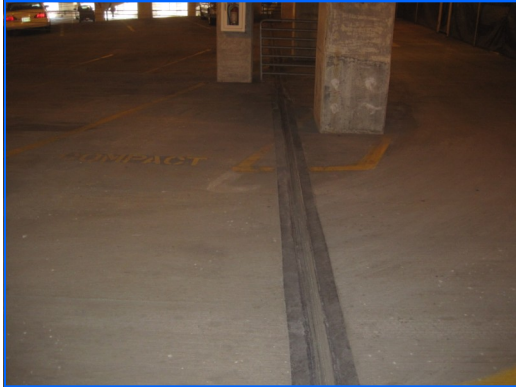
1000 N. Water contains approximately 1,600 LF of expansion joints. The useful life of an expansion joint is 15 years. Parking should budget for expansion joint replacements by 2016 and again by 2031.

Expansion joint

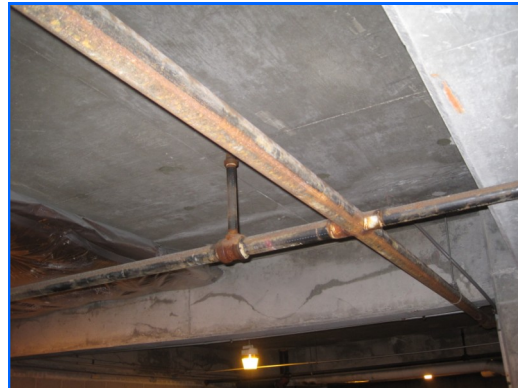
1000 N. Water contains a dry fire suppression sprinkler system that covers approximately 590,000 square feet of surface area. The pipes exhibit a consistent rust coat. Bare metal pipes exposed to uncontrolled atmospheric conditions have a useful life of up to 40 years.

Typical condition of sprinkler pipes

Parking should apply a paint finish application to the fire suppression system pipes by 2012 and again by 2027.

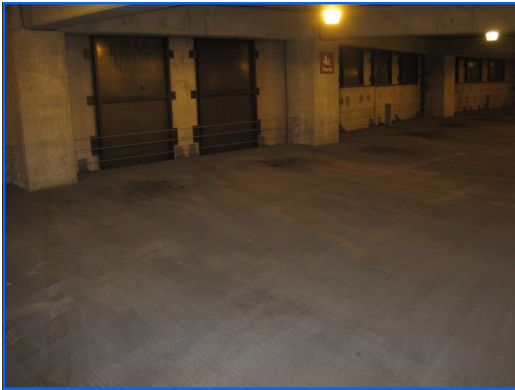
1000 N. Water contains approximately 1,500 parking stalls. Many pavement markings at the stalls exhibit deterioration.

Worn pavement markings

The useful life of pavement markings is up to six years. Parking should conduct pavement marking application every six years beginning in 2011 in conjunction with sealer application.

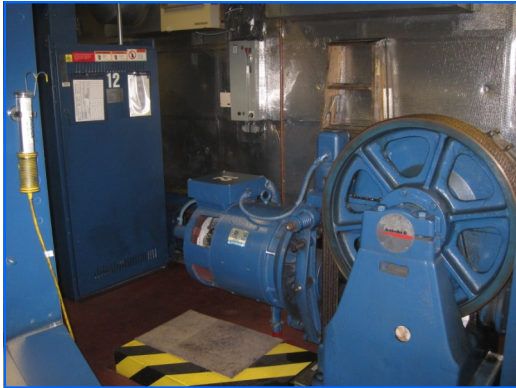
Four elevators serve 1000 N. Water parking. The useful life of traction elevators hoists and controls is up to 45 years. Parking should anticipate their upgrade by 2031.

Elevator hoist and controls

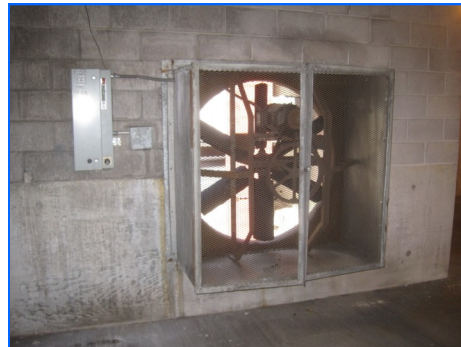
Eighteen exhaust fans serve the parking garage. The motors are 5HP have a useful life of up to 30 years. Parking should anticipate motor replacement by 2021. The housing unit and interim repairs are considered O+M expenditures.

Typical exhaust fans

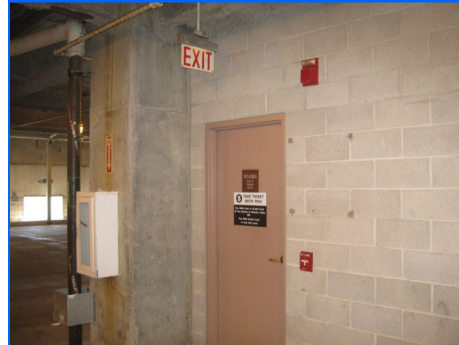
The fire warning system is comprised of a central alarm panel and various detection alarm devices. The useful life for this system is up to 25 years. Parking should anticipate its replacement by 2018.

Fire warning system detection devices

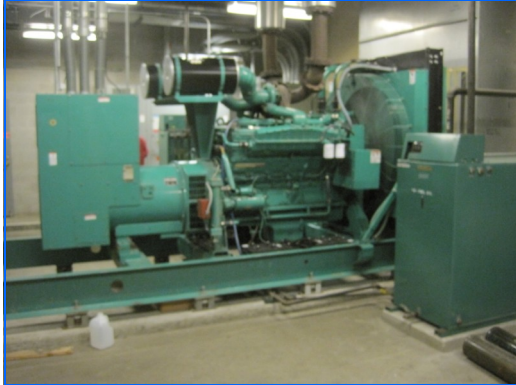
1000 N. Water Parking and Commercial space share an emergency generator that has a 750kVa capacity. The useful life of this component is up to 40 years. Parking should anticipate its replacement by 2027.

Emergency generator

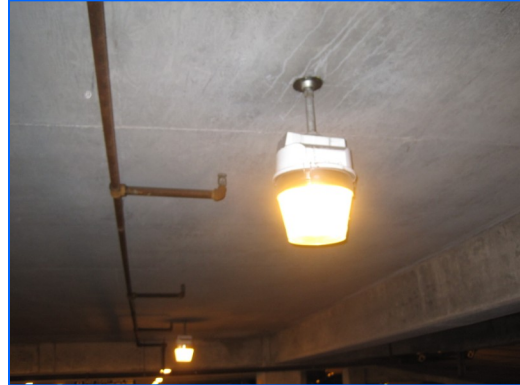
1000 N. Water contains approximately 1,000 light fixtures. The useful life of light fixtures is up to 25 years. Based on condition, Parking should fund light fixture replacement by 2020.

Light fixture

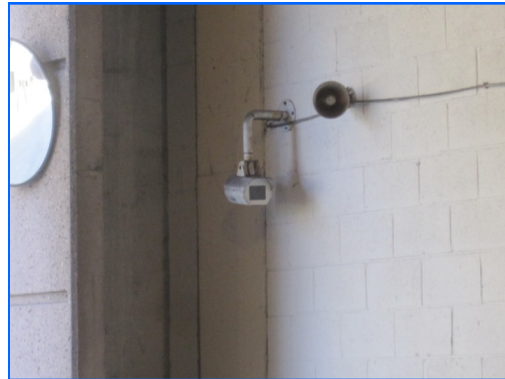
1000 N. Water has 60 security cameras. Video recording devices are the property of the Commercial entity. The useful life of security cameras is up to 12 years. Parking should plan for security camera replacement by 2015 and 2027.

Security camera

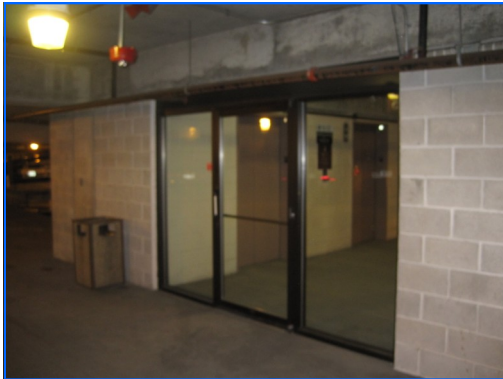
The useful life of metal exterior doors is up to 35 years. Based on the varied conditions, Parking should anticipated phased replacement of 14 doors every six years beginning by 2018.

Glass and metal door

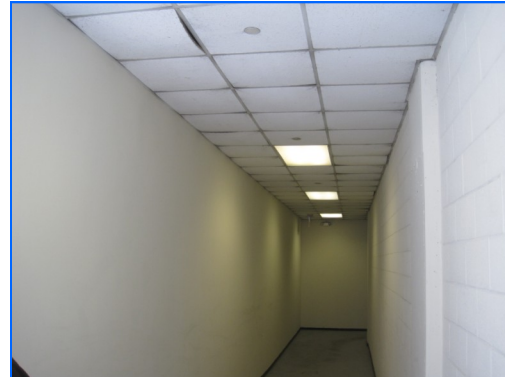
1000 N. Water contains two finished hallways off Market Street. Parking should budget for hallway renovation every 15 years beginning by 2028.

Typical hallway finishes
