2015 N Palmer St. Milwaukee WI  
Photographs

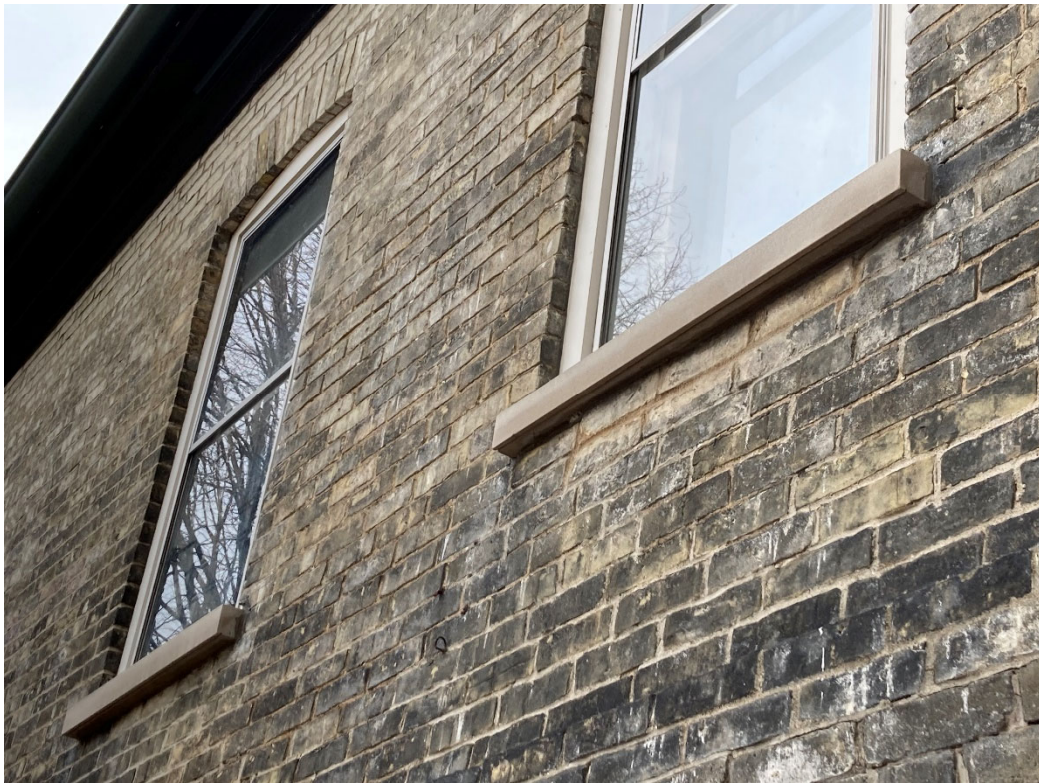
Example of Existing Stone Sills, (North Face)  
Windows to be replaced

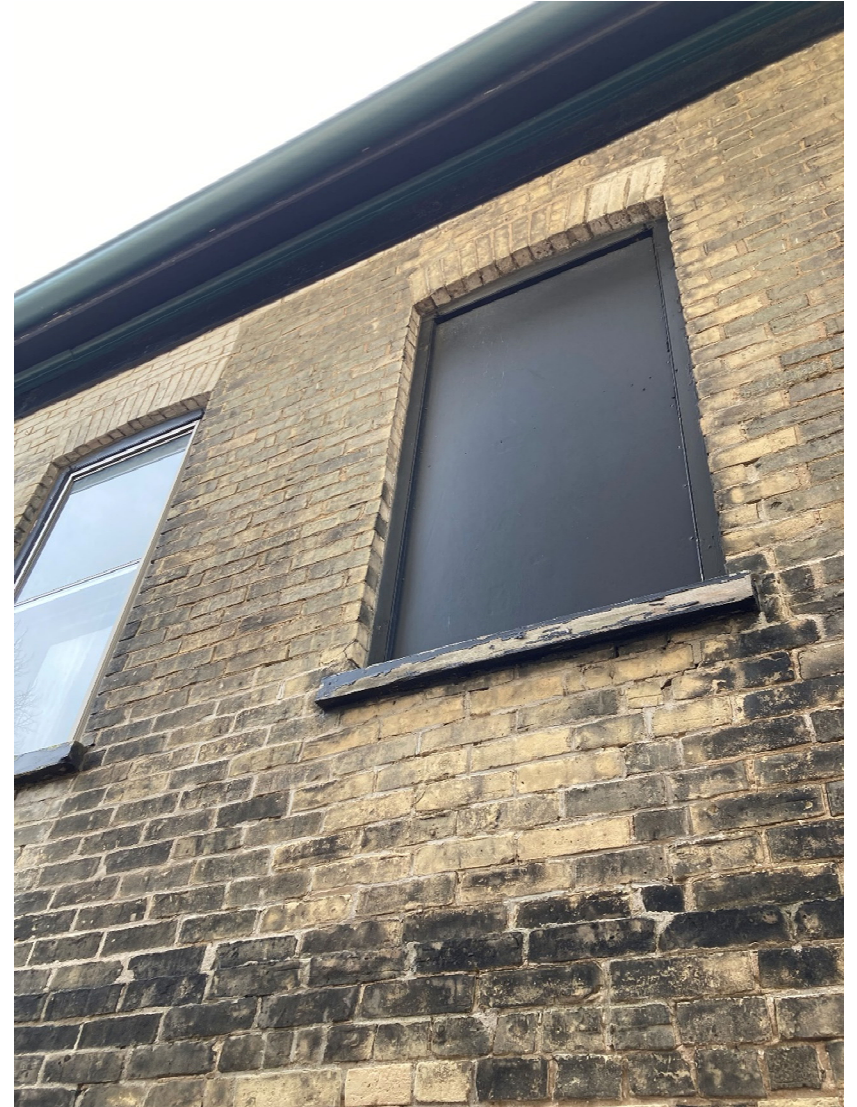
Wooden Sills to be replaced with Stone. Closed Window to be opened. New window to be installed. (North Face)

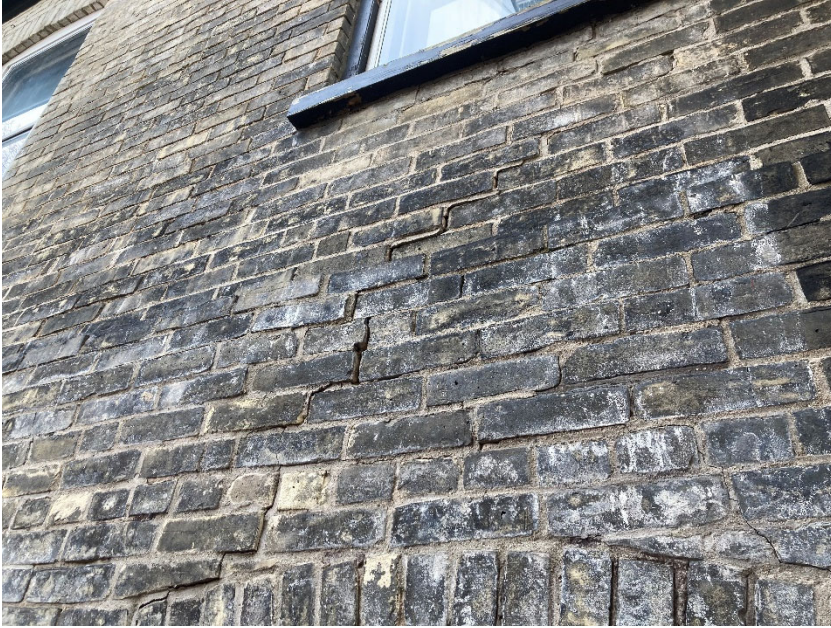
Examples of deterioration to brick to be repaired.

Section above shows signs of delamination.  
Portion of wall to be disassembled and rebuilt.

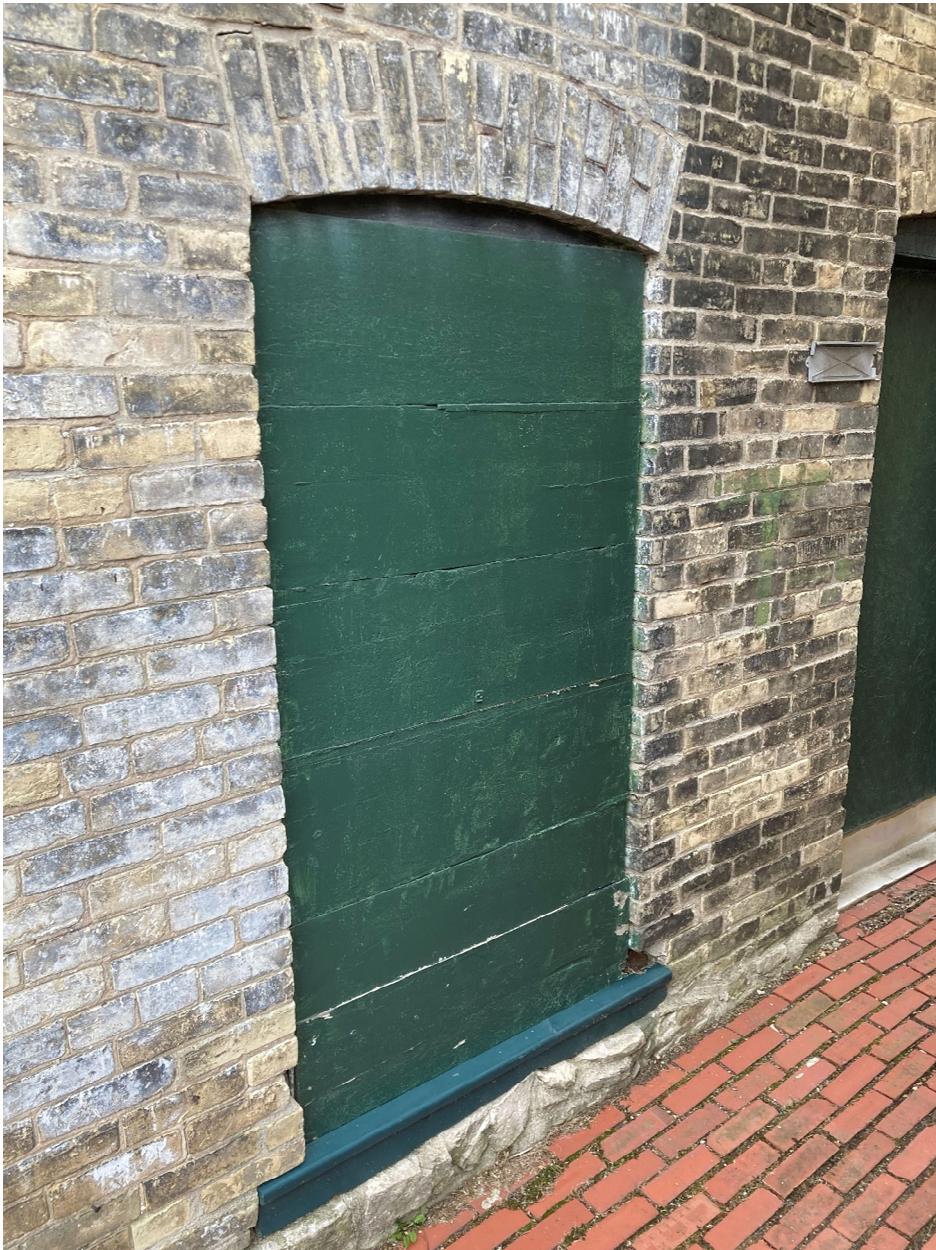
Lower Level Window to be opened up (North Face)

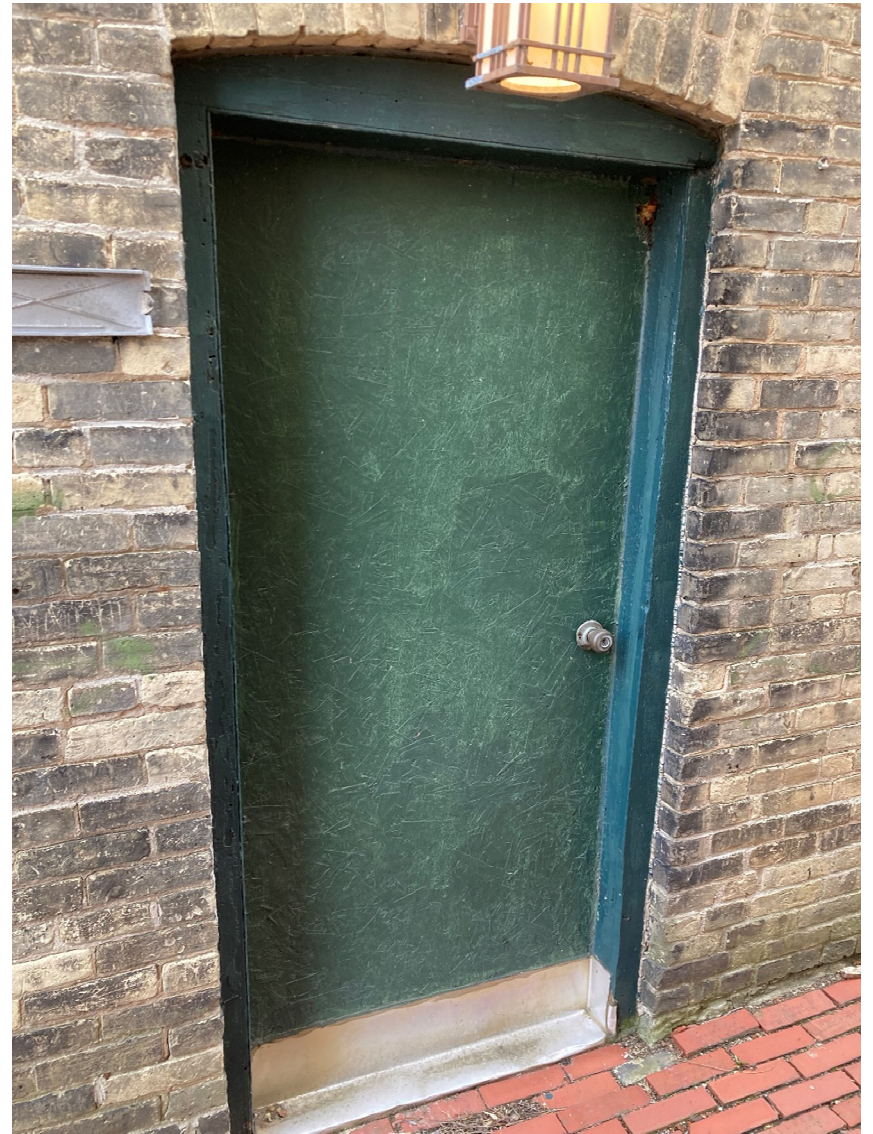
Lower level Side door to be opened up. (North Face)
