At the beginning of the year, the Pabst Mansion Foundation commissioned a facility condition assessment to look at the condition of the building overall. This study is underway but so as to not lose the opportunity to address some conditions adversely affecting the fabric and interior of the building, the Pabst also sought to engage a masonry contractor to carry out a limited number of specific emergency repairs. We are now attempting to bring these two activities into alignment. In addition, the UW Milwaukee's Historic Preservation Institute at the School of Architecture and Urban Planning has scanned the building exterior and is in the process of developing orthographic photos as well as CAD drawings of the major exterior elevations.

Emergency Repair Projects

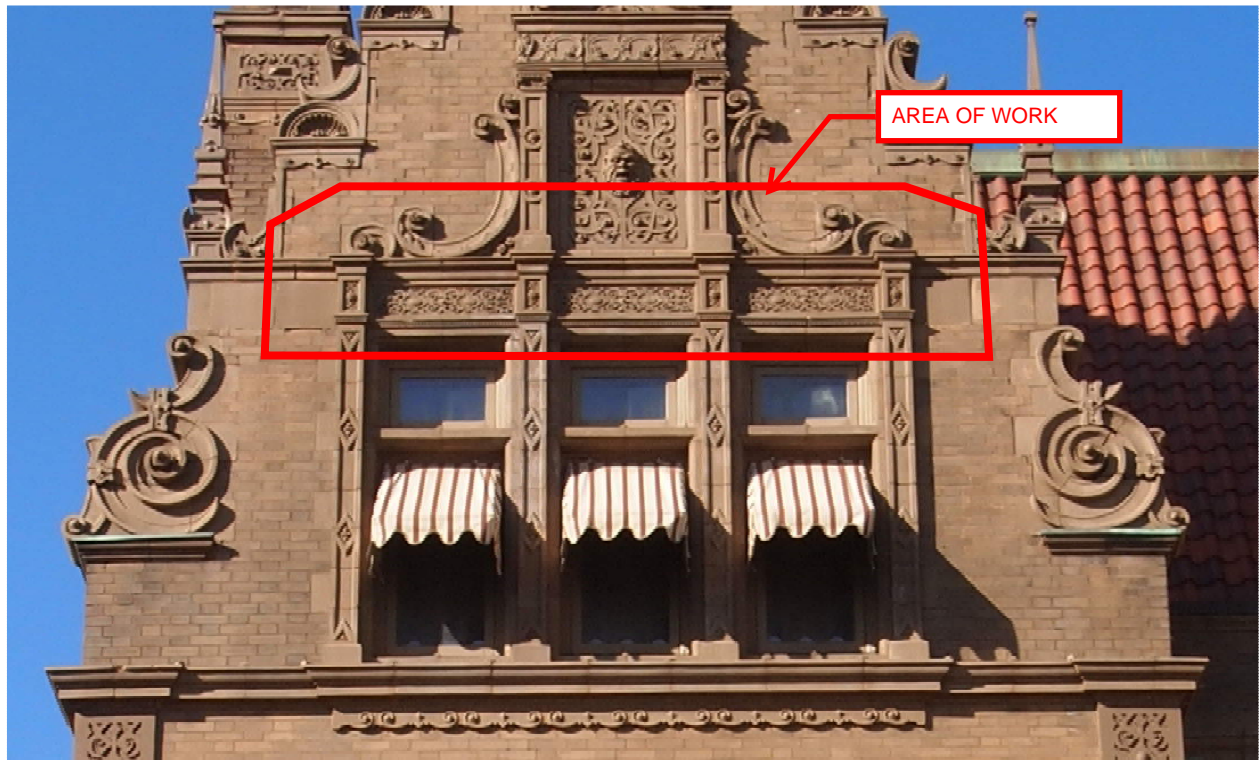
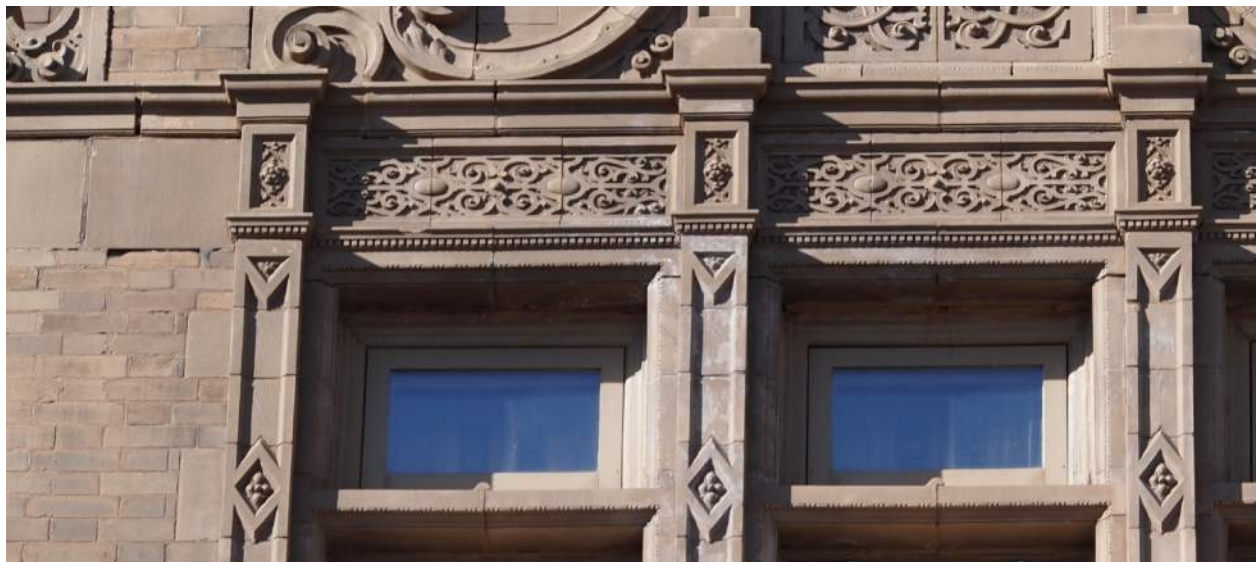
South Elevation, West Gable

Goal: Stop water infiltration through masonry and wood brickmold over and around windows.

Tasks: Repoint terra cotta and brick at all exposed faces within indicated zone. Replace all damaged and failing sealant at brick mold around transom windows and at head of window below.

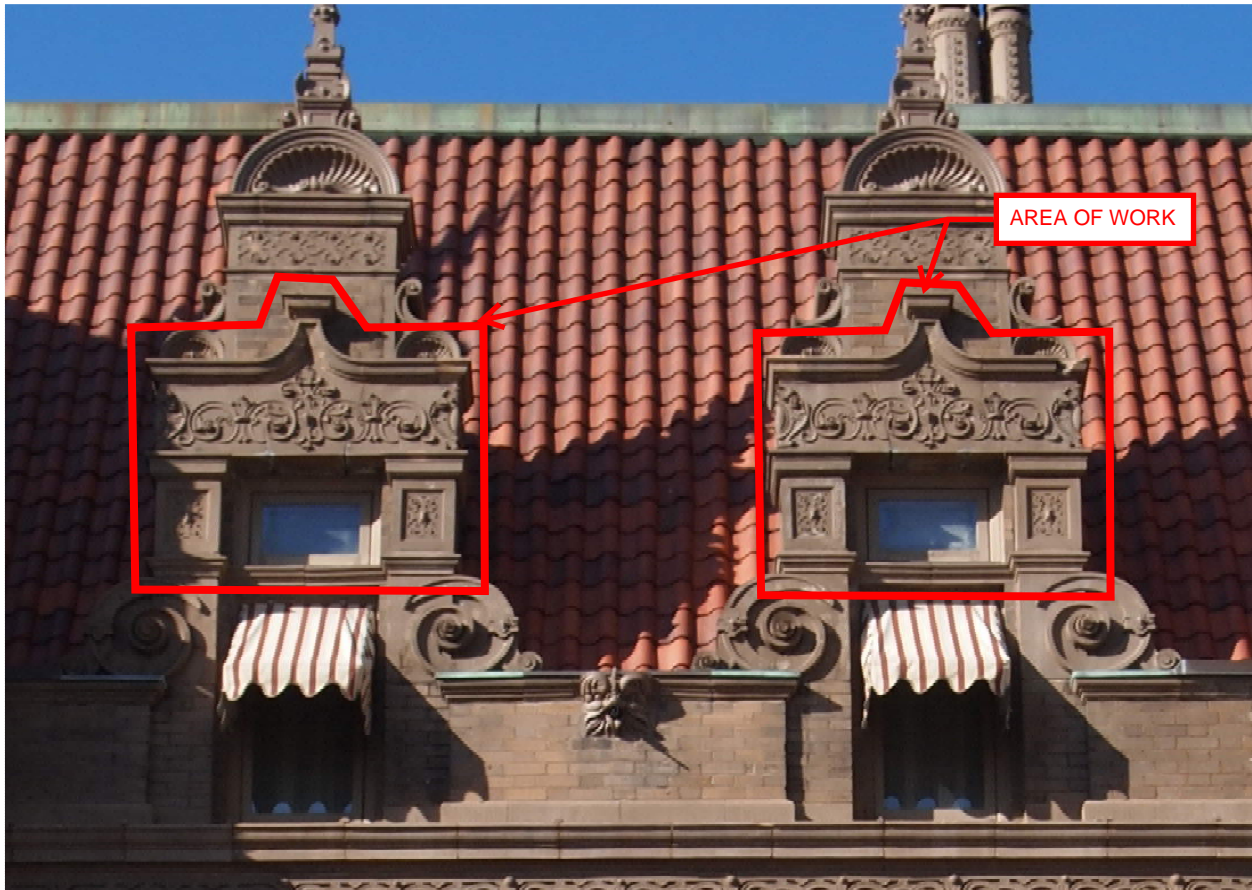
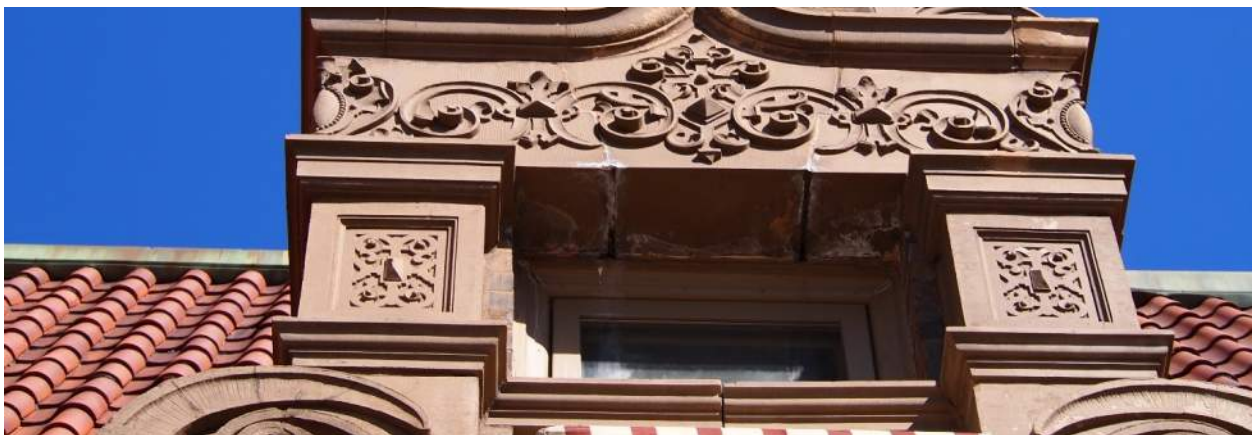
South Elevation, Central Bay Dormers

Goal: Stop water infiltration through masonry and wood brickmold over and around windows.

Tasks: Repoint terra cotta and brick at all exposed faces within indicated zone. Repoint open head joint at horizontal mullion providing elastomeric polyurethane with release tape backer to finish off repointed skyward joint. Replace all damaged and failing sealant at brick mold around transom windows and at head of window below.

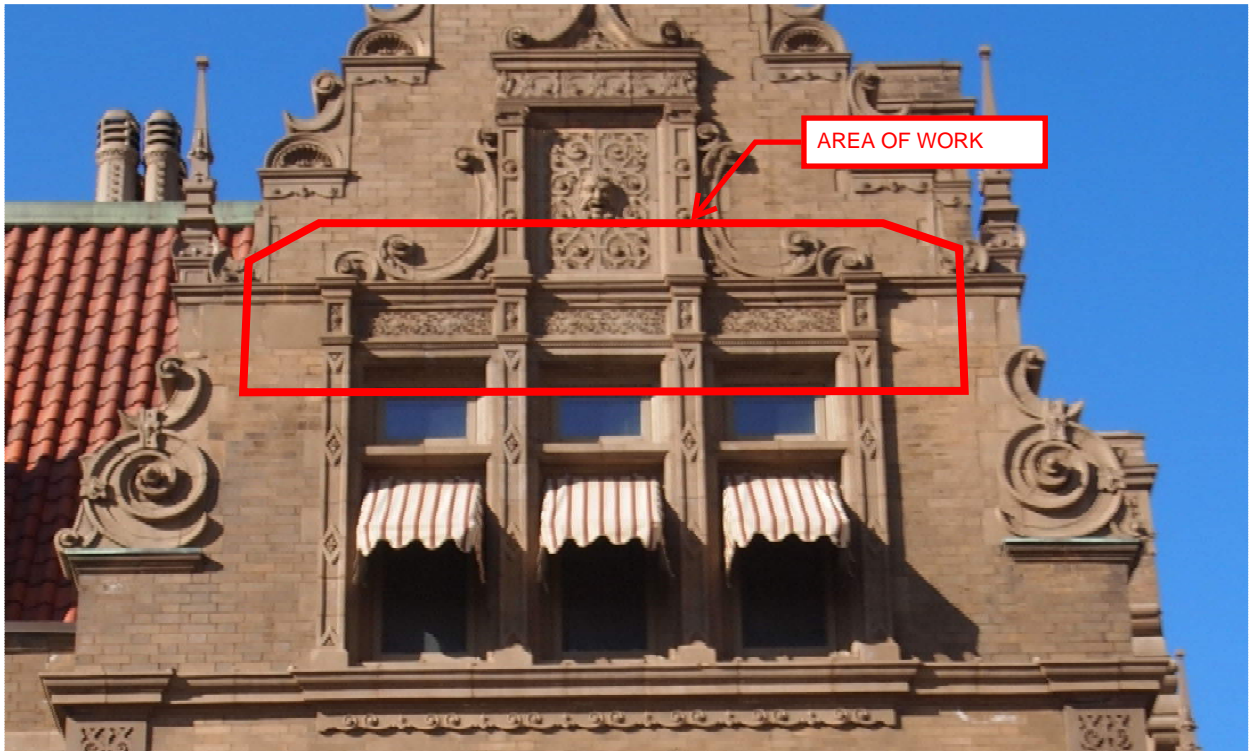
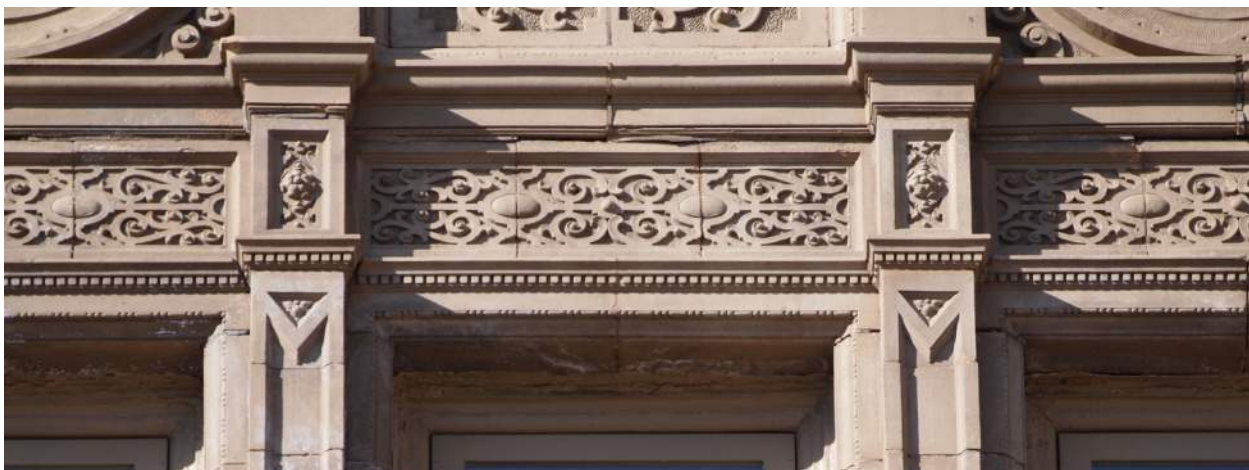
South Elevation, East Gable

Goal: Stop water infiltration through masonry and wood brickmold over and around windows.

Tasks: Repoint terra cotta and brick at all exposed faces within indicated zone, providing elastomeric polyurethane with release tape backer to finish off repointed skyward joints of belt course. Replace all damaged and failing sealant at brick mold at window heads.

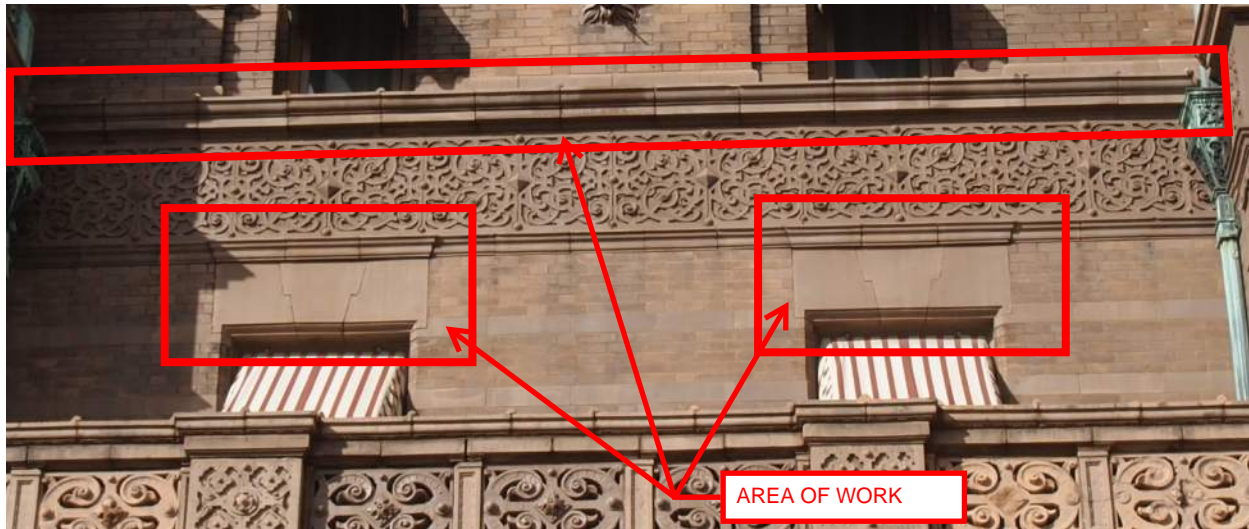
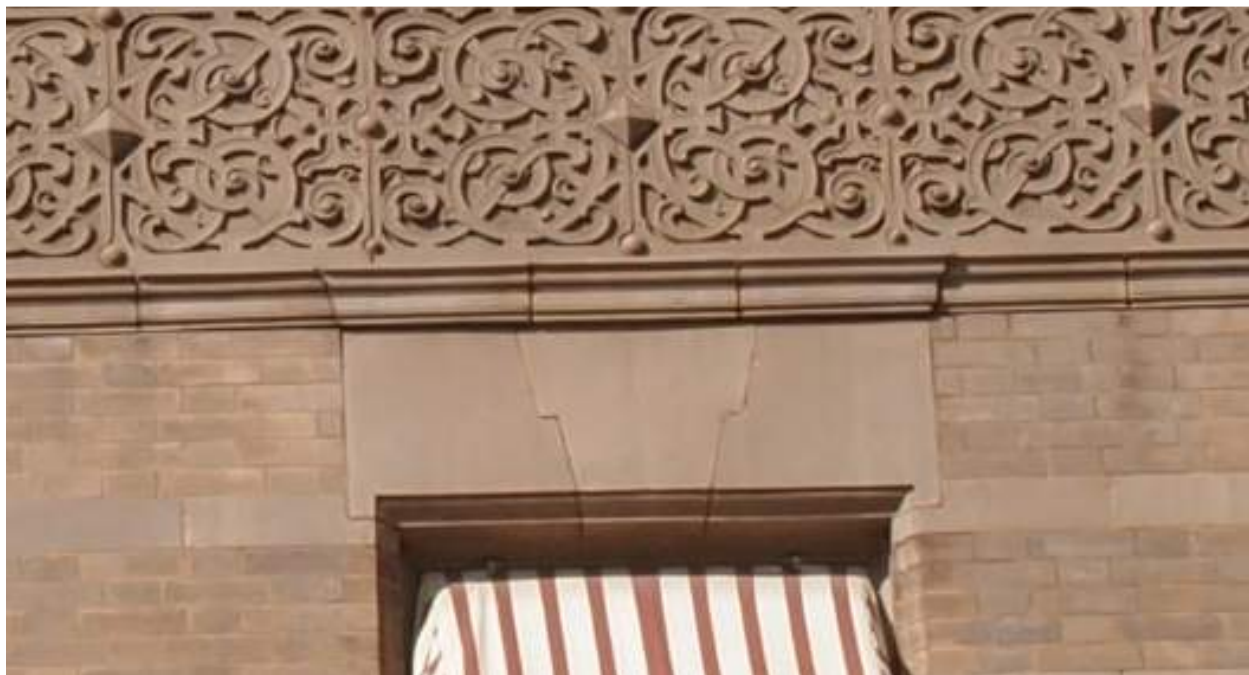
South Elevation, Second Floor Center Bay Windows

Goal: Stop water infiltration through masonry and wood brickmold over and around windows.

Tasks: Repoint terra cotta and brick at all exposed faces within indicated zone, providing elastomeric polyurethane with release tape backer to finish off repointed skyward joints of belt course. Replace all damaged and failing sealant at brick mold around single hung window heads and upper jambs.

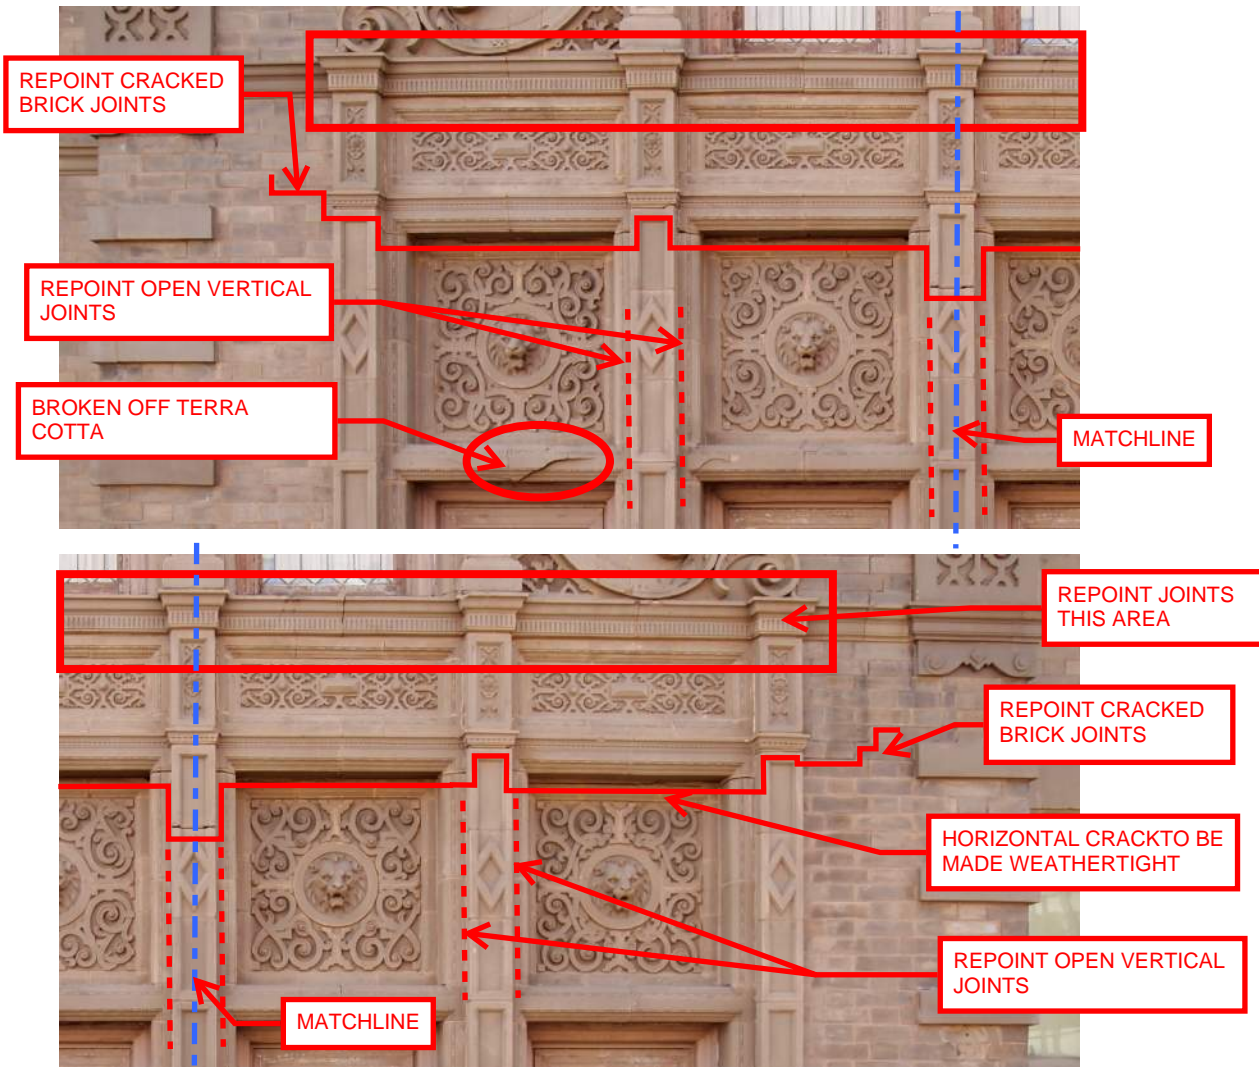
West Elevation, Center Bay, Second & Third Floor

Goal: Temporarily protect exposed steel and interior wall construction from elements, temporarily secure broken off terra cotta face at horizontal mullion in a manner to protect the exposed interior construction from weather and repointing open joints in terra cotta belt/sill course.

Tasks: Provide temporary repointing or closed cell backer rod supported elastomeric sealant joint at horizontal crack in terra cotta, color to be selected from manufacturer's standard colors; repoint adjacent cracked brick joints; repoint deteriorated and cracked joints at stacked terra cotta mullion pieces below crack; repoint deteriorated joints at terra cotta belt/sill course above crack, providing elastomeric polyurethane pointing with release tape backer to finish off repointed skyward head joints.

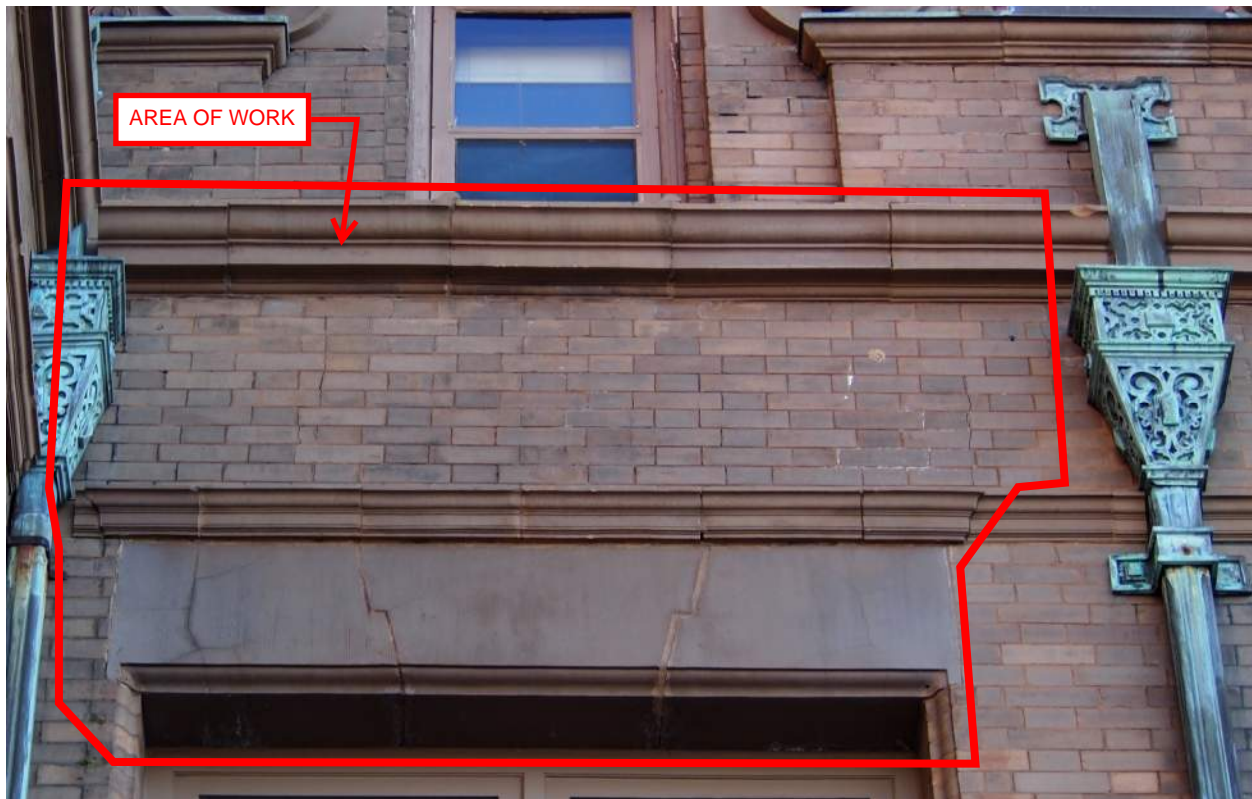
North Elevation, Airing Porches, Second & Third Floor

Goal: Stop water infiltration through brick masonry and terra cotta at second floor Ironing Porch.

Tasks: At areas indicated, repoint all terra cotta and brick joints, providing elastomeric polyurethane with release tape backer at skyward joints. Inspect cracked brick between porch lintel and 3rd floor window sill belt course and determine appropriate action to either replace cracked brick (from owner's supply) or repair cracks with mortar or closed cell backer rod and elastomeric polyurethane sealant with color selected from manufacturer's standard colors and proceed with action following owner review. At east (left) end of 3-piece terra cotta lintel, inspect cracked terra cotta unit and determine appropriate crack repair for unit and proceed with action following owner review.

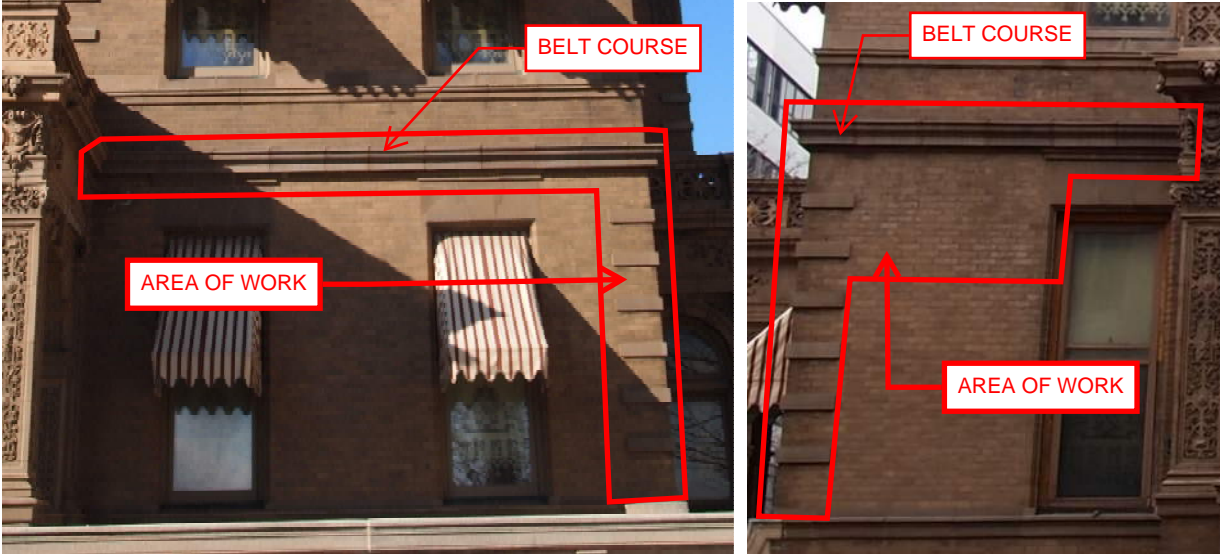
Southeast Corner, Balustrade Up Thru Belt Course

Goal: Stop water infiltration through wall of Music Room where embossed wallcovering is peeling.

Tasks: At areas indicated, inspect terra cottas and brick joints within area indicated and repoint cracked or deteriorated joints as required. Provide elastomeric polyurethane with release tape backer at all skyward joints at the belt course within the area indicated.
