ERNST ARNDT STORE

1937 NORTH MARTIN LUTHER KING JR. DRIVE

Certificate of Appropriateness Application

23 April 2022

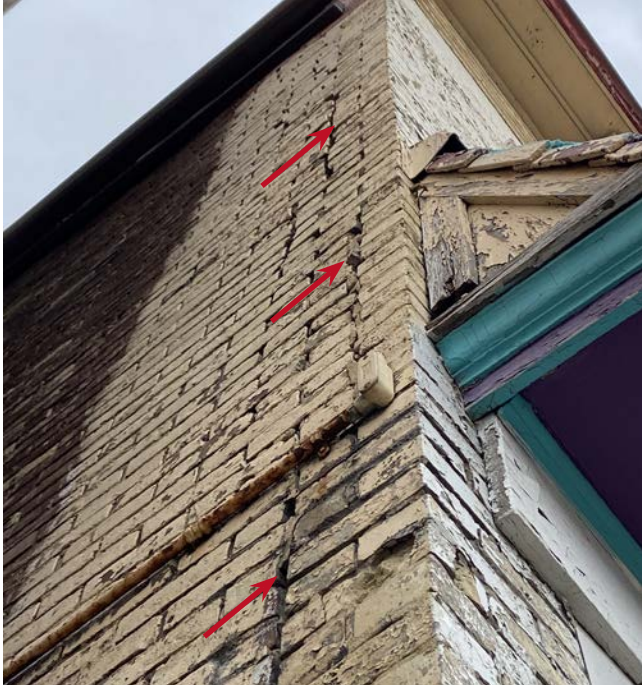
IMAGE 1: Crack at southeast corner showing signs of separation.

- East elevation near apartment unit entrance
 - South elevation at large full-height crack (see Image 1)
 - West elevation at step crack below center second-floor window (see Image 10)

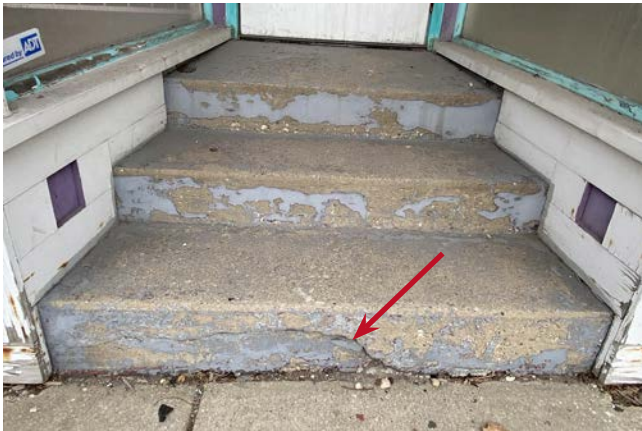
IMAGE 2: Crack at main entrance steps.

- Repair cracks in concrete steps at east elevation main entrance (see Images 2 and 3) using concrete repair material such as Damtite Super Patch or approved equal or better

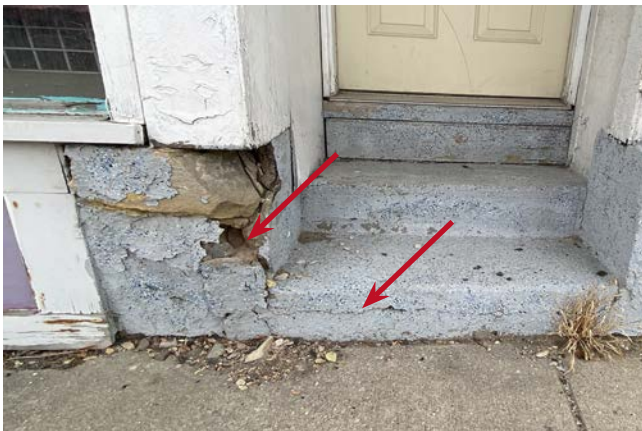
IMAGE 3: Area of impact damage and cracking at east elevation.

- Repair area of impact damage between east elevation entrances; replace broken stone and brick with matching units (see Image 3)
- Repaint concrete steps medium gray

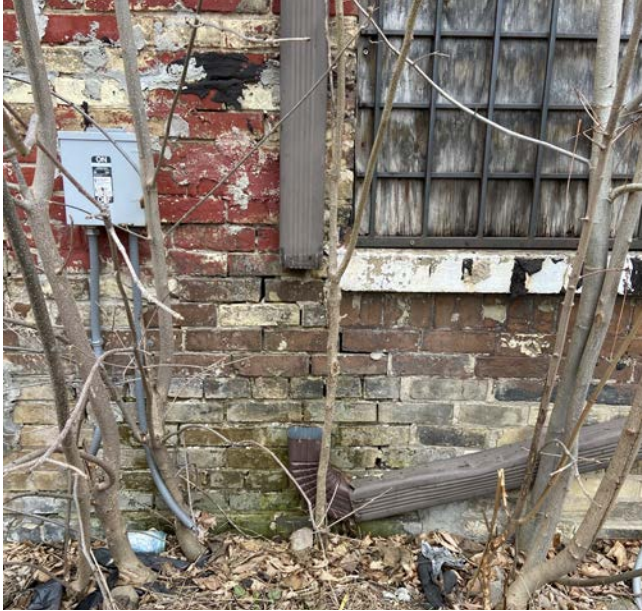
IMAGE 9: Disconnected downspouts and insufficient slope to drainage at rear west elevation near first-floor windows.

- Install new downspout at the rear west elevation
- Inspect and repair all disconnected downspouts
- Connect downspouts to existing sewer inlets

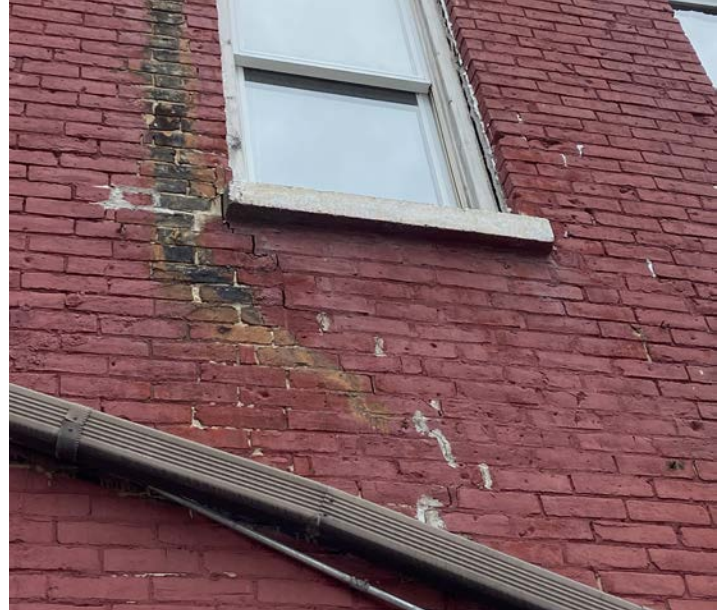
IMAGE 10: Area to be rebuilt below center second-floor window at the west elevation; large step crack and exposure to moisture has resulted in dislodged brick.

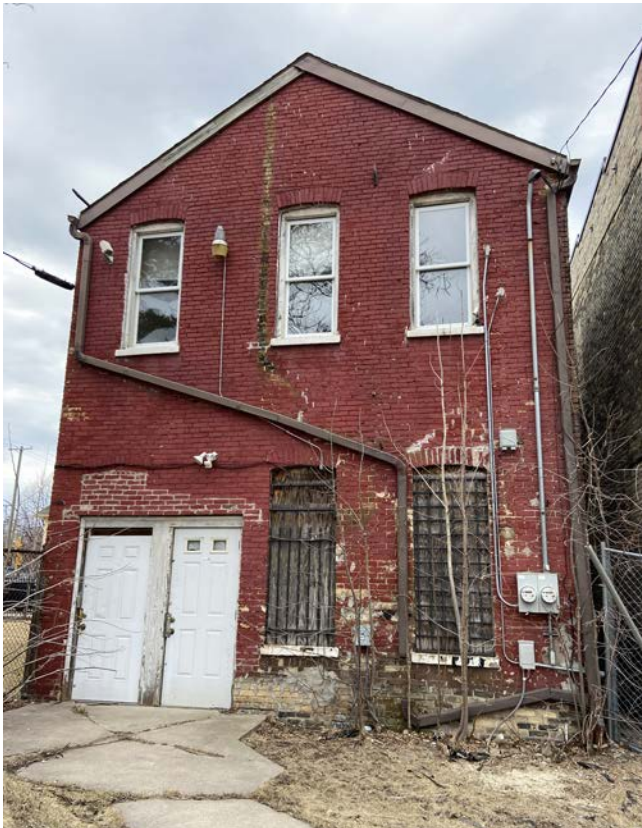
IMAGE 11: Rear area that will be reconfigured for ADA entrance, retaining wall, and new parking slab and walk.

- Build retaining wall according to site drawing, A1.1, split-face, dry-stack concrete masonry units to blend in with surrounding grass/sidewalk
- Demo rear walk and parking area
- Create a quarter bubble away from the building to promote positive drainage of the site
- Pour new parking area and walk; walk not to exceed 1:20 pitch

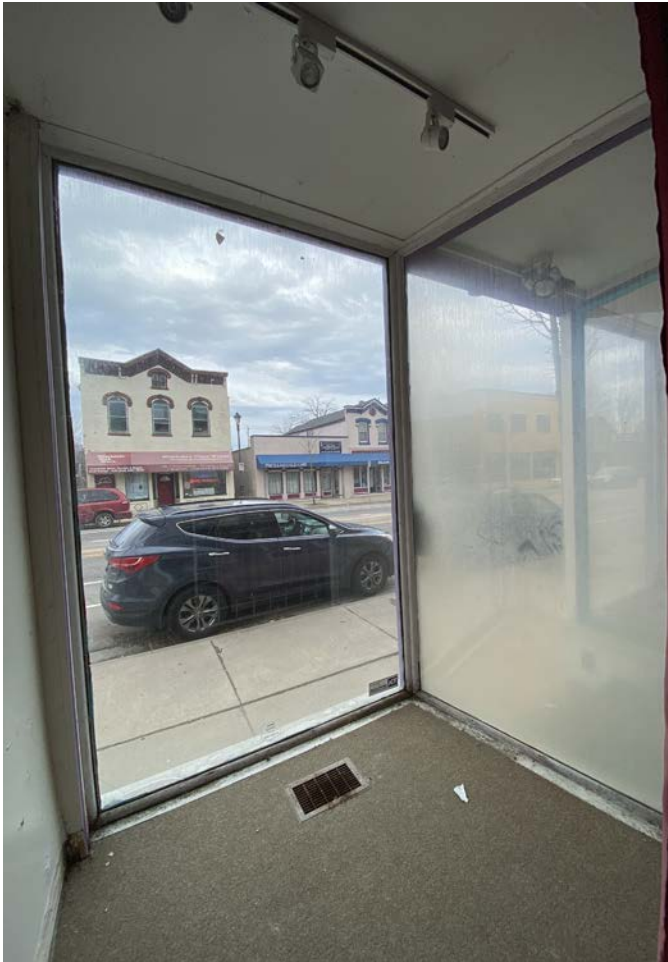
IMAGE 12: Interior side of existing storefront, north bay. New storefronts will preserve existing configuration and daylight openings and configuration.

- Storefront windows are plastic and must be replaced; replace as shown on drawing sheet A1.2
- Retain all existing trim in good condition at storefronts and double-hung units
- Remove all rotted wood frame, sill, and trim members and replace with new wood matching the size and profile of the removed section; splice as necessary; prime and paint
- Install prefinished aluminum flashing at all windows to prevent excess moisture infiltration; match trim color

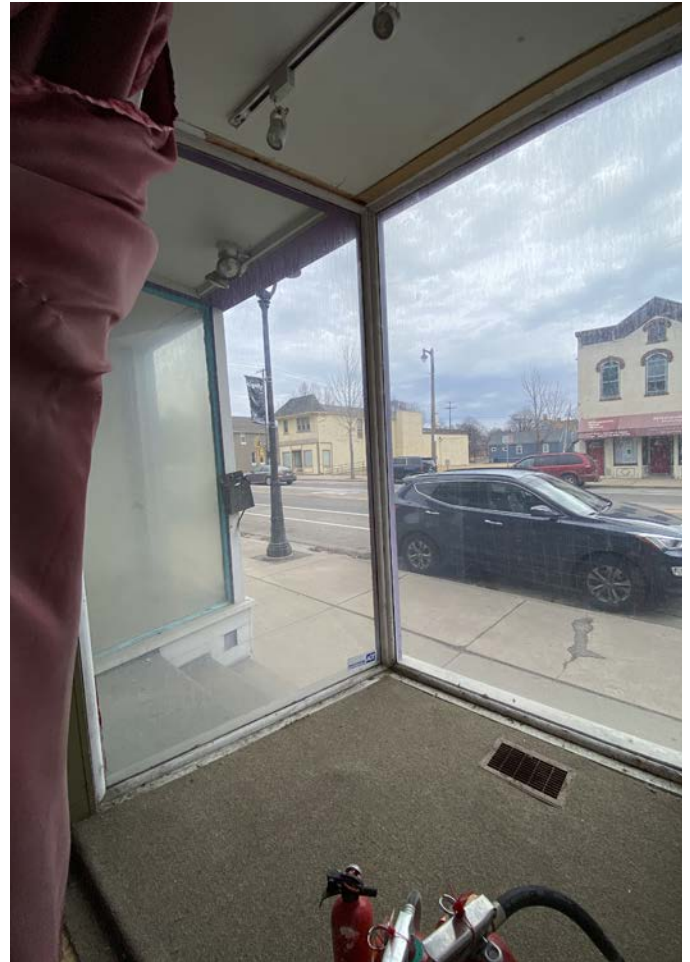
IMAGE 13: Interior side of existing storefront, south bay. New storefronts will preserve existing configuration and daylight openings and configuration.

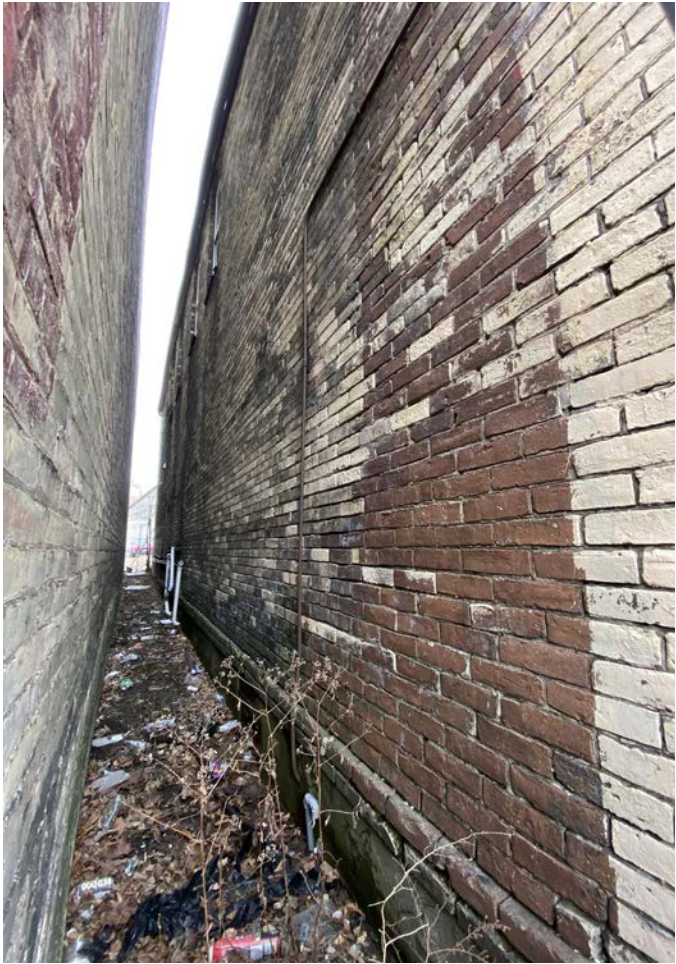
IMAGE 14: South elevation; here work is limited to masonry repairs and flashing at windows as described in the Scope Narrative.

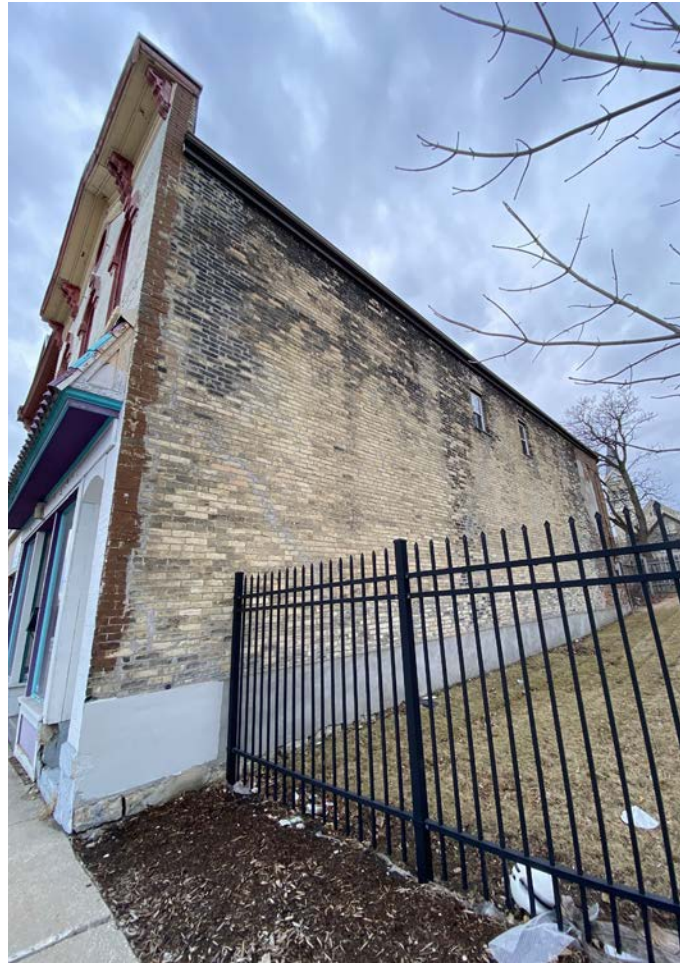
IMAGE 15: North elevation; here work is limited to masonry repairs and flashing at windows as described in the Scope Narrative.

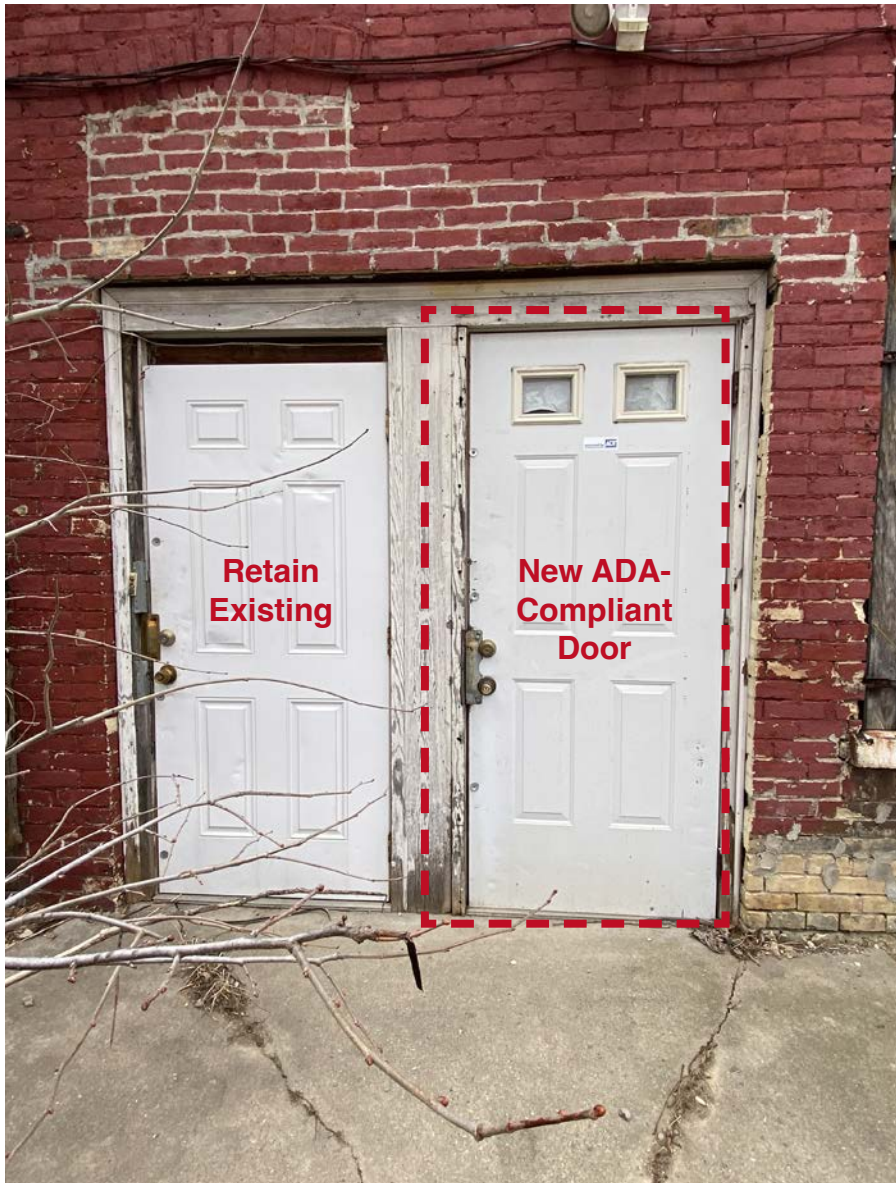
IMAGE 16: Detail view of west elevation doors. The door on the left will be retained and the opening reconfigured to fit more tightly. The door on the right will be replaced with an ADA compliant door as described in the Scope Narrative. Trim around the doors within the masonry opening will be reconfigured and refinished to match the doors and to better address voids. No work is anticipated at the steel lintel.

- Enlarge rough opening to meet ADA requirements and replace rear exit door with steel 6 panel composite frame exterior door, Mastercraft 36"W x 80"H model #4145390 (See Image 6), paint yellow to match front door
- Retain existing second floor exit door at north corner and paint gray to match east apartment entrance
- Install new trim where needed and paint to match doors
