CCF 140507

Northwestern Mutual Life Insurance Company

8-9-2017

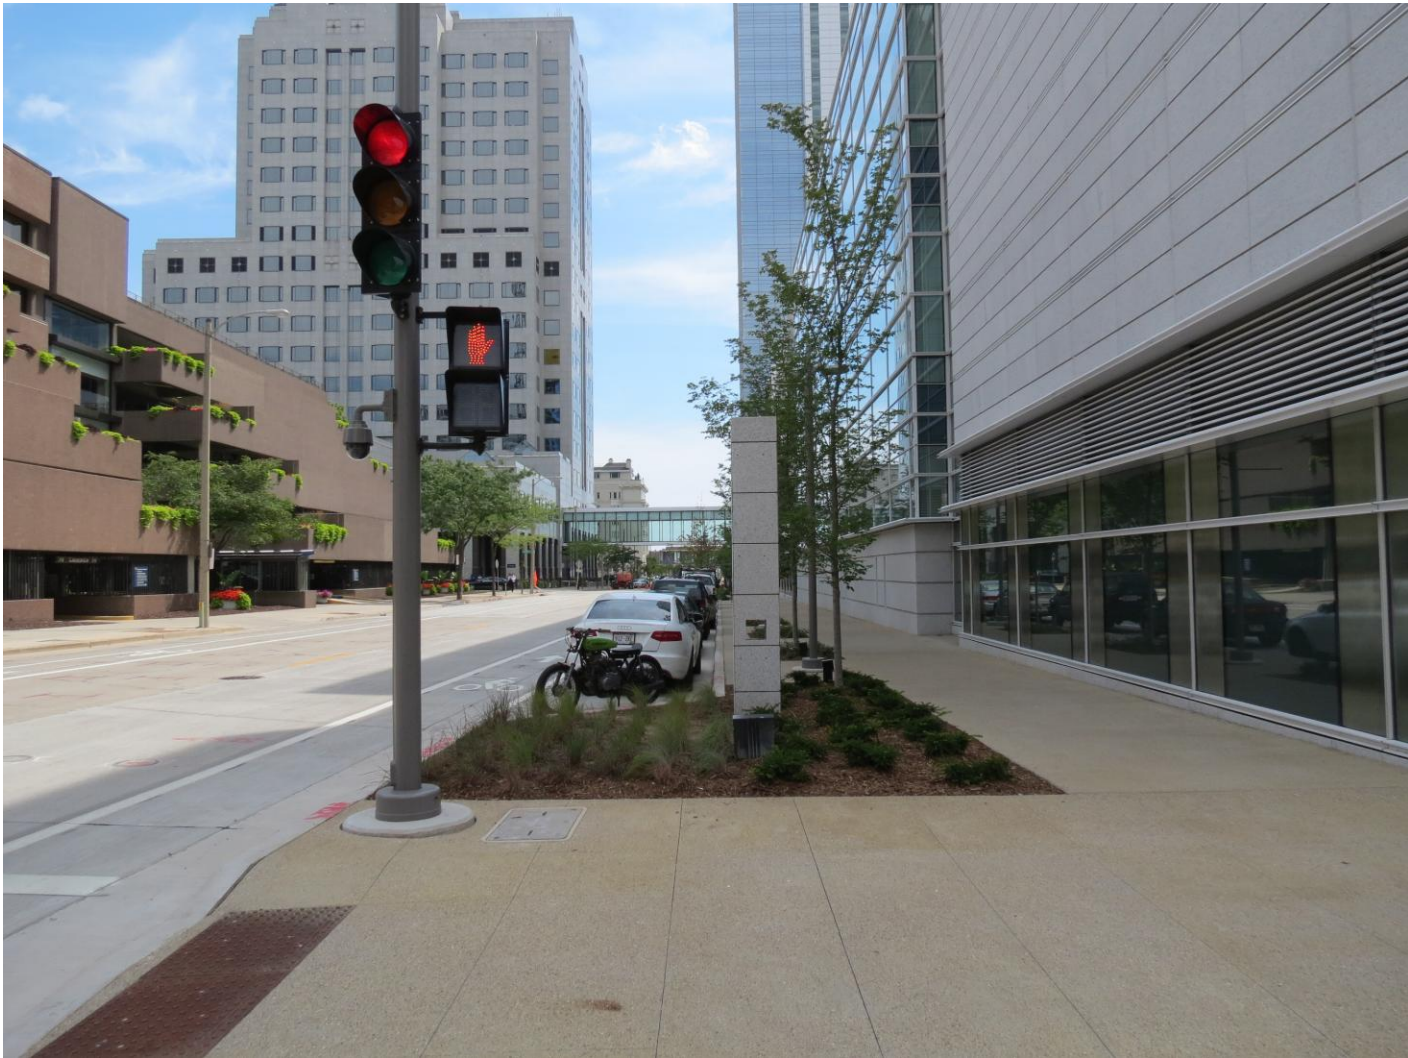
Looking east from North Van Buren Street at monument sign and security camera.

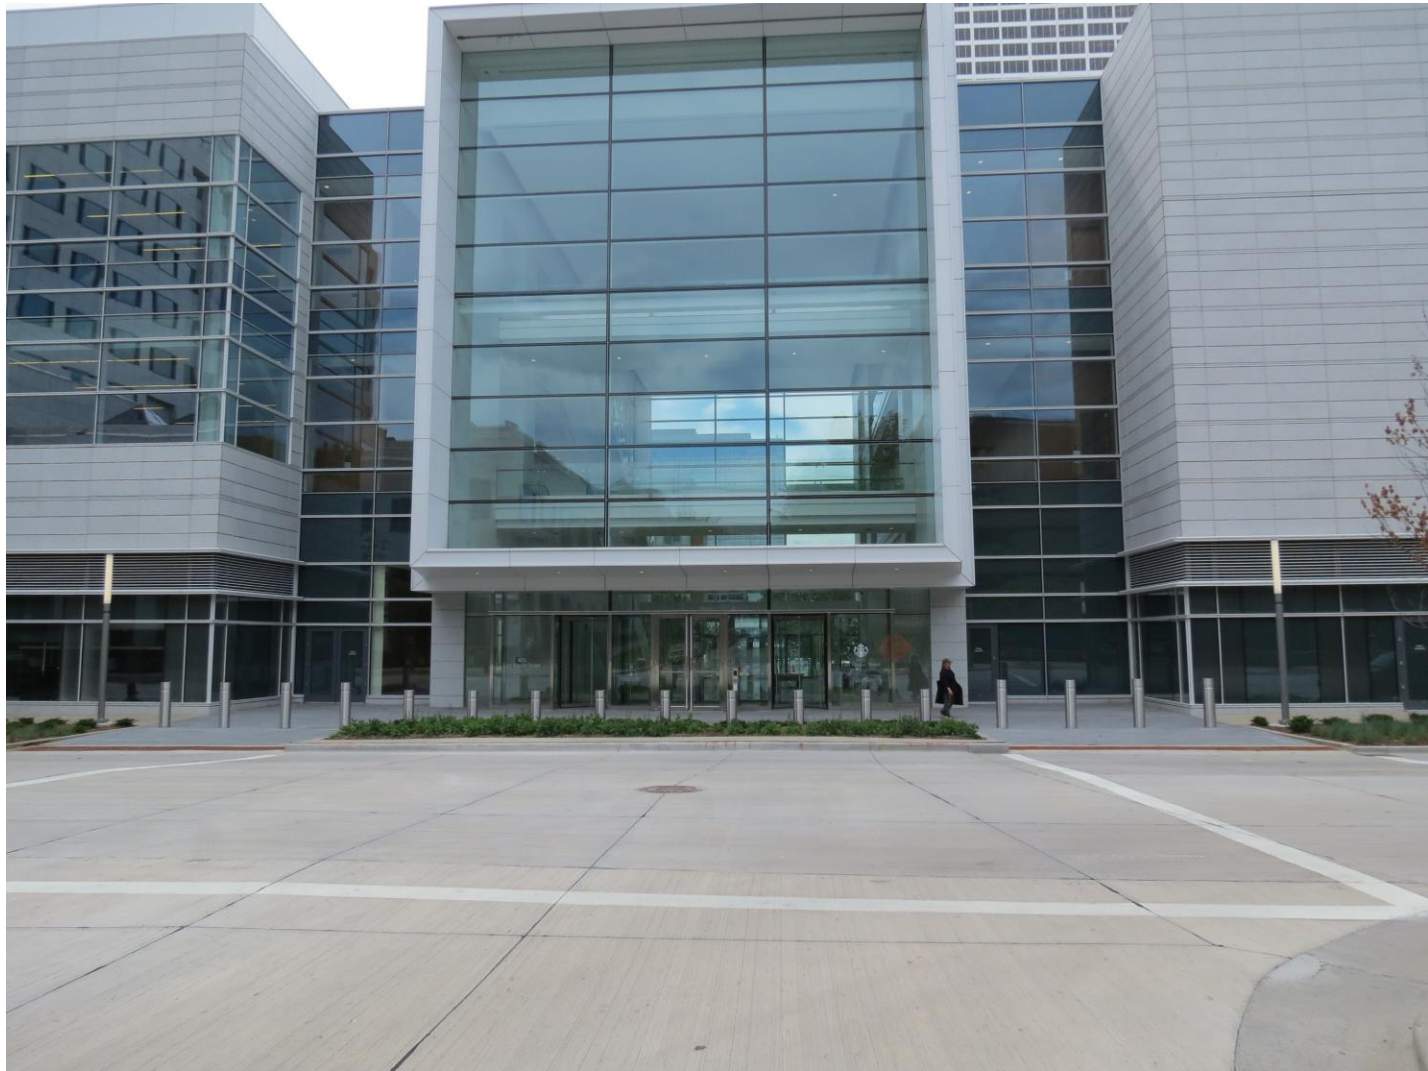
CCF 140507 Northwestern Mutual Life Insurance Company 8-9-2017
Looking south across East Mason Street towards the main building entrance located at
North Cass Street. There are bollards, pavers, and private light fixtures at this location.

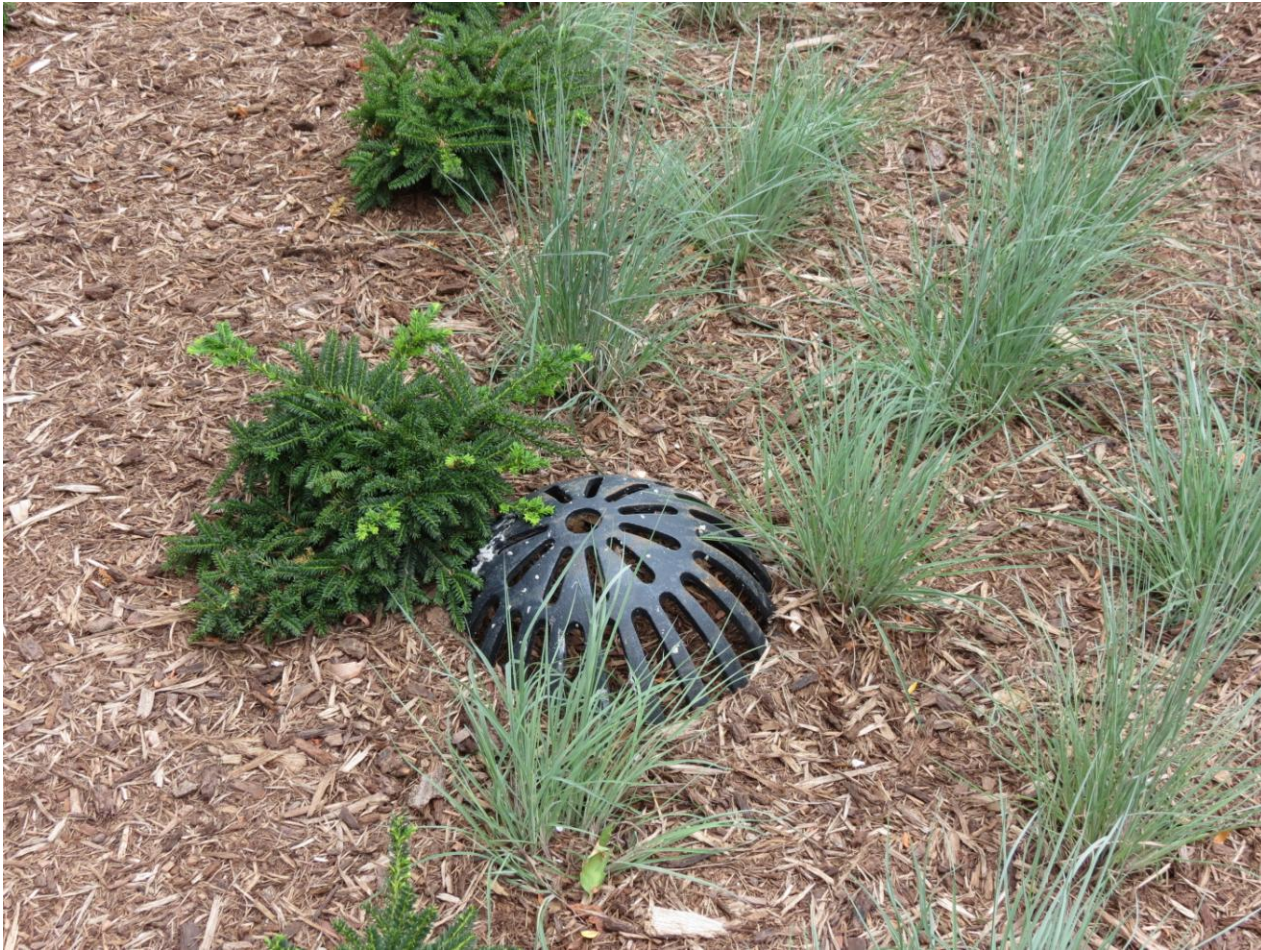
Close up of one of four private storm drains located on the curb extension into the south side of East Mason Street at North Cass Street.

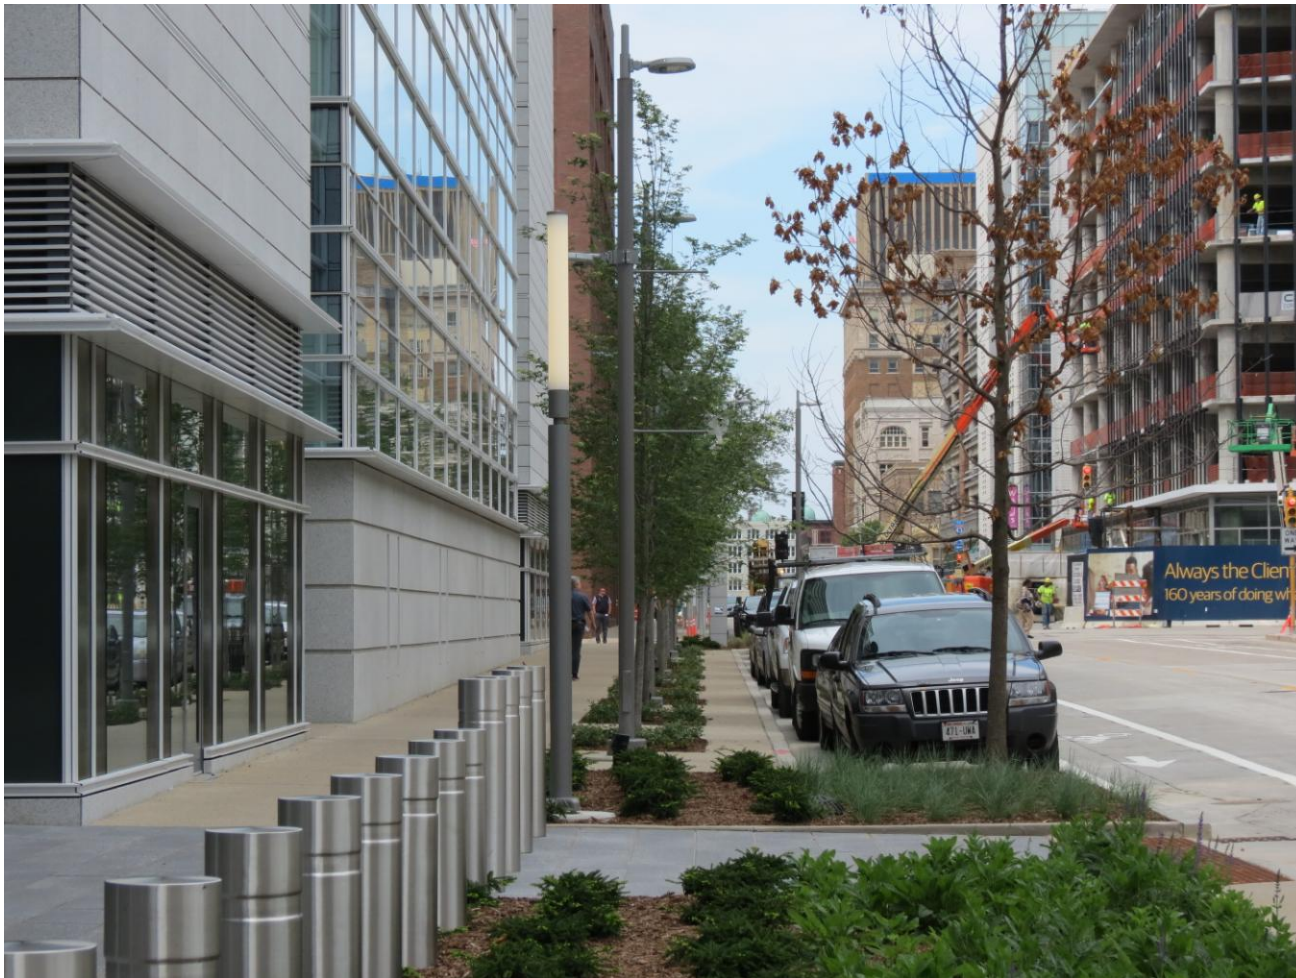
CCF 140507 Northwestern Mutual Life Insurance Company 8-9-2017
Close up of private pedestrian level light located at the main building entrance off of East
Mason Street at North Cass Street. Note: Other specialty streetlight fixtures will be
permitted under a separate maintenance agreement.

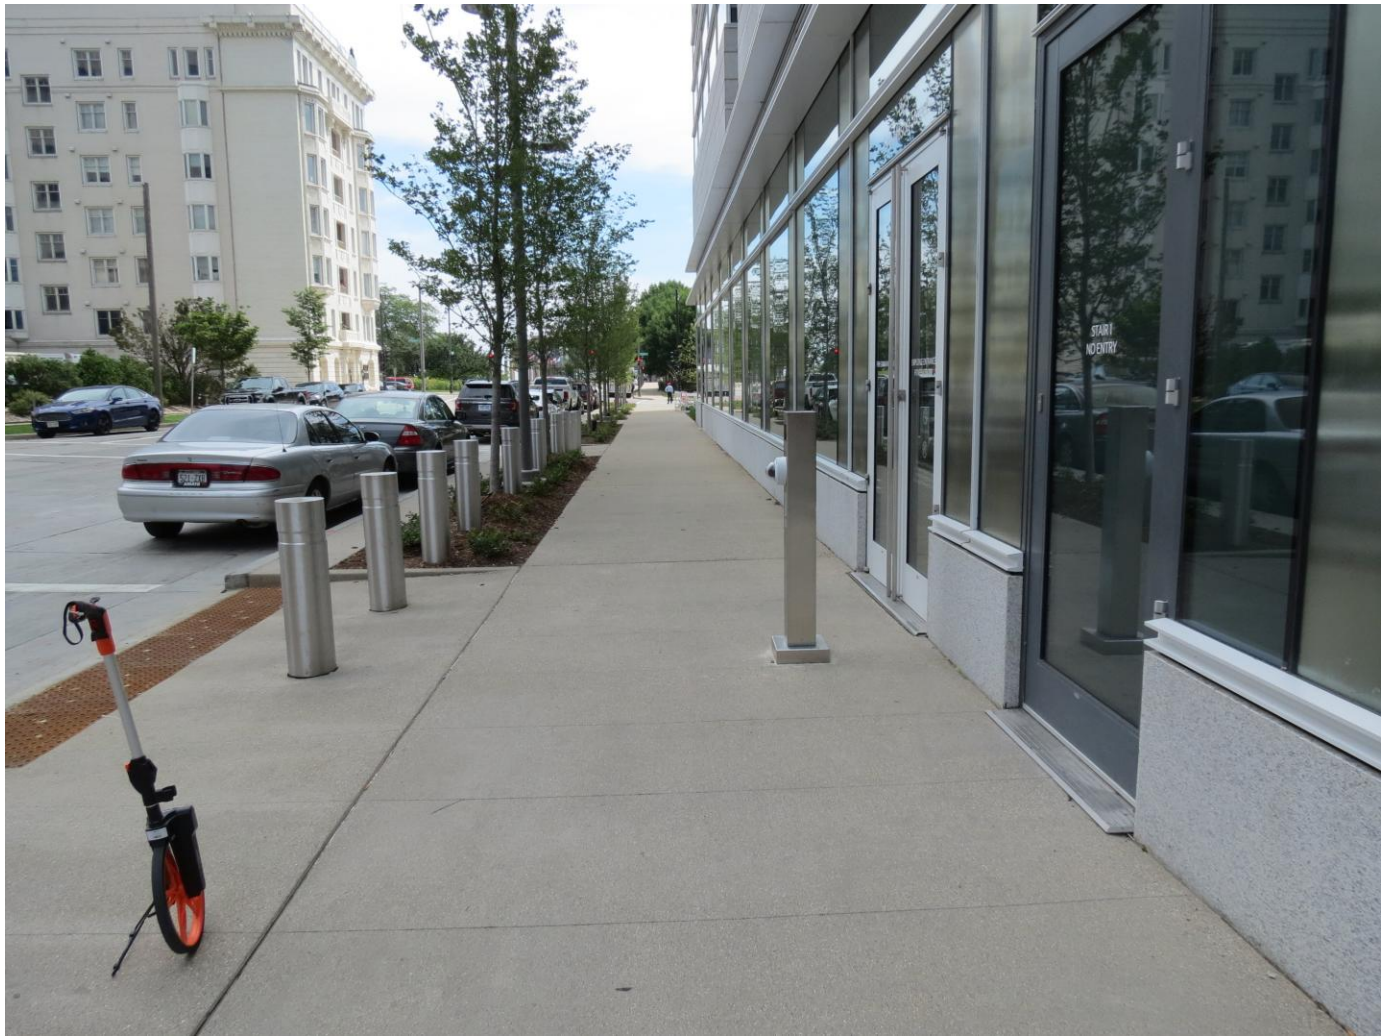
Looking east at the south sidewalk area of East Mason Street at North Marshall Street. In particular, looking at the bollards on the left and the security bollard on the right.

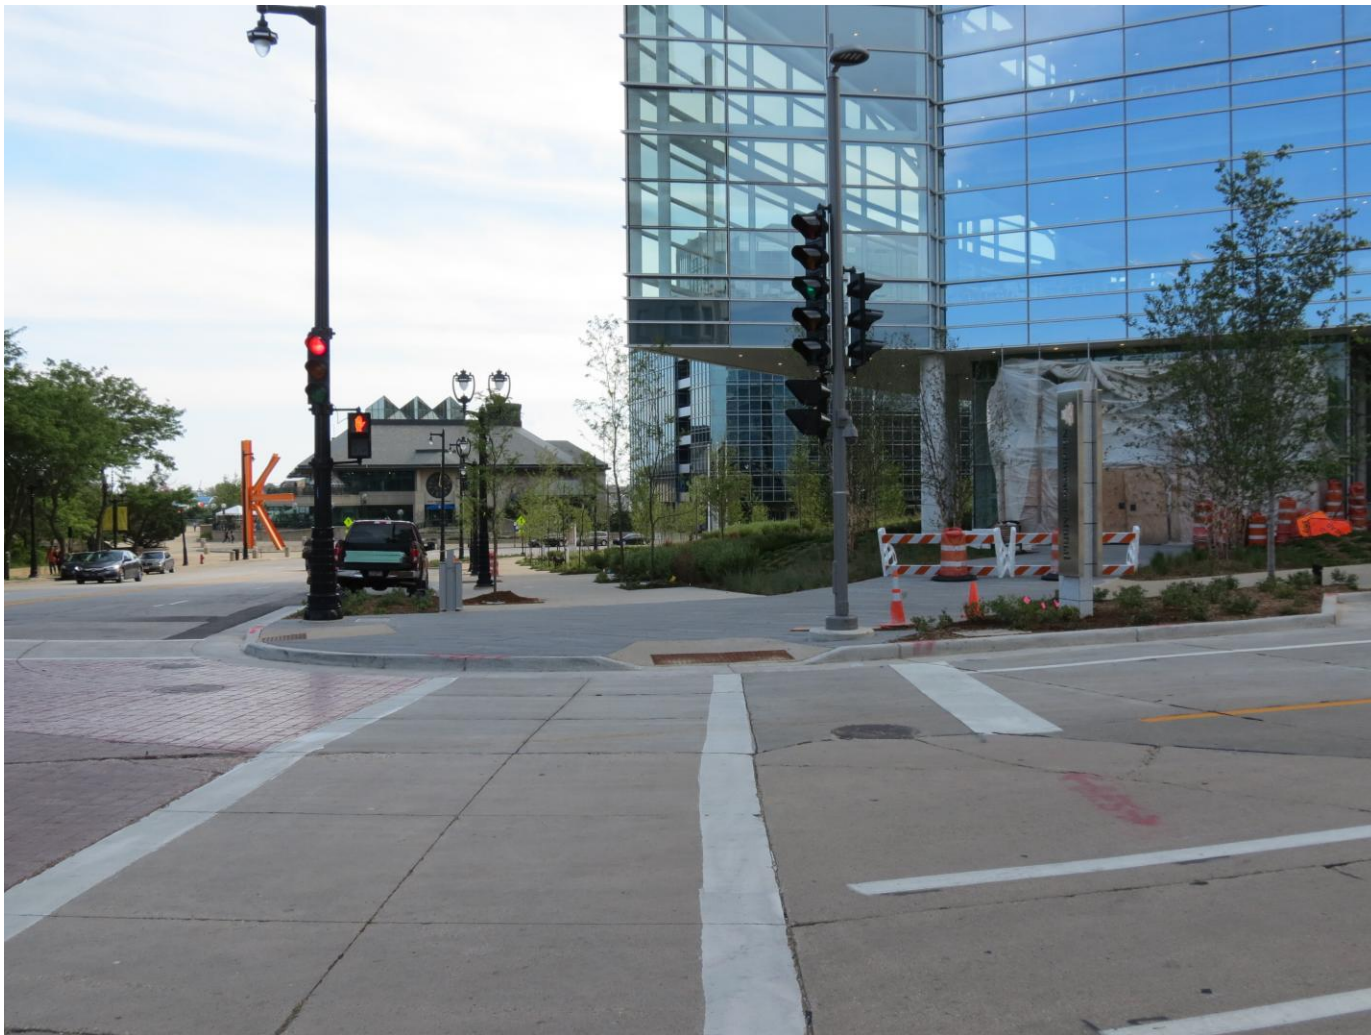
Looking south at the southwest corner of East Mason Street and North Prospect Avenue.

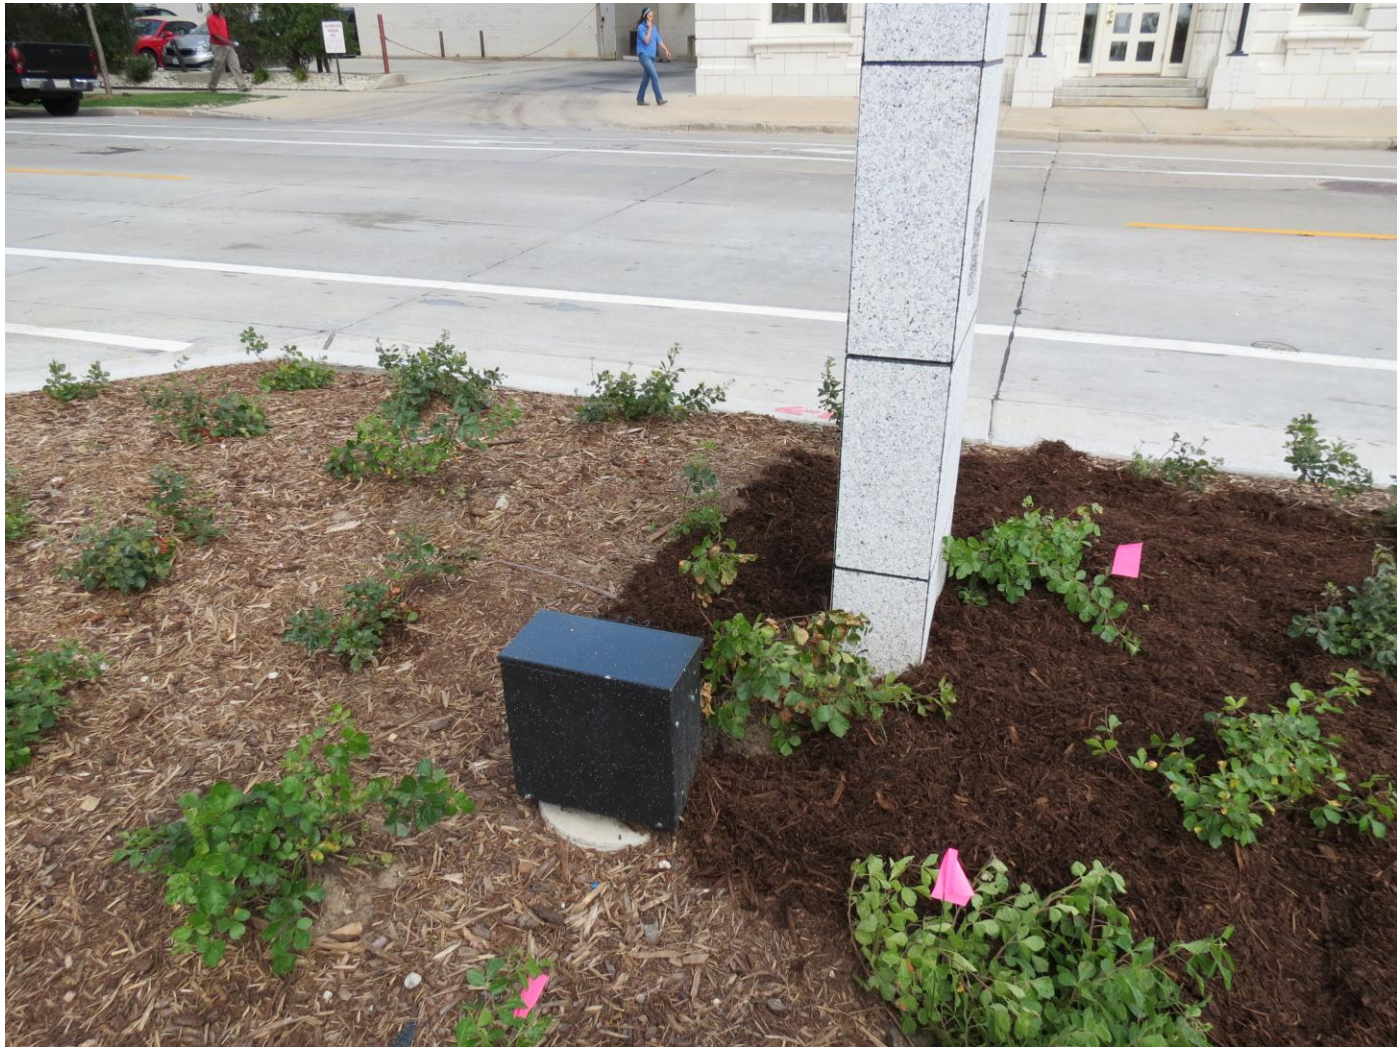
Close up of an electrical control box located in the planters surrounding the office campus.

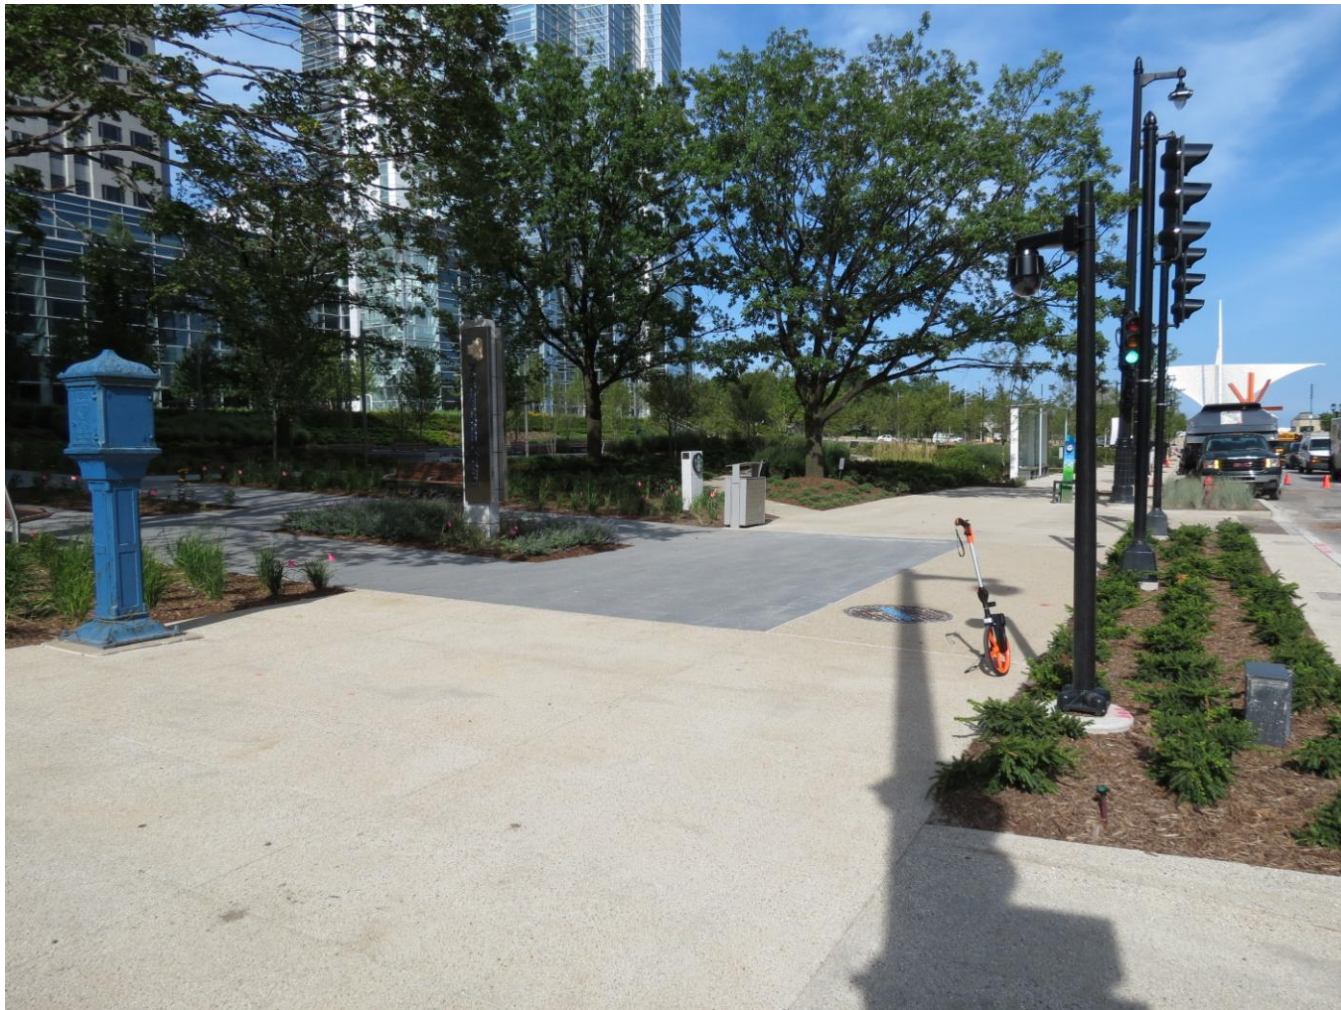
Looking northeast at the pavers on the north side of East Wisconsin Avenue at North Cass Street.

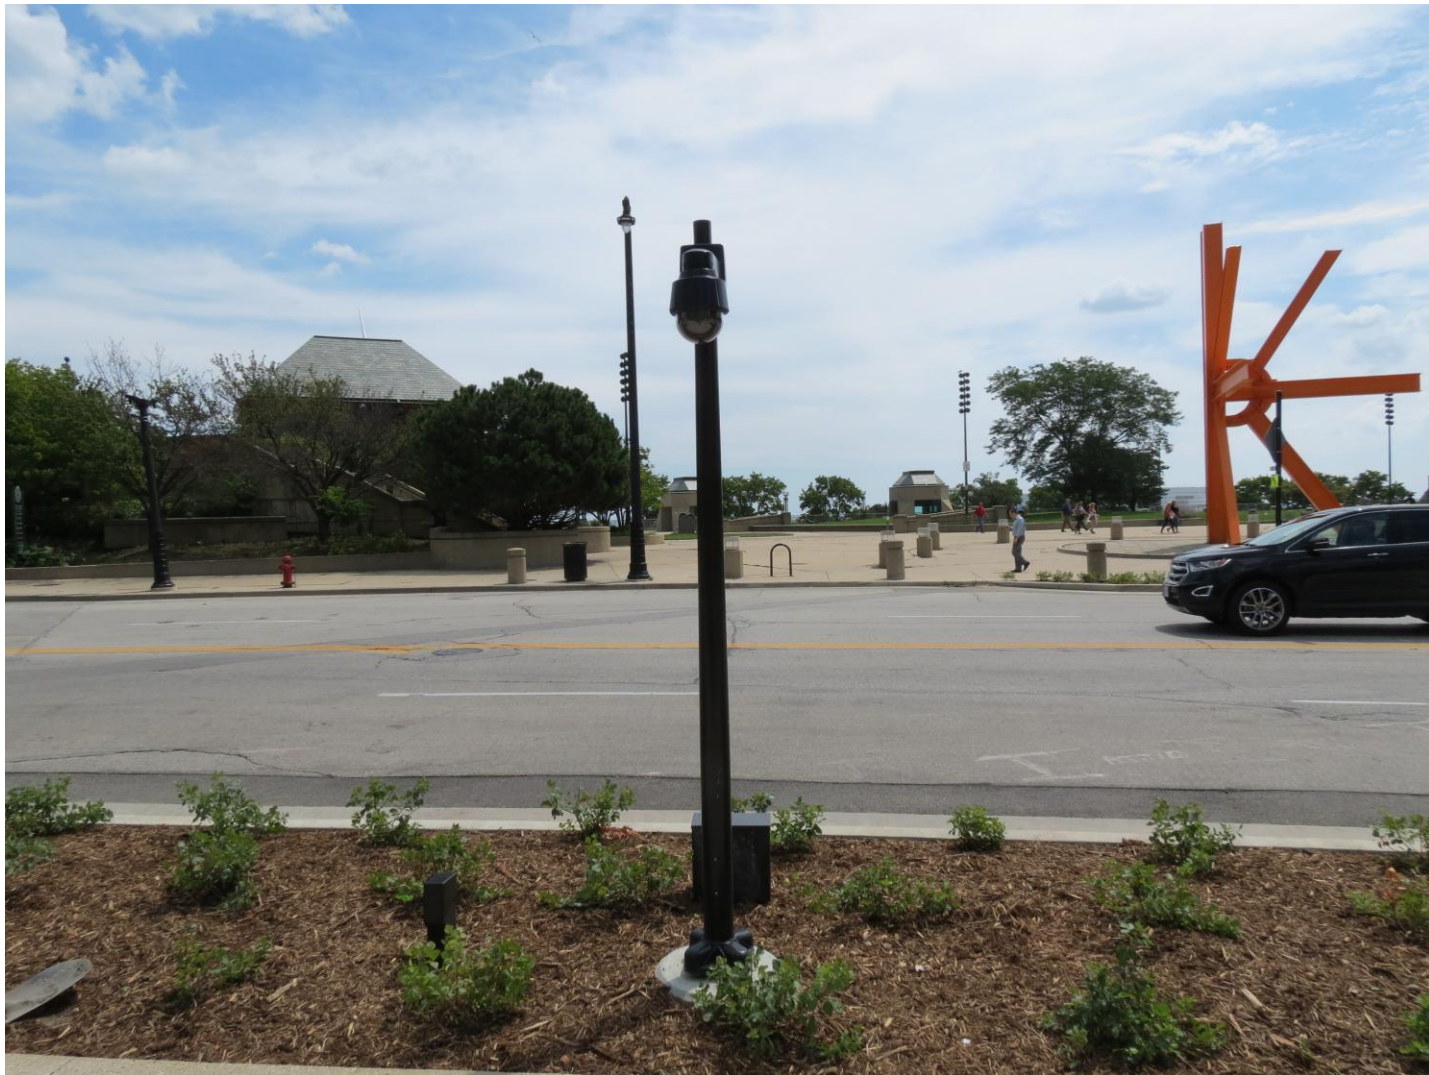
Close up of a freestanding security camera at North Prospect Avenue and East Wisconsin Avenue.

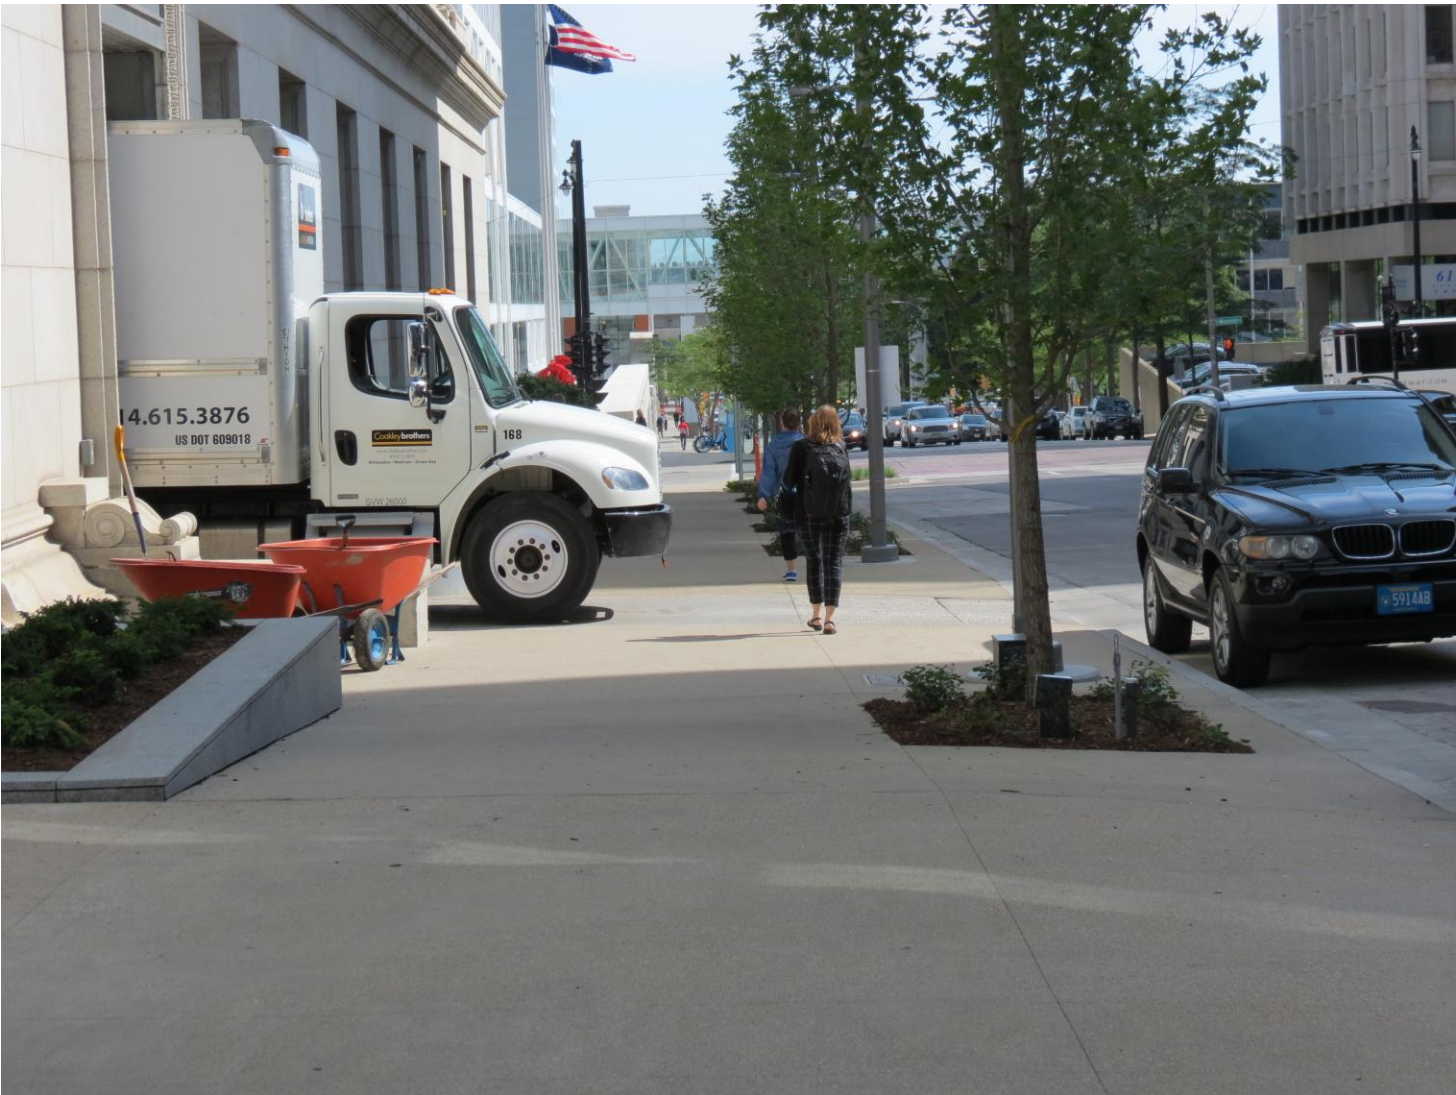
Looking south at the backup driveway in the east side of North Van Buren Street.

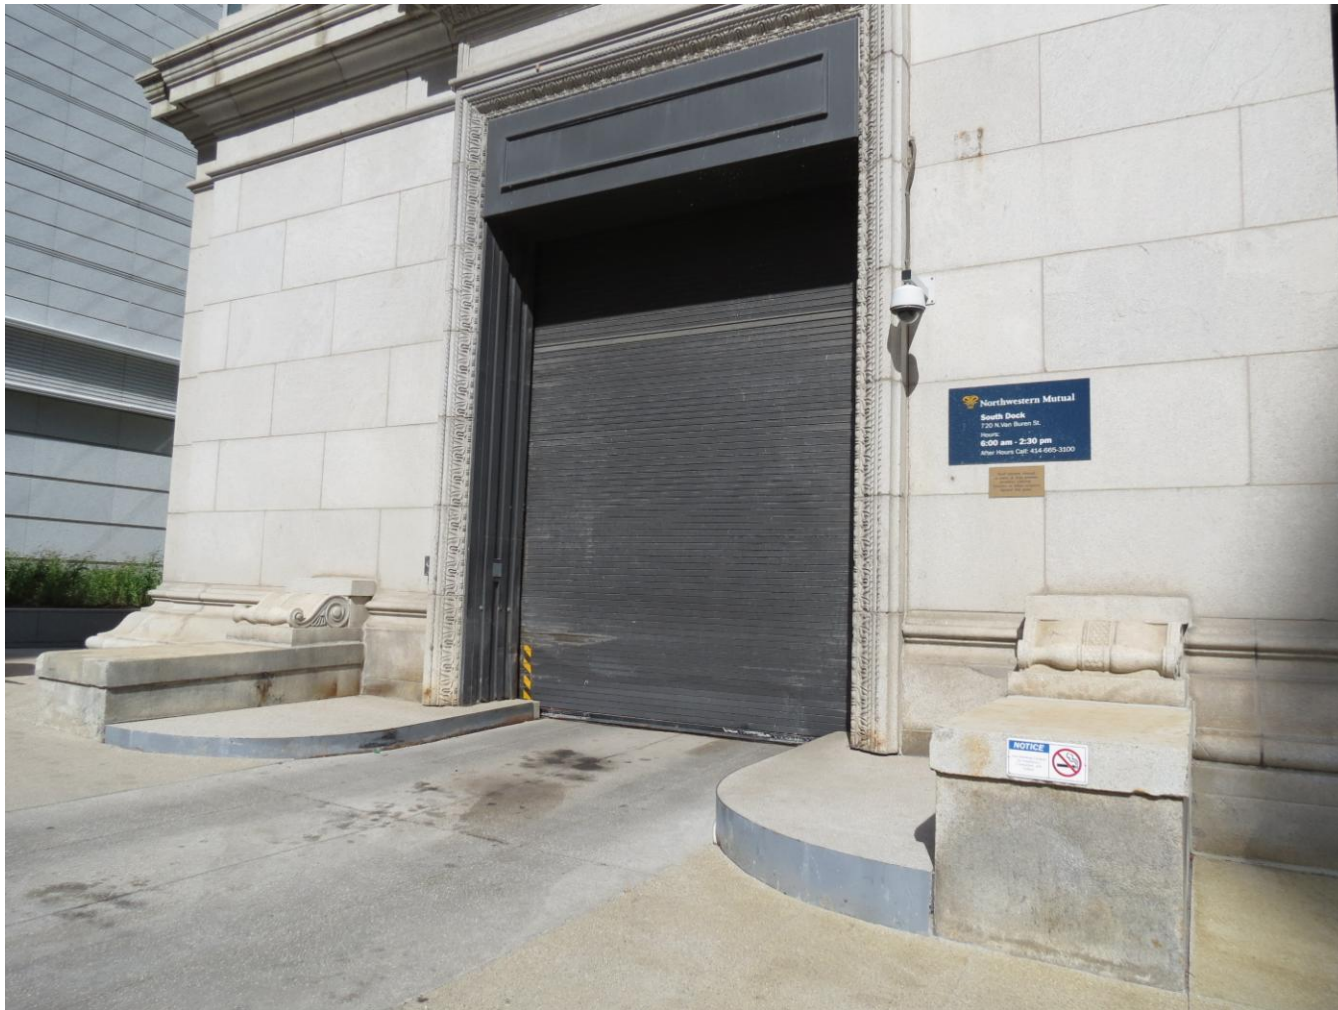
Close up of the loading dock door served by the backup driveway on North Van Buren Street.
