Tuesday | May 13, 2014

**Property and Project Description:**

Charles H. and Matilda Olroge House  
2550 N. 47<sup>th</sup> St.  
Milwaukee, Wi 53211

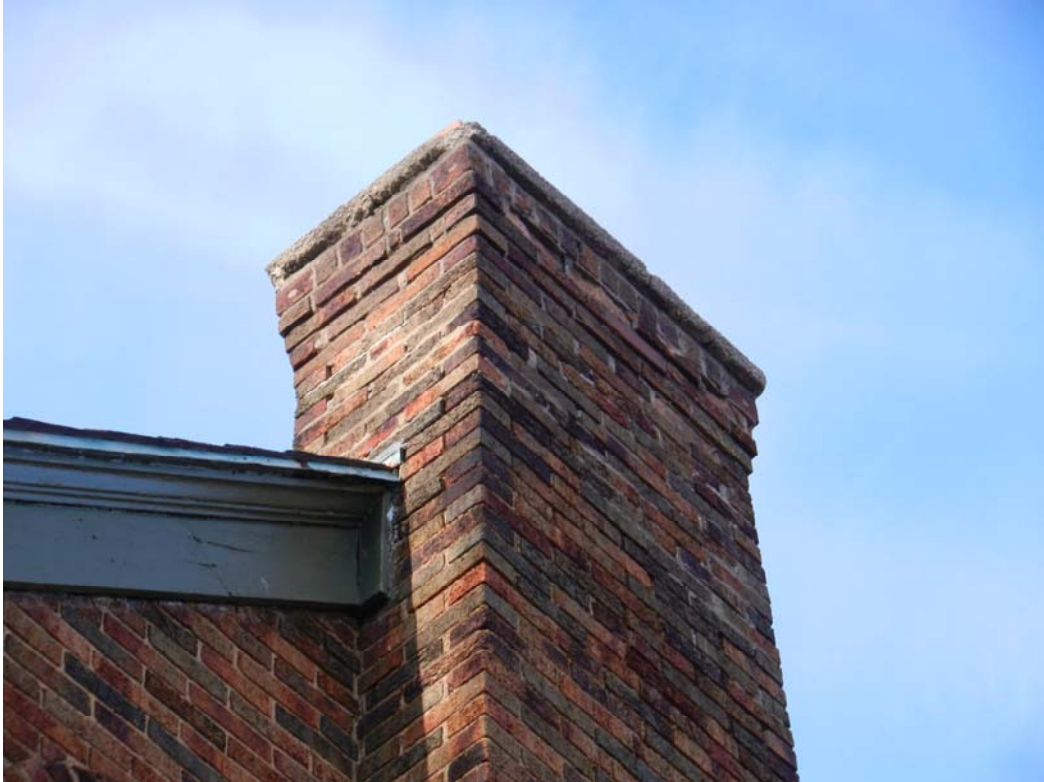
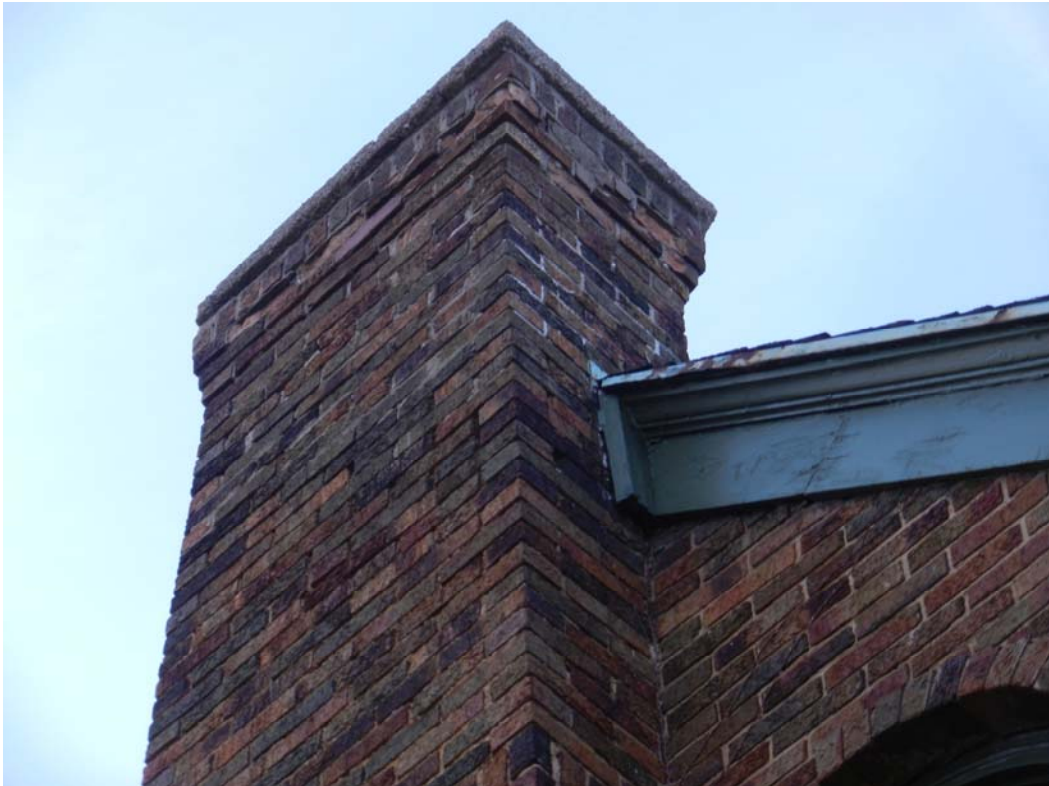
Deteriorated masonry: chimney SW & SE corners

The first phase of the 2550 N. 47<sup>th</sup> St. exterior renovations involve replacing deteriorated brick and rebuilding any structurally unsound portions of the existing chimney located on the south side of the building. The chimney never served the existing fake fireplace and the current furnace and water heater no longer utilize the chimney, because of this it will be capped to prevent future deterioration. This capping will occur within the clay liner and will not be visible from the ground. The second part of the initial project is to repoint the deteriorated and poorly matched replacement mortar beneath the first floor windows and near the downspouts where water has damaged the masonry joints. In addition, existing brick will be re-laid in the northwest corner of the garage. All portions of these projects will reuse and viable brick and if necessary any replacement masonry will match the existing and will be placed in the least visible areas possible. The mortar used will be color matched to the existing and will have a high lime content to avoid damaging the original brick.

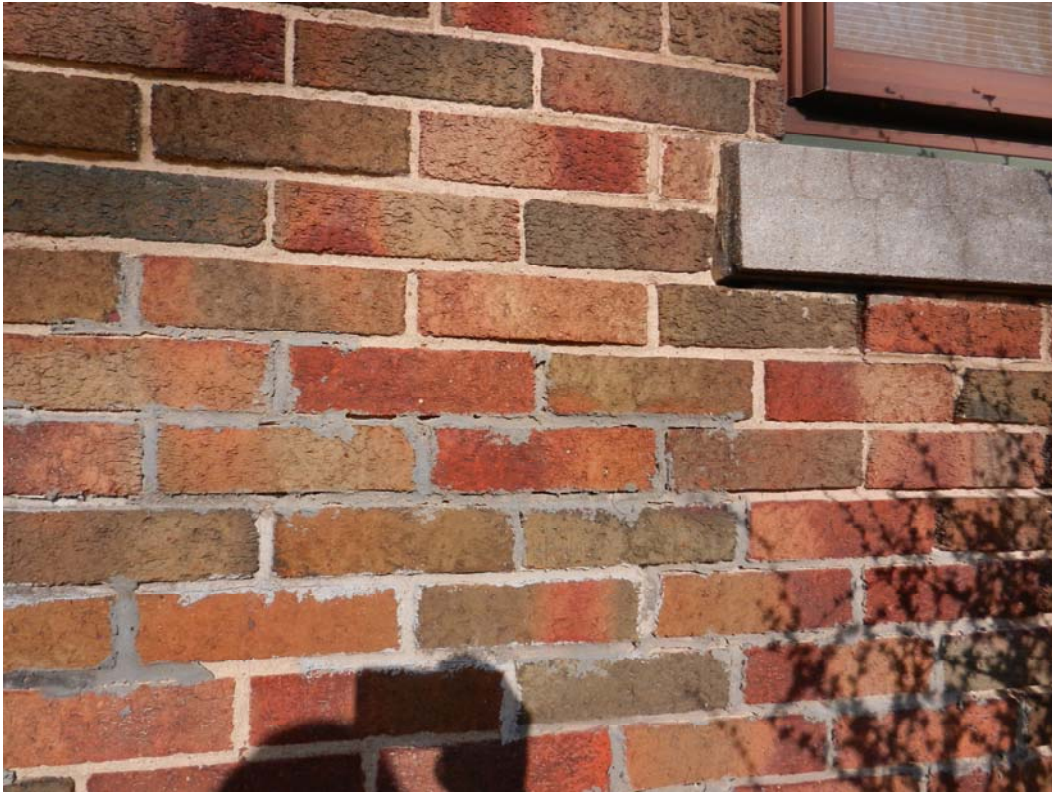
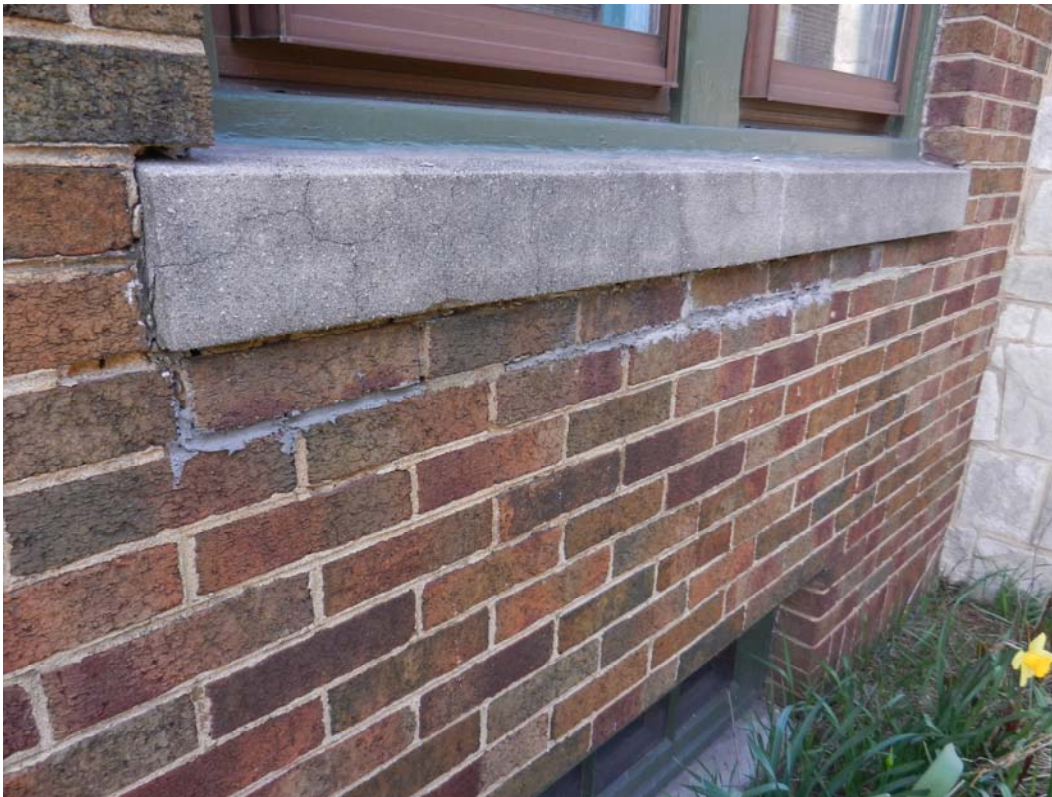
Deterioration below window sills and poorly replaced mortar

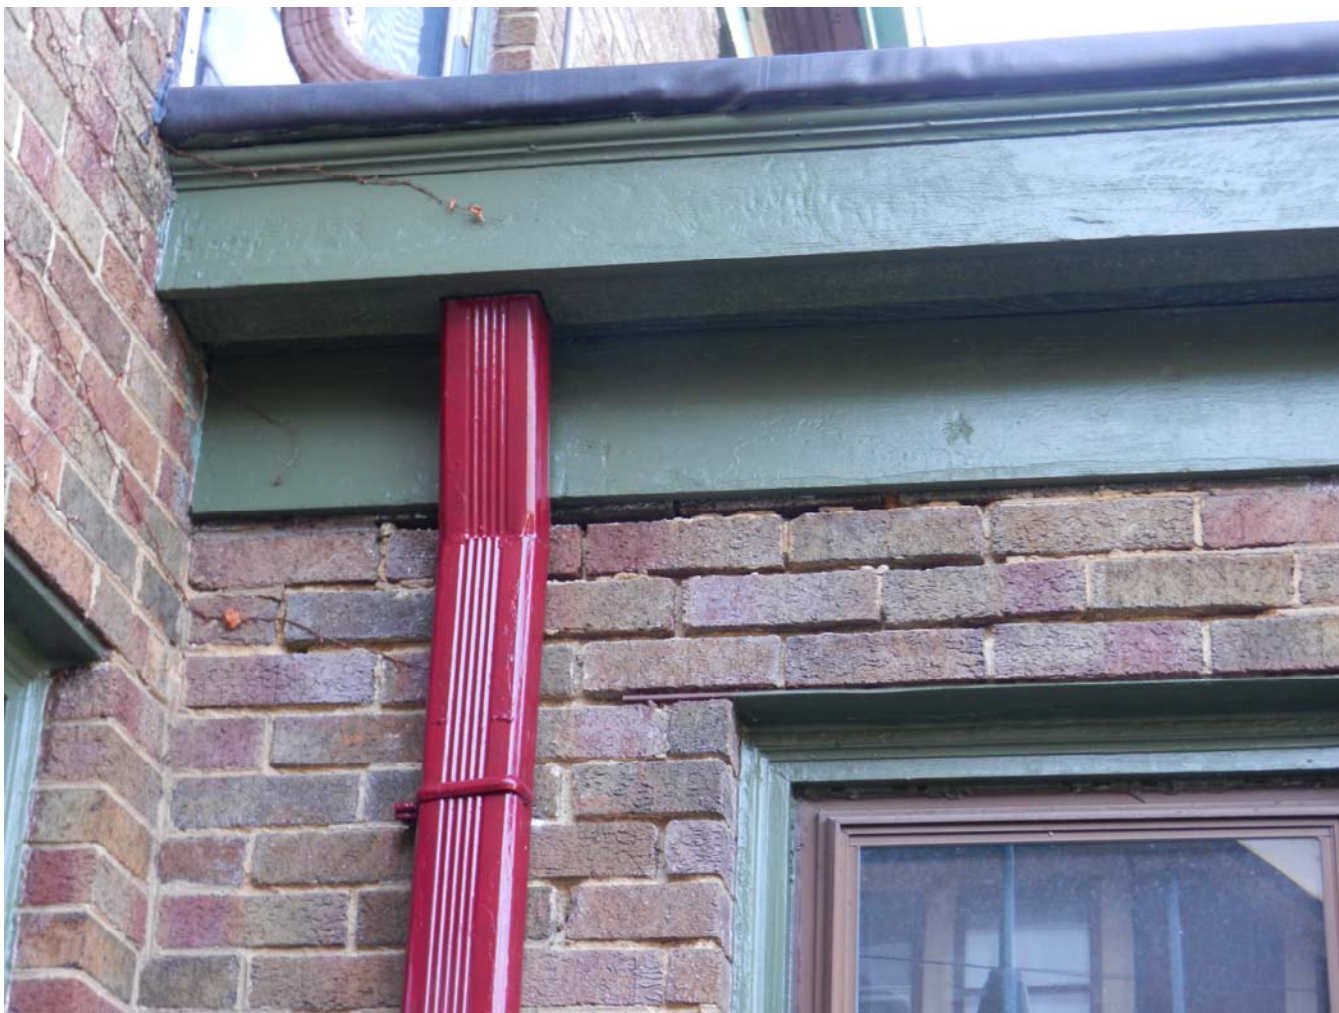
Damaged mortar near downspout

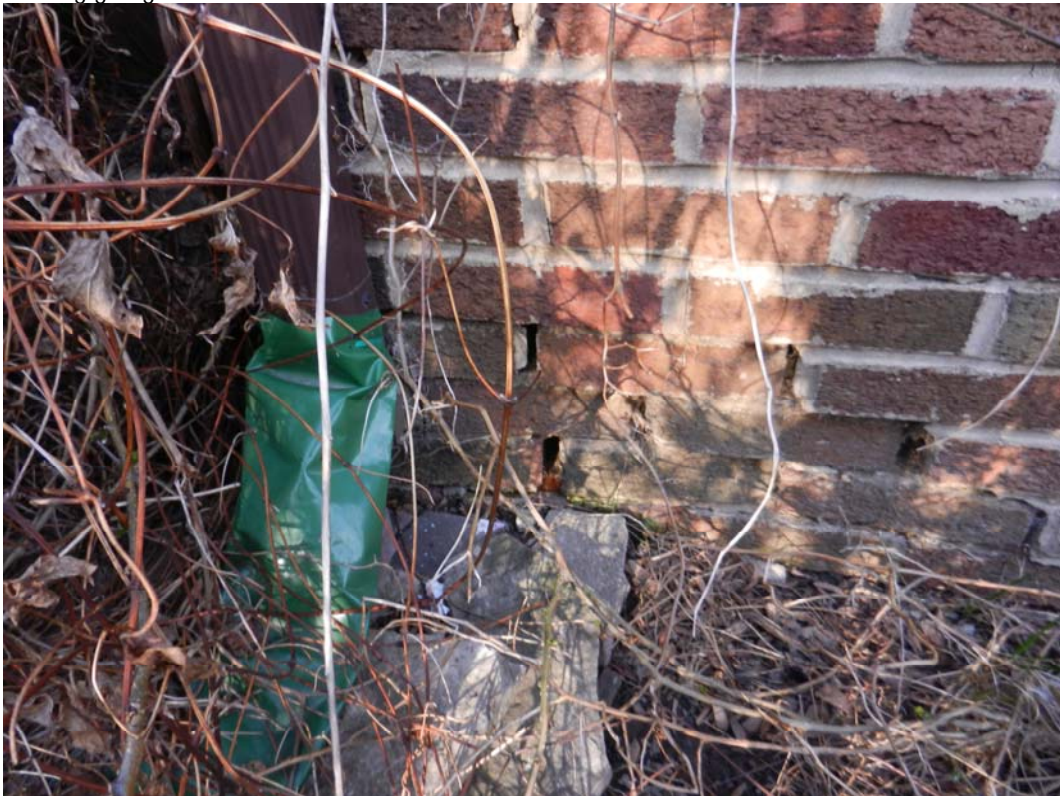
Damaged NW corner of garage.
