Certificate of Appropriateness

2648 N. HACKETT AV. *Kenwood Masonic Temple; Individuals' designation*
Stabilize the front, terra cotta facade. Two general treatments will be used for most of the facade depending on the condition of the original material.

PTS ID 96099 COA, facade stabilization

facade stabilization

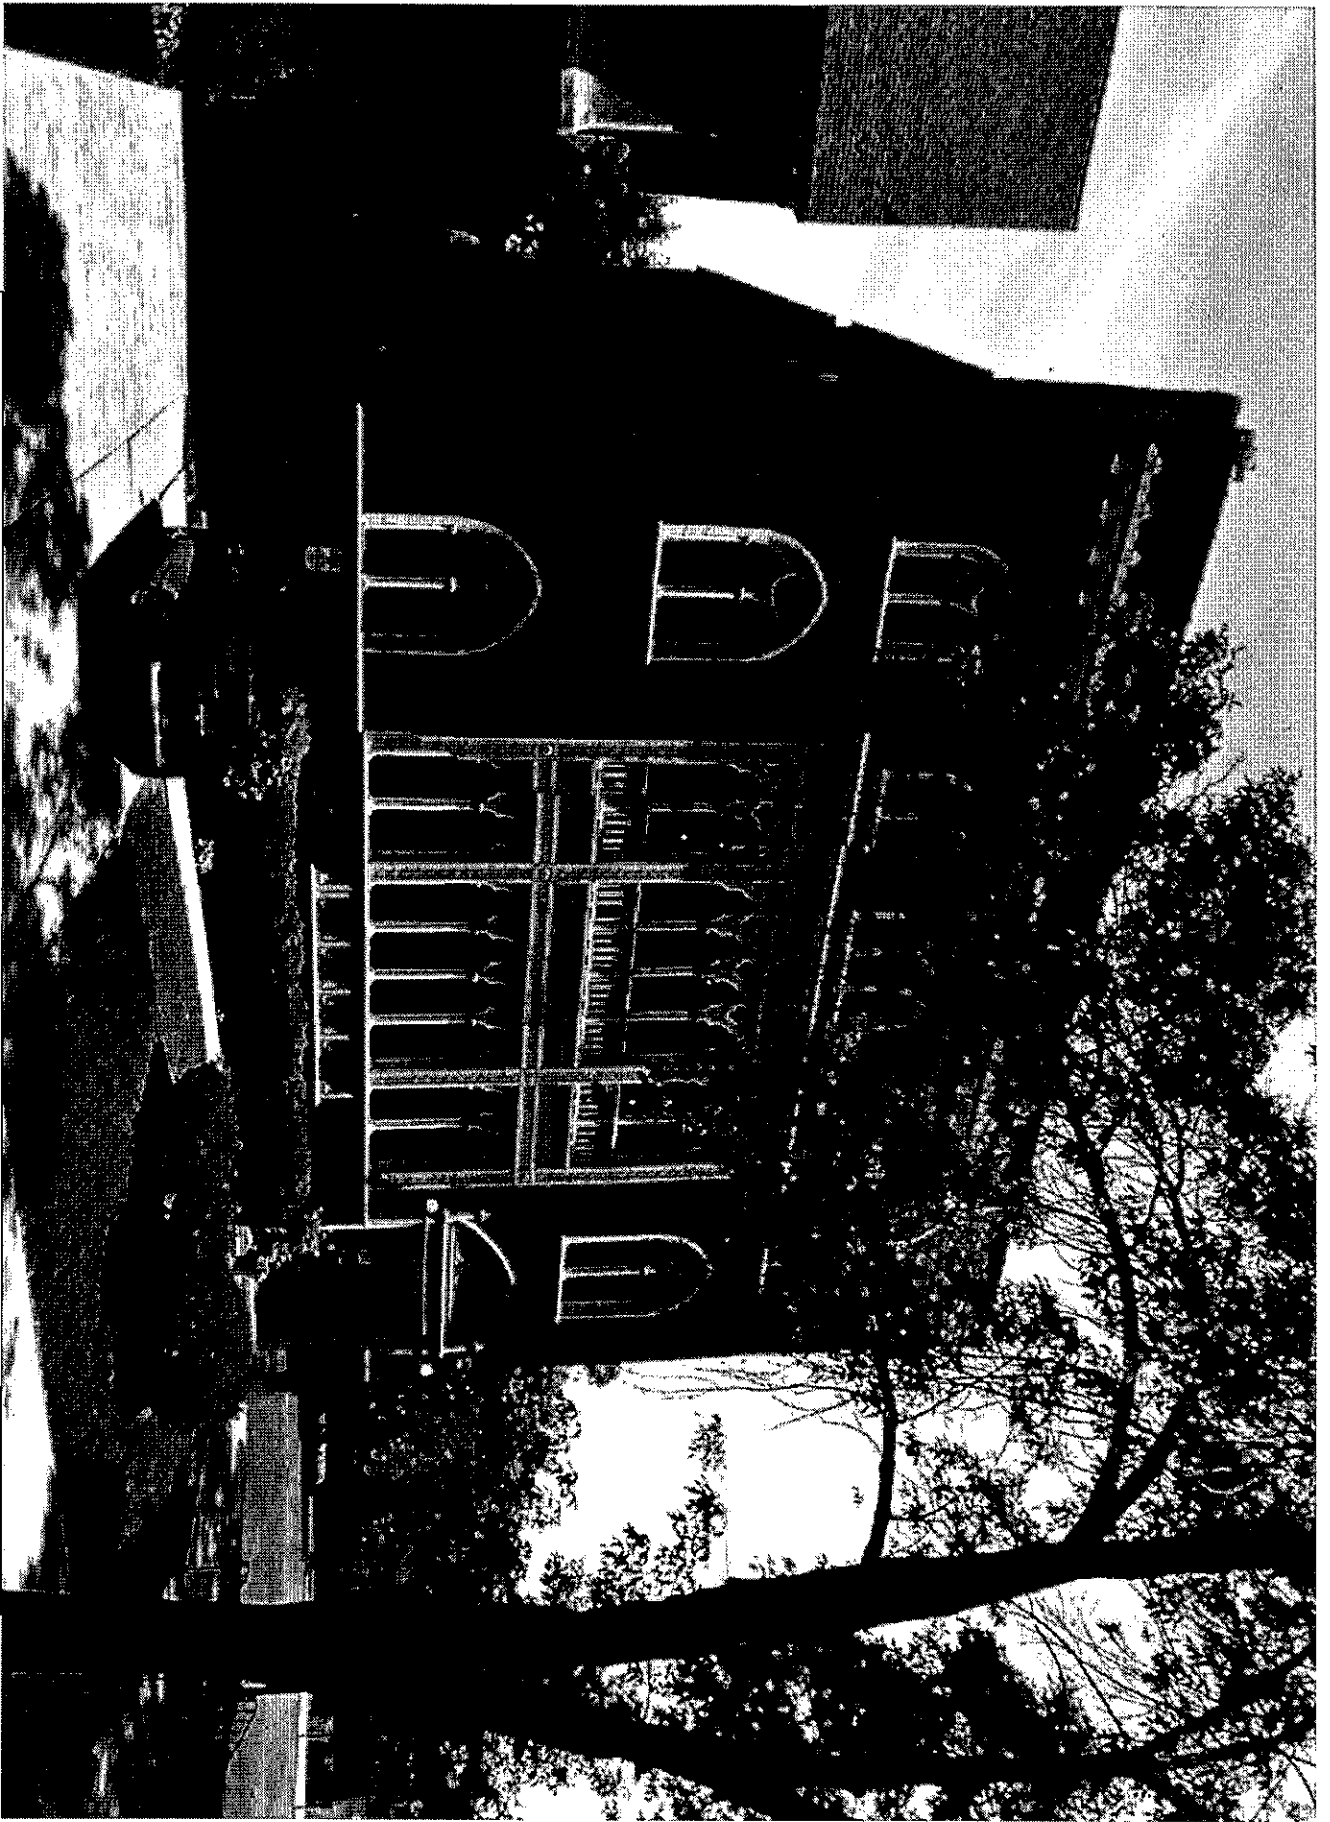
2648 N. Hackett. Repairs, stabilization will be made on the front of building.

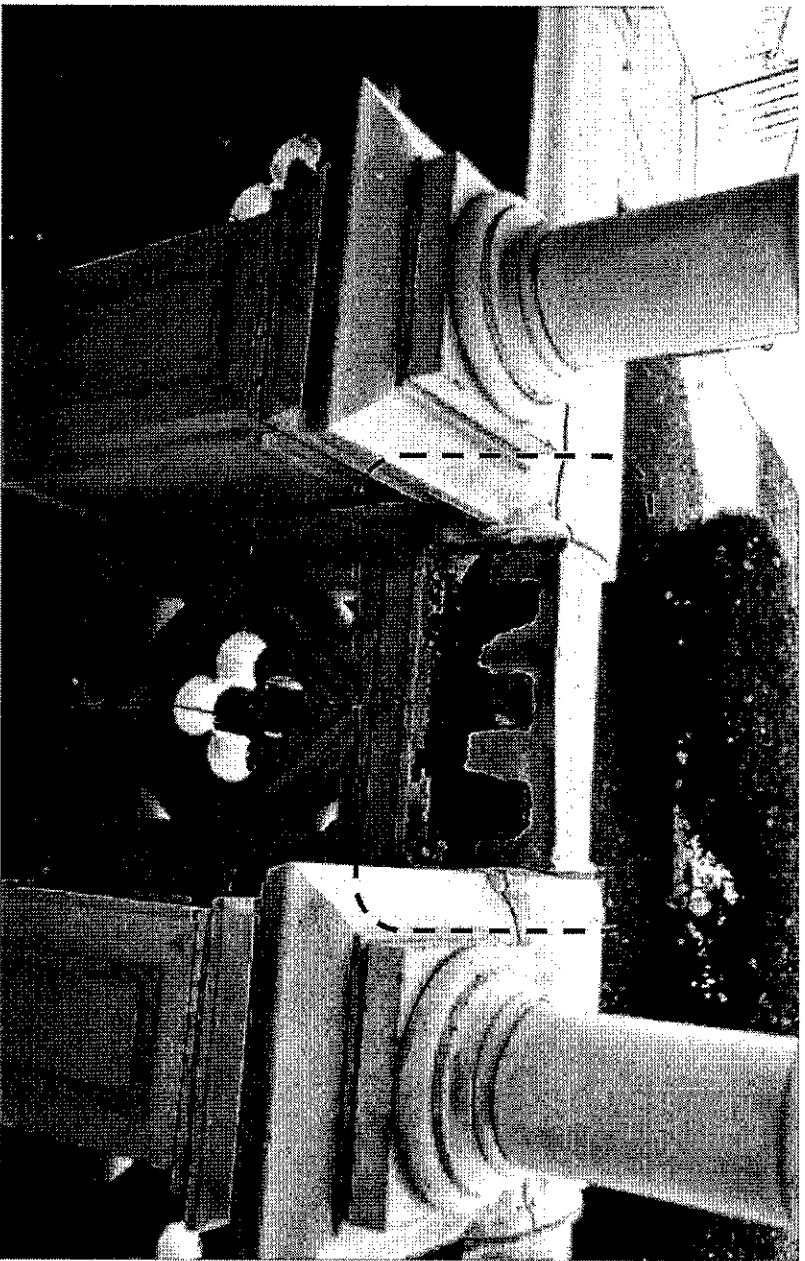
Image A: Terra cotta units are almost completely missing in several locations. These units can be temporarily plugged with clay but eventually require permanent replacement with custom-made units.

Stabilization Treatment 2: Temporary repair of badly broken or missing units.

- a. Remove broken portions of unit carefully, including loose and deteriorated terra cotta, to avoid damaging surrounding intact units.
- b. Catalog and carefully document or store any original fragments that might be needed to faithfully reproduce units in the future.
- c. Clean the area with clean water and a bristle brush to remove any loose particles.
- d. Create a clay plug, carefully fitting the remaining void to prevent any further water infiltration or cover with ice and water shield membrane.

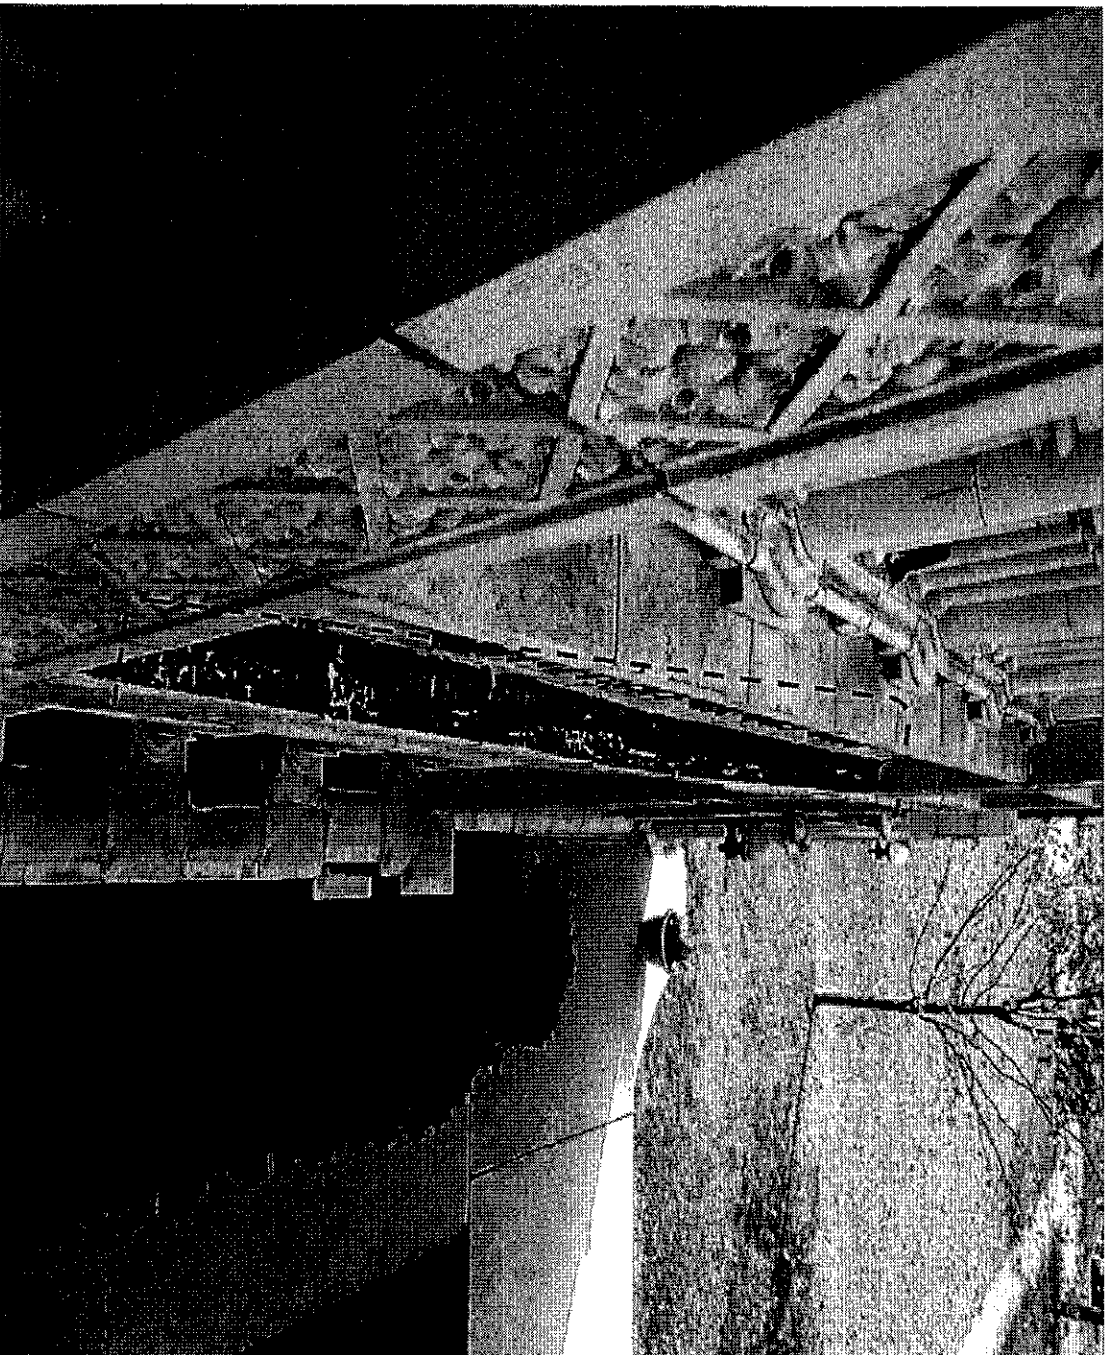
Figure C (right): Cracking along top of projecting signage fascia. A later application of tar is apparent, though crack has reformed. This type of crack indicates terra cotta units may be tilting away from the wall and require additional reinforcement prior to repair. Tar should also be removed prior to repair. Ice and water shield membrane may be added to protect more vulnerable horizontal (skyward) facing cracks such as this one. Stainless steel anchor bolts may be necessary to affix the front face into the back of the unit to prevent catastrophic failure.

Stabilization Treatment 1: Temporary repair of large cracks/voids.

- a. Carefully remove material from any previous repair attempts.
- b. Cut away all loose and deteriorated terra cotta (retain and tag any pieces that can be repaired at a later date).
- c. Clean the area with clean water and a bristle brush to remove any loose particles.
- d. Install a backer rod inside the crack to reinforce terra cotta and sealant.
- e. Seal crack with an elastomeric sealant, such as Sonneborn NP1, color to match terra cotta.
- f. On certain horizontal (skyward) facing cracks, cover terra cotta units with ice and water shield membrane along the length of the crack to further prevent water infiltration.

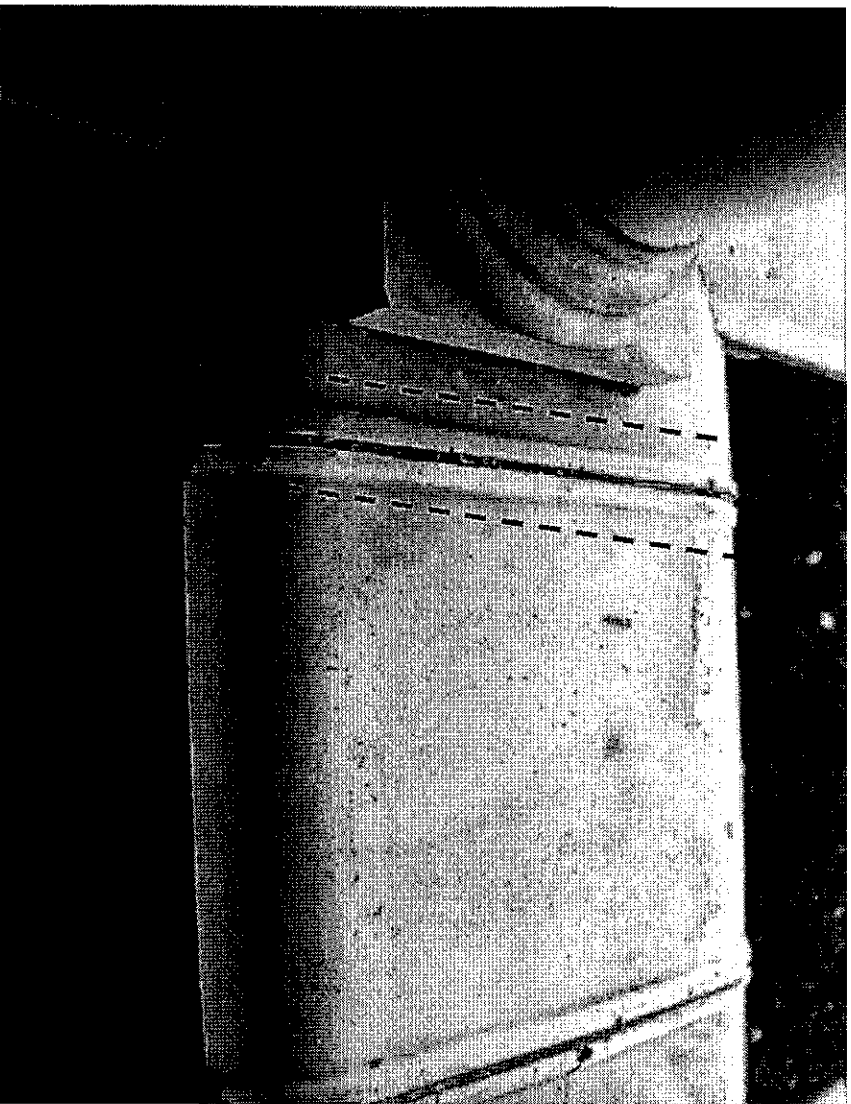
Horizontal (skyward) facing joints on loggia cornices and railing copings are exposed to moisture penetration. The severity ranges from hairline cracks to fully open joints where sealant is missing. Repairing these joints with an elastomeric sealant is a fairly inexpensive solution that prevents further moisture penetration and protects those elements from further deterioration and costly future repairs. Skyward facing joints should never be finished with mortar.

Figure F: Open joints between railing units allow water to seep into railings and walls, hastening the deterioration of terra cotta and masonry below.

1. Cut and resal cracked and open horizontal (skyward) joints and their returns where appropriate.
 - a. Remove existing sealant in cracked and open joints down to bedding mortar.
 - b. Hand cut and use pneumatic chisels to remove any remaining sealant, using care not to damage surrounding units.
 - c. Install an elastomeric sealant, such as Sonneborn NP-11, color to closely match surrounding units, to resal all exposed joints.
