Scot W. McLean, ASHI
333 W. Brown Deer Rd. #117, Bayside, WI 53217
Phone: 414-228-6573
<http://www.tandinspection.com>

Inspection Summary

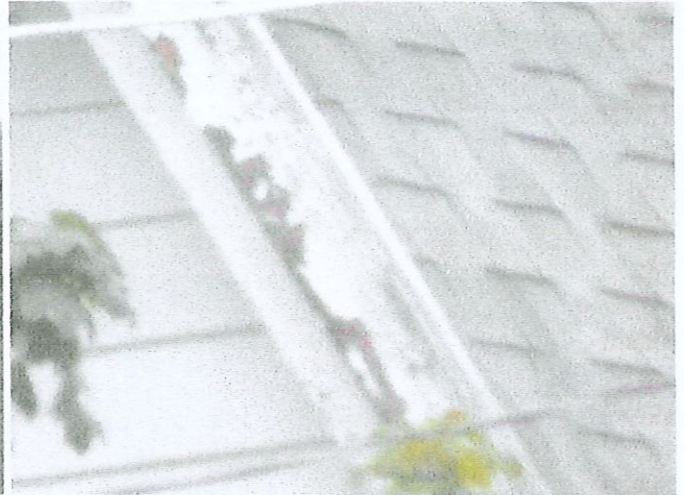
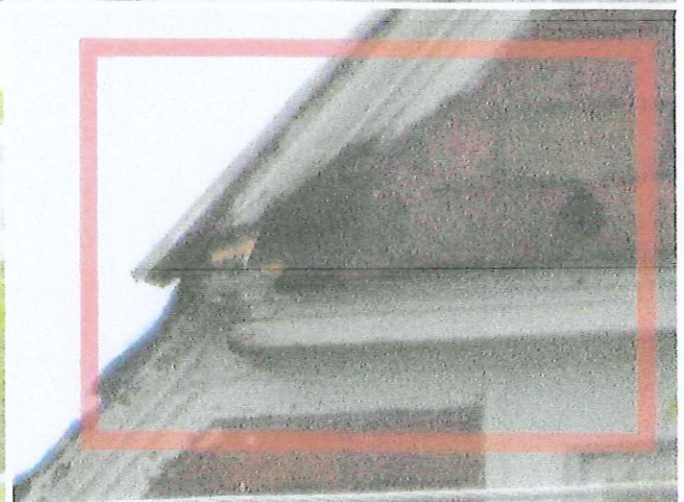
Siding Flashings

Inadequate flashings/sealants appear, There does not appear to be flashing on horizontal trim. This can cause deterioration. Ensure that a secure seal of caulk

is
maintained
as a temporary
measure which
may lead or
install proper
metal flashing.
Missing cap
flashing.
Add flashing to
prevent deterioration
and other water
penetration issues.
Lack of kick
out flashing
noted. Add
as needed.

d.
No/i
mpro
per
flashi
ng at
wind
ows/d
oors/t
rim.
Water
mana
geme
nt
syste
m not
obser
vable.
See
108
in
Refer
ence
Adde
ndum

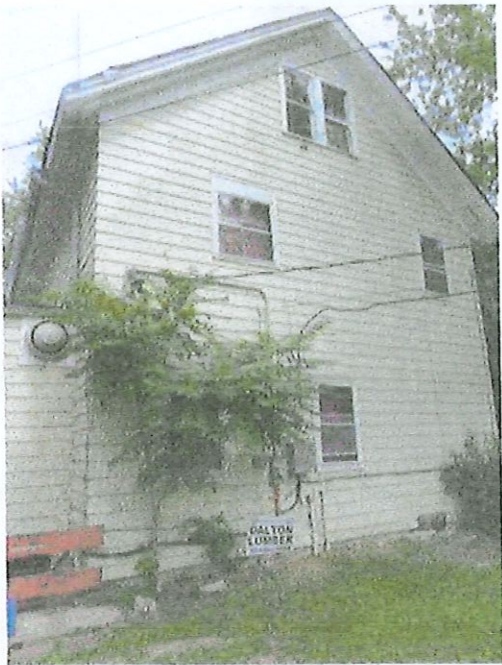
Vinyl/Metal:

Older/worn, Loose siding, Misaligned, Missing sections/corners, Holes/gaps. Seal to prevent pest/water infiltration. Holes, Dents Vintage installation Evaluate now for common maintenance needs. Seal any gaps/openings. Seasonally evaluate for future maintenance needs.

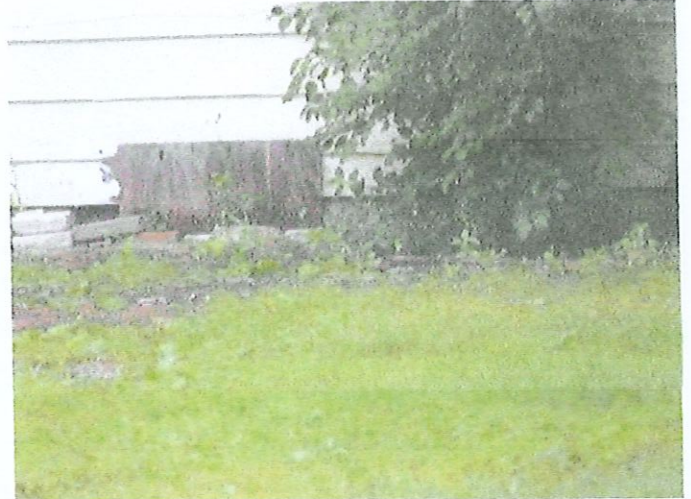
Basement Windows: (5)(a) 3.

Older/worn, Sealed/nailed/boarded/blocked shut.

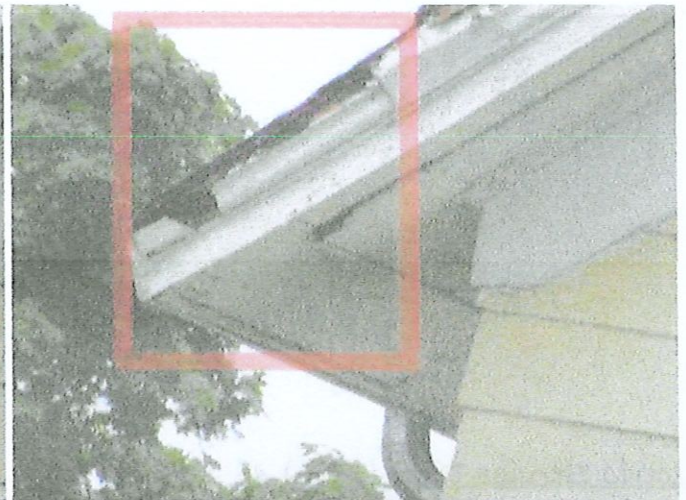
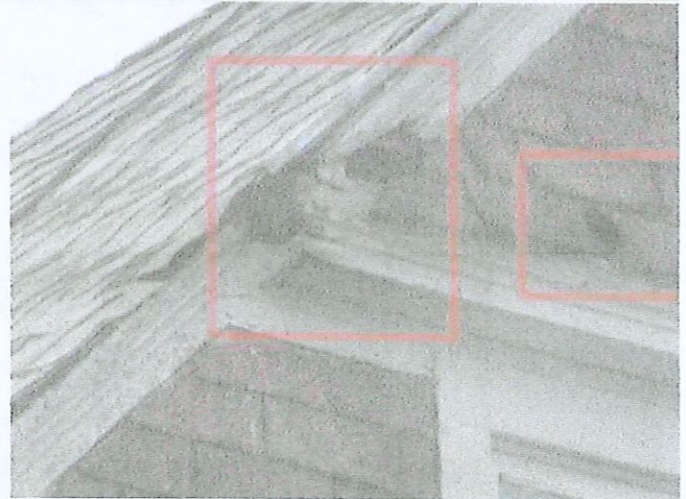
Condition:

Older/worn, Needs paint/stain, Significant deterioration noted at some locations. Needs repair. Warped/loose panels. Seal to prevent pest/water infiltration. Peeling paint. Holes/gaps. Seal to prevent pest/water infiltration. No vents, Water stains, Holes/gaps consistent with vermin entry points. Needs common maintenance/touch up/repairs. Evaluate now for common maintenance needs including flashing maintenance. Seal any gaps/openings. Seasonally evaluate for future maintenance needs.

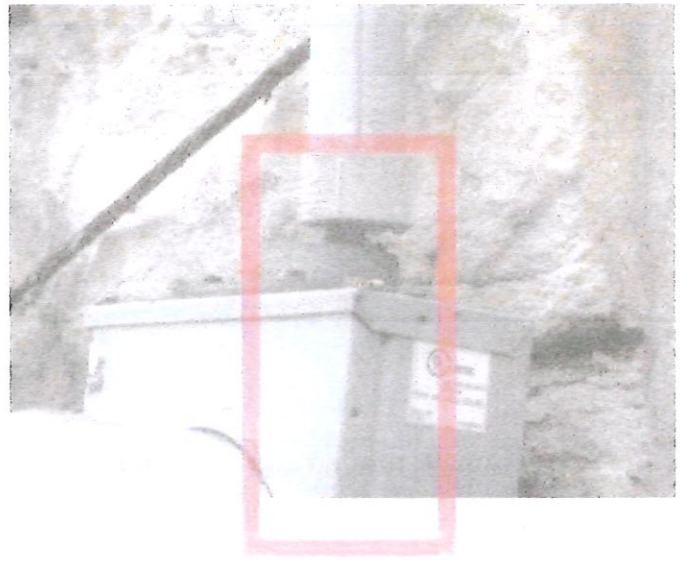
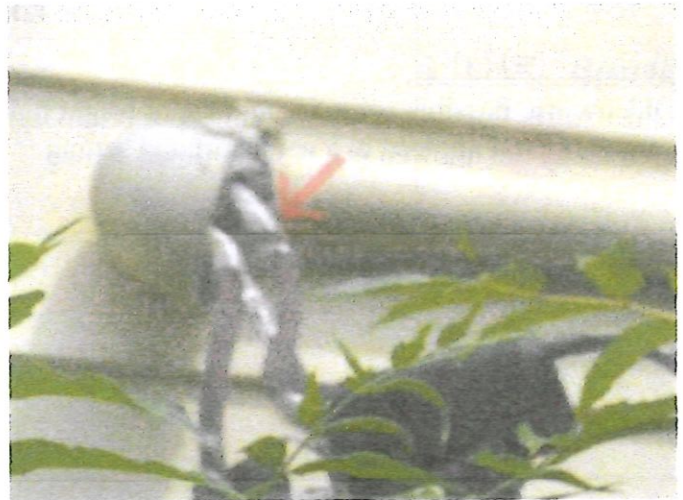
Electric Service Type (7) (a) 4.

Overhead, Cloth vintage era service wire at mast head at exterior. Older/worn. There appears to be fraying present. Overhead, Improperly fastened service conduit, Corrosion noted at service conduit. May need replacement in coming years. Consult an electrician for recommendations. Pulling away from building. This can pull on and detach the service wire connections. Have evaluated and repaired as needed by a licensed electrician for safety and good function. Detached conduit at alley,.

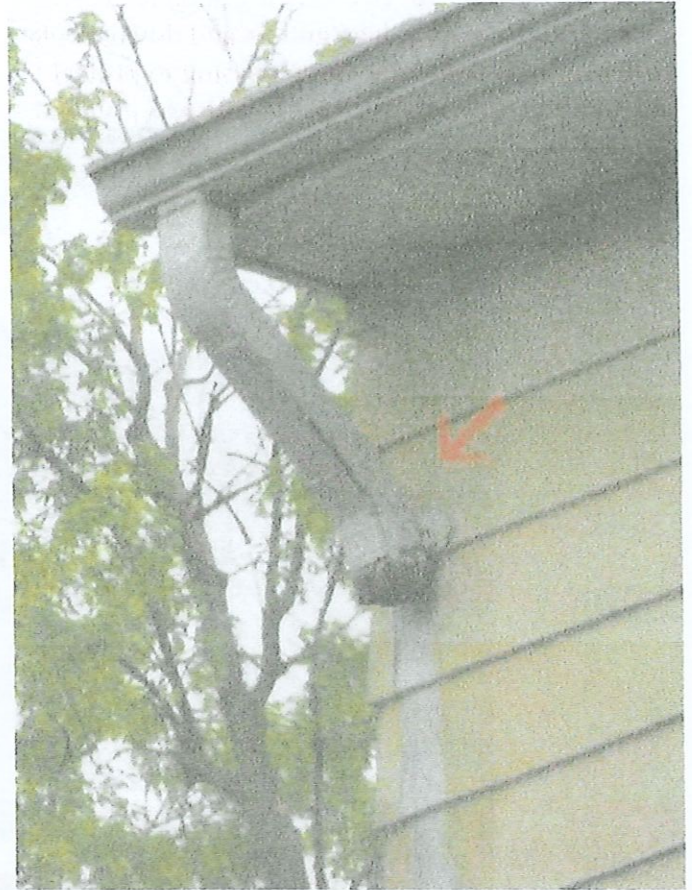
None, Metal, Discharges above grade, Discharges below grade. Monitor for damage, freezing, blockage. Older/worn, Add more downspouts, Disconnected sections, Missing sections, Add and maintain downspout extensions (6 ft minimum from building) and unlog as necessary now. Loose, Corrosion, Split, Drains onto roof. Consider directing to gutter. Downspouts need repair/replacement.

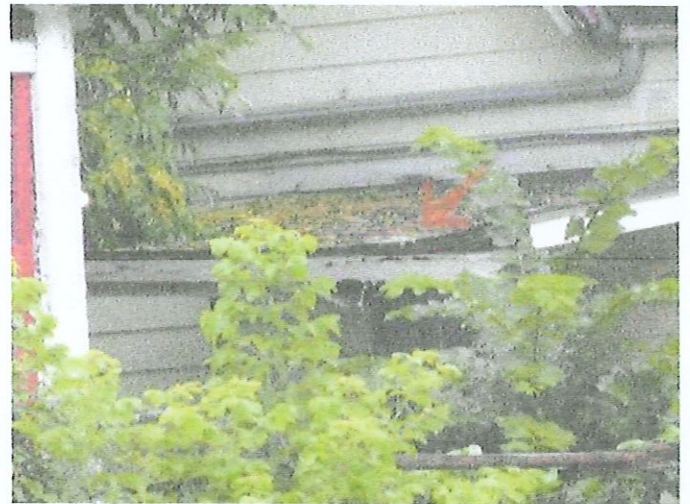
Restricted access/obscured view under deck limits the extent of the inspection. Older/worn, **Significant deterioration noted**. Bounciness/deflection observed. Loose boards, Unconventional construction, Peeling paint, Suggest adding railing. Non-standard rise/run, High step up where walk has settled. Bottom of steps worn. Monitor for maintenance. Warped/bowed posts, Implication- Weakened structure. Water management system not observable. No flashing observed. Structural life 10 - 15 years.

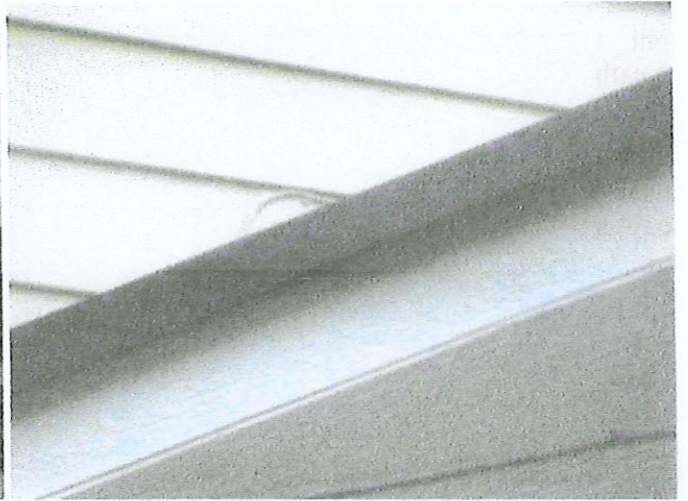
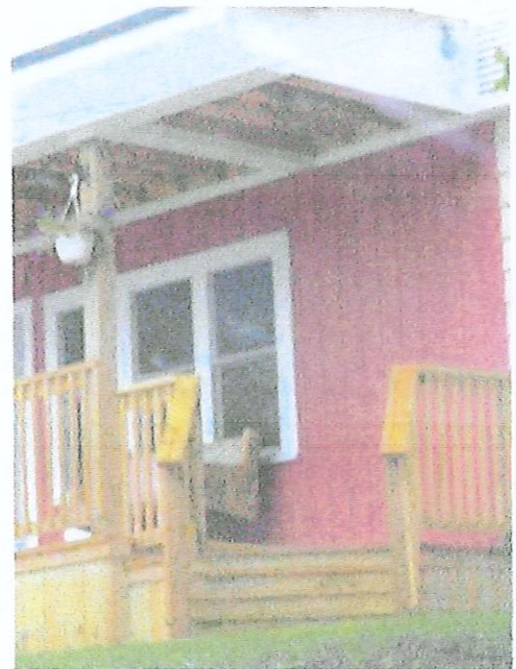
Main Building Front Entry off 24th: (5)(a) 5.

Main building front, with a modern constructed porch entry system and 2 sets of opposite stair systems. Soffit at roof cover system unfinished, with what appears a recessed can 2-4 lights installed, appears as possibly not rated

for
exter
nal
exter
nal
weath
er
and
heat
expos
ure.
Verif
y
instal
lation
and
any
electr
ical
permi
ts as
Open
and
or
close
d as
prude
nt.
Simil
arly
overh
ang at
this
entry,
roofin
g
mater
ial as
obser
ved
unfini
shed
and
functi
on
and
servic

e not
assur
ed.
Edges
unfini
shed
loose
and
hangi
ng,
no
attach
ment
bars
or
edge
fasten
er
syste
ms
obser
ved.

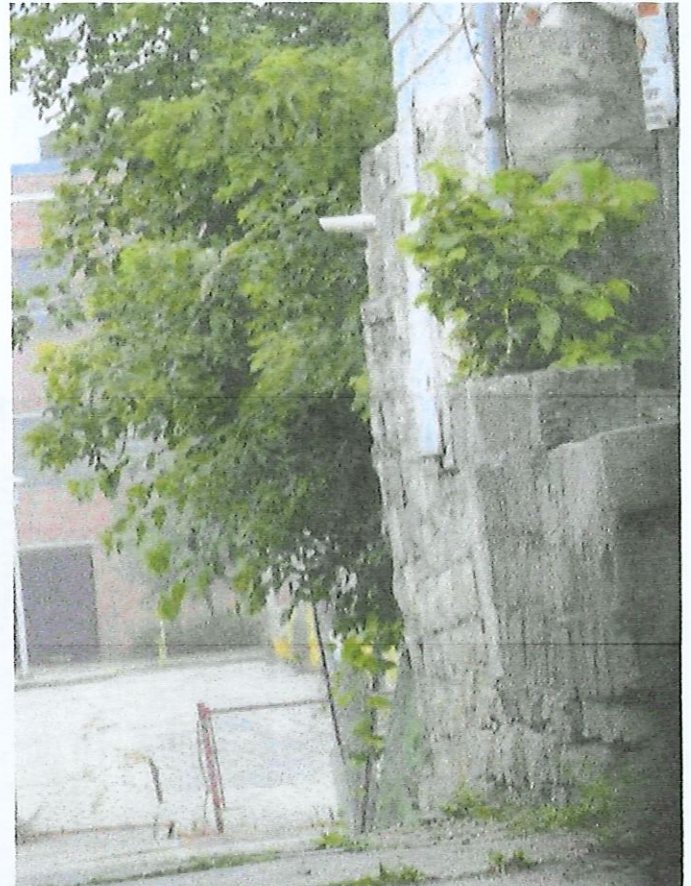
Significant cracks/damage noted. Older/worn, Spalling/shaling/surface deterioration, No drainage noted, Bowed, Leaning, Loose stones, Leaning, bulging, tipping, possible active movement. Open/wide joints between blocks/stones, Maintain grading and deflect water away from the soil behind retaining walls for maximum longevity. Needs replacement. A possible hazard, possible encroachment to/over public thorough-way alley.

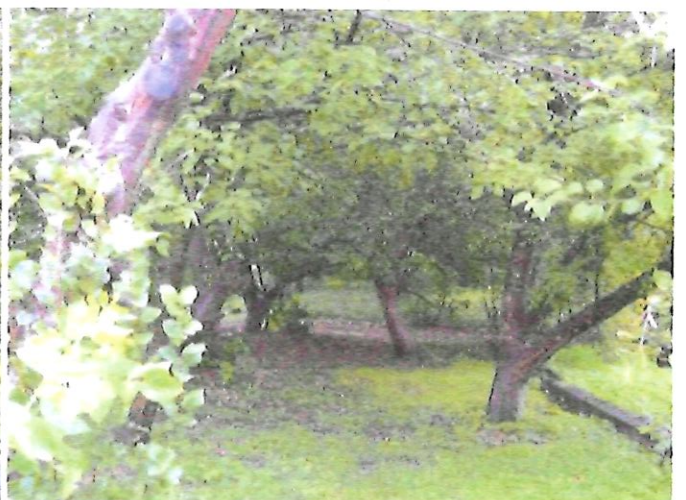
Vegetation

Trees /Shrubbery too close to building; house

Trees too close to roof/screeping on roof.

Correct to prevent damage and evaluate/repair shingles as needed. Need trimming or removing. Verifying the health of the vegetation on the property is beyond the scope of this inspection. In this region, Ash trees in partic

and/or other plants should be kept at least 12 inches away from buildings to prevent trapped moisture and advanced wear to siding/roofing.

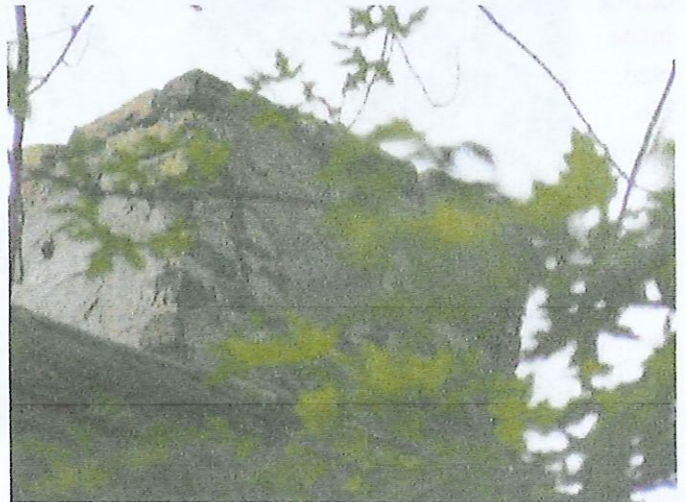
Chimney Cap: (4)(a) 4.

Top of chimney is not observed/evaluated. Major cracks, Wear/tar/patching/cracks noted at sides of chimney cap. Evaluate chimney system by a qualified contractor. Prior repairs noted. Older/worn, Missing/damaged brick/stone, Suggest renewing chimney cap. Consult a chimney or masonry restoration specialist.

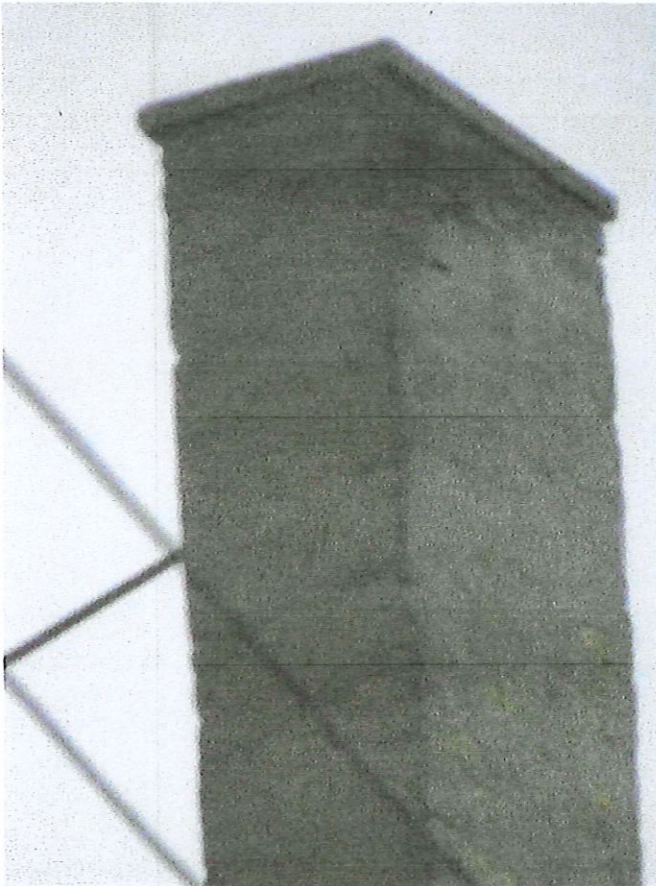
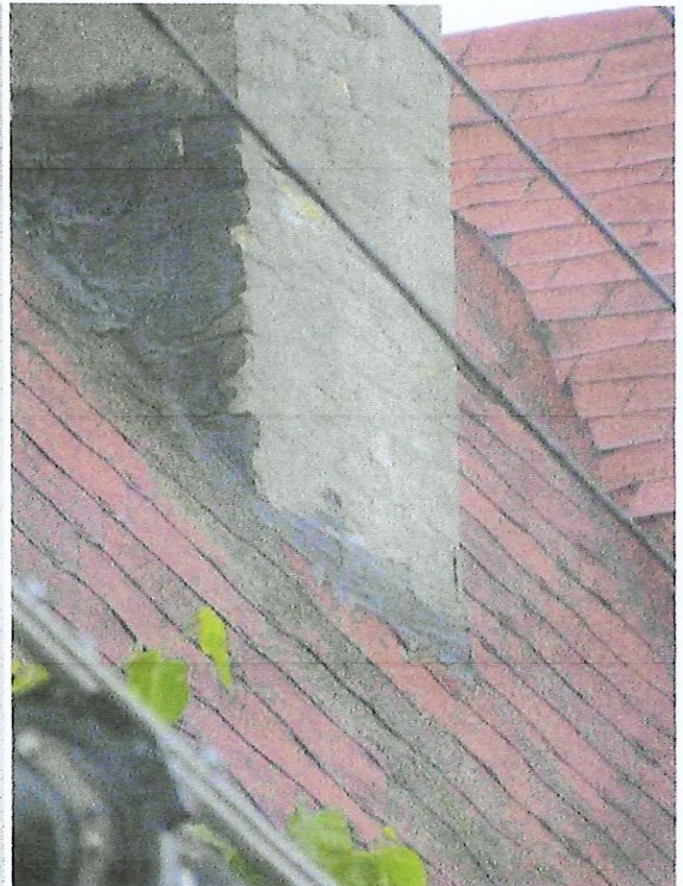
Chimney: (4)(a) 4., (9)(a) 4.

Limit ed/ob struct ed view of flashi ng due to locati on/ac cess. Chim ney flashi ngs are susce ptible to leaka ge at any

time.
Ask
the
seller
for
any
histor
y of
leaks/
water
penet
ration
and
relate
d
conce
rns.
Roofi
ng
masti
c/tar
seala
nt.
These
seala
nts
are
temp
orary
and
susce
ptible
to
leaka
ge at
any
time.
Ask
the
seller
for
any
histor
y of
leaks/
water
penet
