**The Grand Department Store**  
HISTORIC PRESERVATION CERTIFICATION APPLICATION  
PART 1 - EVALUATION OF SIGNIFICANCE & PART 2 - DESCRIPTION OF REHABILITATION

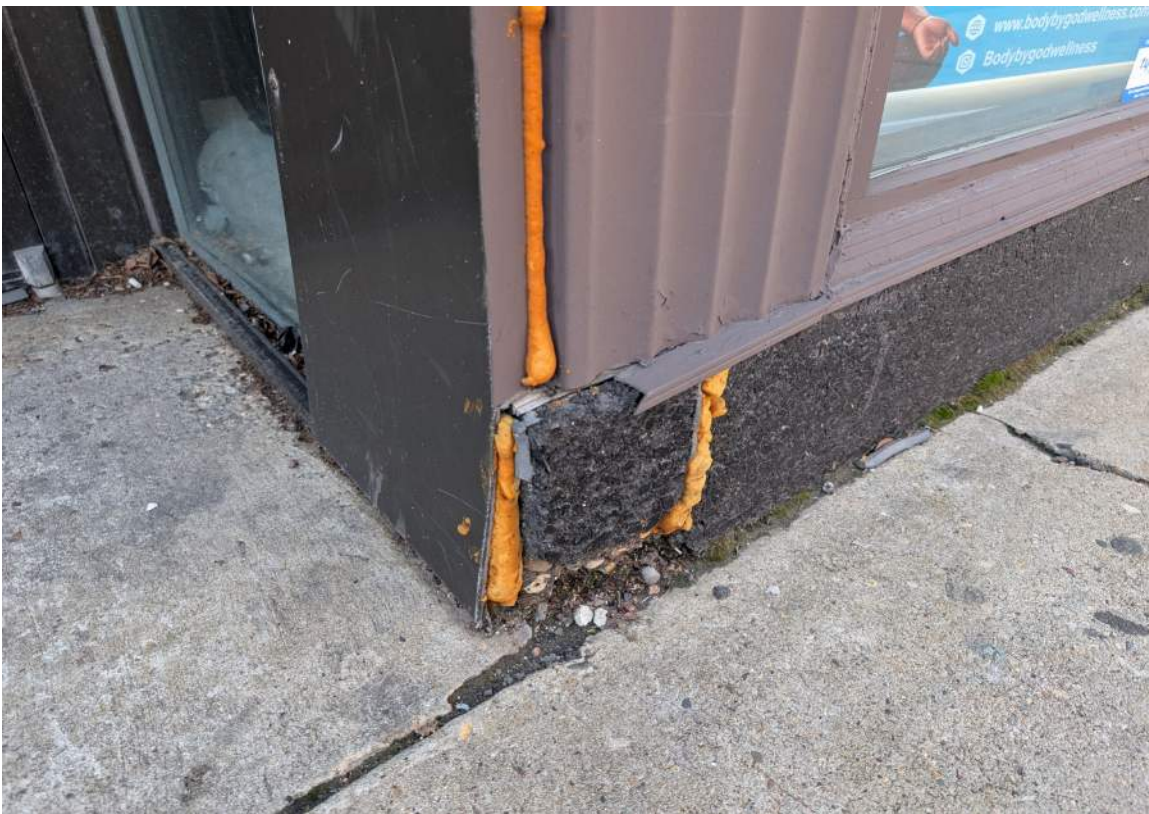
IMAGE 5: Exterior - looking down at deteriorated cast granite panels and existing spray foam insulation

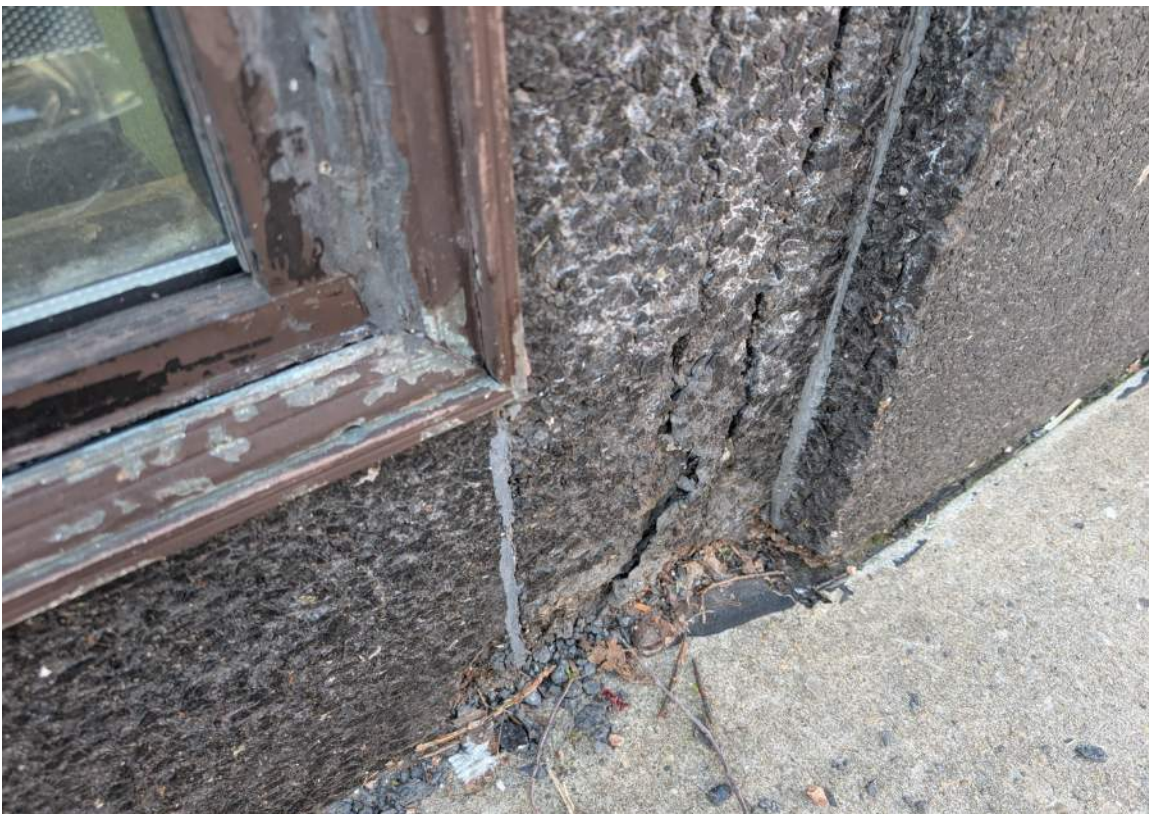
IMAGE 15: Exterior - looking down at deteriorated cast granite panels with existing fill at through cracks; base of existing storefront system with perimeter trims

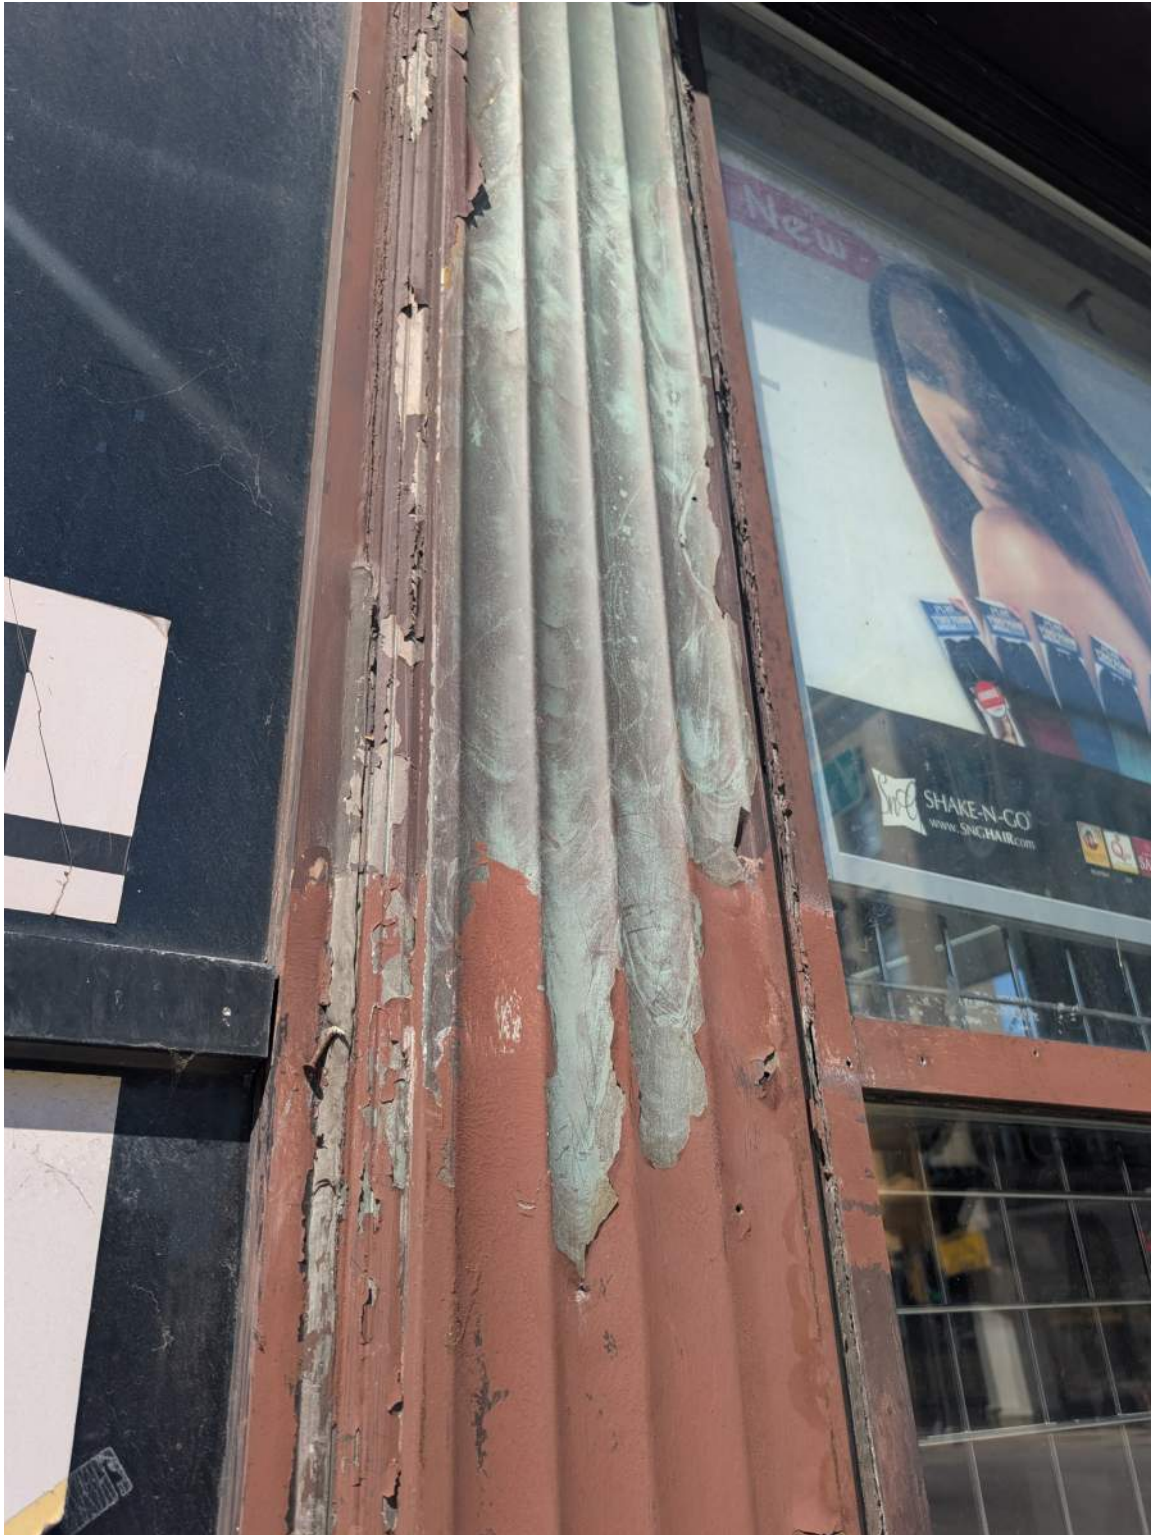
IMAGE 22: Exterior - looking up at bronze fluted mullion with flaking paint and existing storefront system with perimeter trims

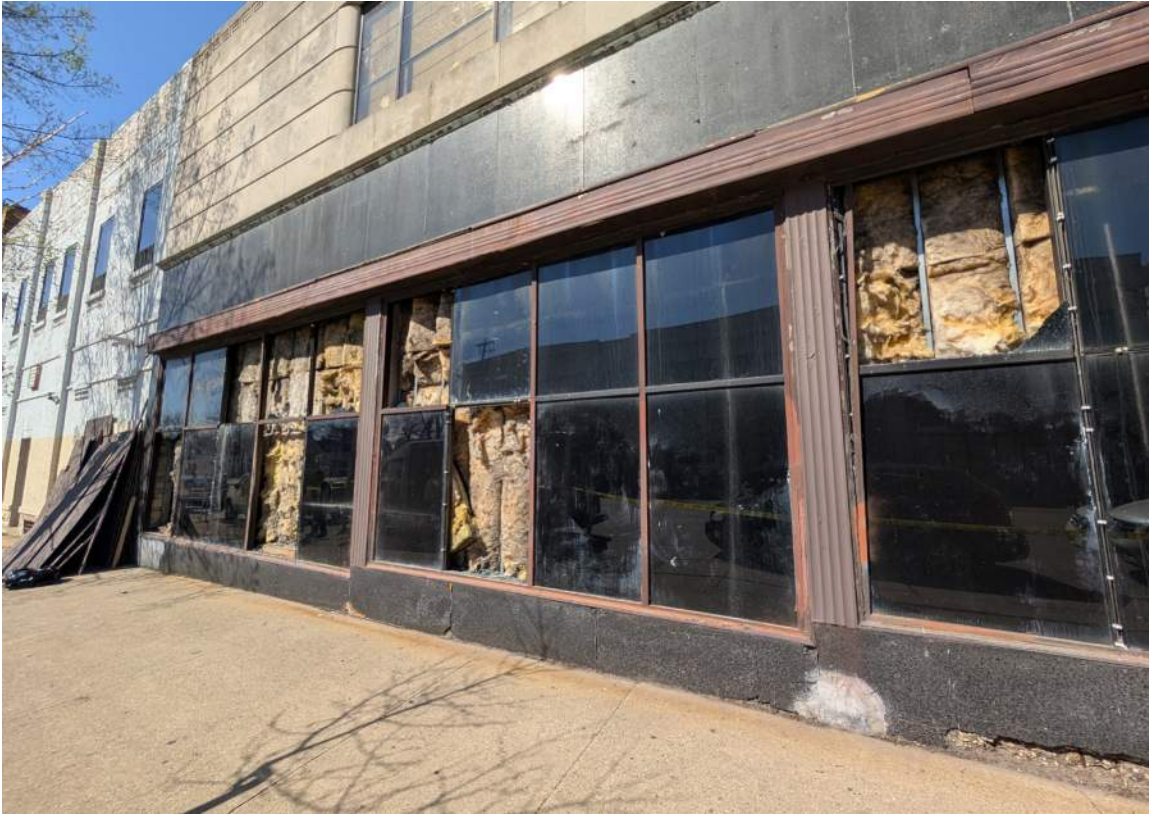
IMAGE 23: Exterior - looking southwest at existing storefront system - broken panes of glass and exposed insulation on backside of interior furring wall beyond

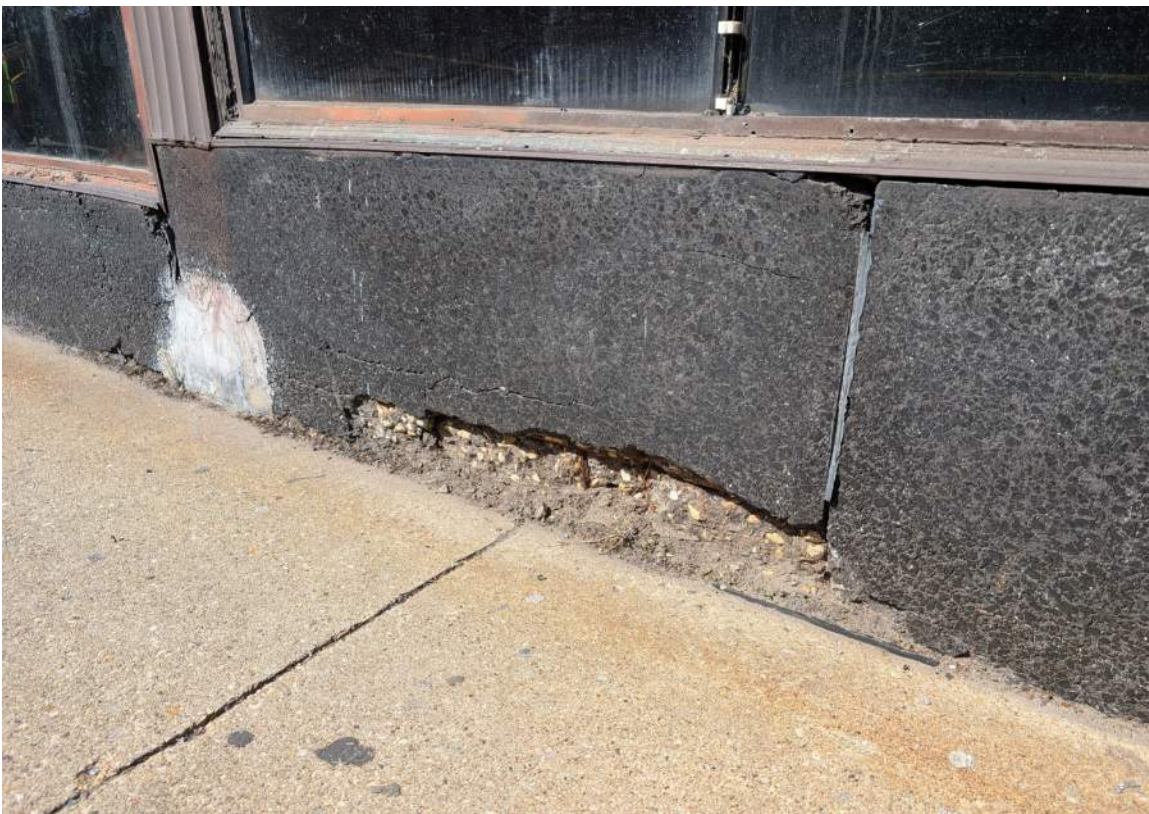
IMAGE 24: Exterior - looking down at broken and missing portion of cast granite panels; existing parking present on the left hand side of photo

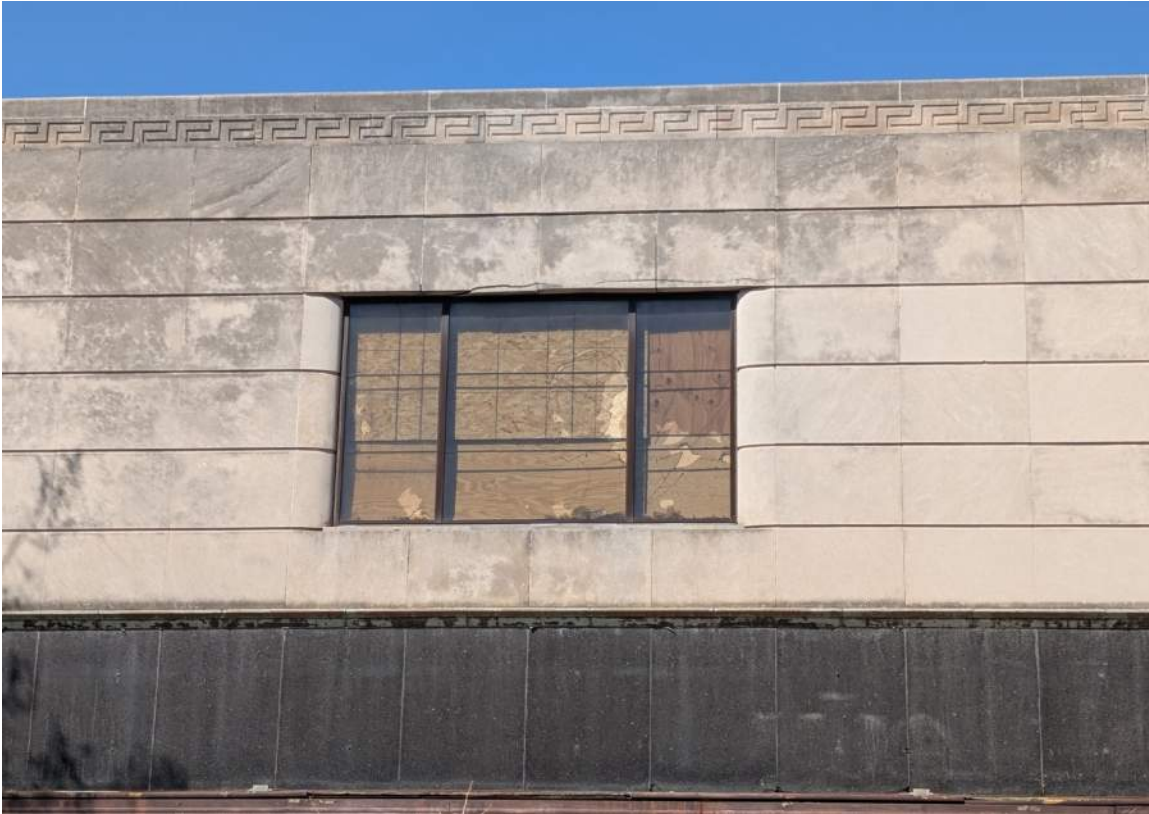
IMAGE 25: Exterior - looking west at existing storefront window in cut limestone facade; split limestone header above window head

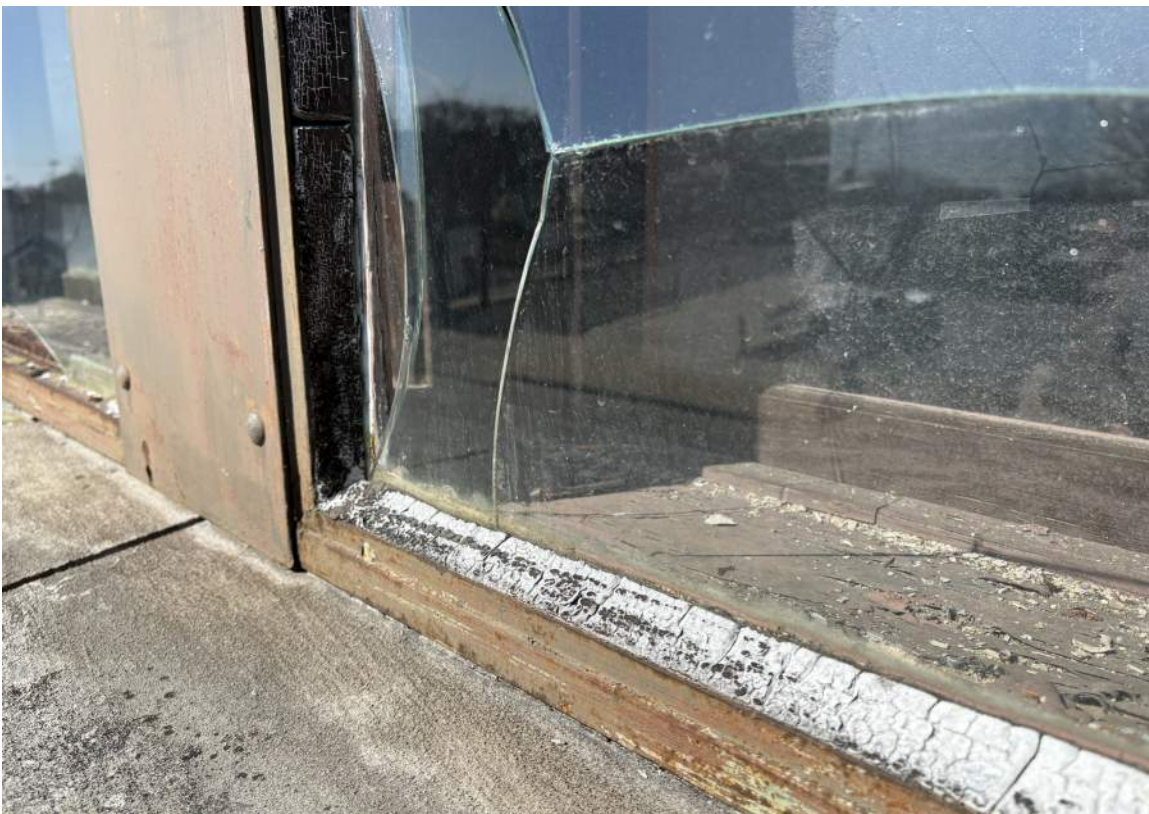
IMAGE 41: Exterior - looking down at sill frame of original steel sash window with broken glass and beveled glazing putty (photo from boom lift)

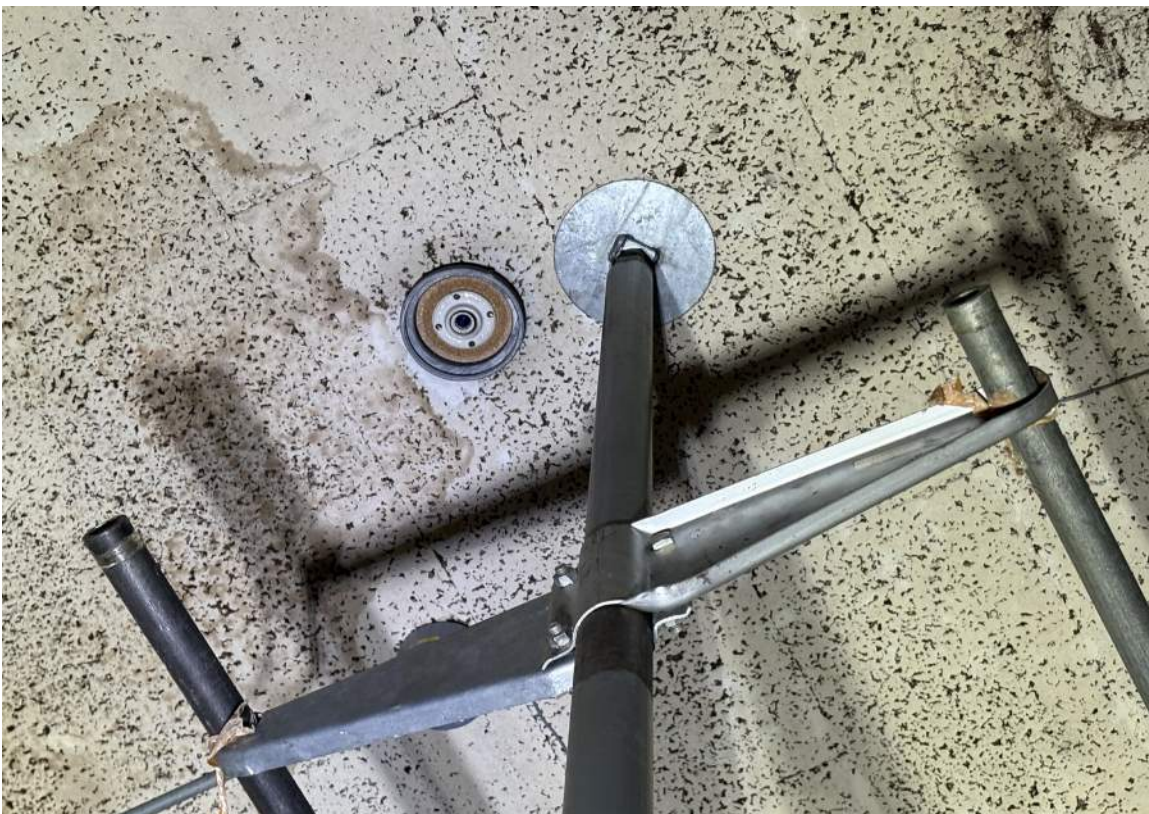
IMAGE 128: Level 02 - 1949 Structure - looking up at deteriorated existing corkboard ceiling finish
