Certificate of Appropriateness Application – Historic Preservation Commission

Project: HG Goll House

Location: 3005 W Kilbourn Ave

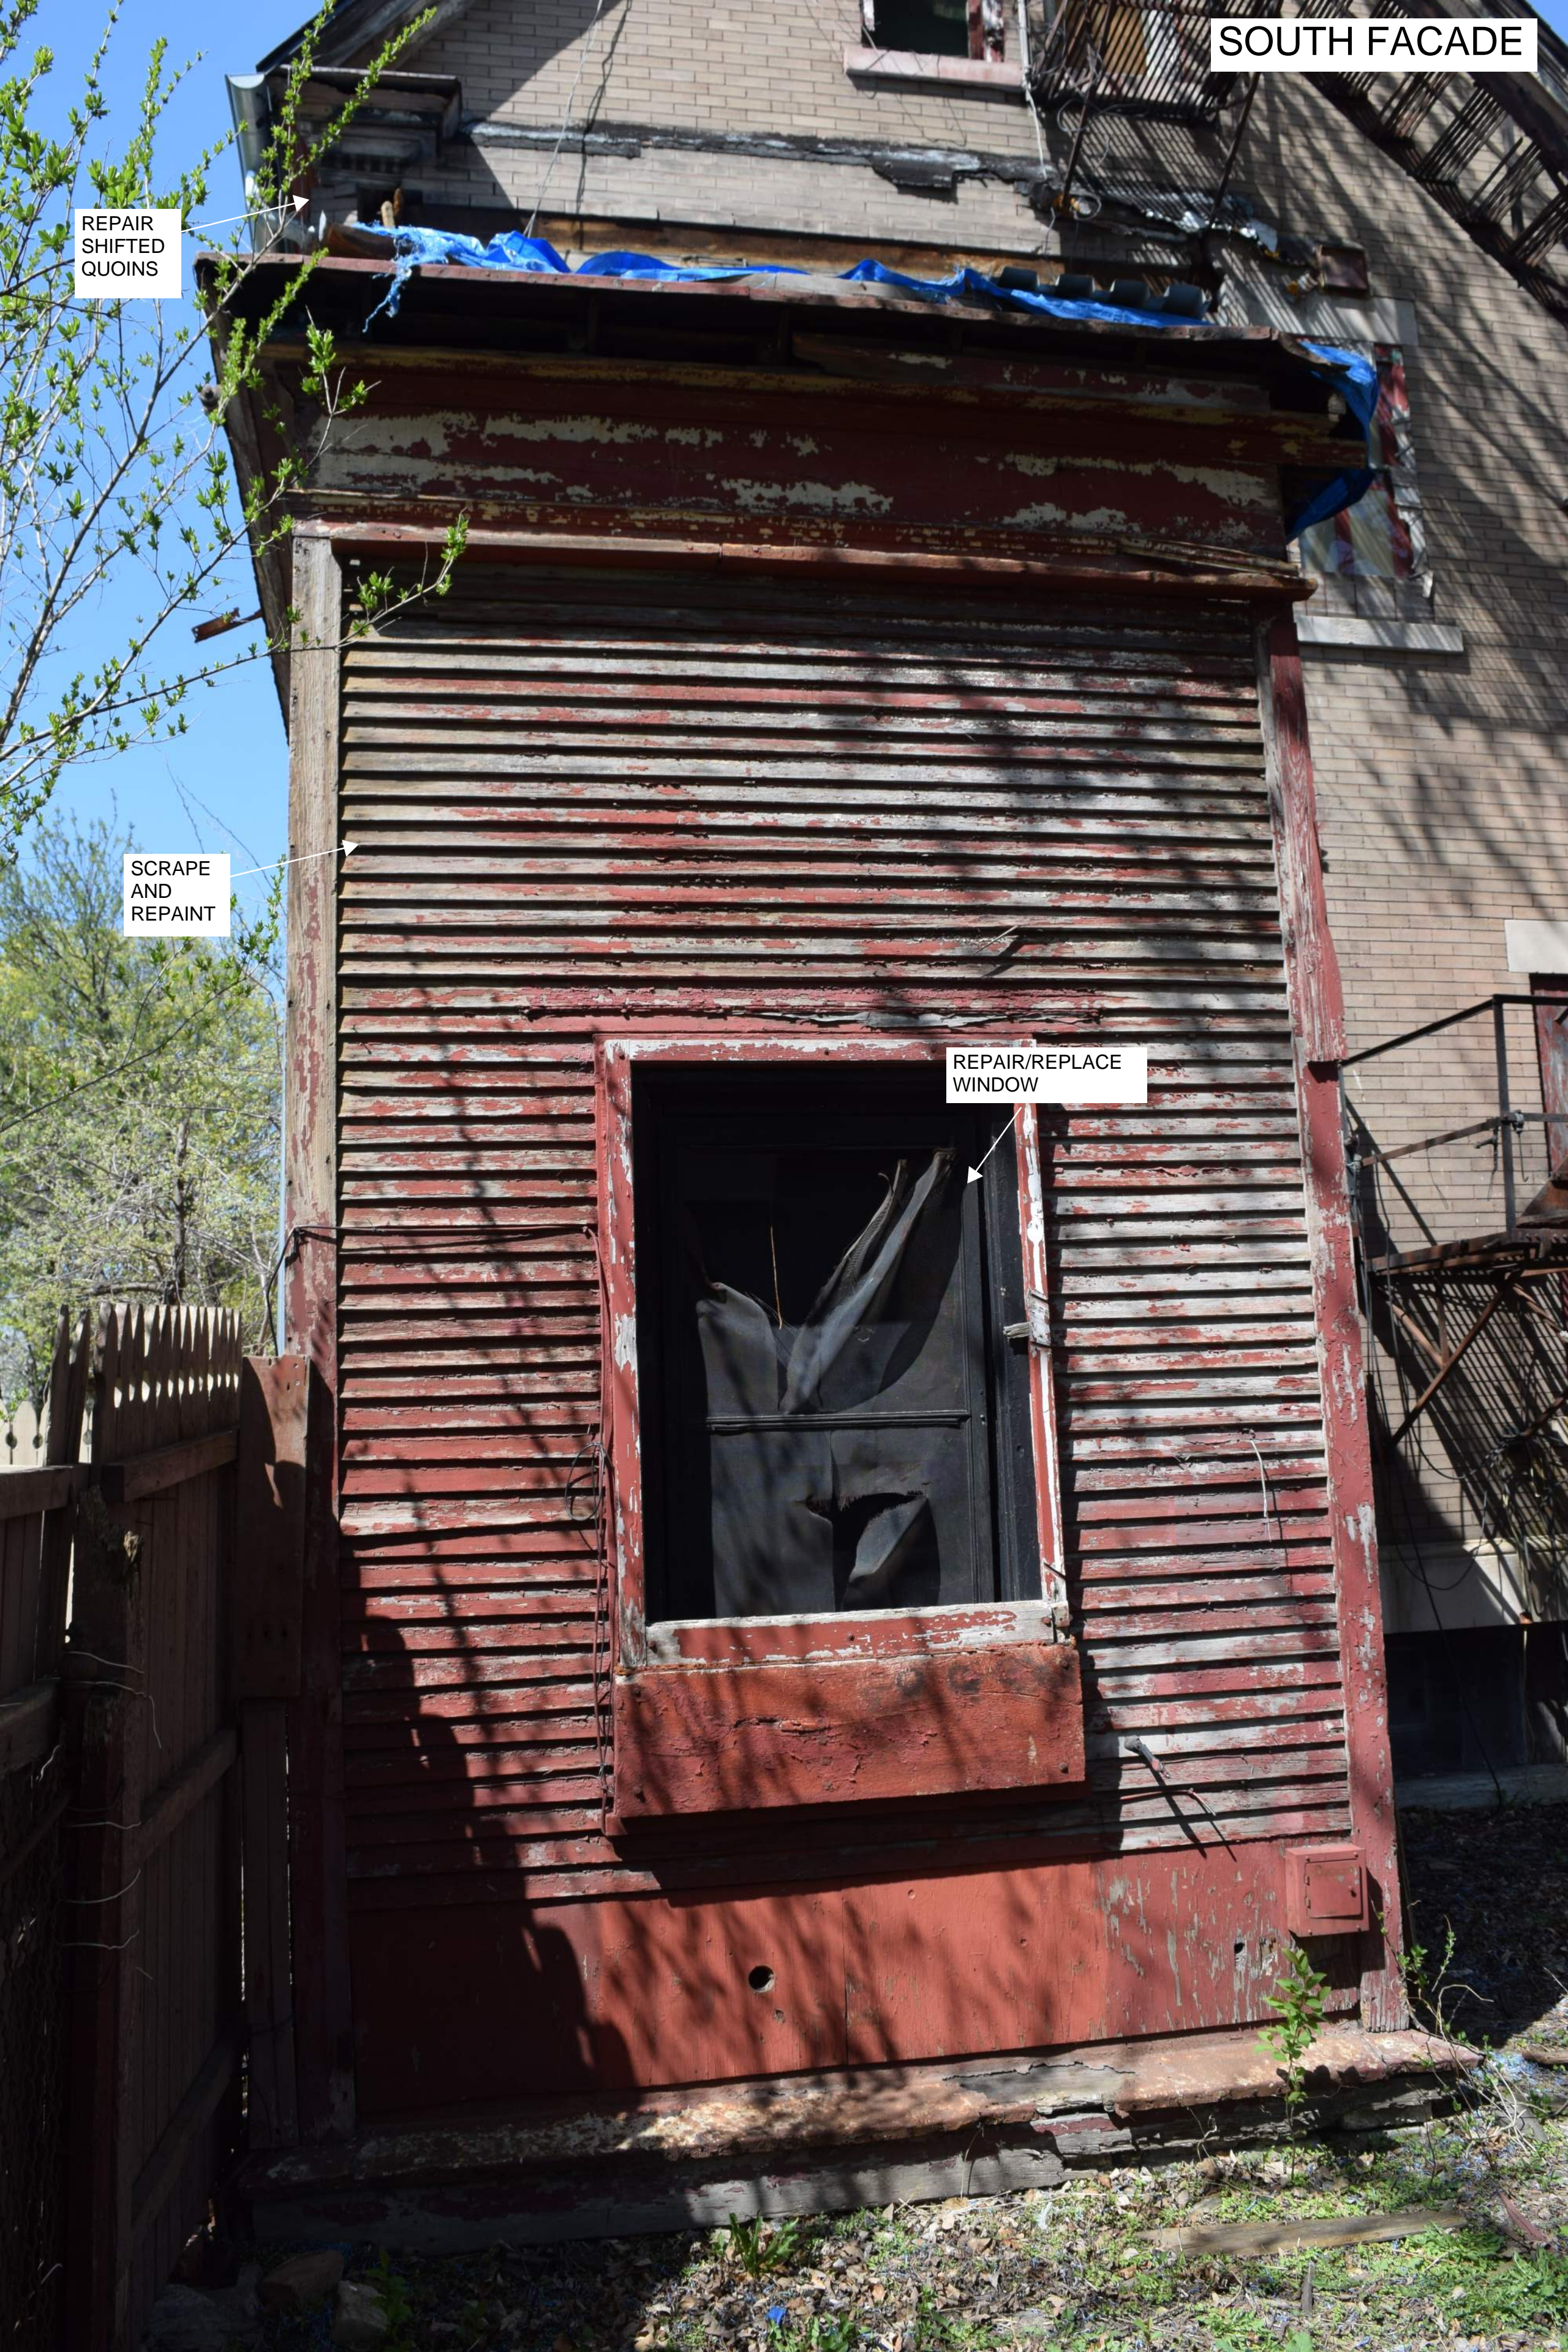
SOUTH FACADE

Shifted quoins on the south-west corner will be removed and rebuilt through reinstallation of the existing materials. Corner parapets that have begun to deteriorate will also be rebuilt using existing and salvaged materials.

REPAIR/REPLACE WINDOW

REPAIR/REBUILD EXISTING CROWN/DENTIL MOULD

REPAIR SHIFTED QUOINS

REPOINT DEFECTIVE MORTAR

REPAIR
SHIFTED
QUOINS

SCRAPE
AND
REPAINT

REPAIR/REPLACE
WINDOW

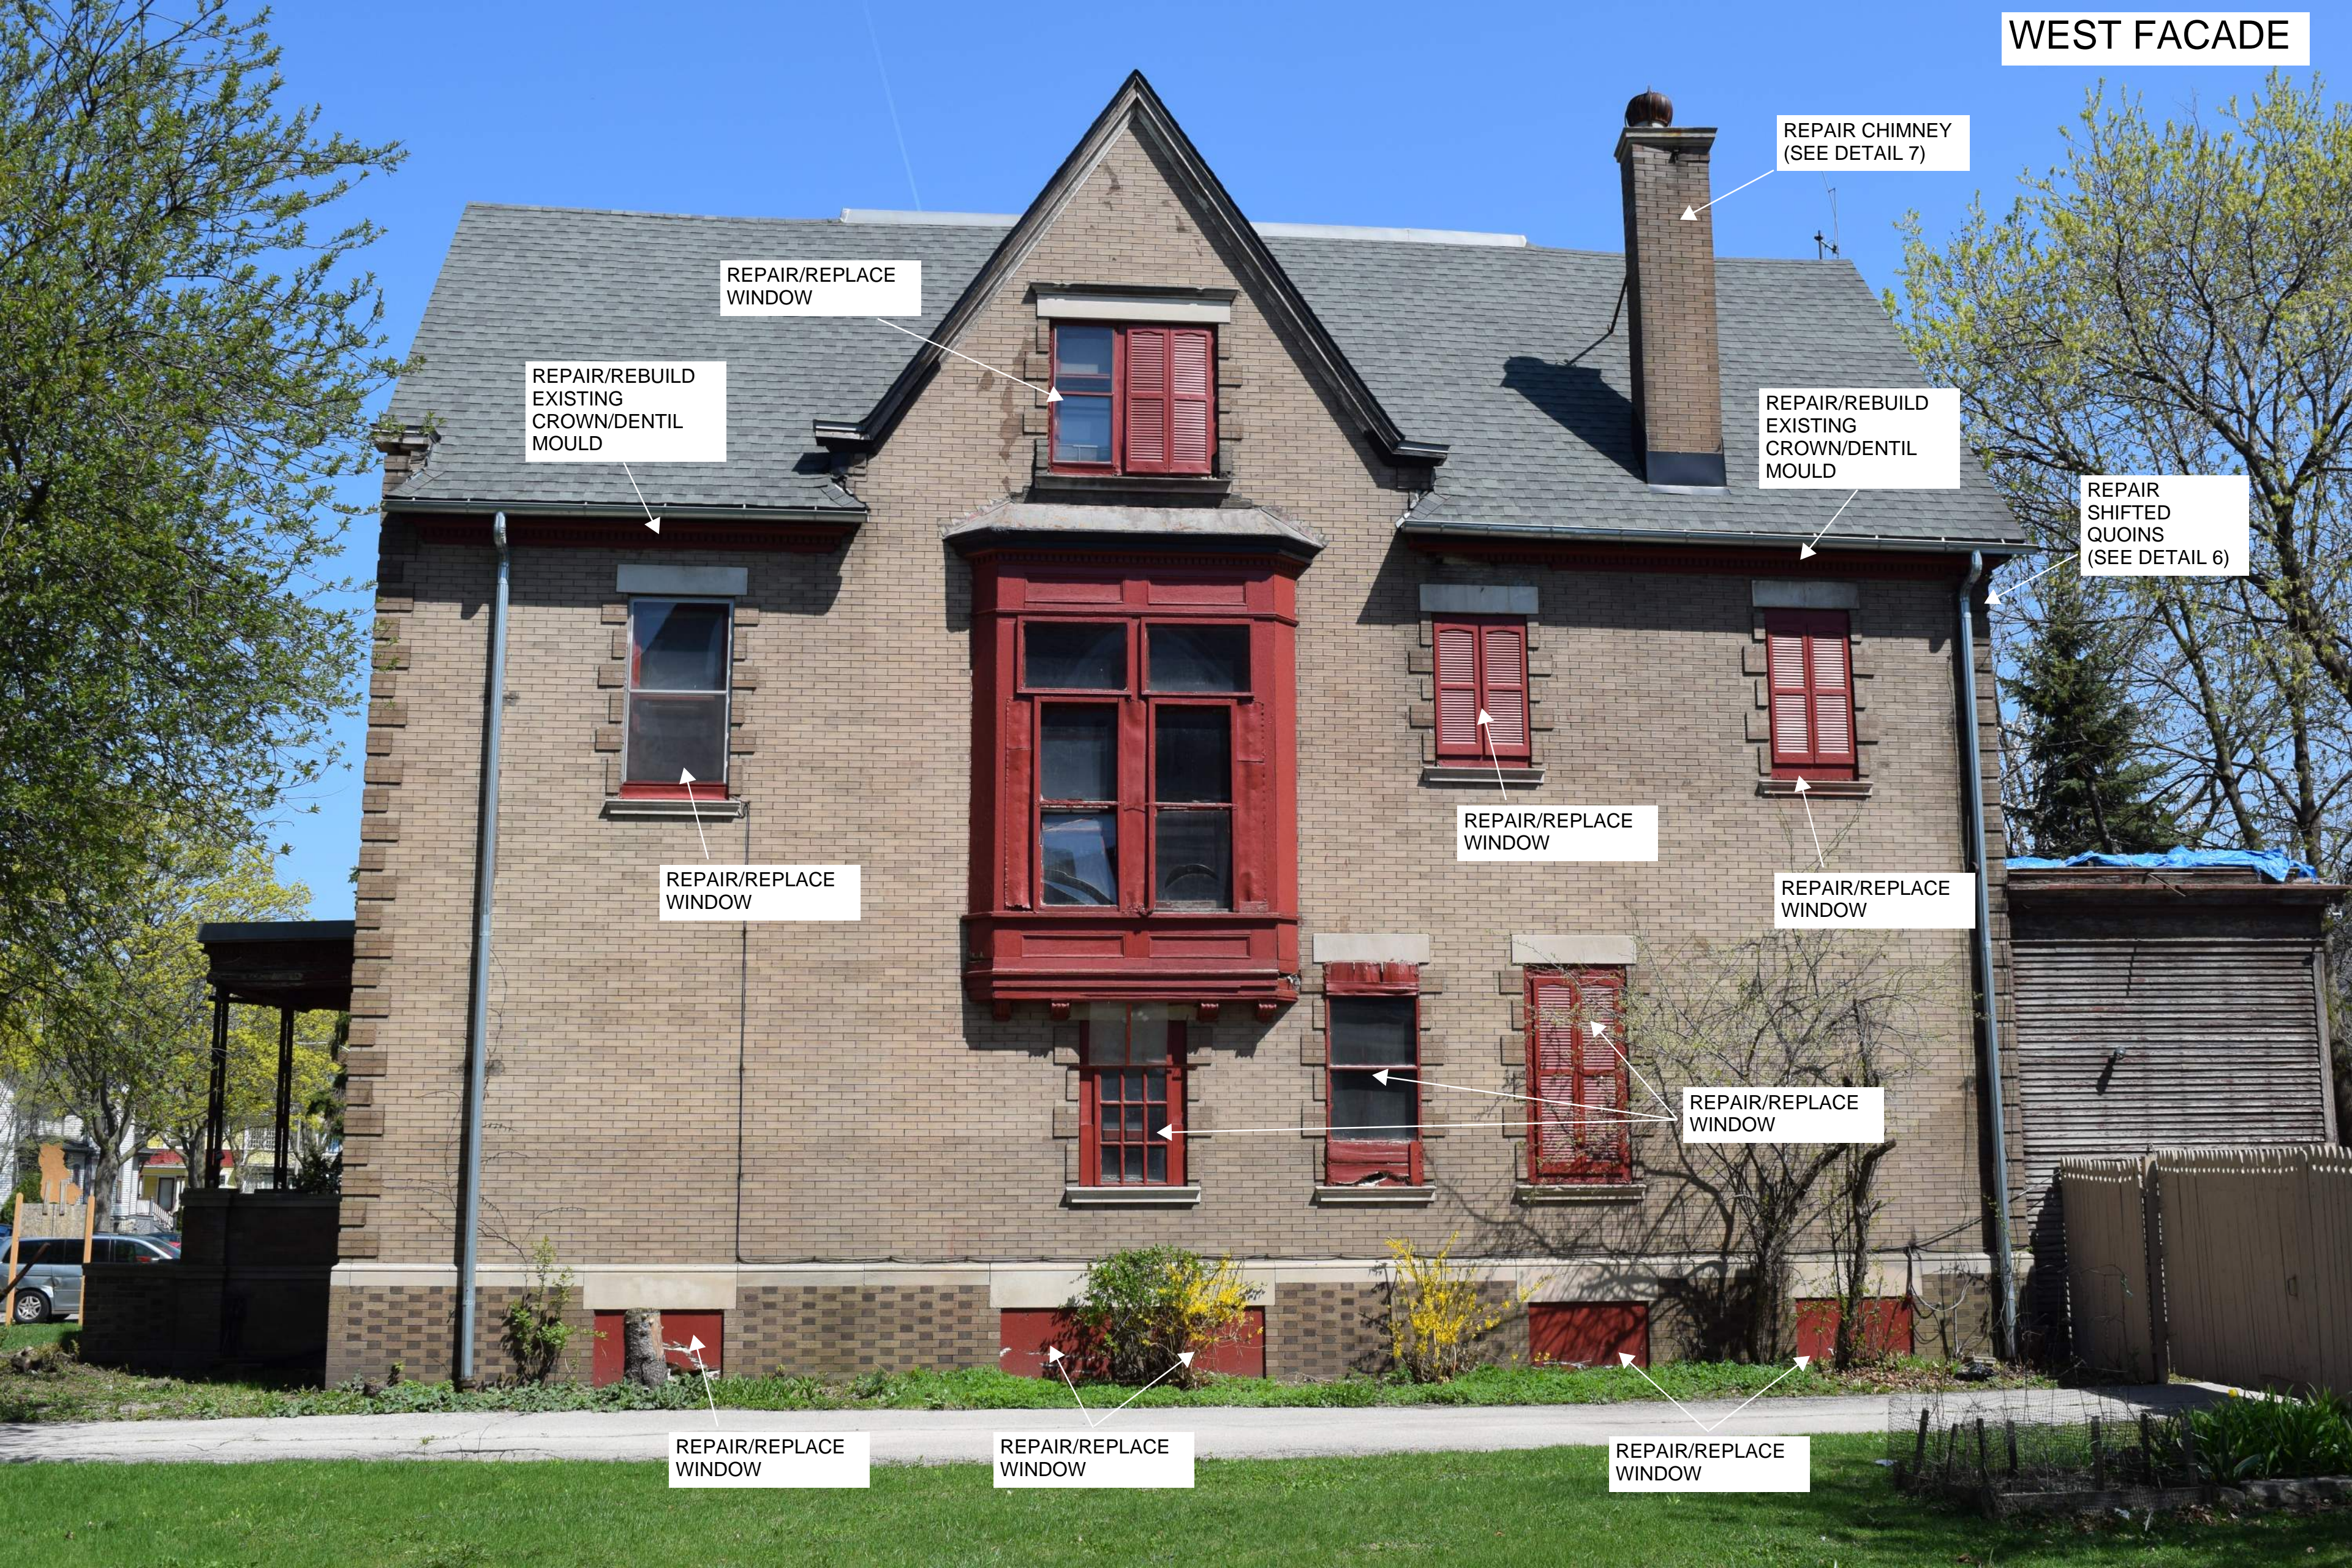
WEST FACADE

The building has two brick chimneys that are in fair condition. Each will be repointed by duplicating the original in composition, color, aggregate, joint style, tooling profile, texture and strength. The western-most chimney has begun to twist away from the main shaft at the existing brace point. The upper row of brick on the shaft and coping will be removed and reinstalled.

REPAIR CHIMNEY
(SEE DETAIL 7)

REPAIR/REPLACE
WINDOW

REPAIR/REBUILD
EXISTING
CROWN/DENTIL
MOULD

REPAIR
SHIFTED
QUOINS
(SEE DETAIL 6)

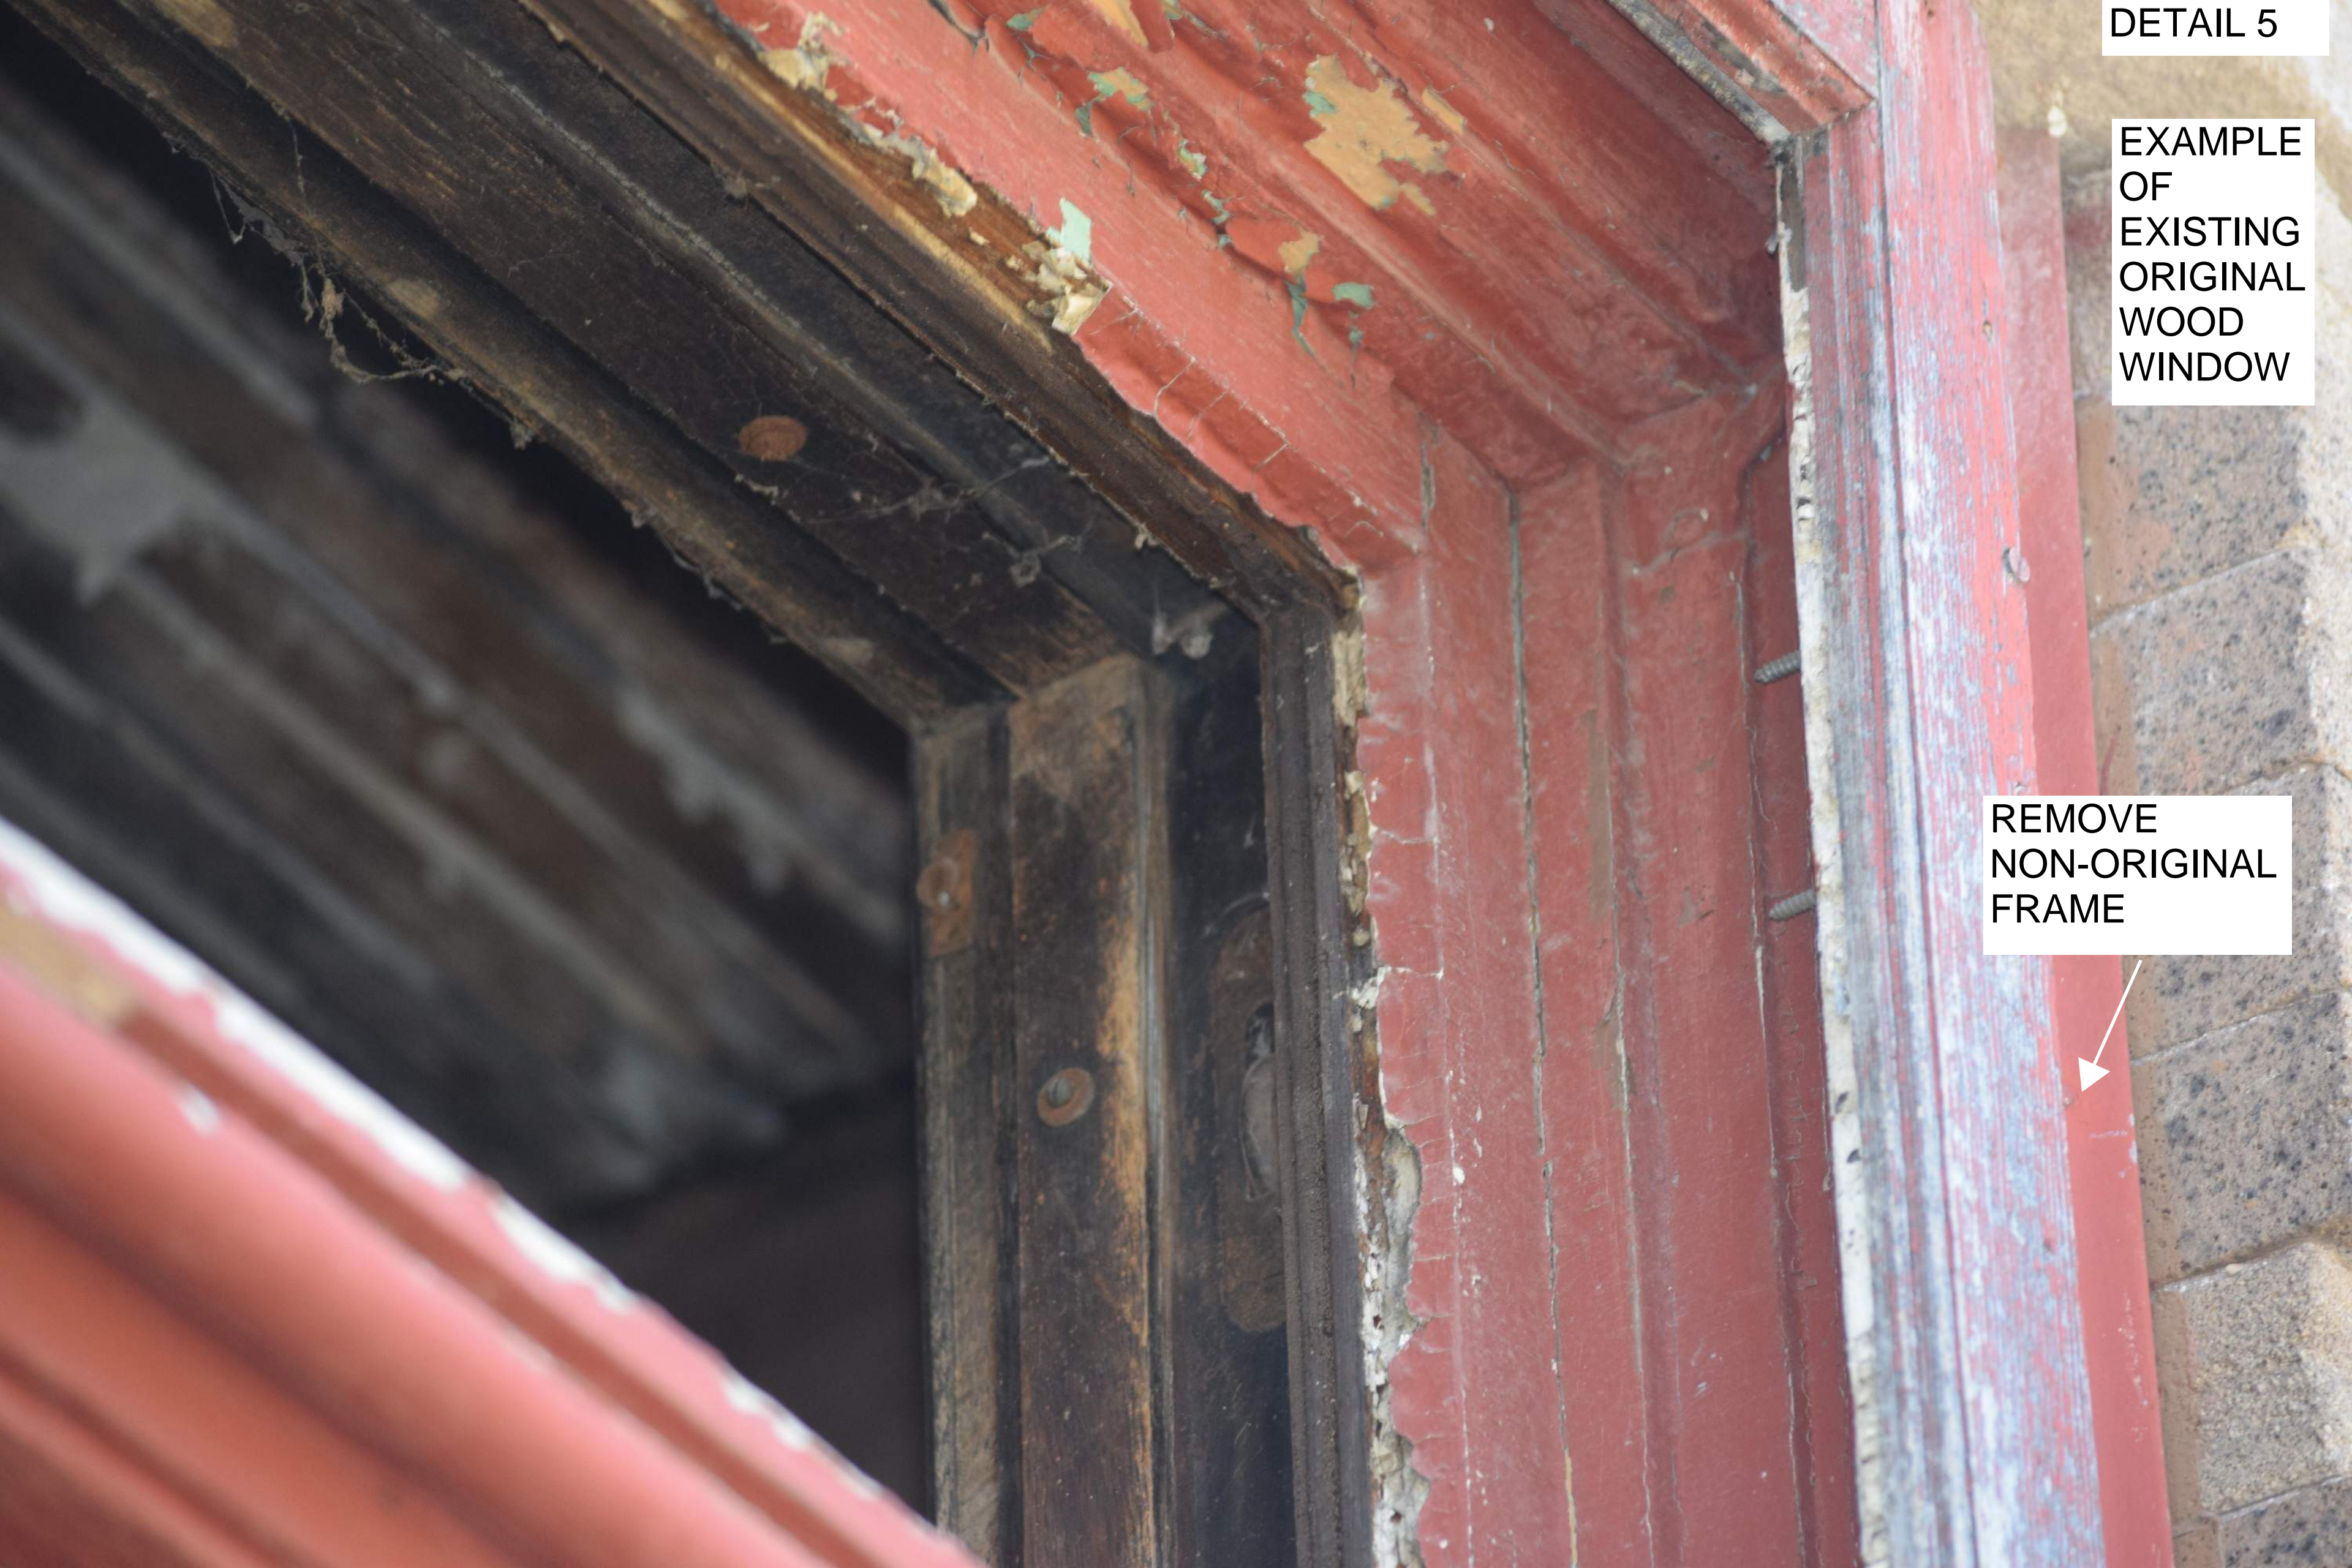
DETAIL 5

EXAMPLE
OF
EXISTING
ORIGINAL
WOOD
WINDOW

REMOVE
NON-ORIGINAL
FRAME

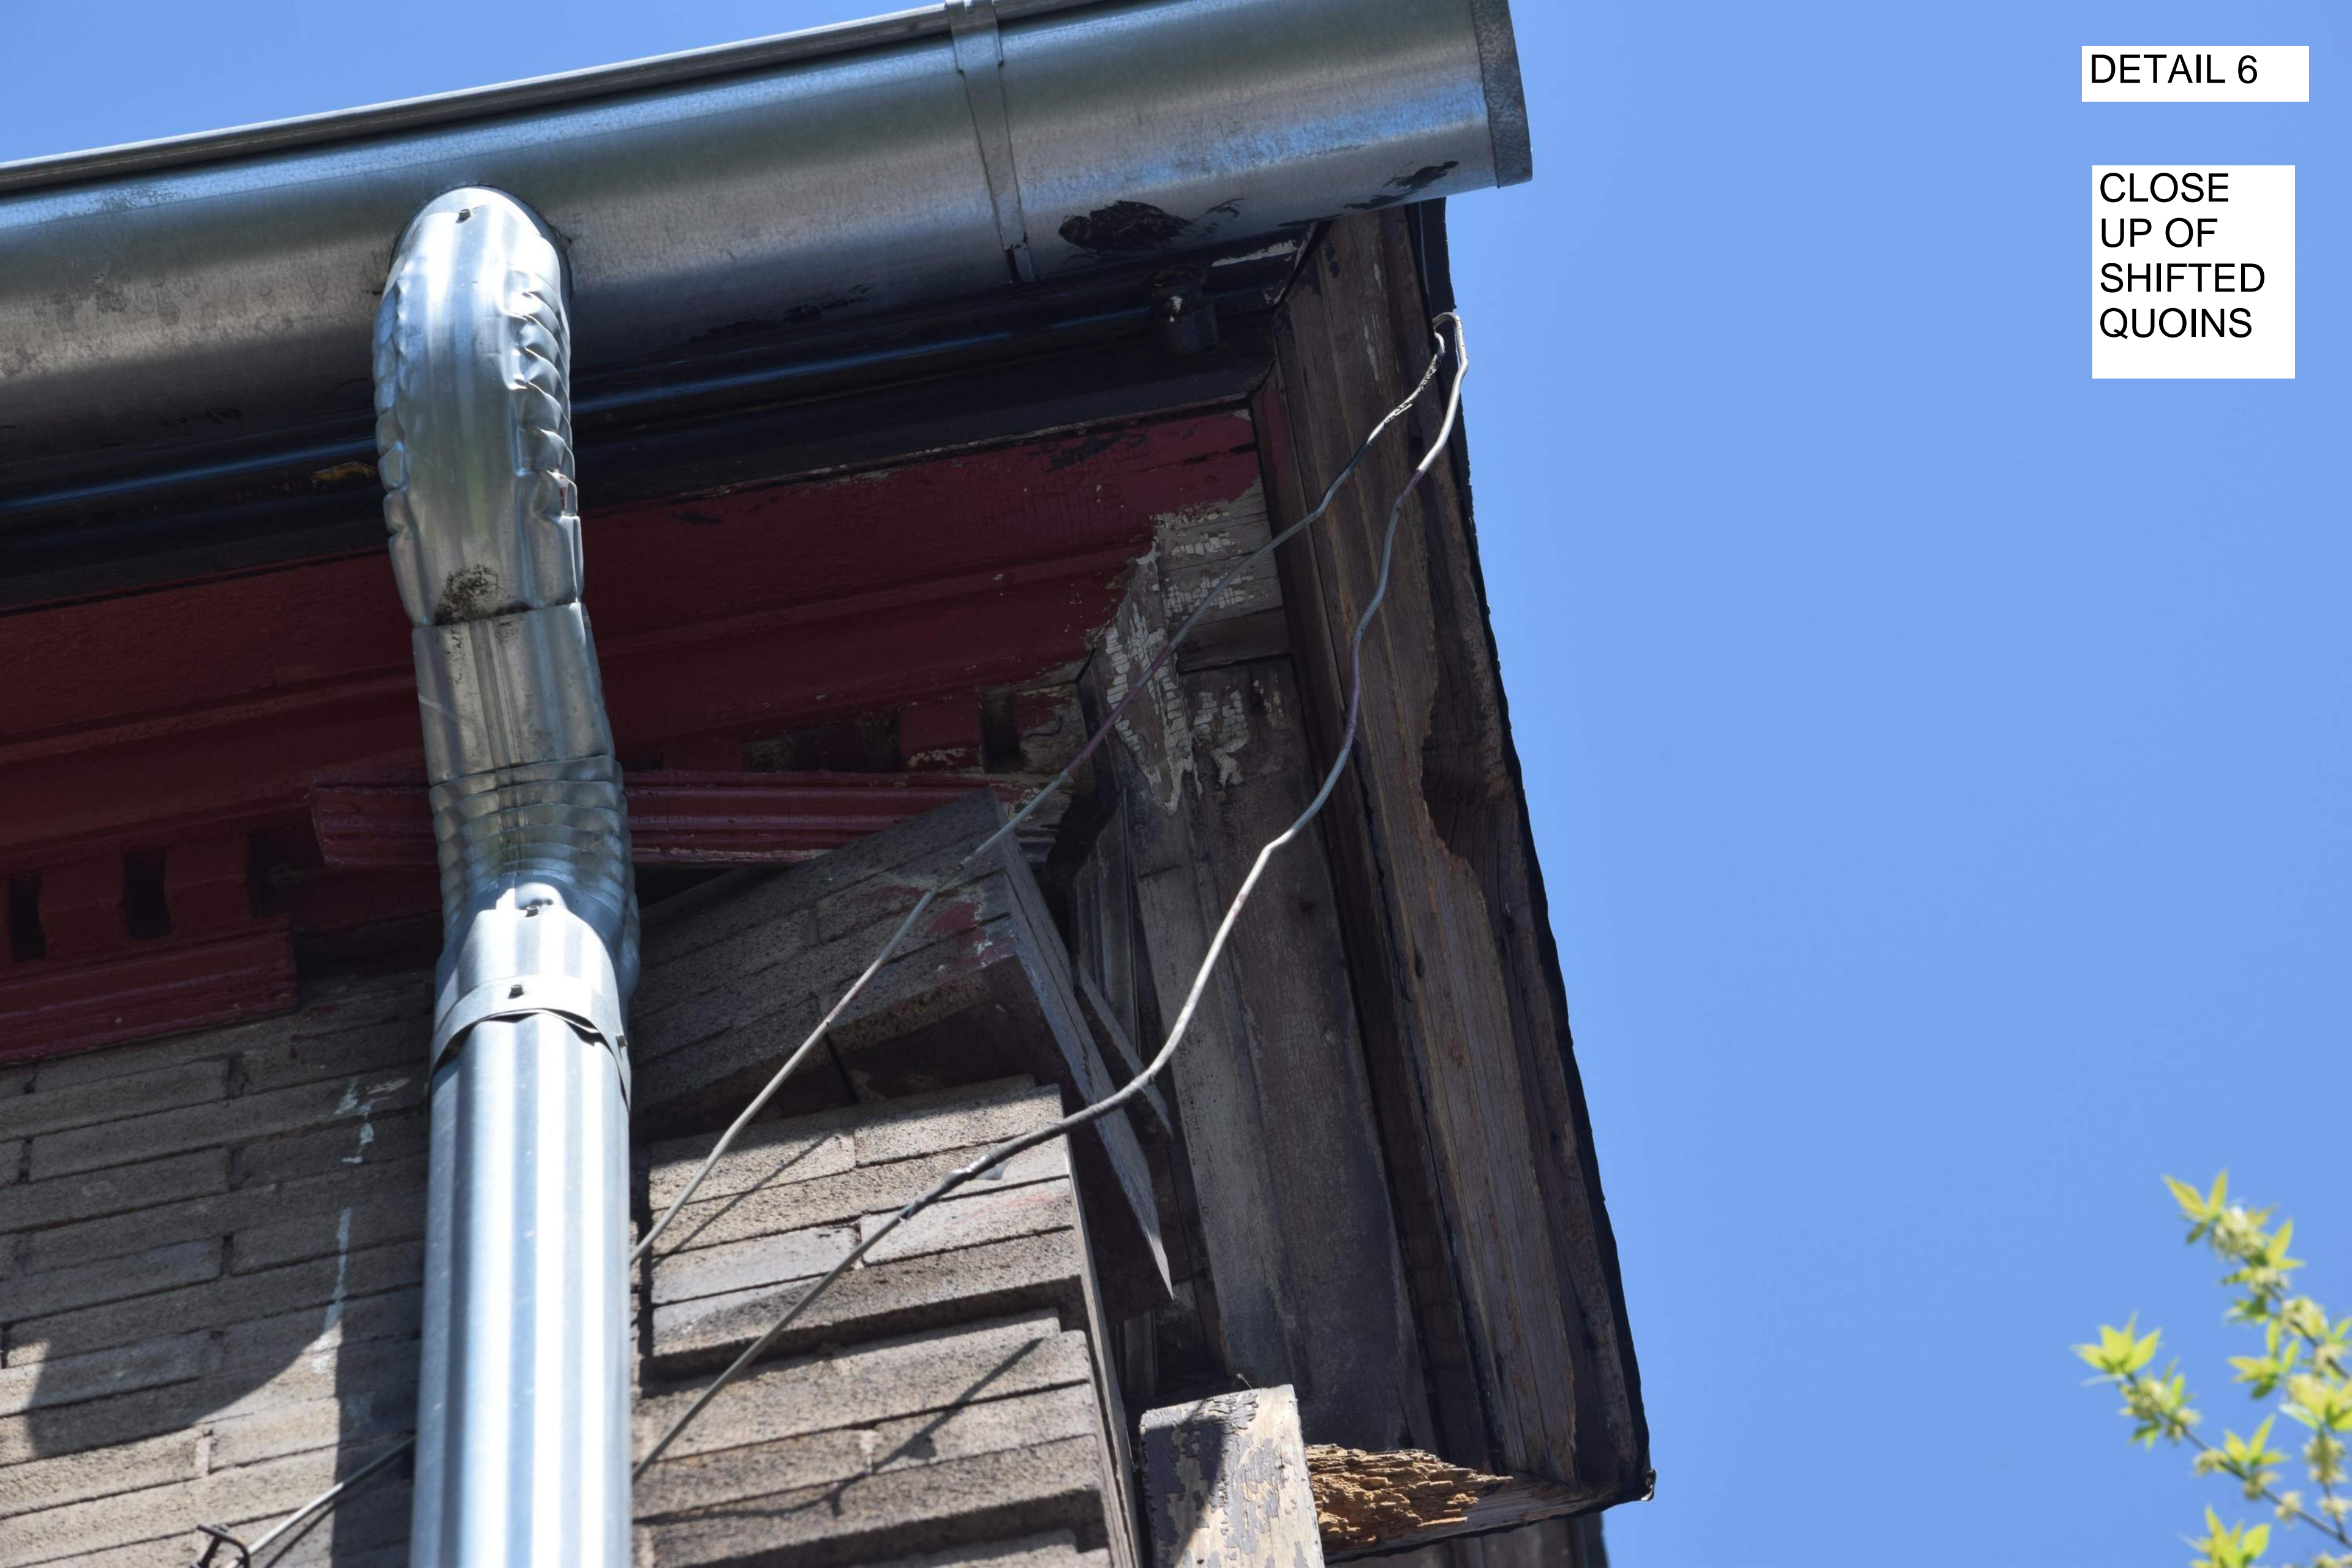
DETAIL 6

CLOSE
UP OF
SHIFTED
QUOINS

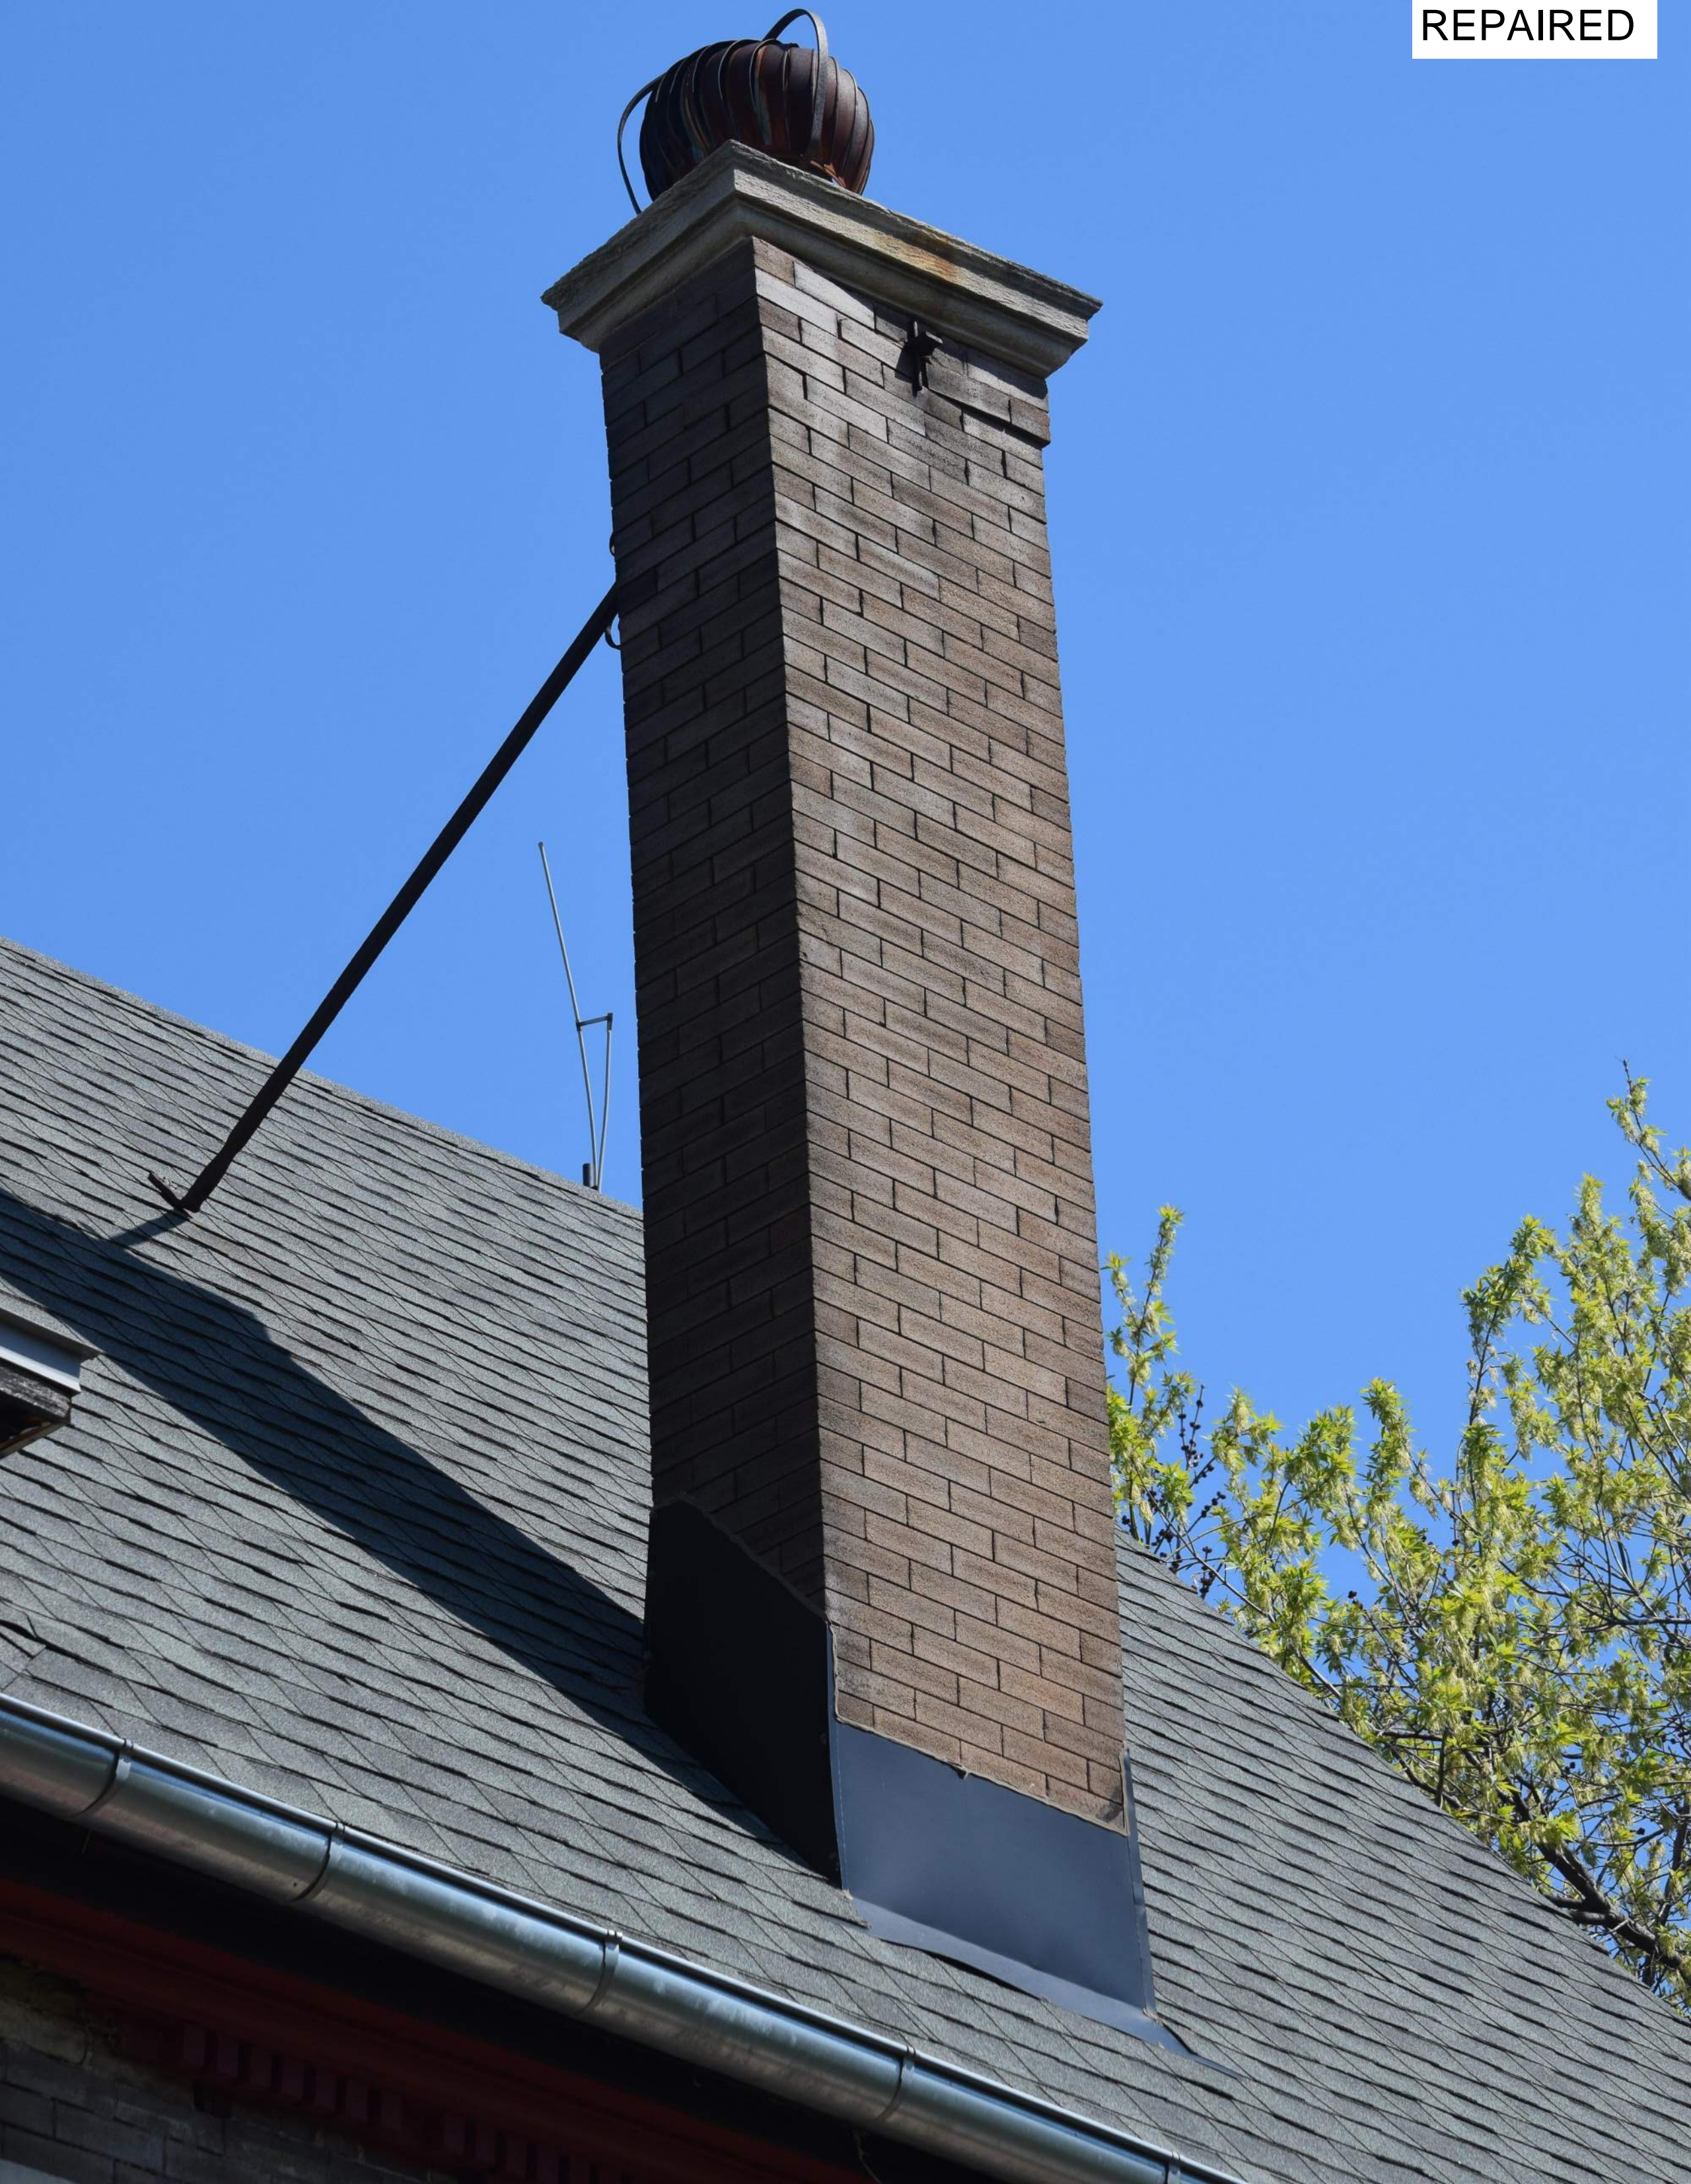
DETAIL 7

CLOSE UP
OF
CHIMNEY
TO BE
REPAIRED
