2045 N. 2nd Street
June 10, 2019

Defective Work By Previous Owner

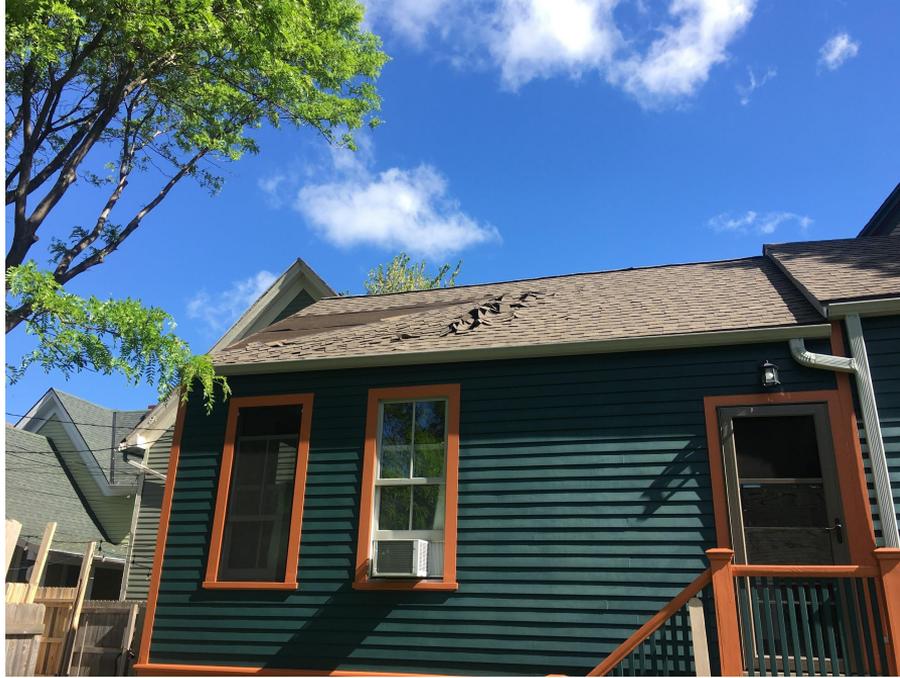
Rear

Defective 6 Year Old Roof System

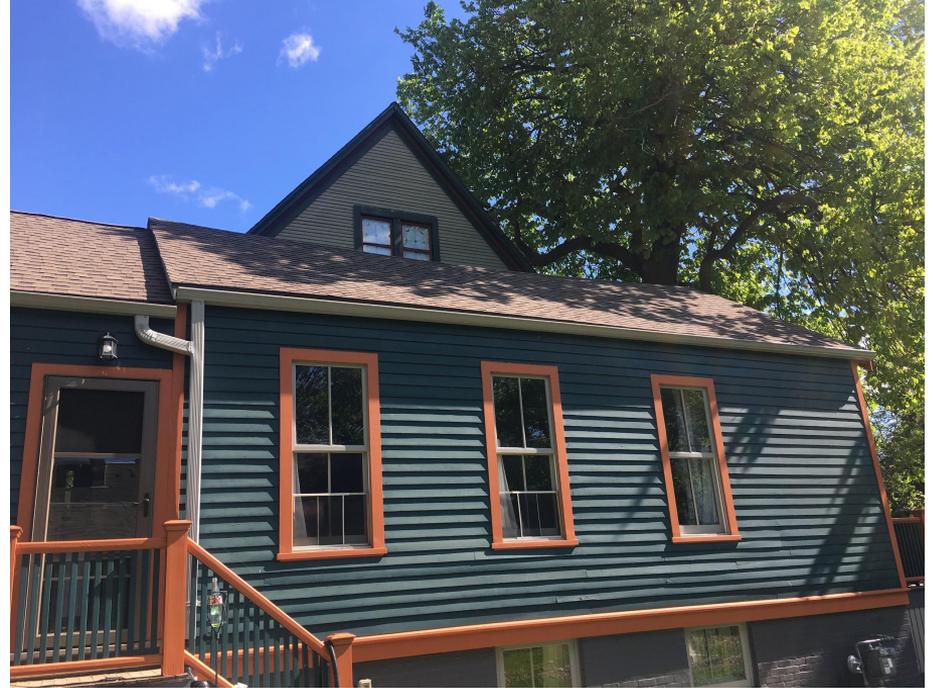
Sagging Ridge and Rafters;
Poorly Installed Siding

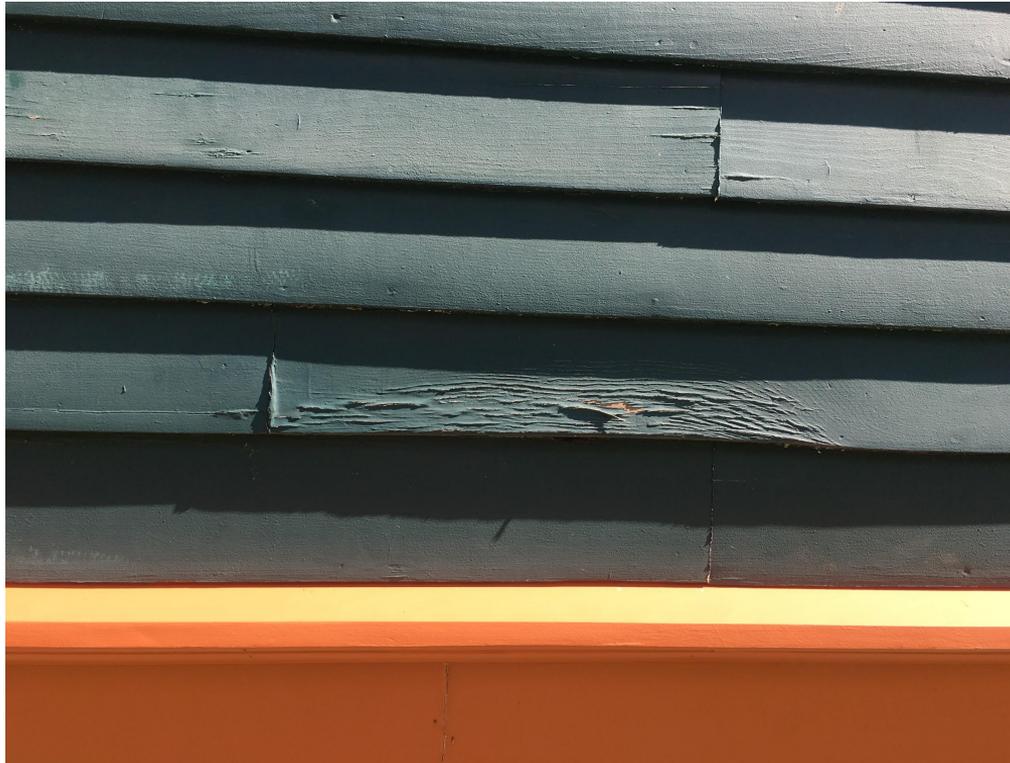
Improperly Installed Siding; Water
Damage

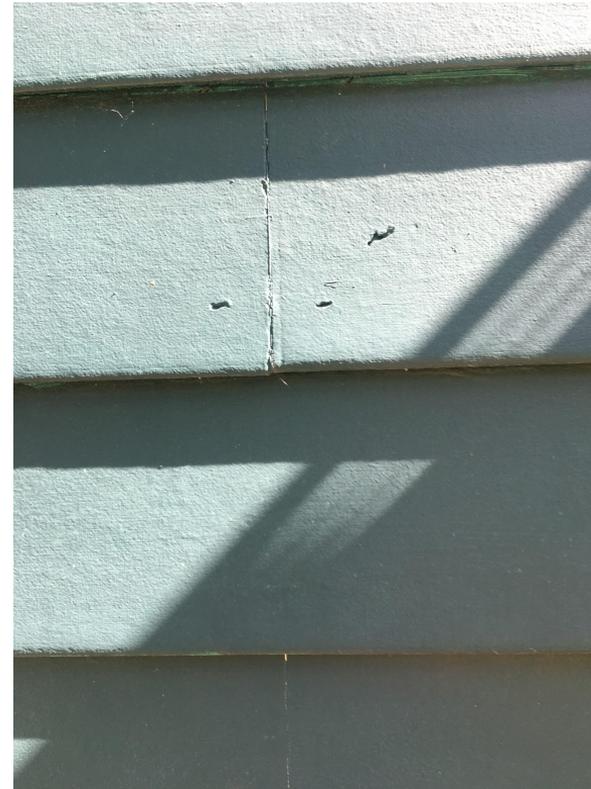
Siding Attached with Staples;
Defective Work

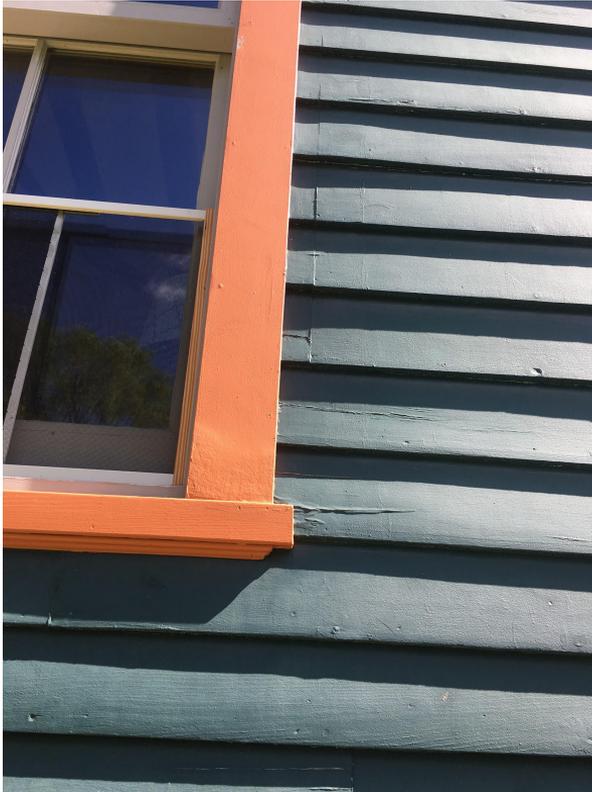
Improper siding installation and water logged window trim

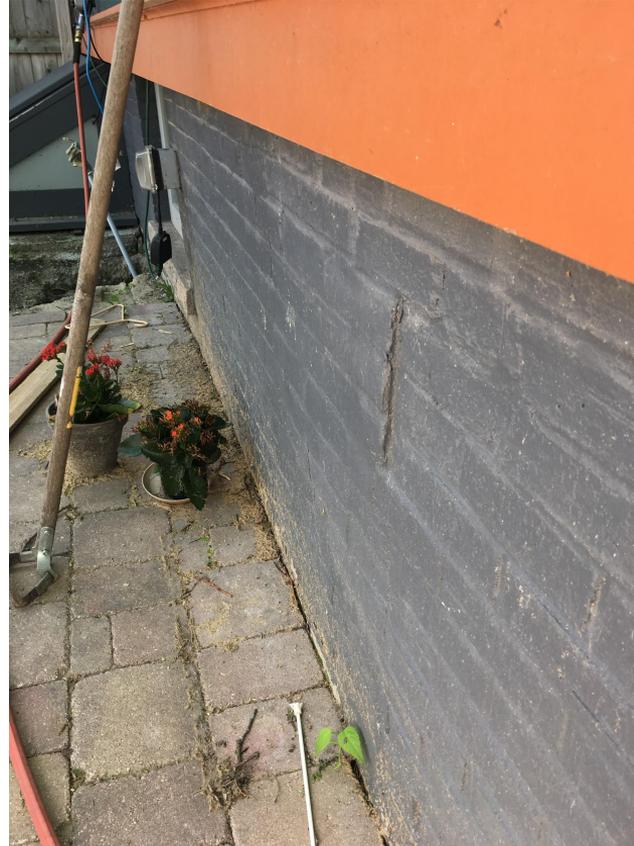
Bulging Brick/Foundation

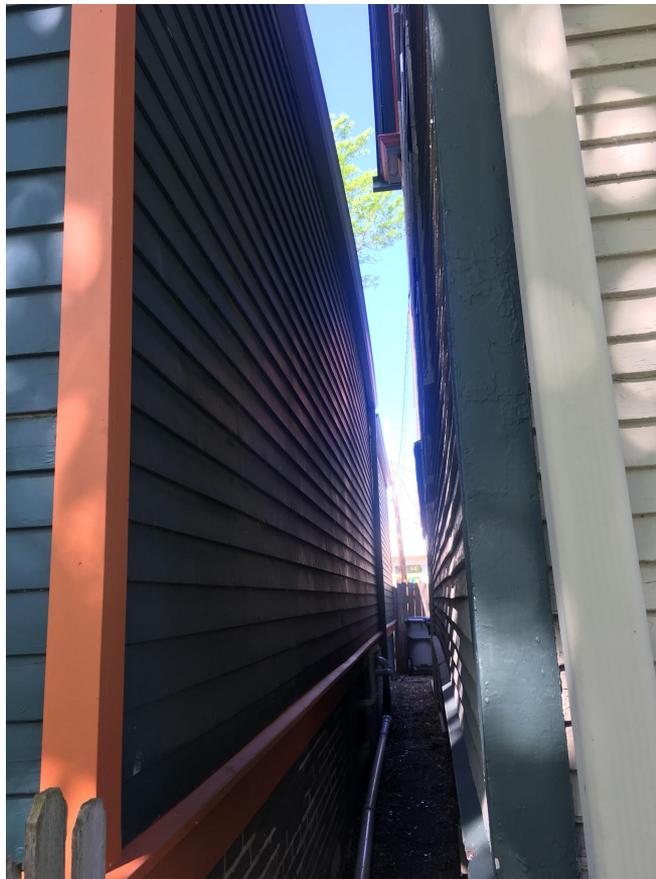
Bowing Northern Wall Caused by Ceiling Joist Removal

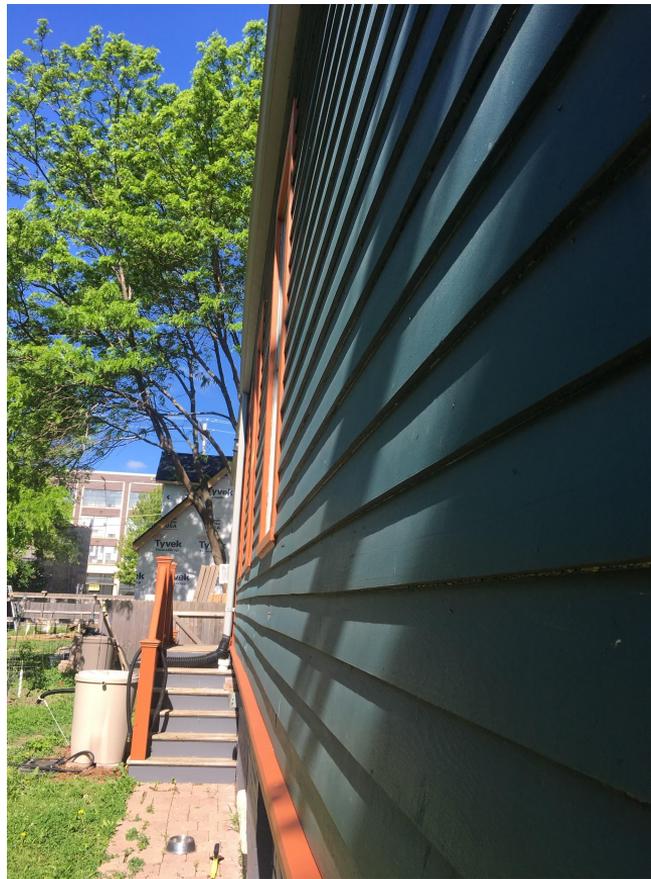
Southern Wall and Window Misalignment Caused by Ceiling Joist Removal
