READ INVESTMENT CO. BUILDING

2565-77 N. DOWNER AVE, MILWAUKEE, WI

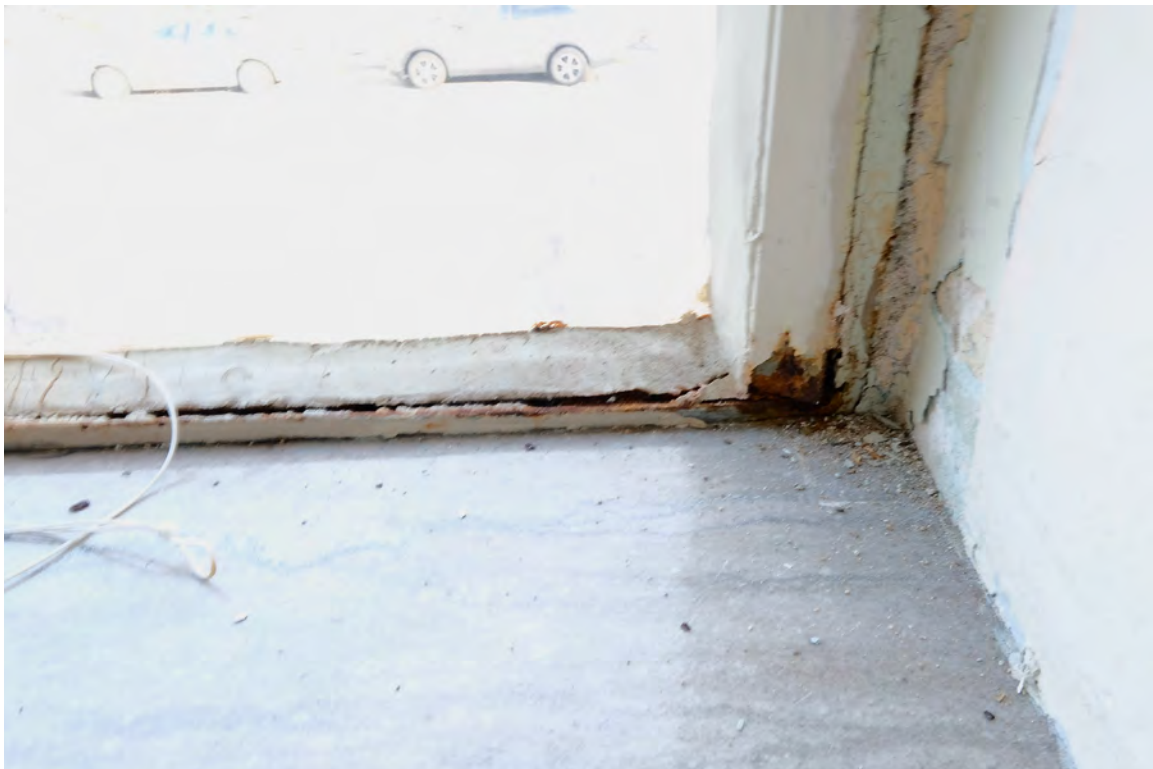
IMAGE 6: Typical corrosion location at the frame corners. Also note expansion cracks at frame and cracked sealant. Preserve, LLC 2021.

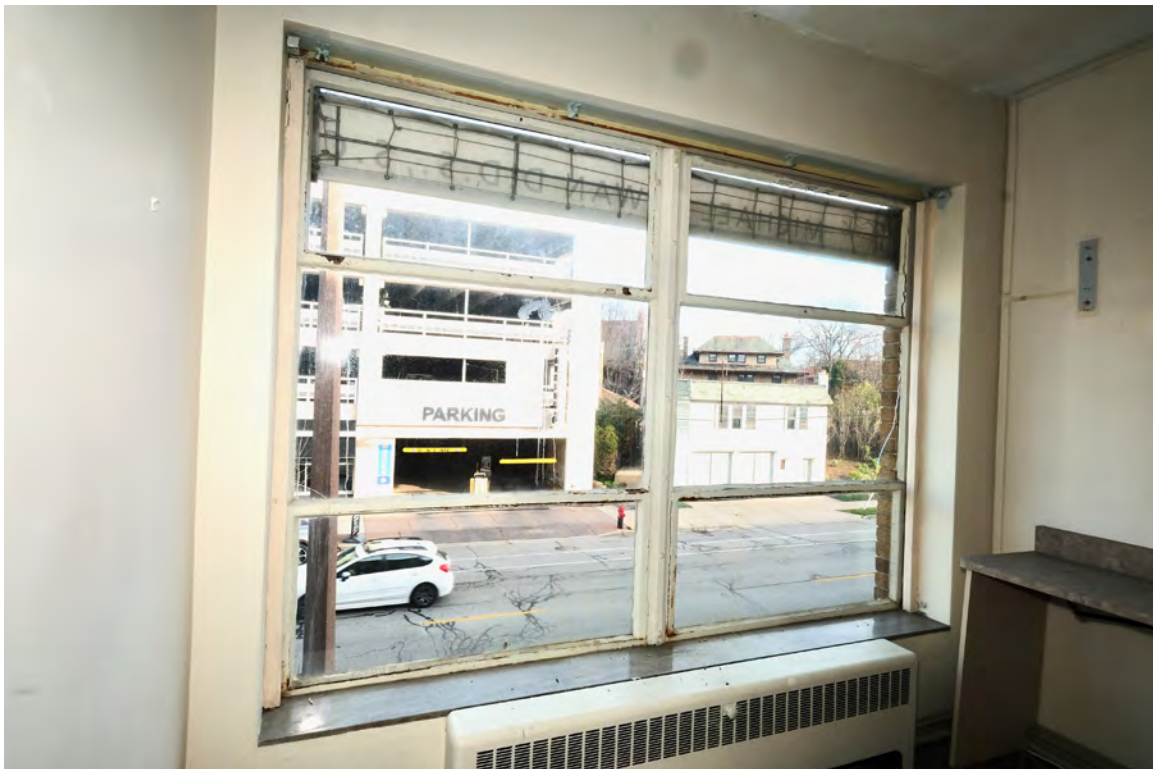
IMAGE 8: Interior side of east-elevation window units. Corrosion is evident throughout and units no longer operate. Preserve, LLC 2021.

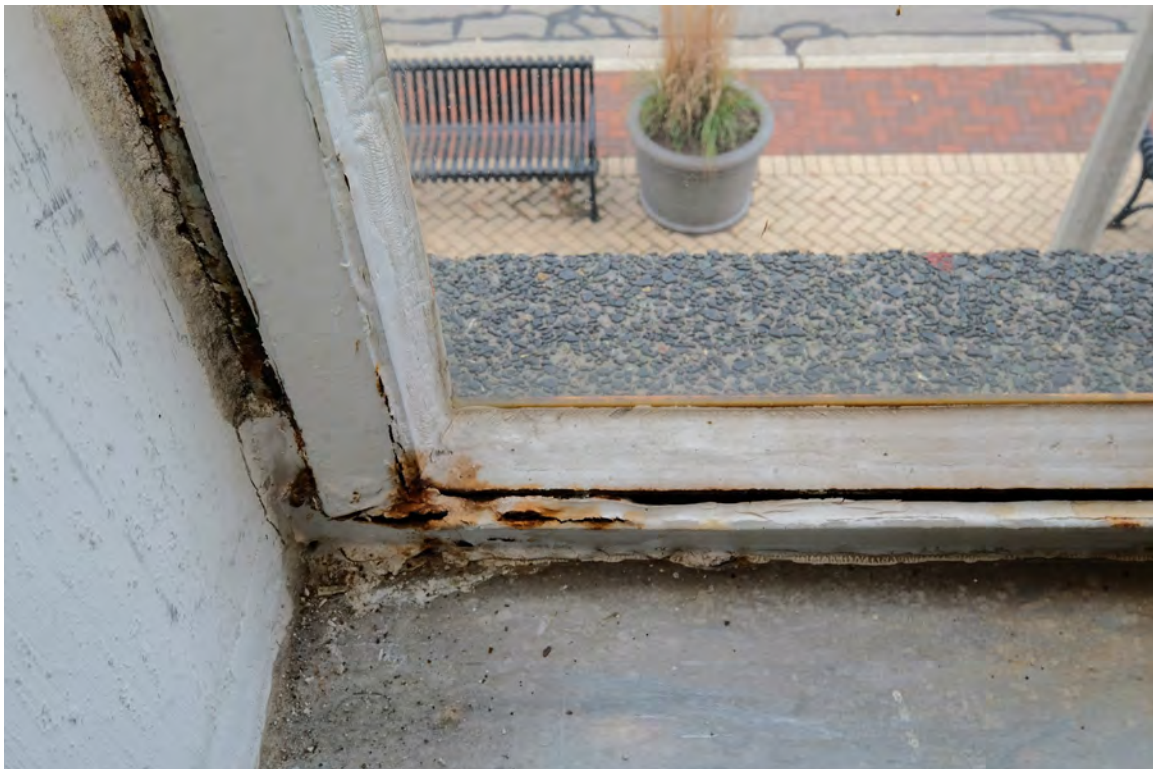
IMAGE 14: View of typical corrosion at frame corners. Frame members and sashes have moved out of plumb due to jacking. Preserve, LLC 2021.

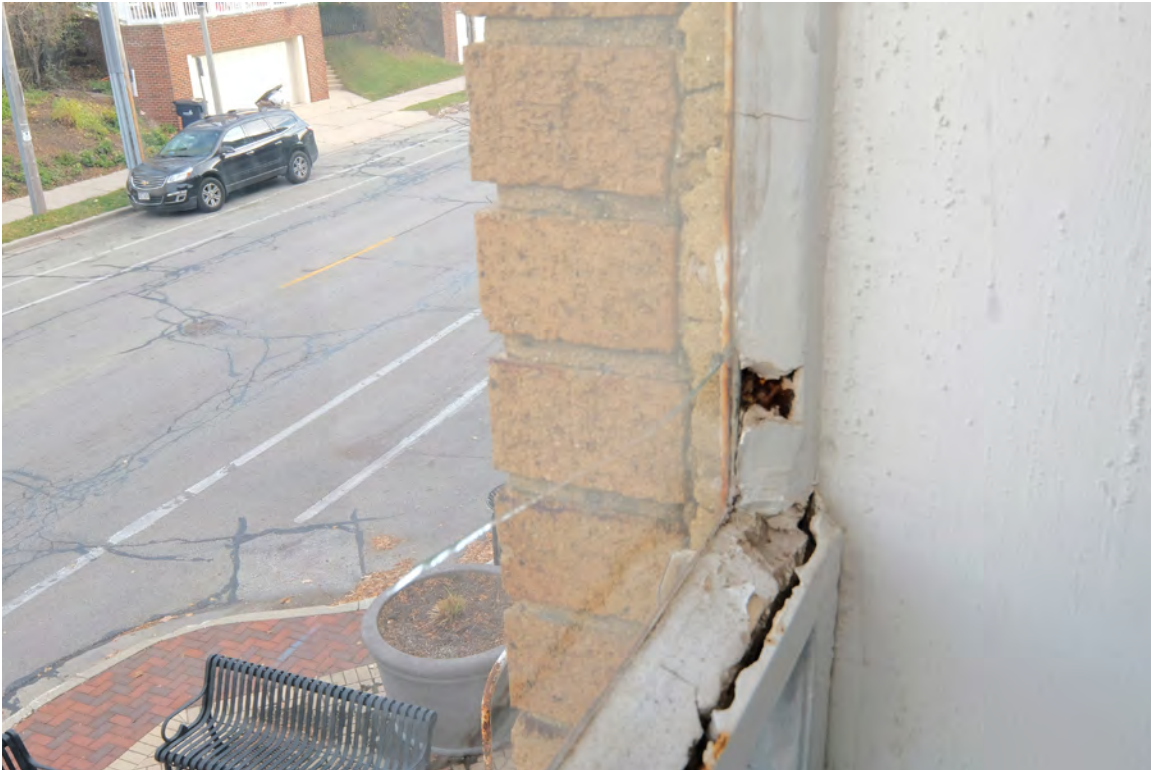
IMAGE 15: View of frame and sash separating at window. Preserve, LLC 2021.

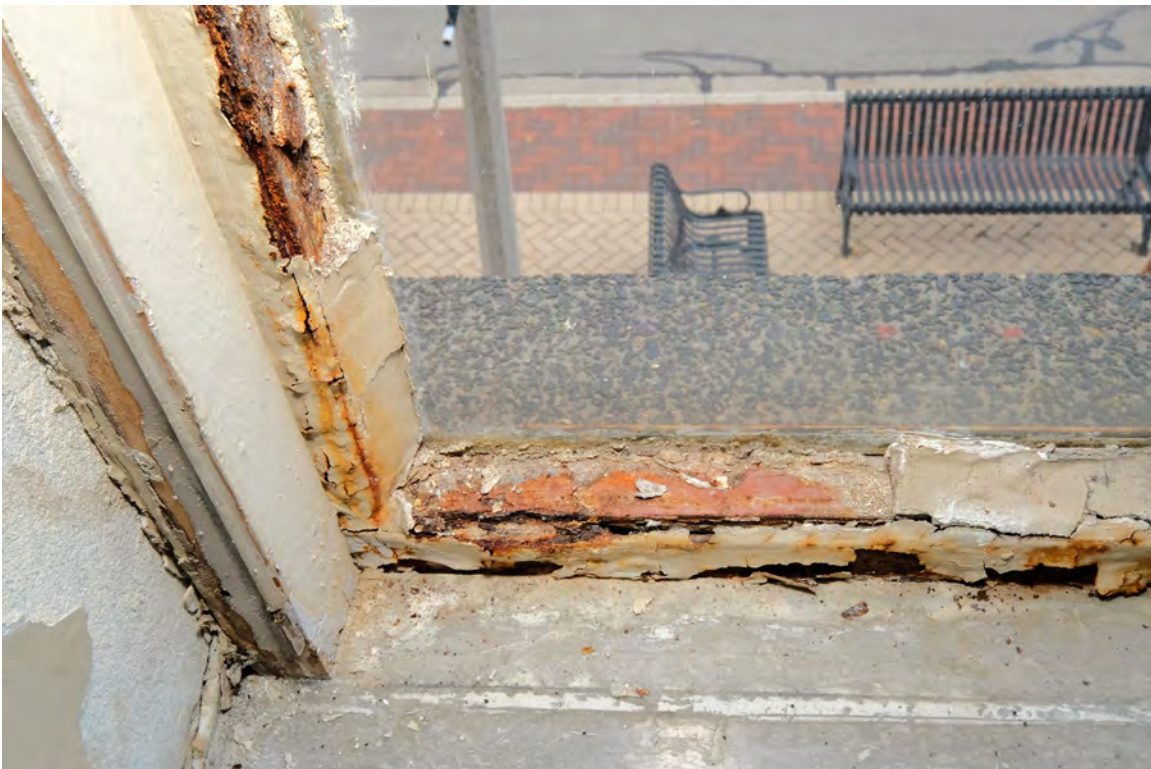
IMAGE 16: View of more severe corrosion at window unit corner. Preserve, LLC 2021.

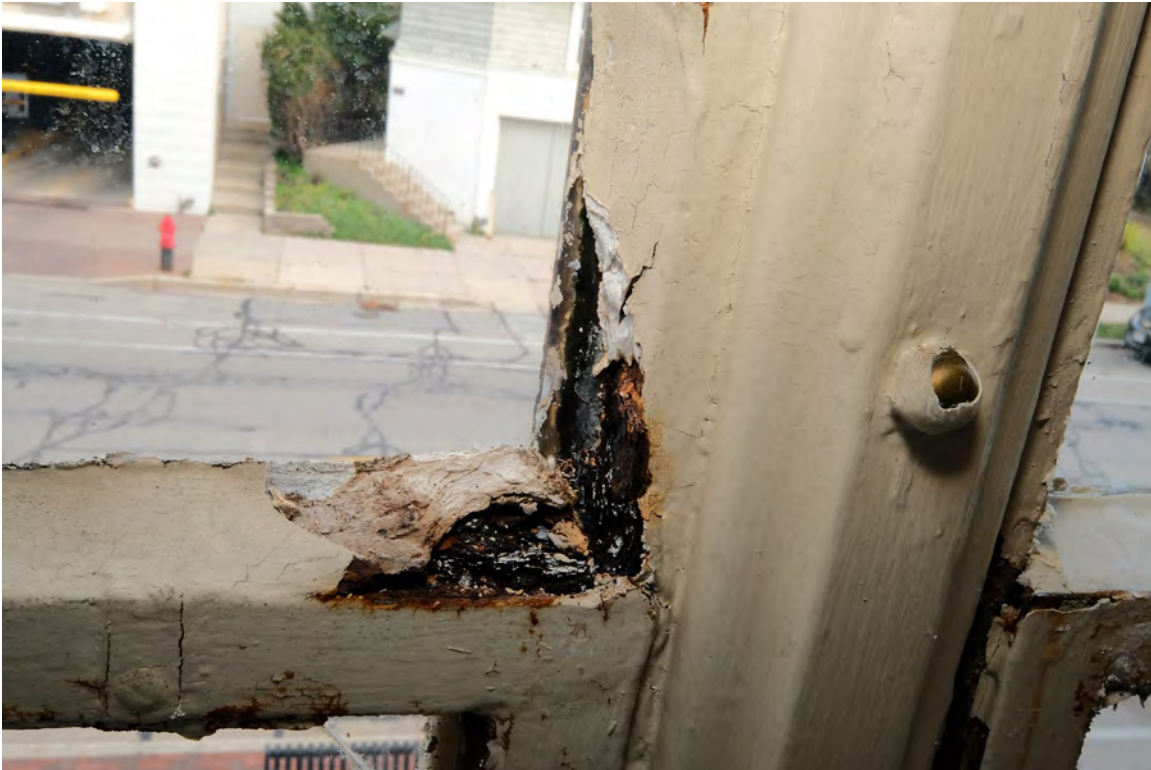
IMAGE 17: View of more severe corrosion at operable sash corner. Preserve, LLC 2021.

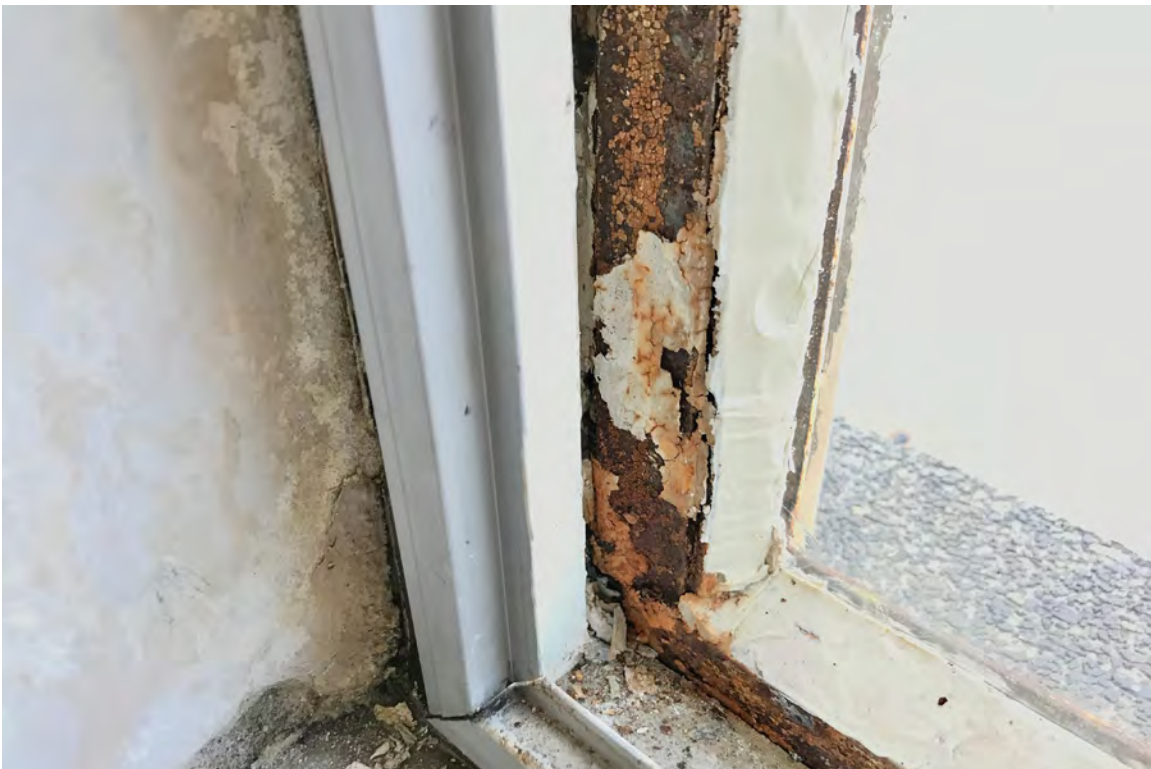
IMAGE 18: View of heavily deteriorated and corroded corner of window frame. Preserve, LLC 2021.

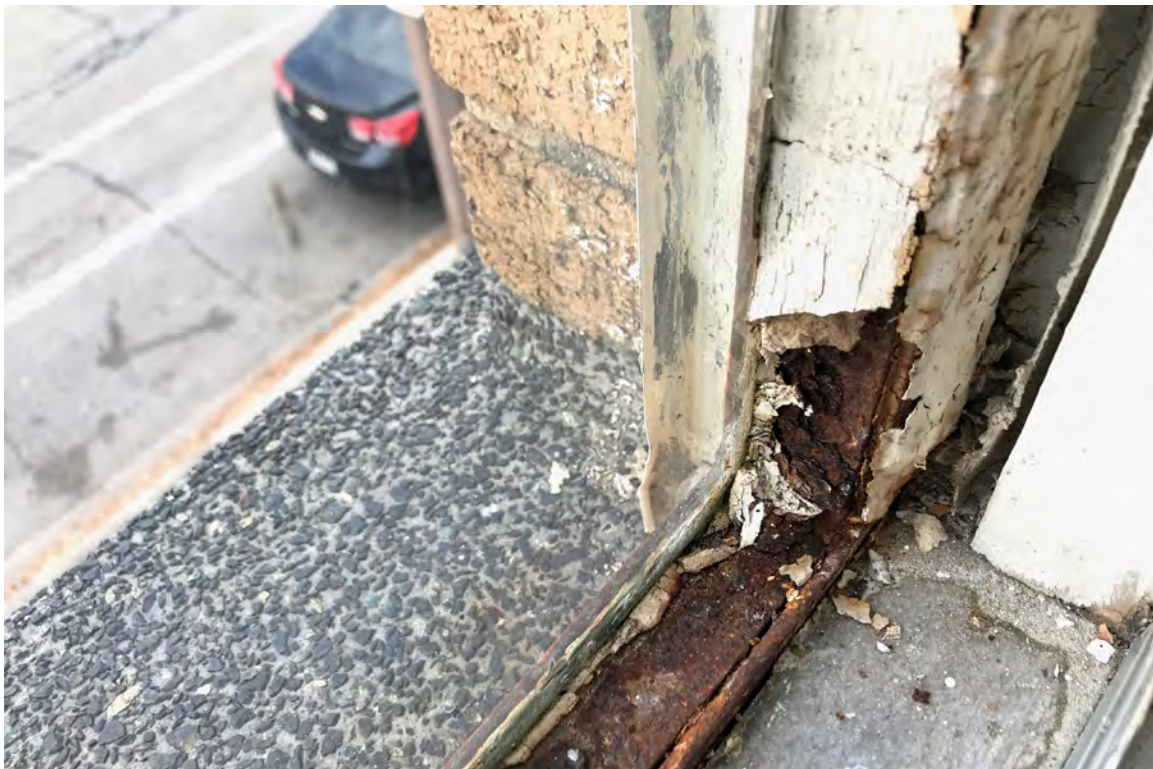
IMAGE 20: View of severe corrosion at the corner of a second floor window frame. Preserve, LLC 2021.

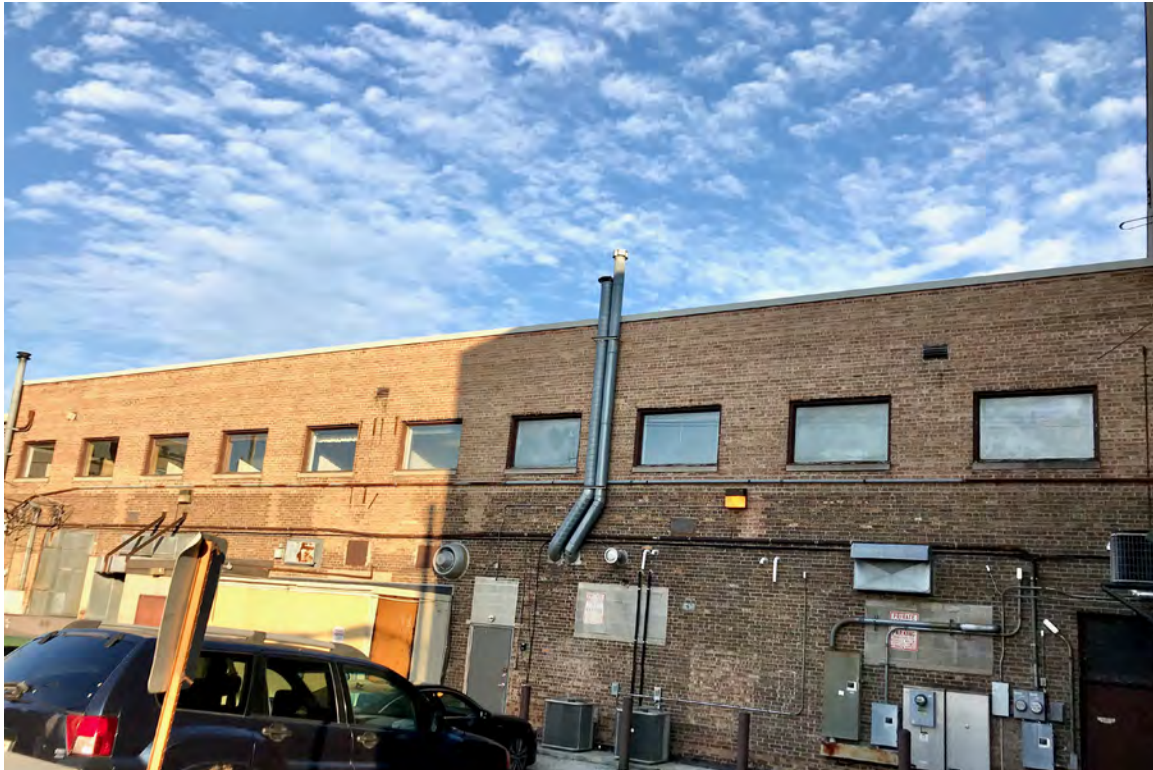
IMAGE 21: View of west elevation facing the alley. Preserve, LLC 2021.

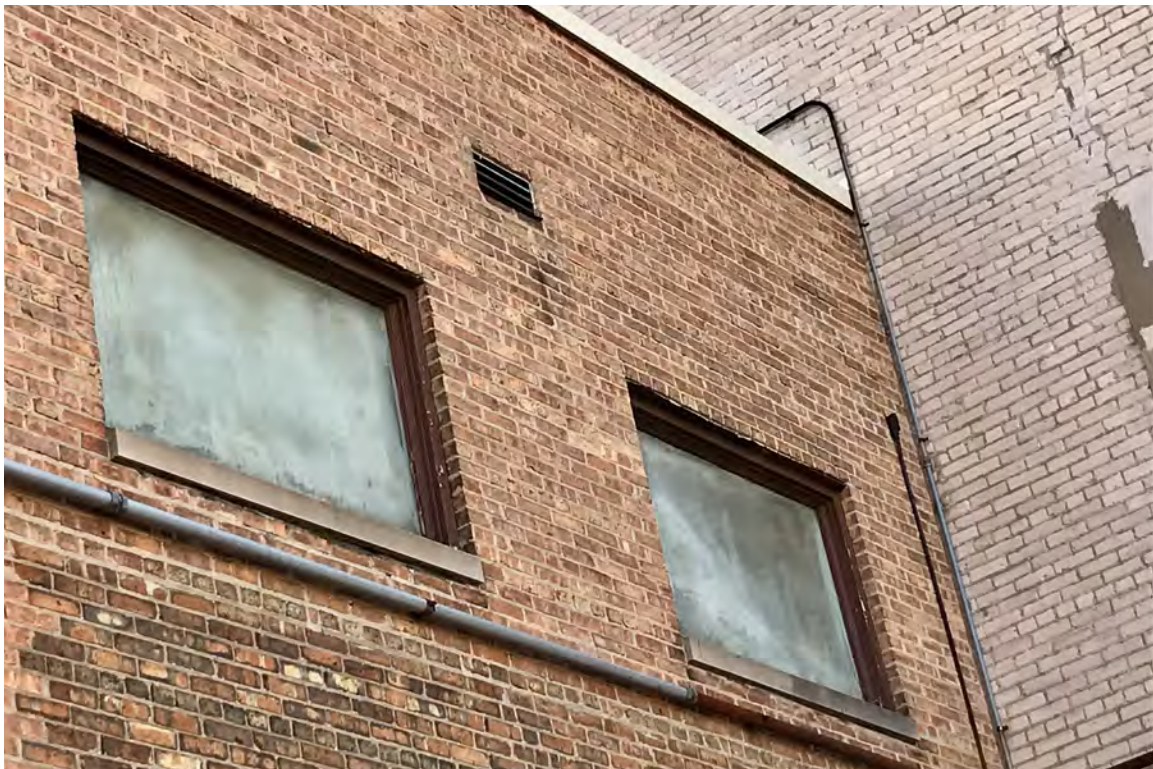
IMAGE 22: View of units with frost and ice located between the panes. Preserve, LLC 2021.

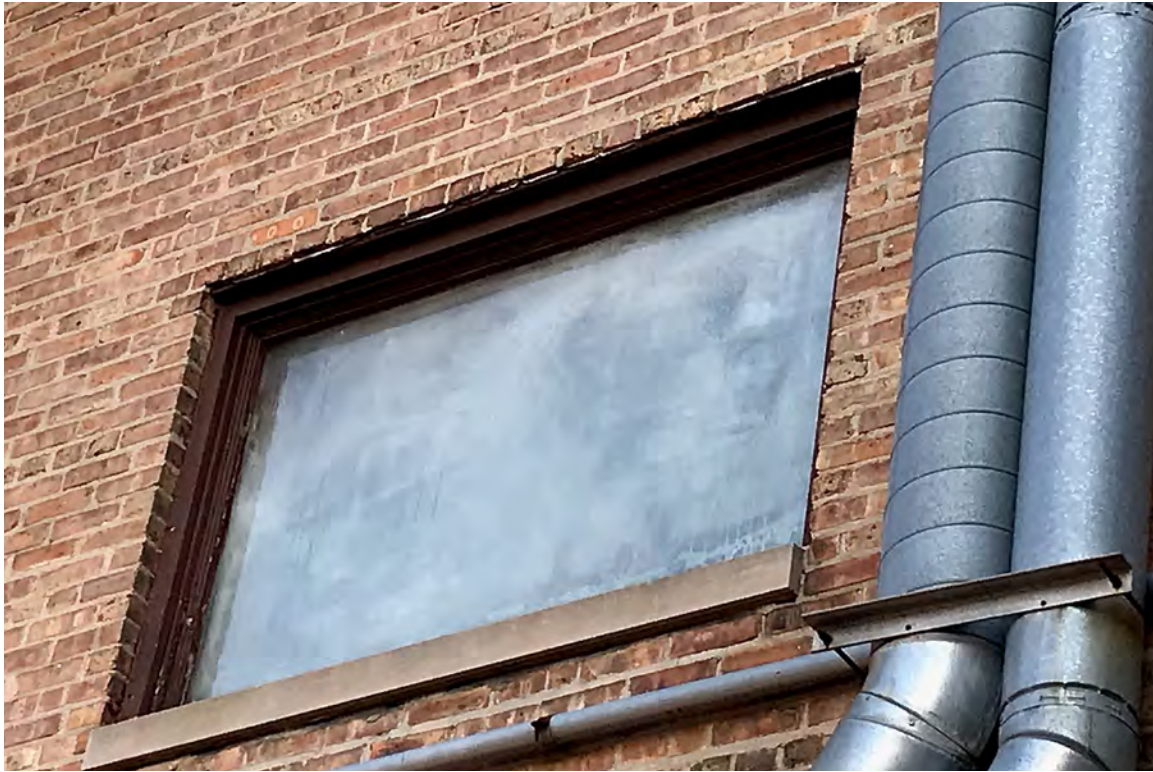
IMAGE 23: Closer view of typical window unit conditions. Preserve, LLC 2021.

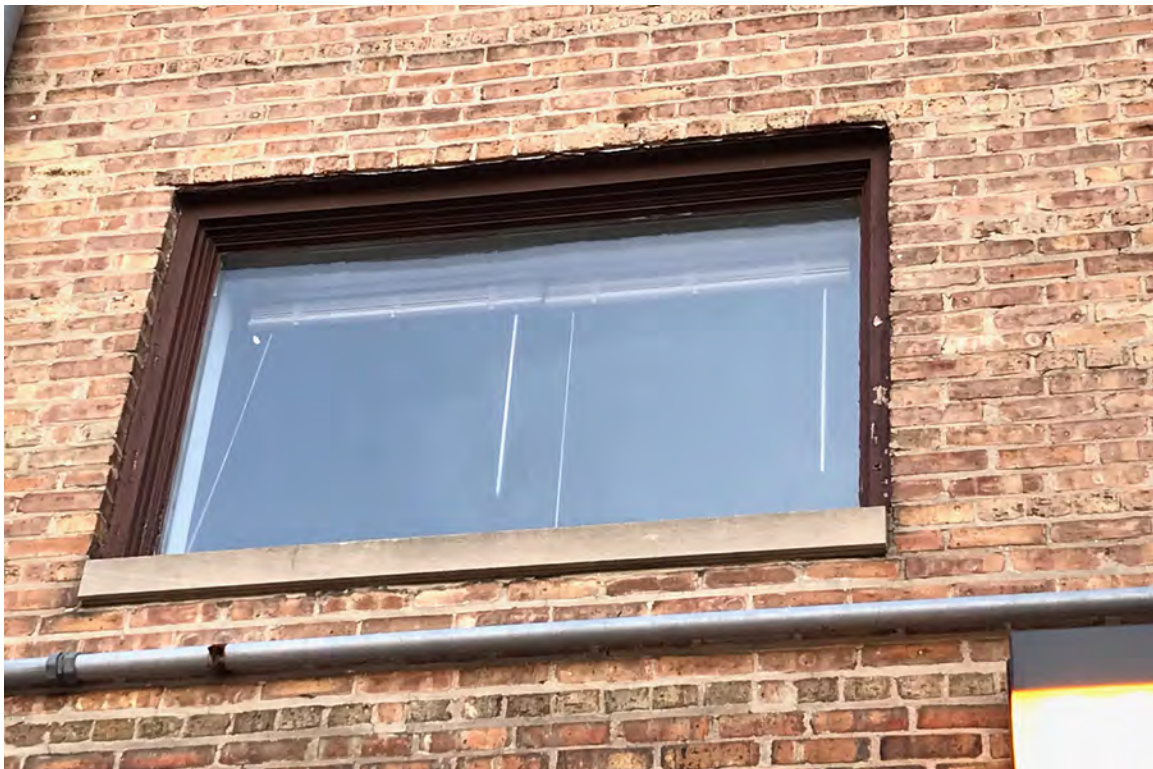
IMAGE 24: View of unit without frost buildup. Approximately half of all units have ice between the panes. Preserve, LLC 2021.

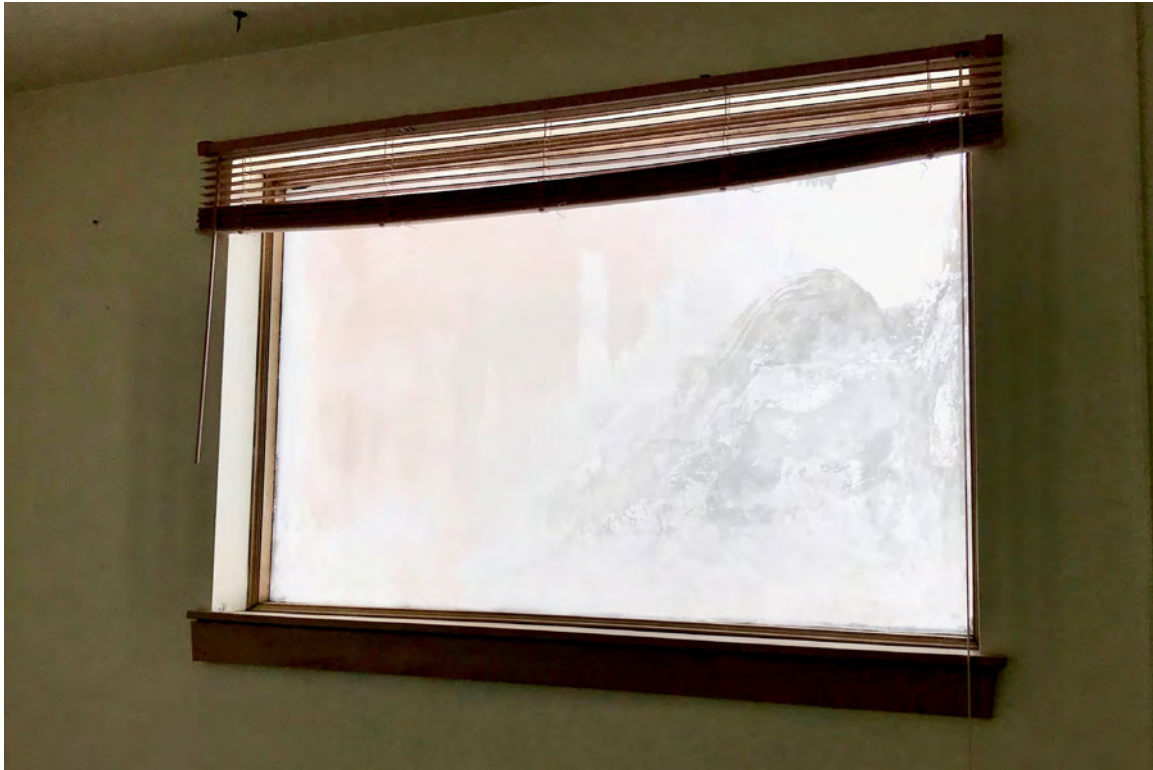
IMAGE 25: View of typical west-elevation window unit. Thermal pane seals are broken and windows leak, resulting in frost and ice forming between the panes. Preserve, LLC 2021.

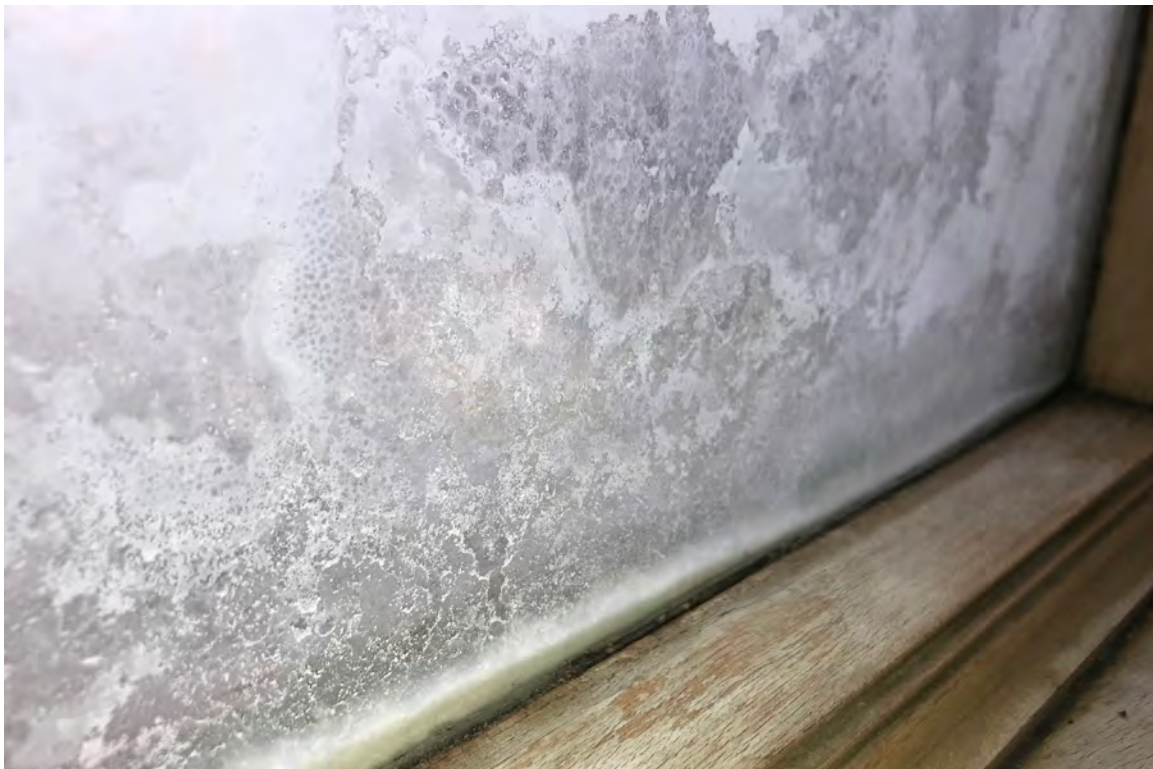
IMAGE 26: Close up view of window sills and frost between panes of modern west-elevation window units. Preserve, LLC 2021.

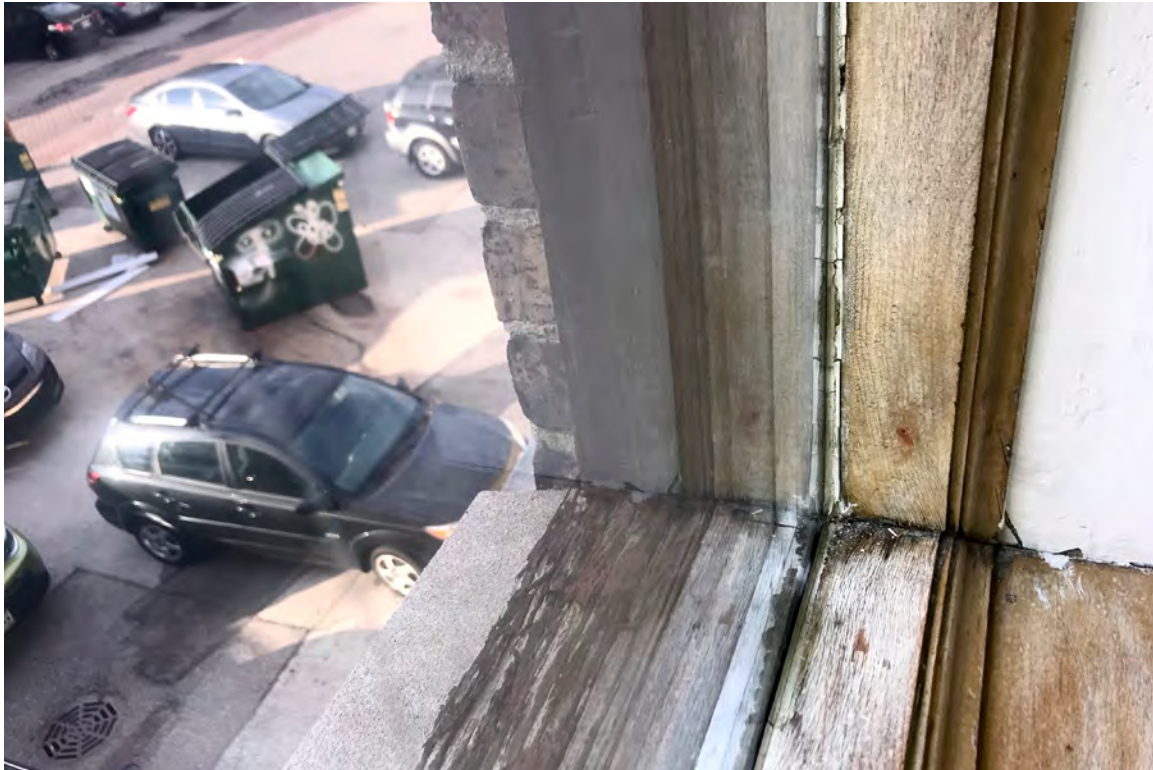
IMAGE 27: View of the typical corner frame and sill at a west elevation window. Seals are broken, wood is rotting, and the exterior sill is almost completely deteriorated. Preserve, LLC 2021.

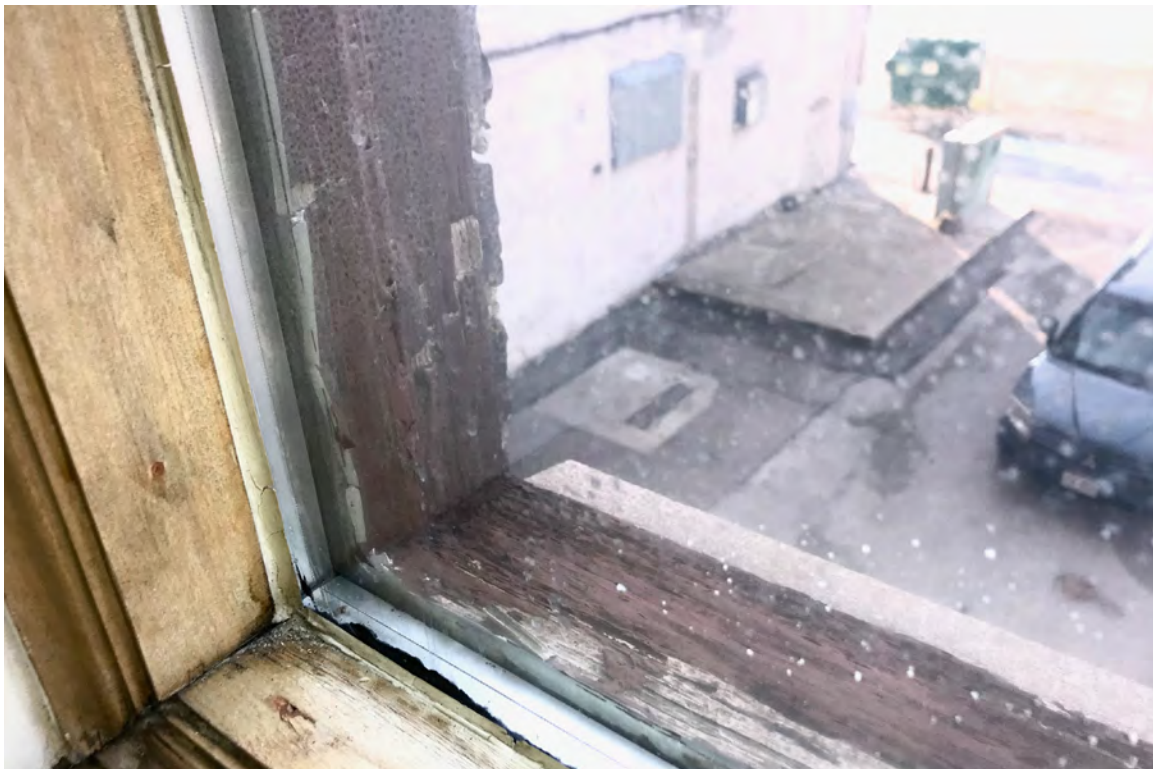
IMAGE 28: View of typical corner frame and sill conditions at a west elevation window. Preserve, LLC 2021.

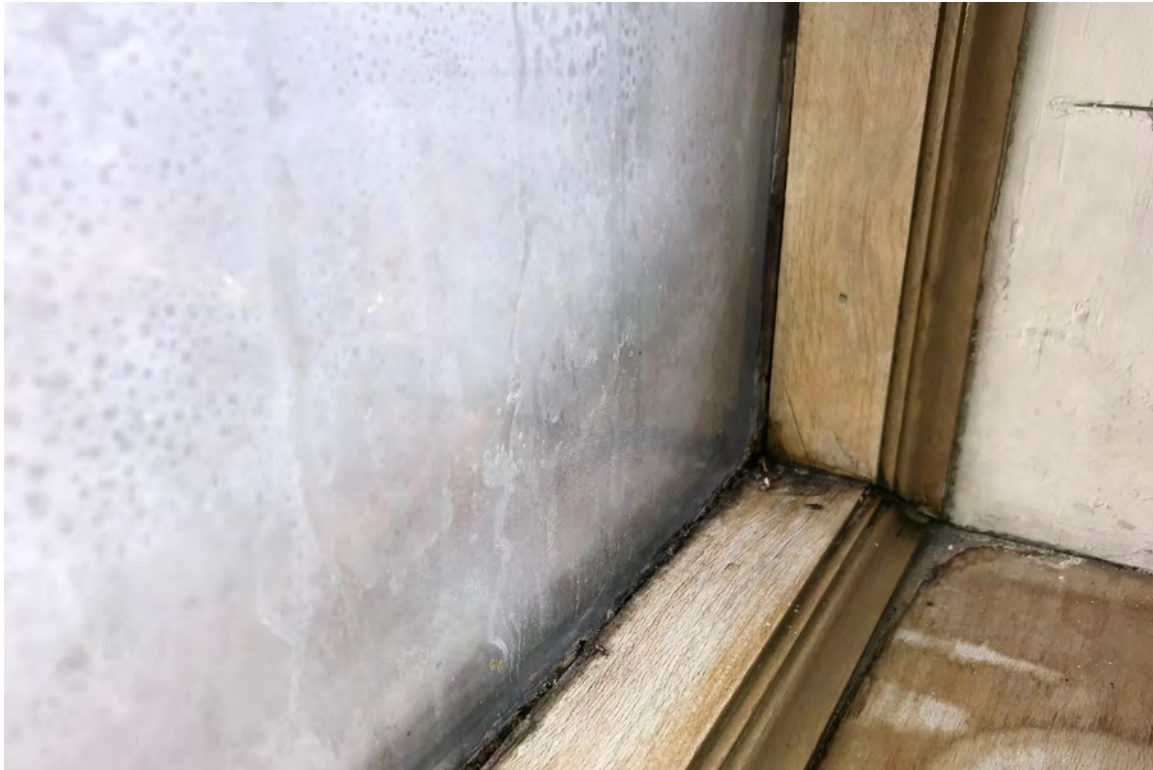
IMAGE 29: View of moisture along glass and at frame corner. Preserve, LLC 2021.

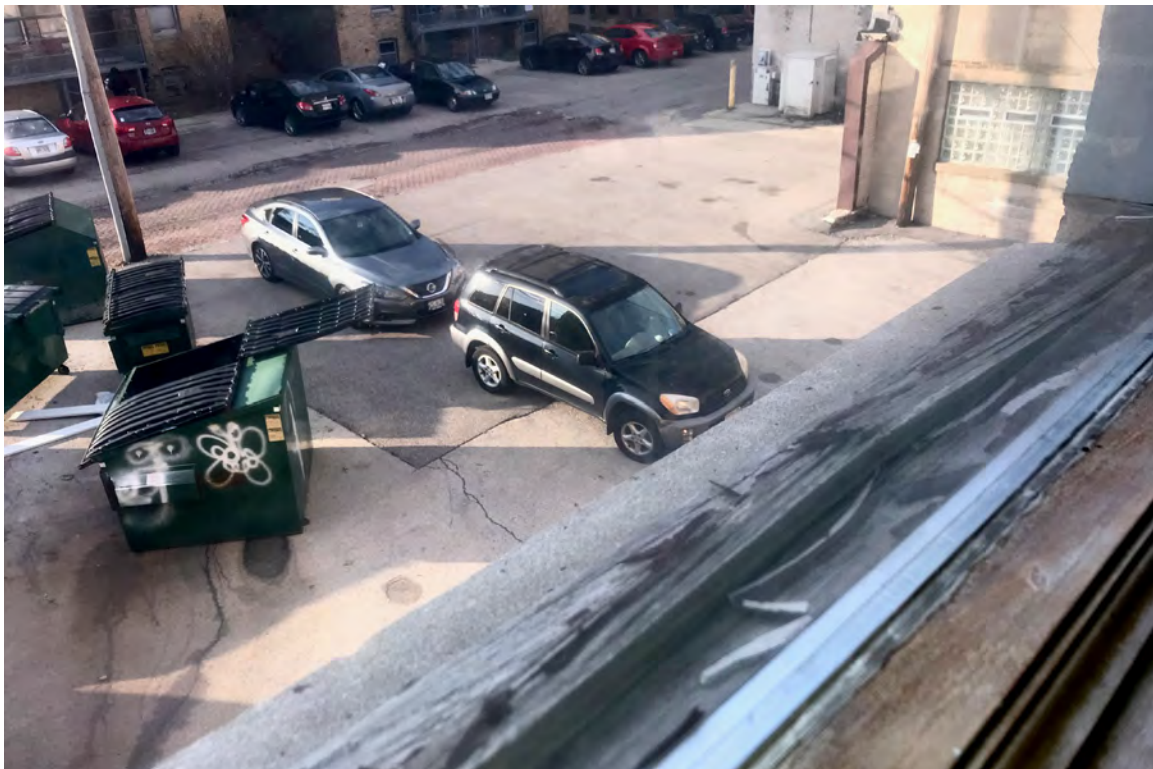
IMAGE 30: View of blown-out sill due to active moisture at window units on west elevation. Preserve, LLC 2021.

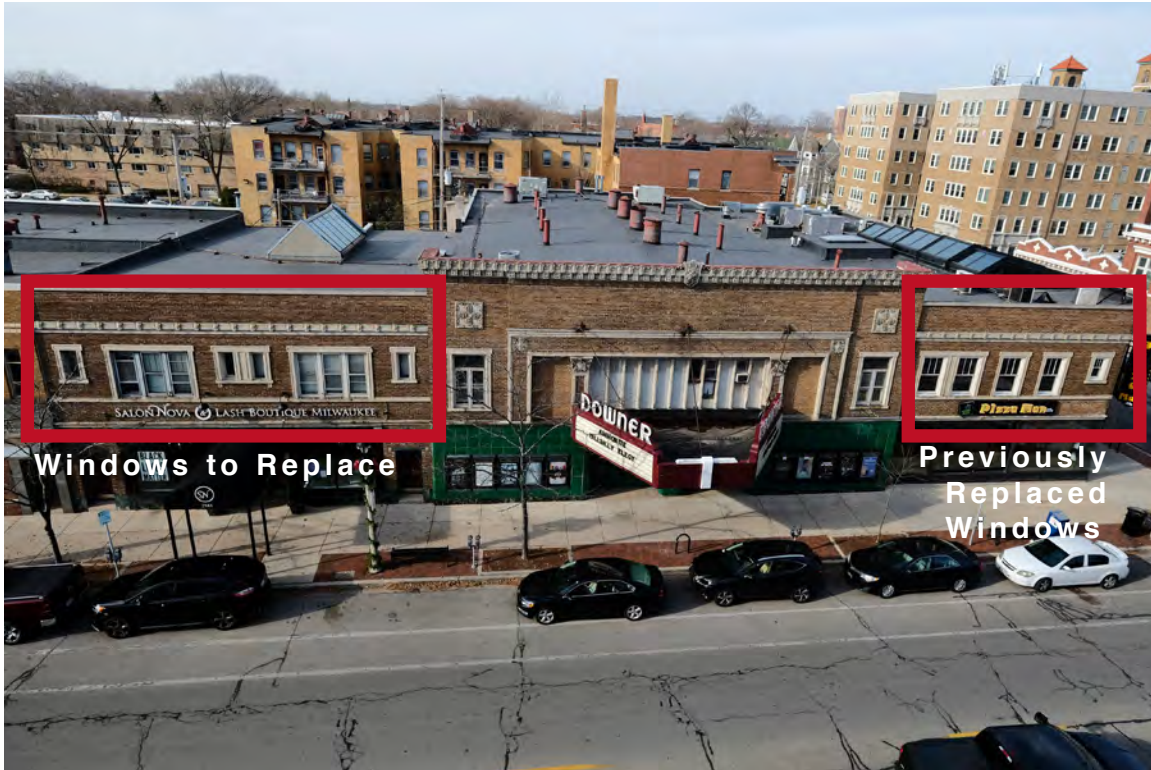
IMAGE 31: View of the Downer Theater building from across North Downer Avenue. The new windows on the south apartments will match the existing units in configuration. Preserve, LLC 2021.

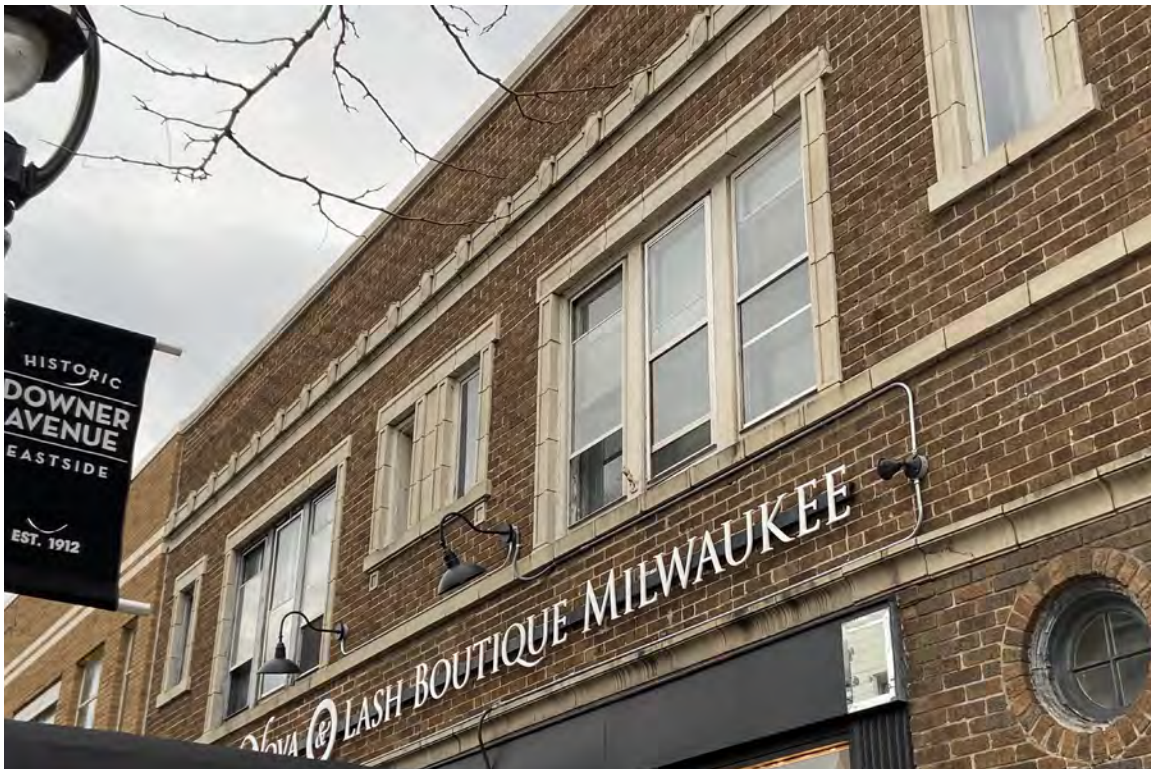
IMAGE 32: View of windows to be replaced on the second floor of the Downer Theater. Preserve, LLC 2021.

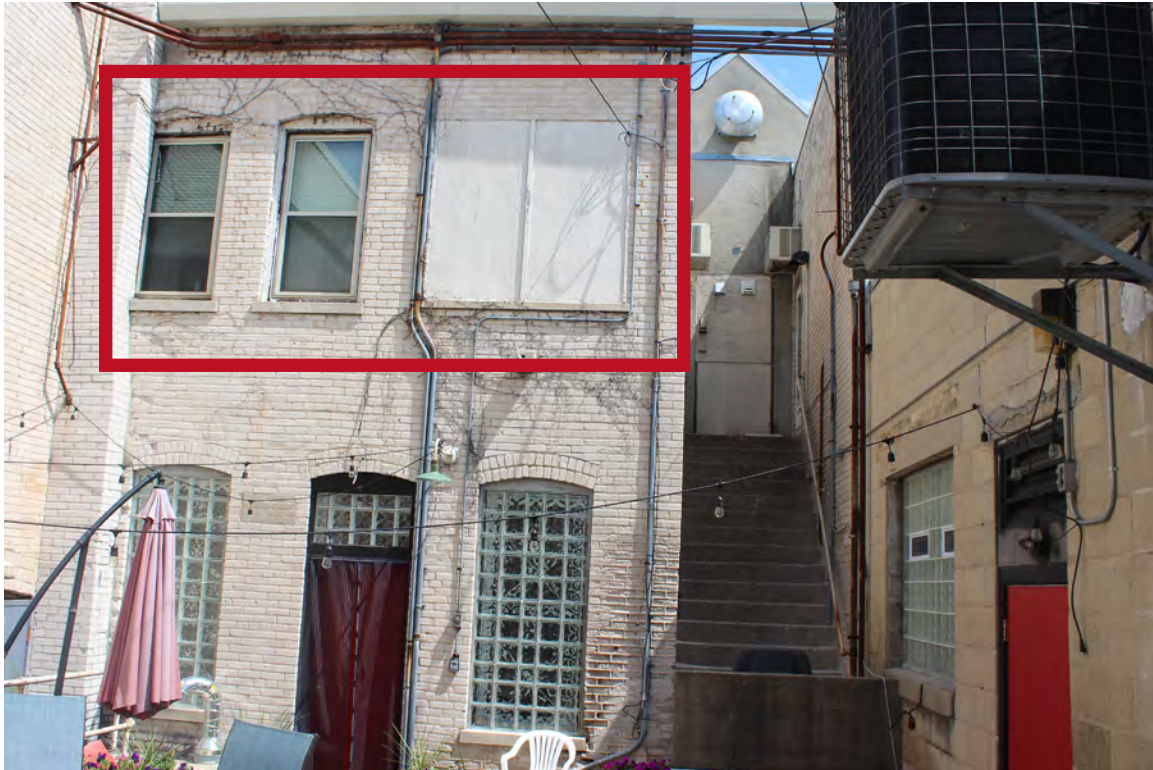
IMAGE 33: View of second-floor window units on the back/west elevation of the Downer Theater building. Preserve, LLC 2021.

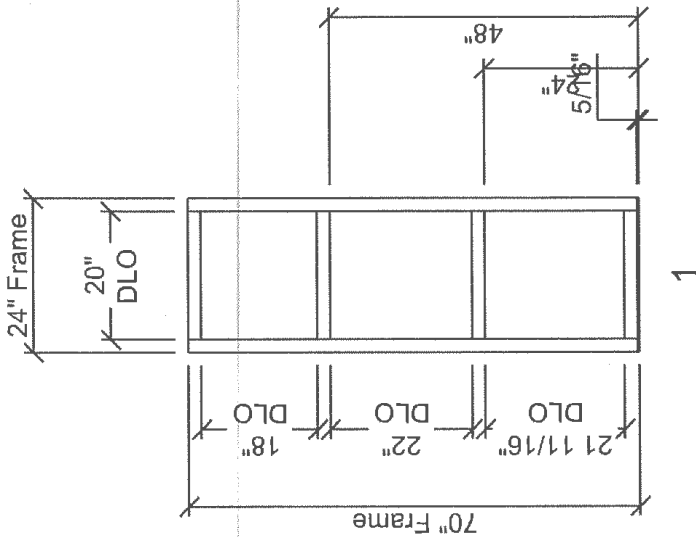
North Downer - 6 - 005 - Type A (2 Thus)
 Frame: (Bronze) B4 : CT451 Storefront (2 x 4-1/2) : 1
 inch Glass : Thermal

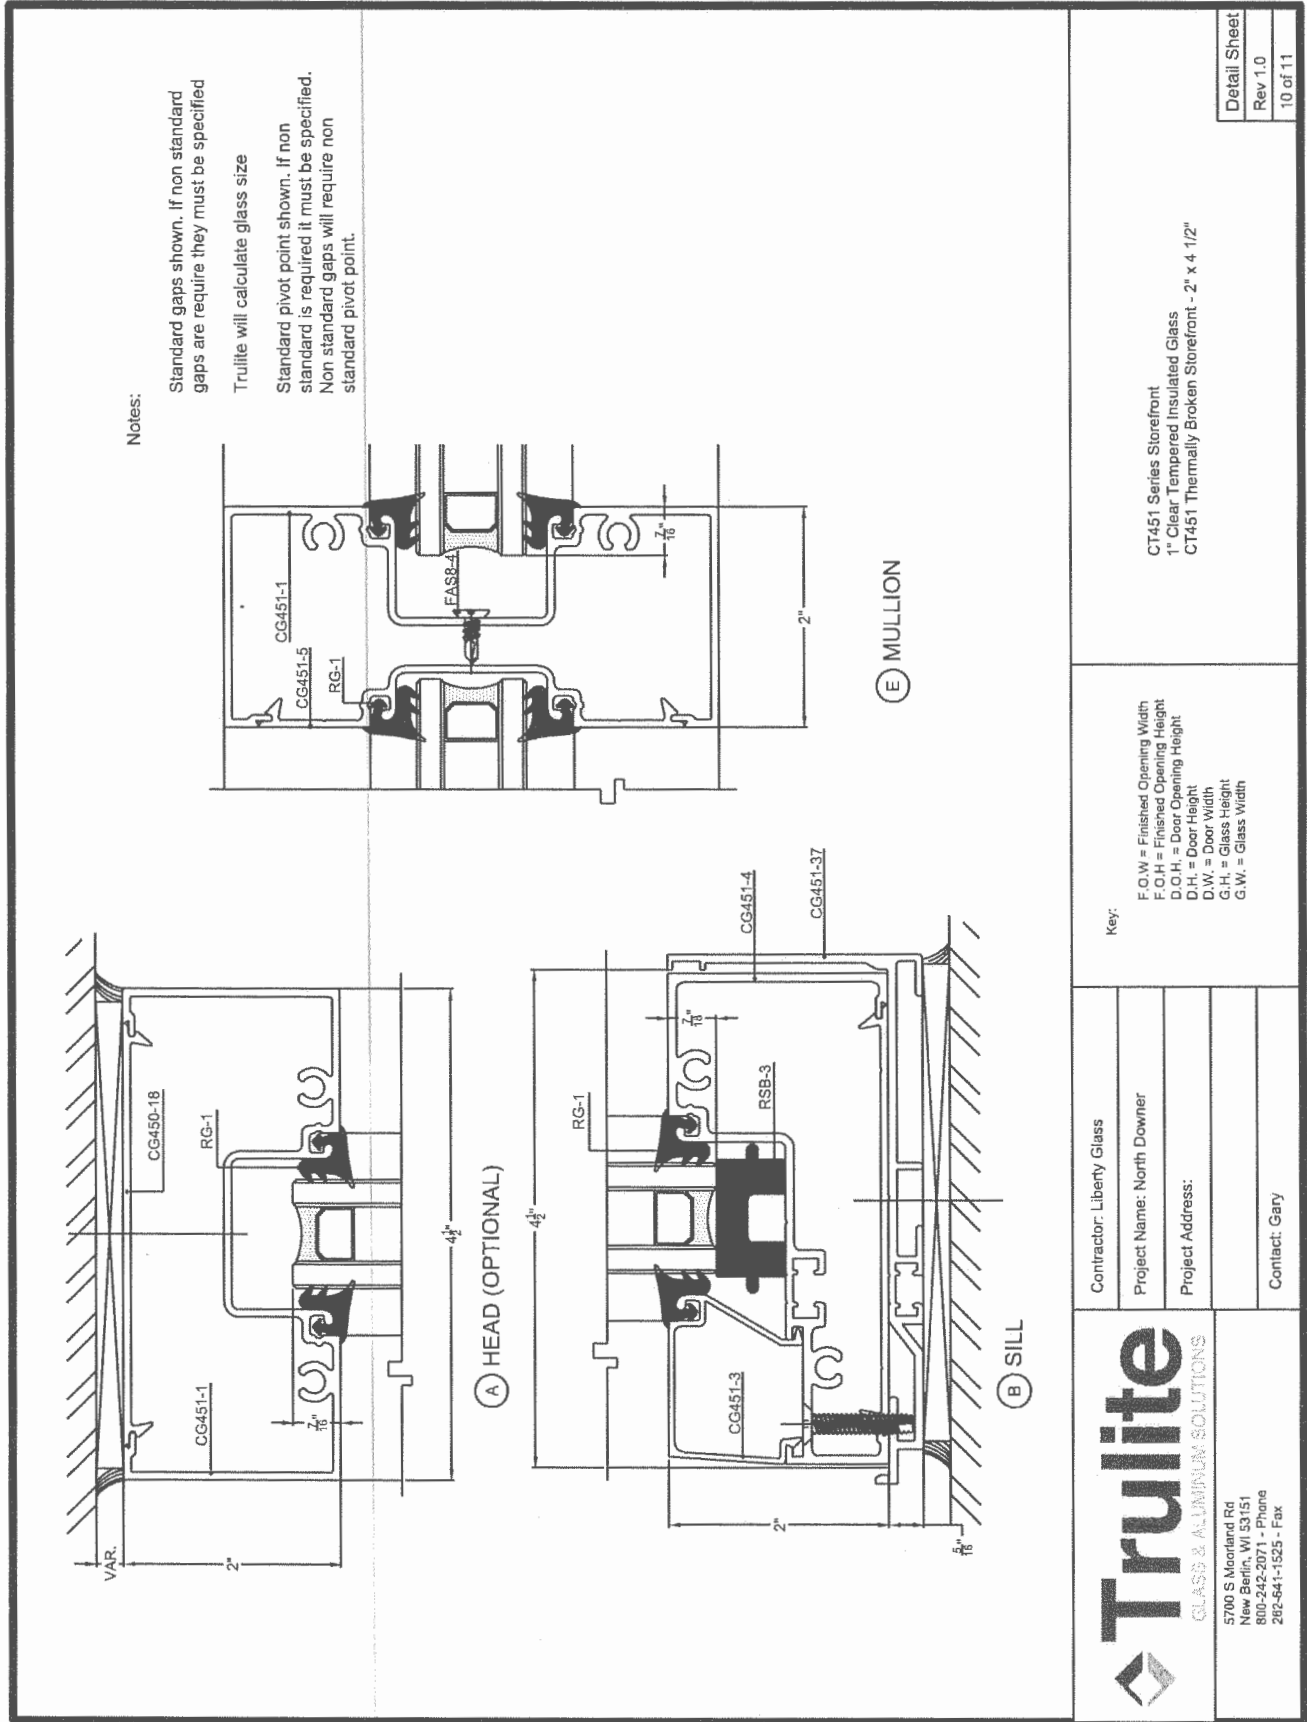
Detail Sheet
 Rev 1.0
 10 of 11
