# CERTIFICATE OF APPROPRIATENESS APPLICATION FORM

Incomplete applications will not be processed for Commission review.  
Please print legibly.

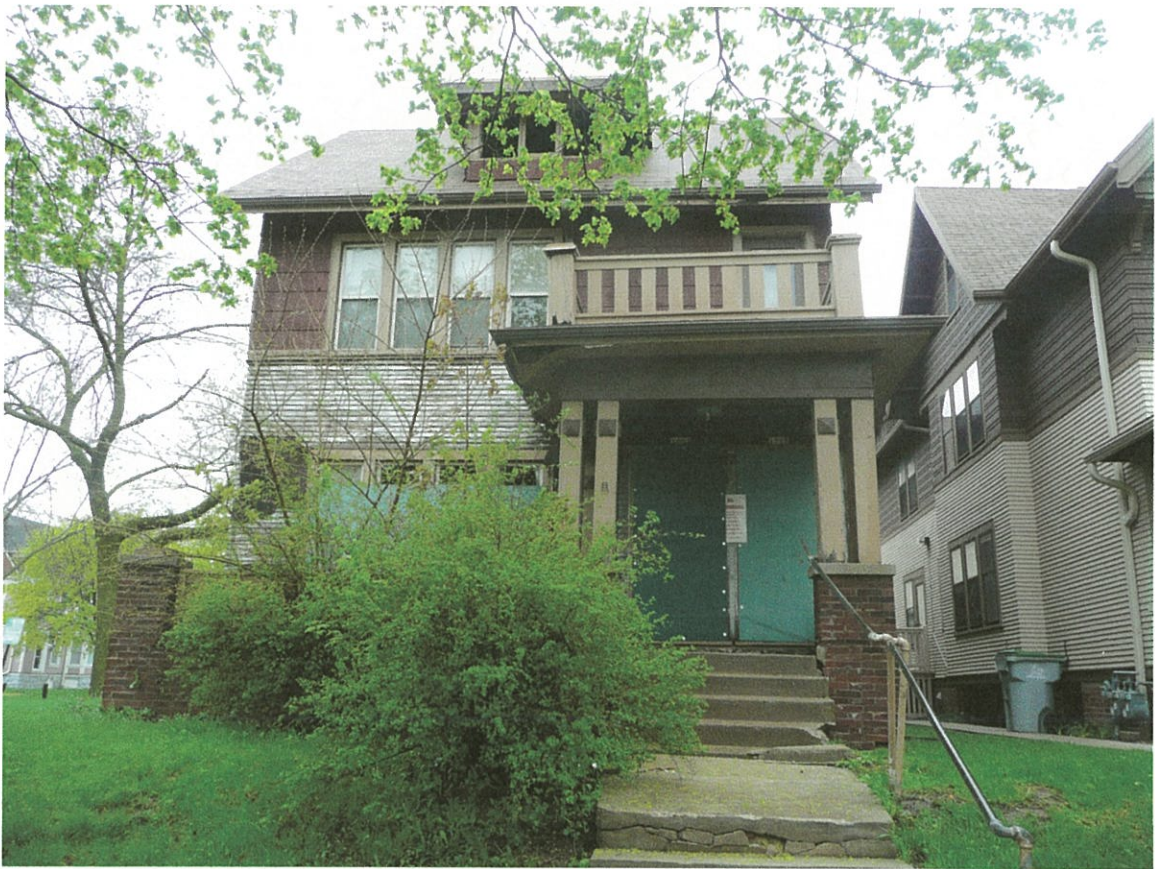
**Figure 1:** East elevation and front porches from 33rd Street.

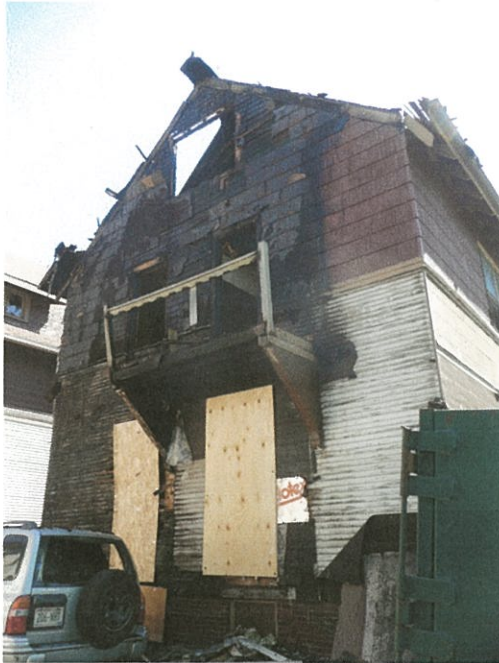
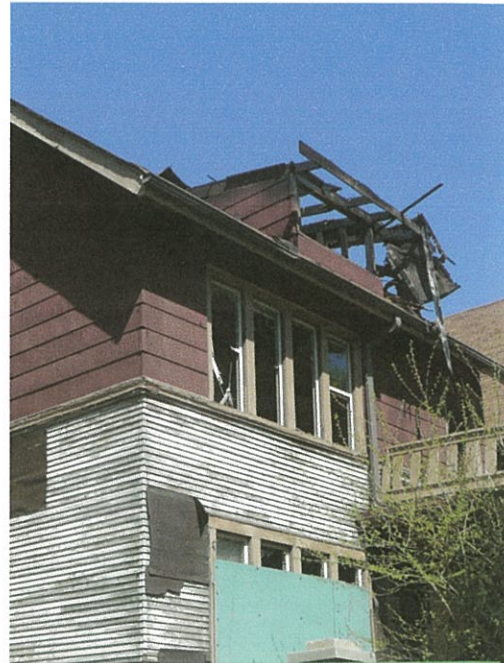
**Figures 7 and 8:** West elevation and east elevation. Roof rafters and dormer destroyed, upper windows broken after May 15 fire.

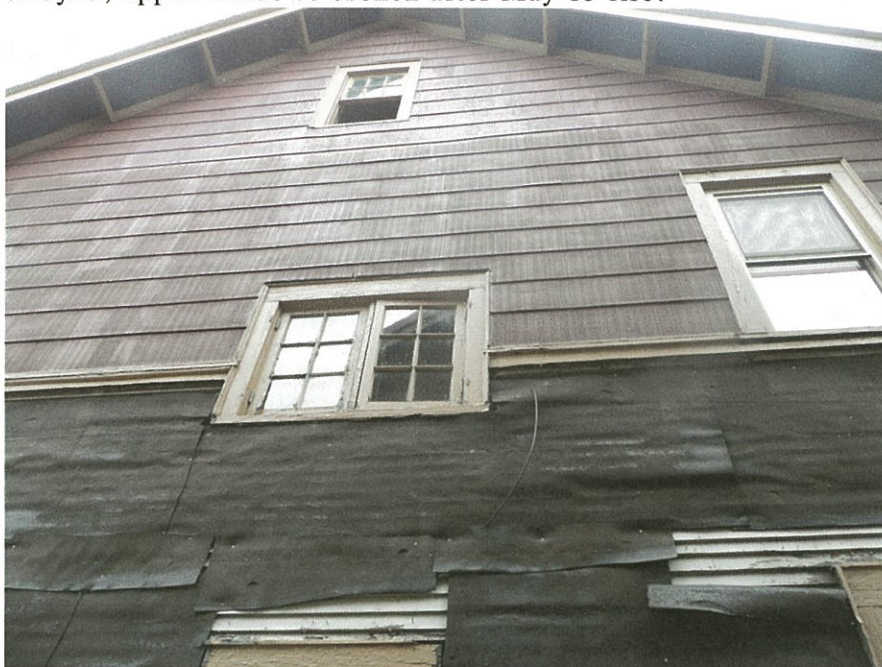
**Figure 9:** Casement, original double hung, and vinyl replacement windows (north elevation).

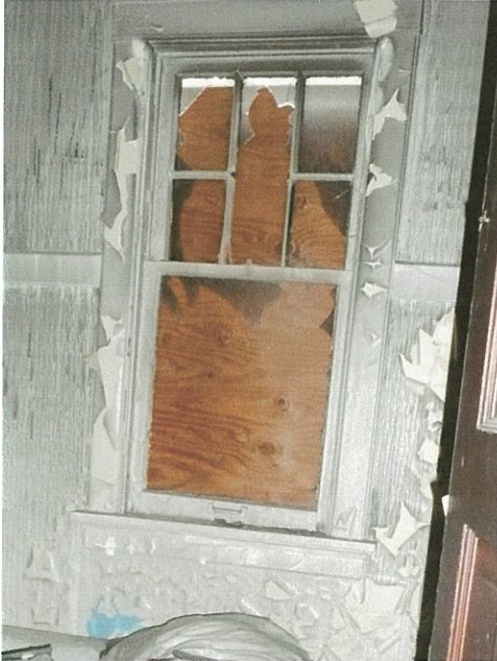
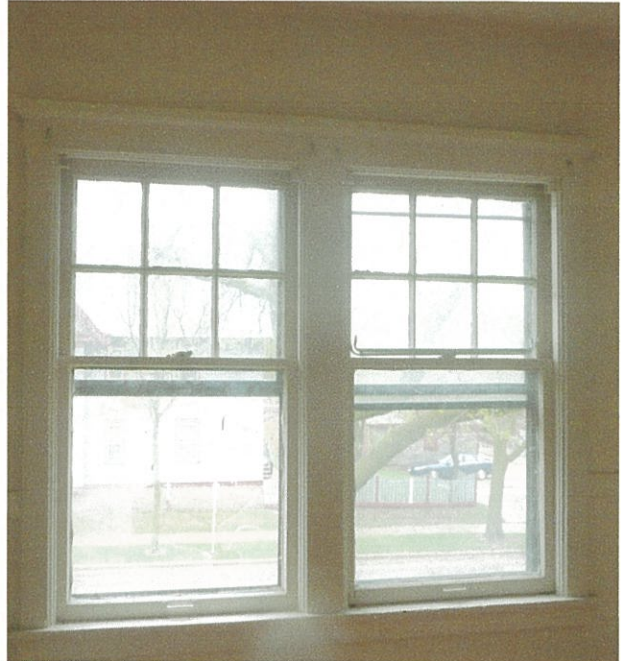
**Figures 10 and 11:** Interior side of original double hung windows.

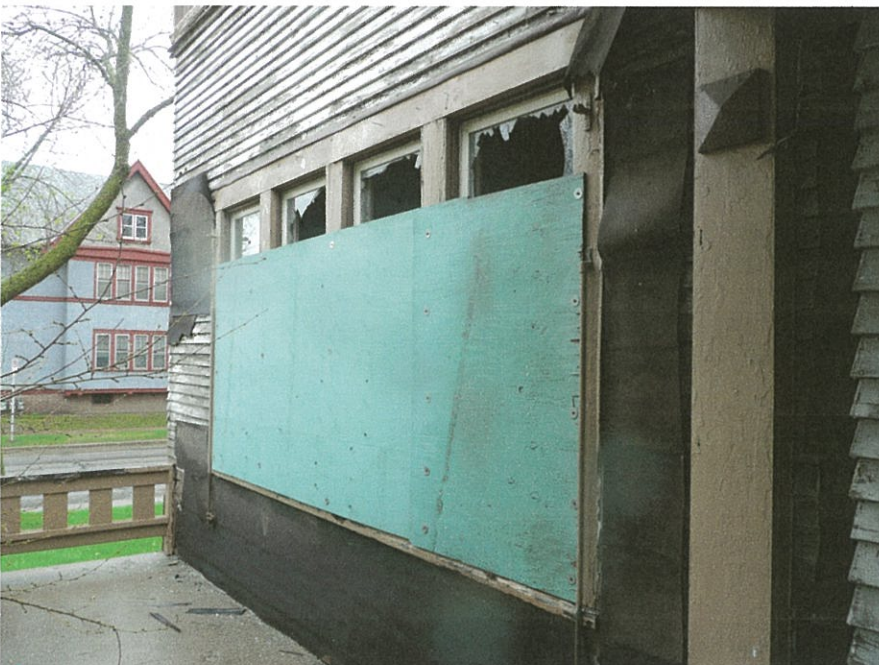
**Figure 12:** First floor windows boarded up following an earlier fire (east elevation). Note all glass and mullions are missing.

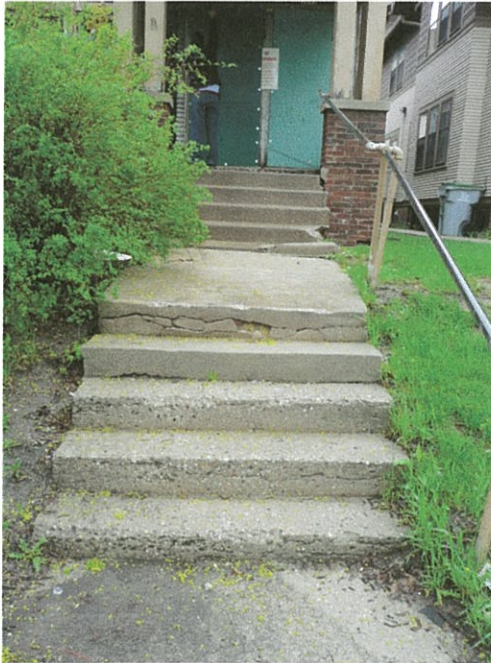
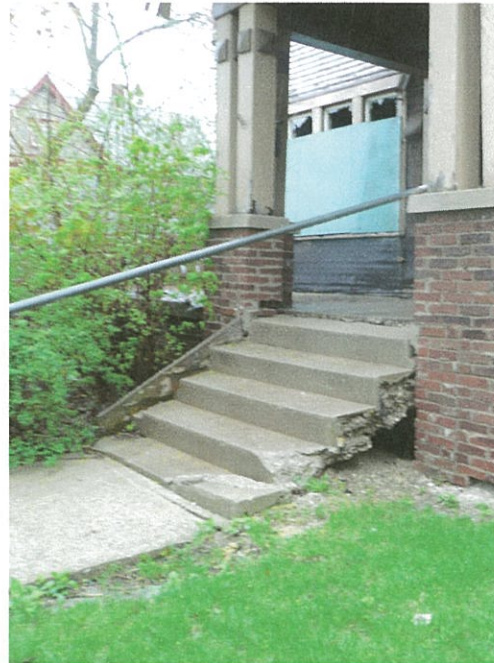
**Figures 13 and 14:** Front steps showing cracked, deteriorated concrete.

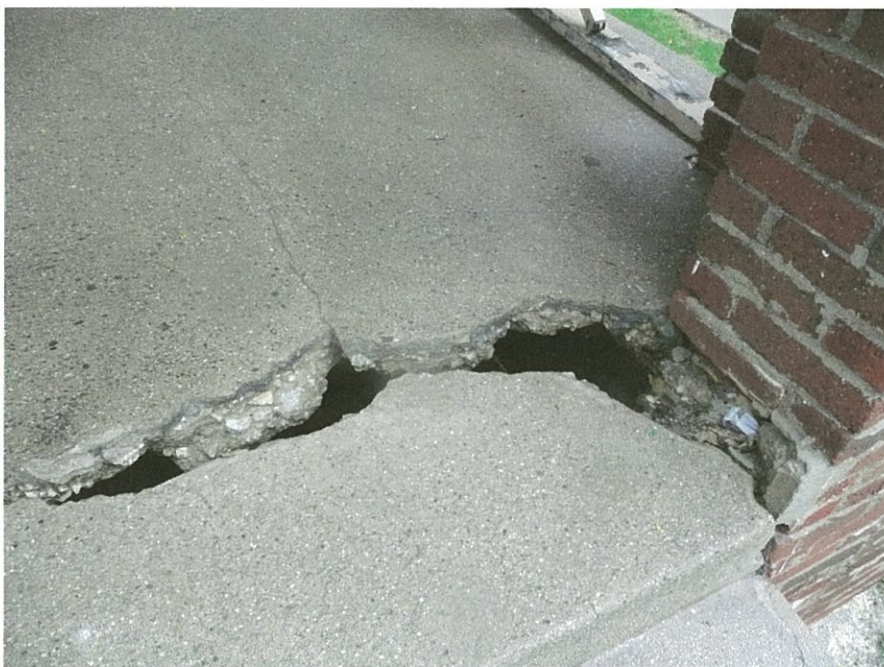
**Figure 15:** Cracked concrete porch (east elevation).

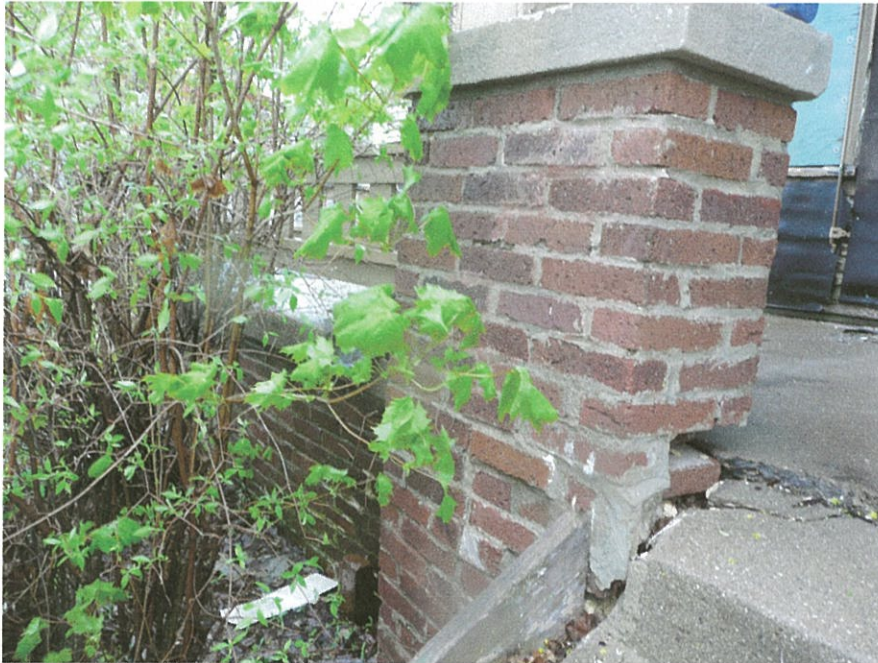
**Figure 16:** Shifting masonry porch piers (east elevation).

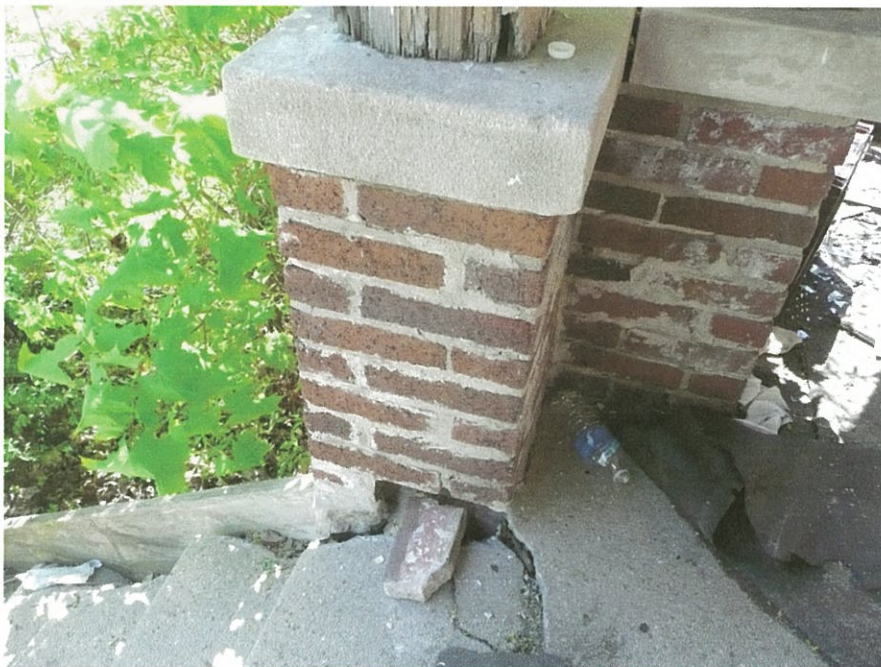
**Figure 17:** Mortar patching, loose brick on masonry porch piers (east elevation).

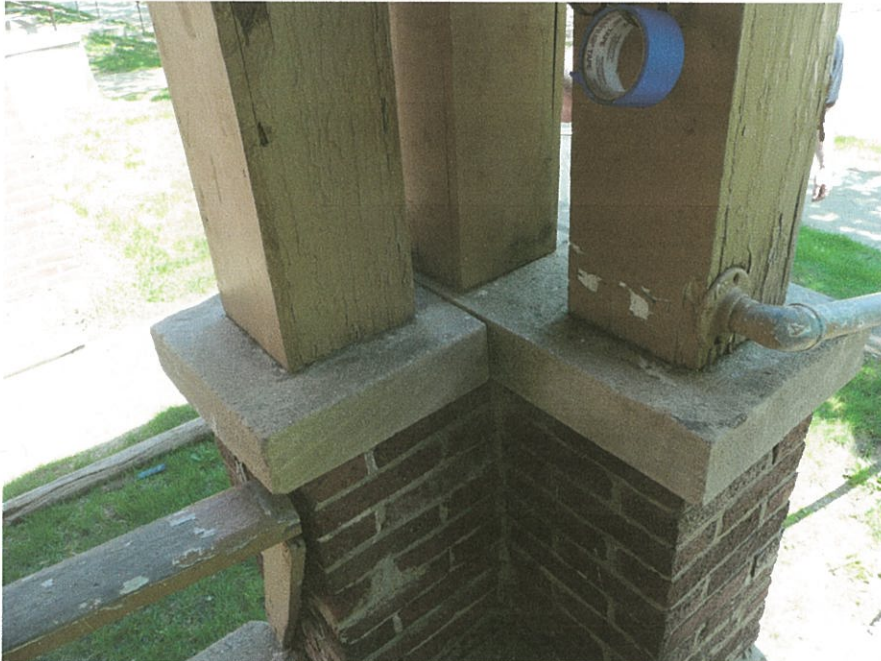
**Figure 18:** Wood columns supporting upper level of front porch on east elevation are original and will be restored.
