elevations

hp1.1

Prospect Management Co.
Lake Drive Town Home Facade Reno
2553-2575 N. Lake Drive
Milwaukee, WI 53211

Historic Preservation
Certificate

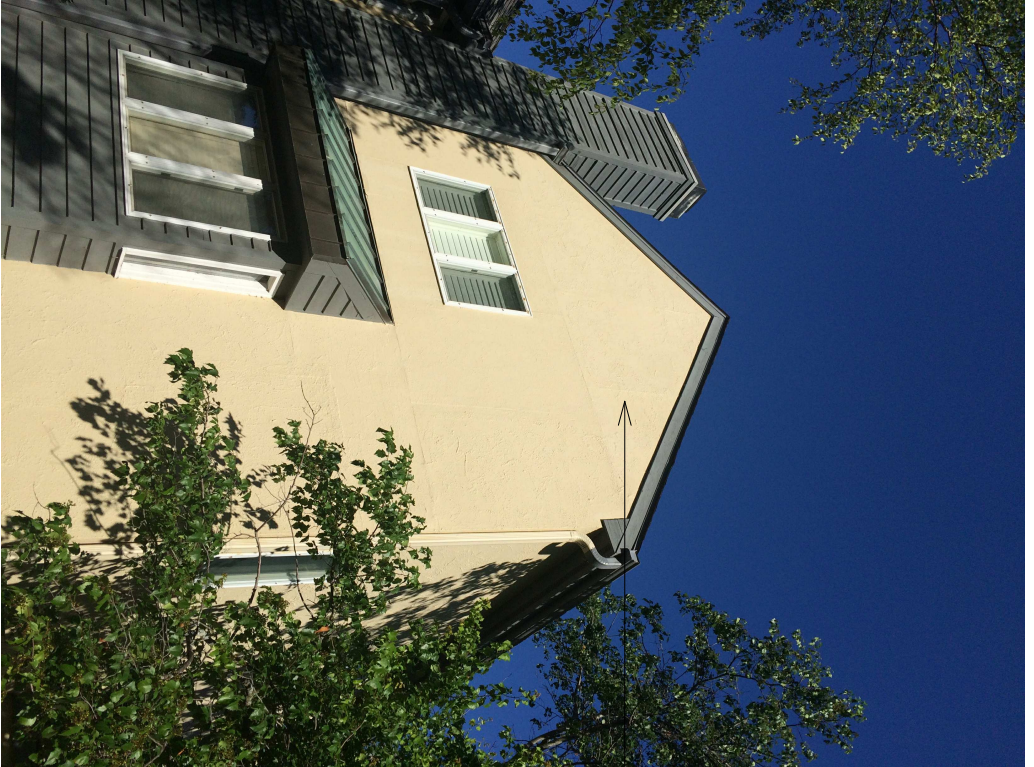
Exterior Facade - showing typical "telegraphing" of sheathing through EIFS finish

Typical seam "telegraphing" @ facade. Telegraphing is symptom of failed moisture barrier and exposure of substrate sheathing to moisture. Repair will require replacement of damaged substrate and new drained EIFS system

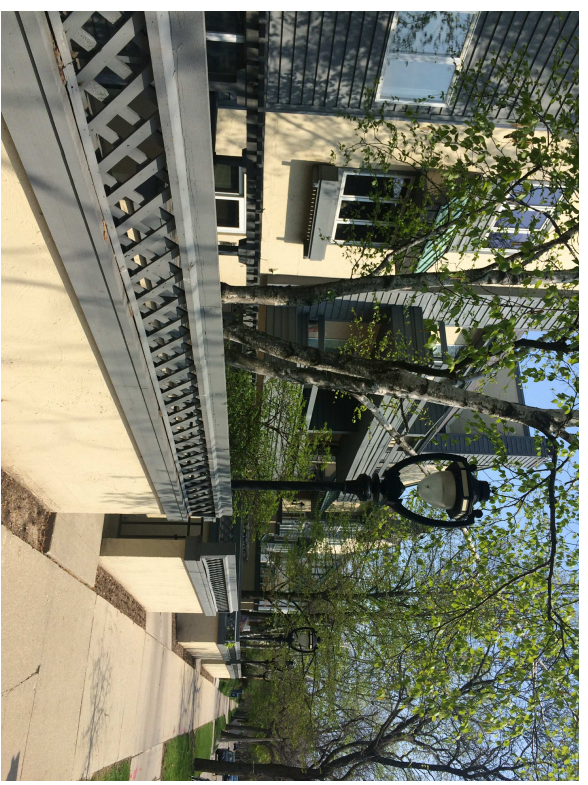
Pedestrian View traveling north - showing half wall to be renovated

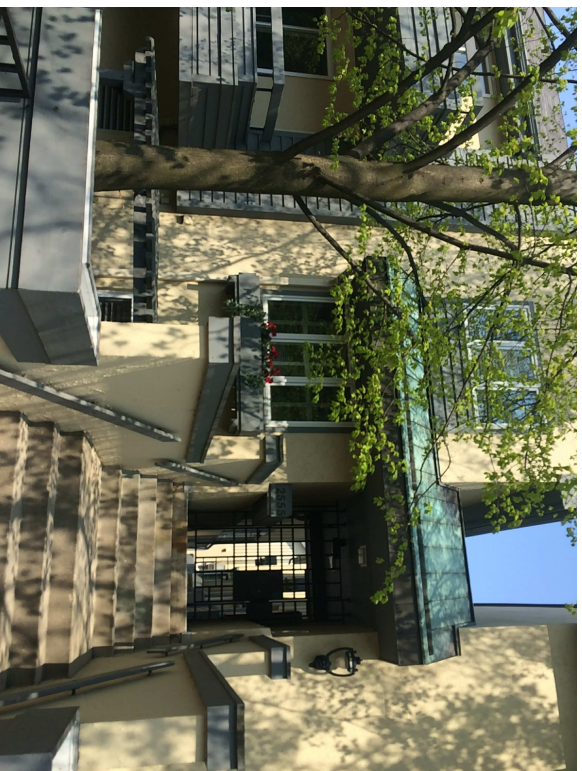
Existing entry gate area to be renovated
