Facilities Condition Assessment Program

MacArthur Square Parking Garage

May 2011

Facilities Condition Assessment Program—MacArthur Square

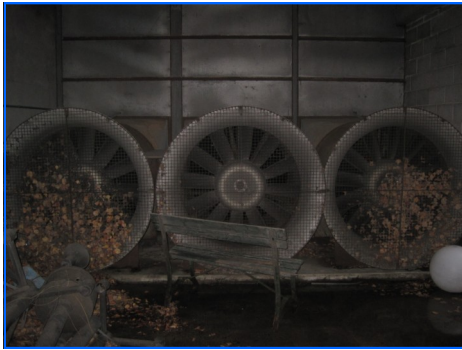
Twenty-one exhaust fans ranging from 30,000cfm 82,000cfm serve the parking garage. The motors have a useful life of up to 30 years. Parking should anticipate motor replacement by 2021. The housing unit and interim repairs are considered O+M expenditures.

Typical exhaust fans

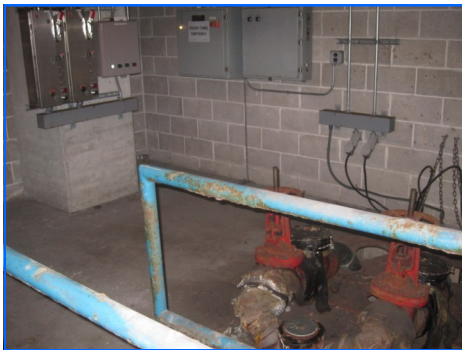
MacArthur Square contains two sump pumps at the Lower Level southeast corner. The submersible pumps have a useful life of up to 15 years. The pumps are planned for replacement in 2011. Subsequent replacement should be anticipated by 2026.

Pumps

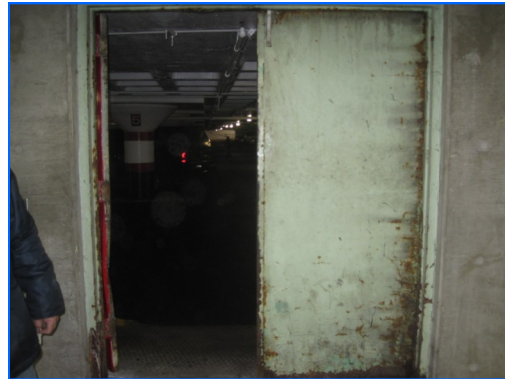
9th Street storage room door interior is rusted. Exterior is painted.

MacArthur Square comprises 79 steel doors, 8 glass doors, and two overhead garage doors. The useful life of metal exterior doors is up to 35 years. Based on the varied conditions, Parking should anticipated phased replacement of 12 doors every five years beginning by 2014.
