Structural Inspection Report

Property Inspected	
Address: 1673 N Farwell Ave	
Age Info: built in: according to online information	
Problem Description: <input type="checkbox"/> Water <input type="checkbox"/> Foundation Structural <input checked="" type="checkbox"/> Other Structural (Fire Escape)	
Inspection Date: 9/1/2021	Report Date: 9/15/2021

Observations
<p>(Description): <u>Critical examination of fire escape</u></p> <p>The noted concern is the condition of the exterior fire escape.</p> <p>The landing at the third floor shows some signs of deterioration due to the elements. The anchor points to the building appear to be imbedded into the building.</p> <div data-bbox="186 1228 1226 1612"></div>

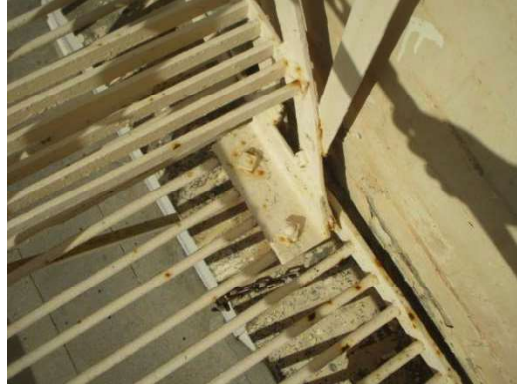
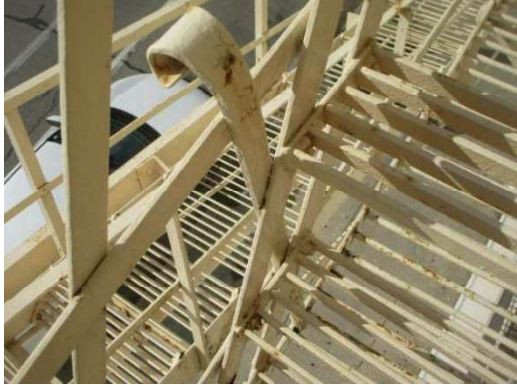
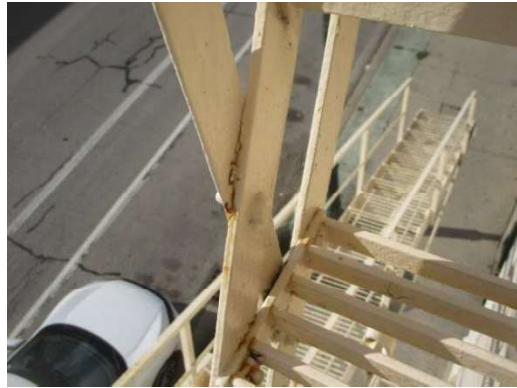
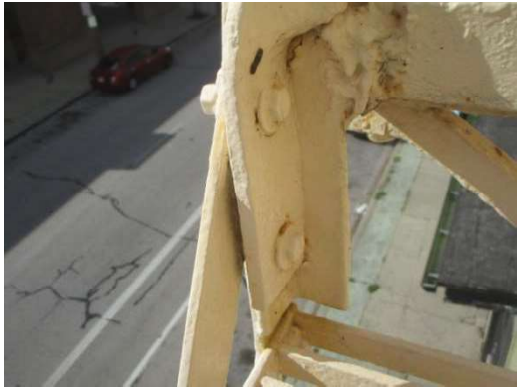
The staircase to the second-floor landing also shows some deterioration and rusting due to exposure to the elements. Some of the hardware attaching the treads to the rest of the structure are also rusted.

1. The fundamental cause of the problems is the steel becoming exposed to the elements. The exposed steel then begins to rust, weakening the material. The fire escape should be scrapped and re-painted to protect the steel.

2. It is recommended that all the hardware be replaced, as even a small amount of deterioration can cause a large loss of strength. The hardware observed showed some deterioration.

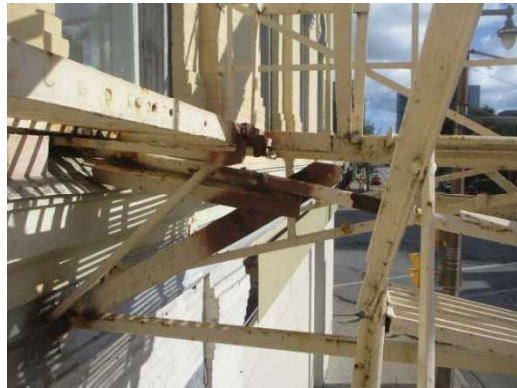
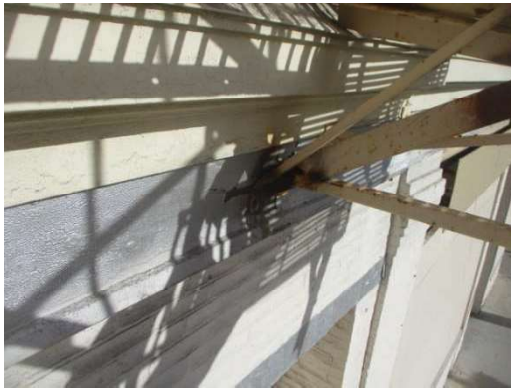
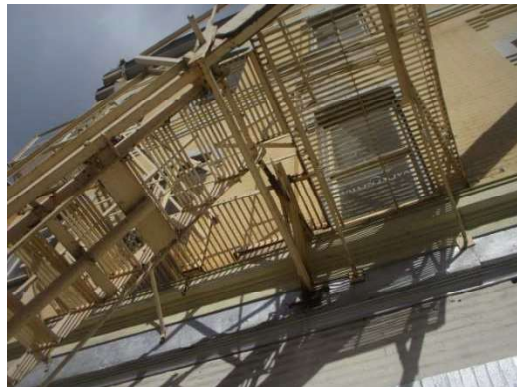
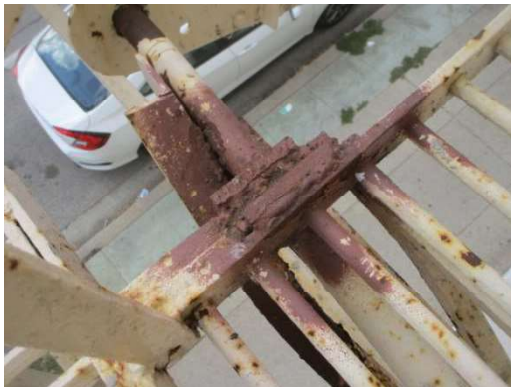
The second-floor landing shows some increased deterioration, as well as past repair. There is evidence of material being welded on as repair patches. Some of the material has twisted and shifted from its original position.

3. The repairs completed to the counterweighted stairs look amateurish and have not succeeded in adequately supporting the structure. This is evident in the twist of the staircase and of some of the supporting members. A new patch/supporting system should be designed and installed. The design of such a system is a service Zerreon Inc. can provide, however falls outside of the scope of this report.

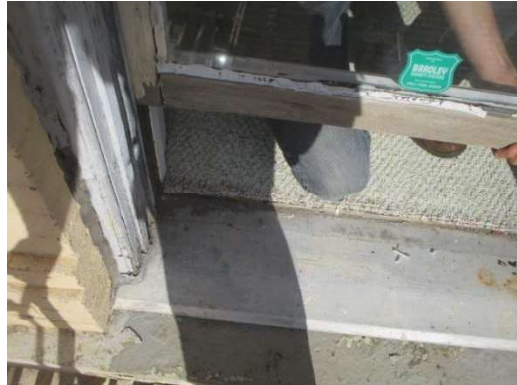
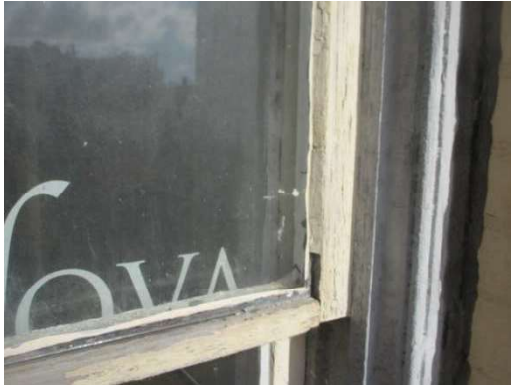
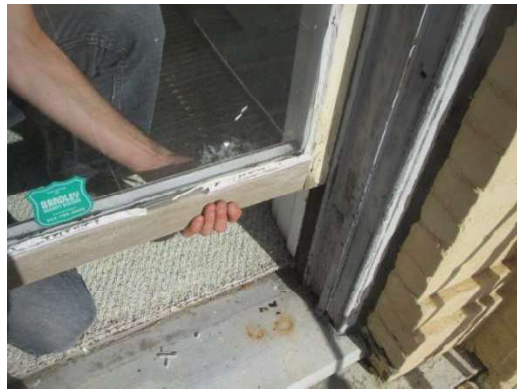
There is an egress window on the second floor to access the platform. The egress window was very difficult to operate and could not be opened all the way.

4. The window egress on the second floor should be repaired or replaced to ensure proper egress paths.

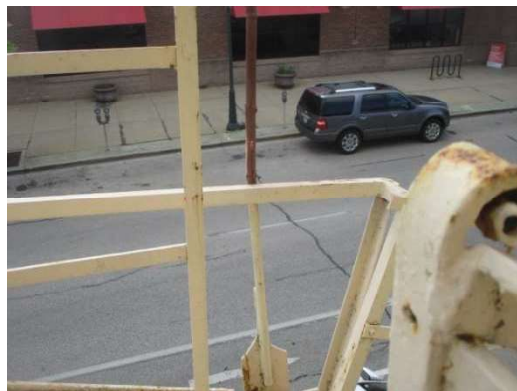
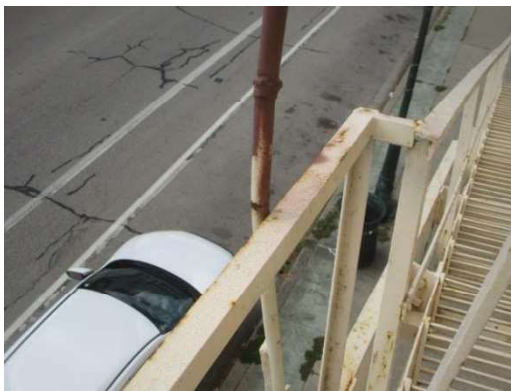
There is a steel rod that supports the counterweight mechanism for the last flight of stairs. This rod has become bent due to proximity with the railing. The flight of stairs has also twisted, making egress difficult.

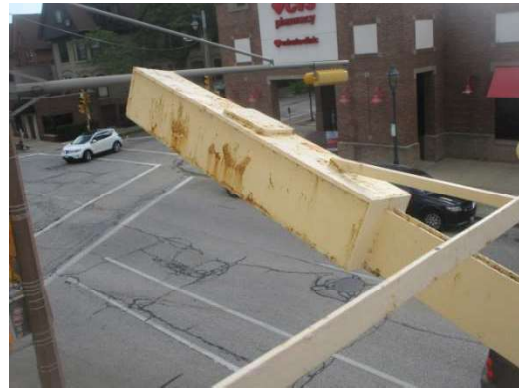
The counterweight system worked properly, except for the interference of the bent rod (see above). The stairs lowered at an appropriate pace and raised back up with minimal assistance once weight was removed.

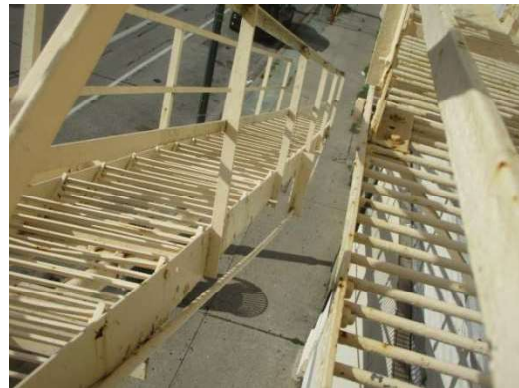
There is observed deterioration and rusting on the final flight of stairs as well. The hardware also shows deterioration.
