BASILICA OF ST. JOSAPHAT EXTERIOR REPAIR

7/16/18 BID DOCUMENTS

INDEX		
Sheet Number	Sheet Name	Drawn By
GENERAL		
G1	TITLE SHEET & INDEX	UWA
ARCHITECTURAL		
A1	KEY PLAN	UWA
A2	KEY ELEVATIONS	Author
A3	KEY PLAN - WINDOW REPAIR	Author
A4	ARCHITECTURAL DETAILS	Author
STRUCTURAL		
S1	NORTH ELEVATION	PE
S2	EAST ELEVATION	PE
S3	SOUTH ELEVATION	PE
S4	WEST ELEVATION	PE
S5	DETAILS	PE

ST. JOSAPHAT
 BASILICA
 FACADE REVIEW
 2333 S. 6th STREET
 MILWAUKEE, WI 53215

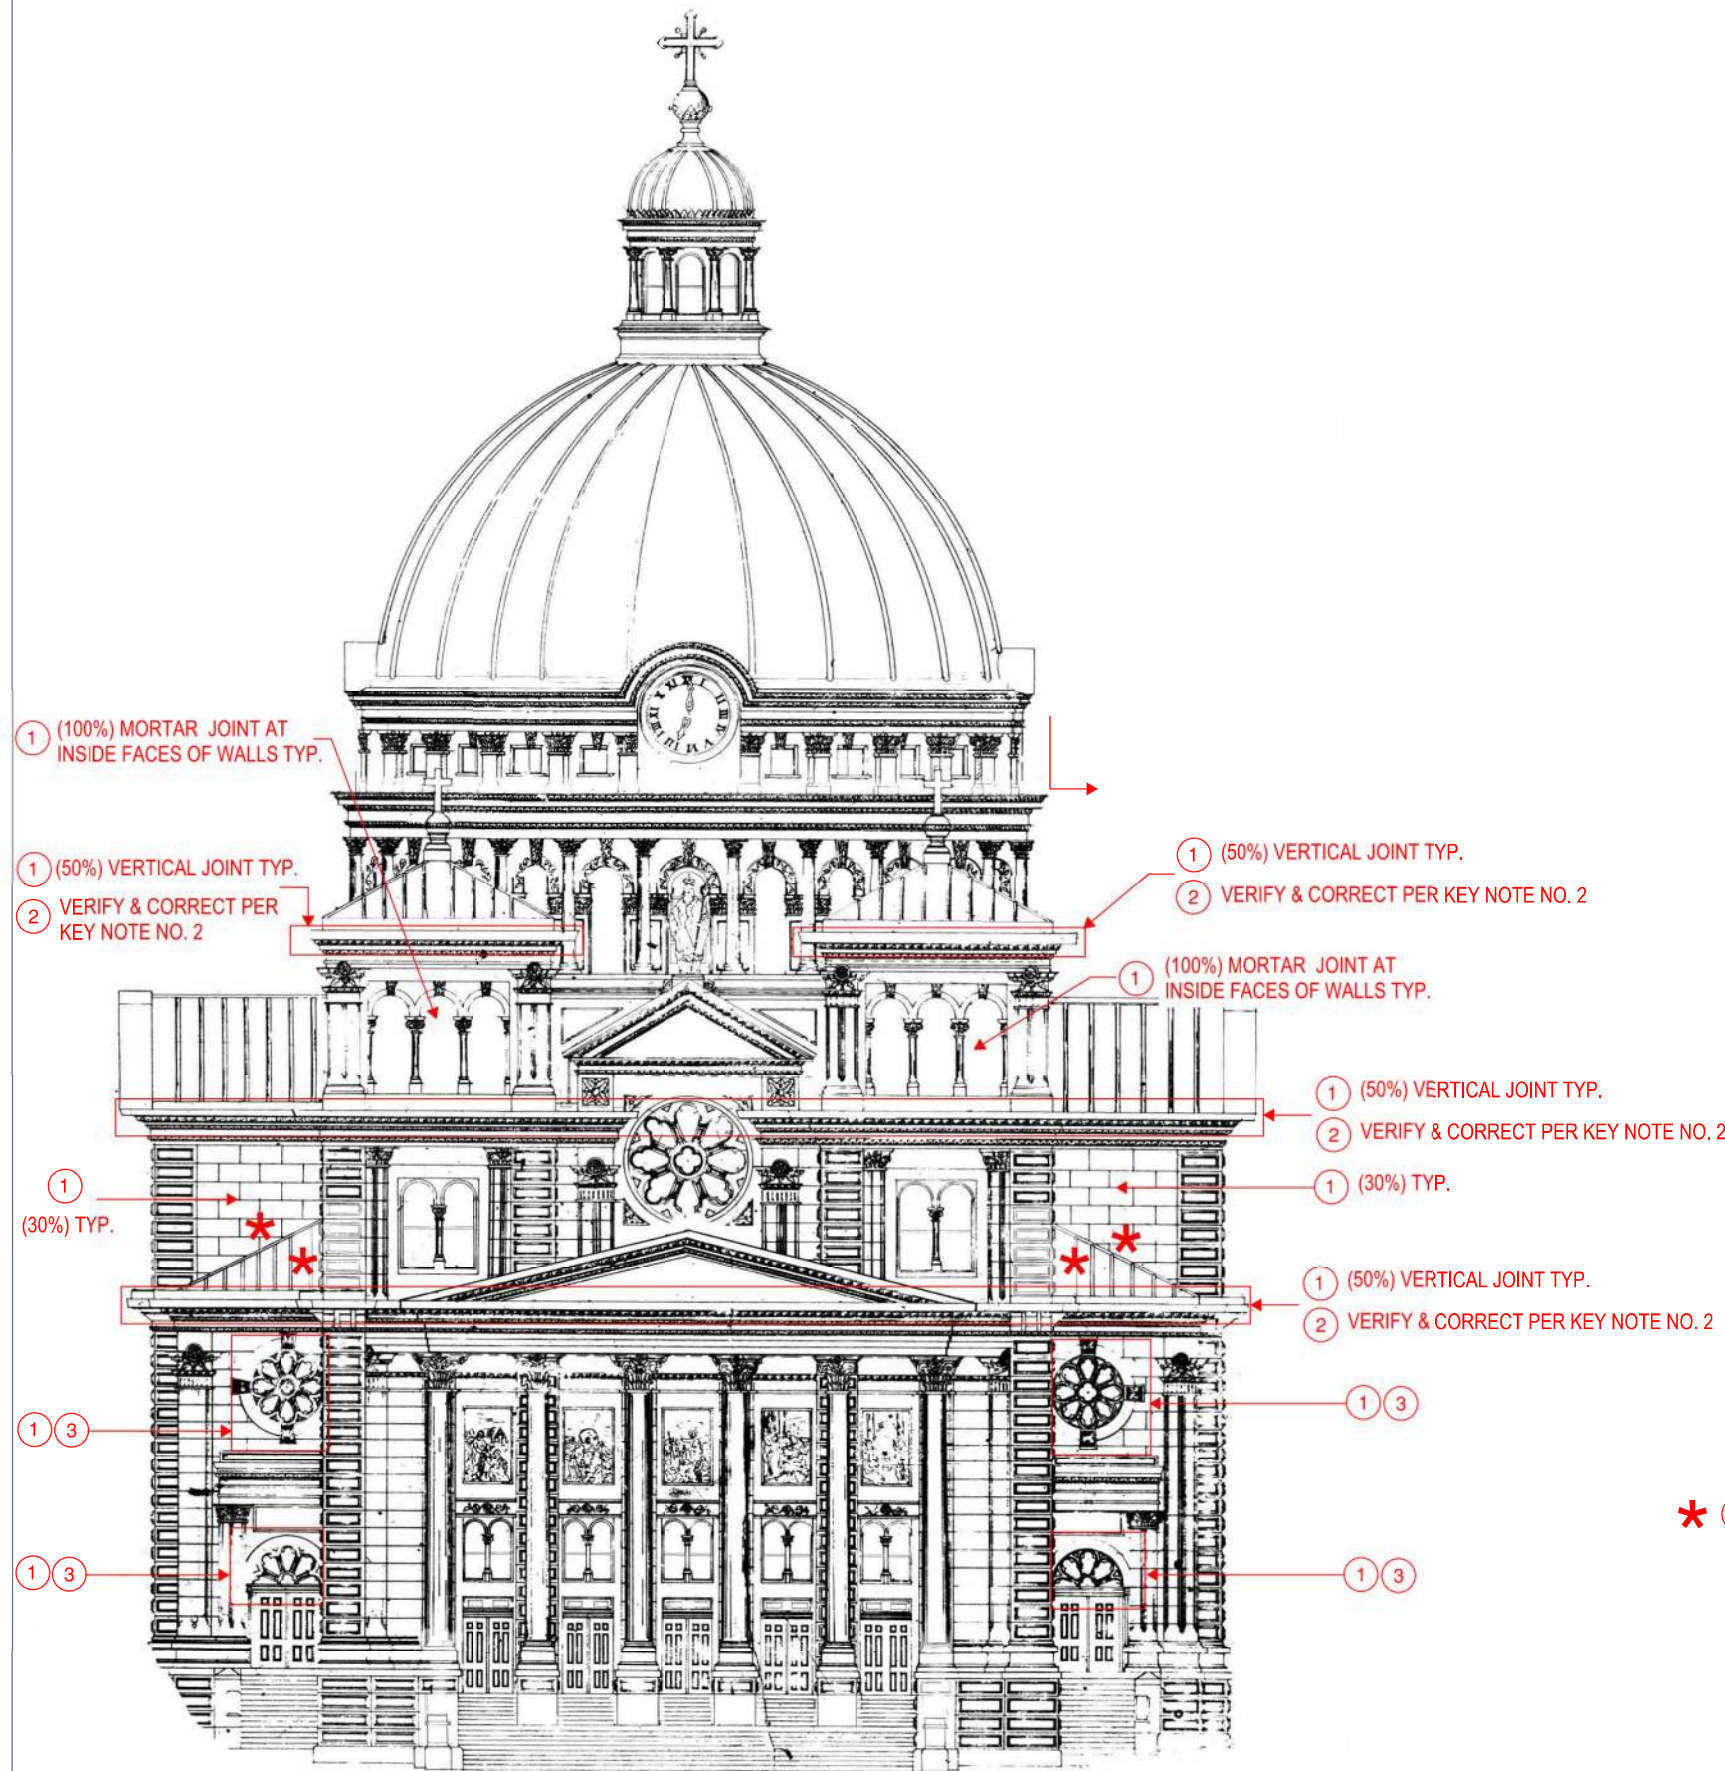
① NORTH ELEVATION
 S1

MARK	DESCRIPTION
①	FAILING/WEATHERED/LOOSE MORTAR IN JOINT. PROVIDE NEW TUCK POINTING. SEE DETAIL 1/S5.
②	SEALANT AT WRONG LOCATION. REMOVE SEALANT AND CLEAN. IF MORTAR LOSS NOTED, PROVIDE NEW TUCK POINTING PER DETAIL 1/S5.
③	FAILING SEALANT AT SKYWARD JOINT. REMOVE SEALANT, CLEAN, AND APPLY NEW SEALANT PER DETAIL 2/S5. IF MORTAR LOSS NOTED, PROVIDE NEW TUCK POINTING PRIOR TO APPLYING SEALANT.
④	SPALL IN STONE FROM ANCHORS BEING TOO CLOSE TO EDGE ALONG STONE PROJECTION. REMOVE LOOSE SPALL AND PREVENT MOISTURE INTRUSION.

NOTE:
 1. SEE ROOFING CONSULTANT'S DETAIL FOR SEALANT AT COPPER FLASHING, TYP.
 2. EXISTING PAINT IN ARCHED WINDOW FRAME HAS PEELED OFF. REMOVE PAINT, CLEAN, AND APPLY NEW BREATHABLE PAINT, TYP.

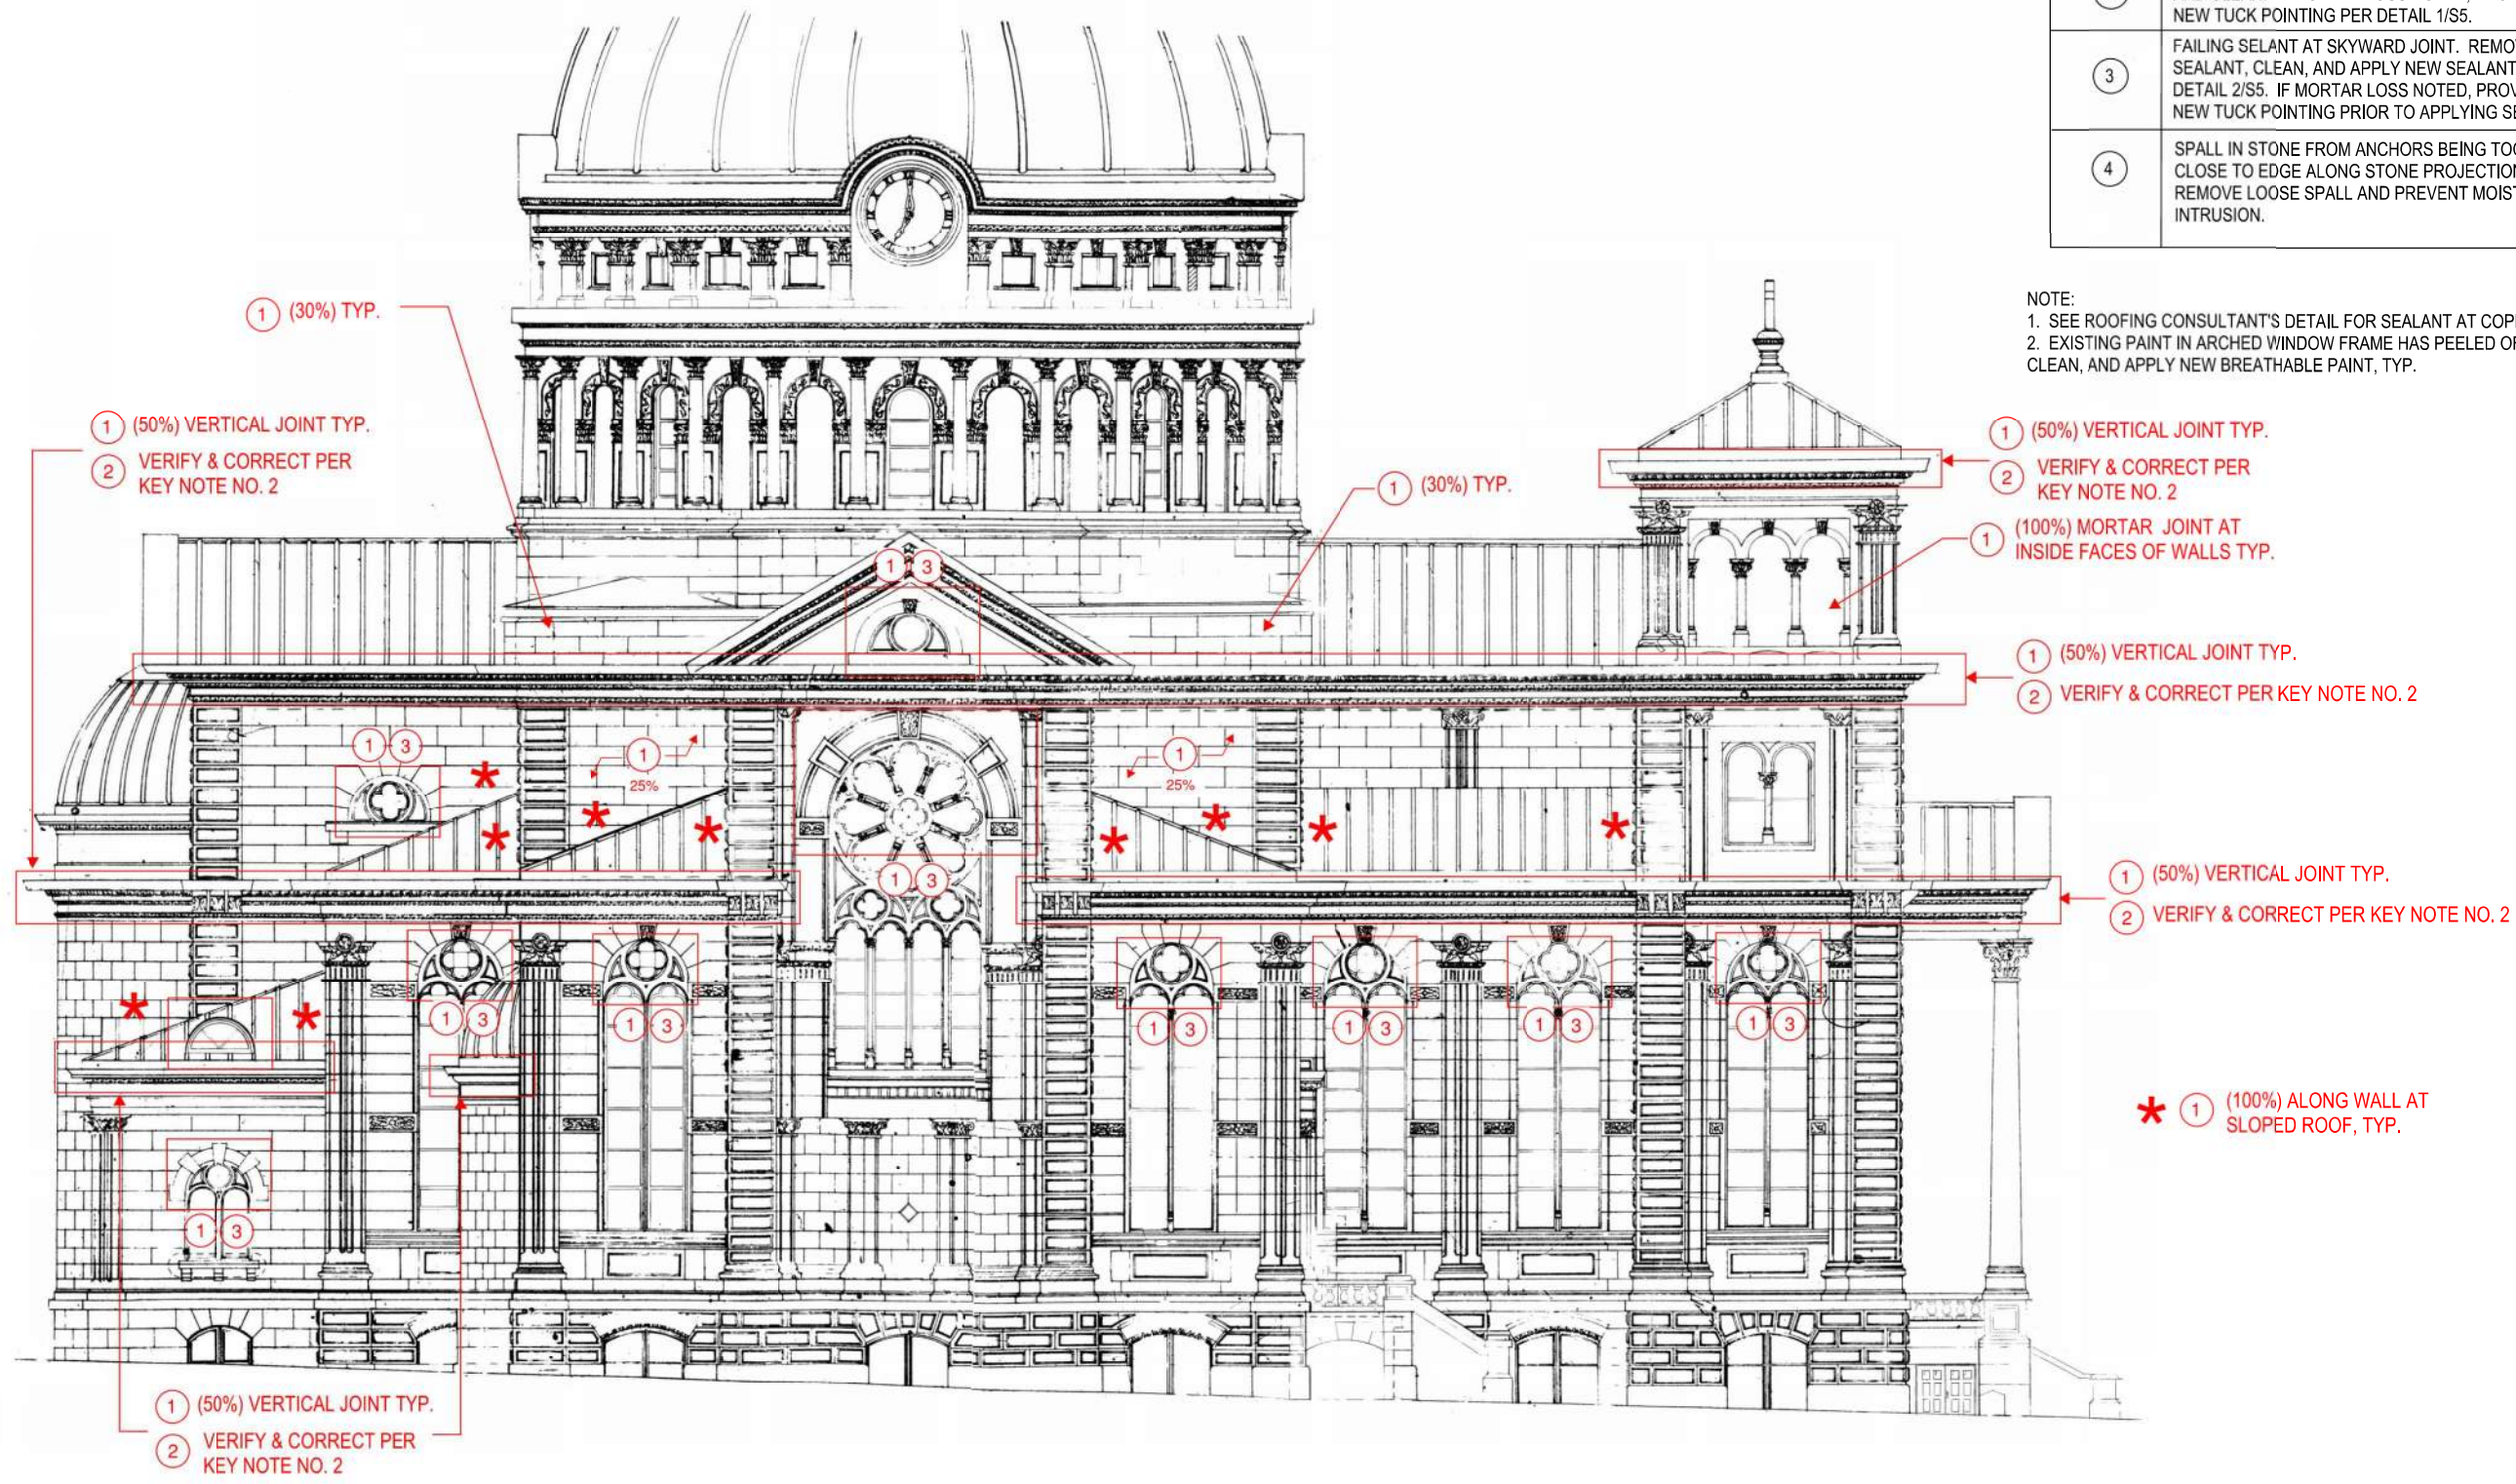
① EAST ELEVATION
S2

MARK	DESCRIPTION
①	FAILING/WEATHERED/LOOSE MORTAR IN JOINT. PROVIDE NEW TUCK POINTING. SEE DETAIL 1/S5.
②	SEALANT AT WRONG LOCATION. REMOVE SEALANT AND CLEAN. IF MORTAR LOSS NOTED, PROVIDE NEW TUCK POINTING PER DETAIL 1/S5.
③	FAILING SEALANT AT SKYWARD JOINT. REMOVE SEALANT, CLEAN, AND APPLY NEW SEALANT PER DETAIL 2/S5. IF MORTAR LOSS NOTED, PROVIDE NEW TUCK POINTING PRIOR TO APPLYING SEALANT.
④	SPALL IN STONE FROM ANCHORS BEING TOO CLOSE TO EDGE ALONG STONE PROJECTION. REMOVE LOOSE SPALL AND PREVENT MOISTURE INTRUSION.

NOTE:
 1. SEE ROOFING CONSULTANT'S DETAIL FOR SEALANT AT COPPER FLASHING, TYP.
 2. EXISTING PAINT IN ARCHED WINDOW FRAME HAS PEELED OFF. REMOVE PAINT, CLEAN, AND APPLY NEW BREATHABLE PAINT, TYP.

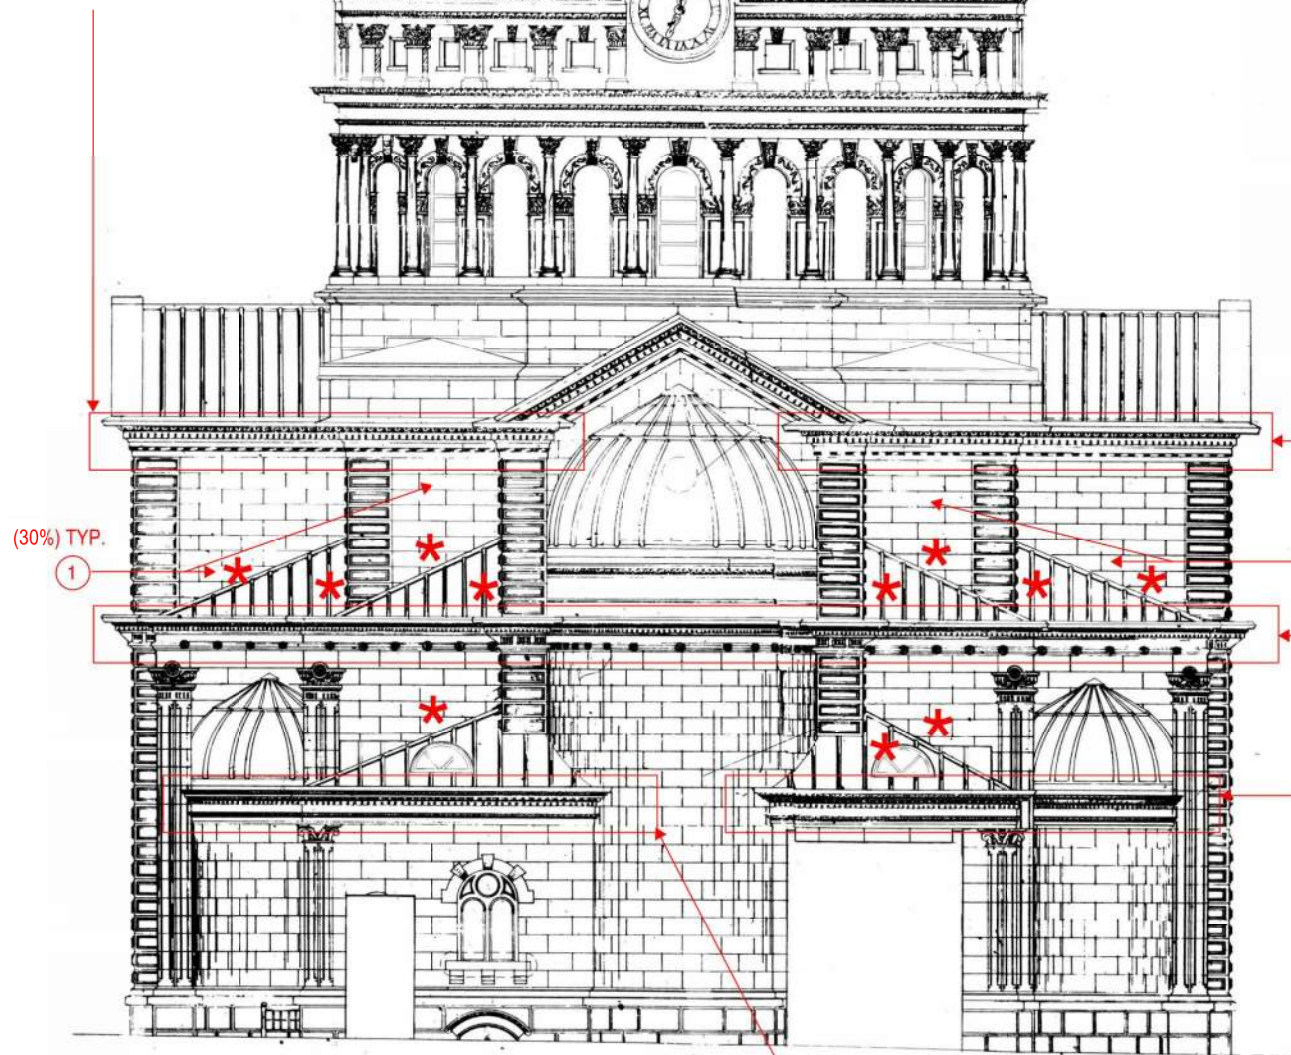
① SOUTH ELEVATION
S3

MARK	DESCRIPTION
①	FAILING/WEATHERED/LOOSE MORTAR IN JOINT. PROVIDE NEW TUCK POINTING. SEE DETAIL 1/S5.
②	SEALANT AT WRONG LOCATION. REMOVE SEALANT AND CLEAN. IF MORTAR LOSS NOTED, PROVIDE NEW TUCK POINTING PER DETAIL 1/S5.
③	FAILING SEALANT AT SKYWARD JOINT. REMOVE SEALANT, CLEAN, AND APPLY NEW SEALANT PER DETAIL 2/S5. IF MORTAR LOSS NOTED, PROVIDE NEW TUCK POINTING PRIOR TO APPLYING SEALANT.
④	SPALL IN STONE FROM ANCHORS BEING TOO CLOSE TO EDGE ALONG STONE PROJECTION. REMOVE LOOSE SPALL AND PREVENT MOISTURE INTRUSION.

- SEE ROOFING CONSULTANT'S DETAIL FOR SEALANT AT COPPER FLASHING, TYP.
- EXISTING PAINT IN ARCHED WINDOW FRAME HAS PEELED OFF. REMOVE PAINT, CLEAN, AND APPLY NEW BREATHABLE PAINT, TYP.

- ① (50%) VERTICAL JOINT TYP.
- ② VERIFY & CORRECT PER KEY NOTE NO. 2

- * ① (100%) ALONG WALL AT SLOPED ROOF, TYP.

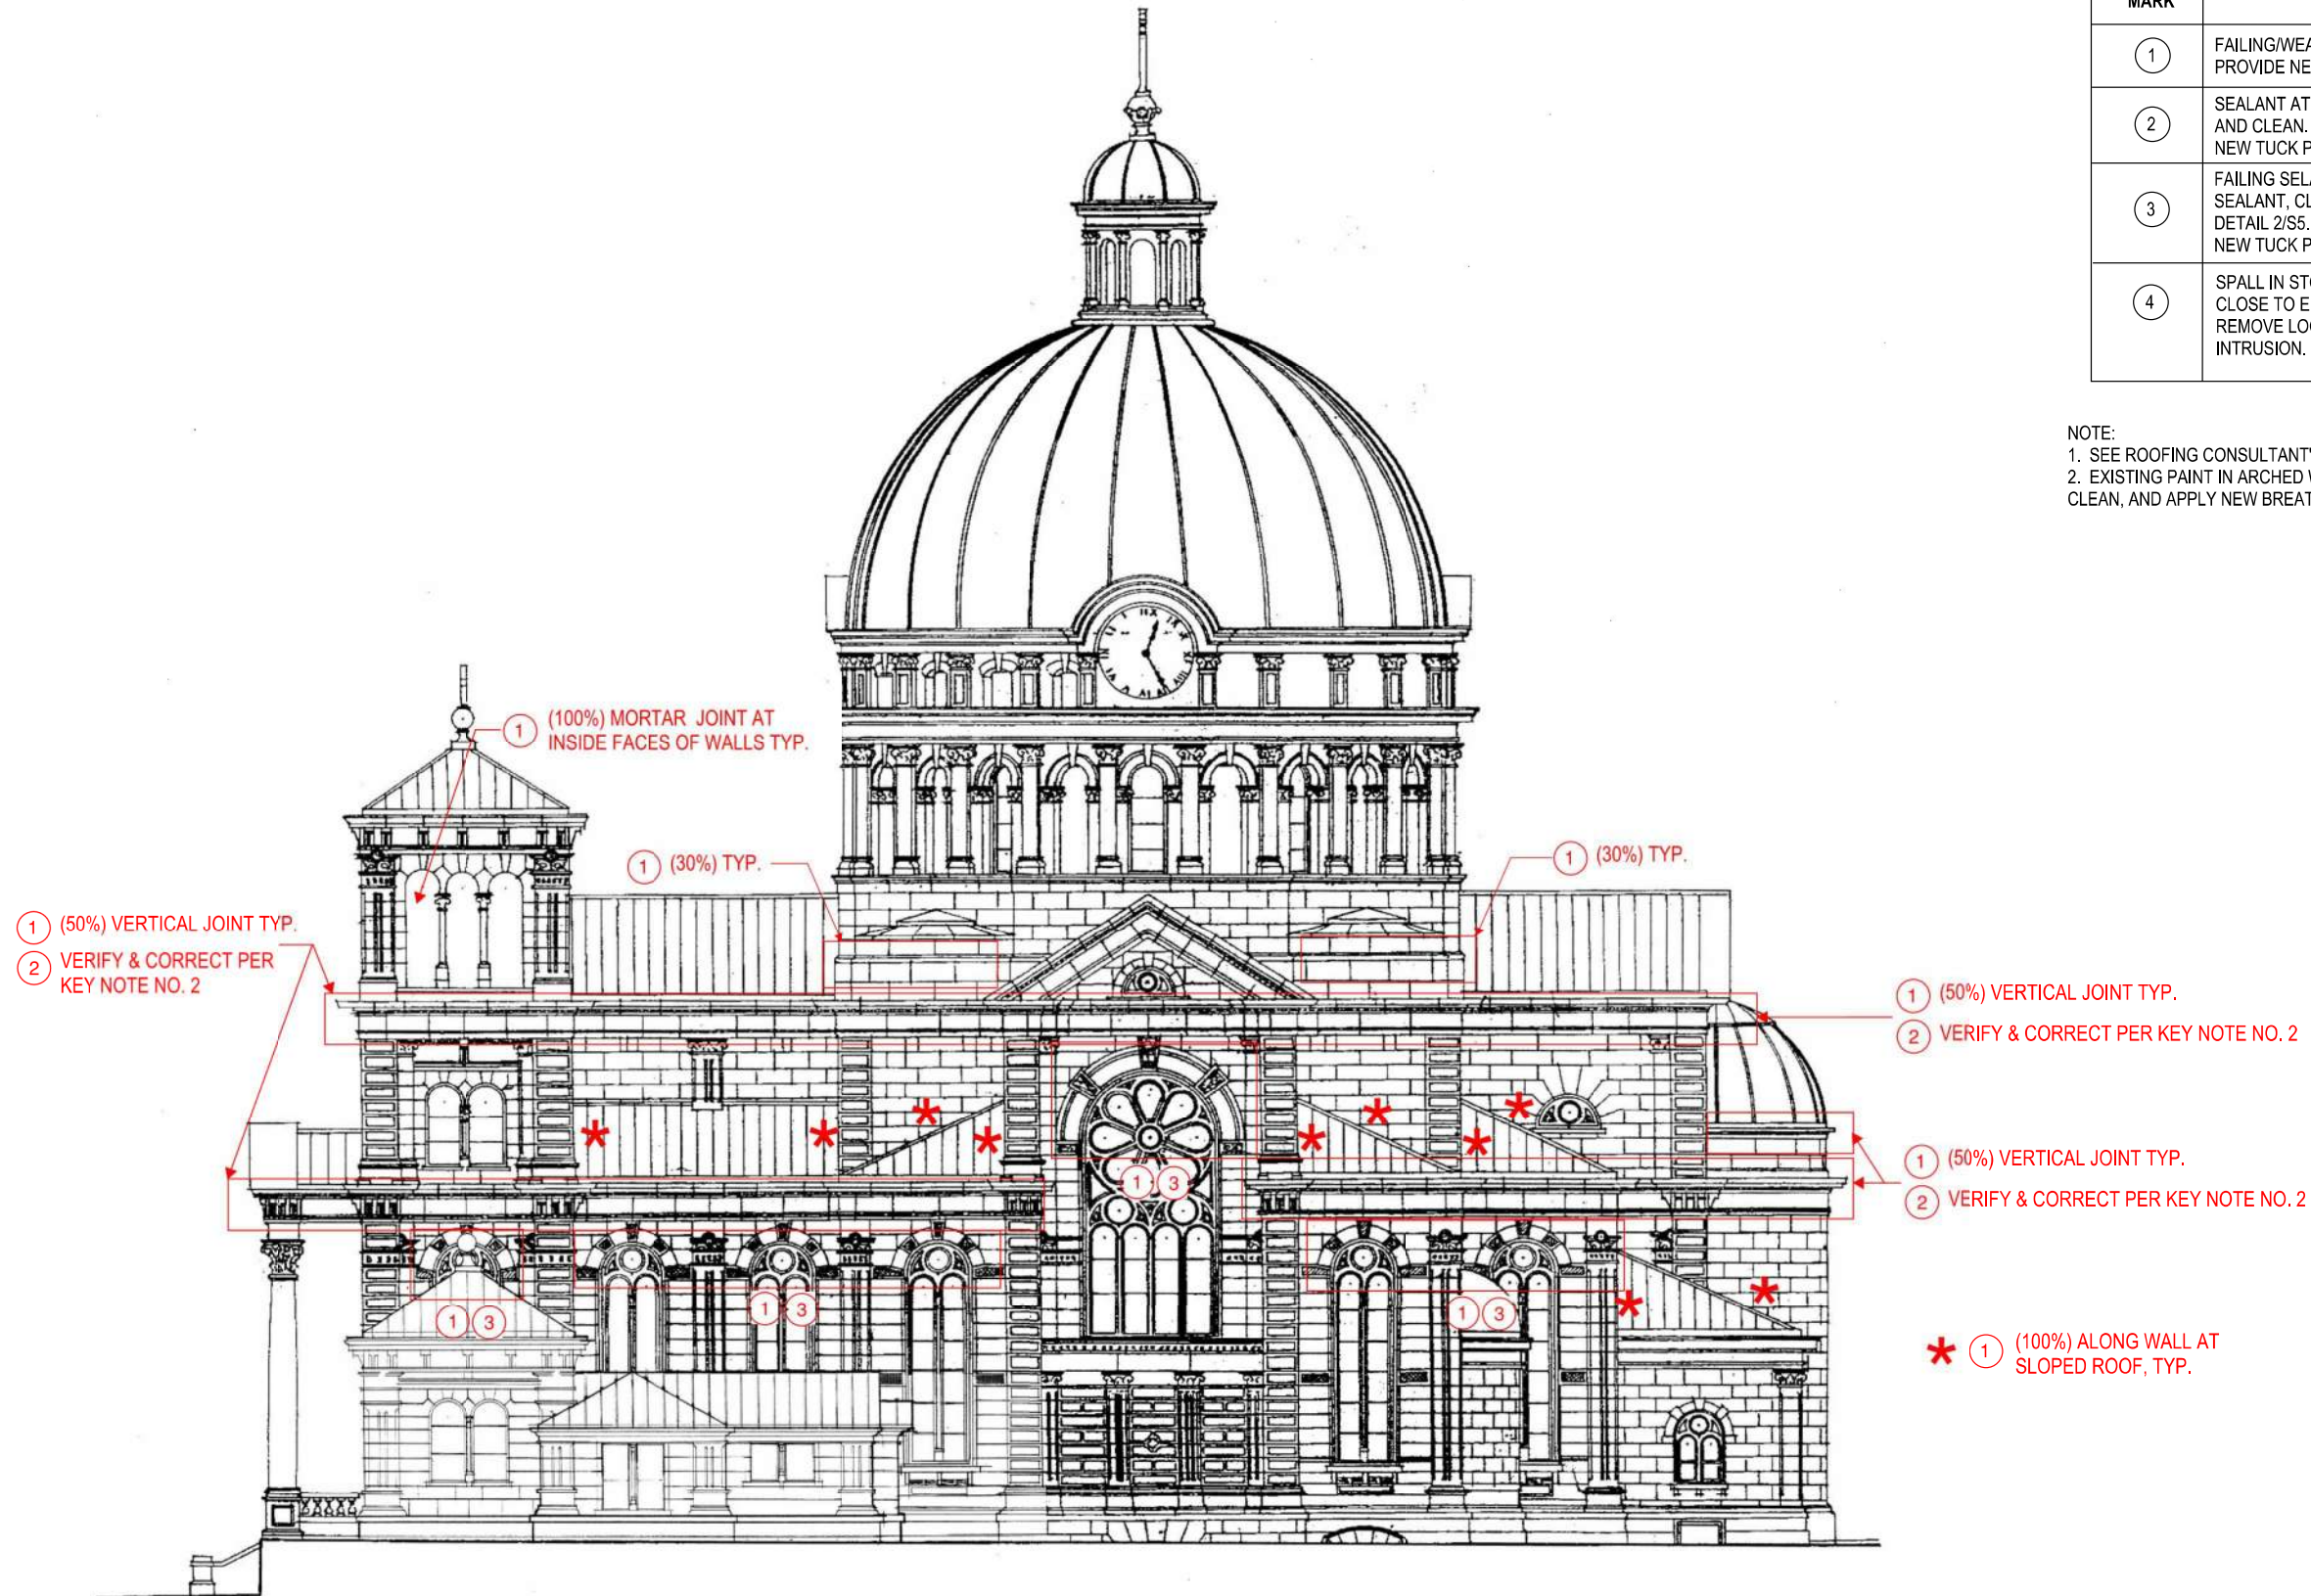
① WEST ELEVATION
 S4

MARK	DESCRIPTION
①	FAILING/WEATHERED/LOOSE MORTAR IN JOINT. PROVIDE NEW TUCK POINTING. SEE DETAIL 1/S5.
②	SEALANT AT WRONG LOCATION. REMOVE SEALANT AND CLEAN. IF MORTAR LOSS NOTED, PROVIDE NEW TUCK POINTING PER DETAIL 1/S5.
③	FAILING SEALANT AT SKYWARD JOINT. REMOVE SEALANT, CLEAN, AND APPLY NEW SEALANT PER DETAIL 2/S5. IF MORTAR LOSS NOTED, PROVIDE NEW TUCK POINTING PRIOR TO APPLYING SEALANT.
④	SPALL IN STONE FROM ANCHORS BEING TOO CLOSE TO EDGE ALONG STONE PROJECTION. REMOVE LOOSE SPALL AND PREVENT MOISTURE INTRUSION.

- SEE ROOFING CONSULTANT'S DETAIL FOR SEALANT AT COPPER FLASHING, TYP.
- EXISTING PAINT IN ARCHED WINDOW FRAME HAS PEELED OFF. REMOVE PAINT, CLEAN, AND APPLY NEW BREATHABLE PAINT, TYP.
