Certificate of Appropriateness

2220 N. Terrace Ave., Villa Terrace Decorative Art Museum

Repair to the retaining wall and fence damaged by a vehicle according to the scope provided below.

Project: Villa Terrace Retaining Wall and Fence Repair

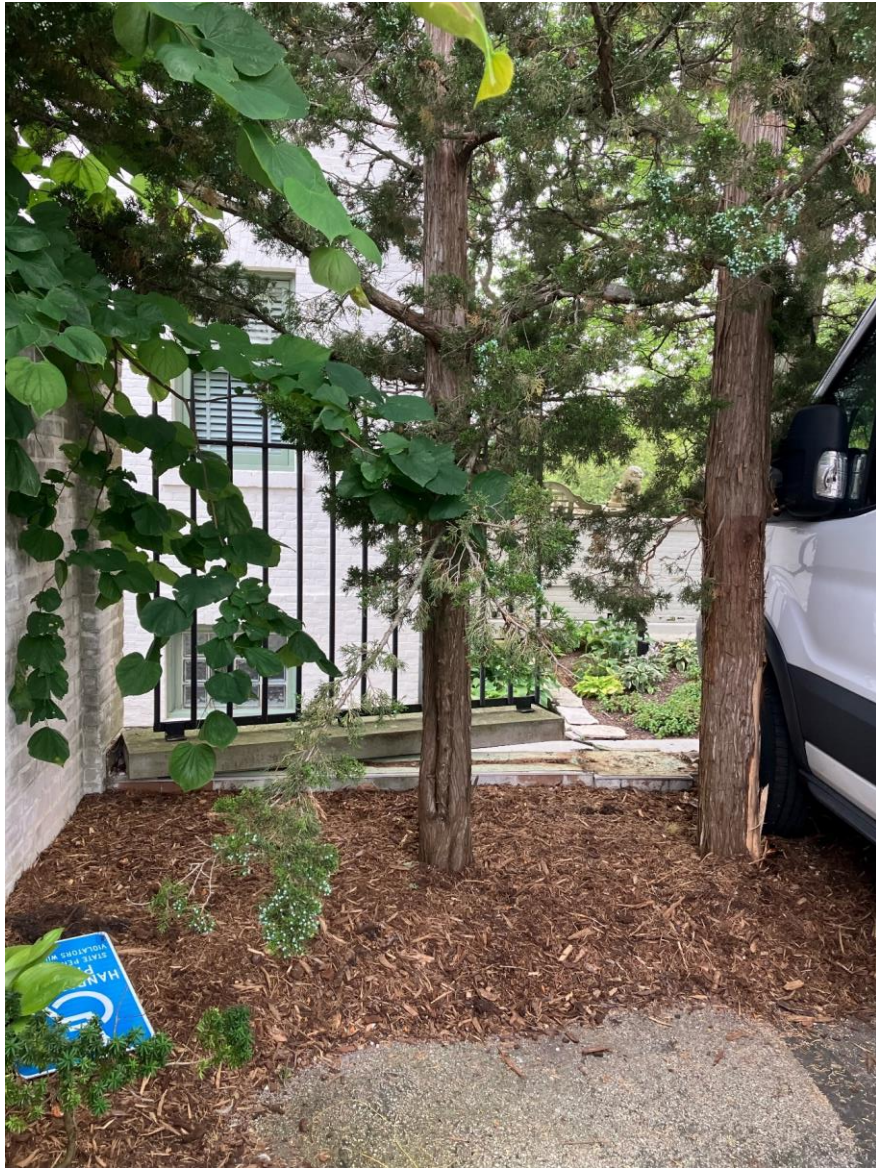
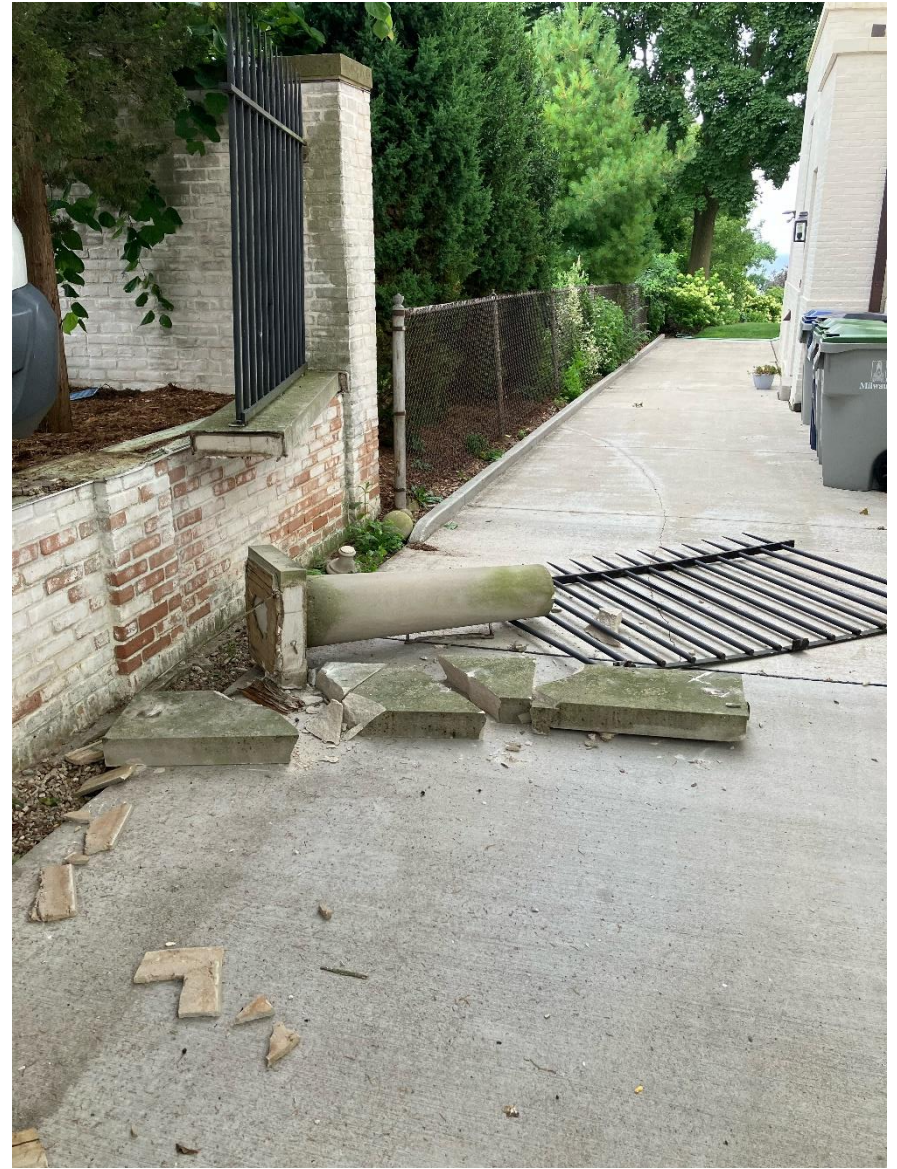
Damage to retaining wall and fence from vehicular accident

Remove cap to the east and column to the west of the south retaining wall. Clean and reinstall cap and column. Install new cap as well as fallen column and column topper. Price to repair column topper as well as manufacturing new topper. Price on the new round finial is \$1155.00. To repair we would save about \$700. Cap sections are \$237.00 apiece and we need 3 ea..
