LIVING WITH HISTORY

# Certificate of Appropriateness Amended

<b>Property</b>	832 N. 29TH ST.	Concordia Historic District
<b>Description of work</b>		
<b>Date issued</b>	11-21-2017	PTS ID 111144 COA Amends COA of 05-27-2016 and 08-18-2016

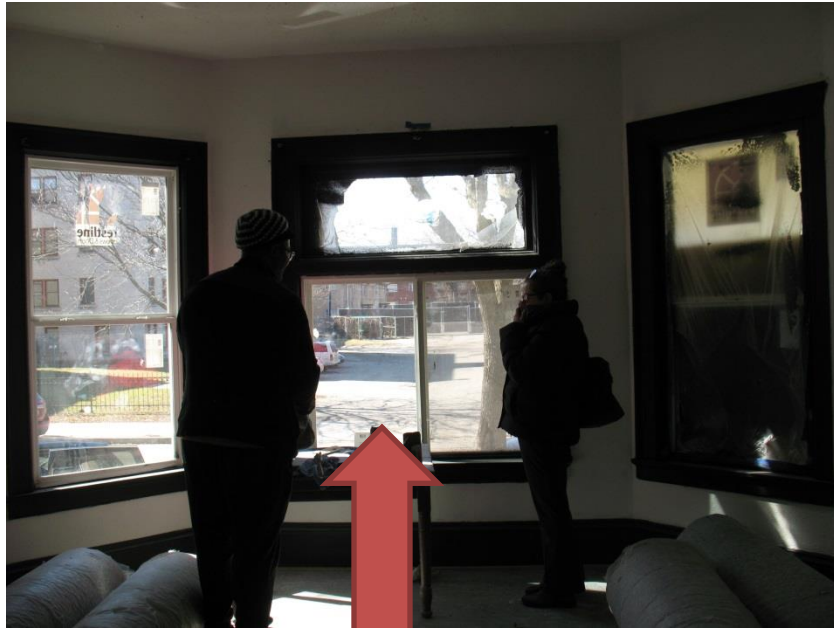
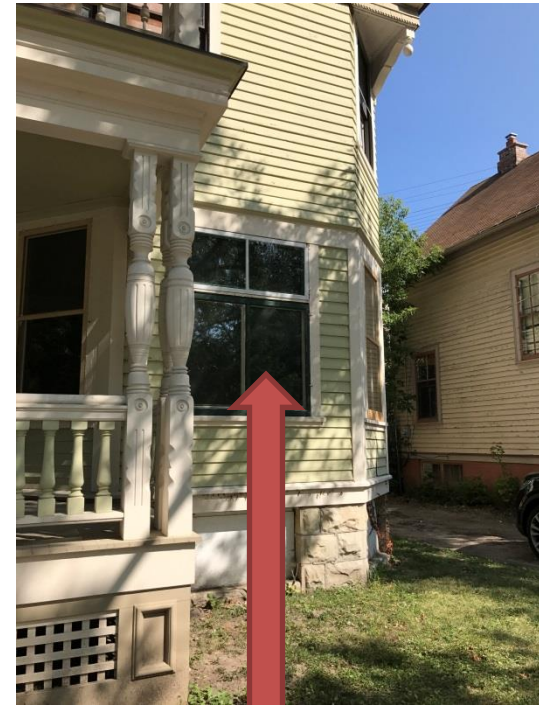
The large landscape sash at the front of the house (west elevation) will be returned to its original condition with one large pane of glass below the fixed transom window. The bottom storm window on the exterior can remain with two panes of glass.

First floor large prime window with transom (called a landscape sash) must have a lower wood sash with a single pane of glass. Transom is wood and can remain. Paint transom and new single pane lower sash. Current storm window with two panes can stay.

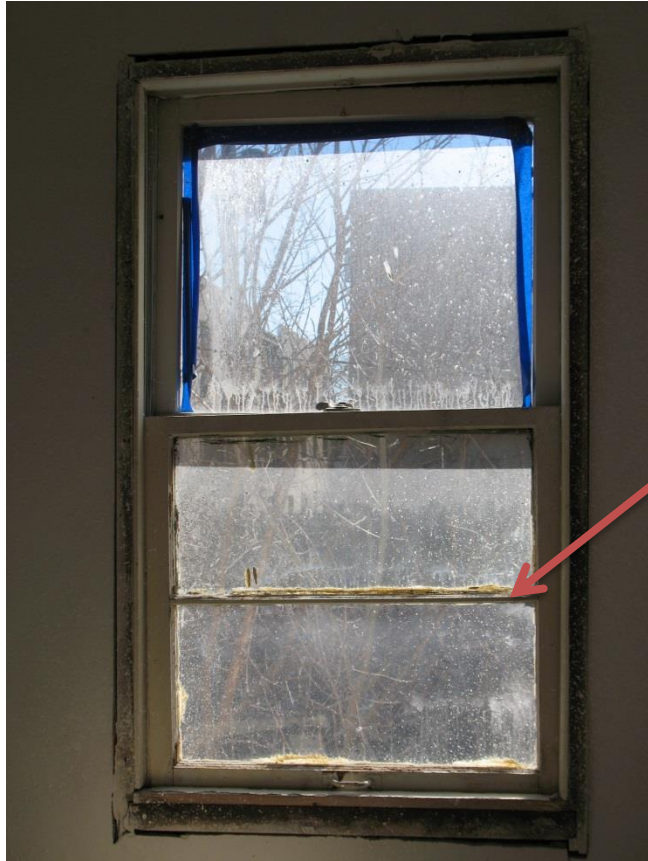
This window, located on the second story of the south elevation facing the driveway, can remain. The bottom sash is divided into two panes.

Two wood windows with non-traditional panes may remain. One is the landscape sash, whose bottom sash is currently filled with two panes instead of one. The other window is on the second story and has a lower sash with two panes instead of one.

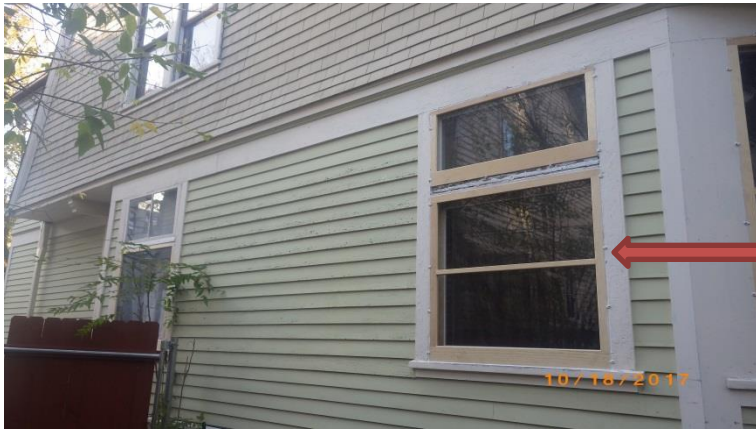
This window is located on the south elevation and faces the driveway. The bottom sash can remain divided into two panes. The wood storm on the bottom portion of the sash can remain divided into two panes. The storms must be painted.

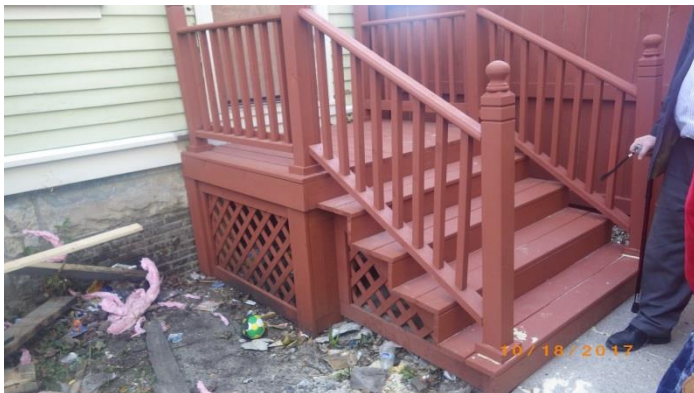
Rear porch has been completely rebuilt, is all wood, and generally meets the design standards of the historic district.

The new rear porch basically conforms to the guidelines for new porch construction.

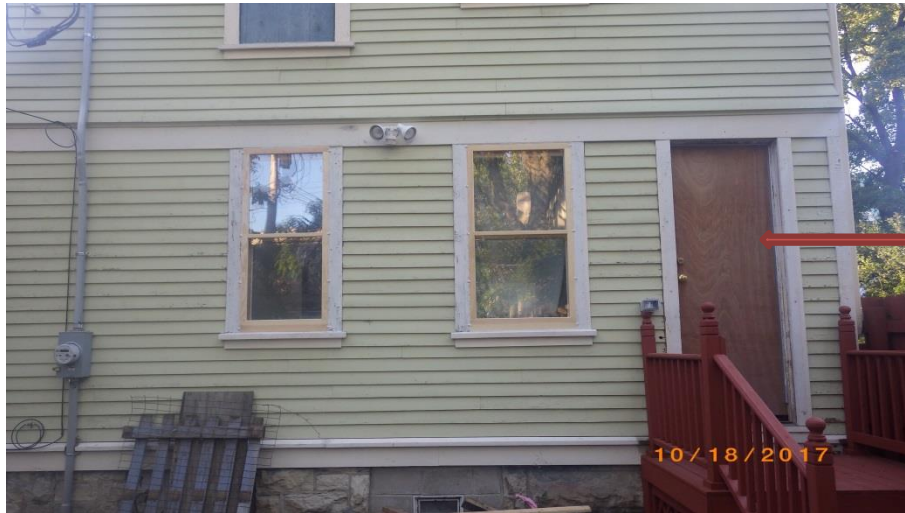
The rear door will be painted and a wood storm door installed. The wood storm door will also be painted.

Install wood storm door at rear entry. Storm door must have wood fame.

Paint rear wood entry door and rear wood storm door.

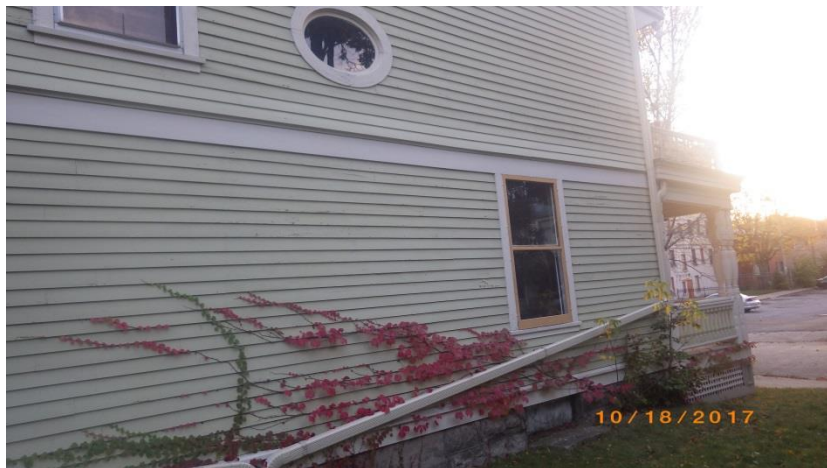
Vines will be removed from the north side of the house. They can do considerable damage as they work their way under the clapboards.

Remove vines that are growing on / adhered to the north wall as soon as possible.

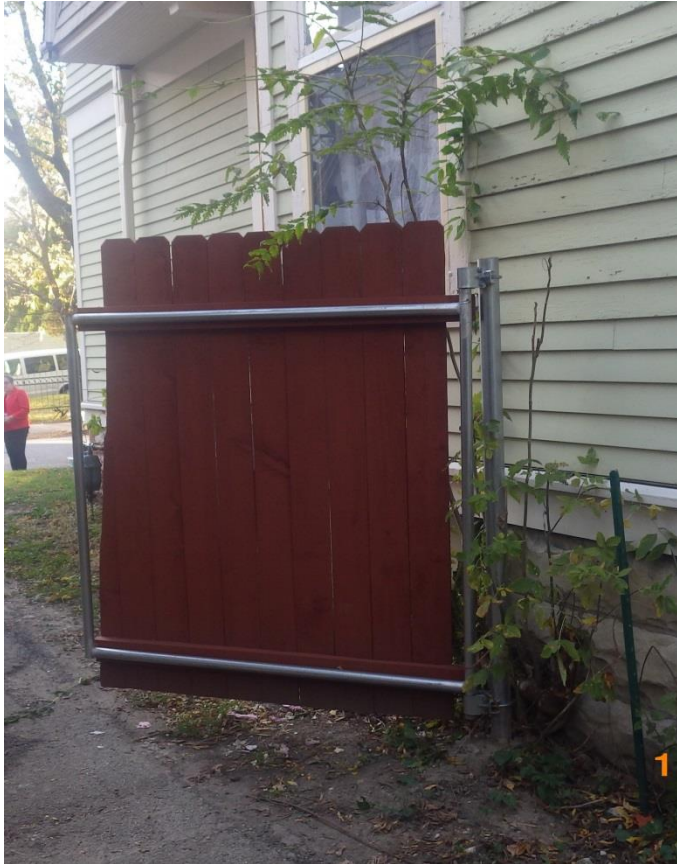
The dog eared boards of the driveway gate will be repaired/replaced where needed.

The wood fence/gate across the driveway at the south side of the house is to be repaired. Repairs consist of replacing broken and damaged wood fence boards.
