# Facilities Condition Assessment Program

## 4th and Highland Parking Garage

May 2011

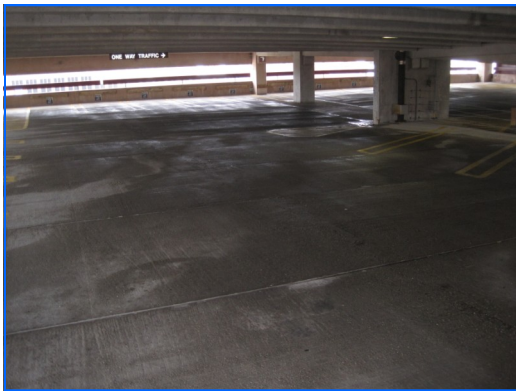
The elevated structural slab exhibits very few areas of deterioration in the form of cracks. However, various columns and shear walls exhibit local deterioration.

Elevated concrete floor slab

The useful life of sealer application is up to three years. Parking should apply the sealer at Floors 2-4 by 2011 and Floors 5-8 by 2012. Subsequent applications should be conducted every six years thereafter.

In addition, Parking should conduct concrete surface repairs at his time.

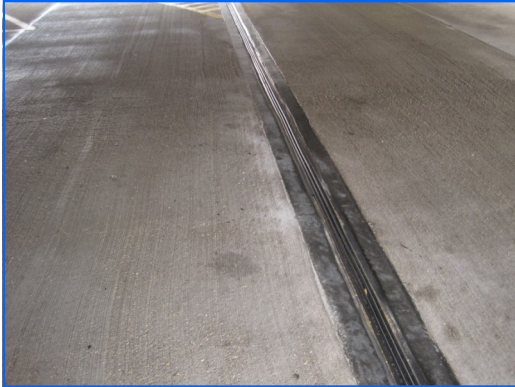
4th and Highland contains approximately 920 LF of expansion joints. The useful life of an expansion joint is 15 years. Parking should budget for expansion joint replacements by 2016 and again by 2031.

Elevated concrete floor slab

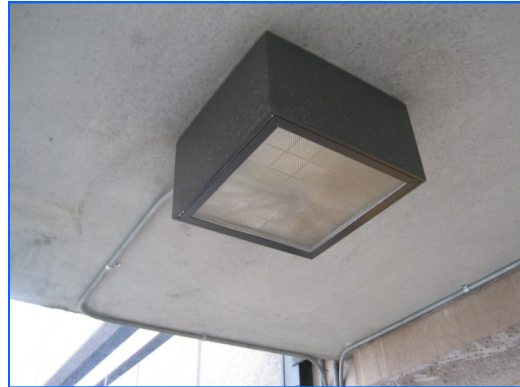
4th and Highland contains approximately 410 light fixtures. The useful life of light fixtures is up to 25 years. Based on condition, Parking should fund light fixture replacement by 2031.

Light fixture

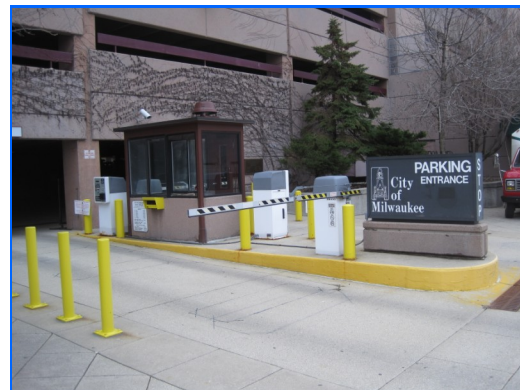
The useful life of these components and operating systems is up to 12 years. Parking should anticipate its replacement by 2019 and 2031. Interim repairs/replacements and upgrade to individual components should be funded by O+M.

Operators and Pay Stations

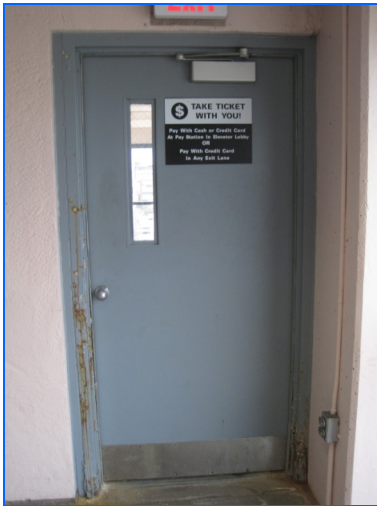
The useful life of metal exterior doors is up to 35 years. Based on the varied conditions, Parking should anticipated phased replacement of 13 doors every six years beginning by 2018.

Metal door

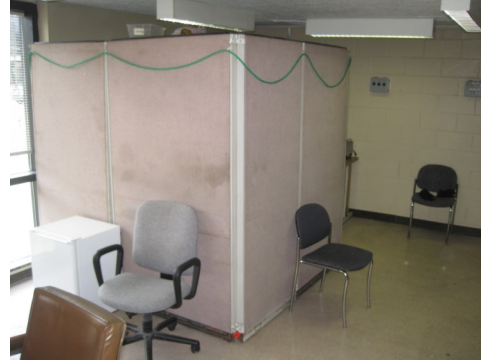
Administration office

4th and Highland contains an administration office and elevator lobby. Parking should budget for hallway renovation every 15 years beginning by 2028.

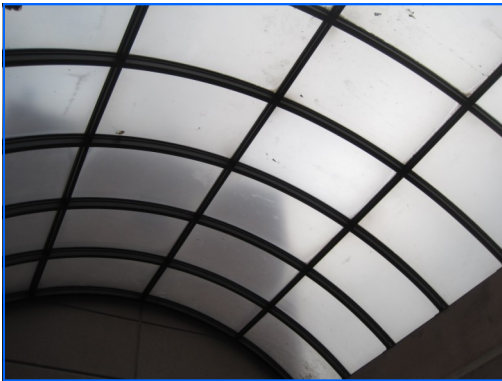
4th and Highland contains curtain walls at the each stairwell and the commercial space. The condition of the components is fair overall.

Part of skylight at south stairwell  
curtain wall

The useful life of window and curtain walls is up to 45 years. Parking should budget replacement of the window/curtain walls by 2028.

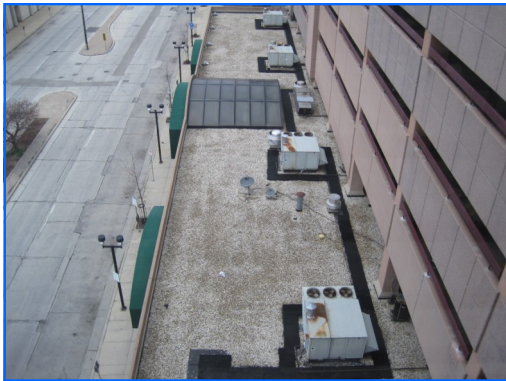
4th and Highland commercial space contains a roof that comprises 70 squares. The useful life of the roof is up to 20 years. Parking should budget replacement of the window/curtain walls by 2017.

Roof at commercial
