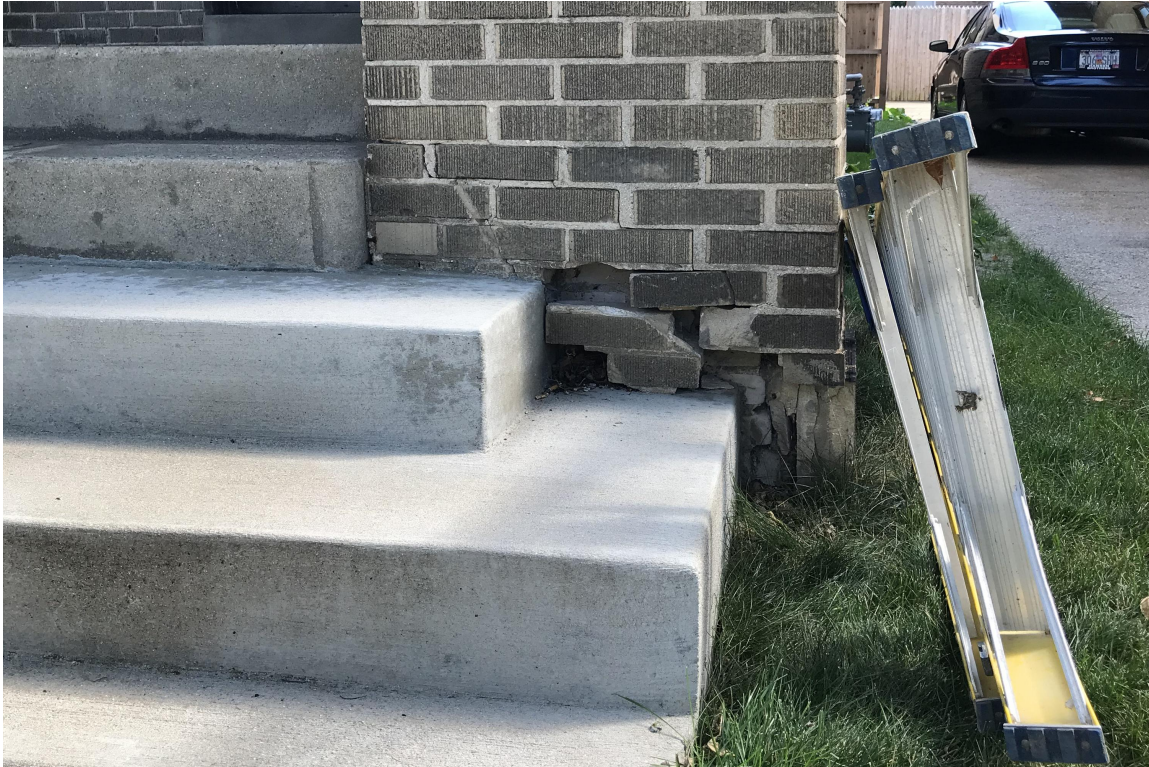
Photo 2 - Damaged Masonry at Base of Brick Columns Supporting Roof Porch

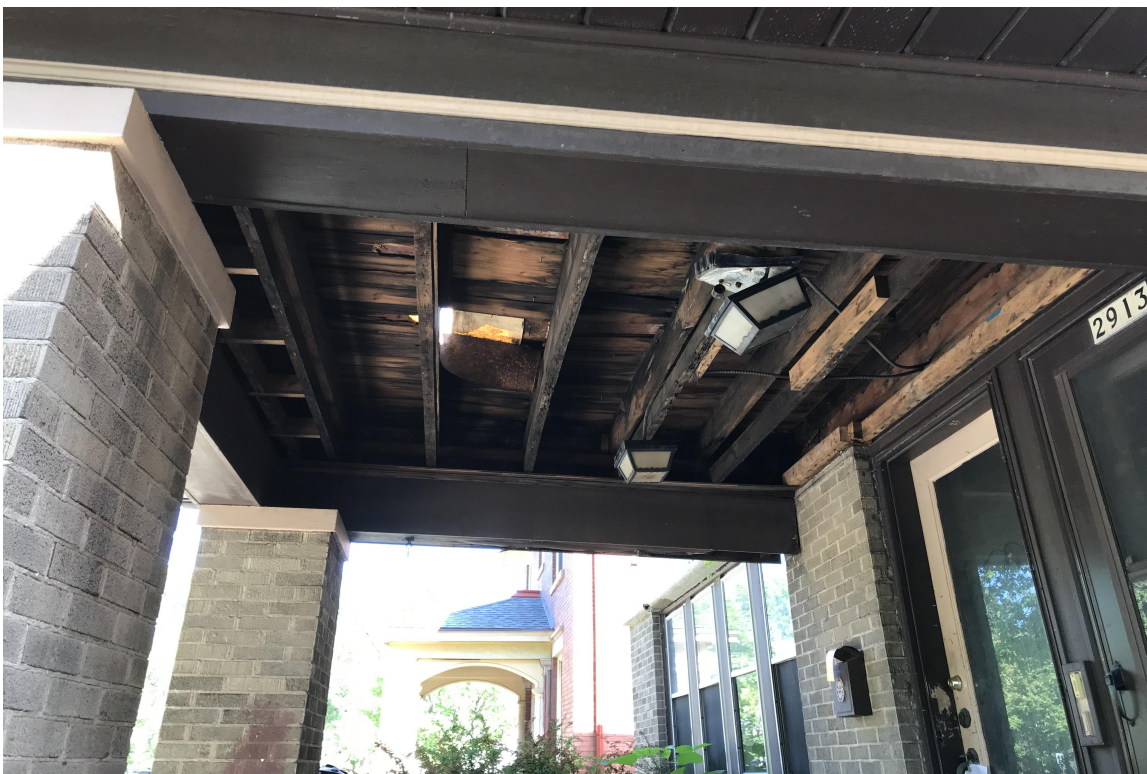
Photo 3 - Underside of Roof Porch Showing Rotted Wood Joists and Damaged Metal Decking

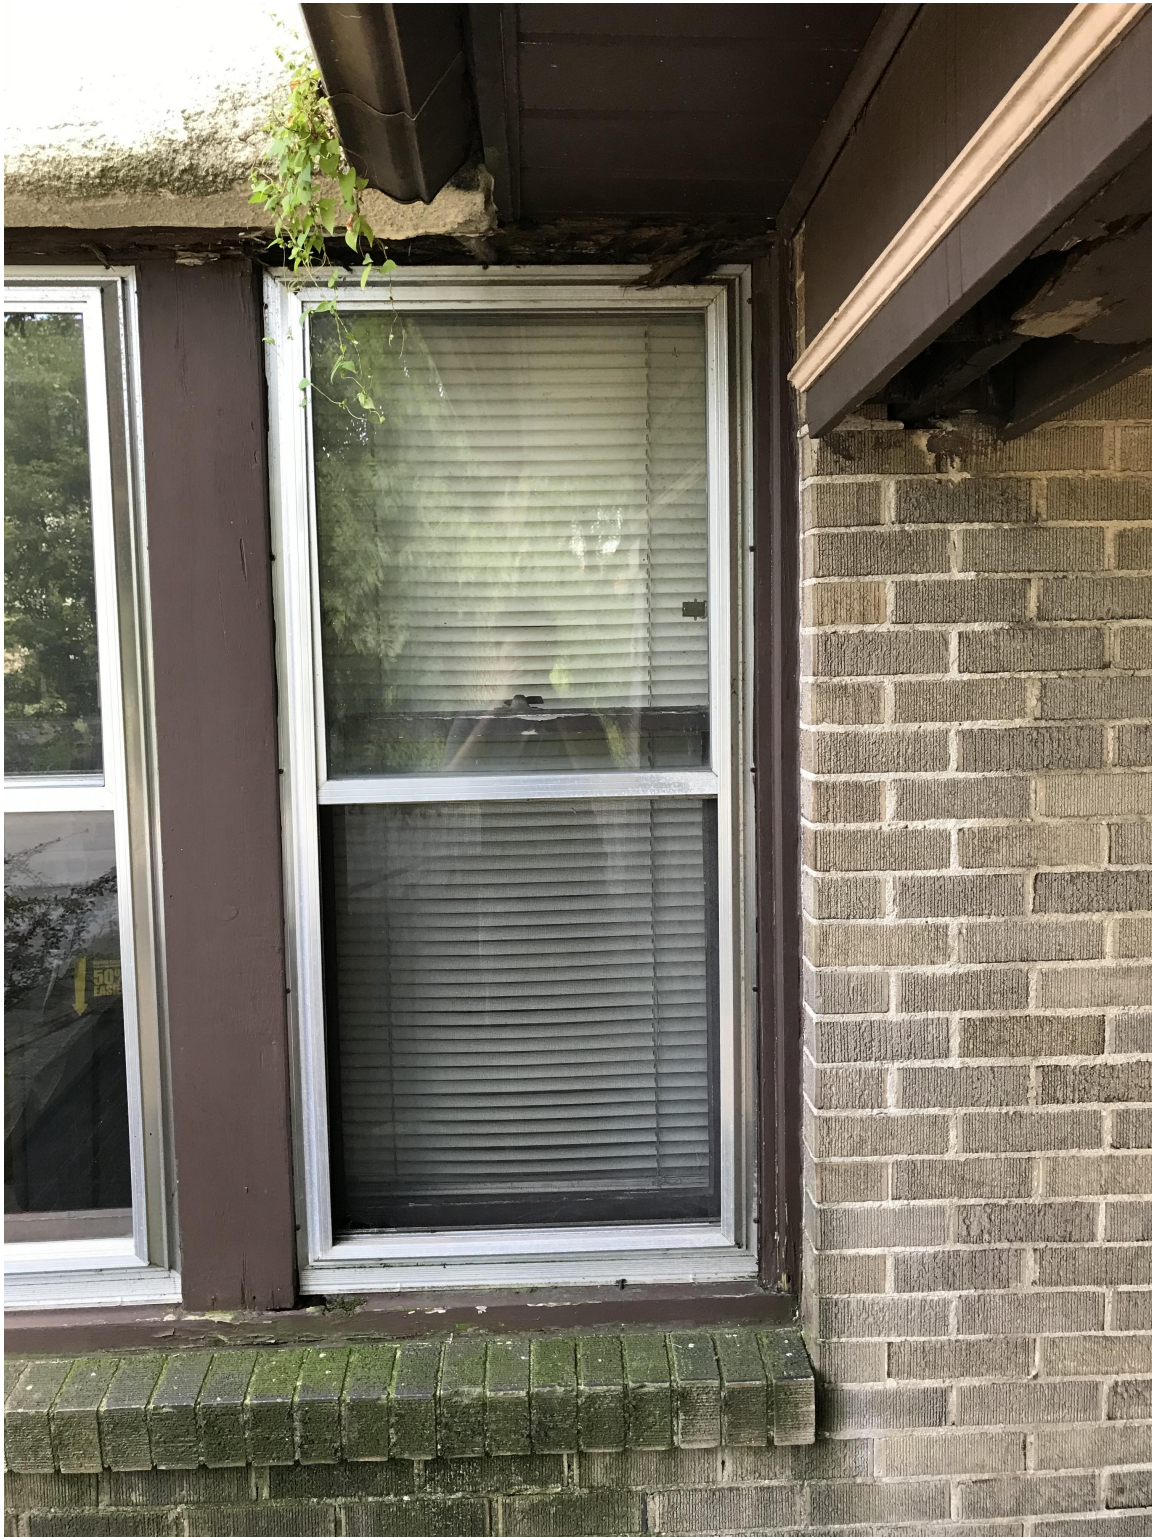
Photo 4 - West Window on North Facade First Floor Showing Rotted Wood at Header and Sill. Damage to Boxed Beam Shown in Upper Right Corner

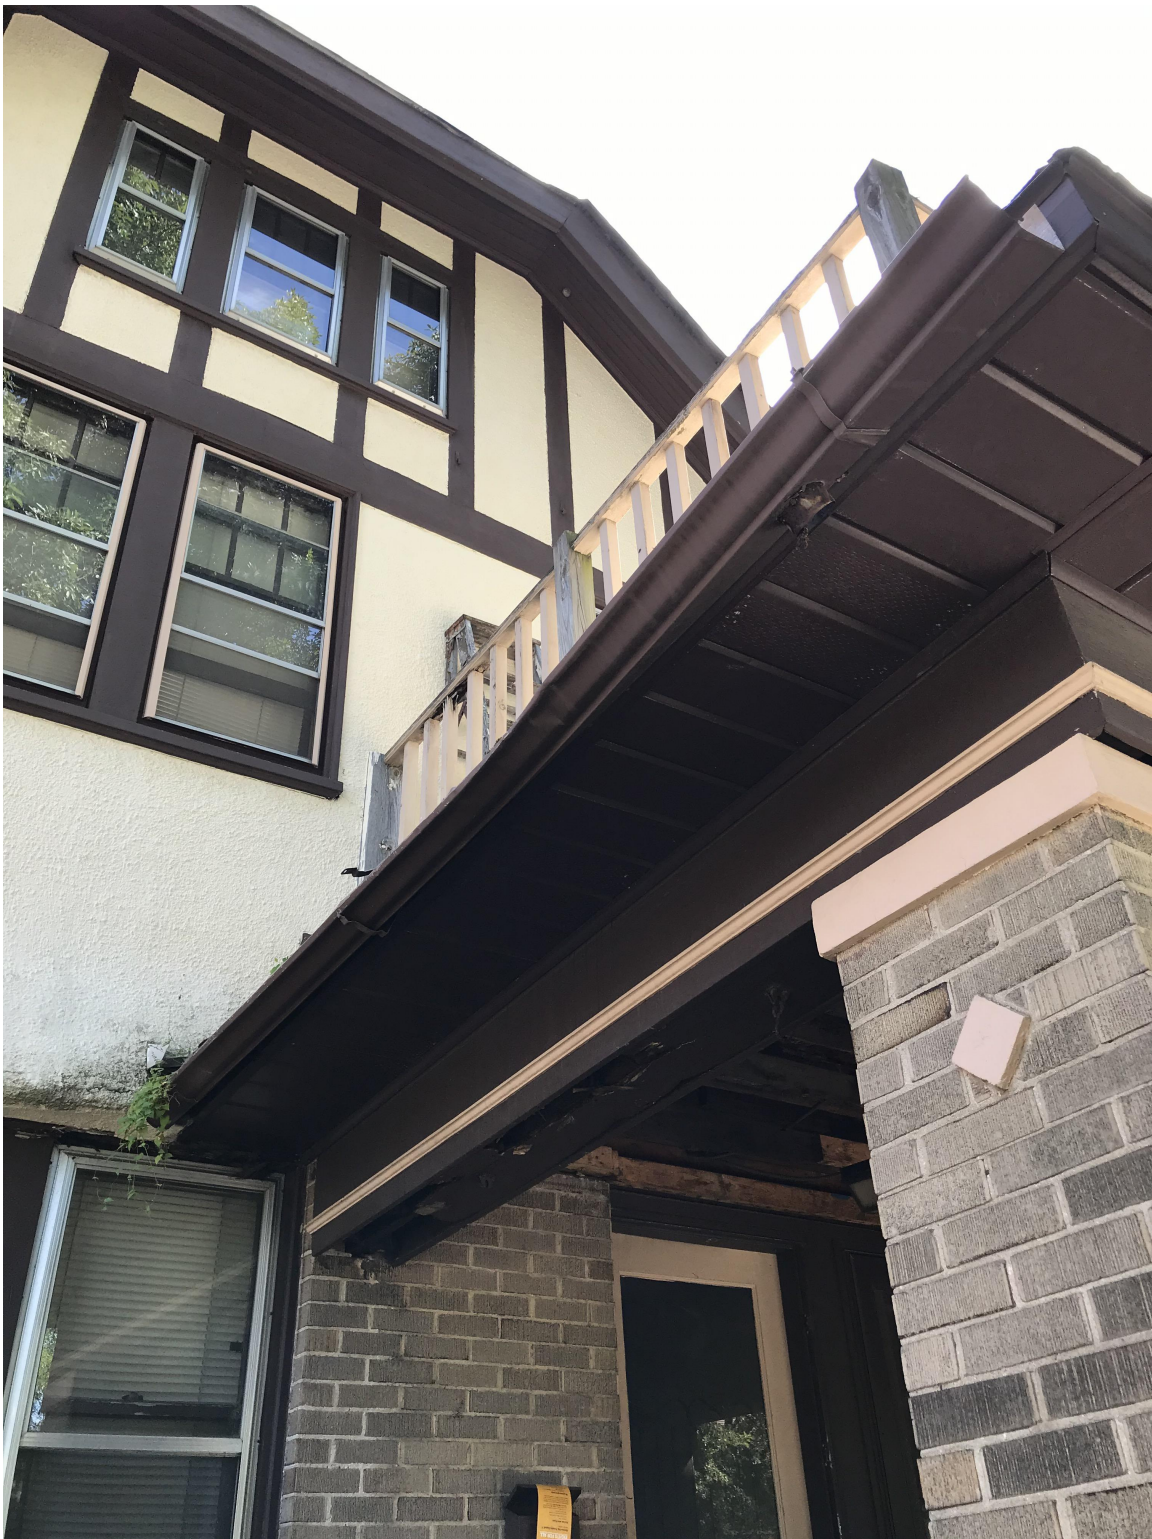
Photo 5 - Underside of Roof Porch Showing Damaged Gutter, Soffit, Boxed Beam, and Existing Wood Handrailing

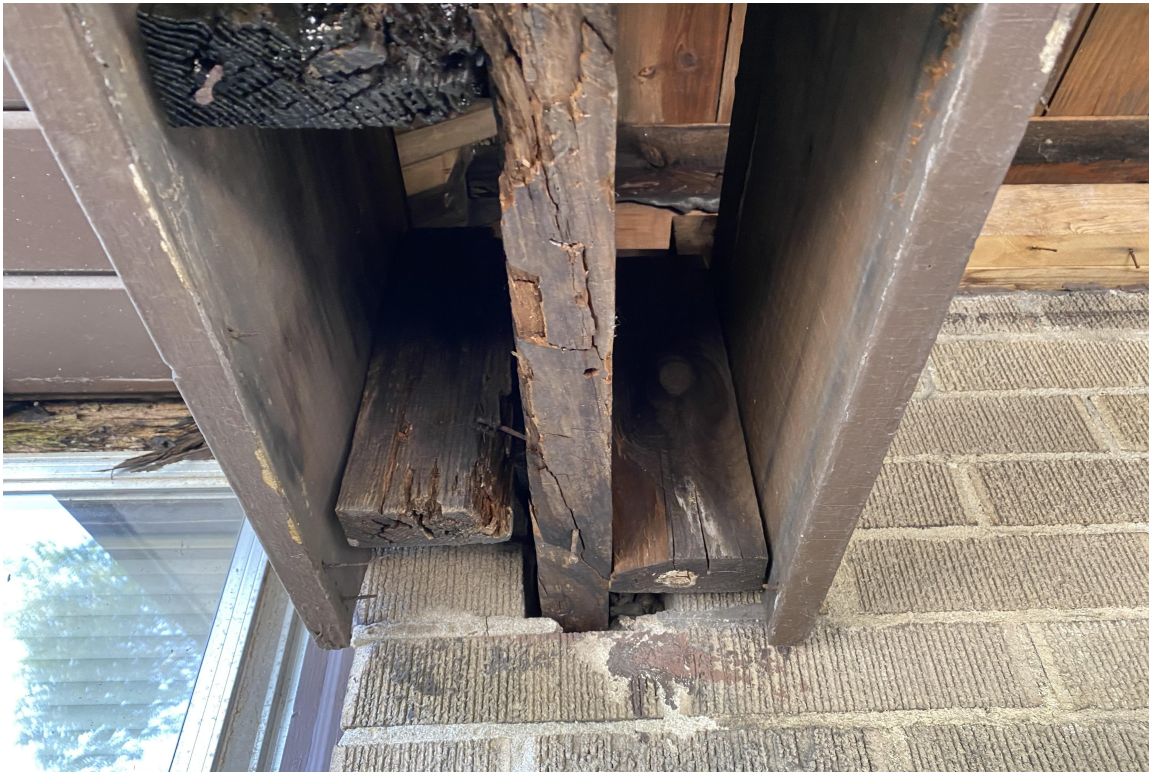
Photo 6 - Underside of East Boxed Beam Showing Rotted Wood from Water Damage

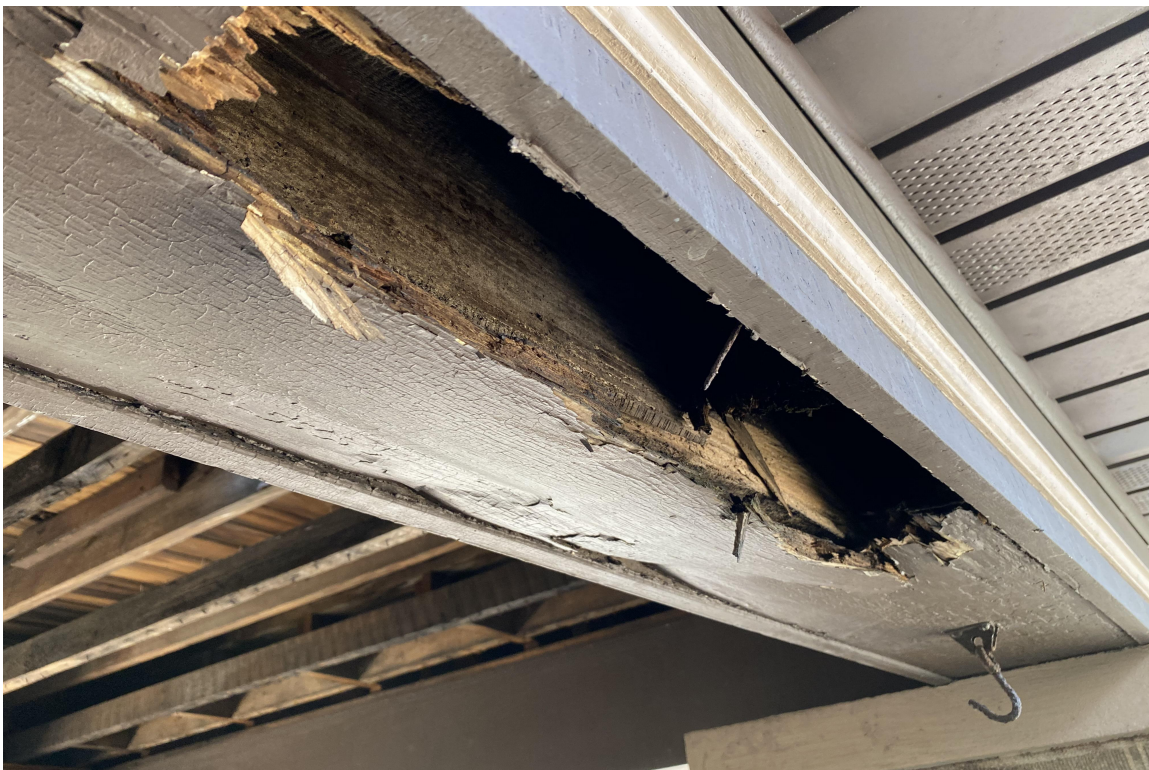
Photo 7 - Underside of East Boxed Beam Showing Rotted Wood from Water Damage

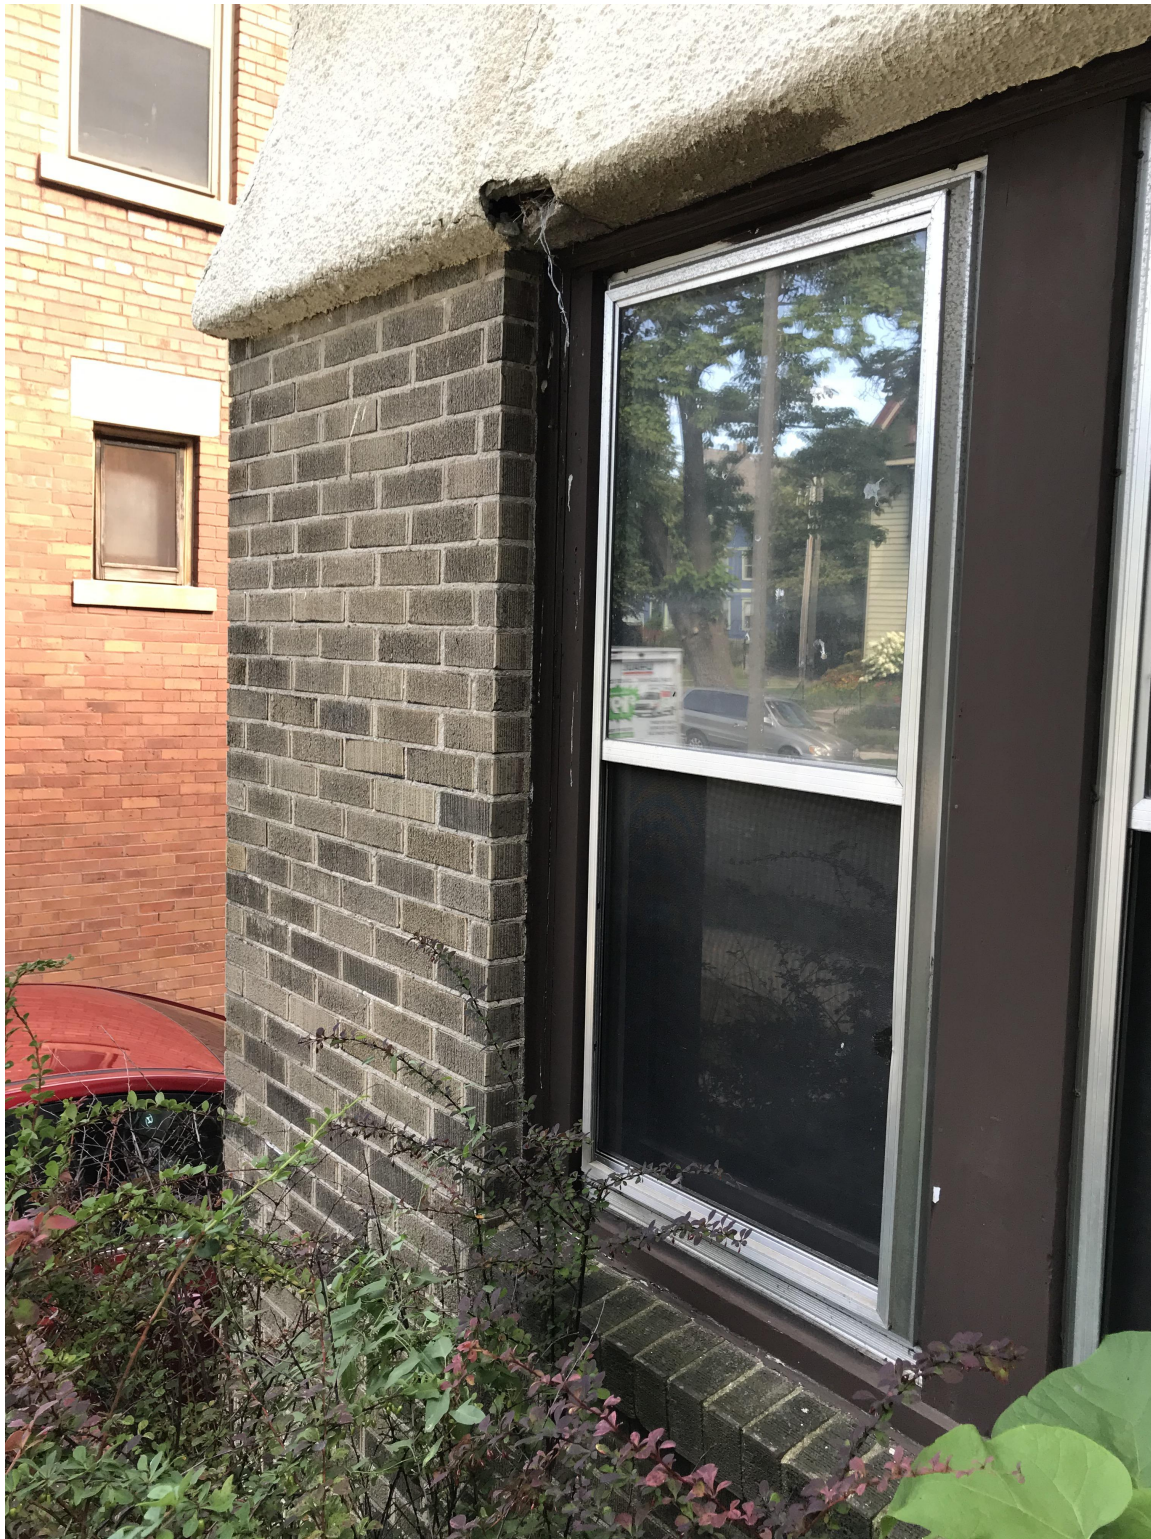
Photo 8 - East Window of North Facade First Floor Showing Damage to Existing Stucco Above Window

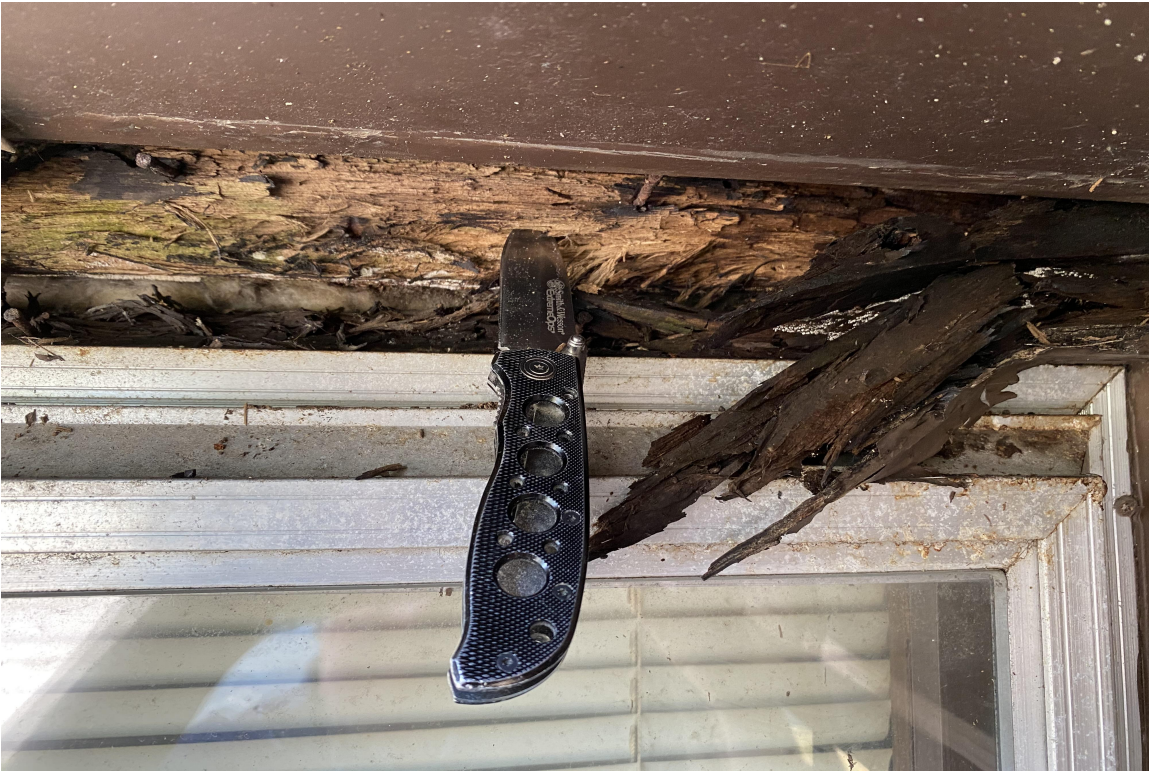
Photo 9 - Damaged Wood Header Above First Floor Windows

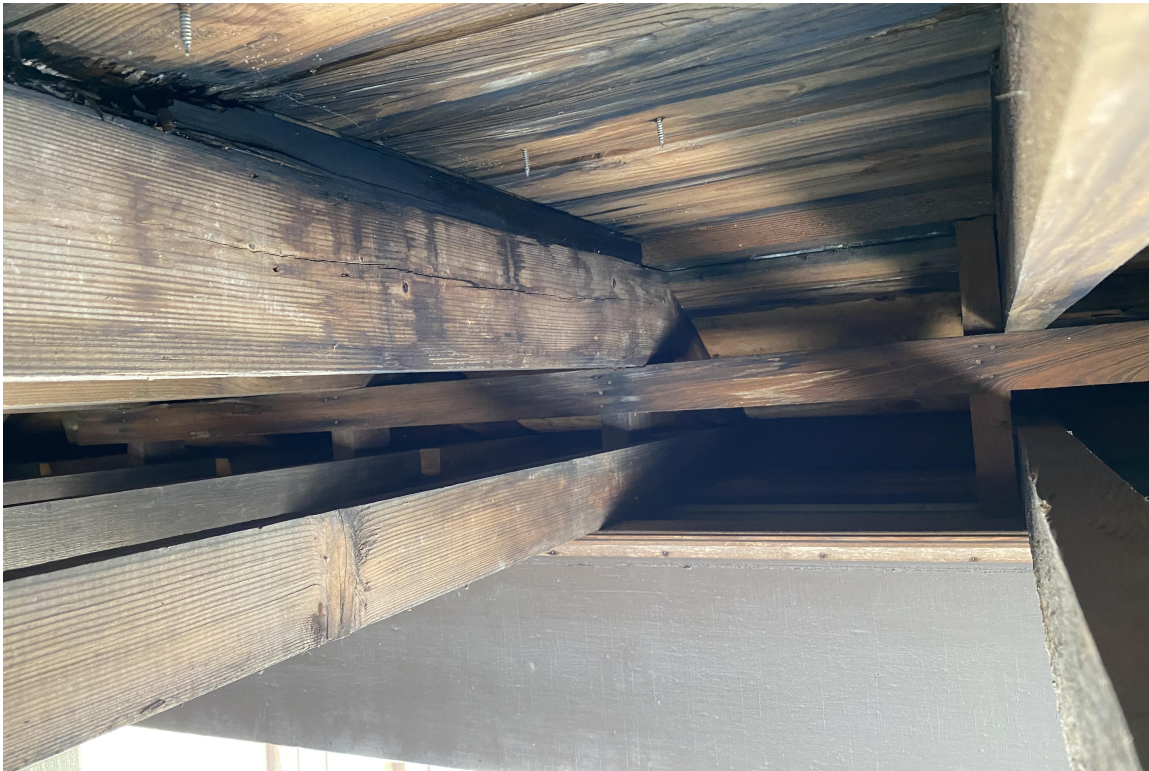
Photo 11 - Underside of Roof Porch Showing Condition of Wood Joists

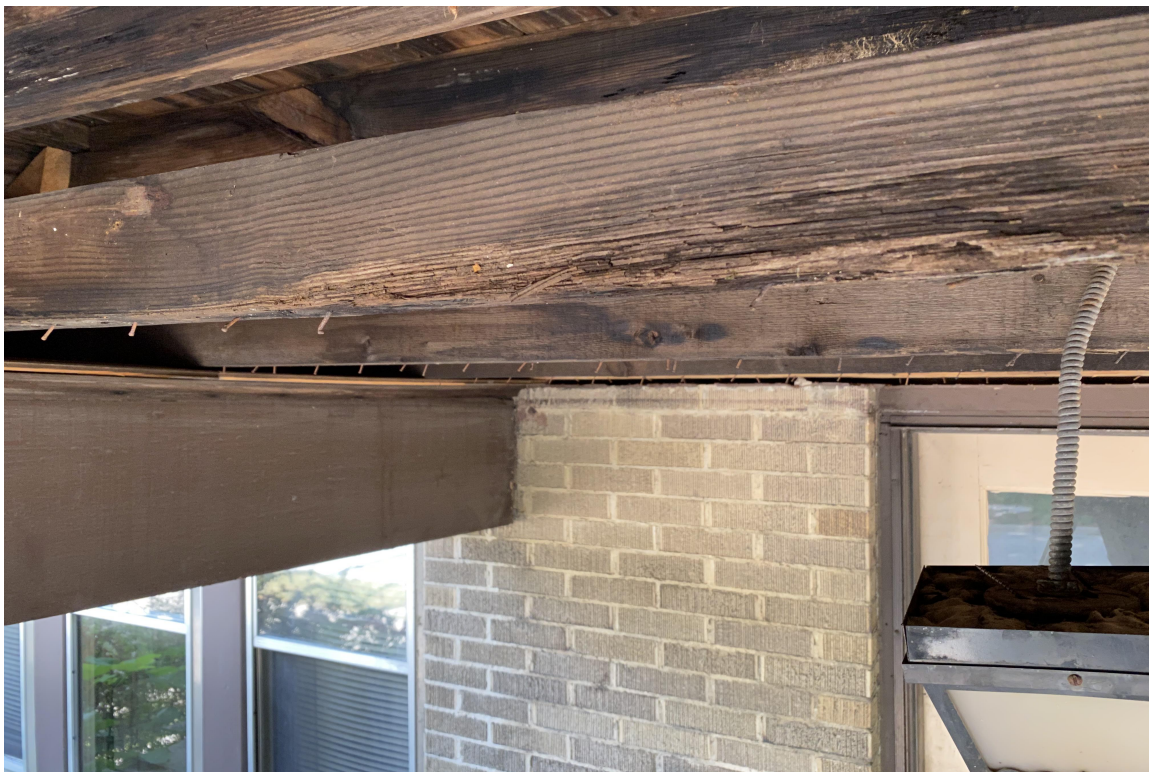
Photo 12 - Underside of Roof Porch Showing Condition of Wood Joists
