## FOUNDATION INSPECTION REPORT

Client: <u>Mr. Jim Sterns</u>	Present: <u>Yes</u>
Inspection Address: <u>2605 N. Summit Ave. Milwaukee WI</u>	
Billing Address: <u>-</u>	
Telephone: <u>414-745-1201</u>	Email: <u>Aggies.stuff@gmail.com</u> <u>JCMeridan@gmail.com</u>

## ENGINEERING REPORT

Property type: Single Family historical home

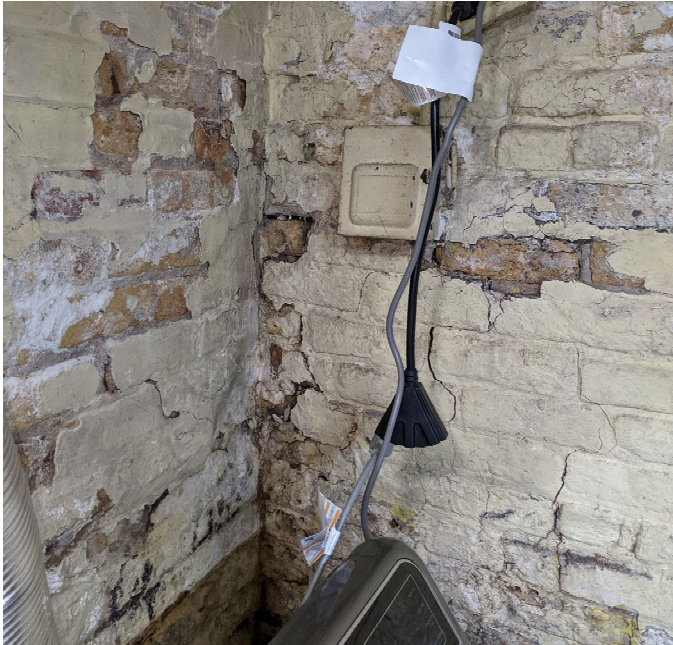
North Wall – As built = – Max = D 2 3/4" Differential = –

West Wall – As built = – Max = D 2" Differential = –

*View of NW foundation corner. Both walls are bowed over 2" from excessive lateral pressures.*

REPORT SUMMARY AND RECOMMENDATIONS
<b>All repairs to be completed per the State of Wisconsin Uniform Building Code (WIUBC)</b>
The Northwest corner foundation walls were found to be excessively displaced. The west ±15'-9" of North wall and North ±9'-6" of the west wall are bowed >2" with damage to brick. It is recommended to shore the structure (two-story brick ext), excavate the NW corner, demo walls and rebuild with new footings and cmu block. See attached wall section detail. The brick exterior must be maintained for historical preservation.
During wall replacement new interior and exterior drain tile is needed with a new sump crack + pump. Follow WIUBC standards.
The exterior sidewalk will require replacement during excavation and should be pitched to the driveway.

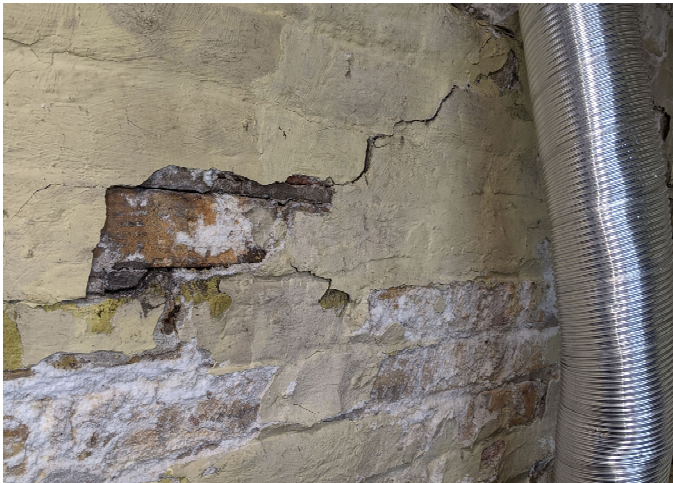
Signs of active wall movement: Yes at North end. Cracks + bow

*View of wall cracks and deterioration along west foundation wall.*

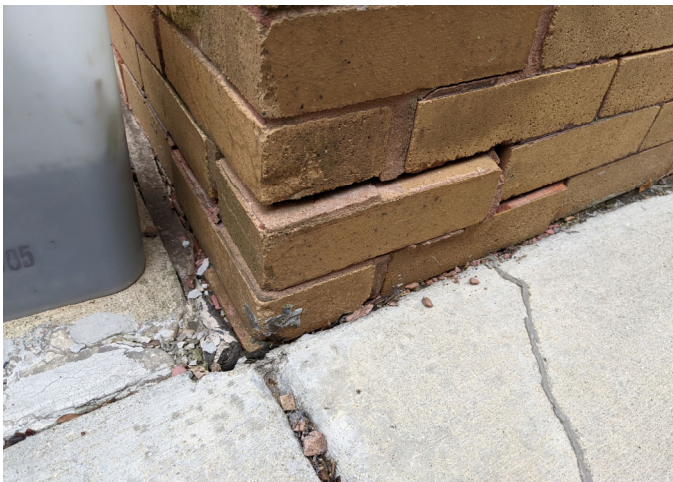
*Exterior NW corner brick damage and movement along displaced foundation walls.*
