MPS - Existing Window Condition

3360 N Sherman Boulevard Milwaukee, Wisconsin

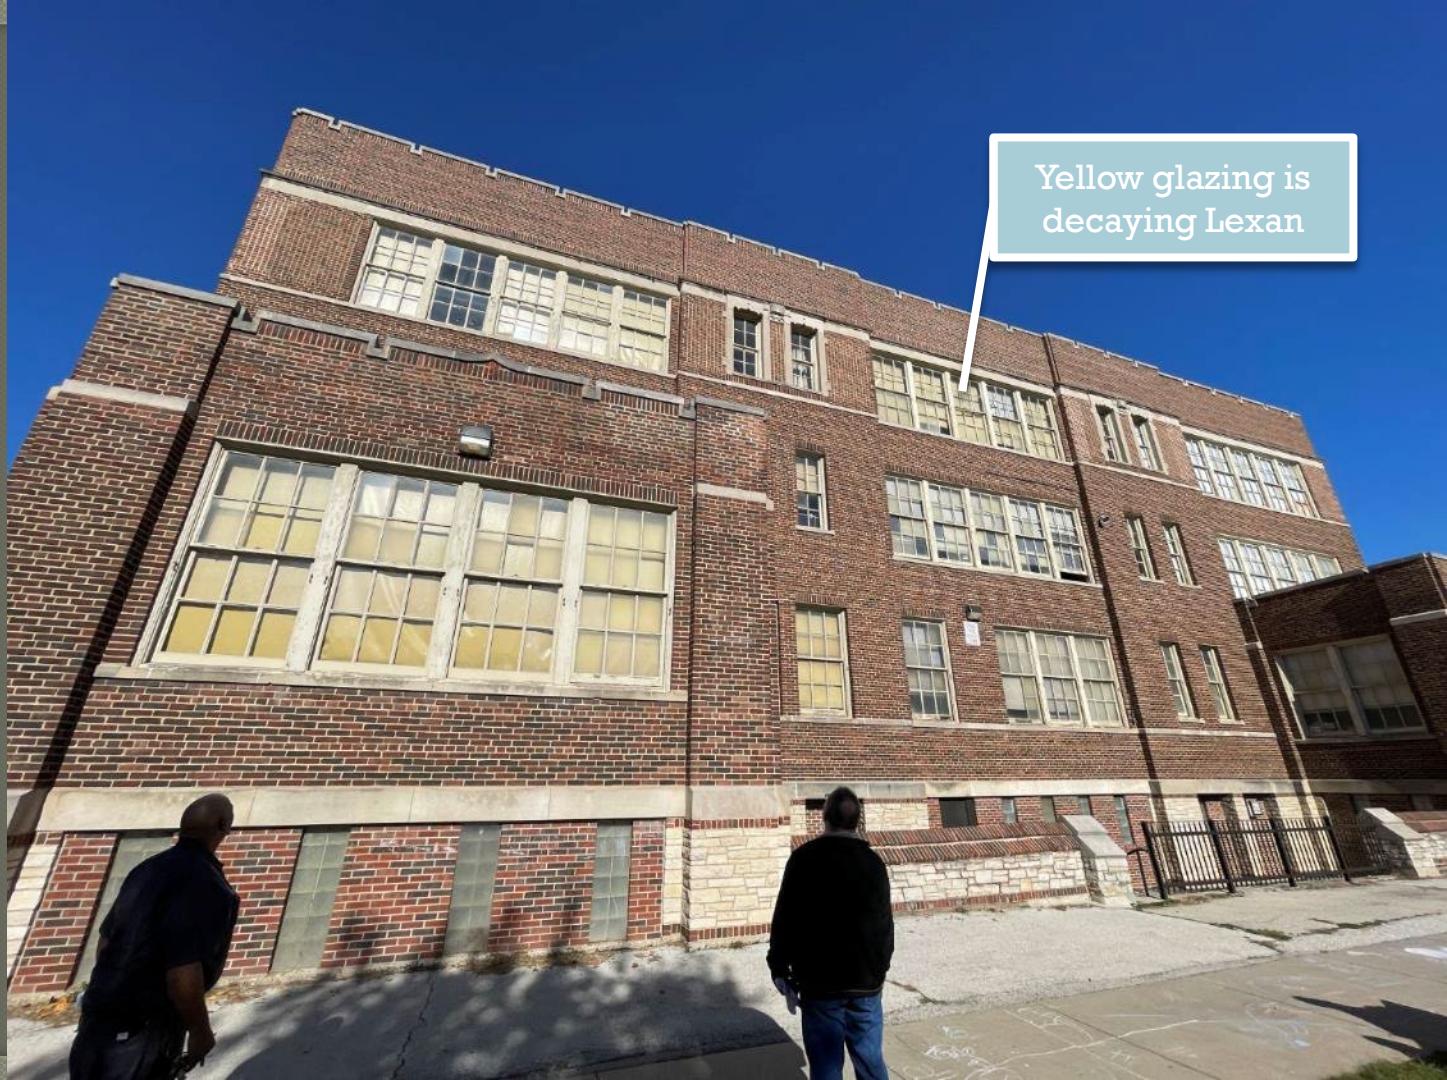
Yellow glazing is
decaying Lexan

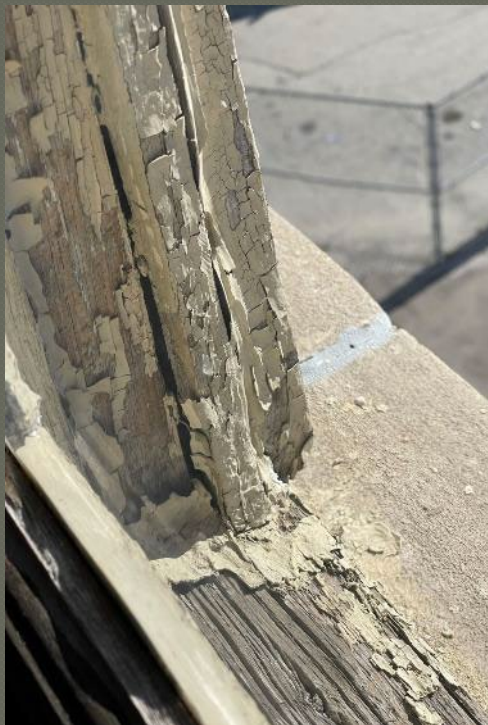
Existing window deterioration

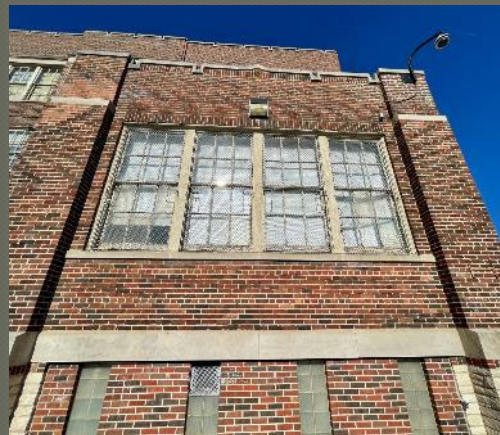
View of exterior existing window

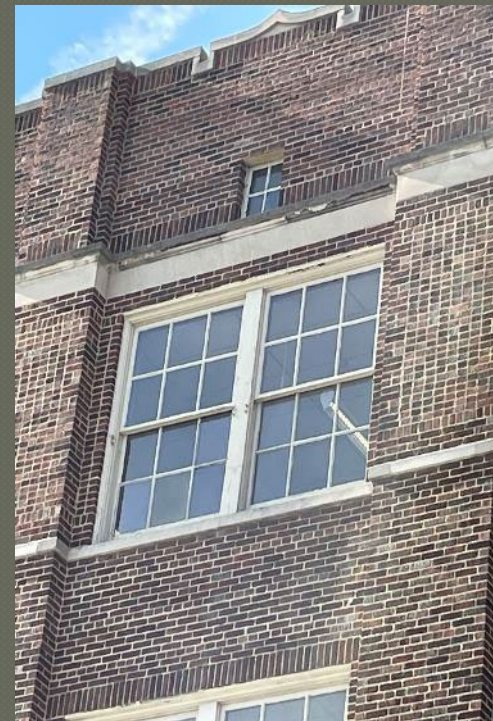
View of exterior existing window

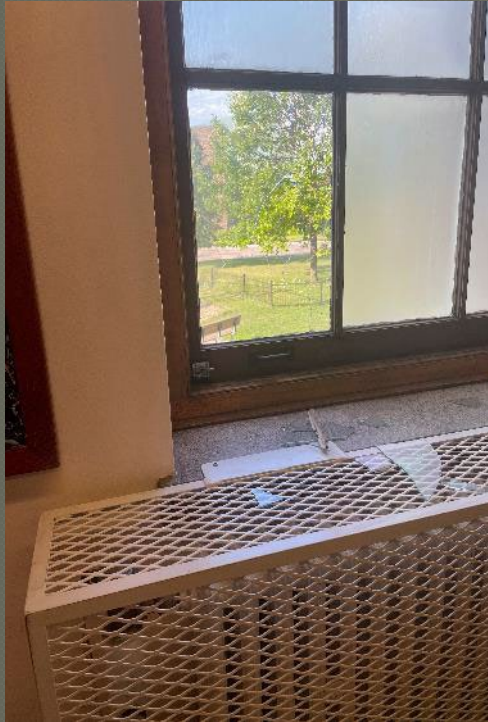
Interior view broken window

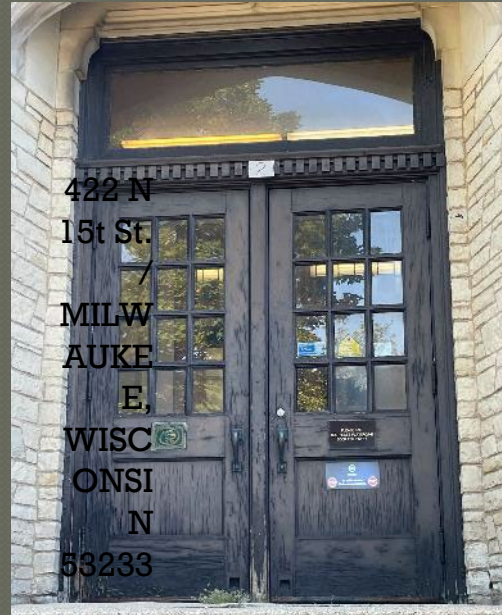
Existing entry doorway

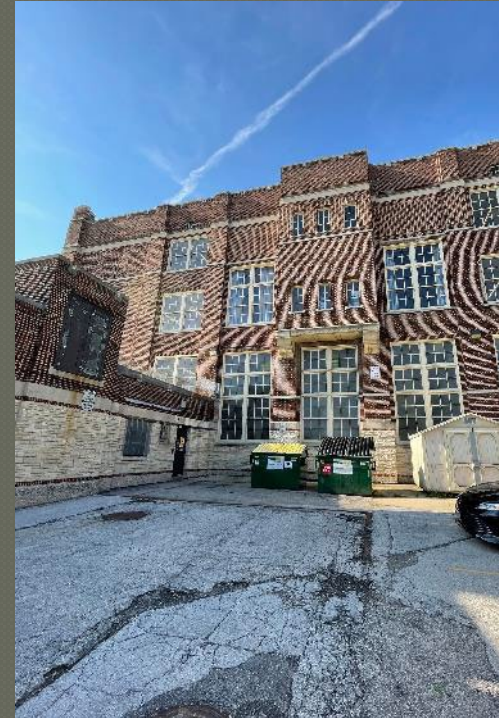
North elevation exterior view

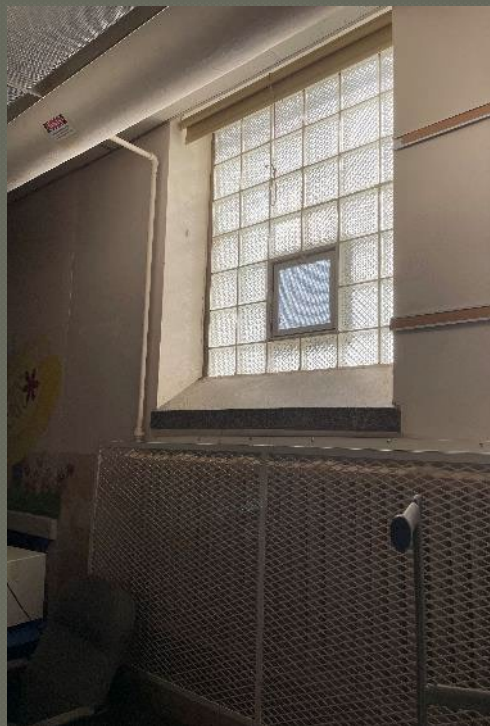
Interior view glass block window

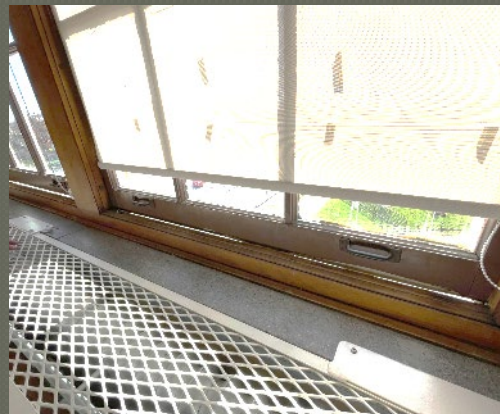
Interior view existing window

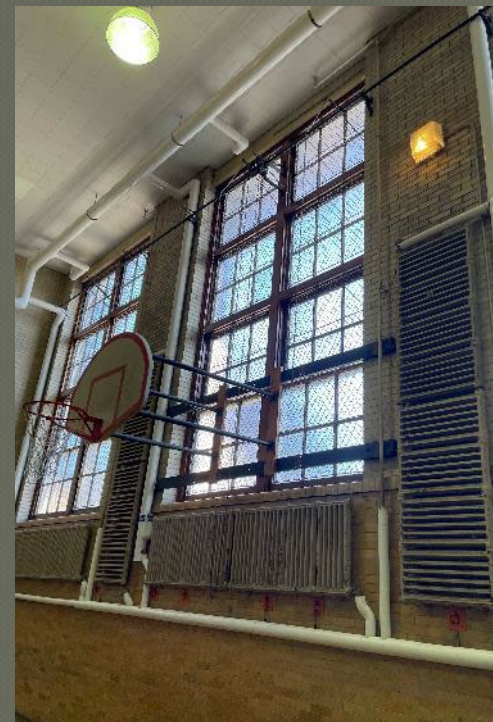
Interior view gym windows

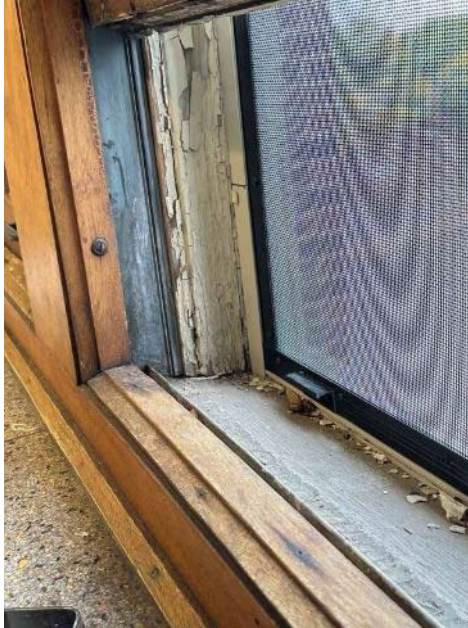
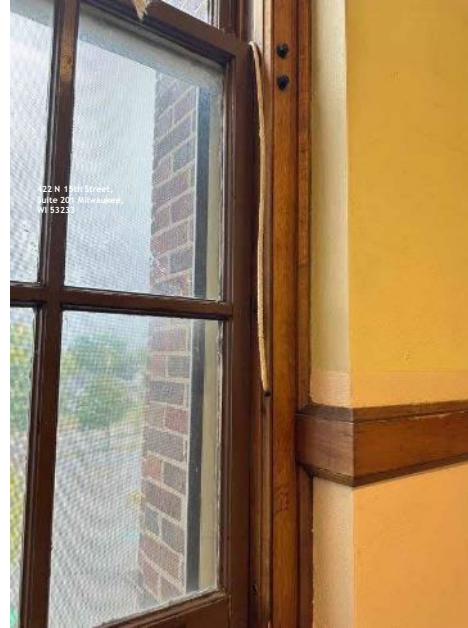
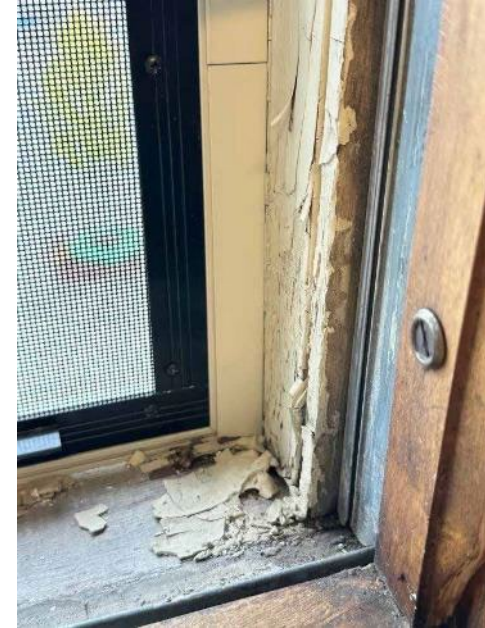
MPS - NE Tower Window Condition

Note: That while all windows in the towers were originally designed to be operable, some are no longer functional due to their current condition.

- Approve replacement of all ordinary, two-sash double-hung windows, all glass block windows, filled-in windows, ground floor windows, and attic windows
- Tower windows appear to be readily repairable

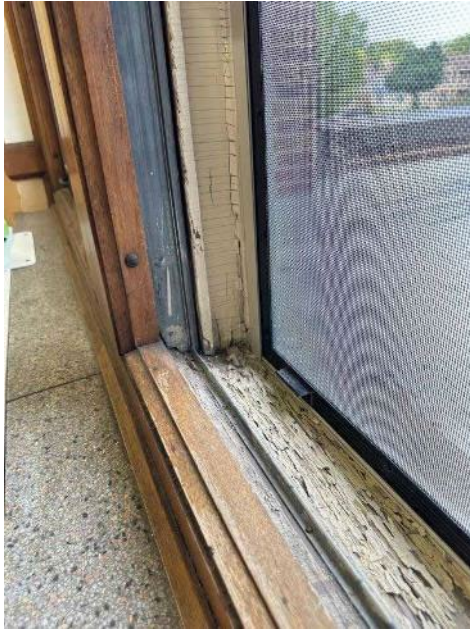
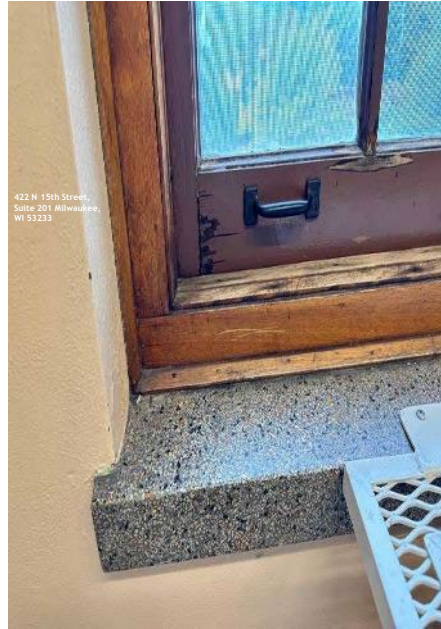
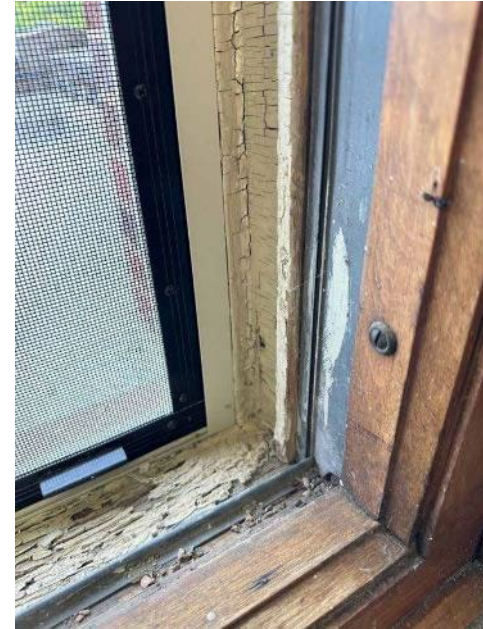
MPS - NE Tower Window Condition

Note: That while all windows in the towers were originally designed to be operable, some are no longer functional due to their current condition.

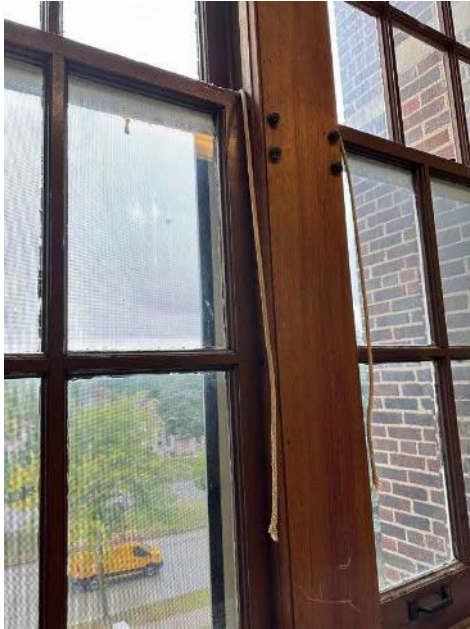
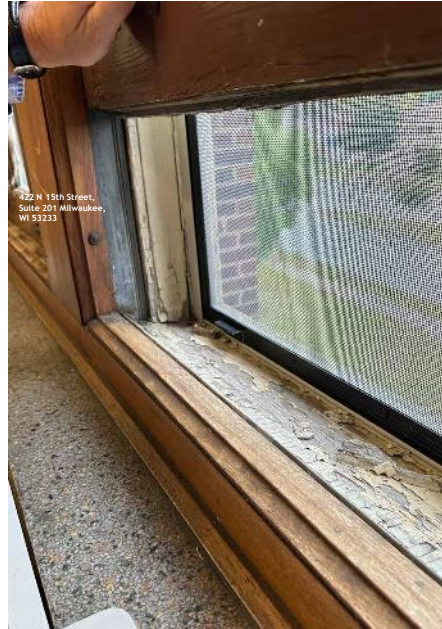
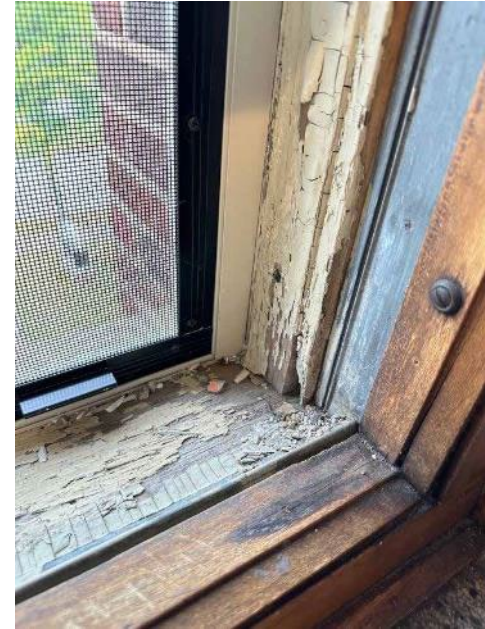
MPS - NW Tower Window Condition

Note: That while all windows in the towers were originally designed to be operable, some are no longer functional due to their current condition.

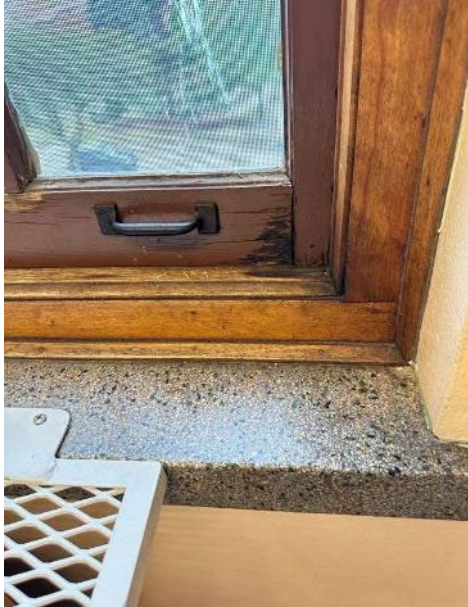
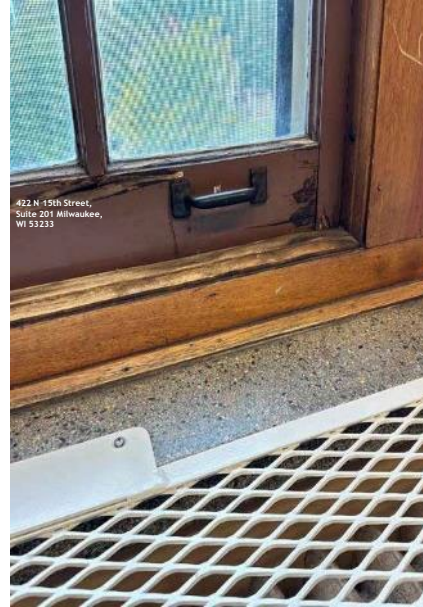
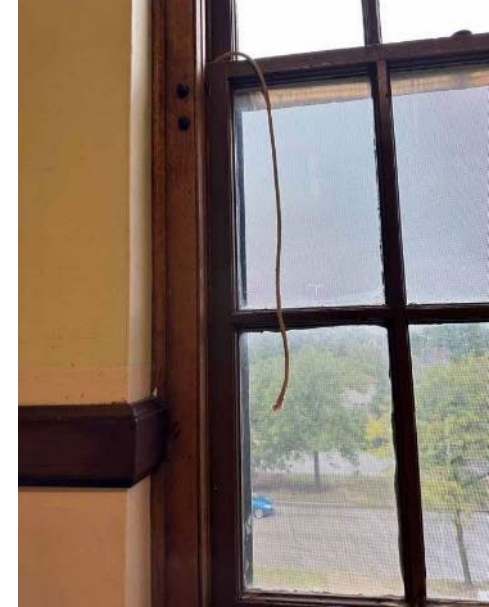
MPS - NW Tower Window Condition

Note: That while all windows in the towers were originally designed to be operable, some are no longer functional due to their current condition.

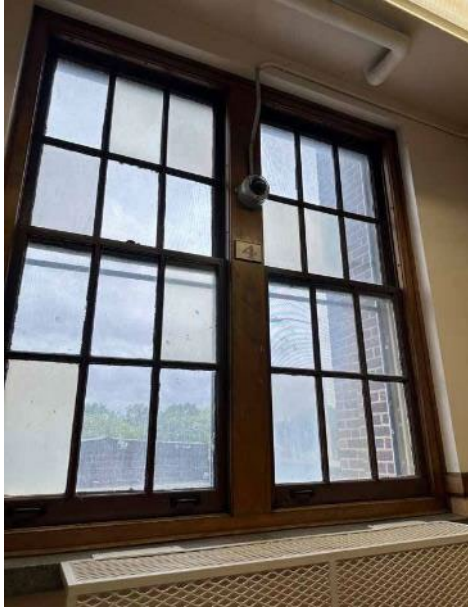
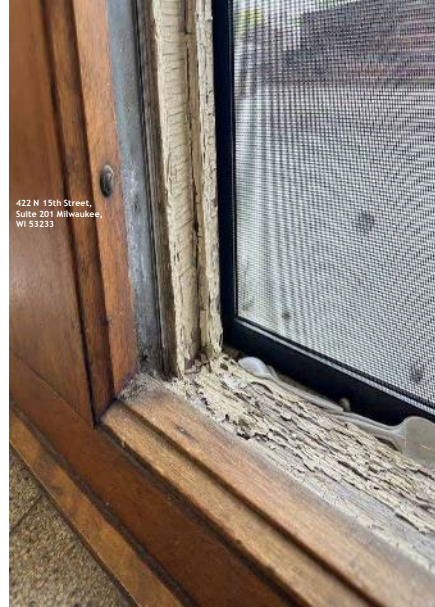
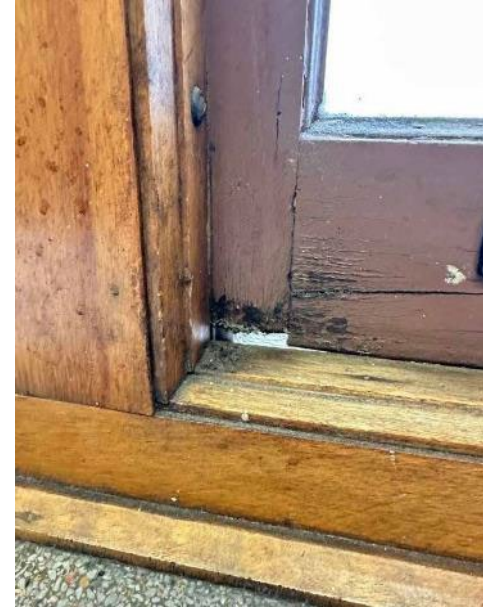
MPS - SE Tower Window Condition

Note: That while all windows in the towers were originally designed to be operable, some are no longer functional due to their current condition.

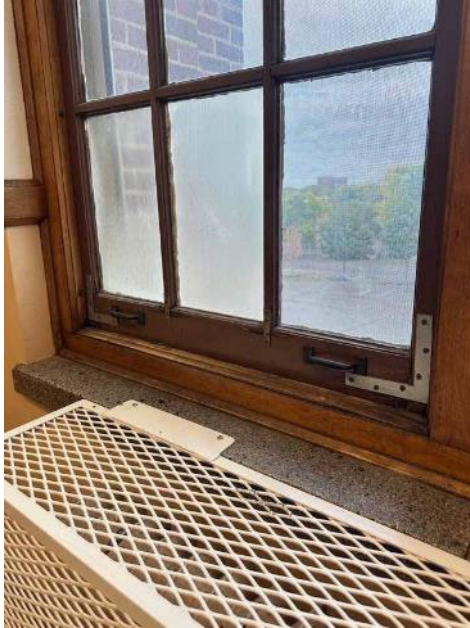
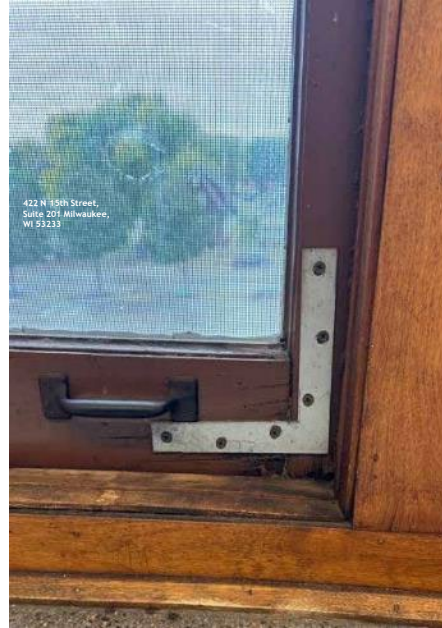
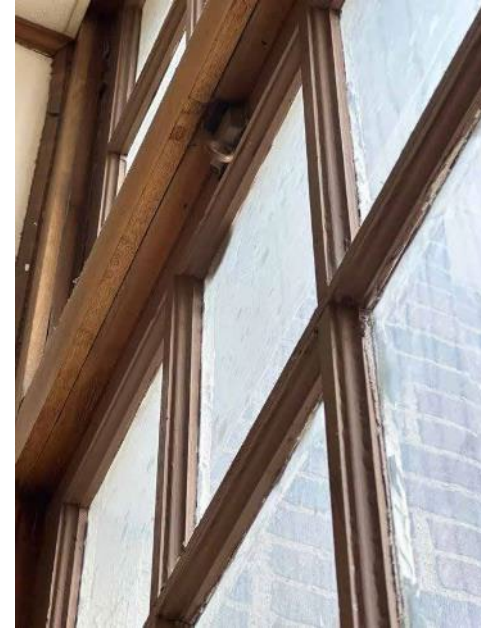
MPS - SE Tower Window Condition

Note: That while all windows in the towers were originally designed to be operable, some are no longer functional due to their current condition.

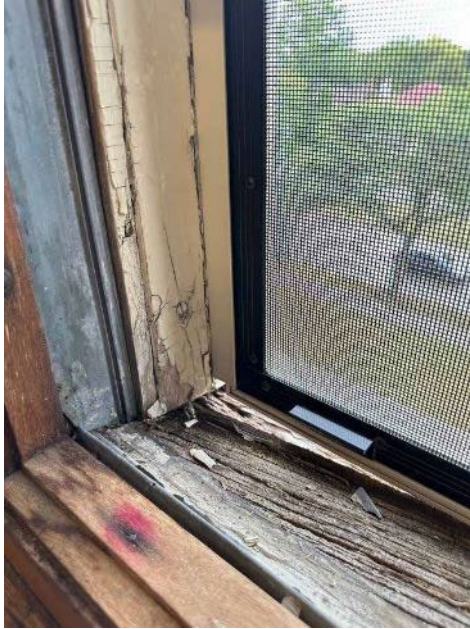
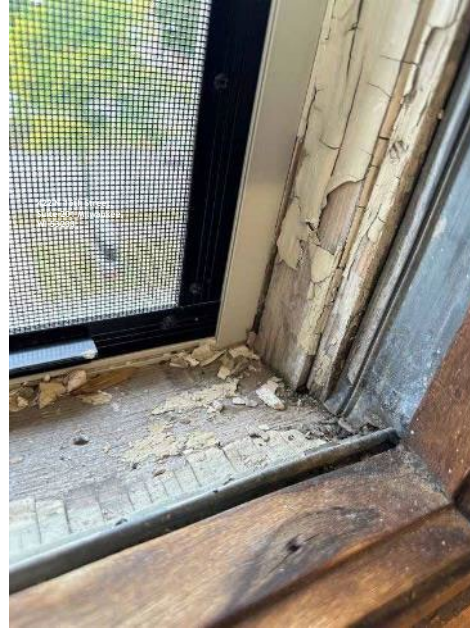
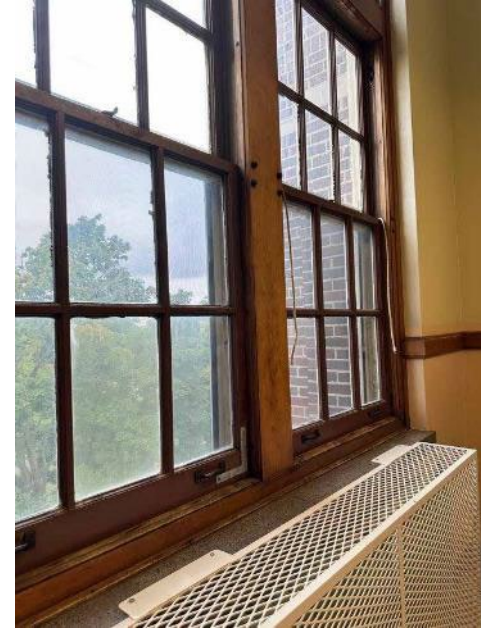
MPS - SW Tower Window Condition

Note: That while all windows in the towers were originally designed to be operable, some are no longer functional due to their current condition.

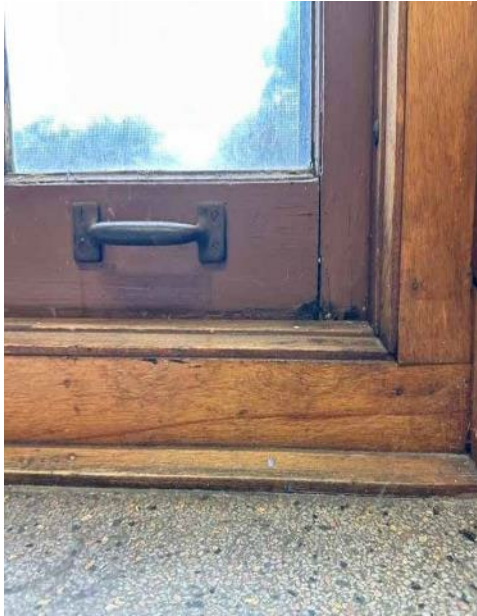
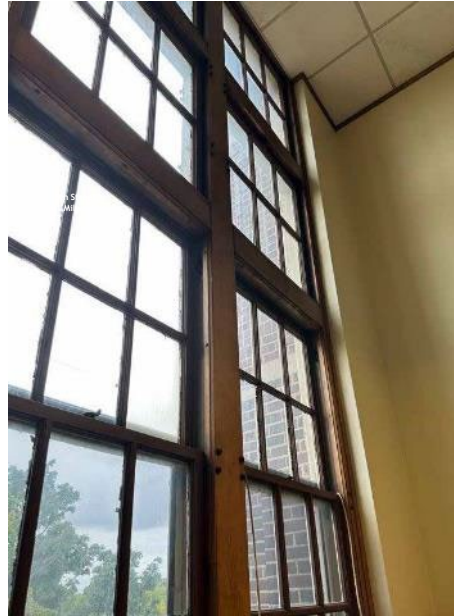
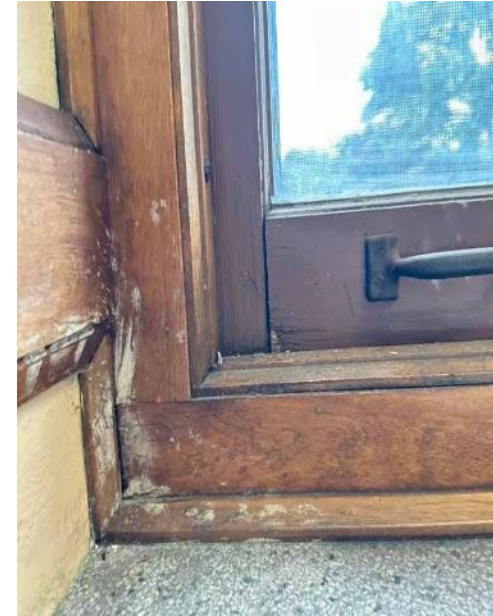
MPS - SW Tower Window Condition

Note: That while all windows in the towers were originally designed to be operable, some are no longer functional due to their current condition.
