On the evening of October 31, 2024, around 6 PM, a large portion of a tree fell onto our front yard at our home address of 3234 N 49th St Milwaukee, WI 53216. The tree was a City of Milwaukee tree between the sidewalk and the street. (the tree was actually in front of 3228 N 49th St).

The tree branches enveloped our 2015 Toyota Sienna (VIN: 5TDKK3DC4S666096, 75,146 miles). A branch dented the roof, broke the driver's side mirror, and caused numerous dents and scratches across the side and back of the van. Repairs were estimated at no less than \$14,220 (see enclosed 2 *preliminary estimates*) with the possibility of needing and incurring more expenses during the repairs to completely bring the van up to its prior state from before the event.

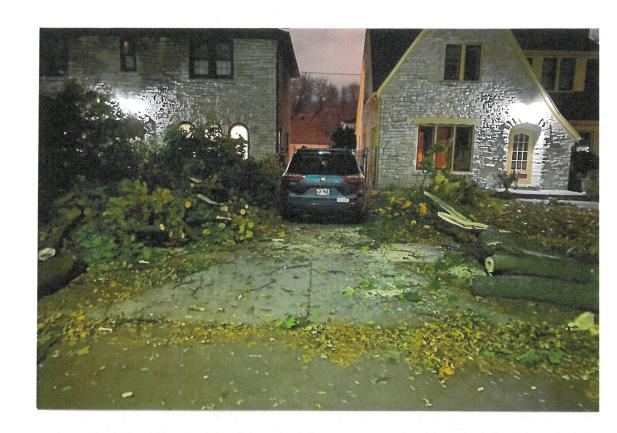
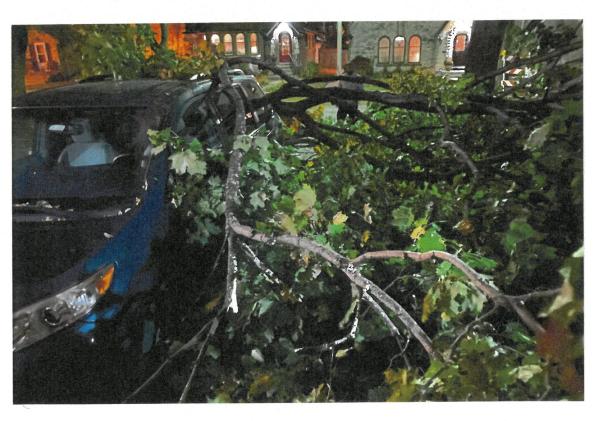
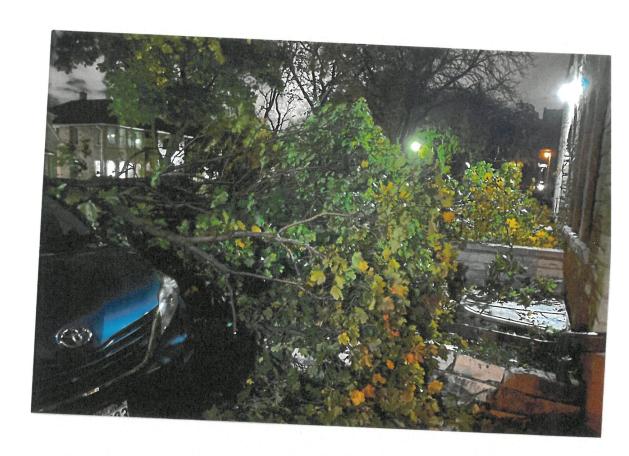
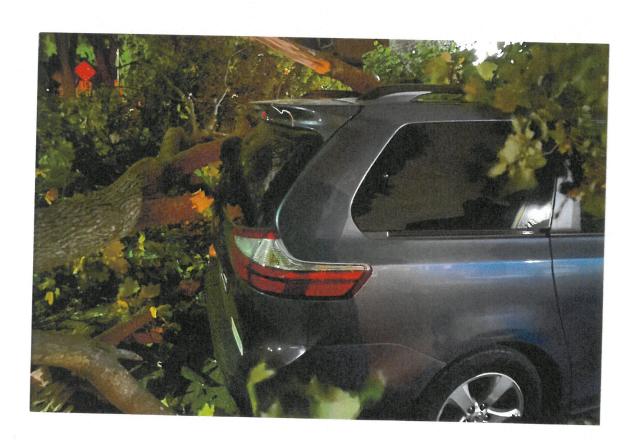
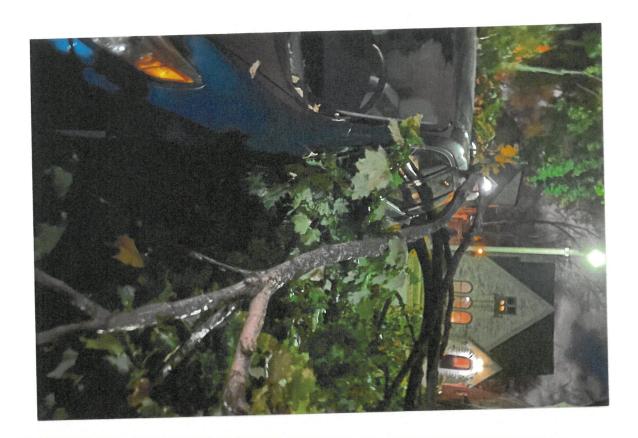
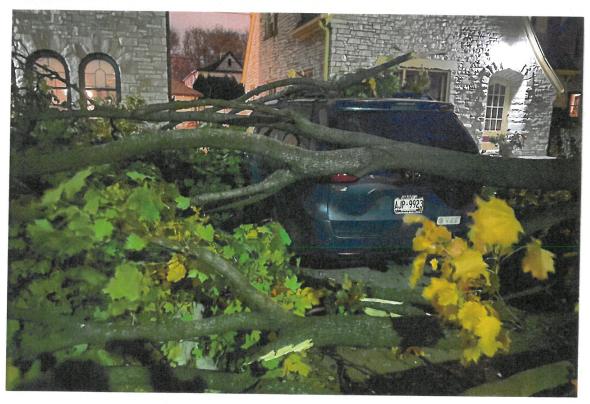
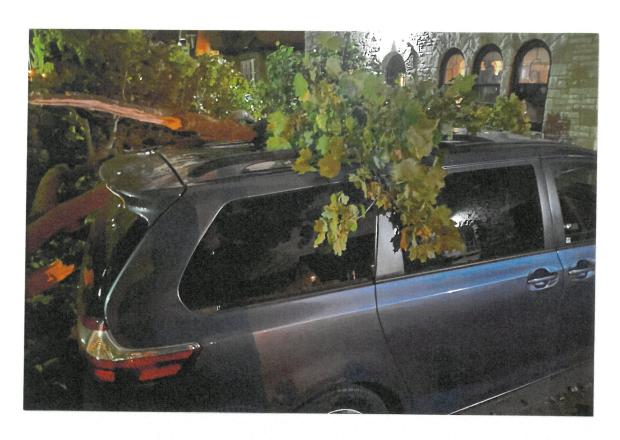
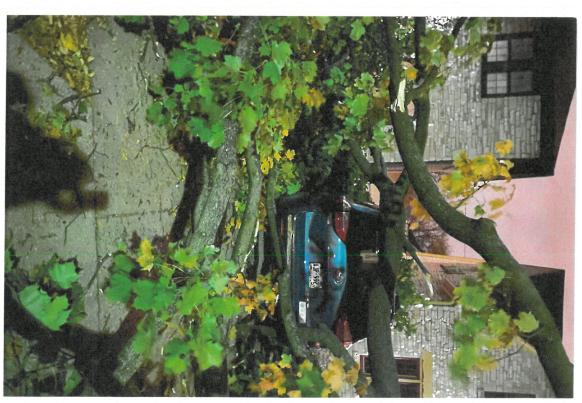
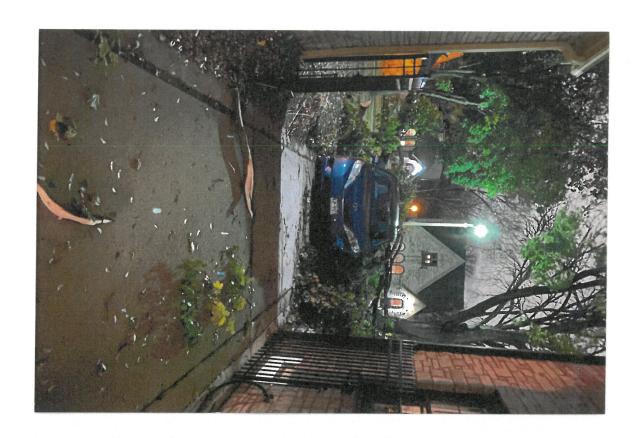
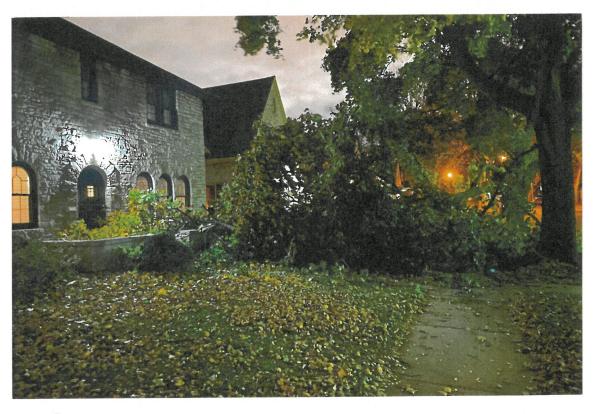
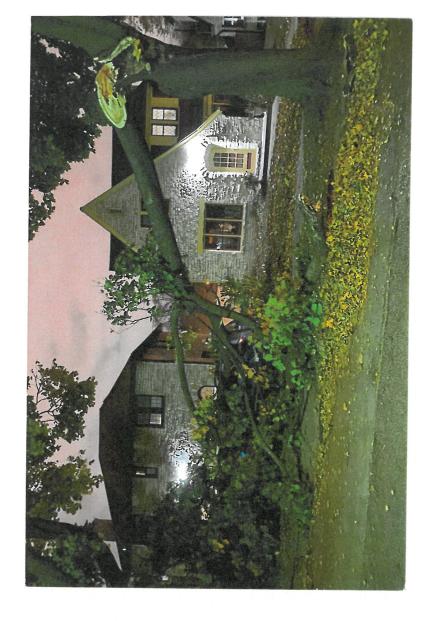
Please see the enclosed photos of the incident. A friendly neighbor offered to cut away some of the branches shortly after the incident. These photos were taken at the time while the branches were still over and on top of the van. Later in the evening, a crew came from the Dept of Forestry (10 PM) and took pictures as well of the damages. By then though, the branches had already been cleared from around the van.

The forestry crew (who did an excellent and expeditious job clearing the debris) did confirm that there were signs of decay on the tree at the time of failure. There were visible mushrooms at the location of the break. The head of the crew, "Bruce" did confirm this and showed me his documented report on this as well.
