1 BUILDING ELEVATION
SCALE: 1/2" = 1'-0"

2 END DAM DIAGRAM
SCALE: N.T.S.

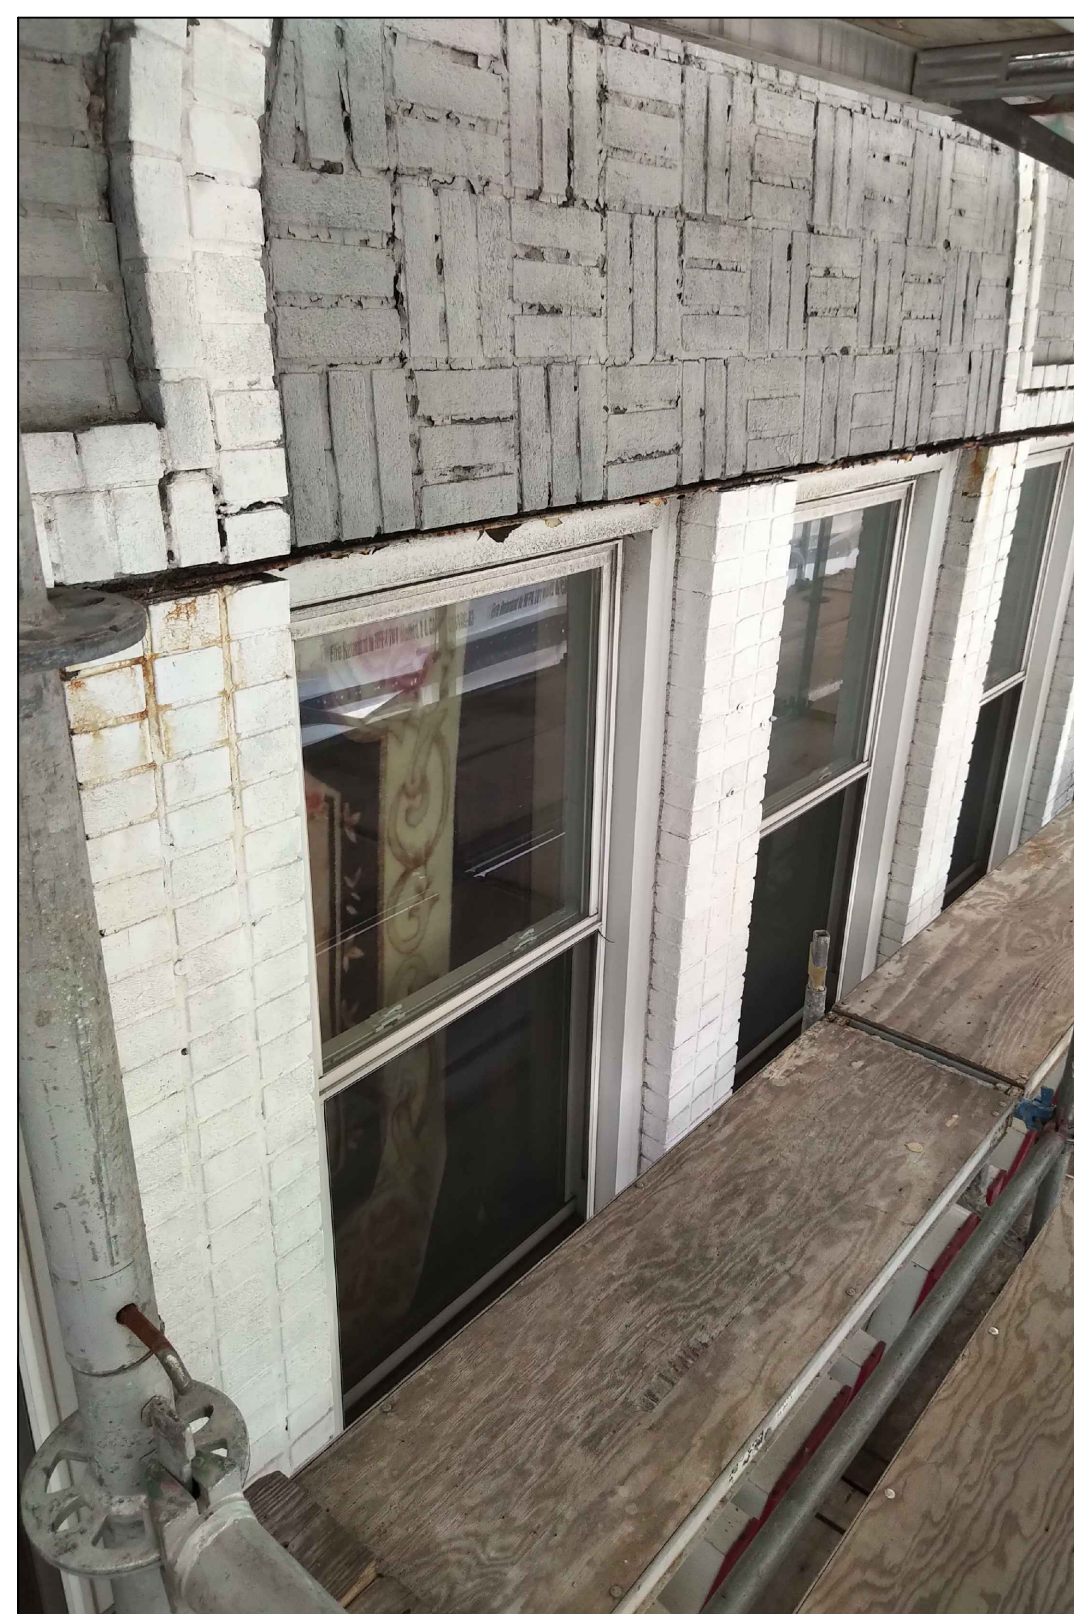
SECOND FLOOR WINDOWS: BRICK JAMBS HEAD AND ARCH DETAIL. FACADE MOVEMENT; CRACKED DAMAGED AND PROTRUDING BRICKS
MOVEMENT GAP NOTICEABLE AT WINDOW HEAD.

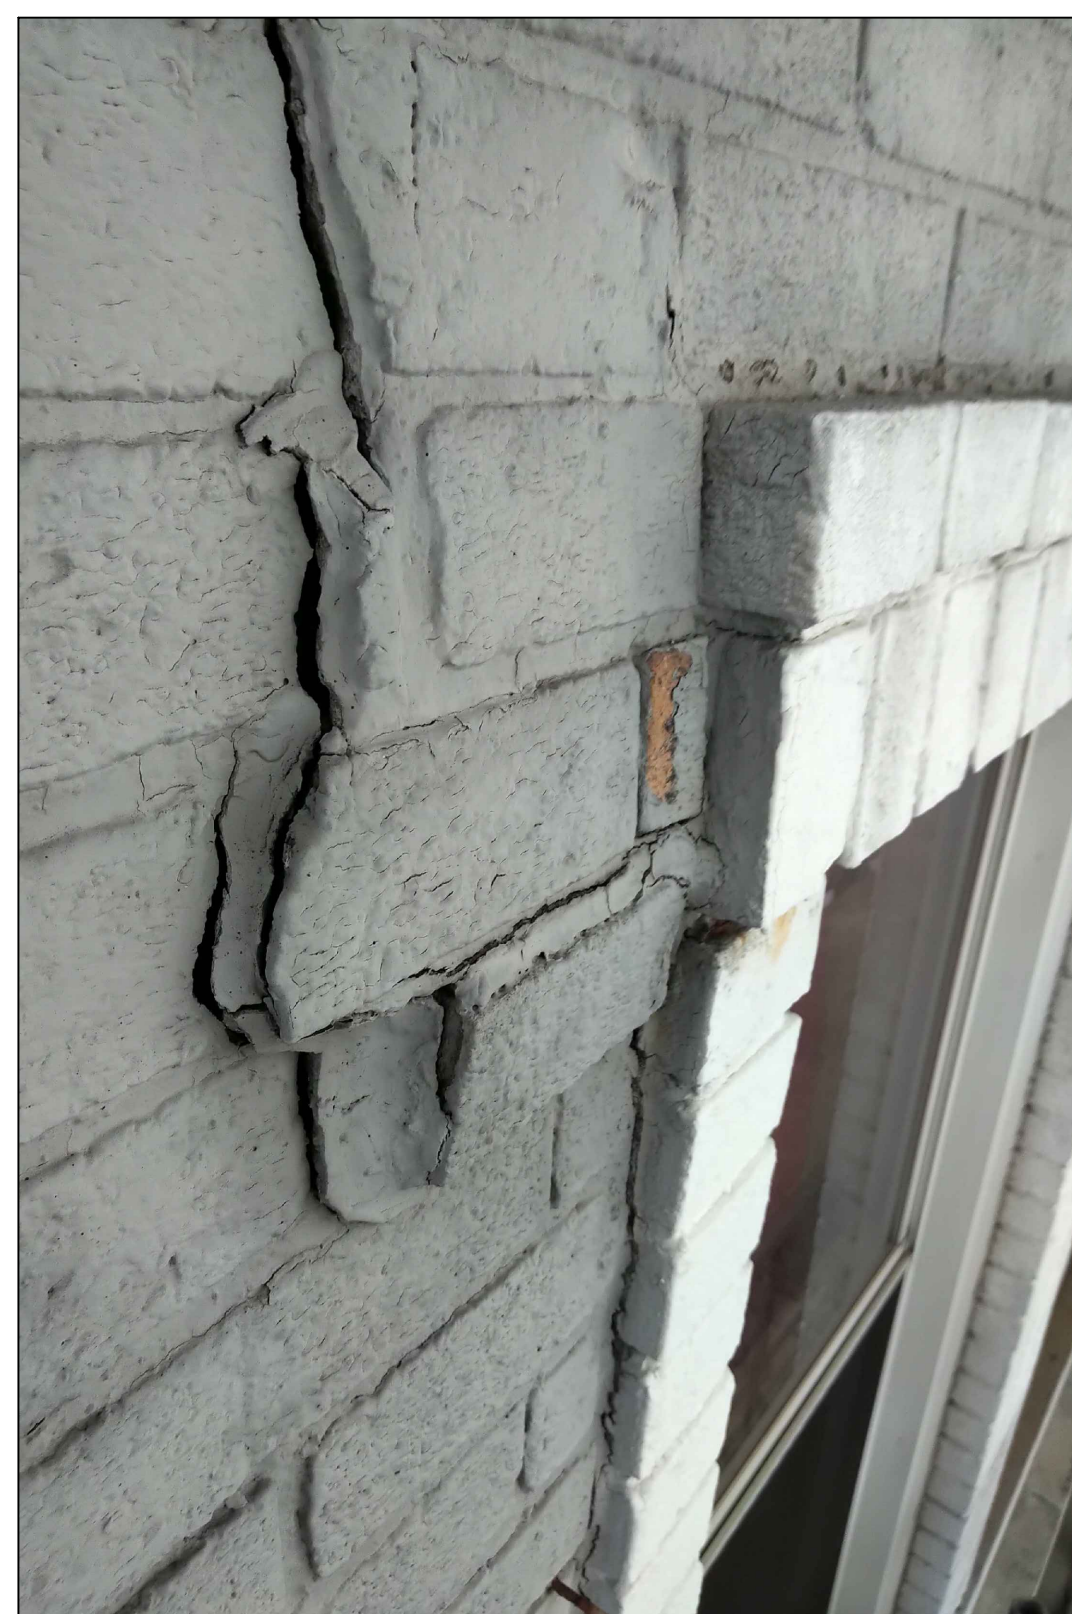
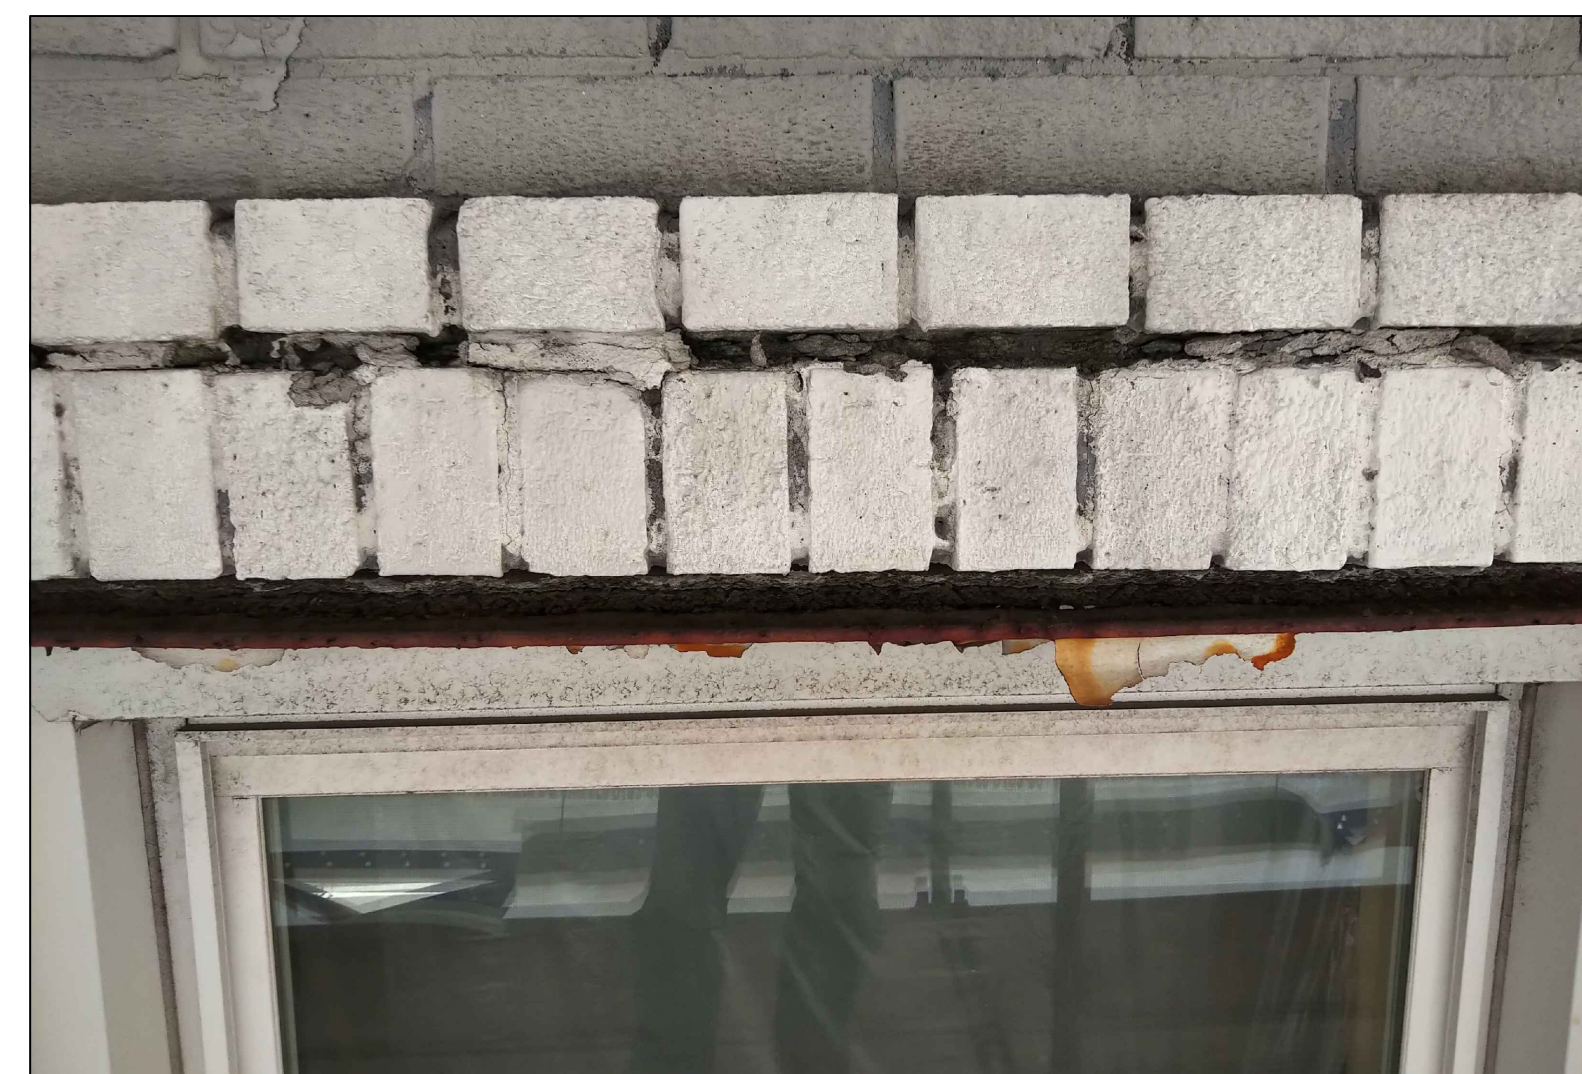
MISSING MORTAR, EXPANDED JOINTS BECAUSE OF MOVEMENT; GAP AT STEEL LINTEL
NOTE THE RUST STAINS FROM THE LINTEL ON THE WINDOW

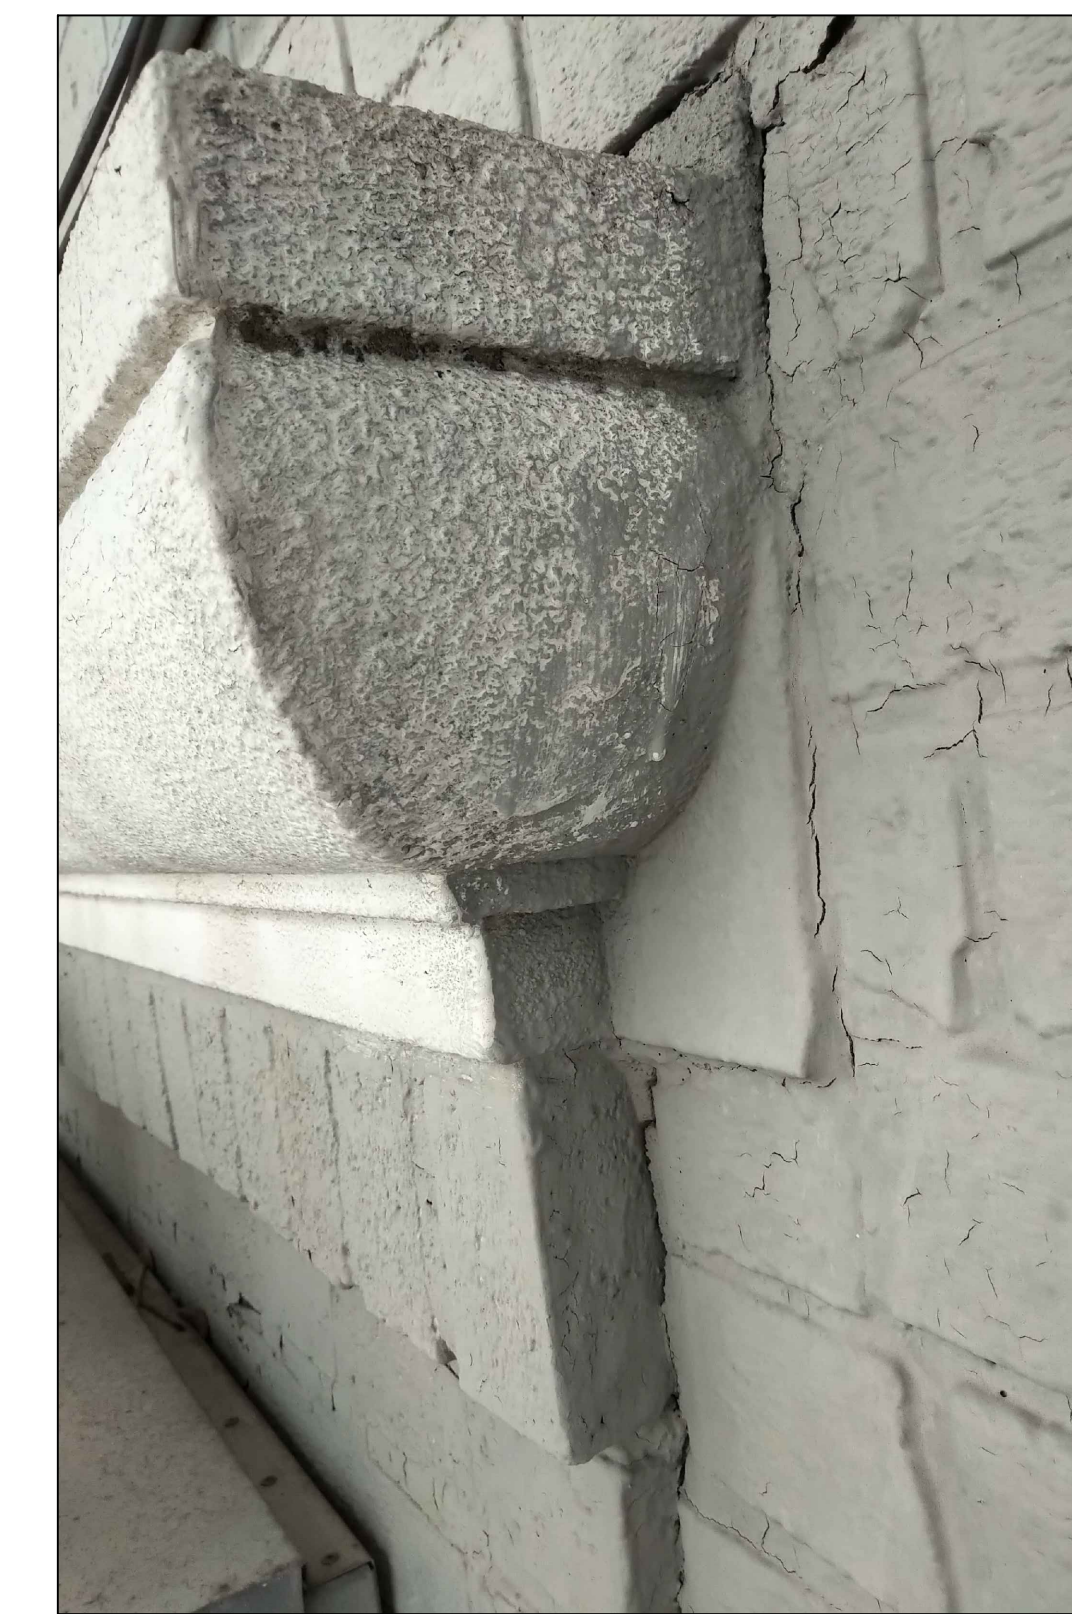
STONE SILL AND BRICK DETAIL

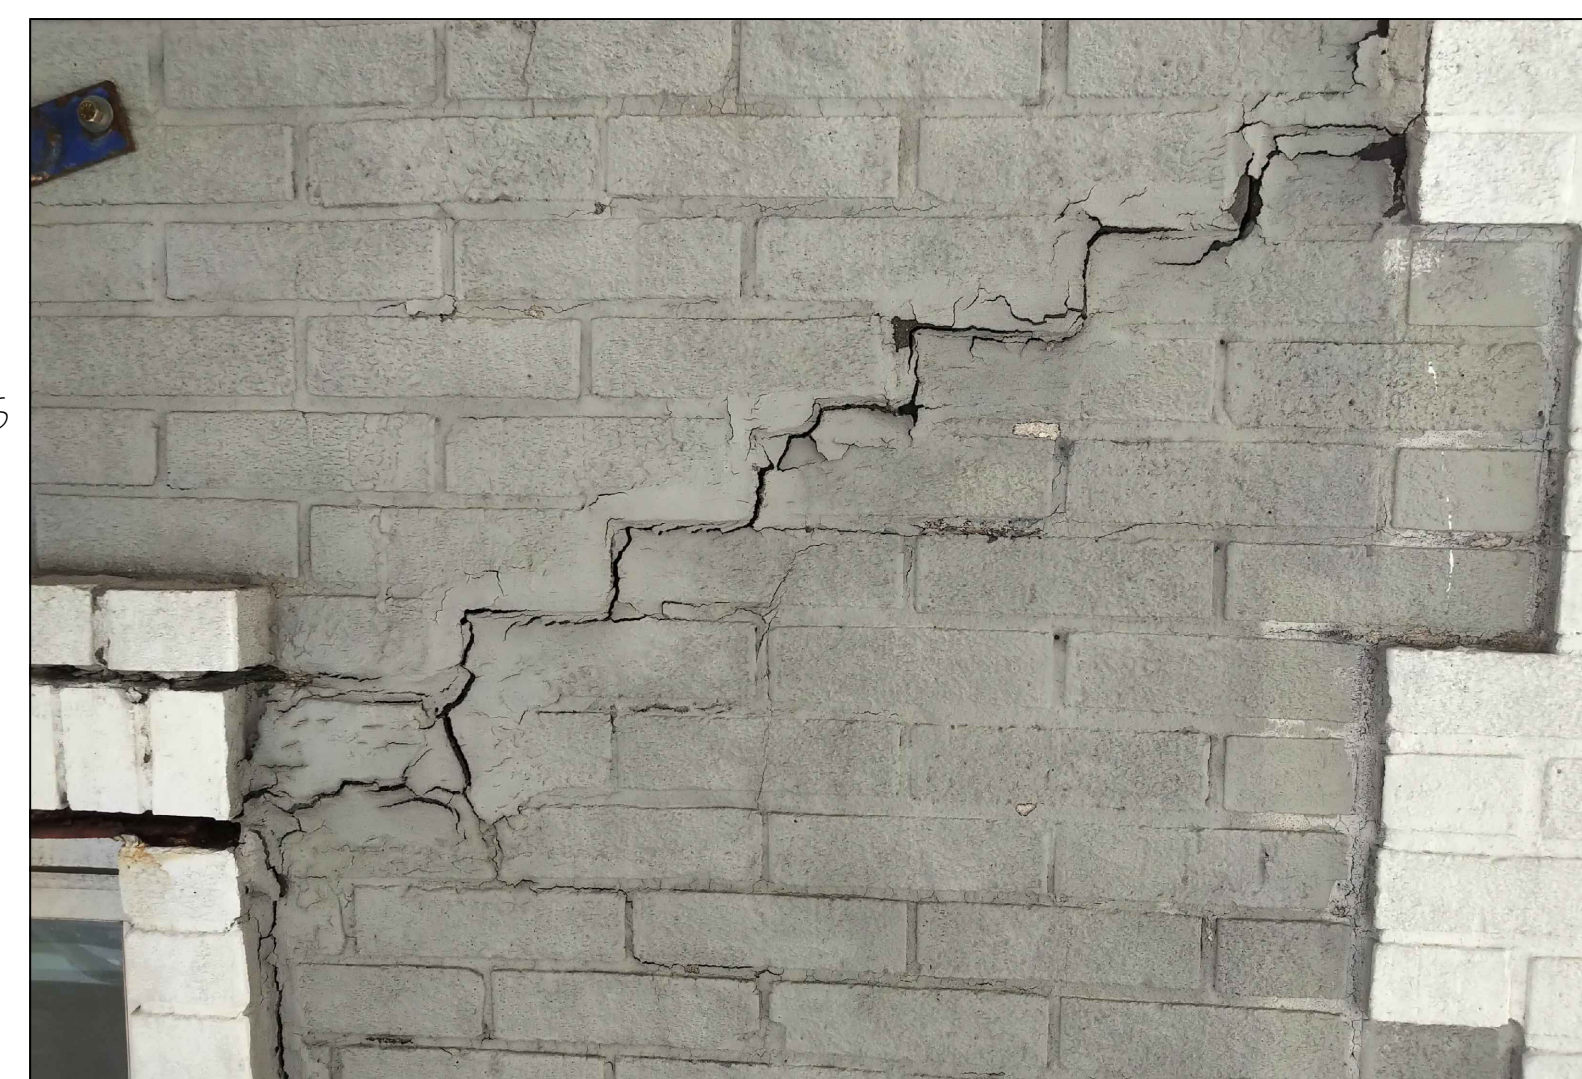
MOVEMENT CRACK FROM WINDOW LINTEL TO WEST WALL AT COIN DETAIL

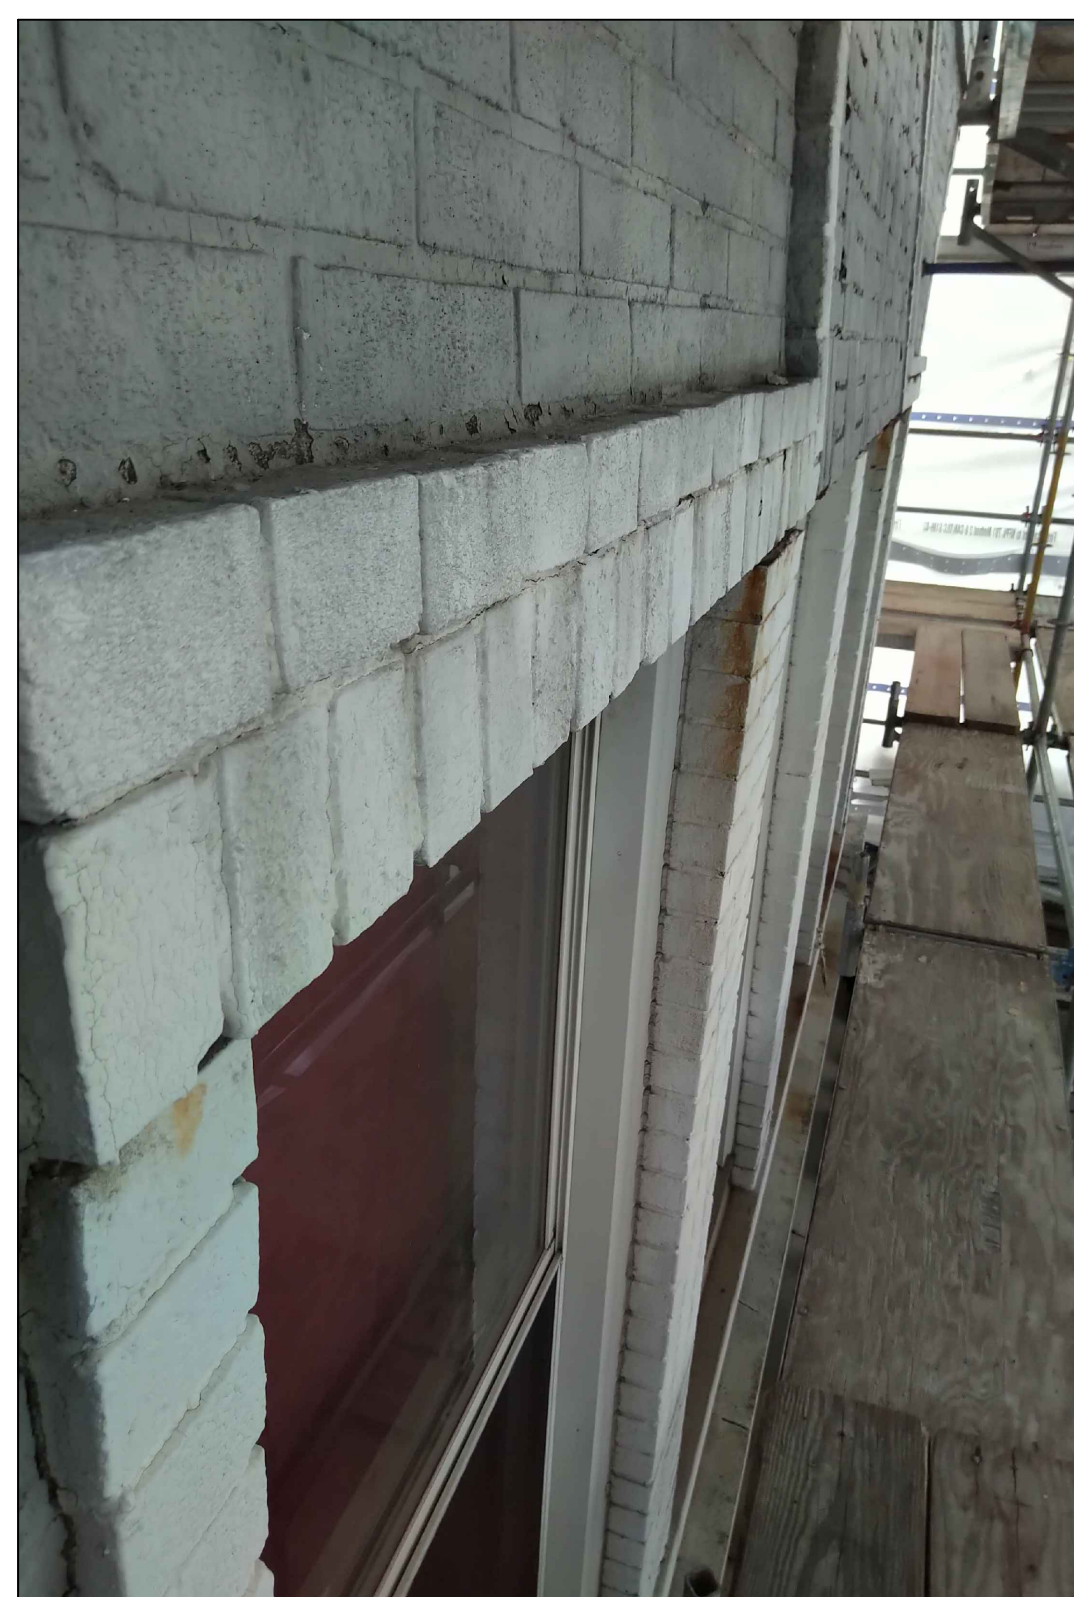
UPPER WINDOW HEADER BRICK DETAIL

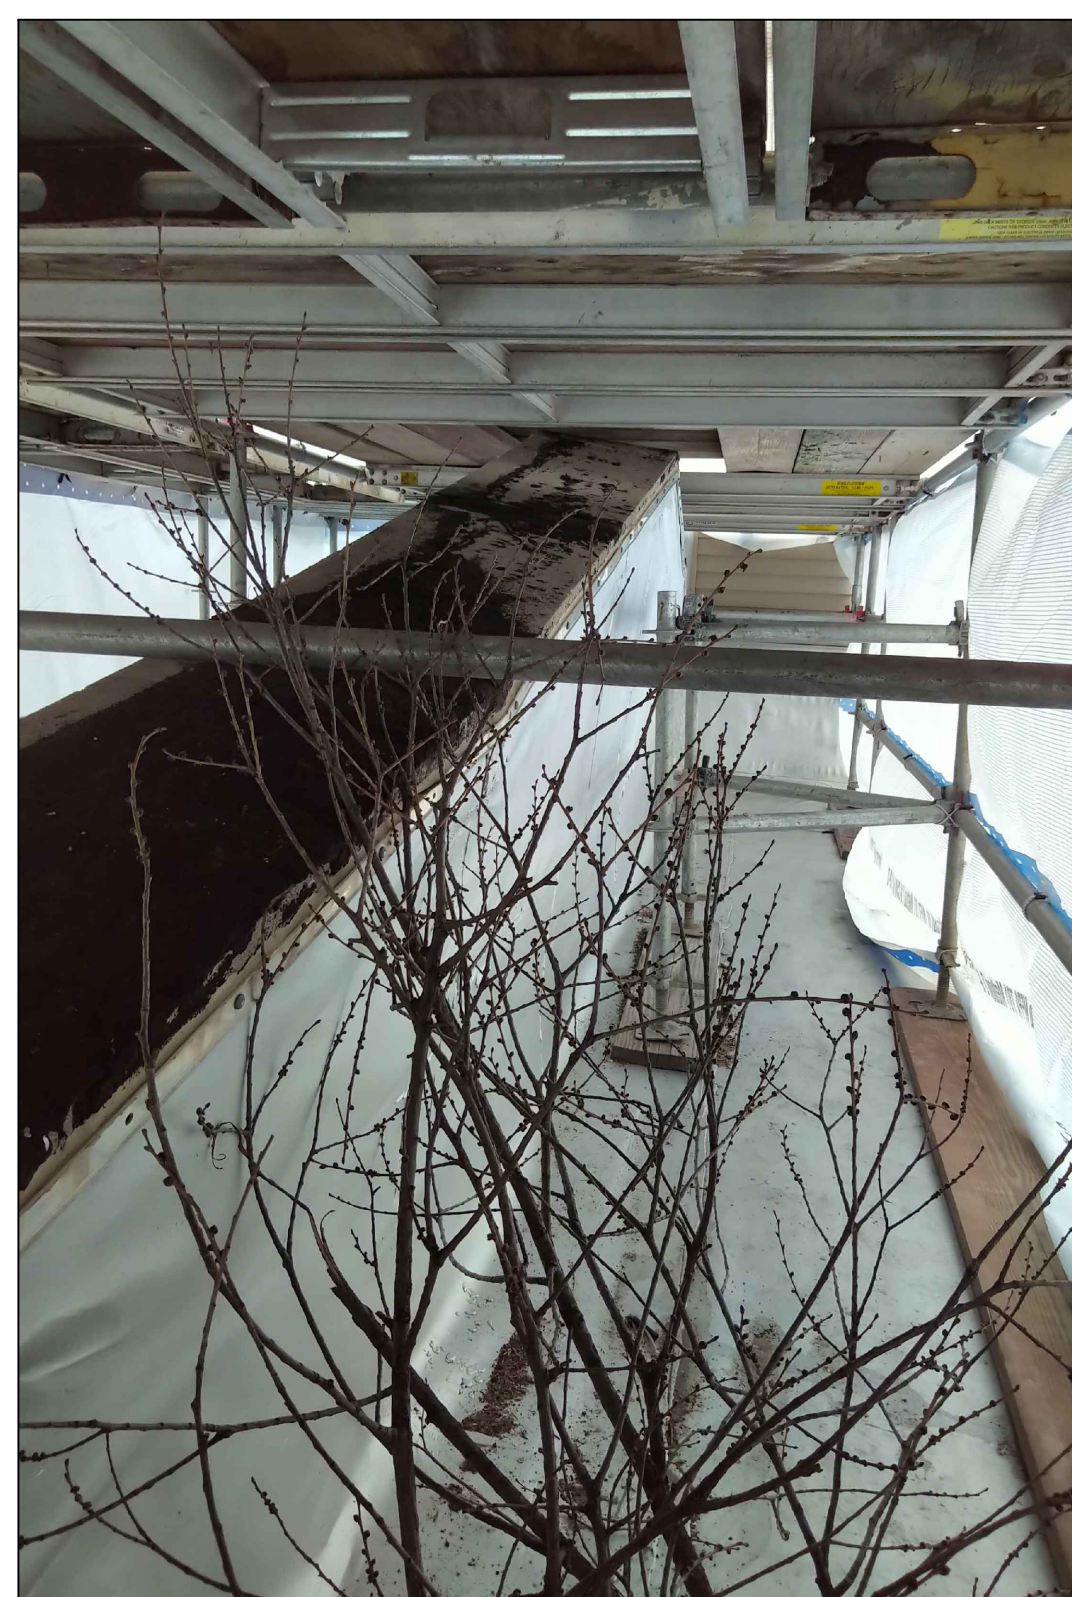
TREE GROWING ON ROOF - ROOF DAMAGE; WATER DAMAGE TO WALL AND POOR DRAINAGE. BAD JOINTS BETWEEN COPING STONES

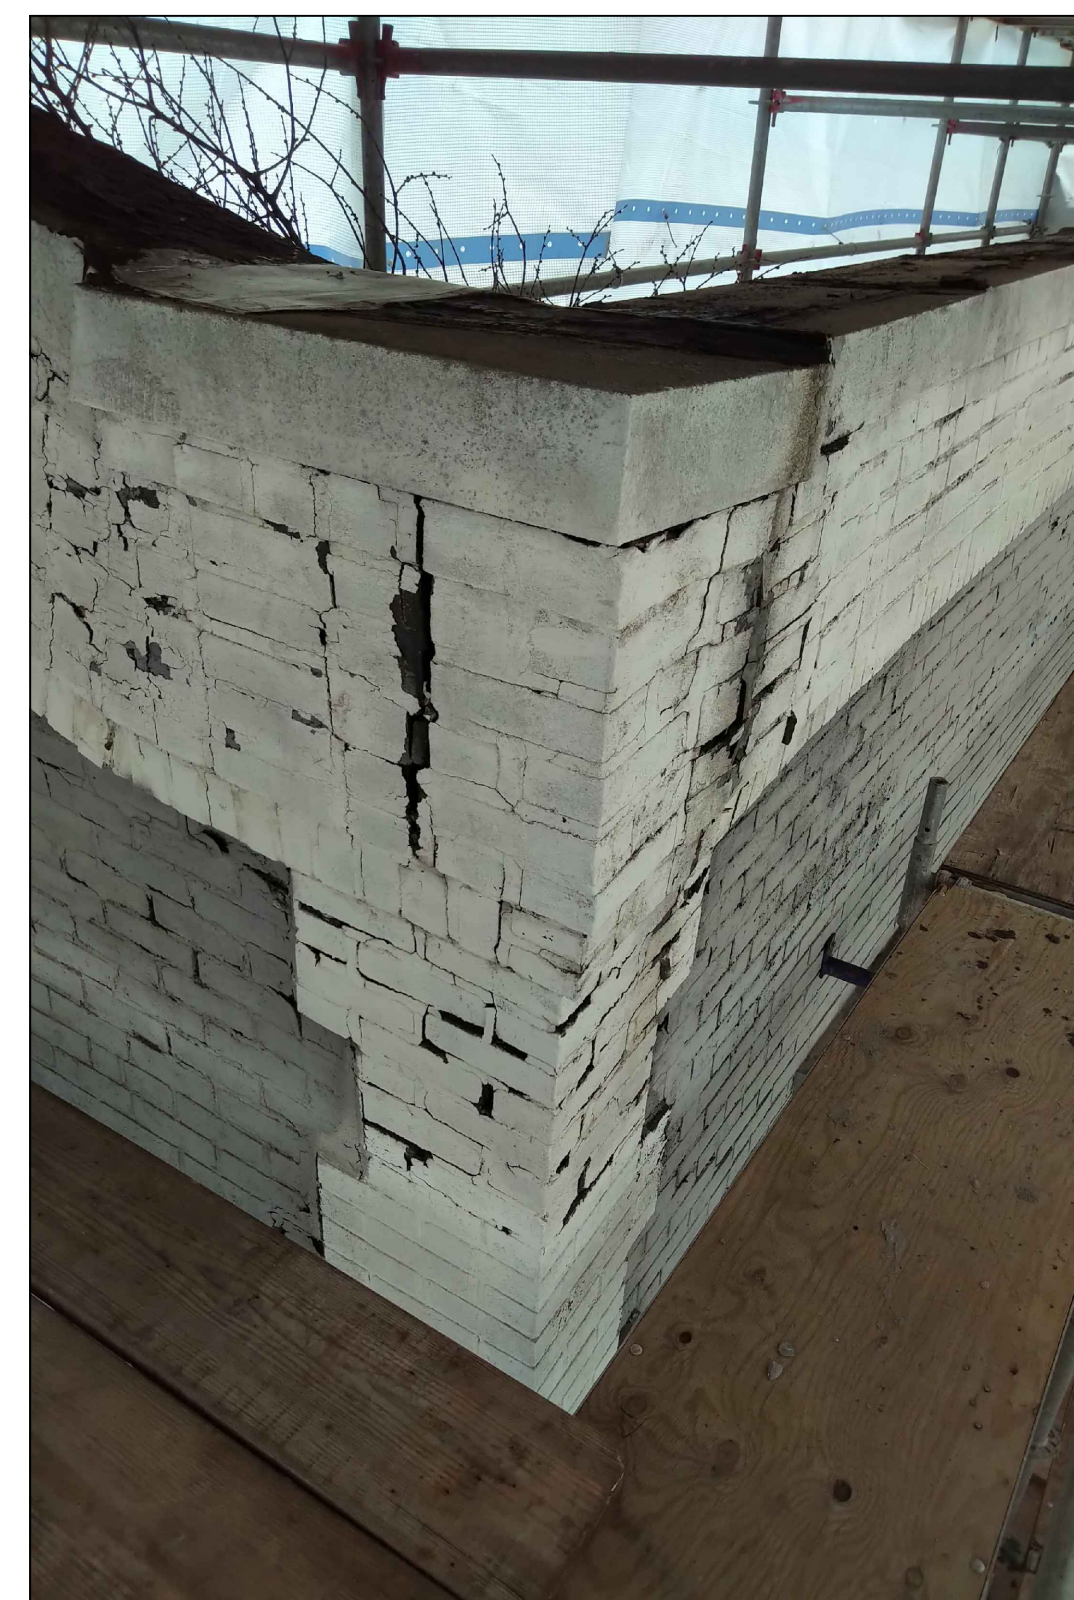
UPPER WEST CORNER DETAIL - WATER INFILTRATION DAMAGE
BRICK AND COPING MOVEMENT

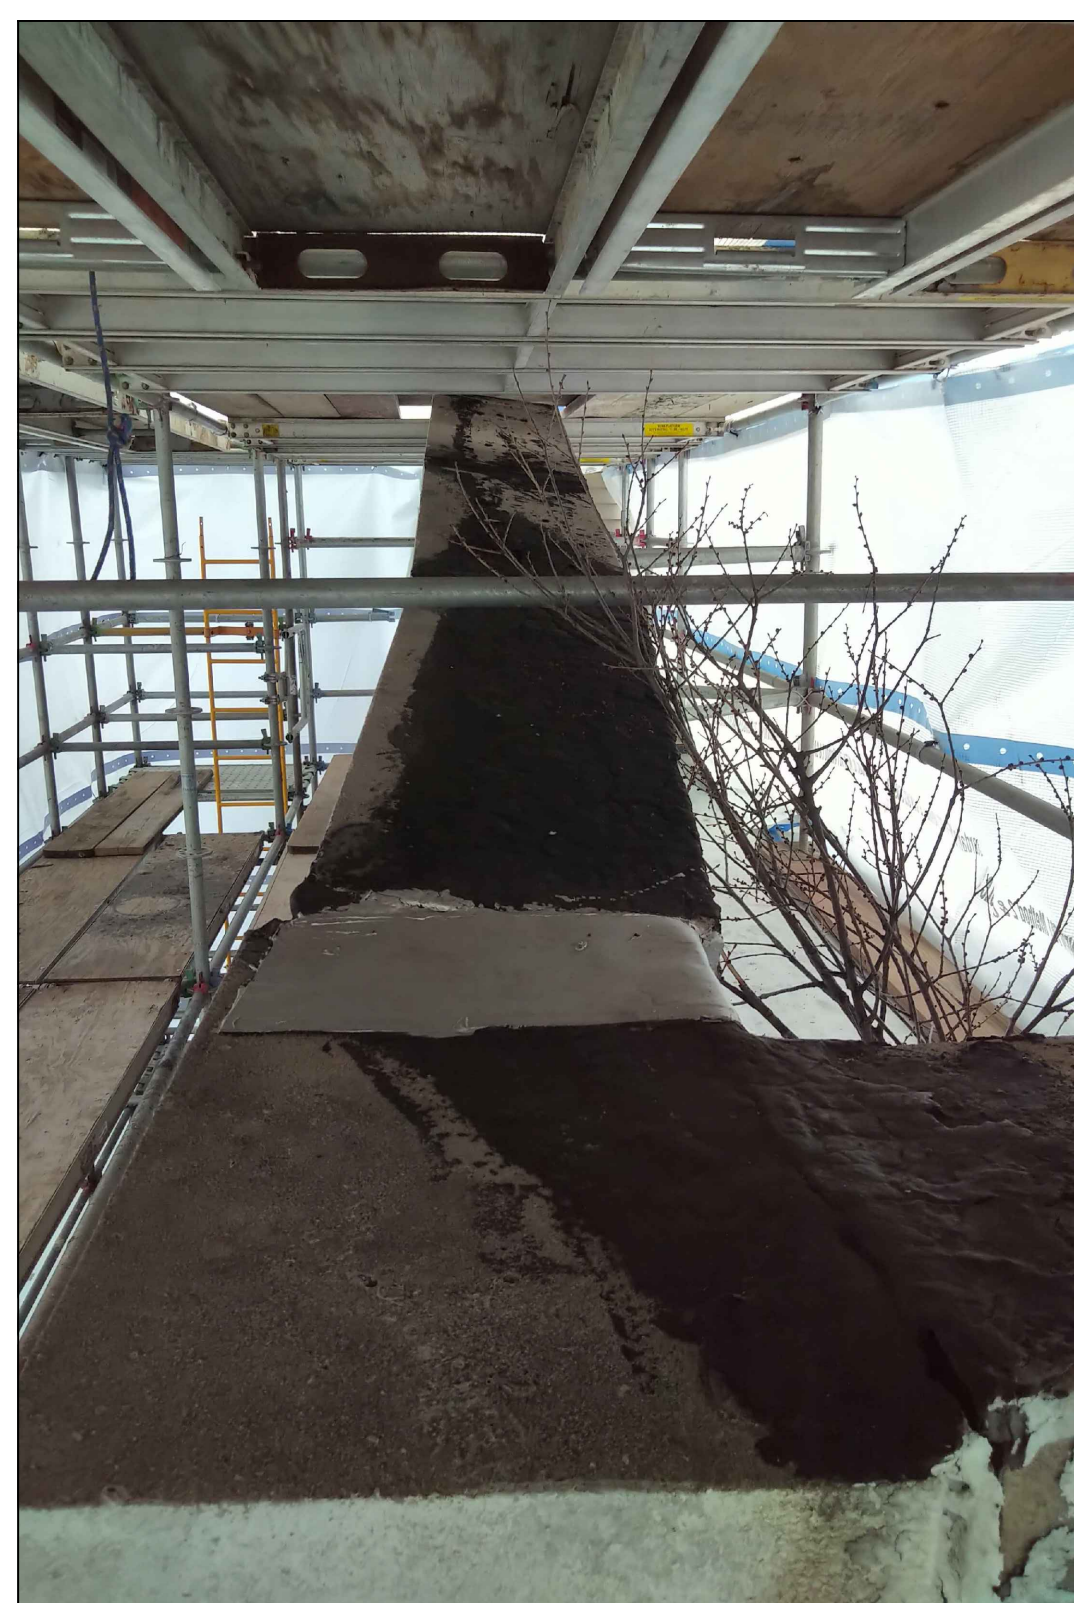
COPING STONES IMPROPERLY SEALED WITH ASPHALT

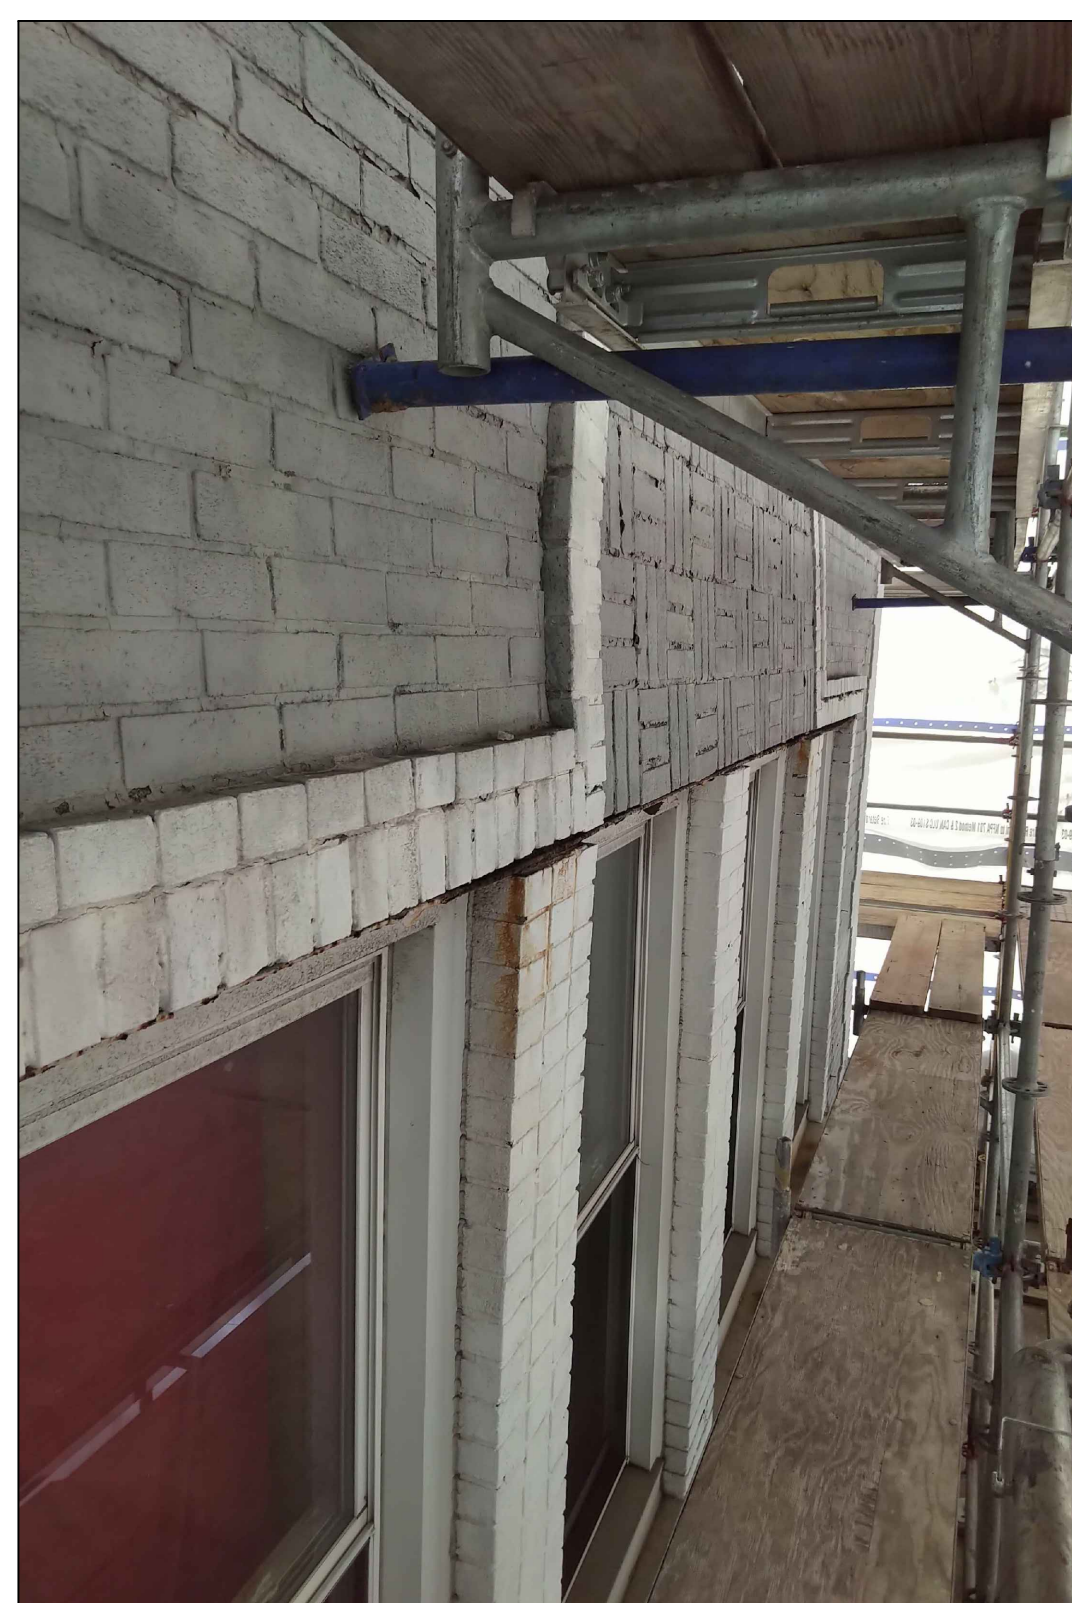
BEST PHOTO TO SHOW THE "LEANING" OF THE UPPER PORTION OF WALL. AT LEAST 5 DEGREES OUT OF PLUMB

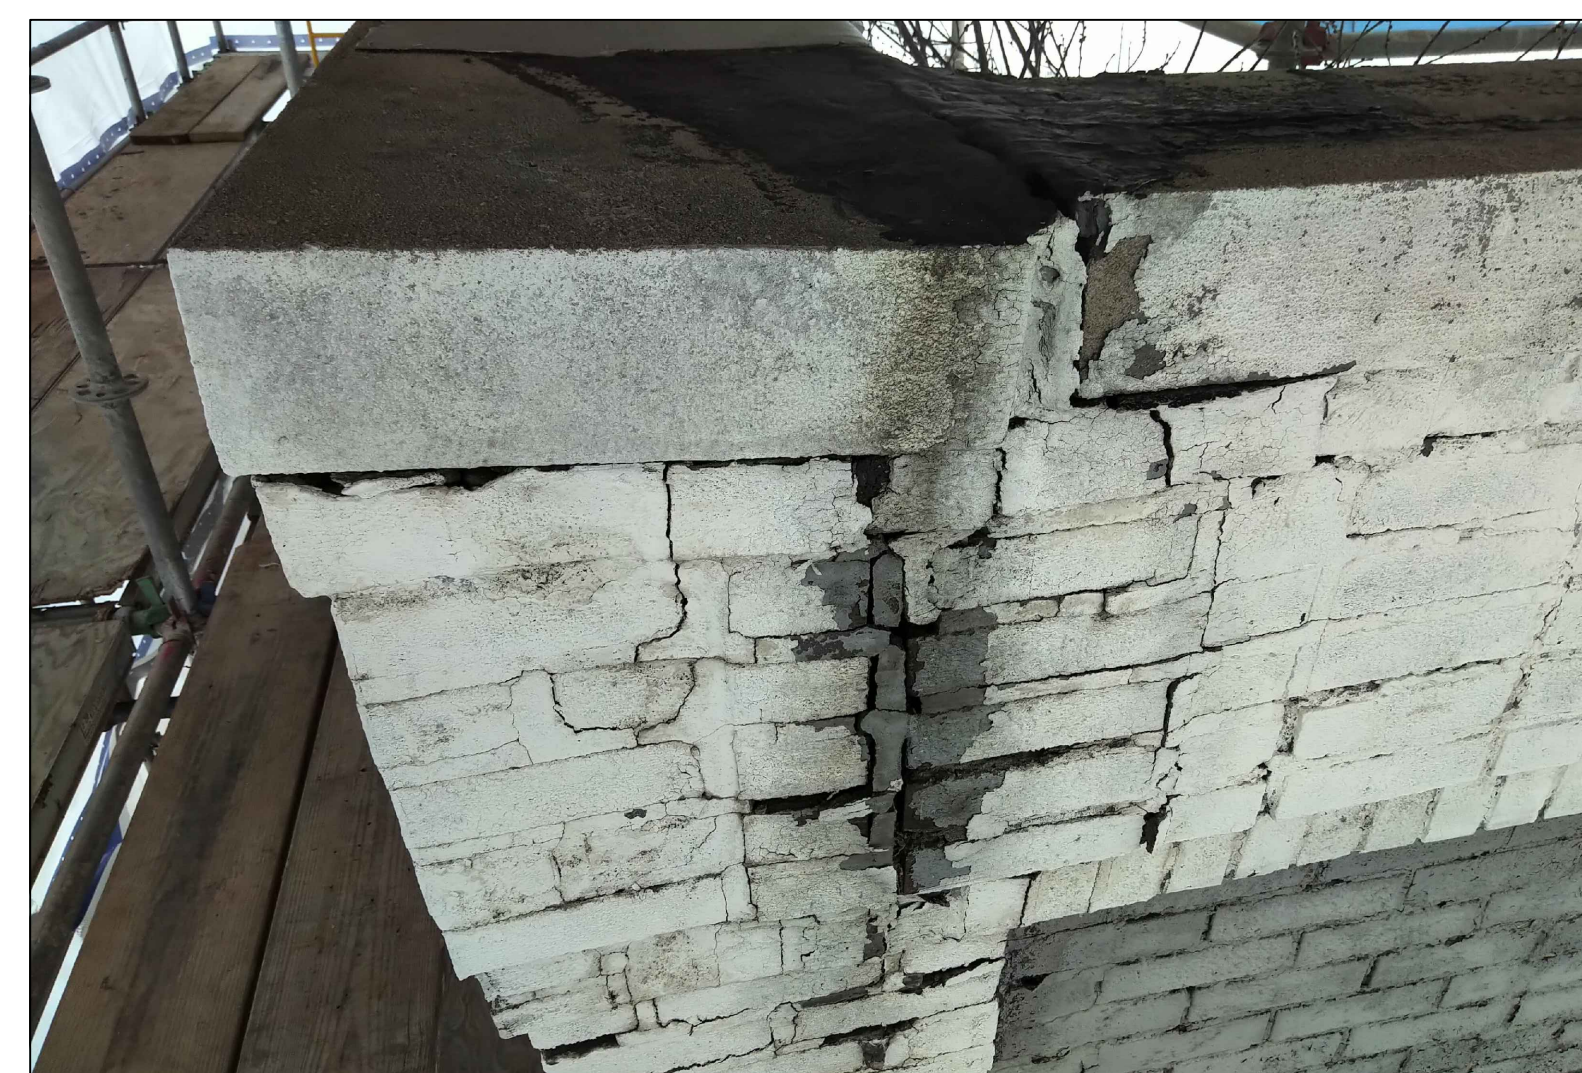
UPPER WEST CORNER DETAIL - WATER INFILTRATION DAMAGE
BRICK AND COPING MOVEMENT - POOR JOINT REPAIR
