PowerPoint Slides Containing

Photographs and information in
support of the claim at 3123 N.
Humboldt Blvd, Milwaukee WI 53212

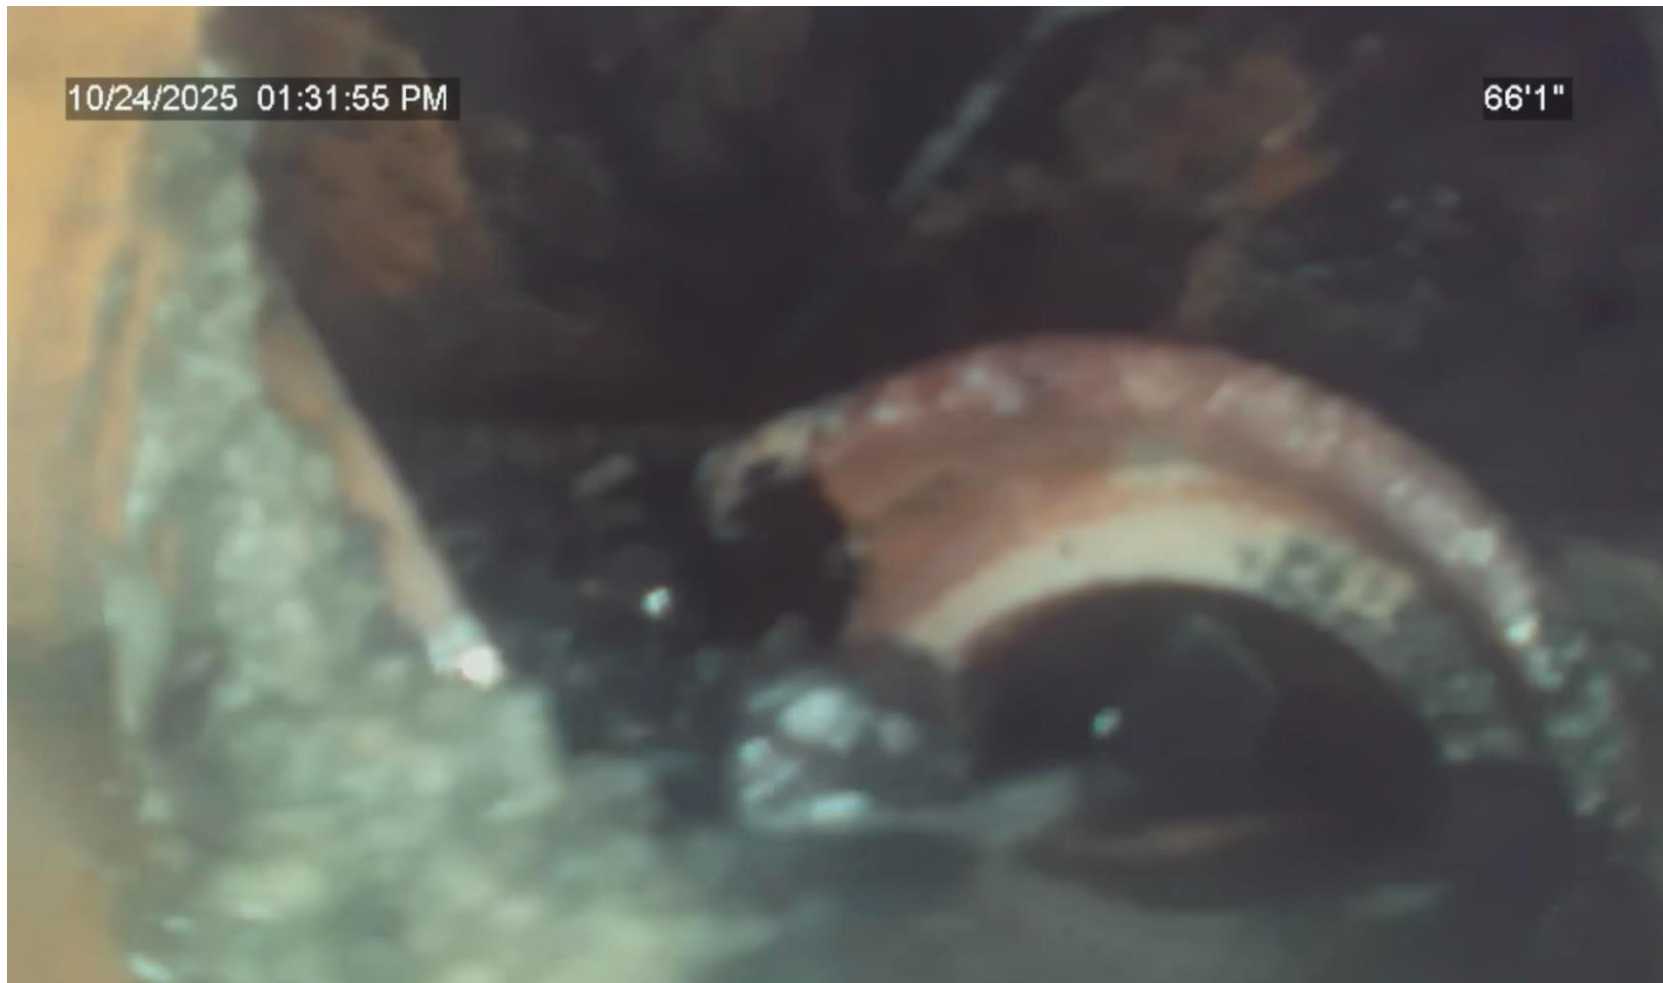
10/24/2025: Screen Grab from Video Showing Compromised Pipe

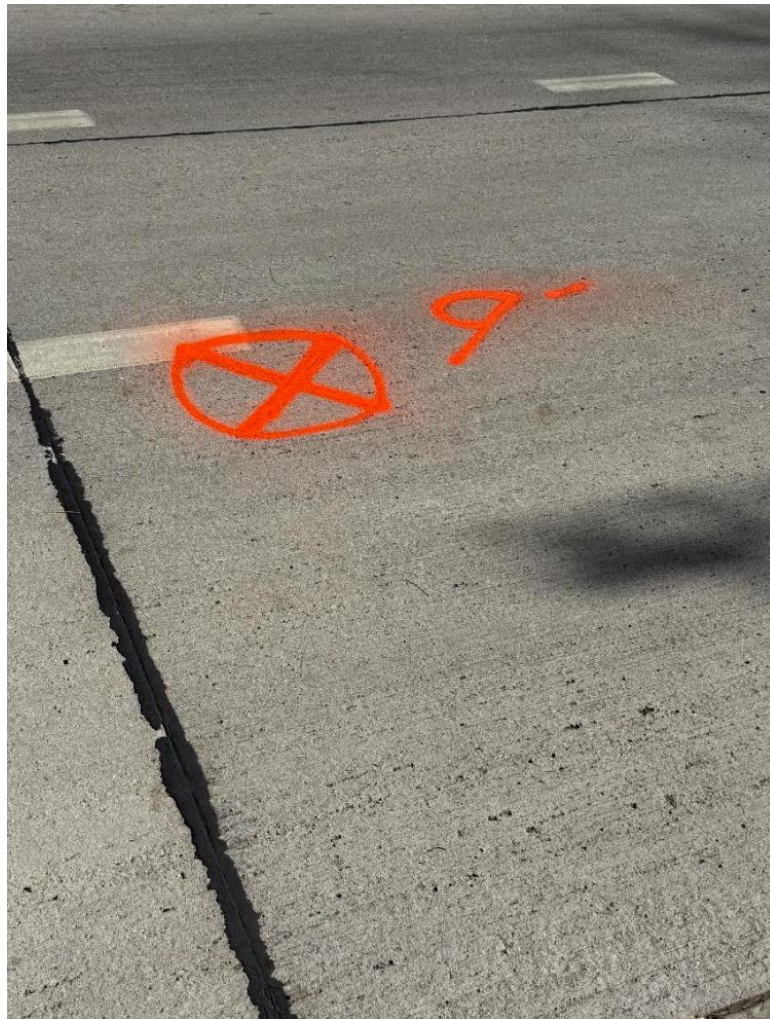
10/24/2025: Mark Denoting Locator Location of Compromised Section in the Southbound Parking Lane of N. Humboldt Blvd.

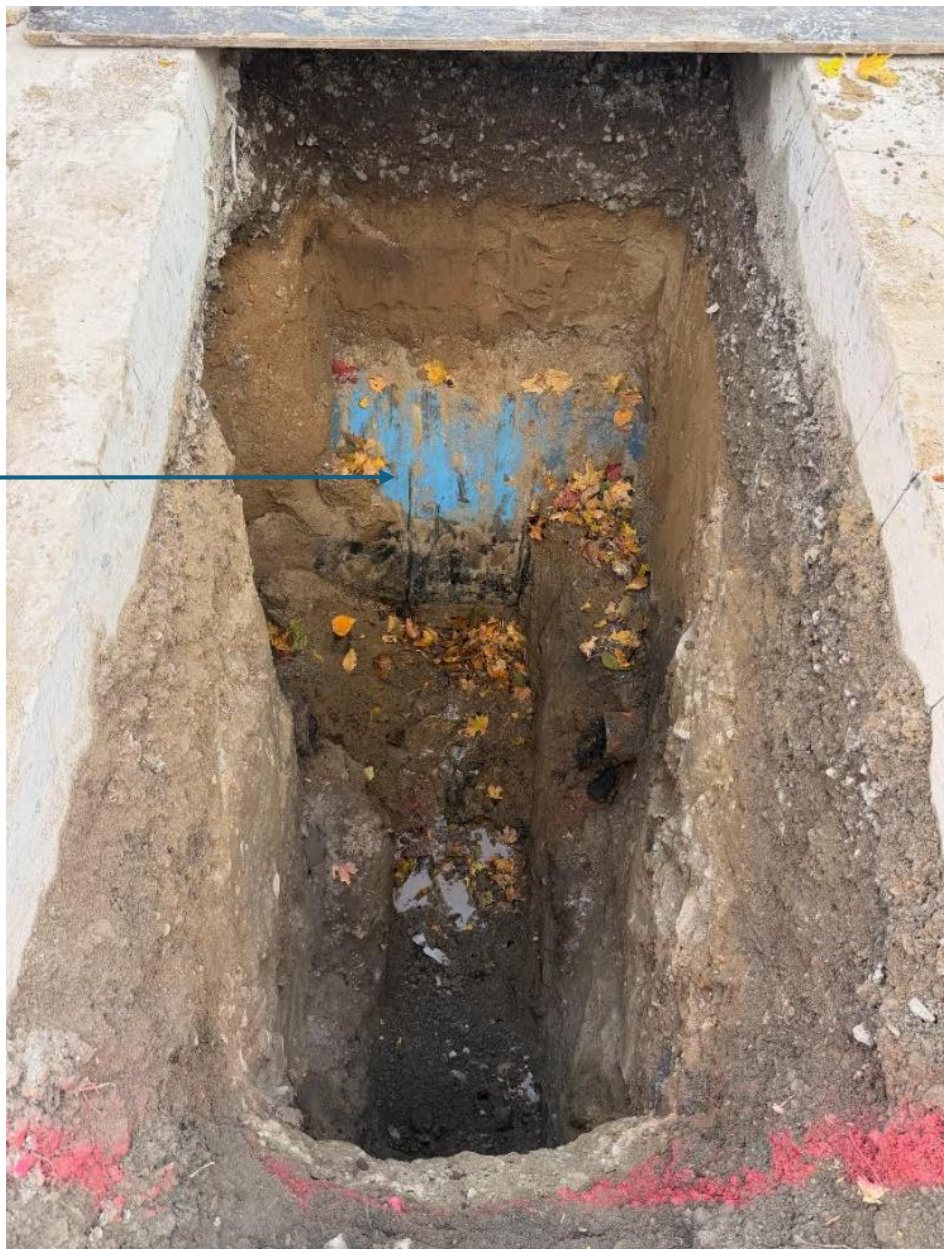
11/11/2025: Initial Excavation Showing 54" Water Main

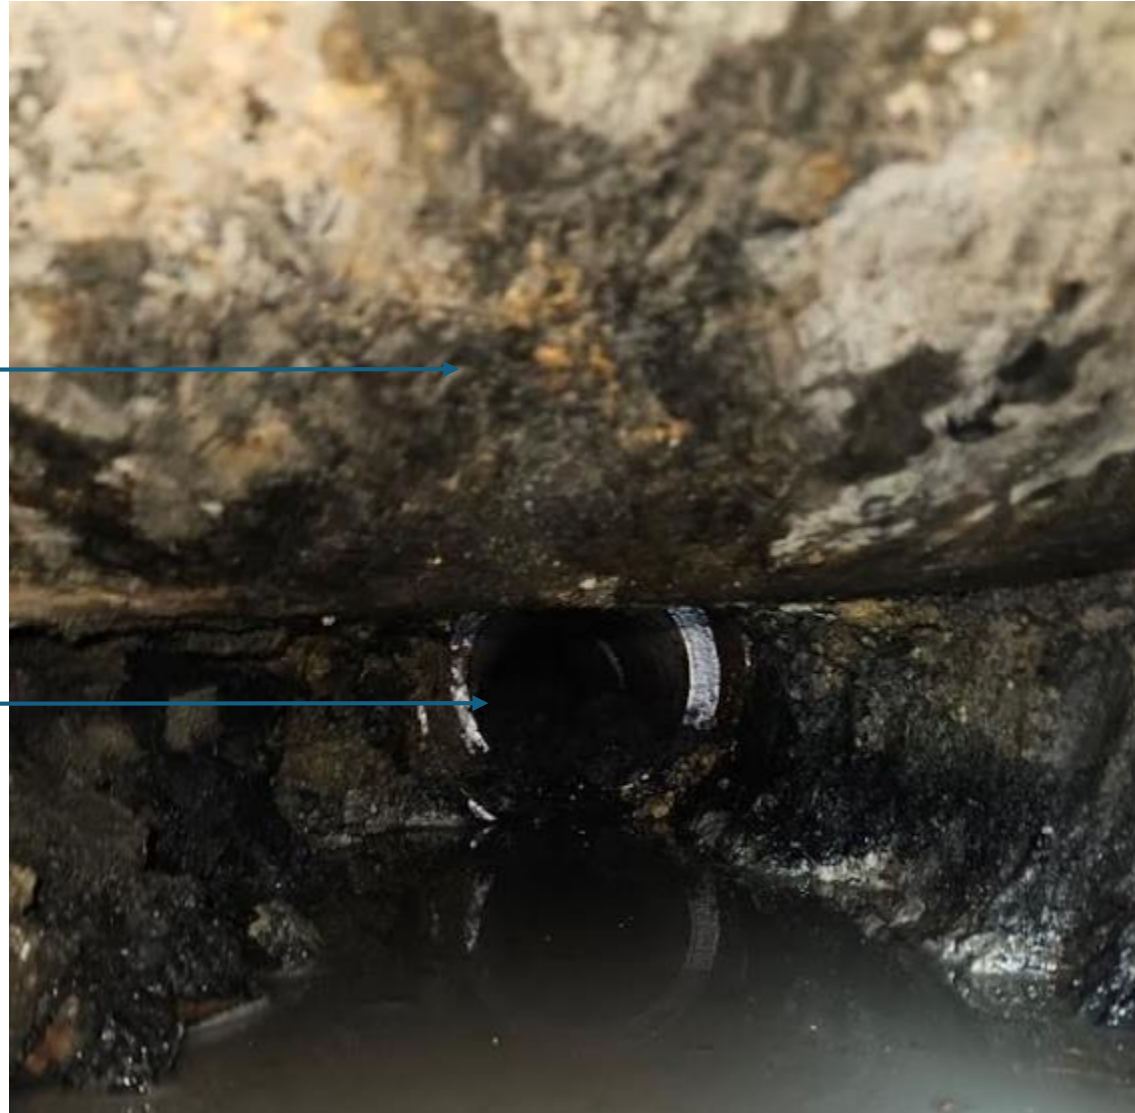
11/12/2025: Excavation Showing 54" Water Main Having Crushed Sewer Pipe

- The 6" clay sewer lateral for 3123 N. Humboldt was compromised under the Milwaukee Water Works 54" water main.
- Because the sewer pipe was not damaged outside of the immediate vicinity under the 54" water main, this suggests settling or shifting of the water main was the cause of the sewer pipe damage.
- The above is further supported by the analogous issue ~5 houses to the north of our property at 3149/3151 N. Humboldt.
- It is our claim that a shift this significant constitutes a defect during construction of insufficiently supporting the water main to prevent damage to our sewer lateral.

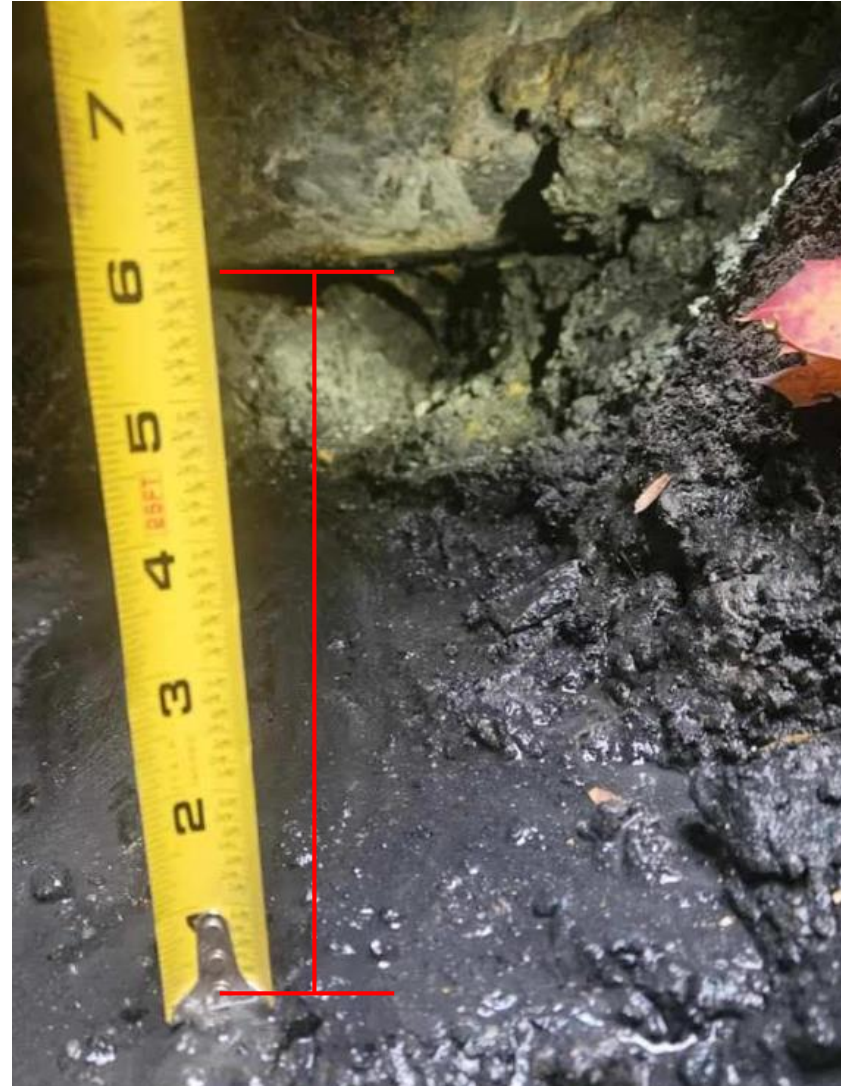
11/12/2025: Measurement Between Hard-Wood Sewer Support & Bottom of 54" Water Main

Note: <6" between the bottom of the water main and the previous hard wood support for the clay sewer pipe.

O.D. of 6" clay pipe is approximately 7.5-7.75"

OD of 6" PVC pipe is approximately 6.625"

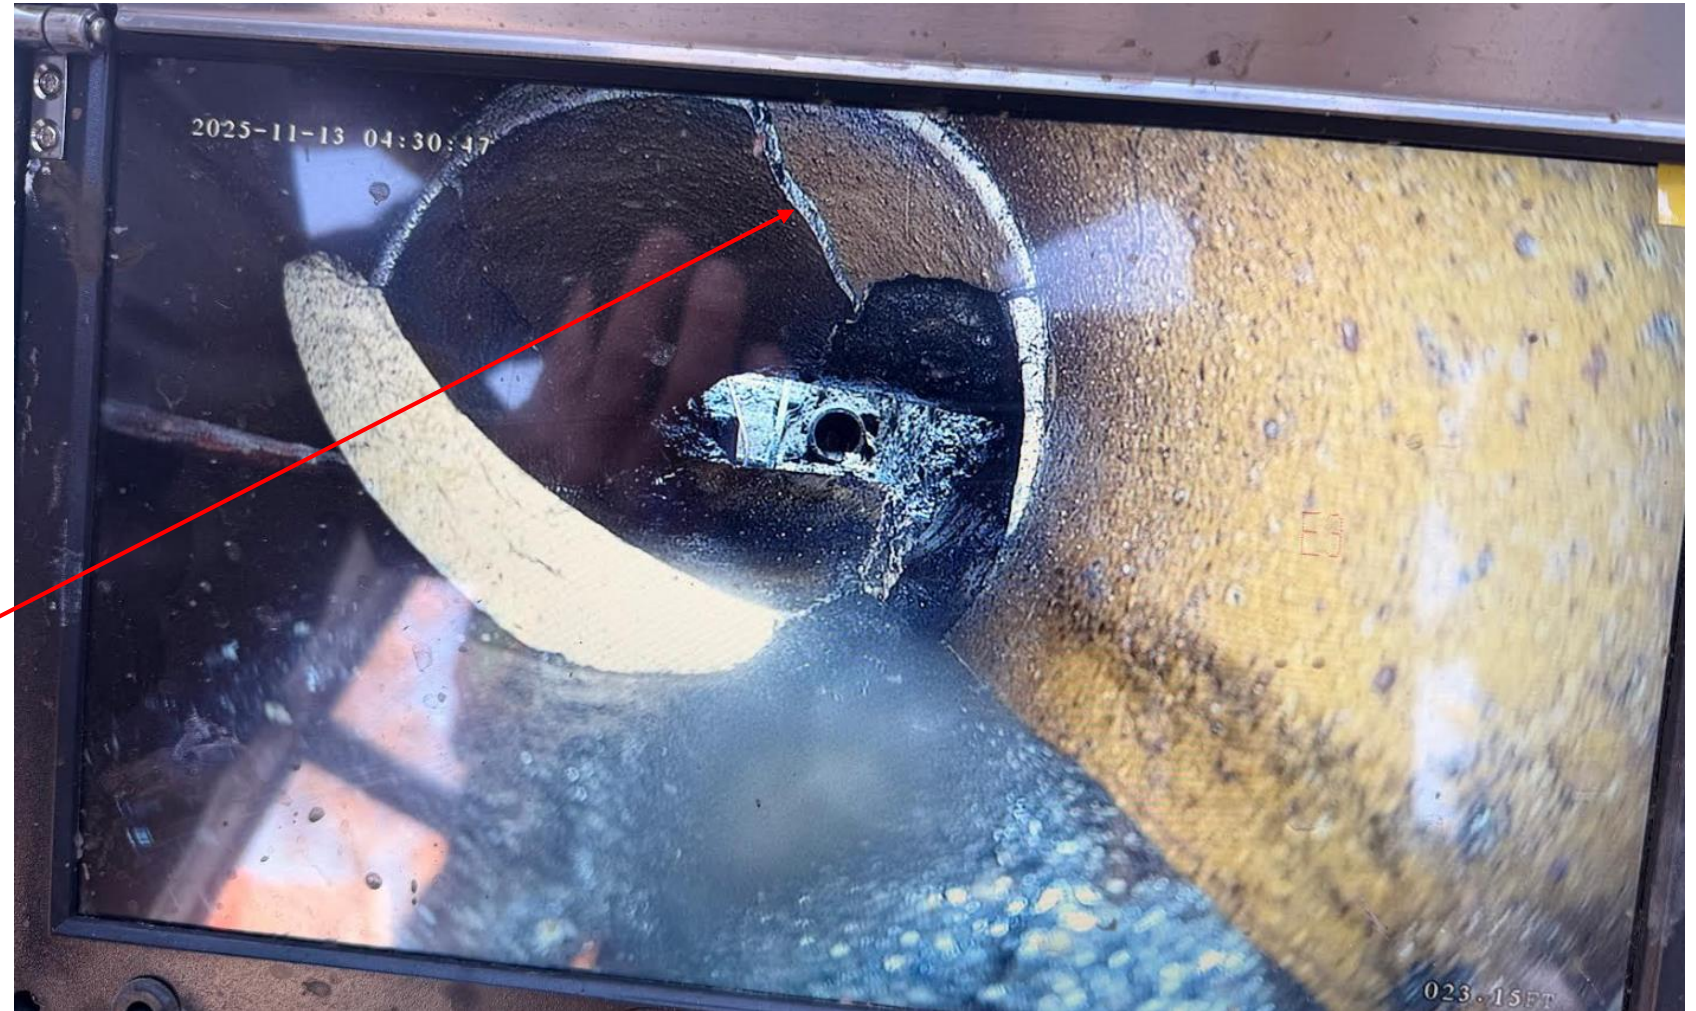
11/13/2025: Further Diagnosis of Sewer Lateral Damage

A camera was used to identify any further damage to the sewer pipe. The camera showed a distinct crack in the top of the sewer pipe.

The camera identified the location where the crack was no longer visible. This spot was marked in the top of road. Crack in top of sewer pipe

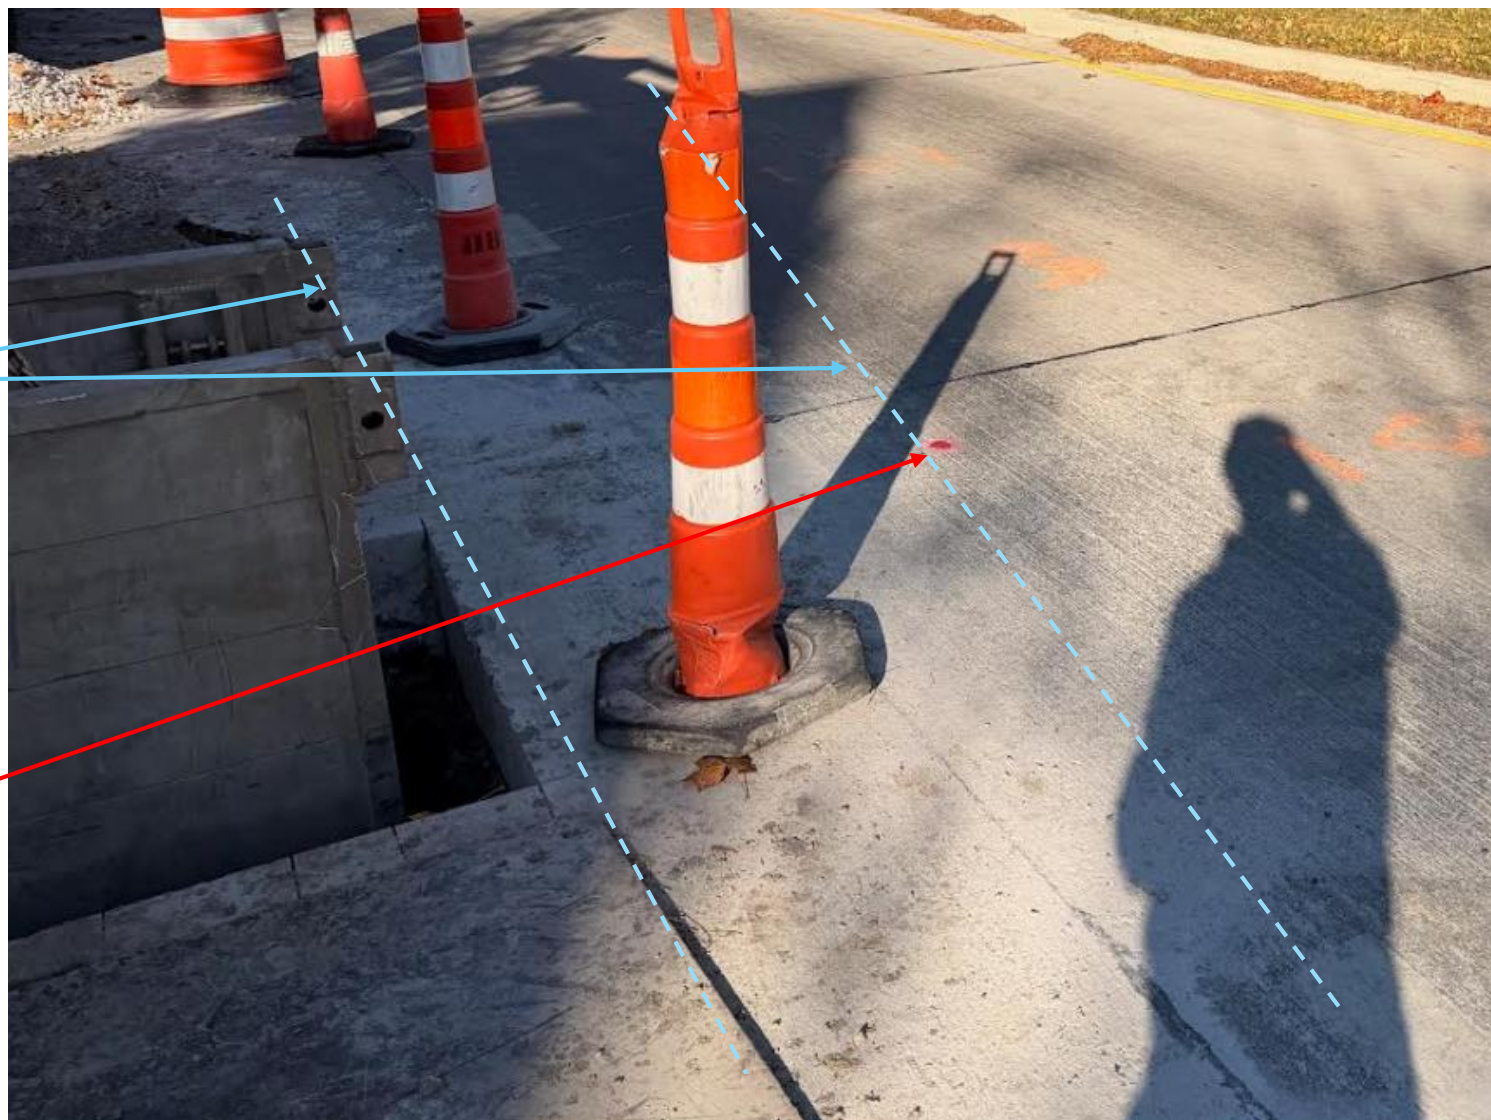
11/13/2025: Further Diagnosis of Sewer Lateral Damage

For visualization -
approximate width of
54" water main

Mark
denoting the
end of the
crack in the
sewer pipe

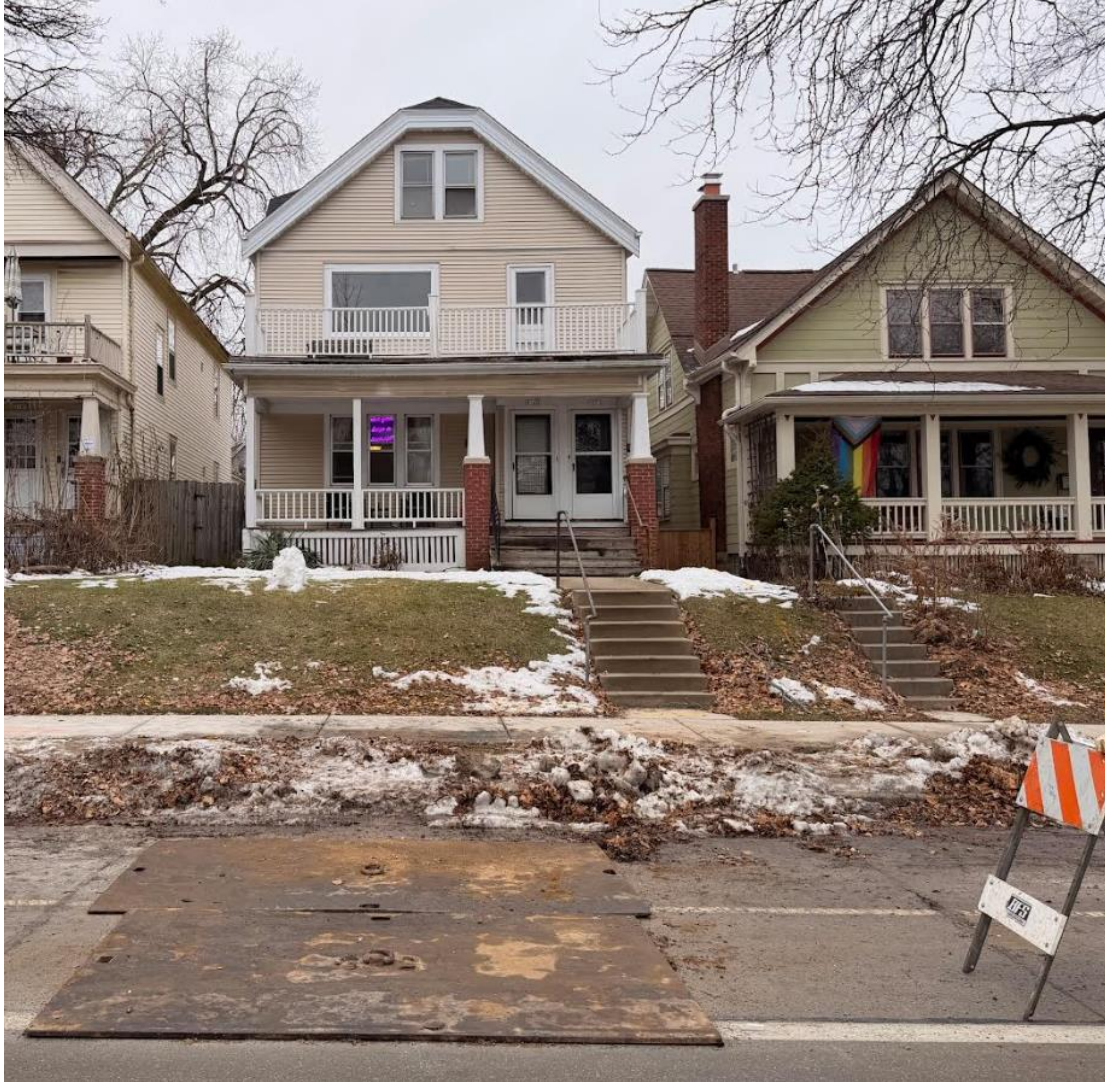
Pictures from 3149/3151 N. Humboldt Blvd

- On 12/23/2025 we became aware that a very similar issue occurred at 3149/3151 N. Humboldt.
- Initial excavation evidence suggests the 54" water main caused damage to the sewer lateral at this address as well.
- Photos on next slide

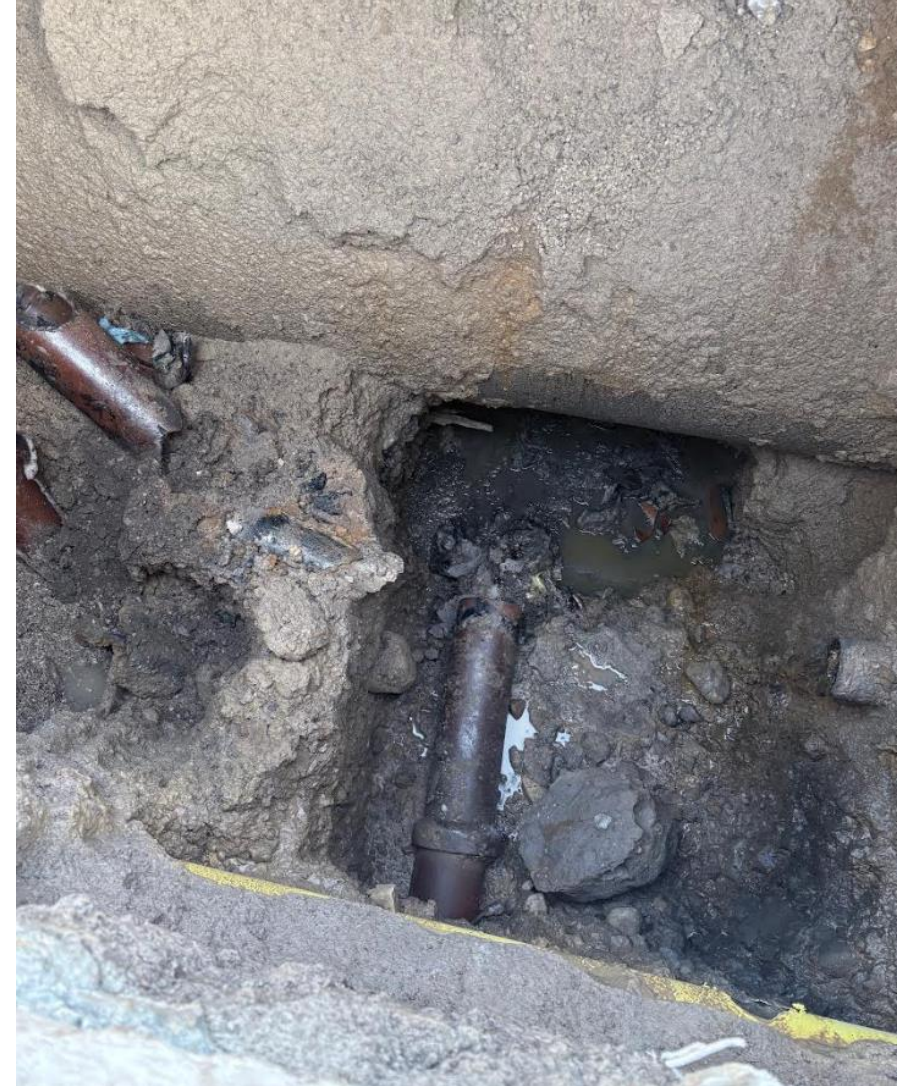
Photo showing excavation location at
3149/3151 N. Humboldt

Photo demonstrating damage at
3149/3151 N. Humboldt consistent with
damage in our claim - lateral
compromised under the 54" main.
