# MILWAUKEE CITY HALL FOUNDATION RESTORATION

October 19, 2016  
Project Update

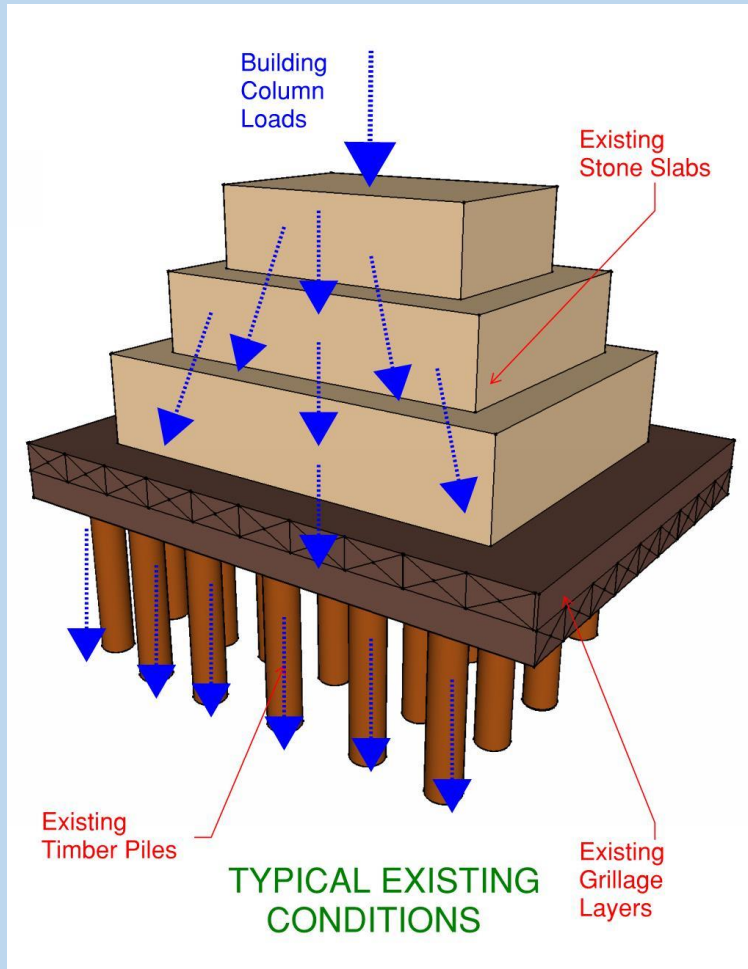
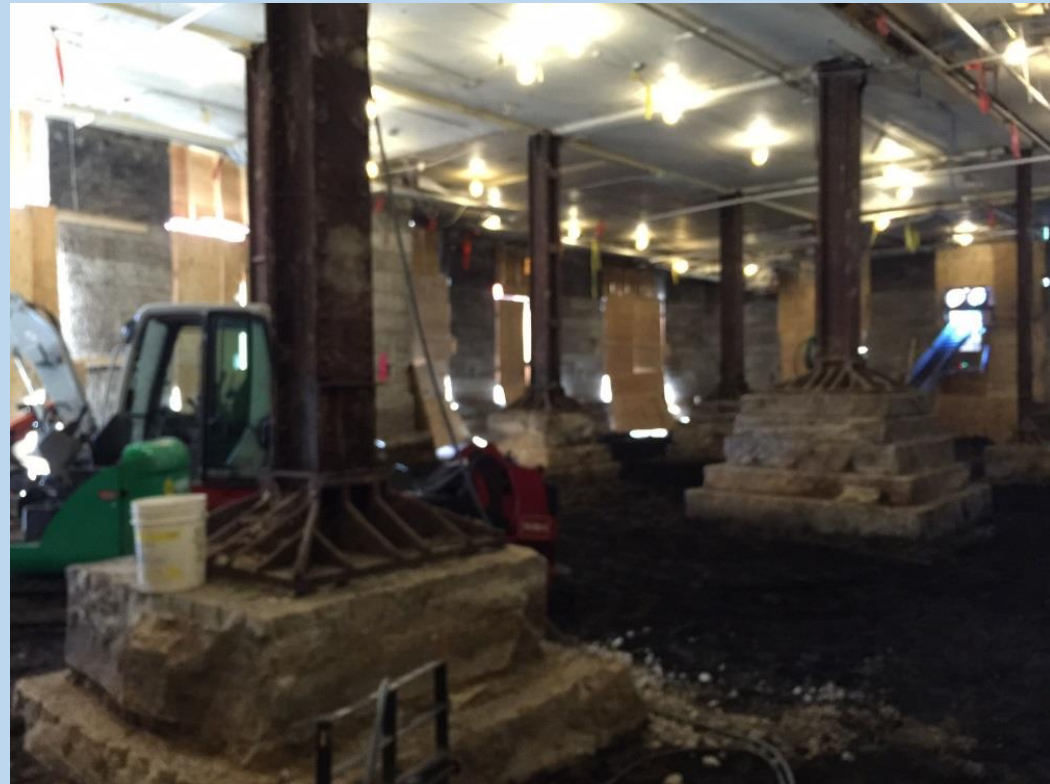
# PHASE 1 EXISTING / PRE-REPAIR CONDITIONS

- ❖ City Hall is supported by over 2,500 untreated wood piles driven in marshy land adjacent to the Milwaukee River
- ❖ Pile lengths are estimated between 23ft and 27ft
- ❖ Oak “grillage” layers are placed horizontally in alternating directions directly on top of the wood piles
- ❖ The oak grillage supports stone pile caps which in turn support the exterior walls and interior columns/piers of the building
- ❖ The building has experienced differential settlement over the years as a result of fungal rot/decay of the grillage and pilings, a process that is difficult to forecast and predict
- ❖ The differential settlement is monitored through a series of survey points around the building
