**From:** Isaac Hatfield  
**Sent:** Monday, June 30, 2025 10:57 AM  
**To:** Ellis-Garcia, Aaron  
**Cc:** Nabeel Raazi  
**Subject:** Columbia St Mary's - Heritage Elevator Shaft  
**Attachments:** 2025 06 30 - Columbia St Mary Elev Shaft - Photo Documentation.pdf

As requested, we have completed an inspection of the external elevator shaft located at the Columbia St. Mary's Heritage Building in Milwaukee, WI. The inspection was performed on June 26, 2025, with the assistance of Medxcel personnel. The following summarizes our findings, conclusions, and recommendations:

# PHOTOGRAPHIC DOCUMENTATION

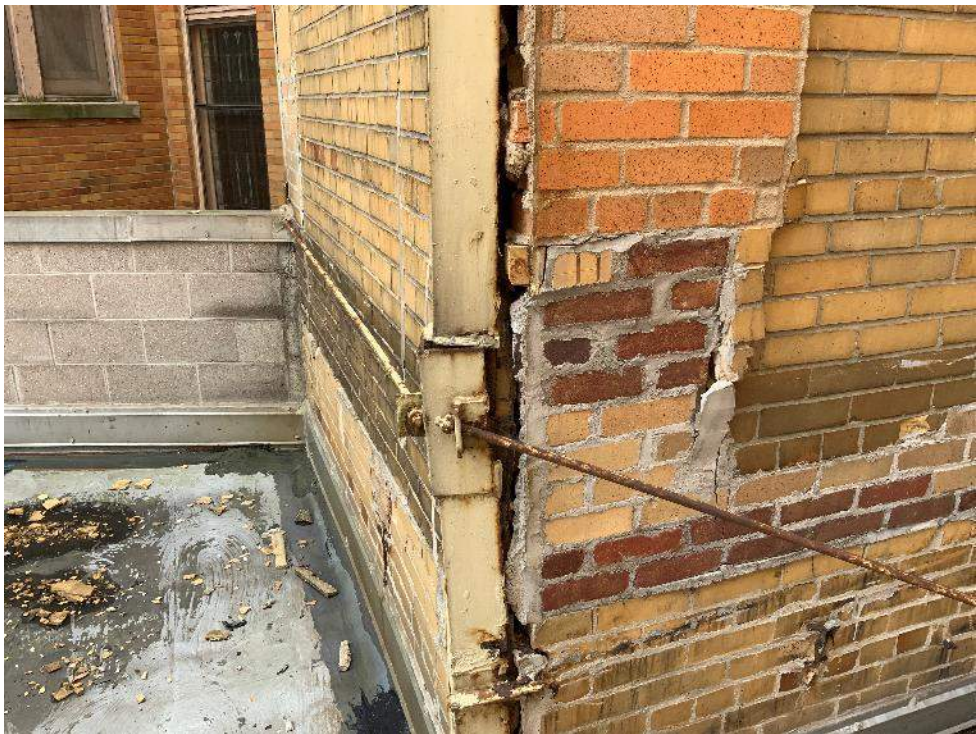
Photo 2.1 – Warped Steel Framing

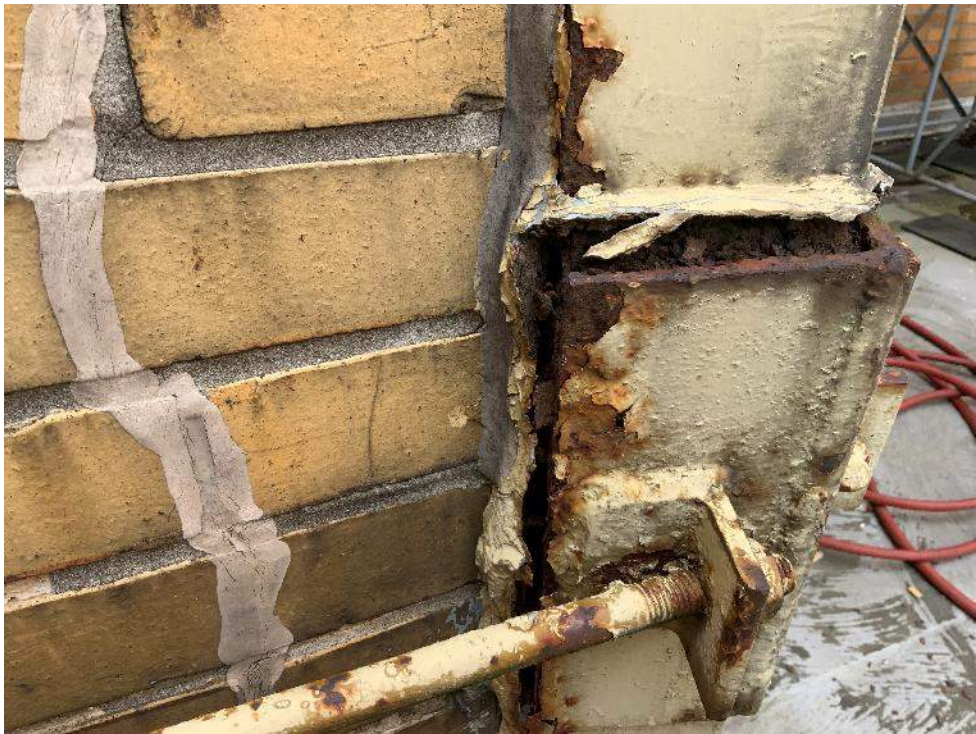
Photo 2.2 – Deteriorated Steel Framing

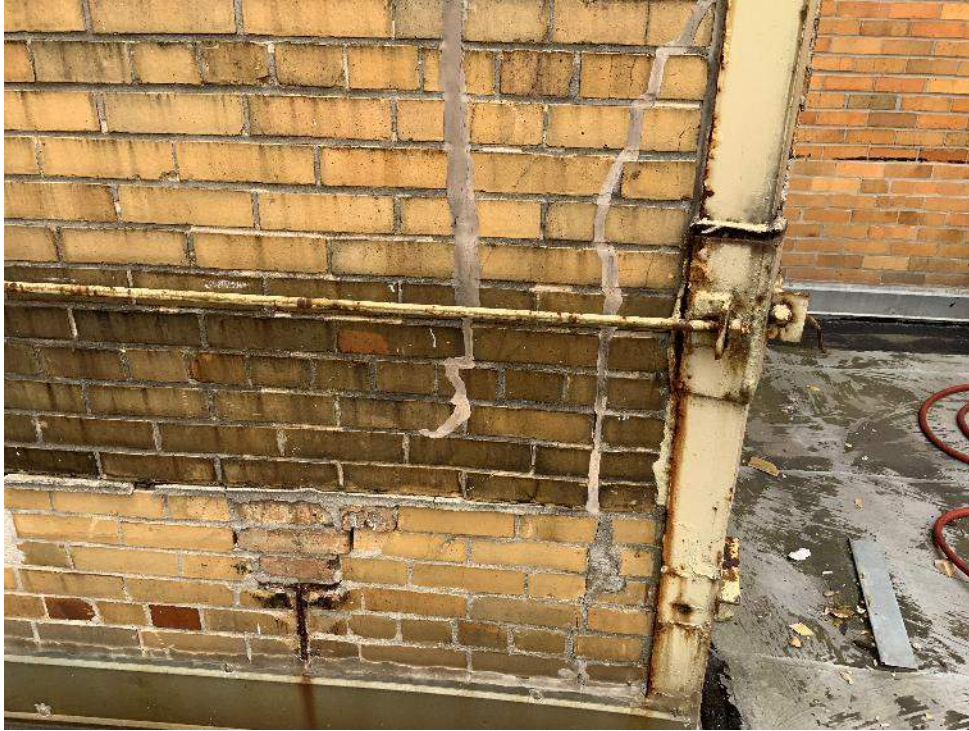
Photo 2.3 – Deteriorated Brick

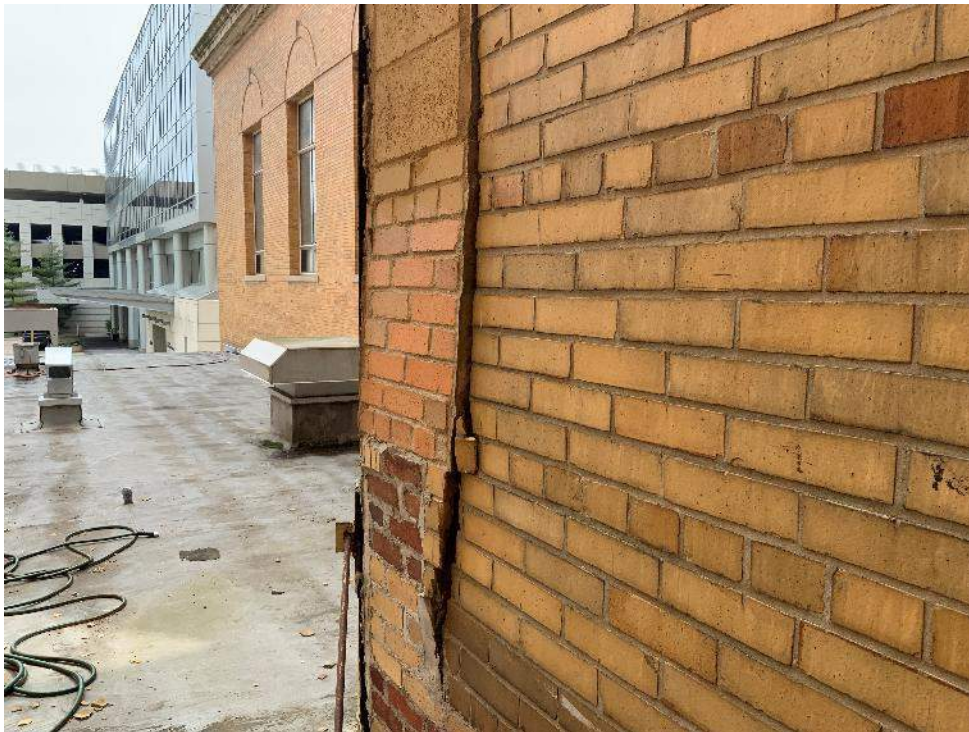
Photo 2.4 – Loose & Displaced Brick

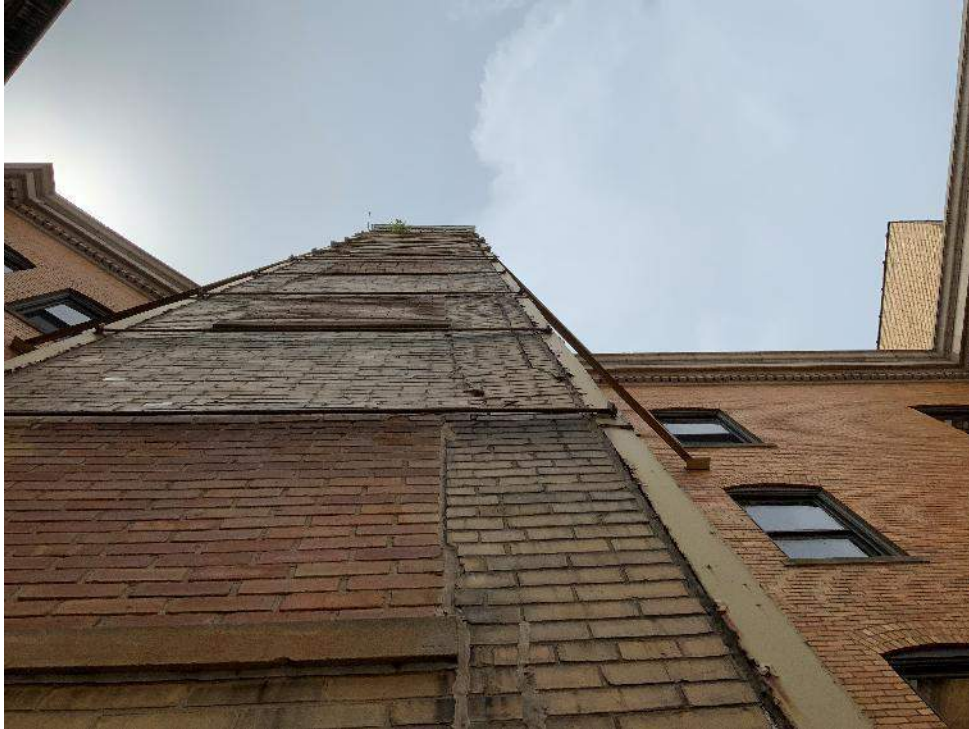
Photo 2.5 – Brick Wall Cracks

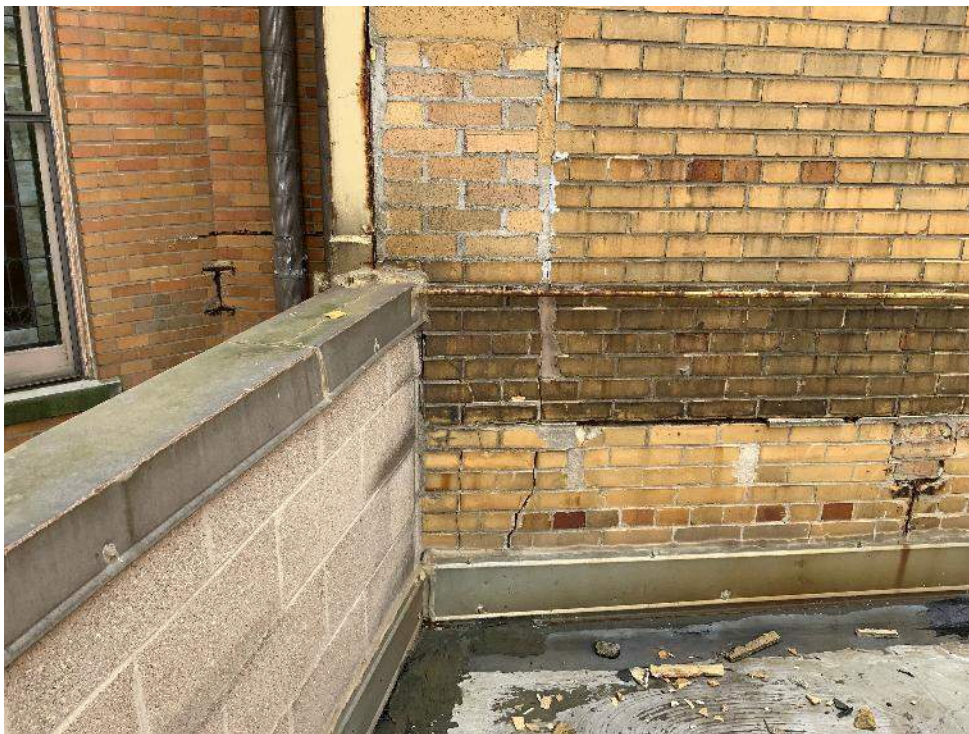
Photo 2.6 – Brick Wall Cracks

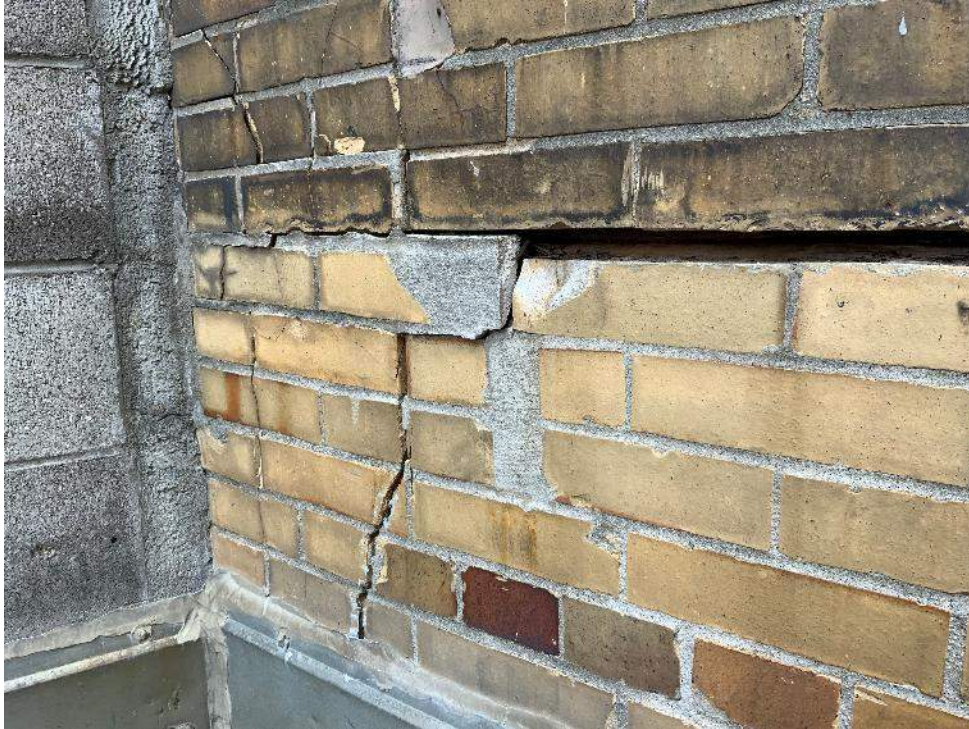
Photo 2.7 – Cracked & Displaced Brick

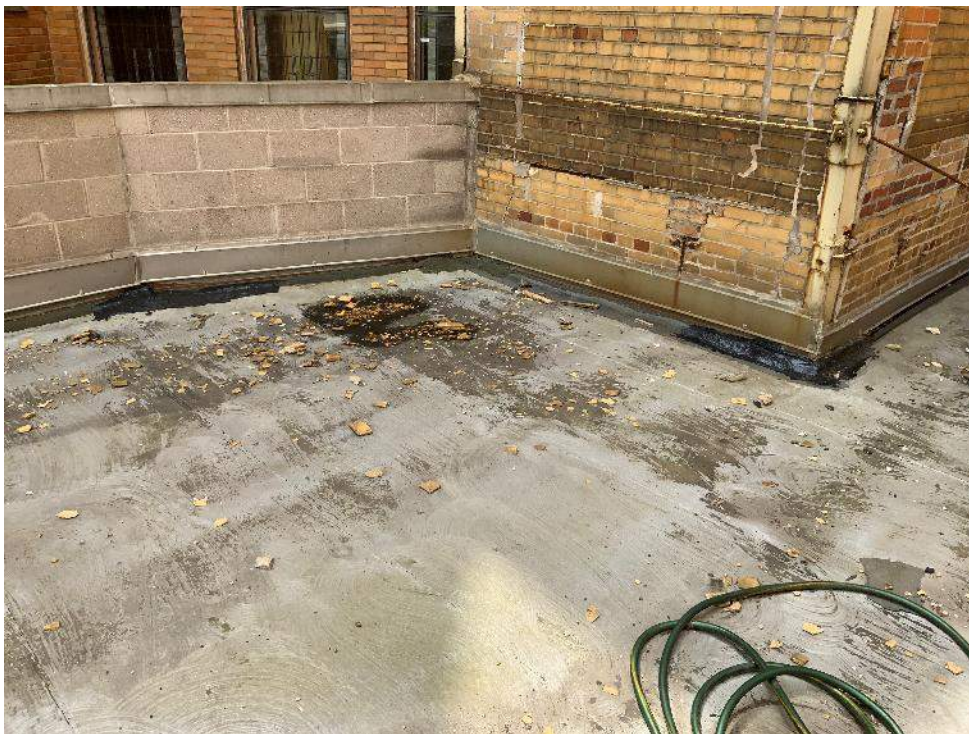
Photo 2.8 – Falling Brick

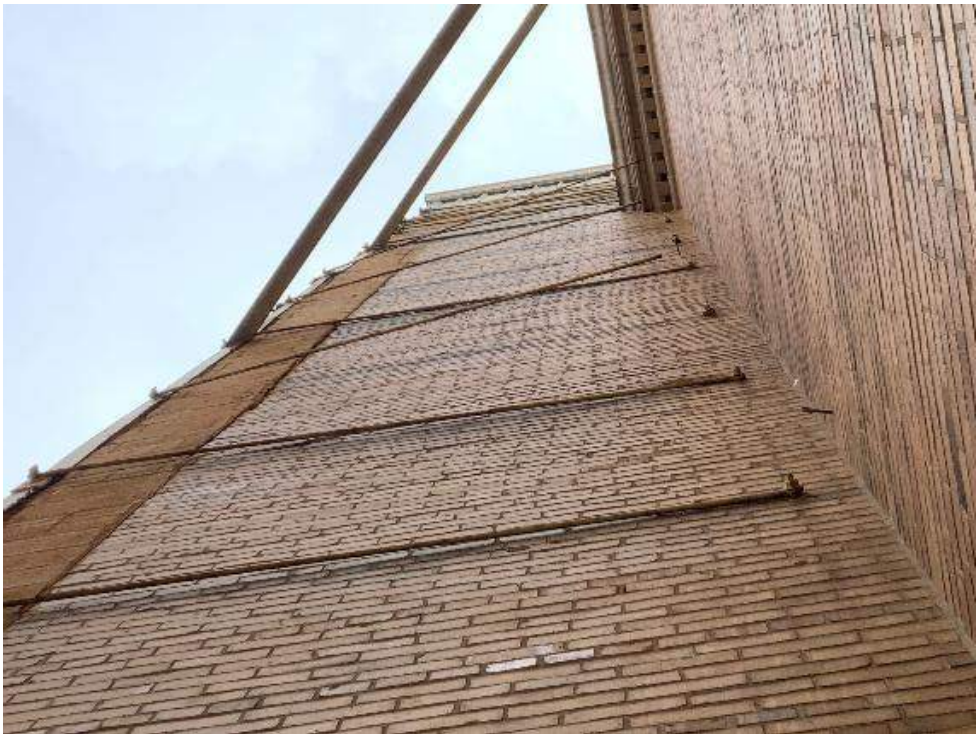
Photo 2.9 – Broken Steel Bracing

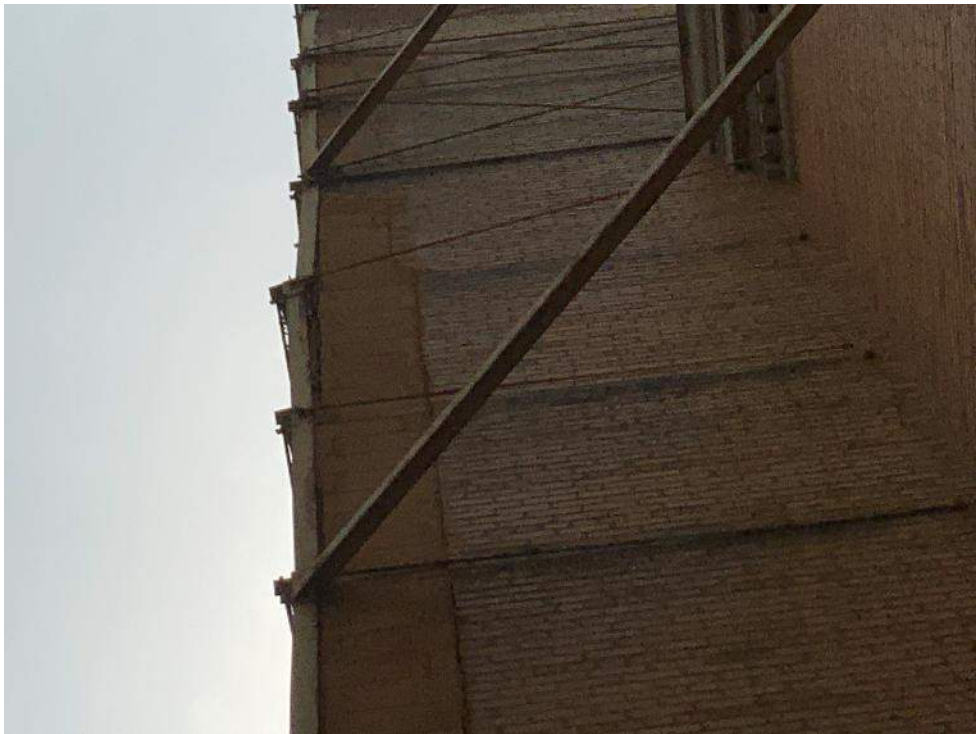
Photo 2.10 – Broken Steel Bracing

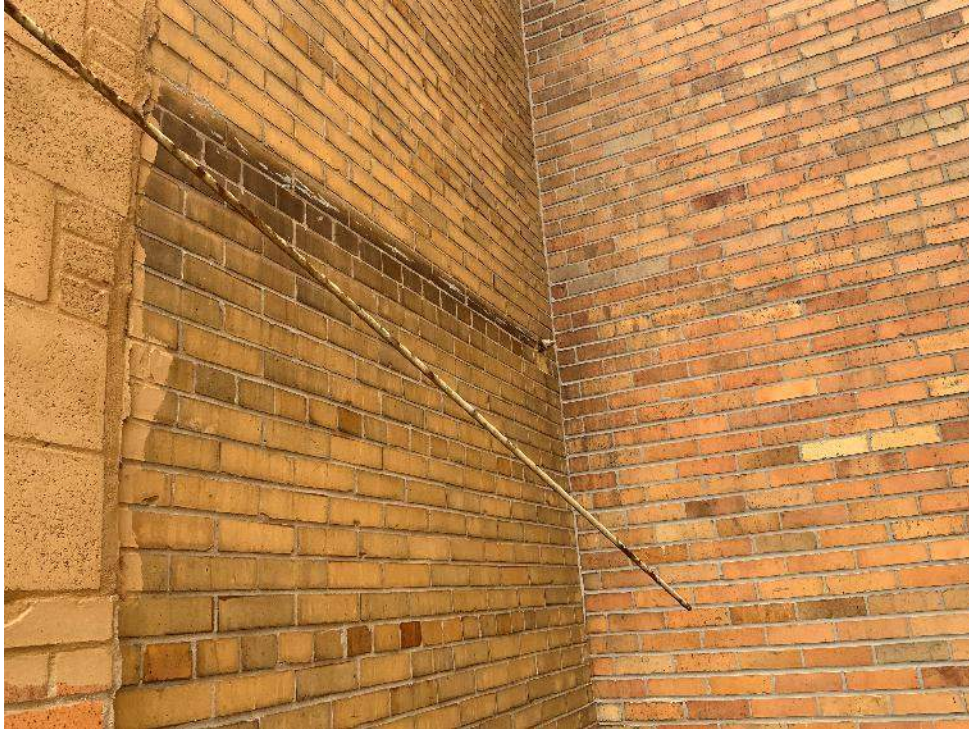
Photo 2.13 – Broken Steel Bracing

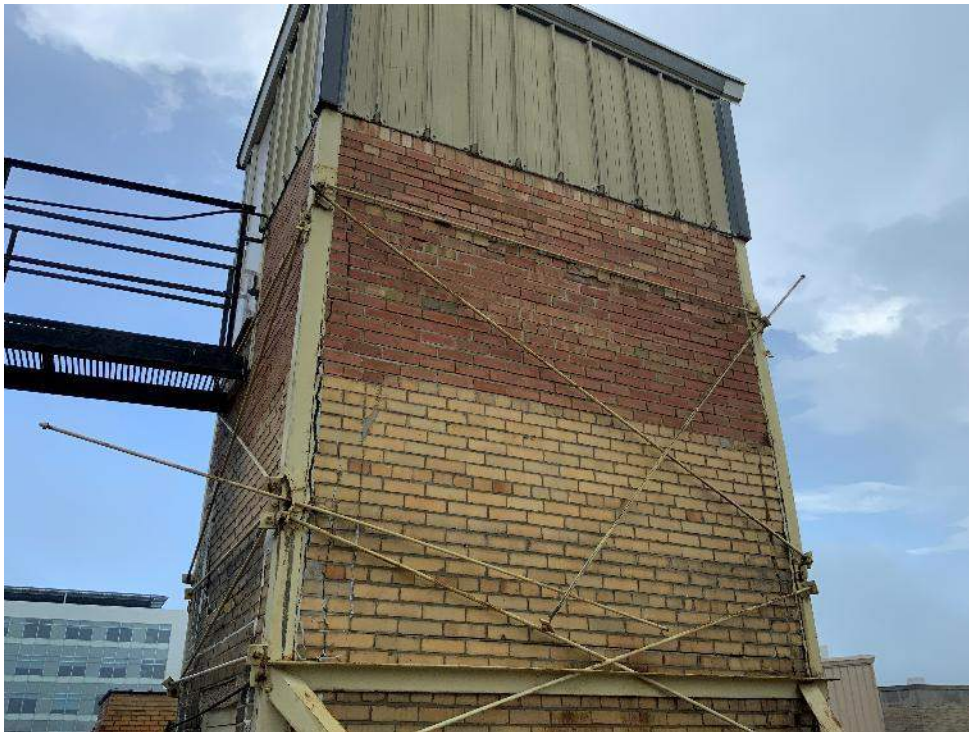
Photo 2.14 – Broken Steel Bracing

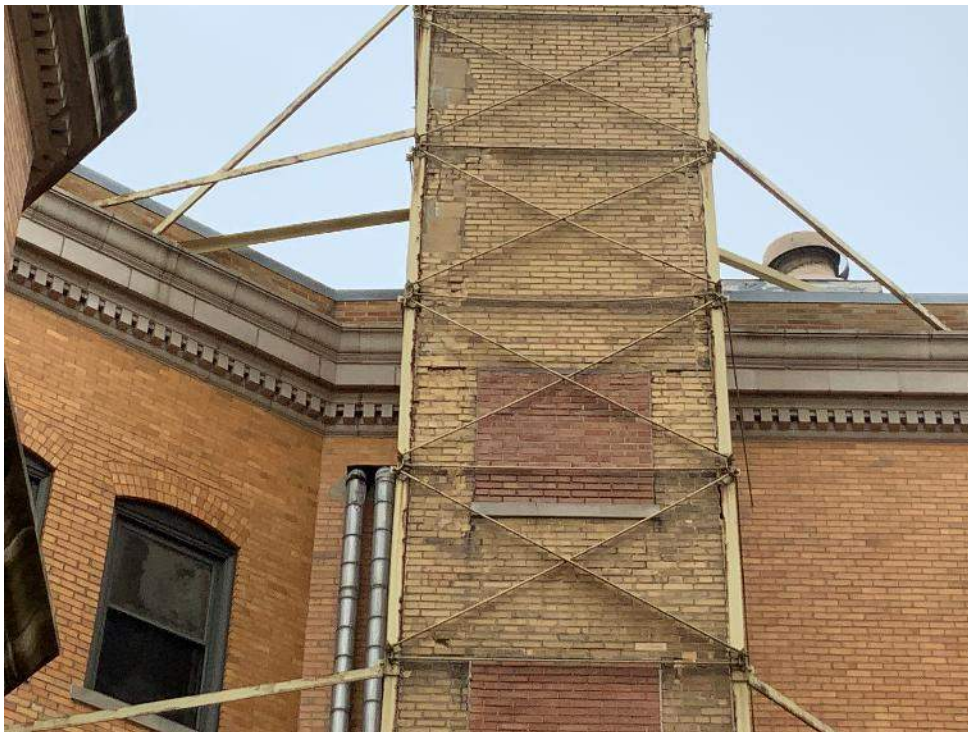
Photo 2.15 – Receding Mortar Joints

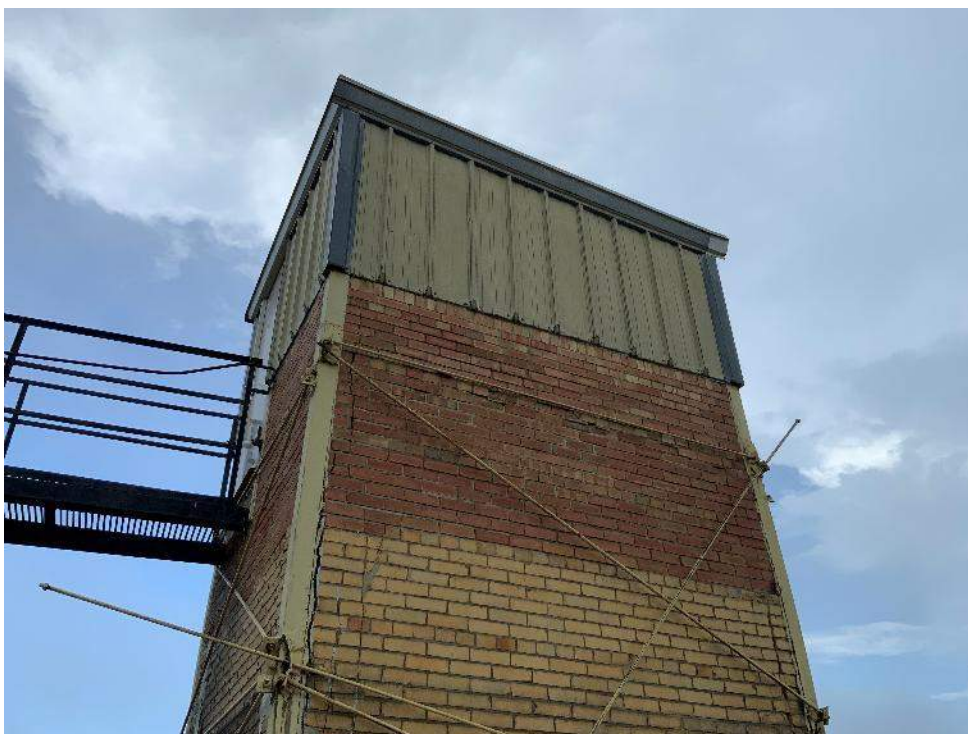
Photo 2.16 – Cracked Brick & Receding Mortar Joints

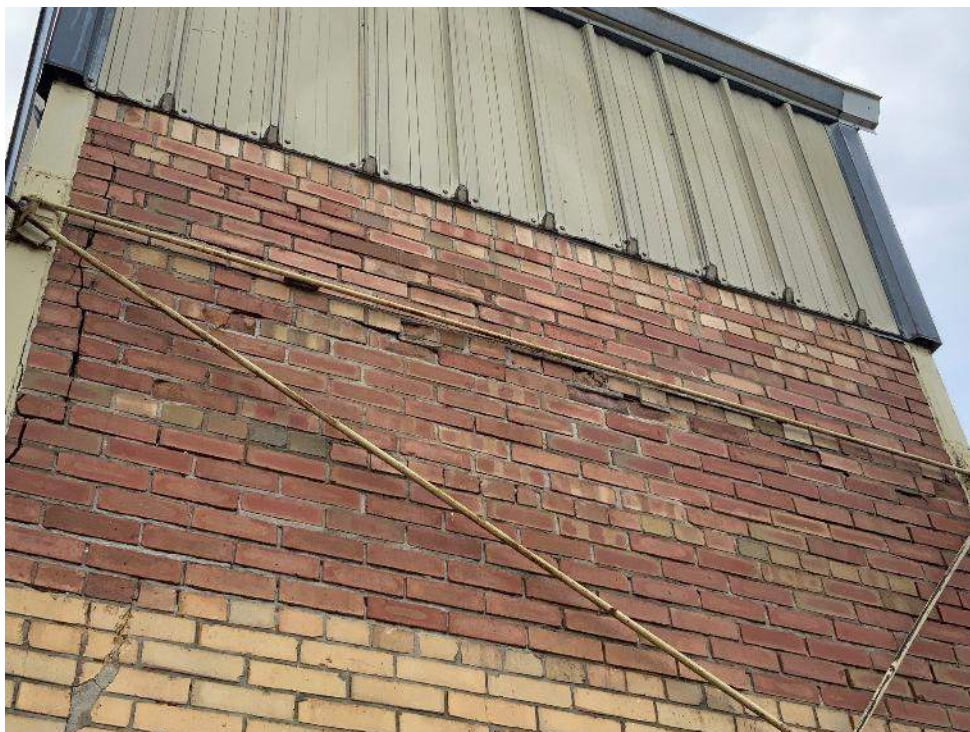
Photo 2.17 – Deteriorated Brick

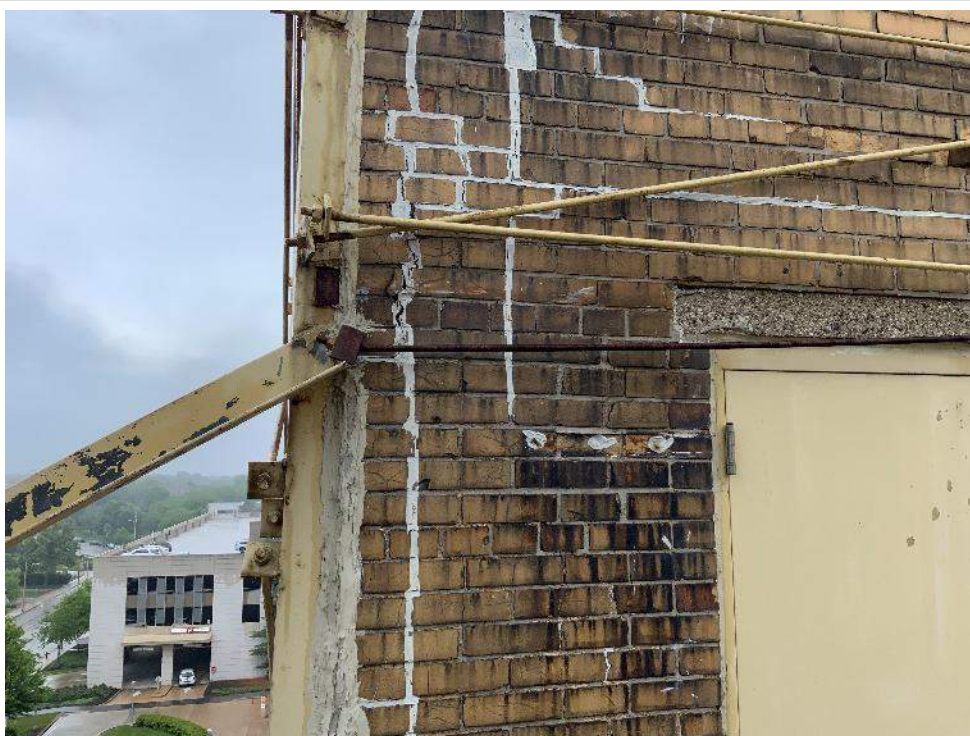
Photo 2.18 – Deteriorated Brick

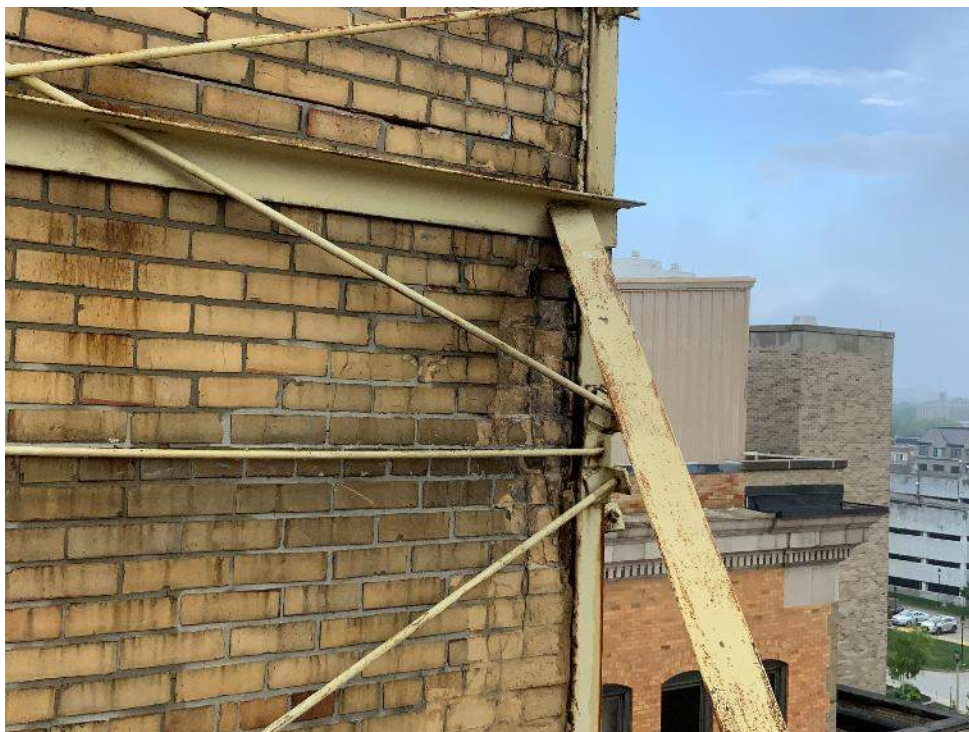
Photo 2.19 – Spalled Brick

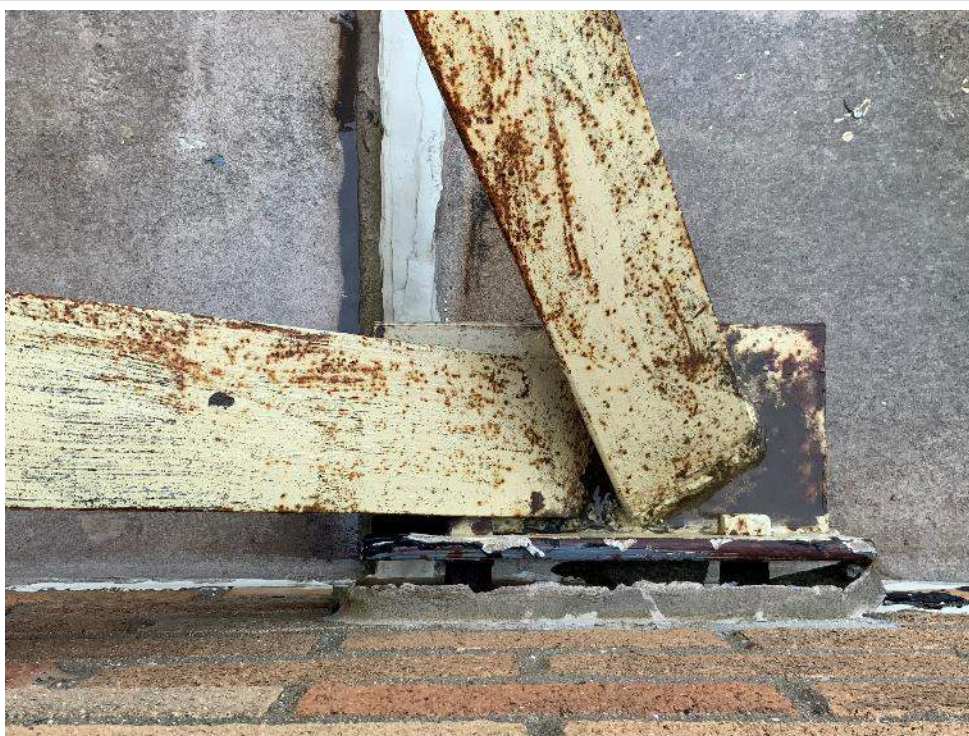
Photo 2.20 – Steel Anchorage Pulling out of wall
