Detailed Incident Report

Date of Incident: September 20th, 2010 at approximately 2:30 pm

Location of Incident: The Intersection of Center Street and Martin Luther King Jr. Blvd (as abbreviated MLK in the recollection below)

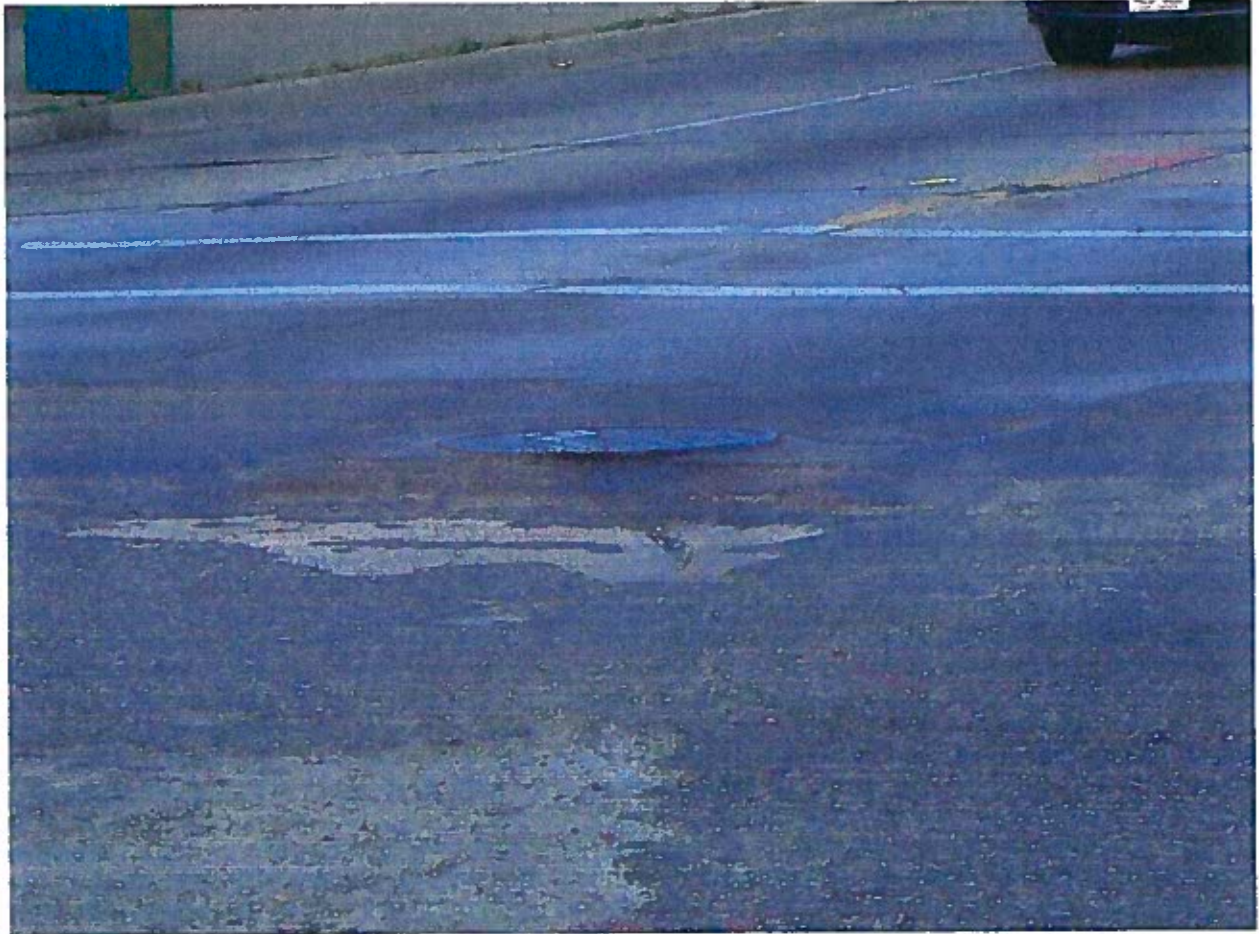
Continuing through the intersection, I attempted to take evasive action but was prevented from doing so by an illegally parked SUV. Further, cars were following at a close distance, eliminating the possibility of an abrupt stop even though traffic volume was moderate. My only choice was to proceed through the intersection, over the protruding manhole cover (See Attachments C and D).

Attachment C : *The unmarked manhole cover located at the intersection of Center St. and Martin Luther King Jr. Drive.*

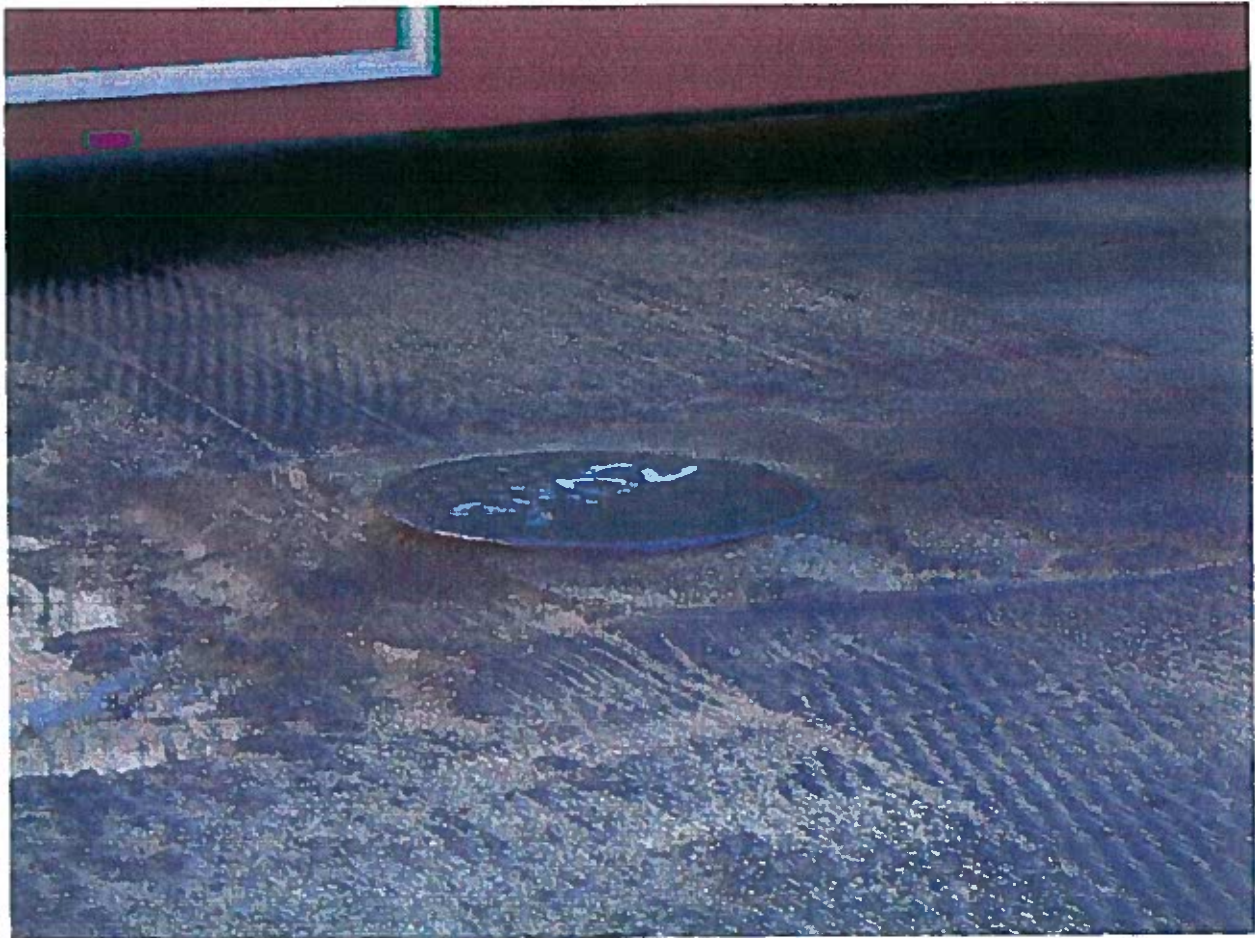
The combination of an uneven road surface with the street clearance of my vehicle's chassis resulted in the undercarriage striking the northernmost edge of the manhole cover with a severe jolt and pronounced scraping sound. Almost instantly, my vehicle began to shake violently. I continued to proceed through the intersection. An onboard warning light immediately indicated low oil pressure and displayed that I should stop the engine promptly. I looked for the nearest place to stop out of traffic which was roughly 1-1/2 blocks from the intersection.

Attachment D: A picture on the very uneven road surface around the manhole cover. Also in this picture: the darker area immediately left of the "3" was fresh oil released from my oil pan.

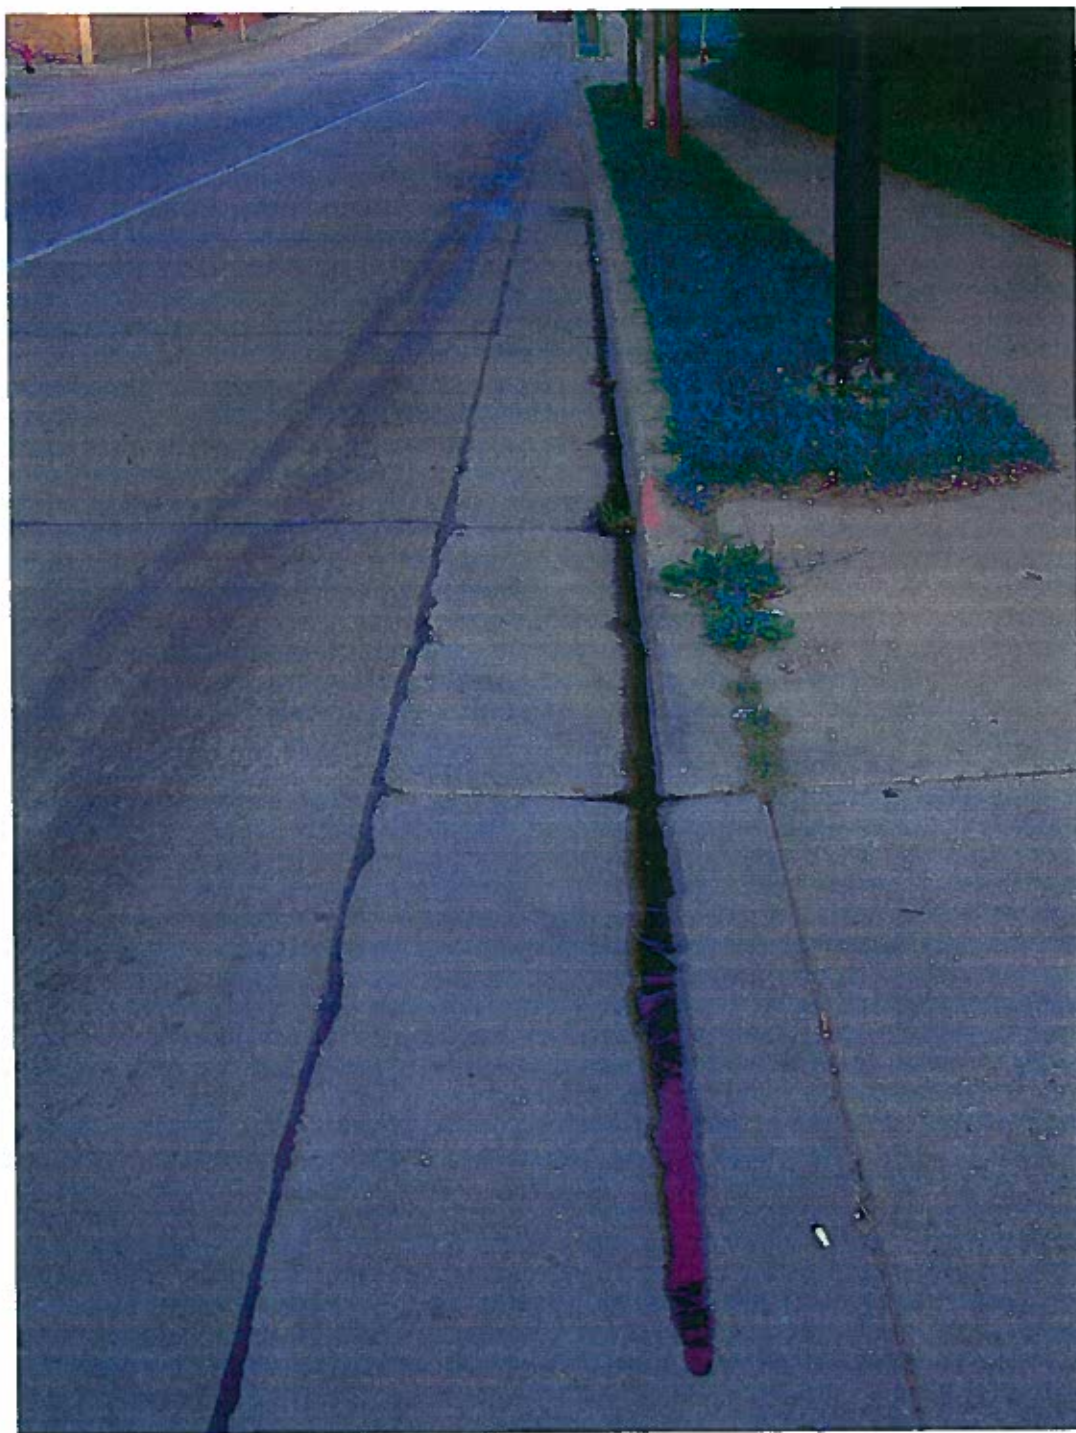
As I approached the curb, I noticed a fluid streak leading from the intersection to my car. It appeared to be oil. Once parked, I crouched to look under my vehicle, and spotted the source of the oil: a gaping hole in the oil pan, with oil steadily streaming out. I looked back to see a trail leading from the point where I exited the intersection to where I was parked. I would estimate

that I lost approximately 5 quarts of oil. Realizing the loss of oil was significant, I called a tow truck as my vehicle was inoperable. (See Attachments E, F, and G)

Attachment E: Moments after my vehicle had been towed; a fresh slick of oil can be seen on the nearby pavement. The left-hand slick from when the vehicle was in motion. The right-hand slick developed while the vehicle sat parked.

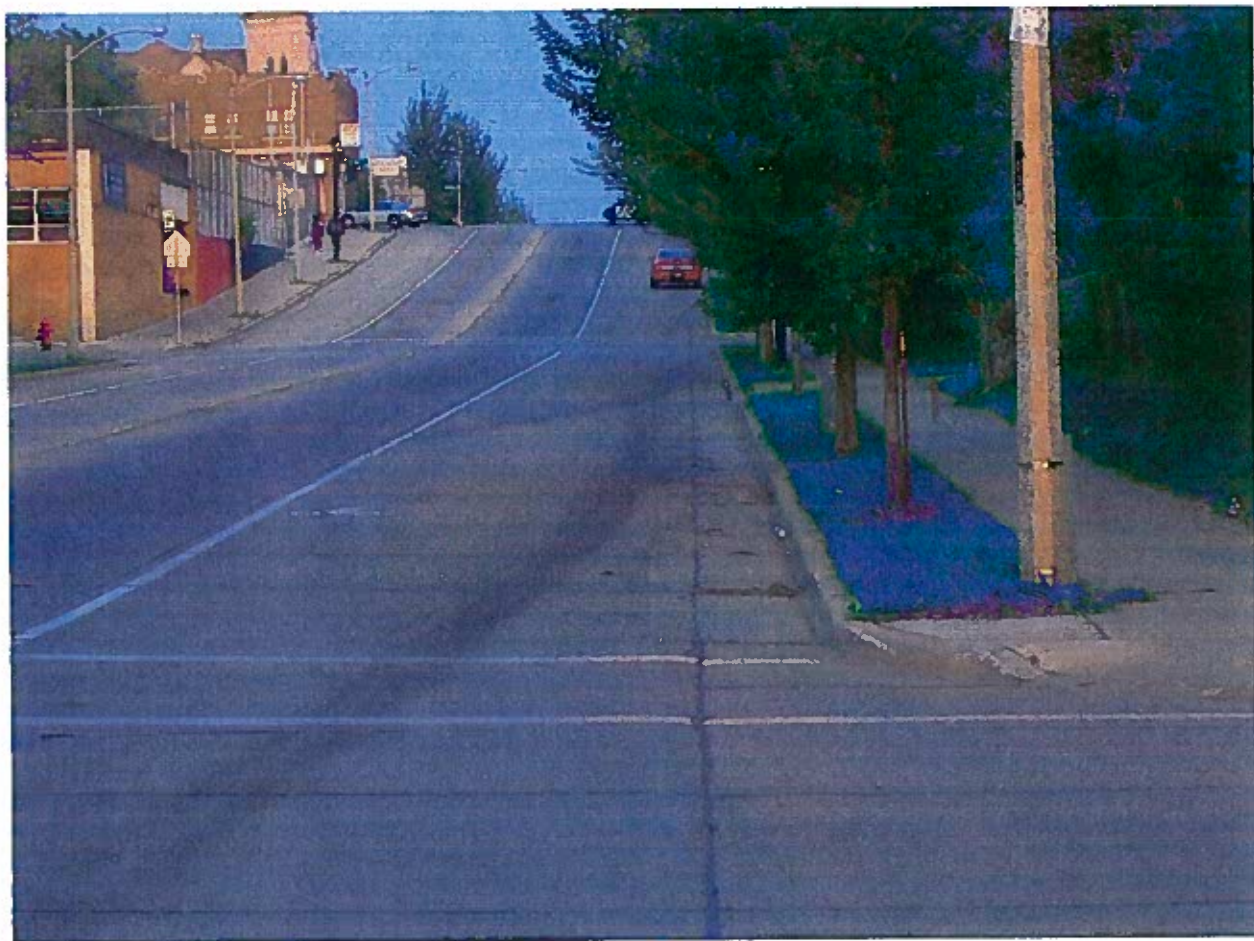
While I waited for the tow truck, cars in the parking lane began clearing. It was at this time that I noticed the stains from my vehicle were 1 of 3 similar stains, all beginning at the protruding manhole. Given the definition of the other two streaks I saw, the oldest streak appeared to be at least 2 weeks old. (See Attachment F)

Attachment F: Two almost identical oil slicks leading away from Center and MLK. The second visible streak was my own.

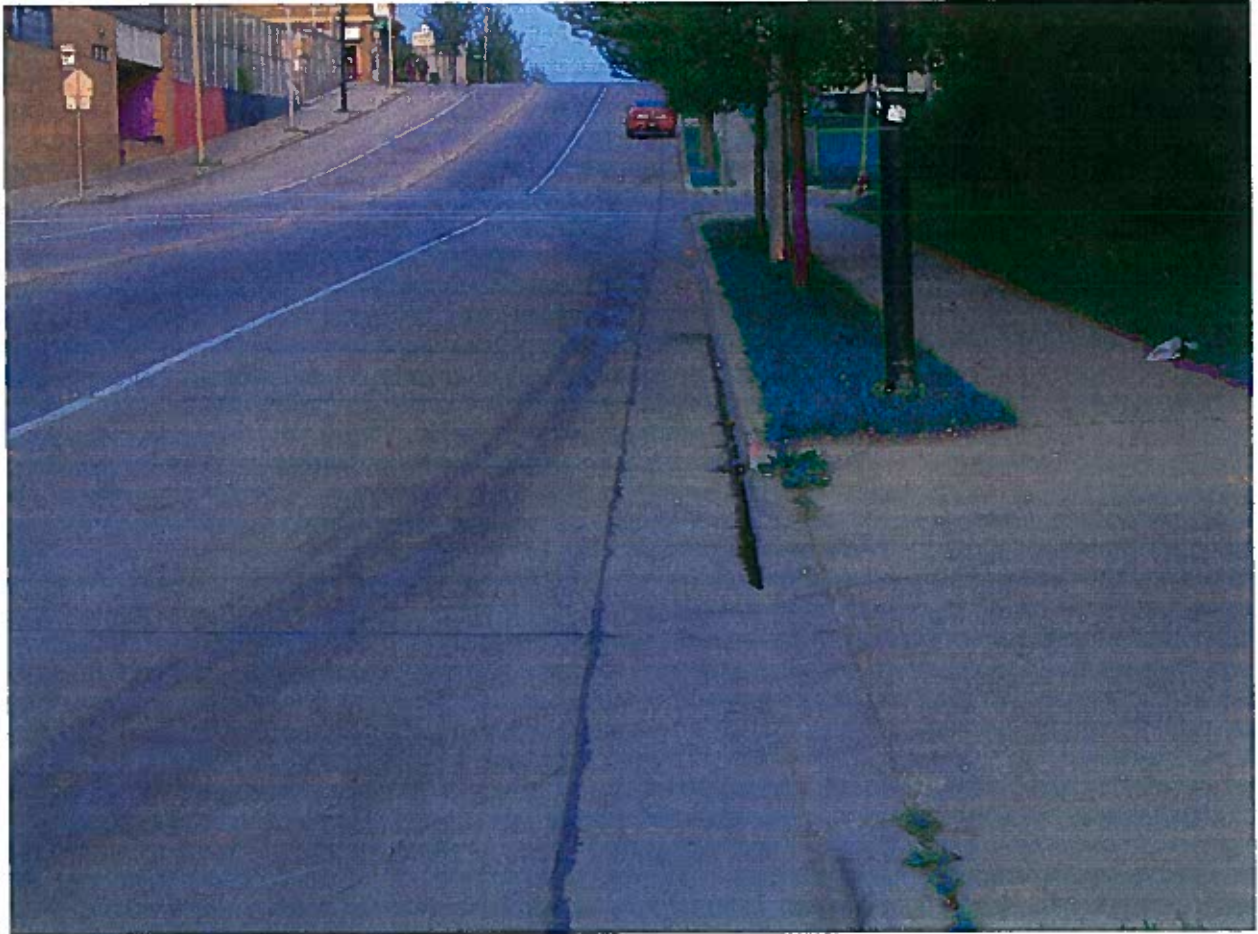
Attachment G: *The streak shows my vehicle exiting traffic and coming to a stop near the corner of Center St. and 1st Ave.*

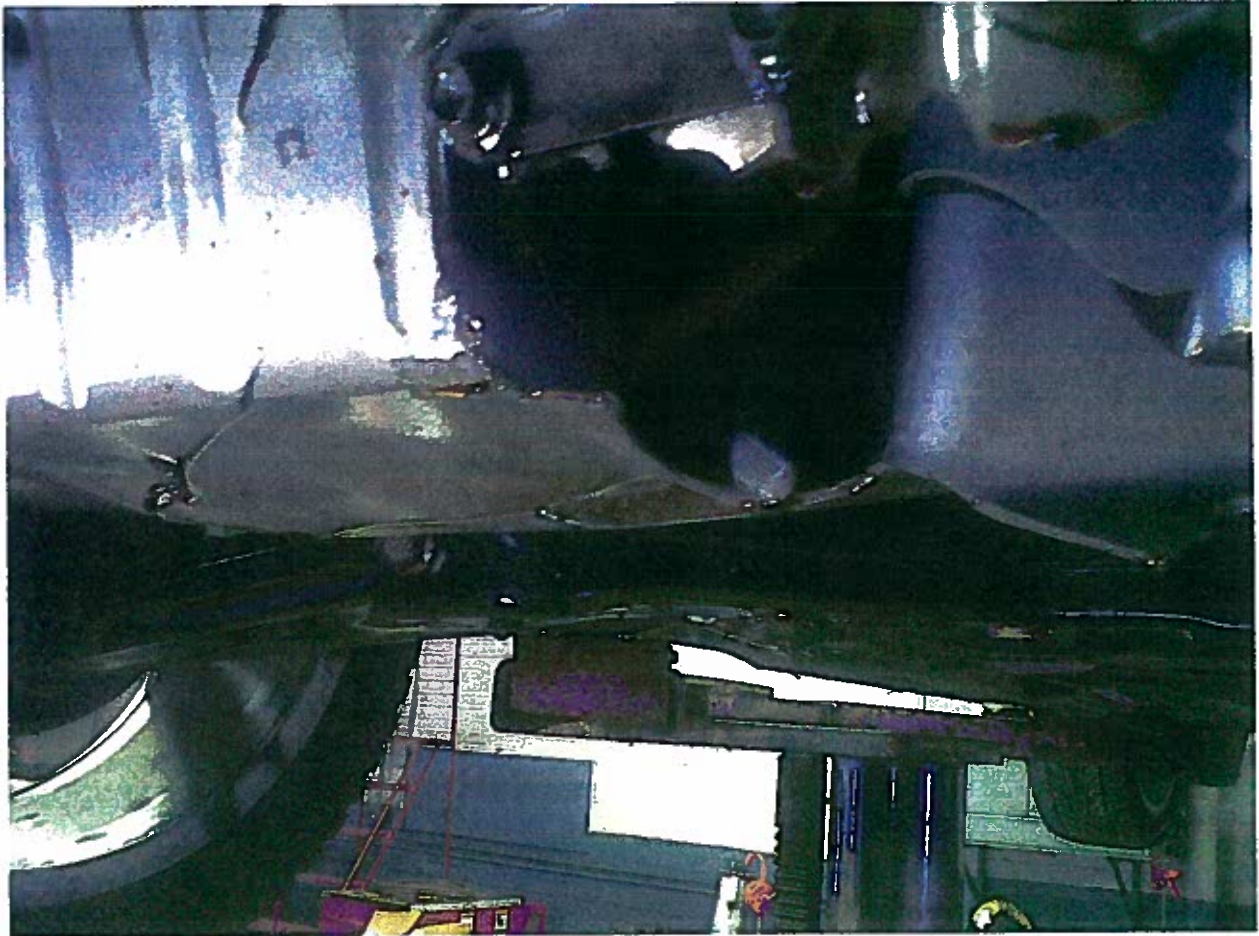
I looked once again underneath the vehicle to notice that, in addition to a crack in the oil pan, the impact of the manhole cover to the oil pan had forced one of the engine mounts to buckle. The engine appeared to have pivoted on the drive axles, forcing the lower portion of the crankcase toward the back of the engine compartment. (See Attachment H)

Shortly after assessing the damage, a tow truck arrived and transported my vehicle to a nearby automotive repair shop. It was here that the true extent of the damage was assessed by a mechanic. Besides the large hole in the oil pan, buckled mount, and disheveled engine position, the mechanic called my attention to a large gouge in the transmission housing. The gouge also had a fairly pronounced crack leading from it. In addition to the gouge, another prominent crack extended from across the lower portion of the transmission housing. (See Attachments H and I)

Attachment H: *A picture of the cracked and otherwise destroyed oil pan*

Shortly after the thorough inspection I had the mechanic draft an estimate for \$713.20 which was later revised to \$4,413.40, which was again further revised three more times to \$6,851.36 as new information became available throughout the repair. In all, the new oil pan, new oil, new clutch kit and flywheel for the used replacement transmission, rebuilt drive axels, assorted seals, hardware, and labor brought the total cost of the repair to \$6,967.94 (an itemized receipt is attached below.)

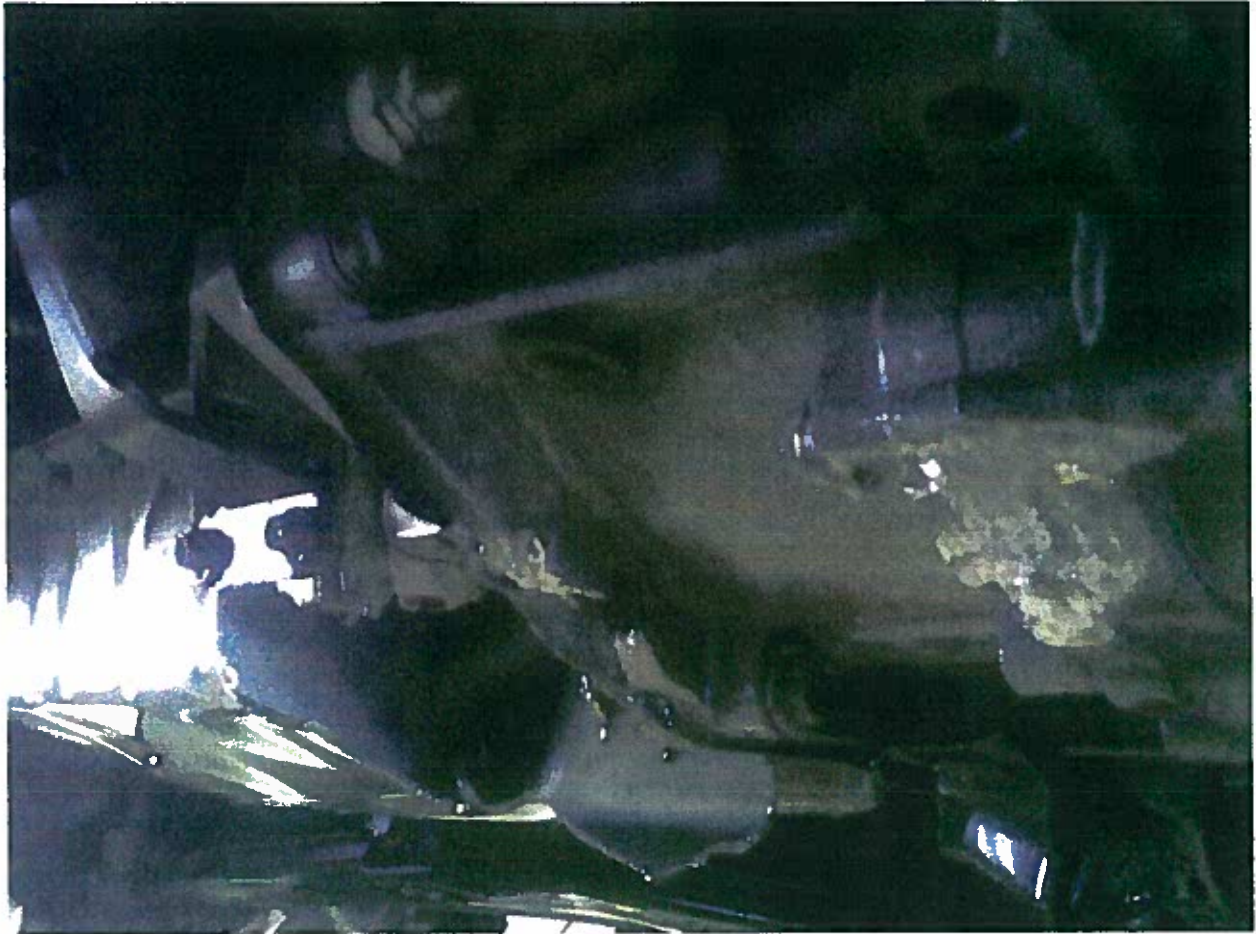
Attachment I: Damage from Right to Left: (Right) A Gouge in the transmission housing (Bottom Right) The collapsed mount (Center) A crack through the transmission housing (Left) What is left of the oil pan
