# FACADE RESTORATION 1119 WEST HISTORIC MITCHELL STREET MILWAUKEE, WI 53204

PROJECT NO. 22047.00  
DATE 8/25/2022  
DRAWN BY  
CHECKED BY

SHEET CONTENTS  
PHOTOS

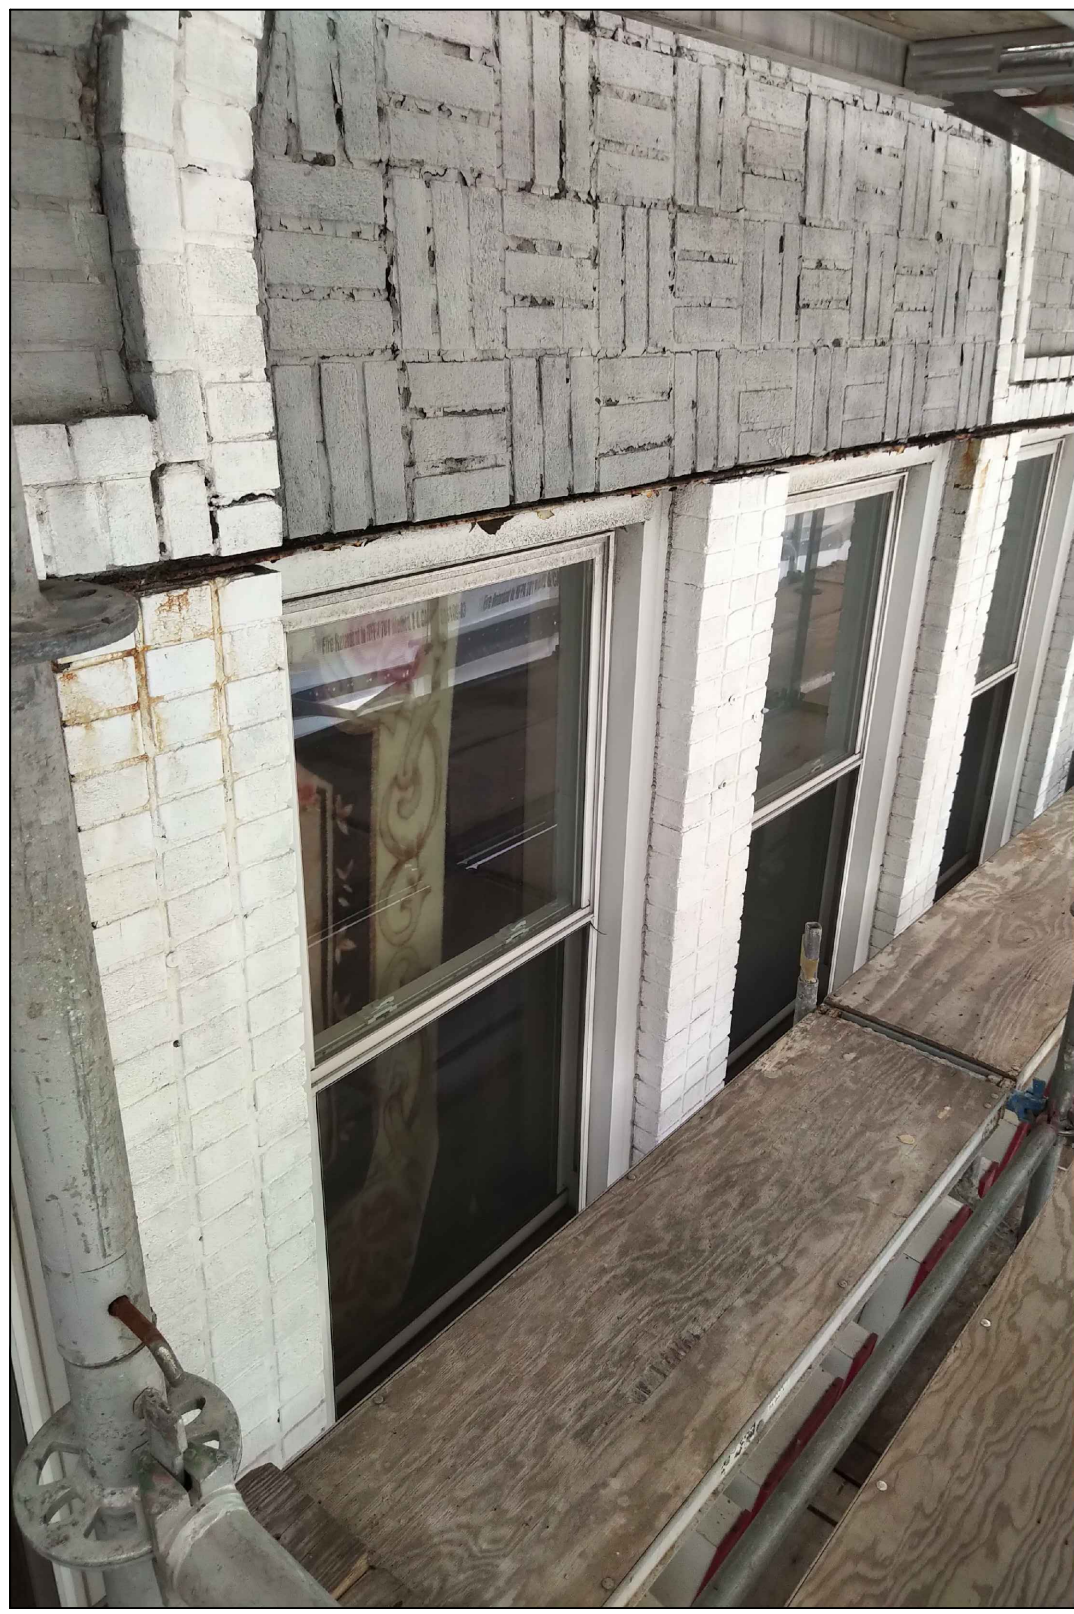
SECOND FLOOR WINDOWS: BRICK JAMBS HEAD AND ARCH DETAIL. FACADE MOVEMENT; CRACKED DAMAGED AND PROTRUDING BRICKS  
MOVEMENT GAP NOTICEABLE AT WINDOW HEAD.

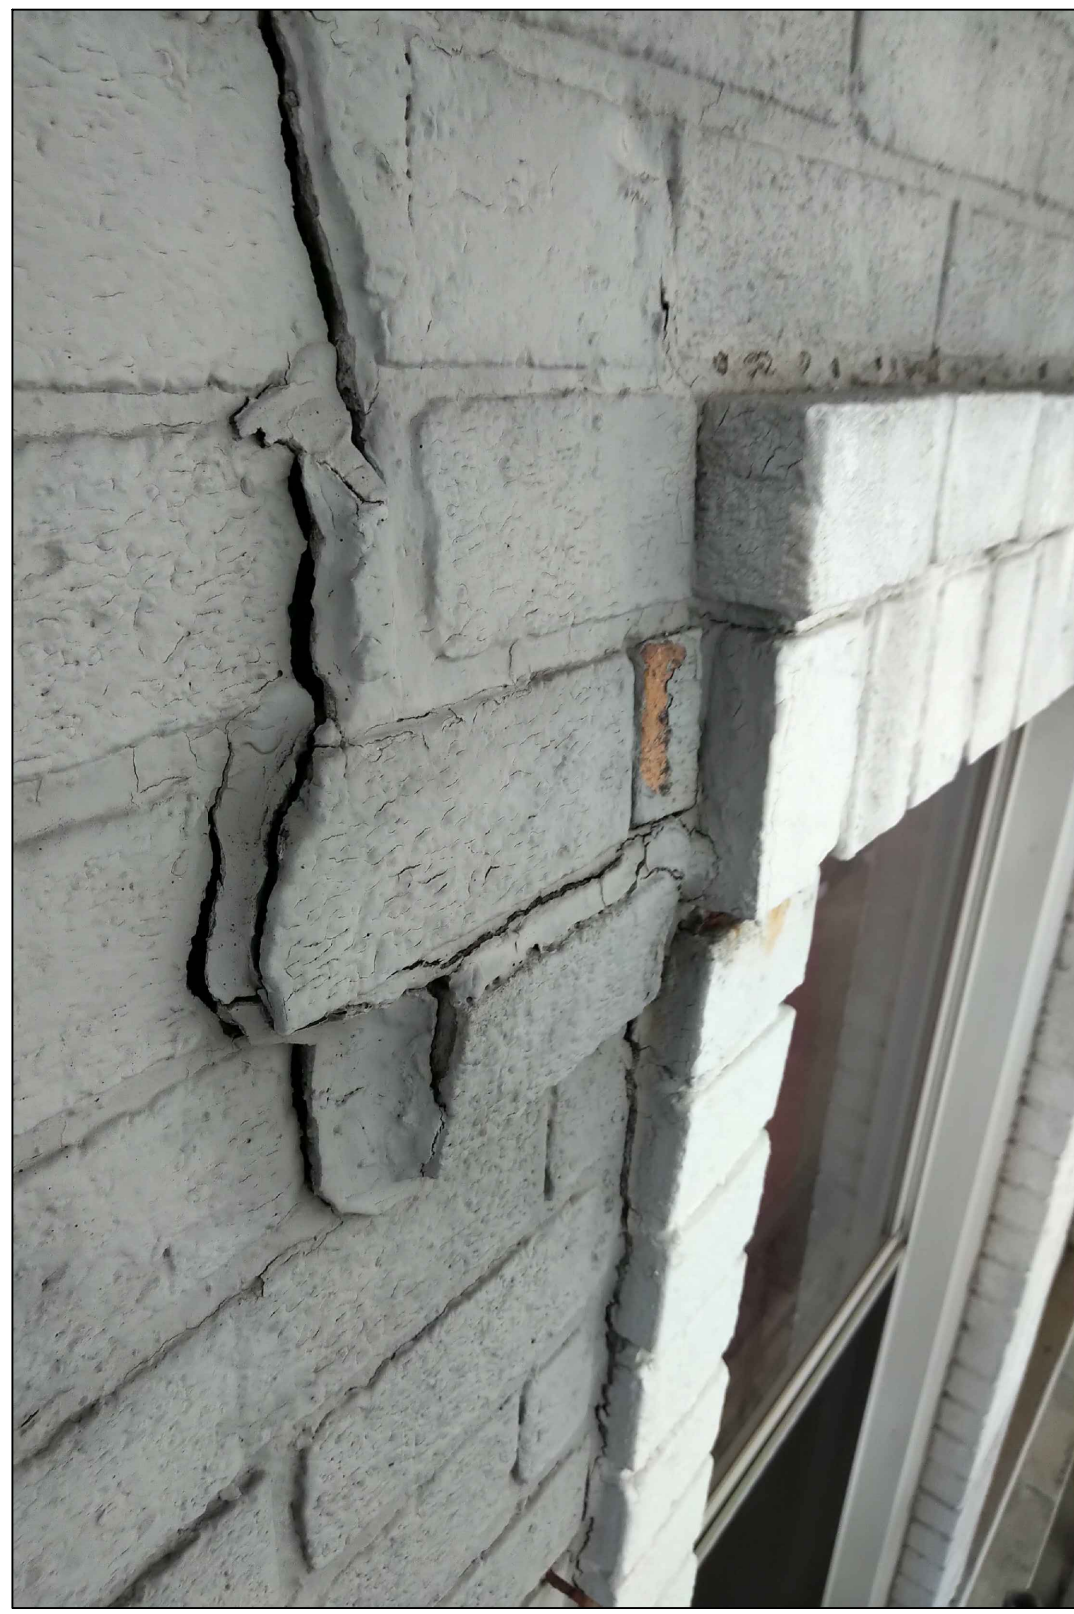
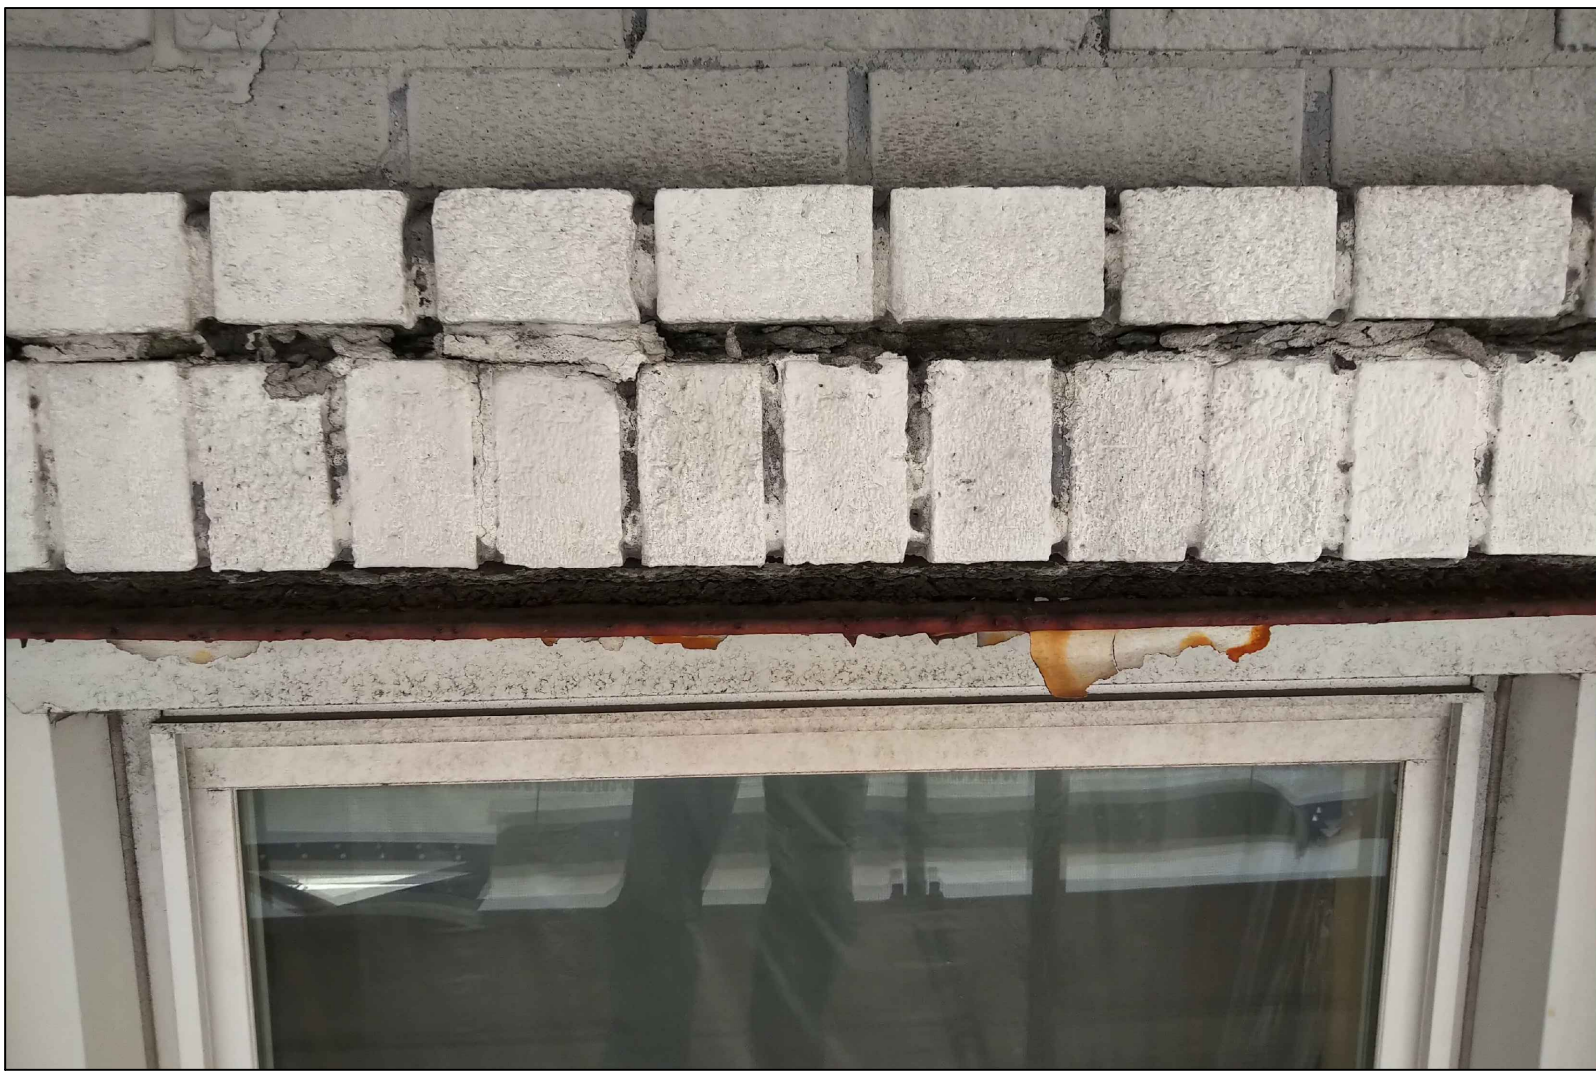
MISSING MORTAR, EXPANDED JOINTS BECAUSE OF MOVEMENT; GAP AT STEEL LINTEL  
NOTE THE RUST STAINS FROM THE LINTEL ON THE WINDOW

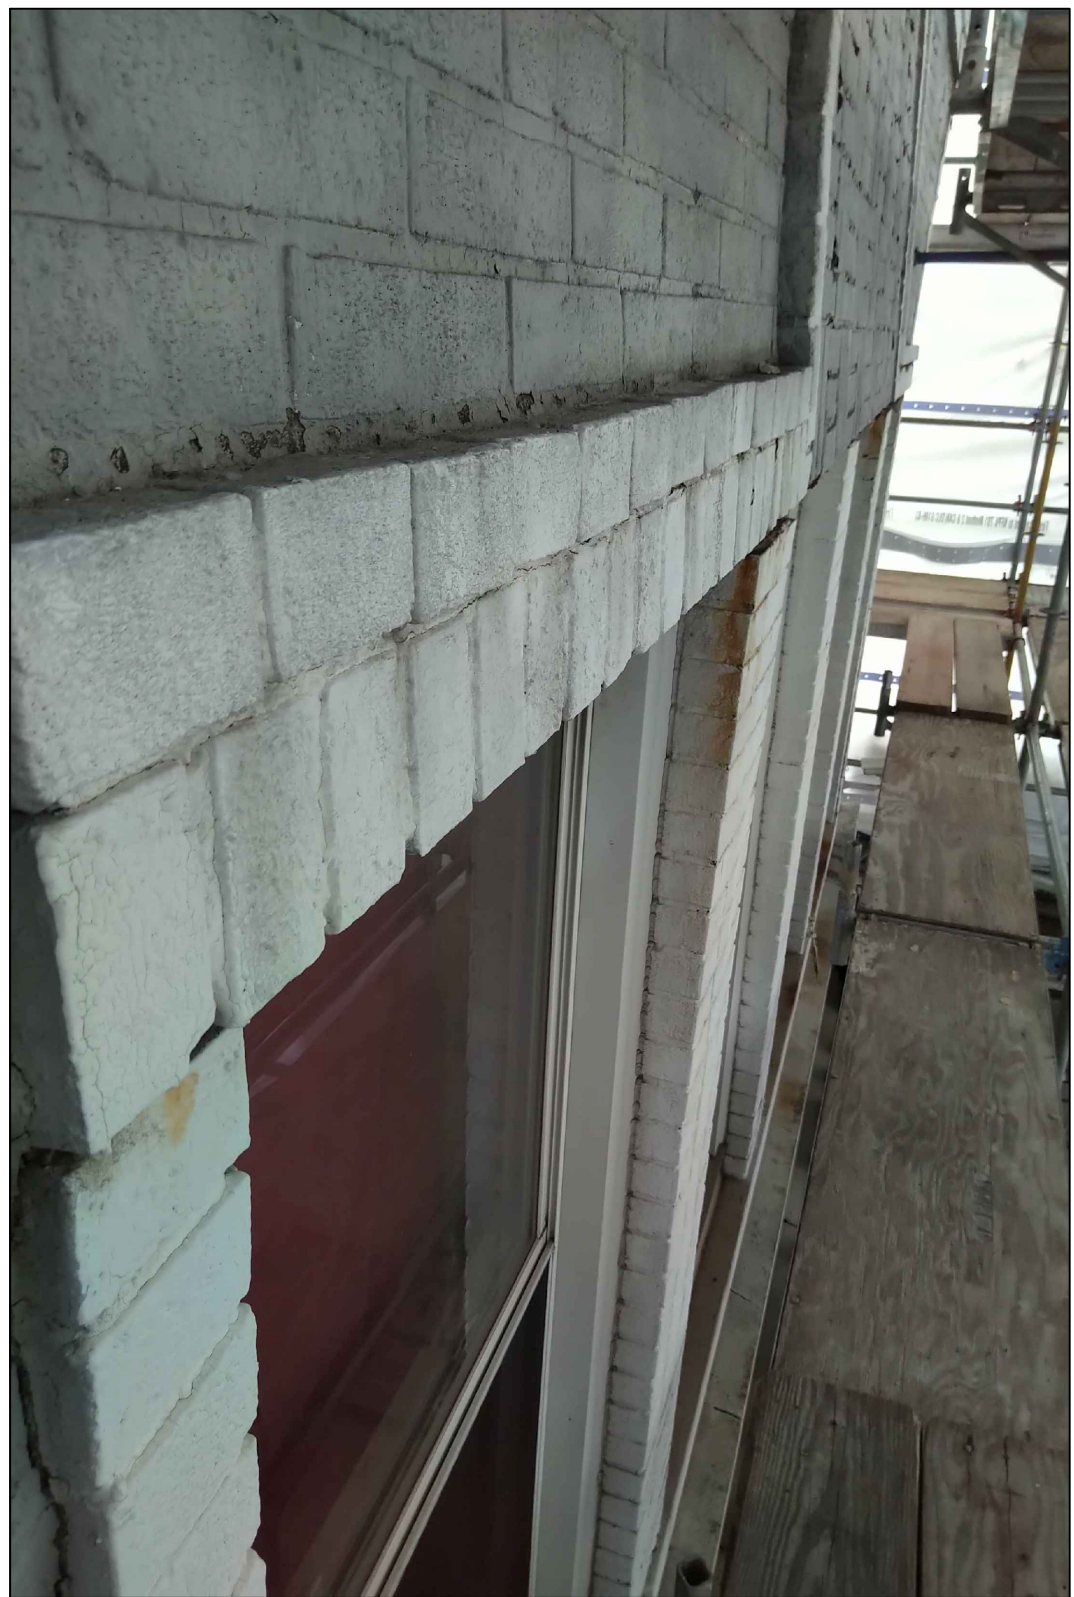
UPPER WINDOW HEADER BRICK DETAIL

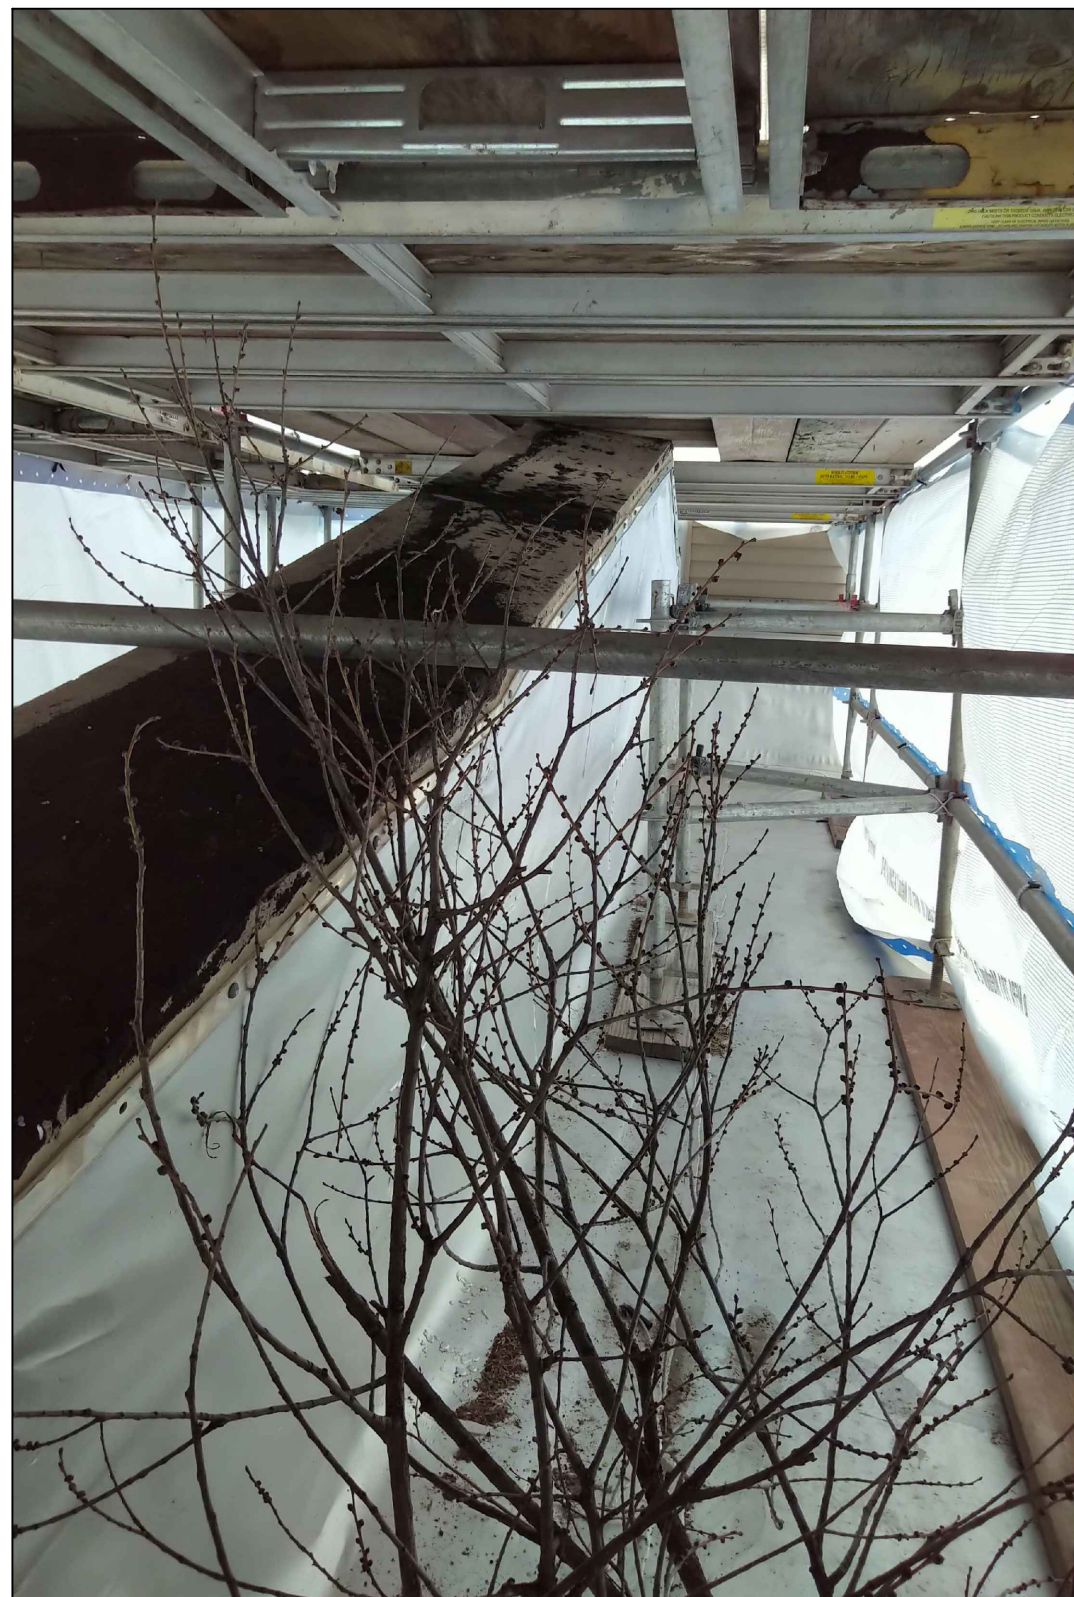
TREE GROWING ON ROOF - ROOF DAMAGE; WATER DAMAGE TO WALL AND POOR DRAINAGE. BAD JOINTS BETWEEN COPING STONES

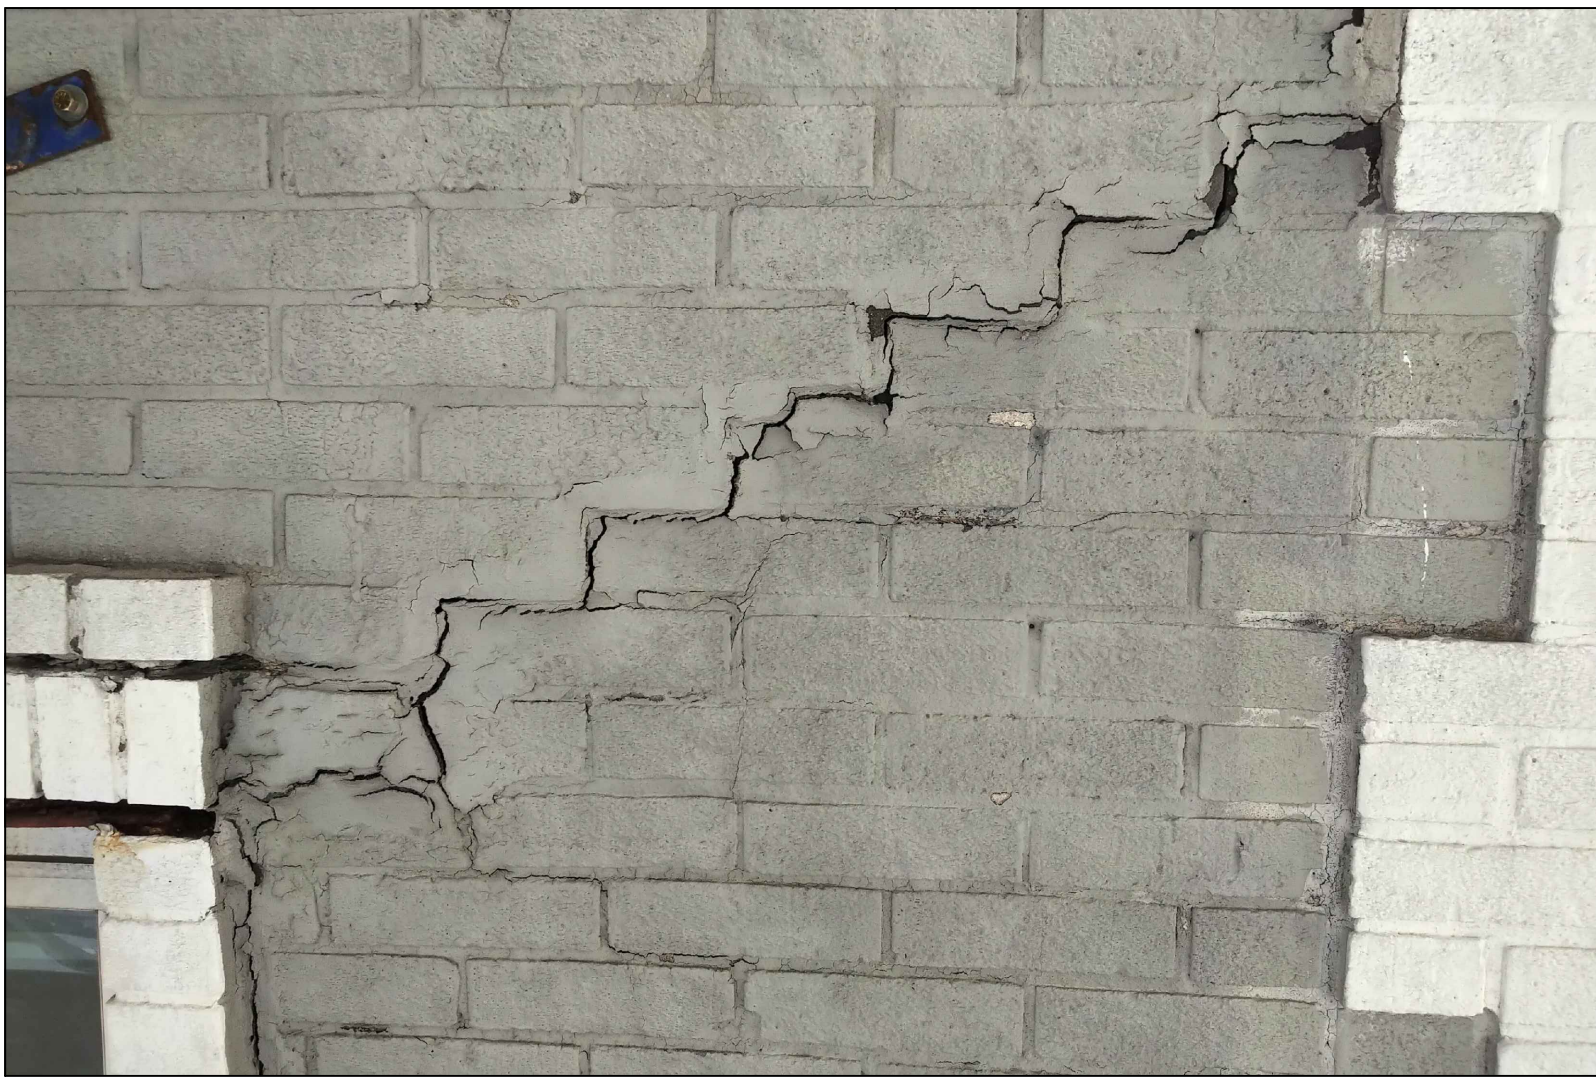
MOVEMENT CRACK FROM WINDOW LINTEL TO WEST WALL AT COIN DETAIL

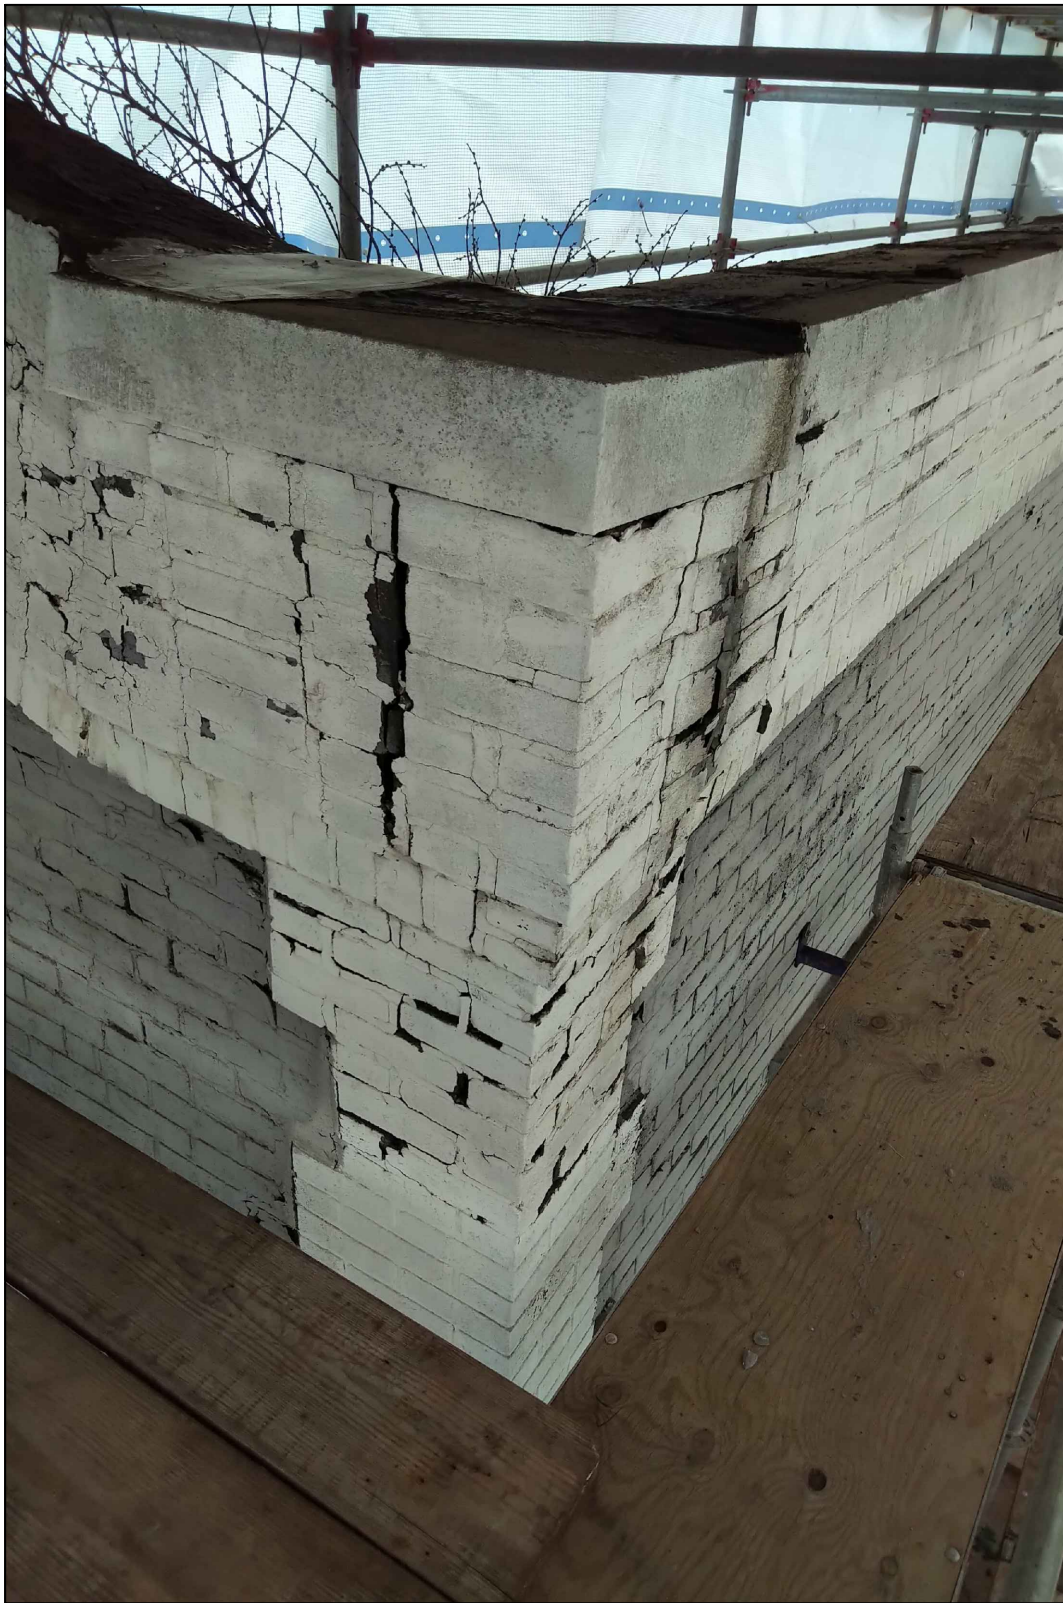
UPPER WEST CORNER DETAIL - WATER INFILTRATION DAMAGE  
BRICK AND COPING MOVEMENT

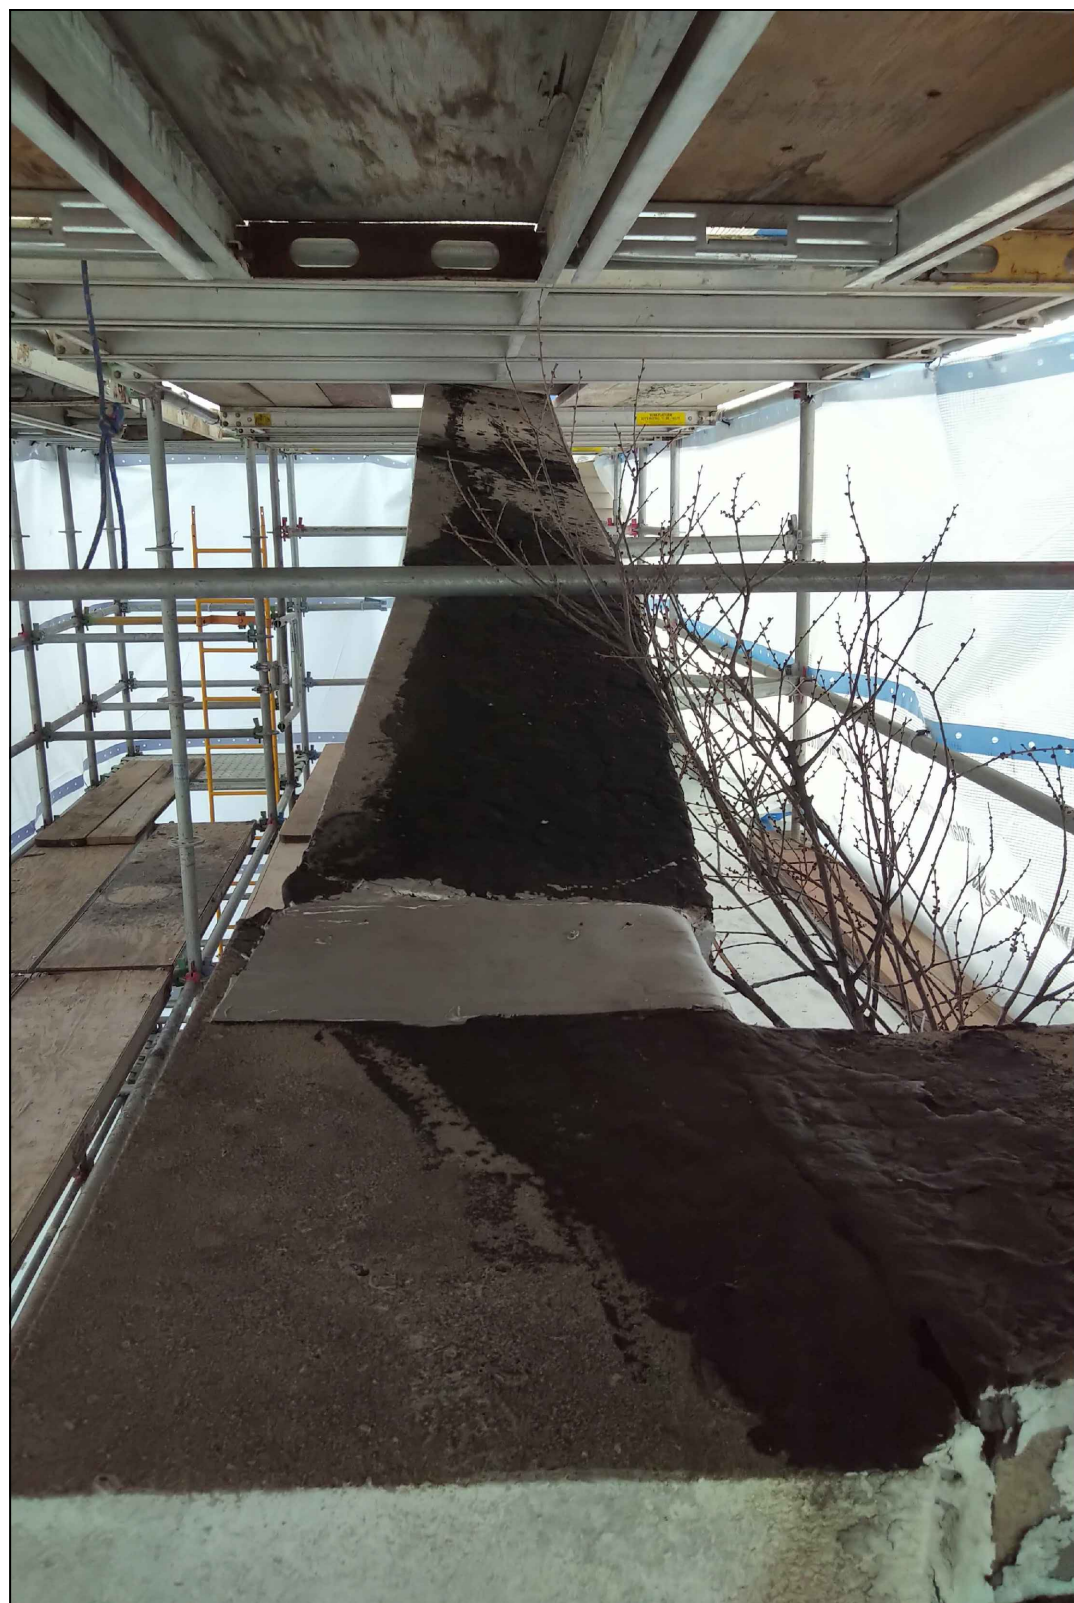
COPING STONES IMPROPERLY SEALED WITH ASPHALT

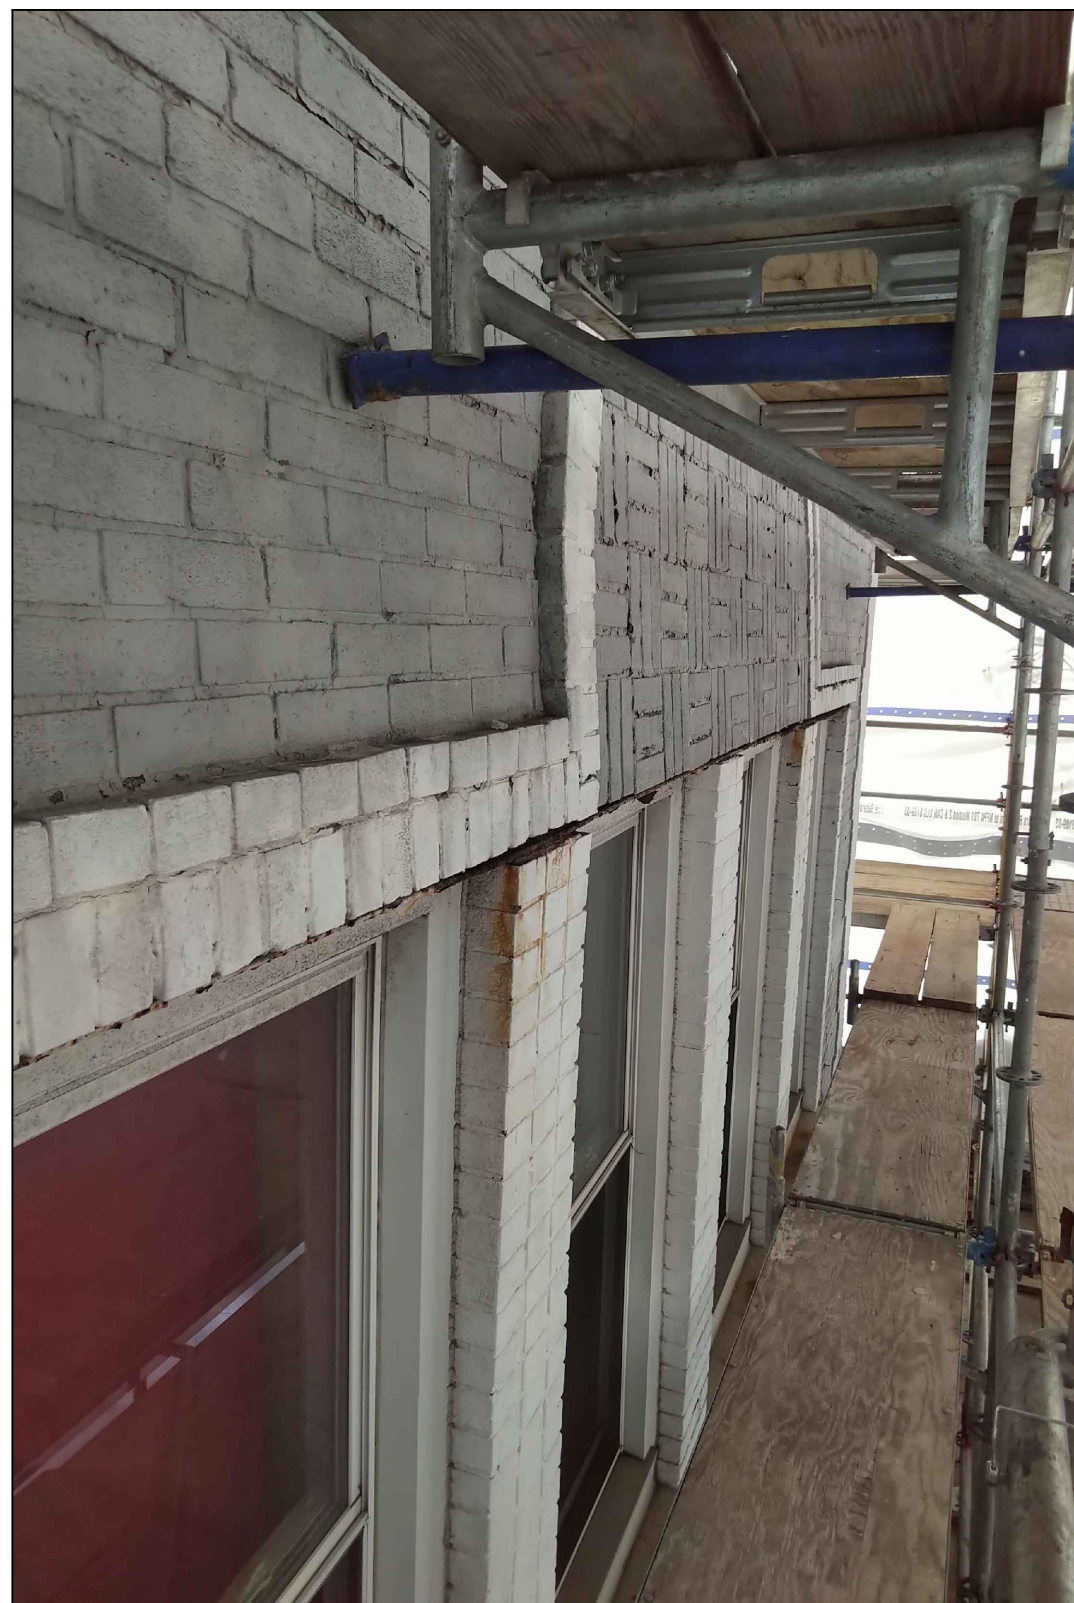
BEST PHOTO TO SHOW THE "LEANING" OF THE UPPER PORTION OF WALL. AT LEAST 5 DEGREES OUT OF PLUMB

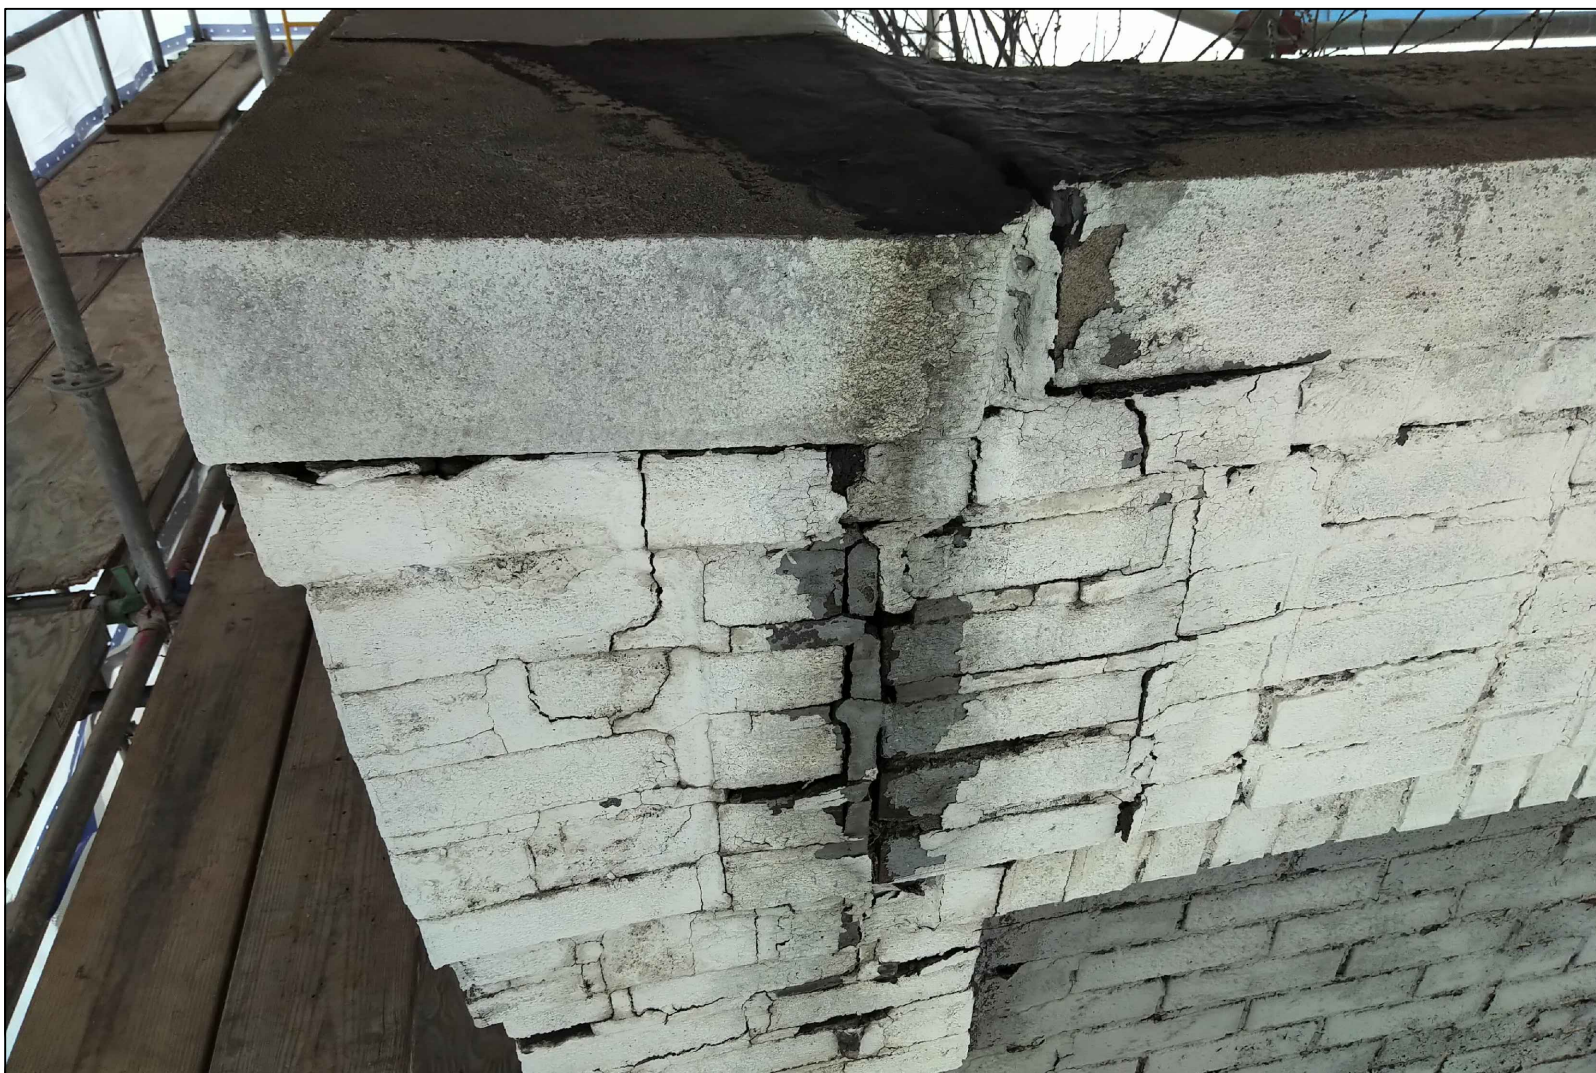
UPPER WEST CORNER DETAIL - WATER INFILTRATION DAMAGE  
BRICK AND COPING MOVEMENT - POOR JOINT REPAIR
