OFFICE OF THE CITY CLERK MILWAUKEE, WISCONSIN 200 E Wells Street, Room 205 Milwaukee, WI 53202

STATEMENT OF CLAIM

On Tuesday, August 10th at approximately 8:10 PM a storm same to Milwaukee with winds strong enough to deroot trees. A tree owned by the city of Milwaukee, that lies between the sidewalk and street, directly in front of the plantiffs address (1630-1632 N 60ths St, Milwaukee, WI 53208) was derooted and fell on the home. Damages from the tree to the home include, but may not be limited to, gutters, facia, flashings, railing, shrubs, lawn, structural, siding, and drywall.

hail and wind damage

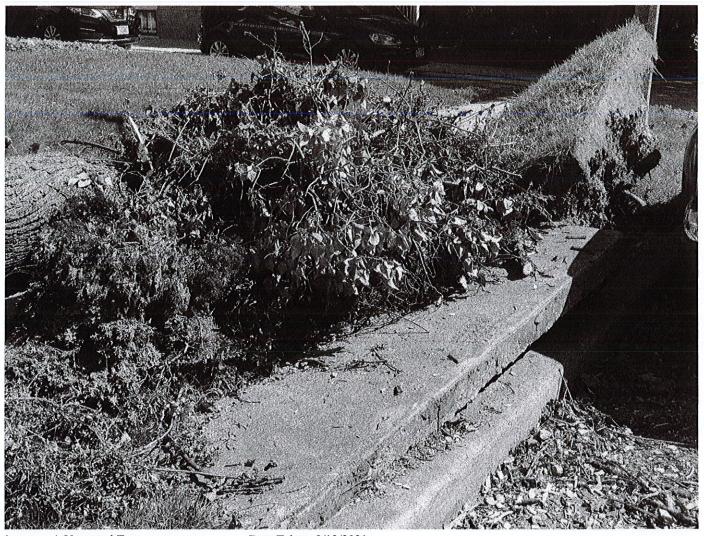
1-Uprooted Tree

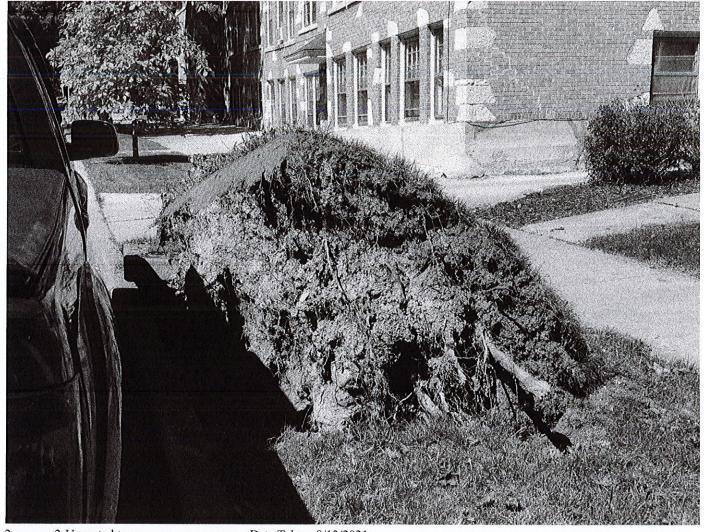
2 2-Uprooted tree

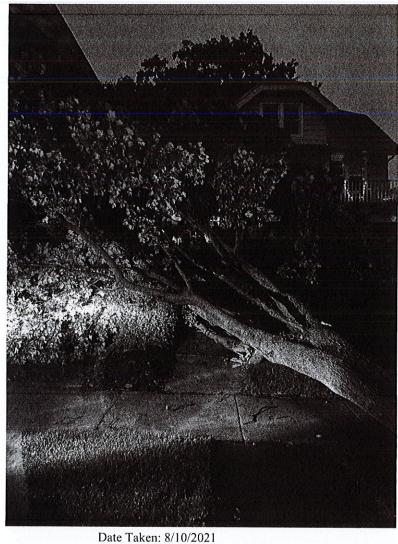
3

3-Tree on house

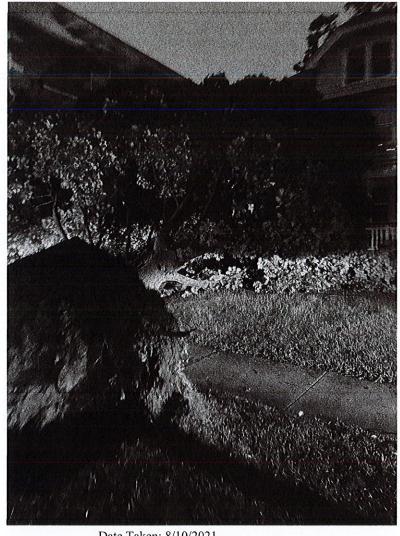
4-Tree on house

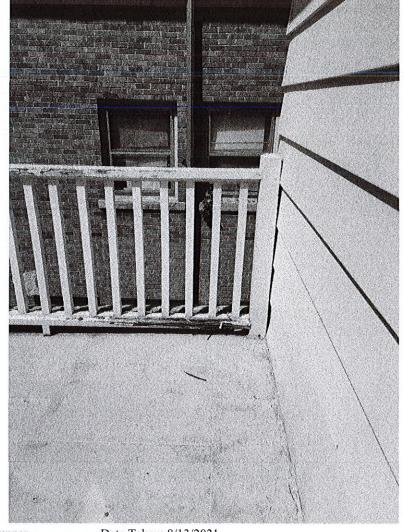
11

11-Busted railing upper

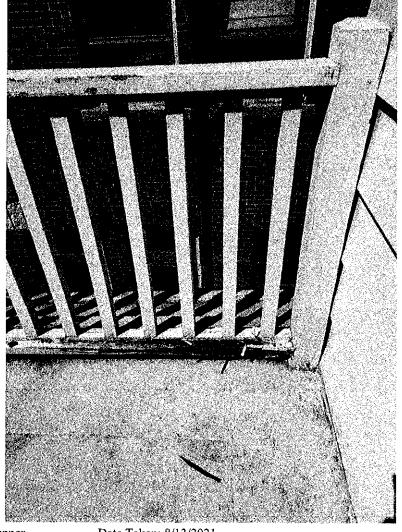
12 12-Busted railing upper

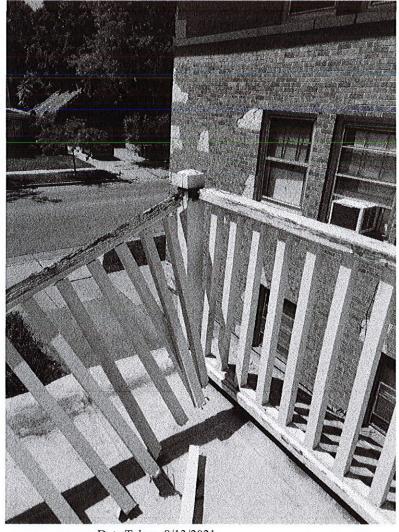
13

13-Upper railing

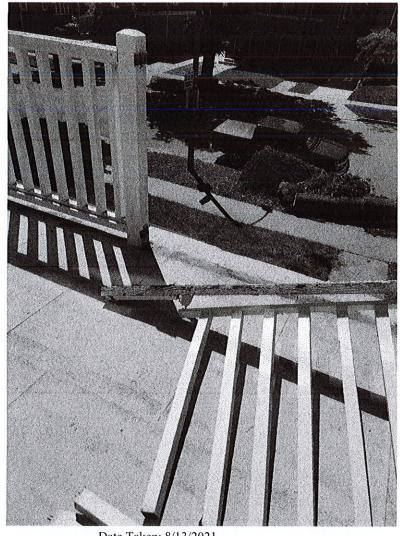
14

14-Upper railing

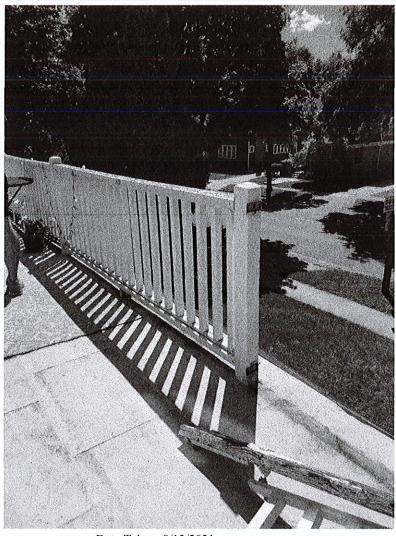
15 15-Upper railing

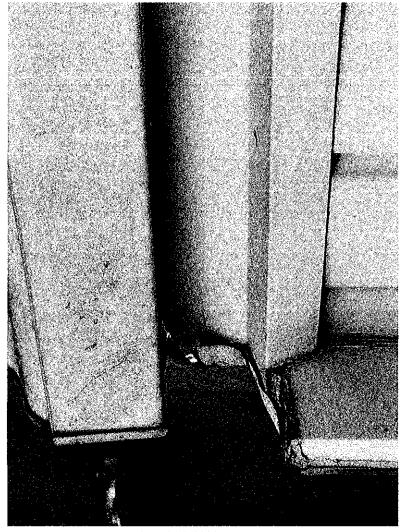
16 16-Top porch damage Date Taken: 8/13/2021

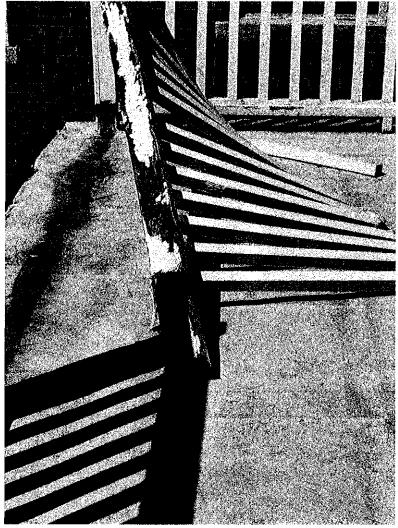
17

17-Damaged railing

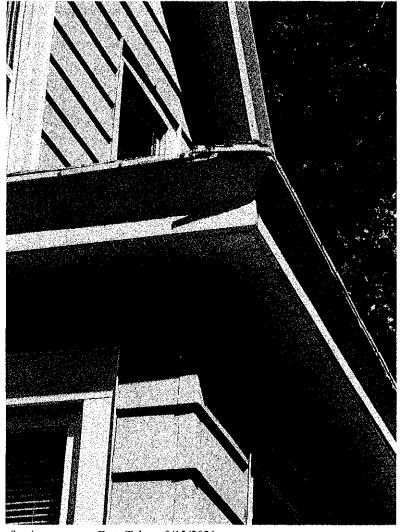
19

19-Storm samage to fascia

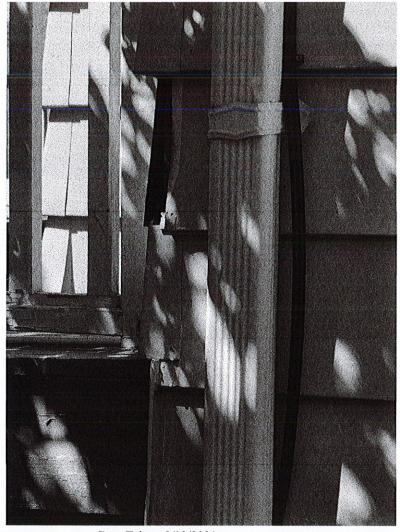
21

21-End cap damages

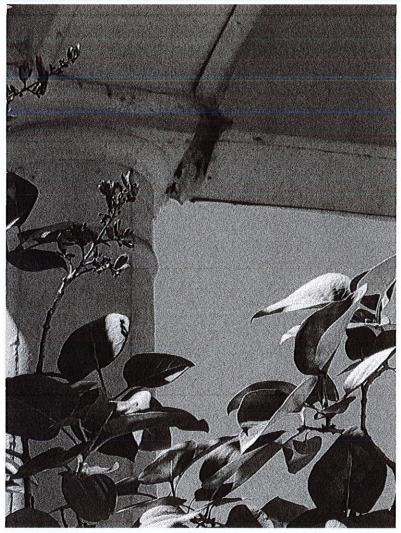
22

22-Separation of the bent gutter

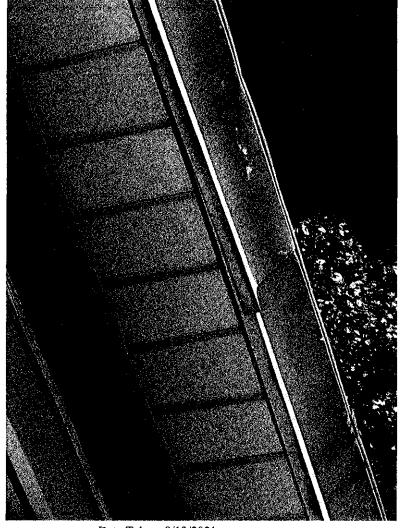
23

23-Fascia damage Date Taken: 8/13/2021

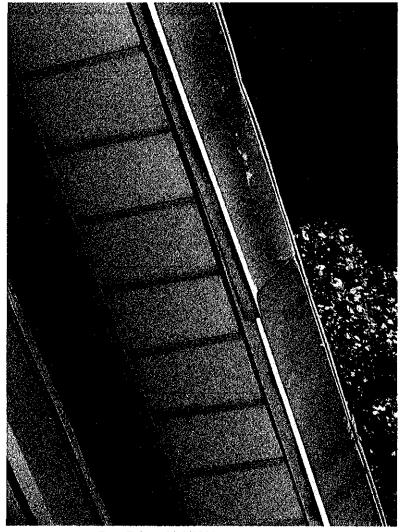
24 24-Fascia damage

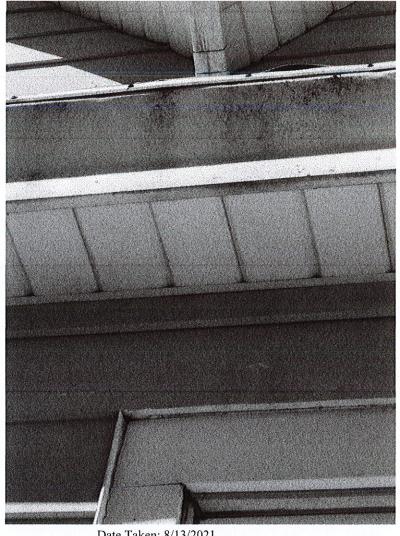
26 26-Rubber roof Date Taken: 8/13/2021 Rubber roof damaged causing the leak inside of the home.

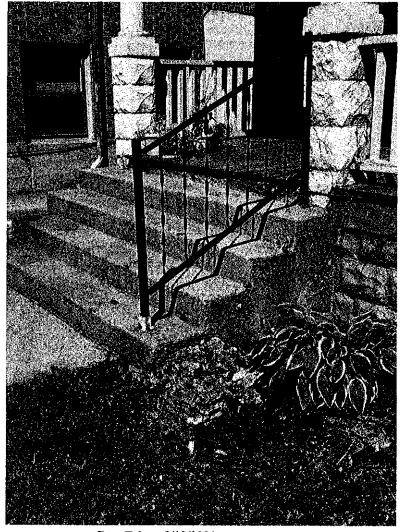
27 27-Railing Date Taken: 8/13/2021
The railing you see is weak as a result of the weight of the tree. Needs replacing.

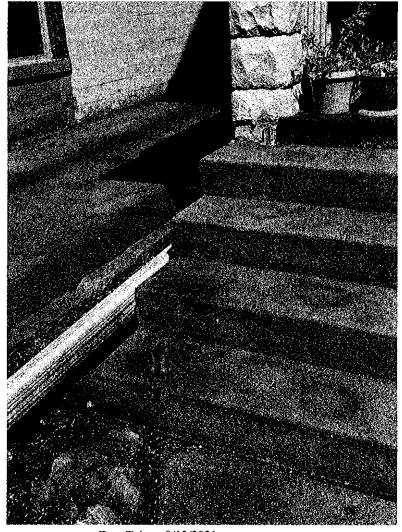
28 28-Missing railing Date Taken: 8/13/2021
There was a black metal raining on the stair that the tree took out.

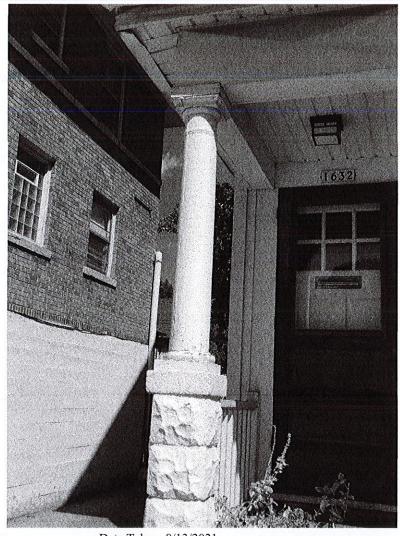
29 29-Column Damage Date Taken: 8/13/2021
The colomn is damaged as a result of the weight of the tree. This supports the left upper deck porch.

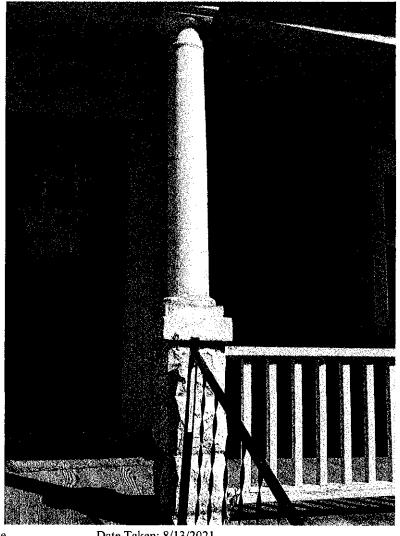
30 30-Column Damage Date Taken: 8/13/2021

The colomn is damaged as a result of the weight of the tree. This supports the upper deck porch.

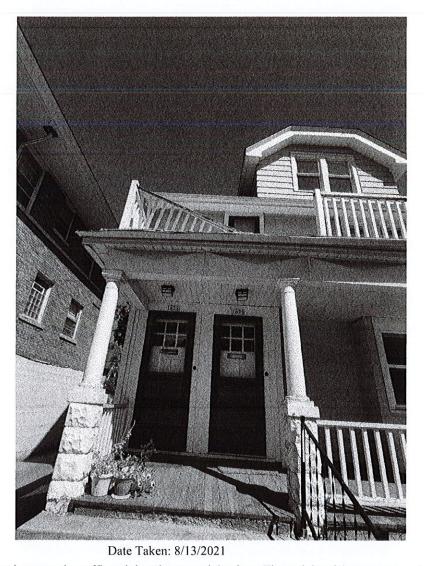
31 31-Separation

There is separation between the soffit and the trim around the door. The weight of the tree was weighing down the upper deck porch causing the separation.

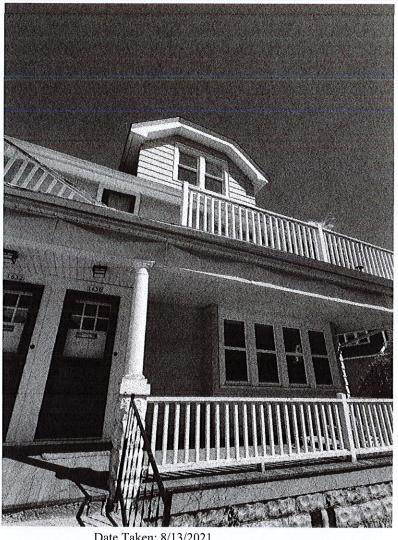
32 32-Upper Porch

Here you can see the damage showing the weight from the tree has unsecured the upper deck porch. Needs a structure inspection.

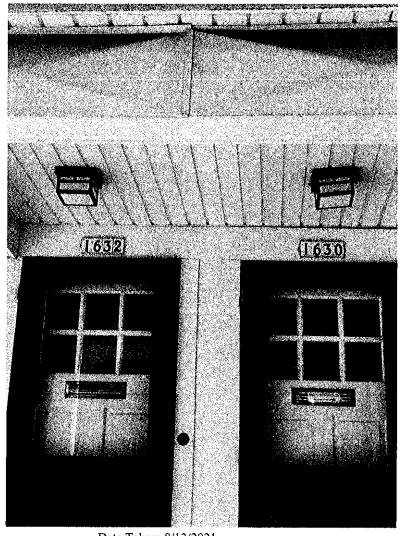
33 33-Fascia Date Taken: 8/13/2021
Weight of the tree has bowed down the structure causing the damage to the fascia and deck.

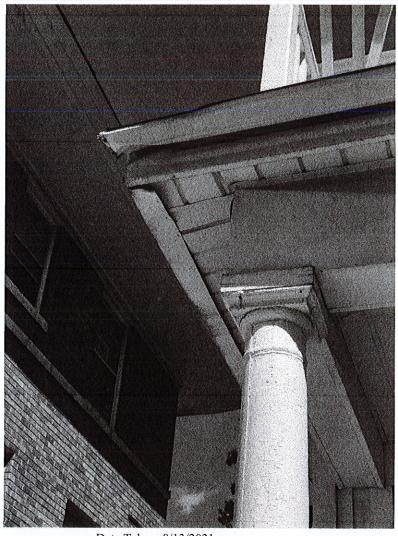
34

34-Gutter & Soffit Gutter and soffit damage.

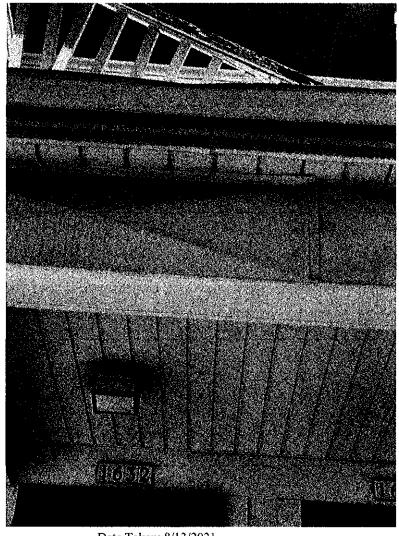
35

35-Gutter & Soffit

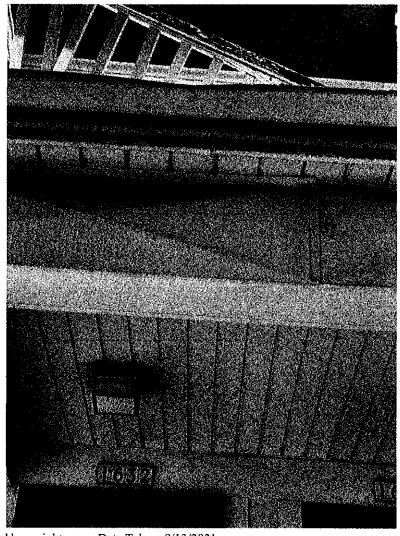
36

36-Damaged caused by weight

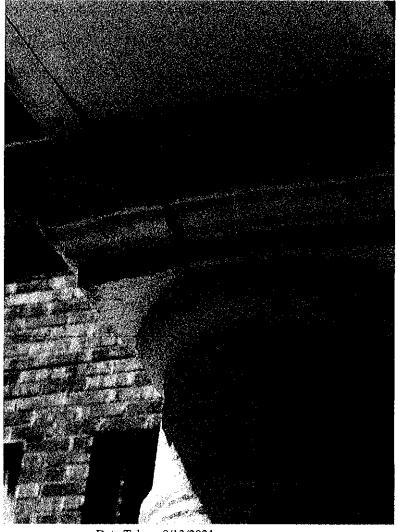
38 38-Top Column Date Taken: 8/13/2021
The column has cracked from the weight of the tree. This supports the upper deck porch.

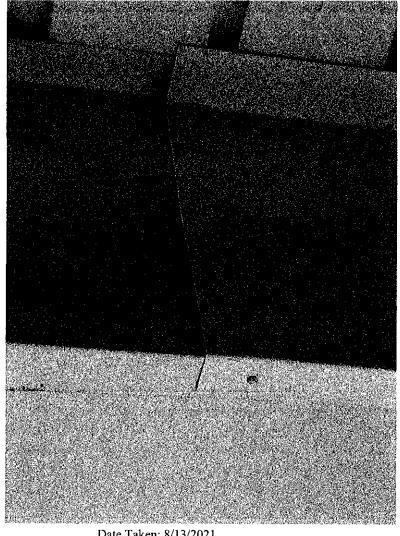
40 40-Fascia Date Taken: 8/13/2021

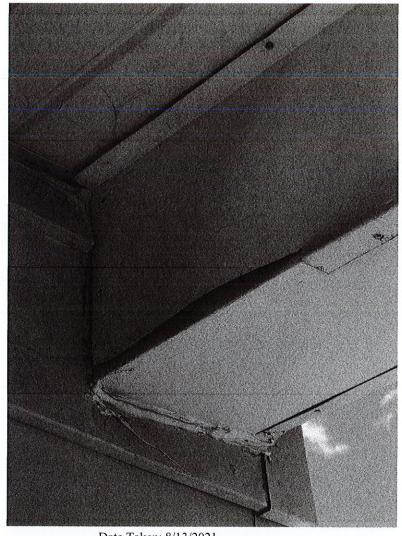
43 43-Fascia buckled Date Taken: 8/13/2021

Buckled fascia. Not sure about the condition of the wood underneath it from the weight of the tree when it hit.

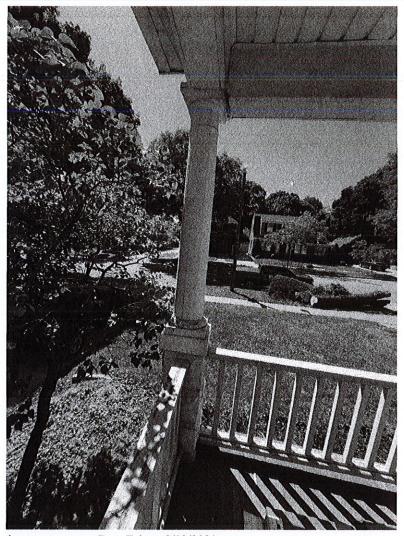
44 44-Showing Separation Date Taken: 8/13/2021 Between soffit and fascia separation.

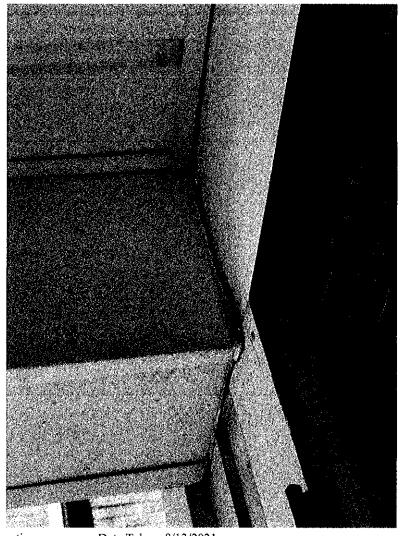
45 45-Upper deck separating Date Taken: 8/13/2021 Upper deck is separating a bit from the house.

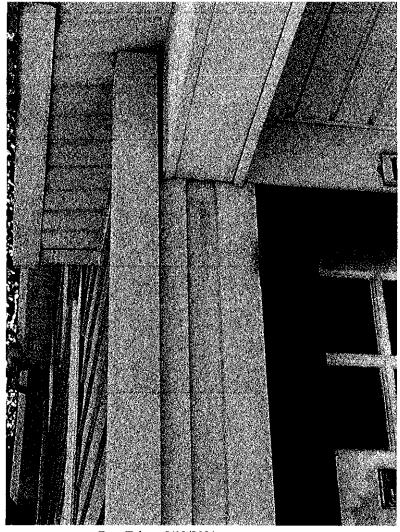
46 46-Left side Date Taken: 8/13/2021 Soffit and fascia damaged. Separation is visual here as well.

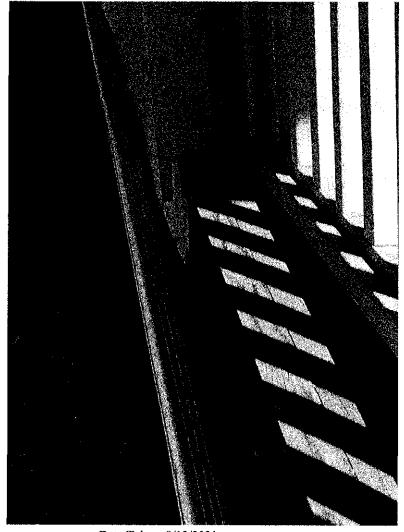
47 47-Side gutter Date Taken: 8/13/2021
This gutter was damaged by the tree.

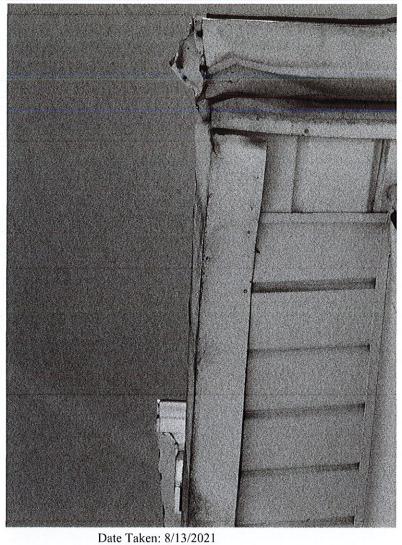
49 49-End of gutter

Left side damage from the tree.

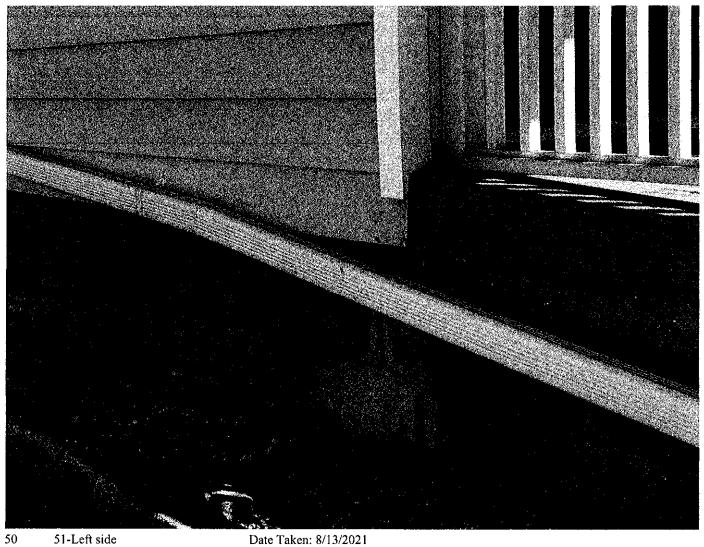
Gutter damaged.

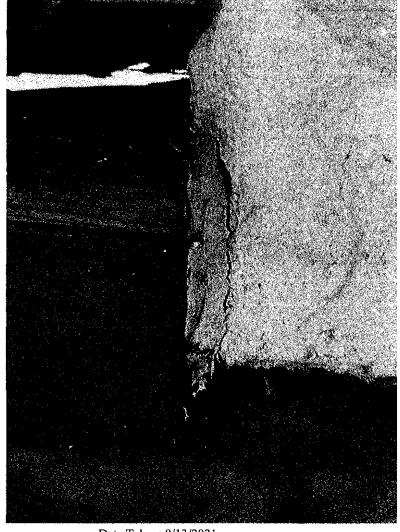
51 52-Cracking Date Taken: 8/13/2021 The column on the right side is sitting above this.

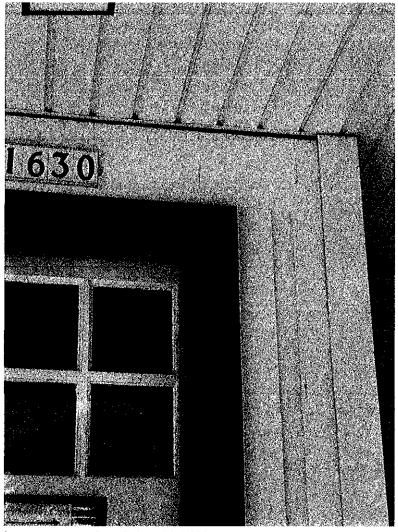
52

53-Showing separation

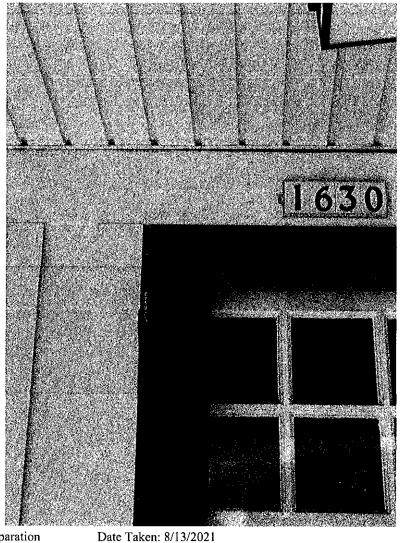
53 54-Showing the separation Date Taken: This is part of the upper deck porch.

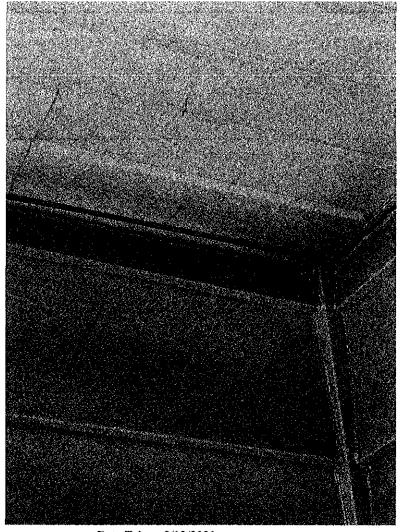
54

55-More separation Date Taken: 8/13/2021

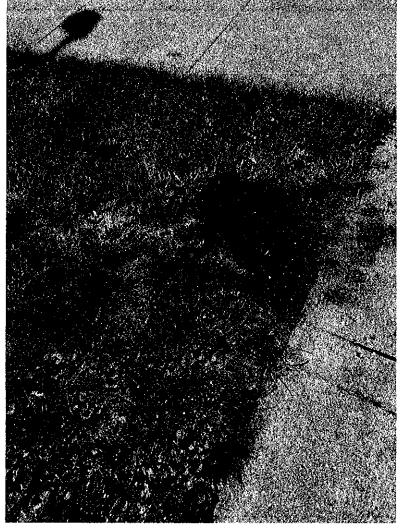
55 56-Lawn damage

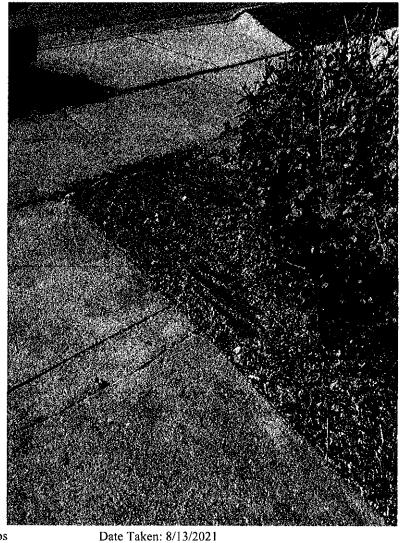
56 57-Damaged shrubs

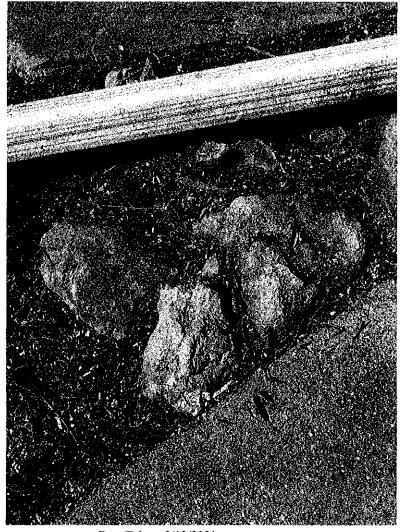
57 58-Missing tree Date Taken: 8/13/2021
Home owner had a smaller tree here. The city tree took that out too.

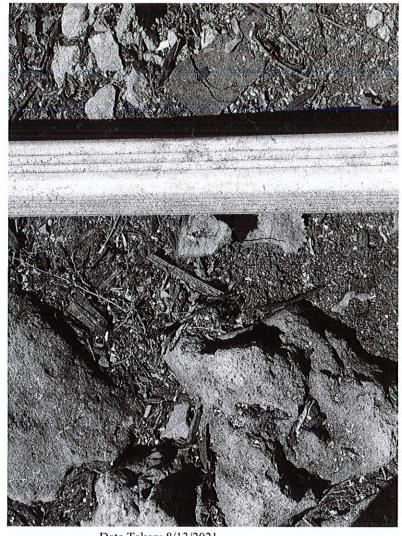
58 59-Another image Date Taken: 8/13/2021
Another image of where the tree was that the home owner had.

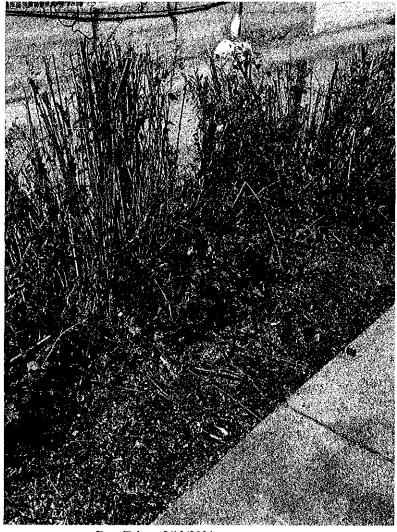
59 60-Damaged shrubs

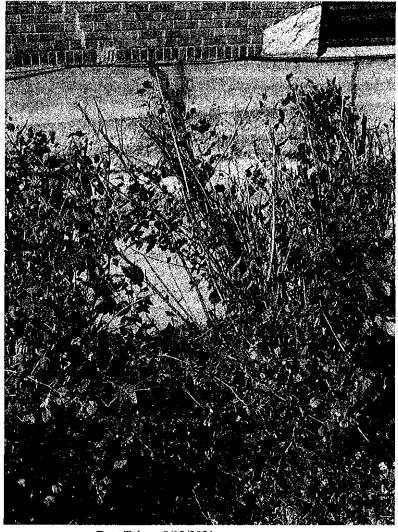
60 61-Damaged shrubs
