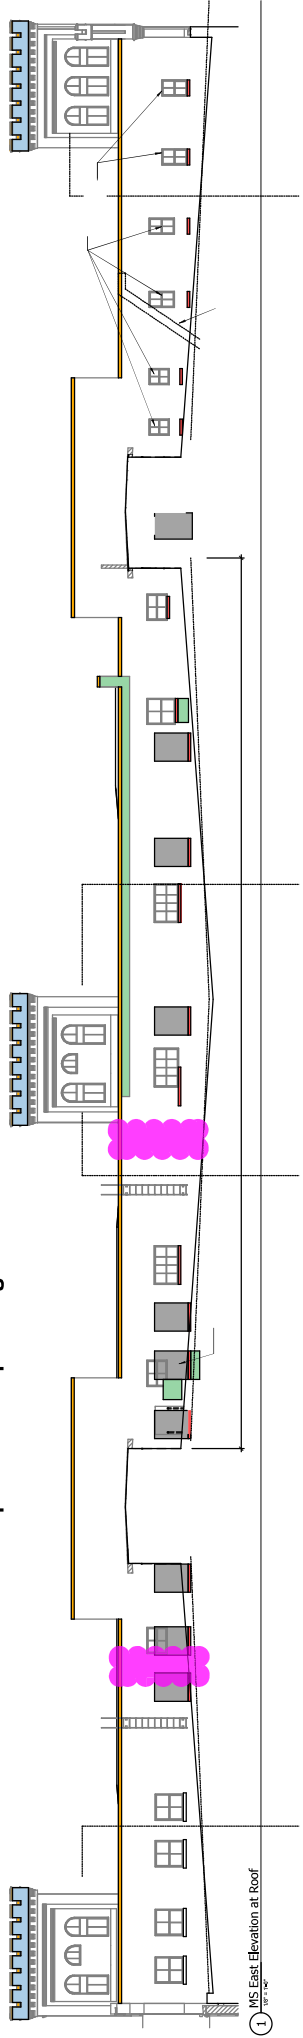
① MS East Elevation at Roof

Approximate location of
step-crack tuckpointing
